**Inspection Photos**  
**Location Name: Diemoz A pad**  
**Location: 419380**

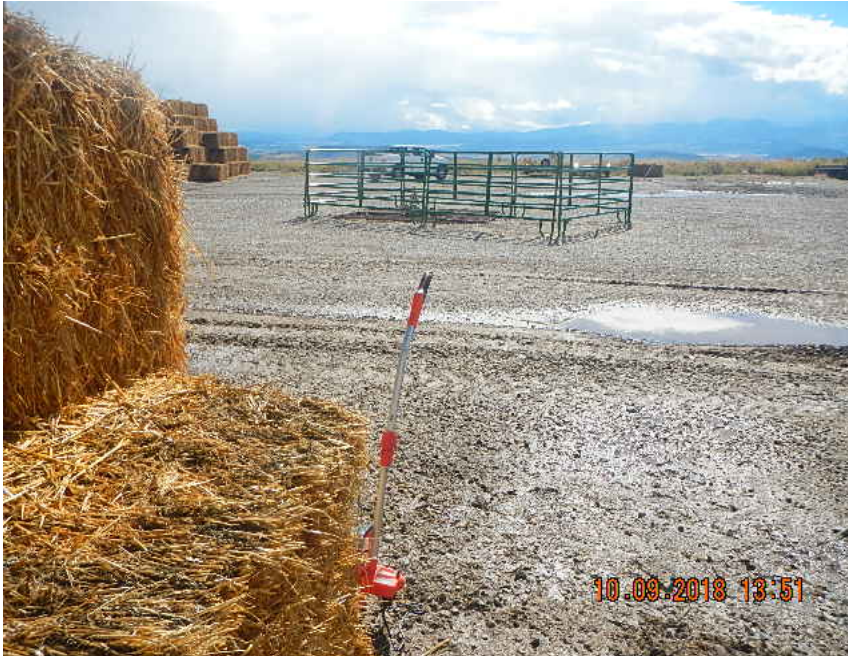
**Stack on North side of pad 35ft from stock panel**

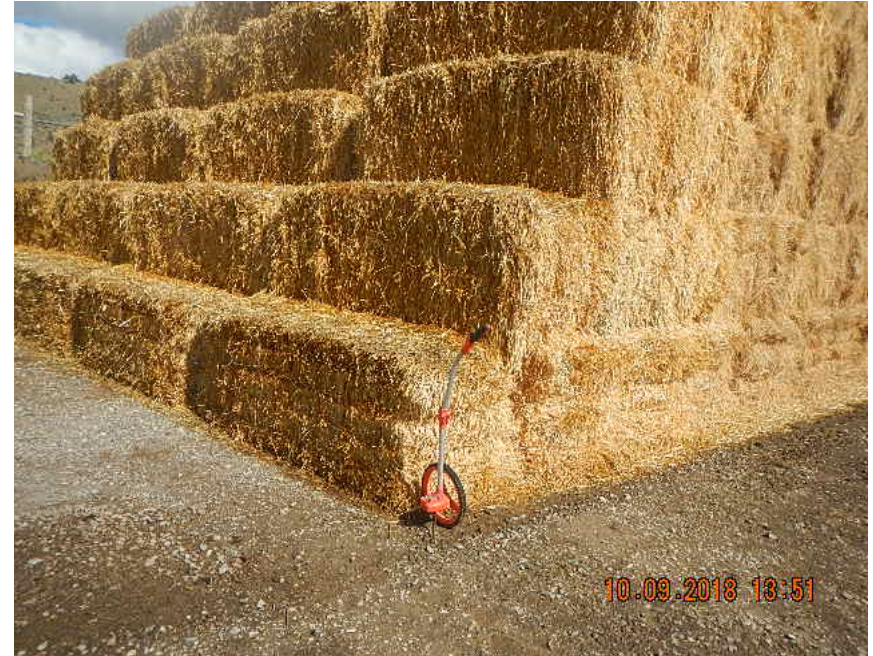
**Stack is 35 ft from the stock panel around well head**

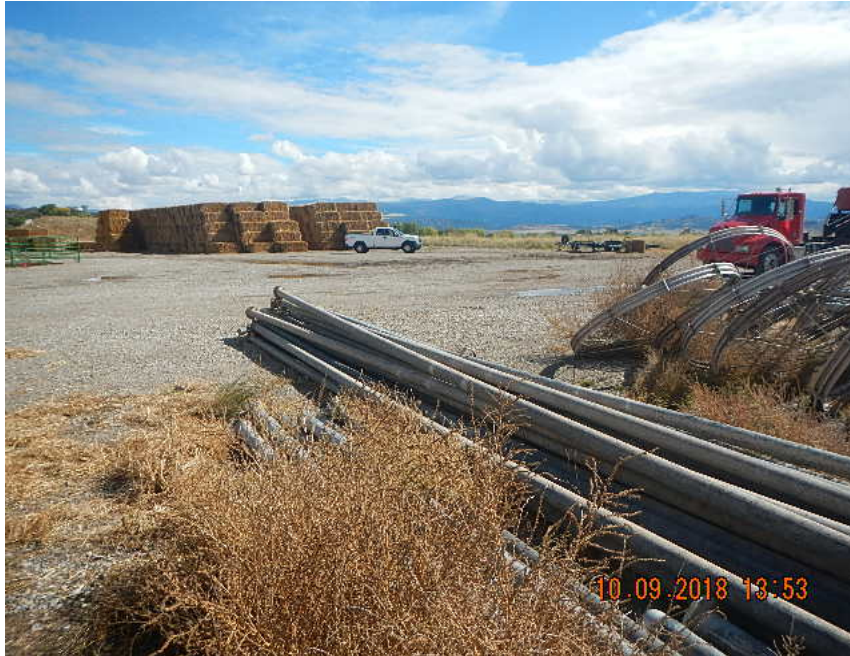
**Equipment stored on the west side of location**

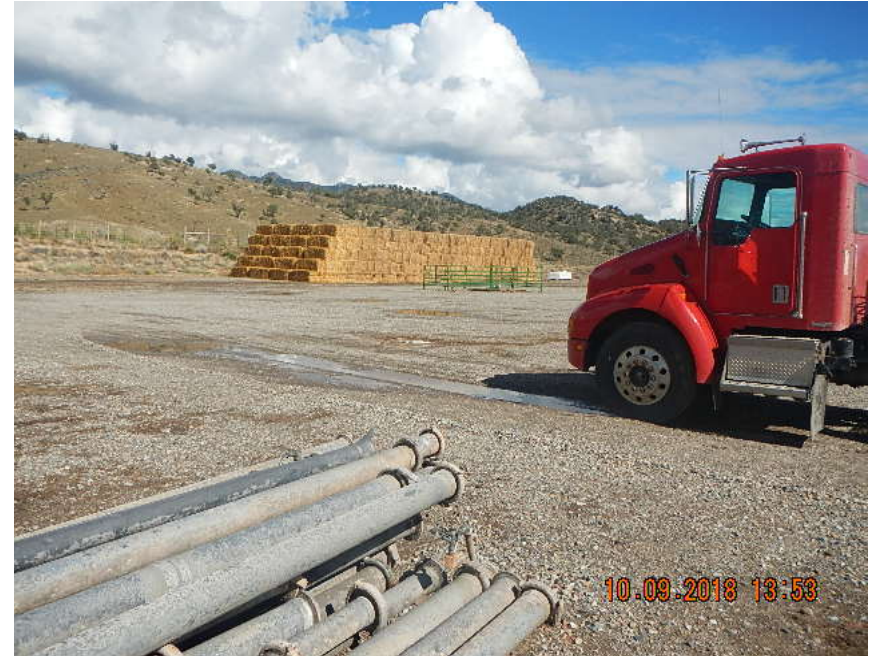
**Equipment stored at the SW corner of location**

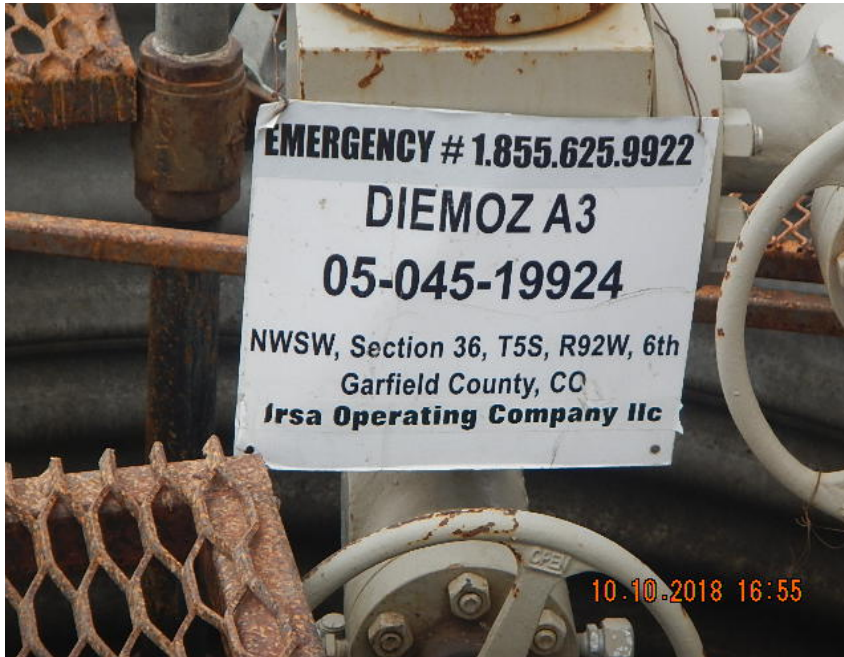
Well head sign does not include all required information

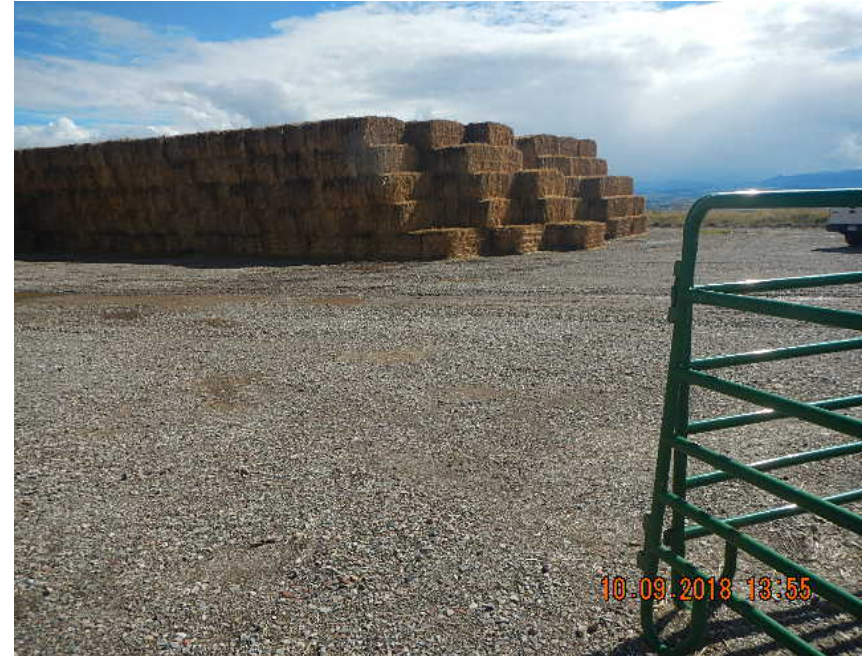
Stack at the SE corner of location is 55ft from stack panel

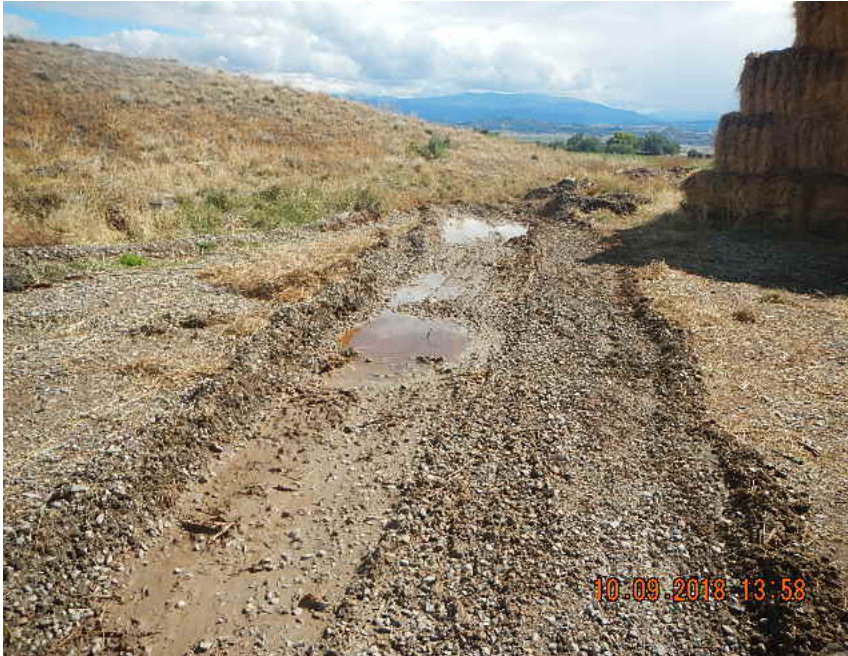
**Drain path cut into pad to move storm water away from hay**

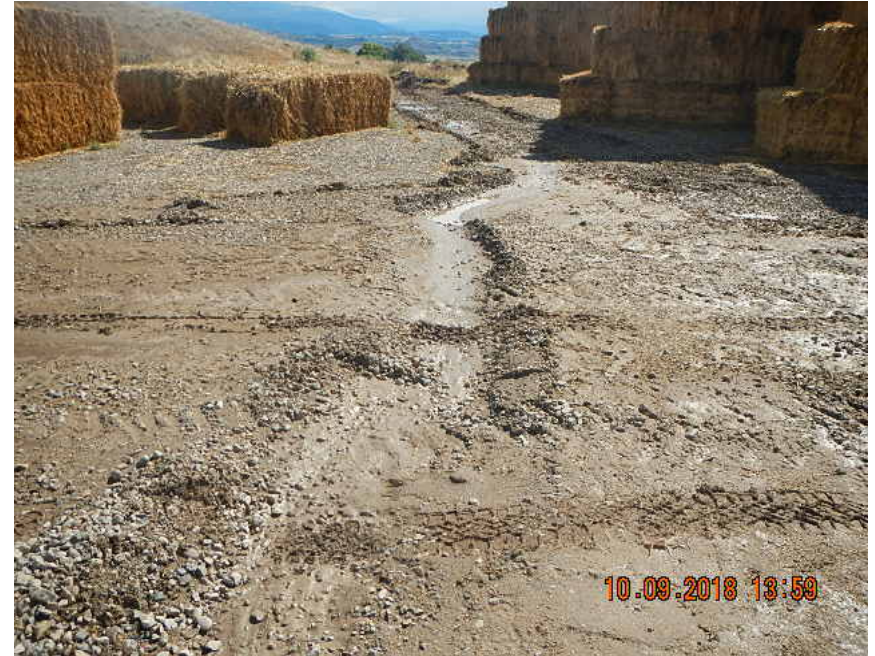
**Drain path on east side of pad**

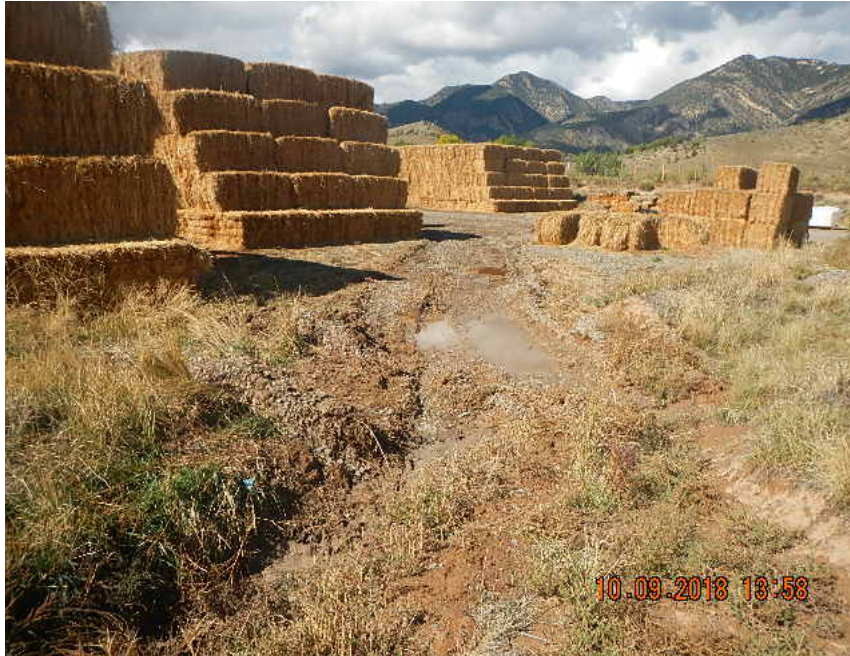
**Drain path moving off of pad, no stabilization or BMP's**

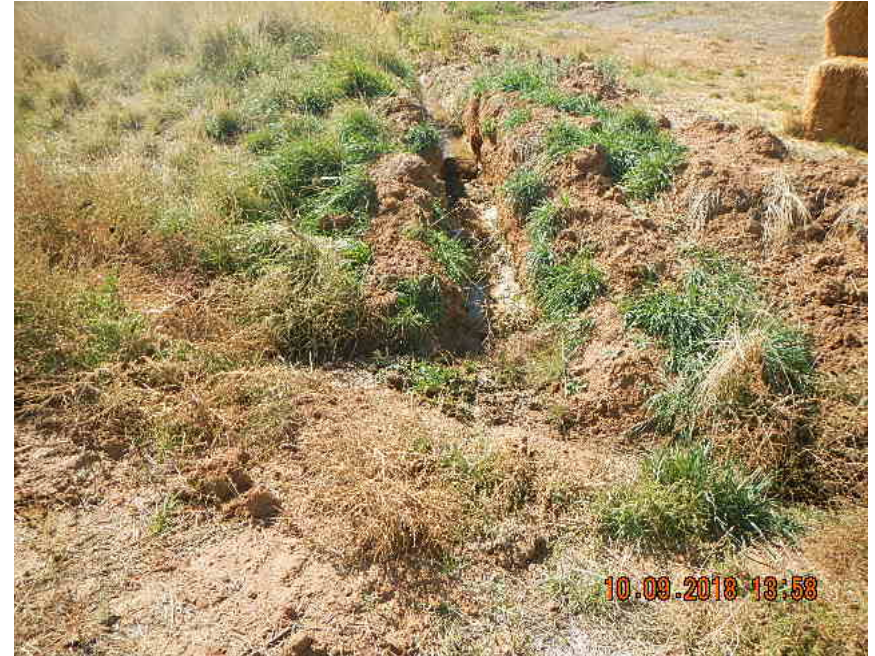
**Storm water routed off of location into existing ditch**

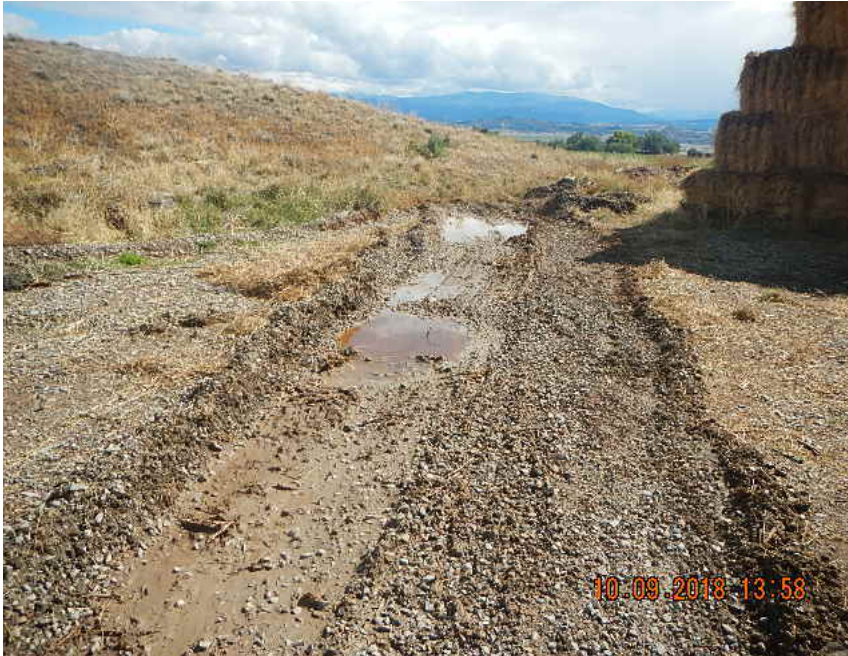
**Notified operator of Storm Water Impacts on 10/9,  
requesting immediate action.**

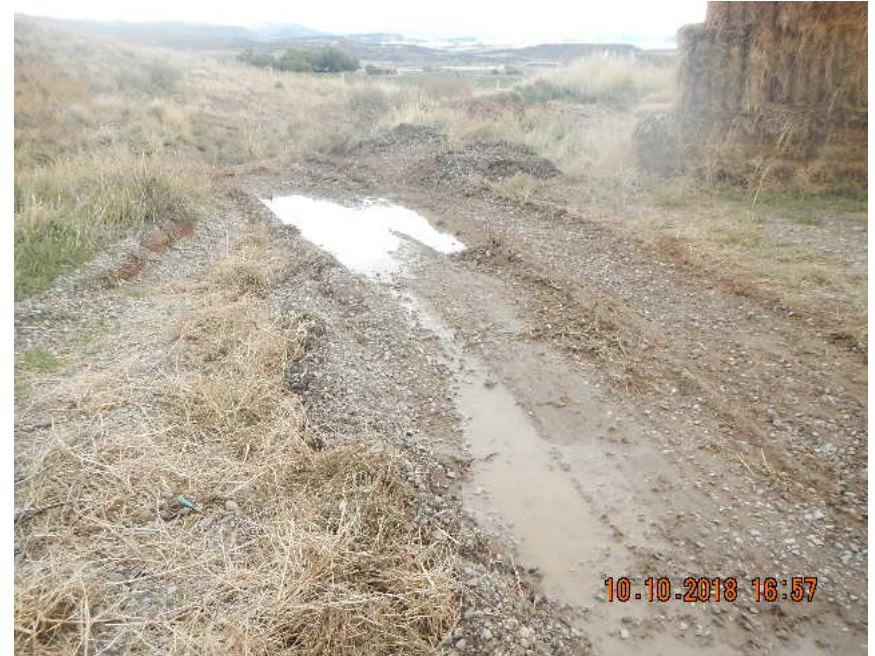
**10/10 no action taken by operator to install BMP.**
