# TEP Rocky Mountain LLC Clough NR 22-3 Casing Integrity Report

## Casing Integrity Interpretation

TEP Rocky Mountain LLC  
 Clough NR 22-3  
 API # 05-045-23904  
 October 06, 2018

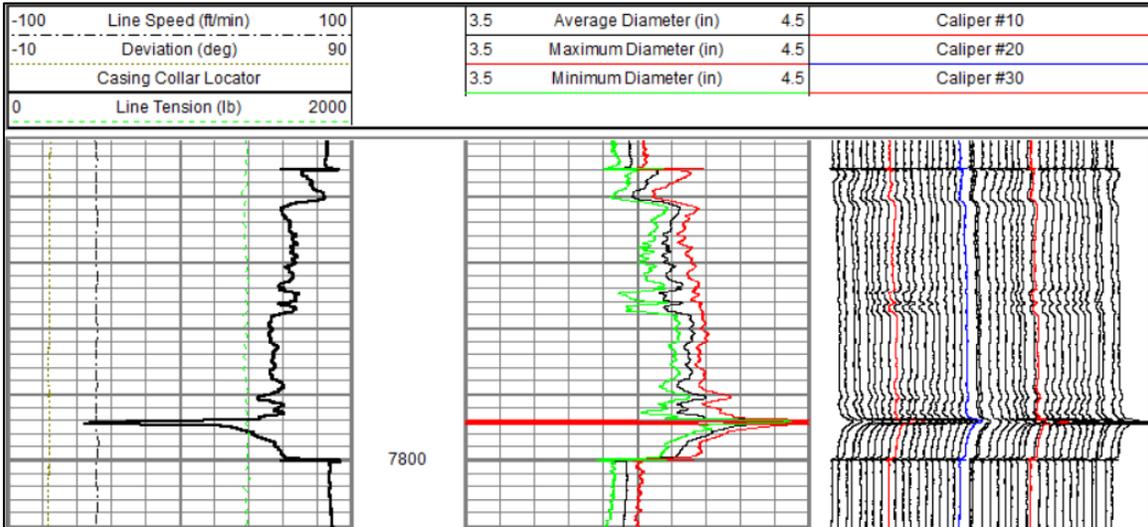
The largest anomaly in the well has a maximum penetration value of 100% at a depth of 7794.5 feet. This is a repeatable multi-finger anomaly and is classified as a possible hole. A “possible hole” is any anomaly with a penetration value larger than 80%. Even though only the largest anomaly for this joint is listed in the report, it’s important to note that the ID of the entire joint is very inconsistent with average ID values, ranging from 3.98 – 4.21 inches (not including the hole). In fact, approximately half of the joint has ID values greater than 4.11 inches. The log data showing this anomaly is shown in Figure 1, the cross section is shown in Figure 2, and 3D images of this anomaly are shown in Figure 3 and Figure 4.

Figure 1. Log data of the anomaly at 7794.5 feet.

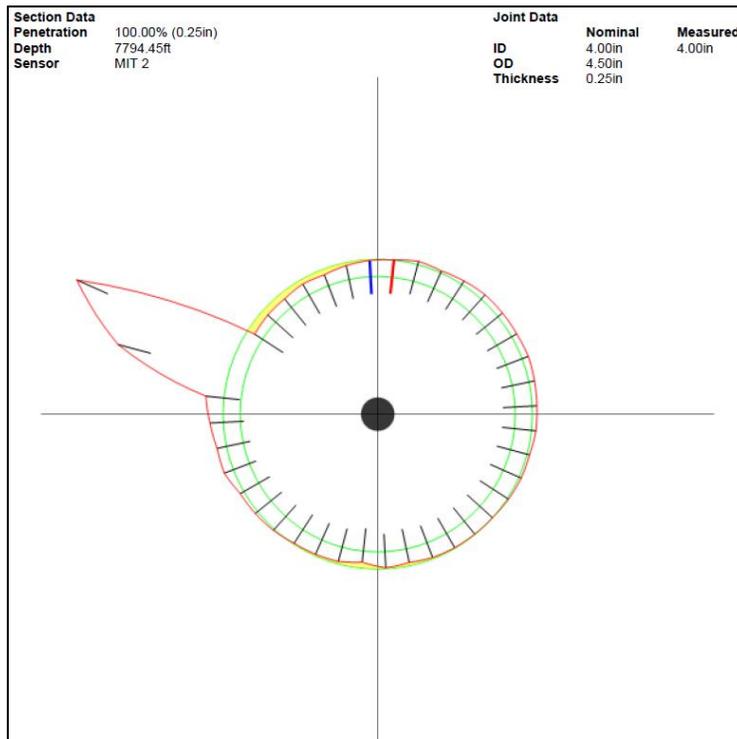
Figure 2. Cross-section of the anomaly at 7794.5 feet.

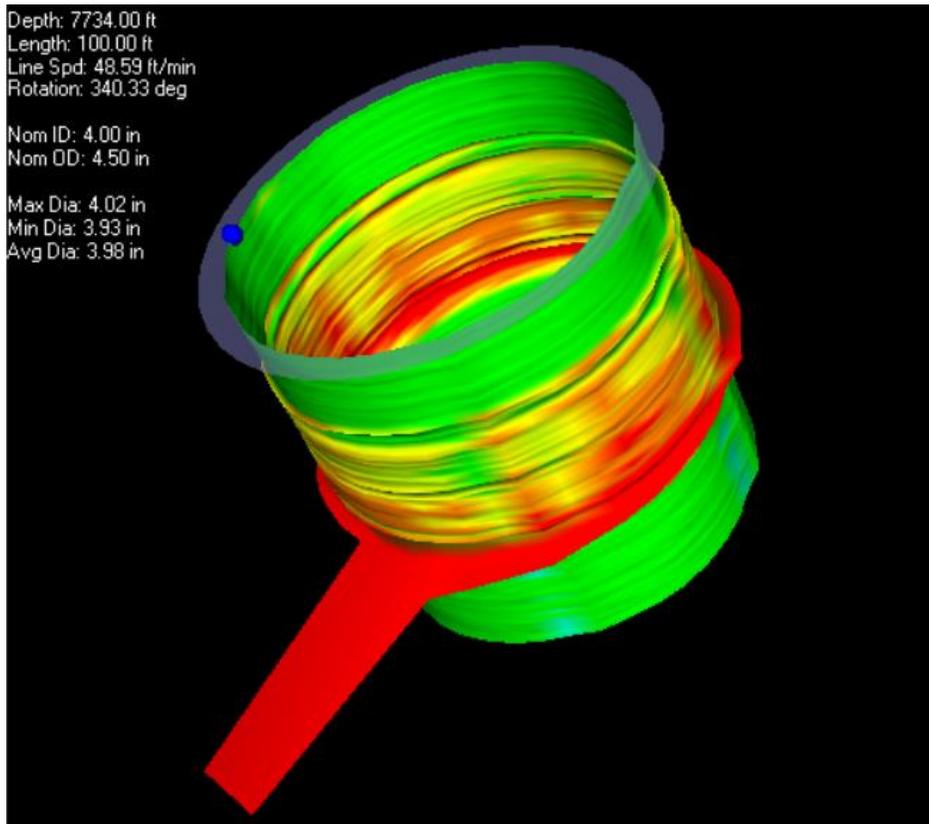
Figure 3. 3D image of the anomaly at 7794.5 feet.

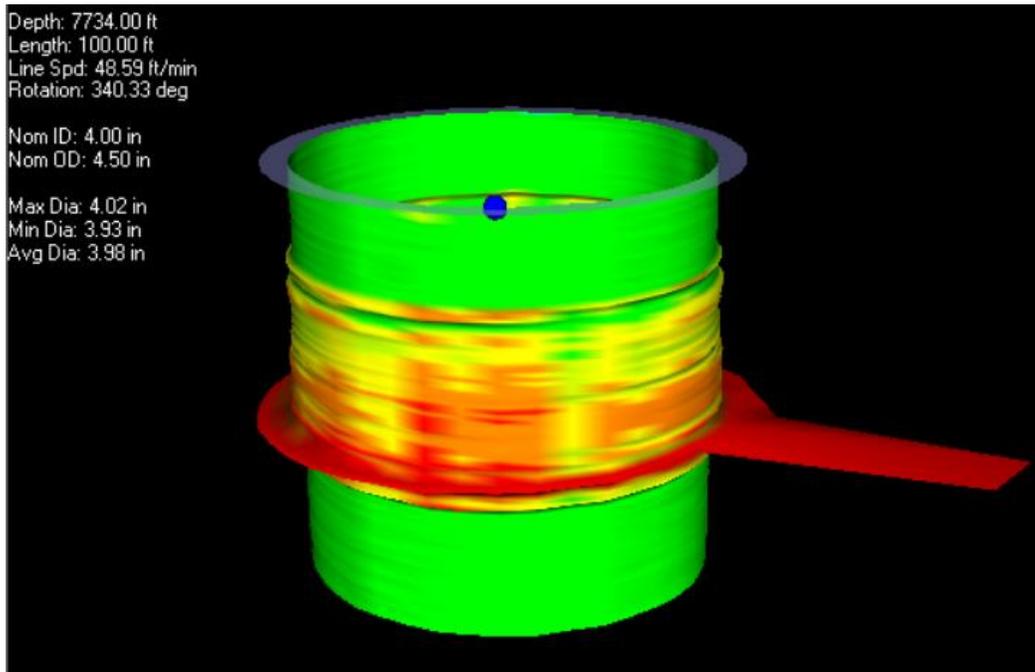
Figure 4. 3D image of the anomaly at 7794.5 feet.

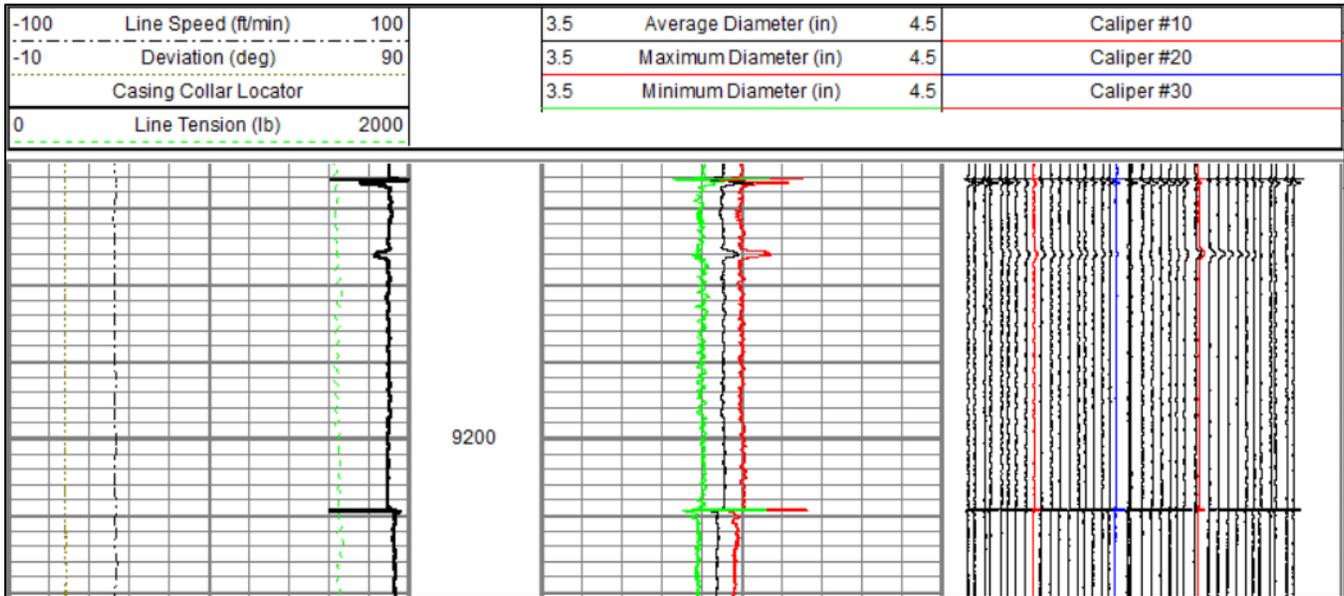
The second largest anomaly in the well has a maximum penetration value of 21.01% at a depth of 9176.2 feet. The log data showing this anomaly is shown in Figure 5, the cross section is shown in Figure 6, and 3D images of this anomaly are shown in Figure 7 and Figure 8.

Figure 5. Log data of the anomaly at 9176.2 feet.

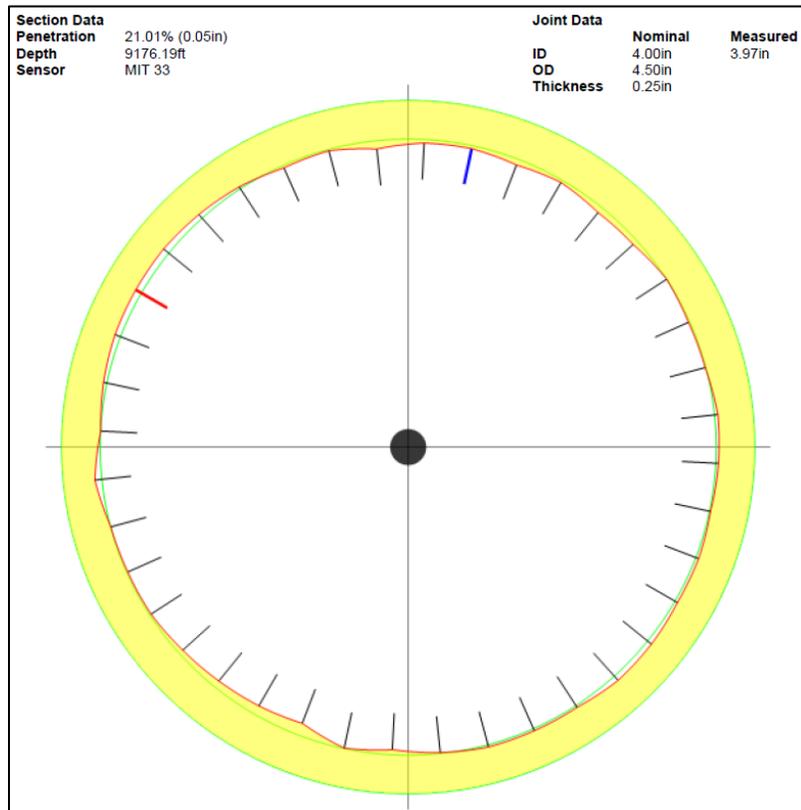
Figure 6. Cross-section of the anomaly at 9176.2 feet.

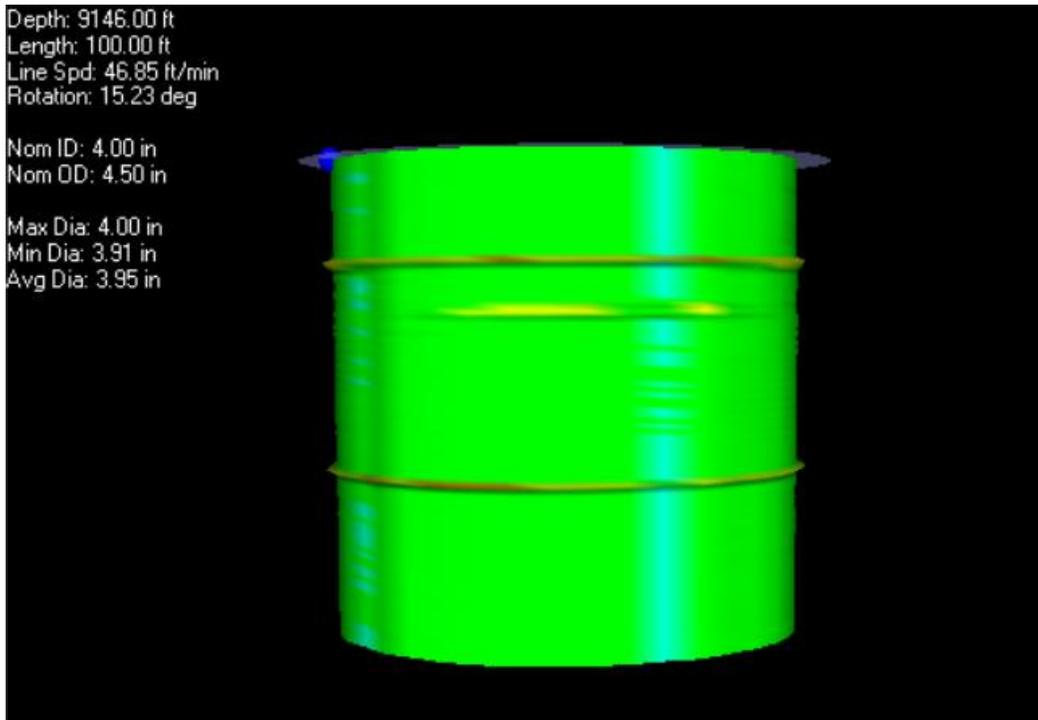
Figure 7. 3D image of the anomaly at 9176.2 feet.

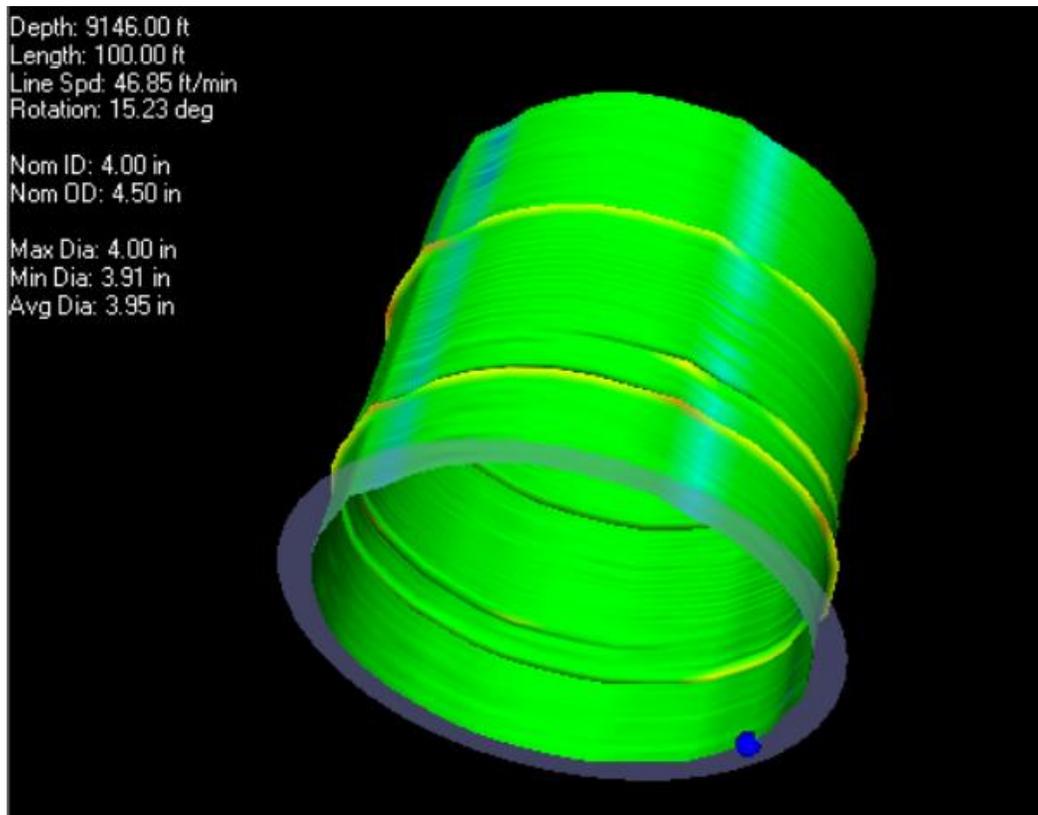
Figure 8. 3D image of the anomaly at 9176.2 feet.
