# Inspection Photos

Operator: Hilcorp Energy Co.

API: 05-067-07031

Date: 10/03/2018

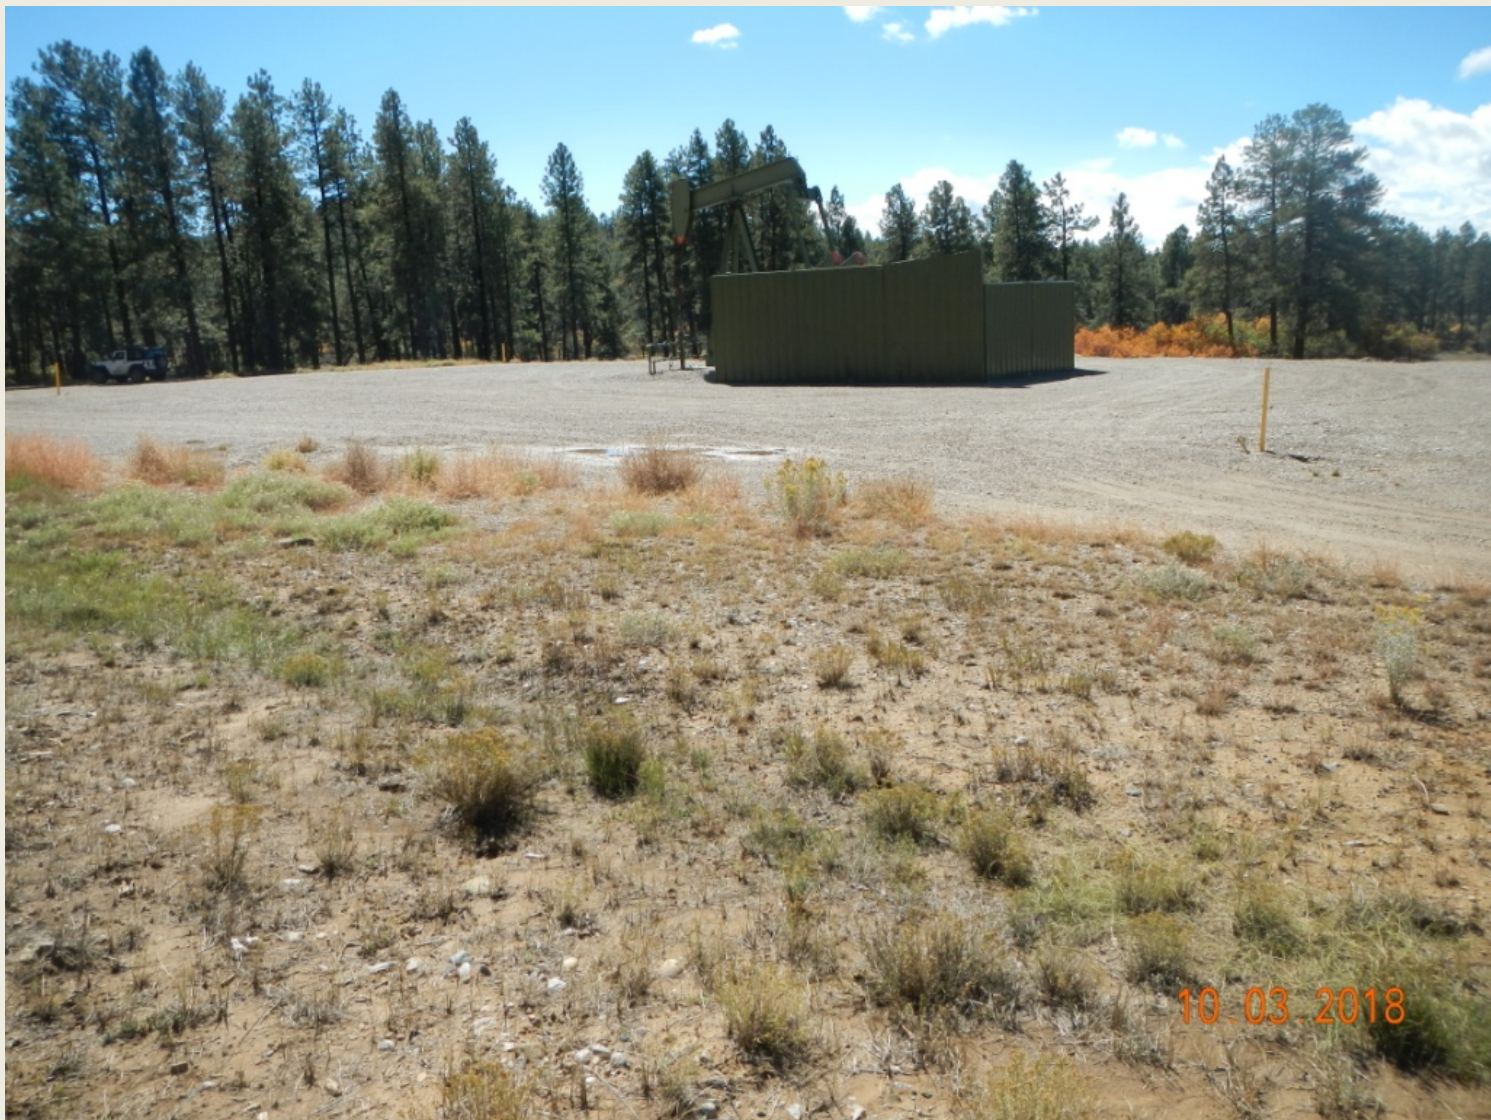
**Photo 1. View of the project area from the northern corner facing center.**

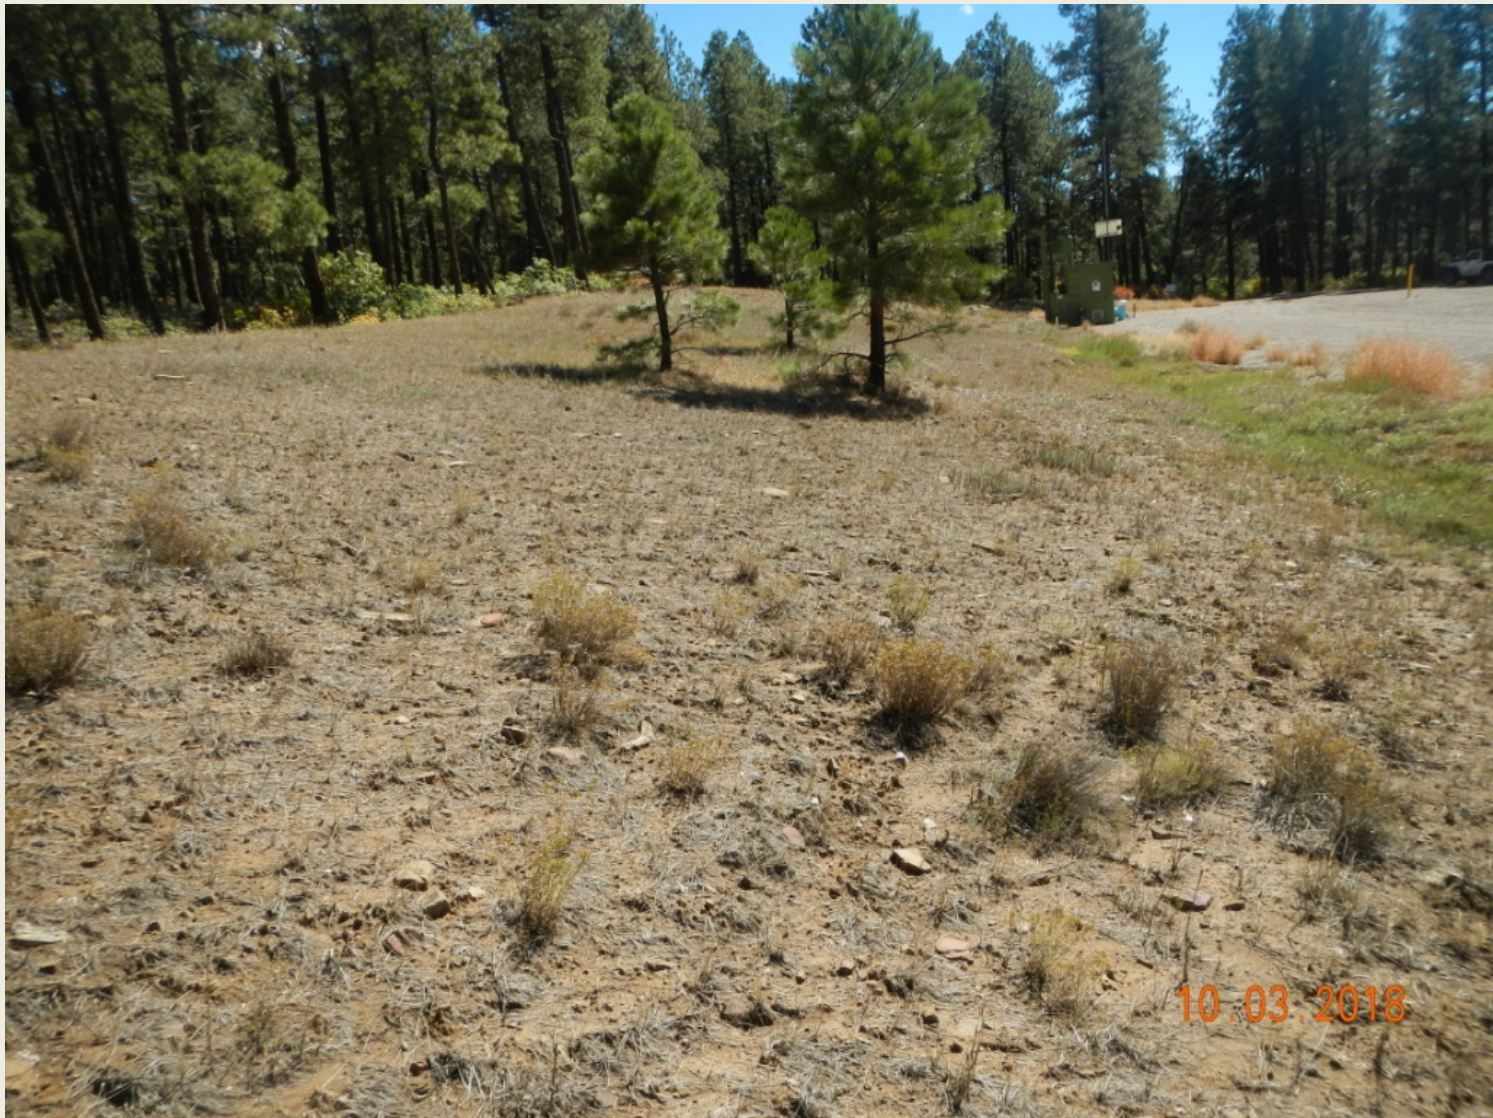
**Photo 2. View of the eastern project area from the northern corner facing southeastward. Vegetation is becoming established with grasses such as western wheatgrass (*Pascopyrum smithii*) , sand dropseed (*Sporobolus cryptandrus*), and forbs such as hairy goldenaster (*Heterotheca villosa*).**

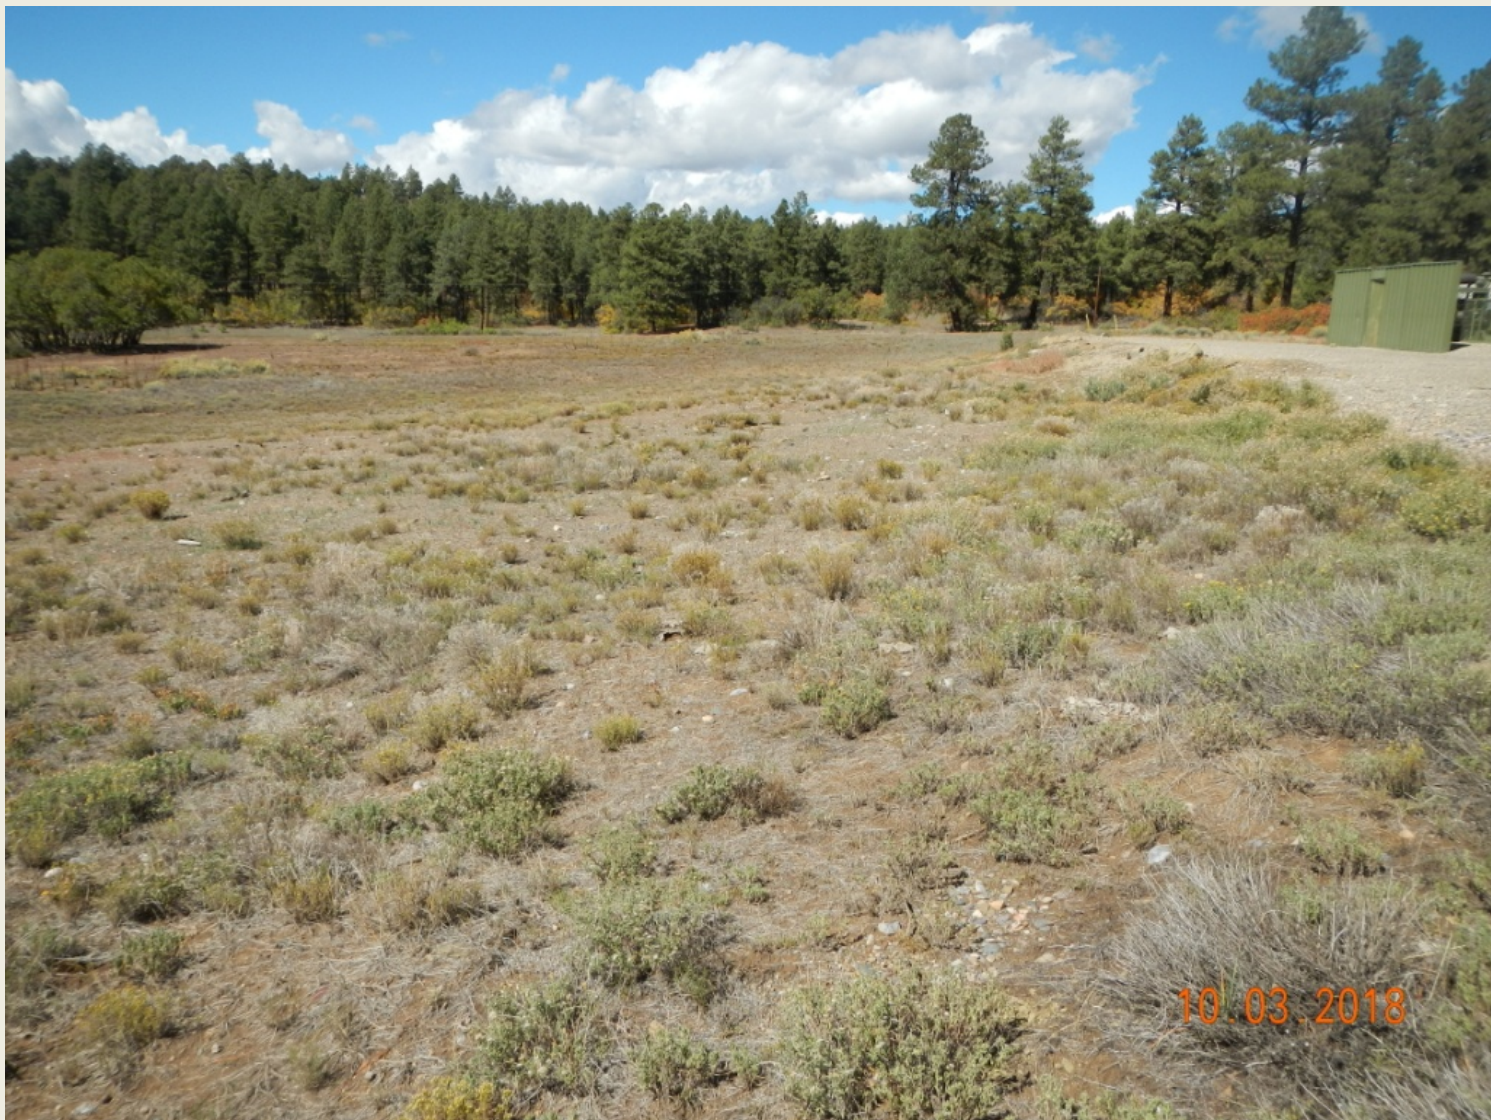
**Photo 2. View of the western project area from the southern corner facing northward.**

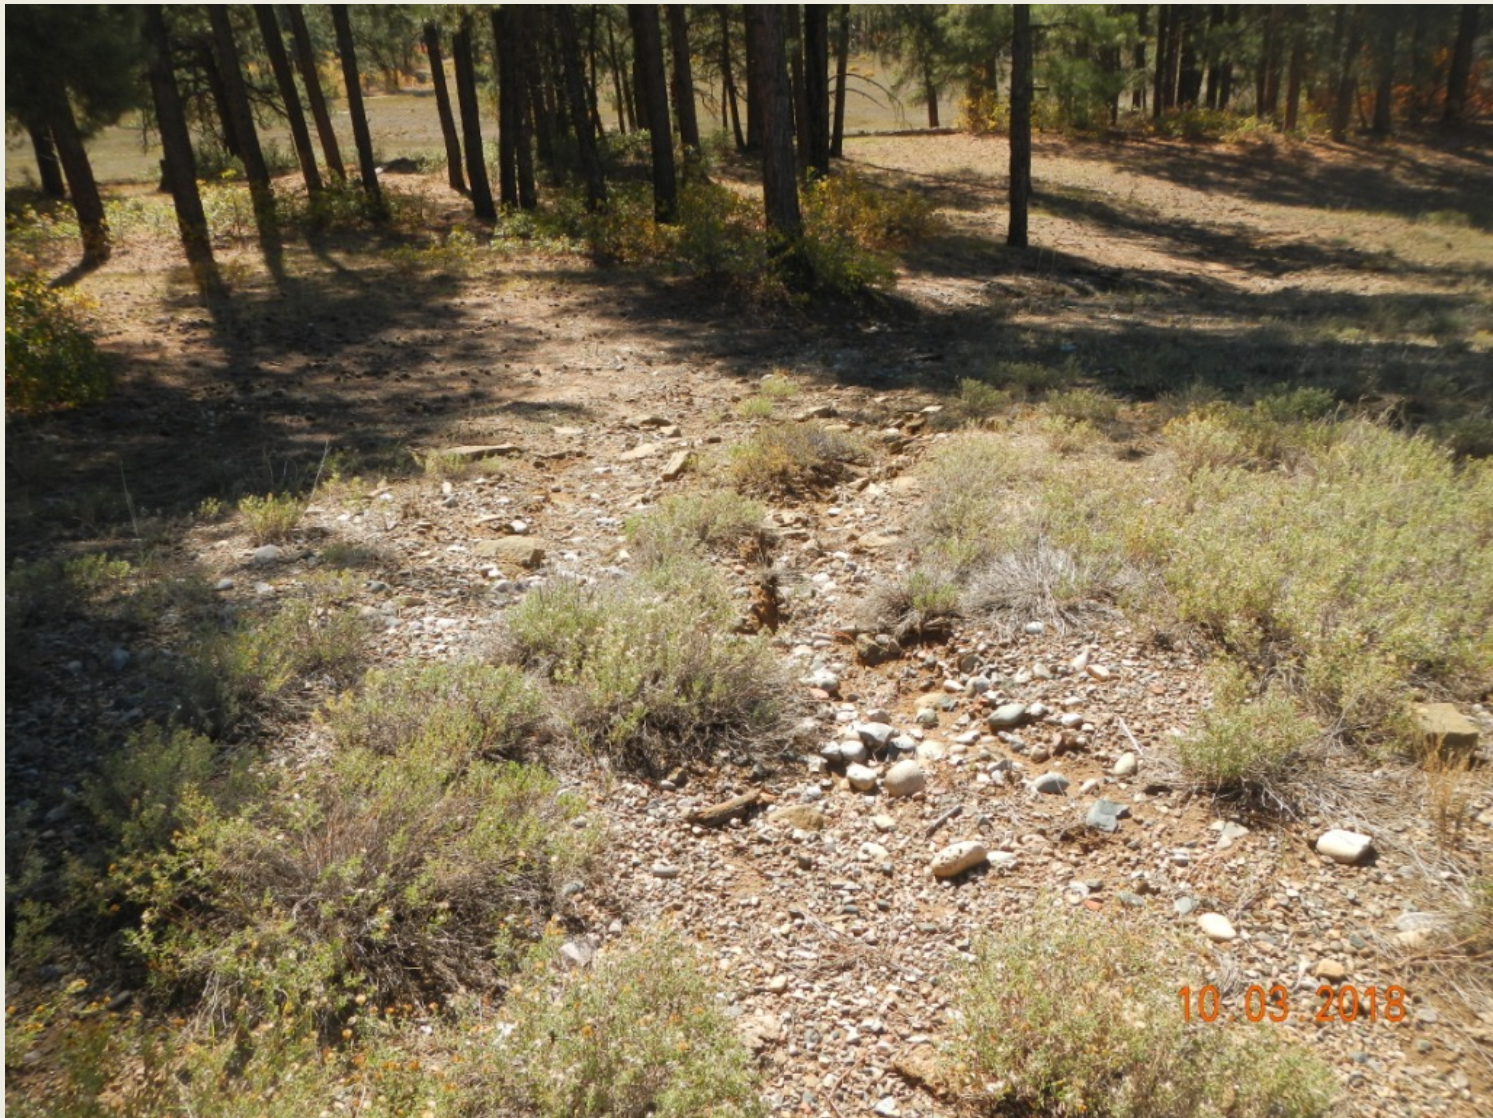
**Photo 3. View of area in the southern project area where stormwater flows off of the well pad, scouring the rocky upper portions, and depositing sediment down-slope.**

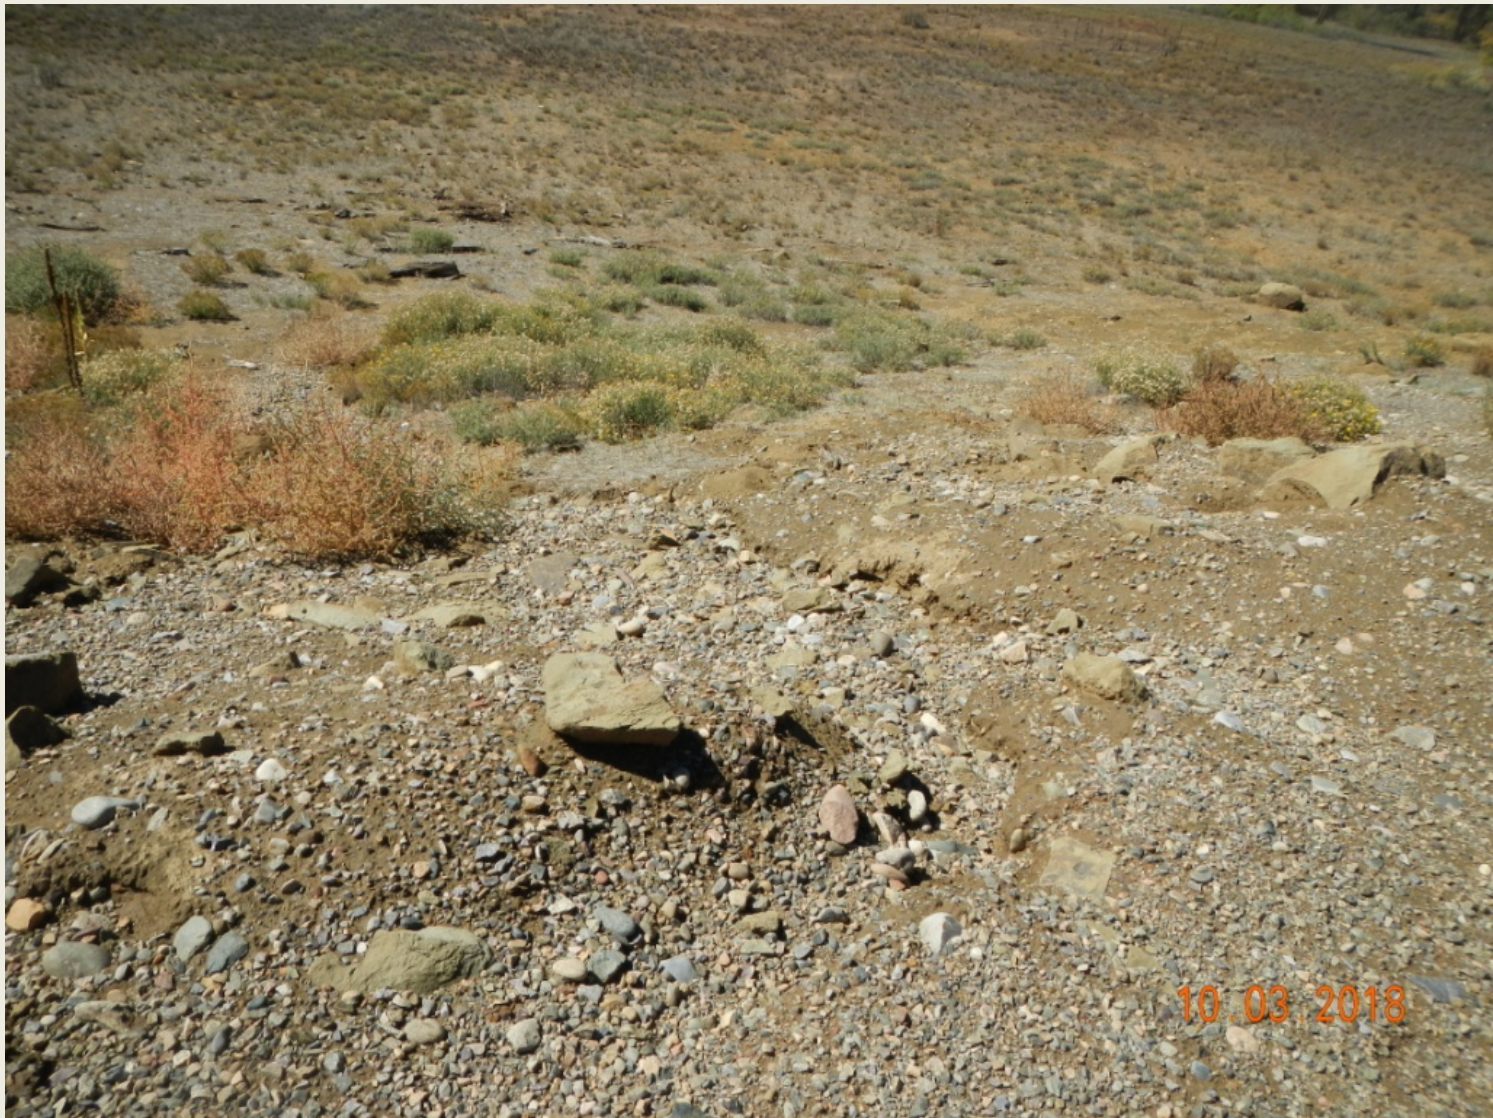
**Photo 4. View of another area where erosional scouring and erosional channels are forming within the western project area.**
