Inspection Photo
Mamm Creek Fed. 13D
API # 045-12492
Inspection # 689302107

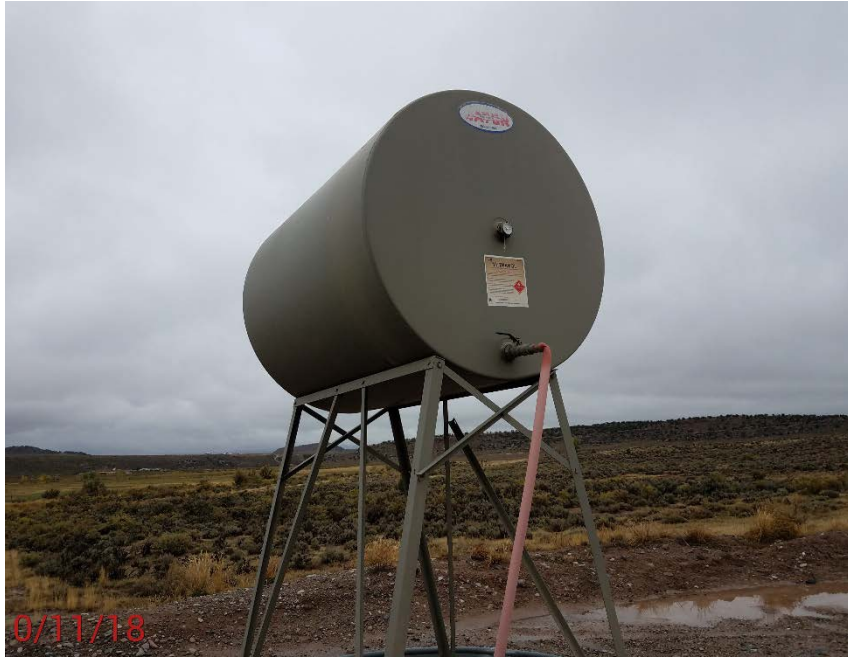
Location Photo #3, missing sign

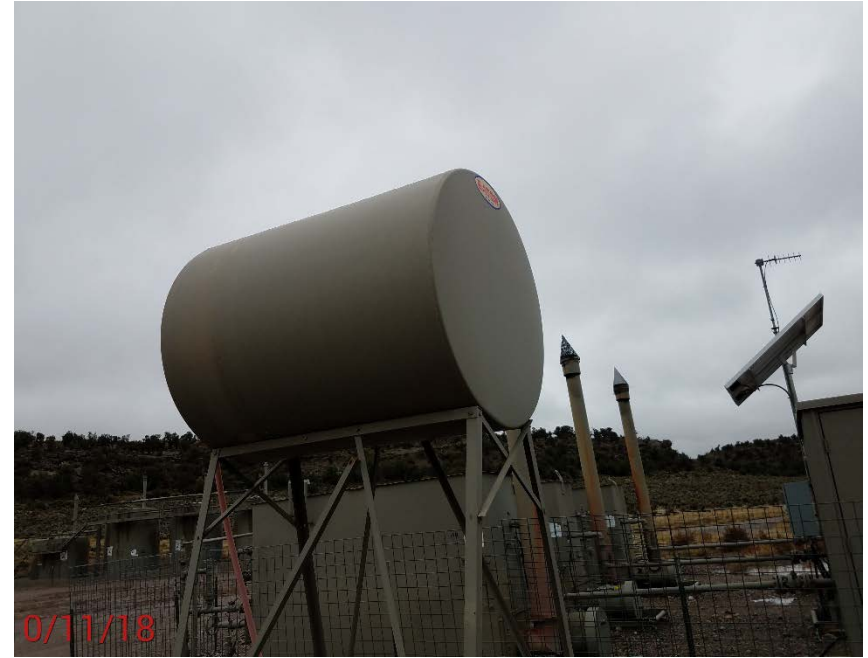
Location Photo #4, missing sign

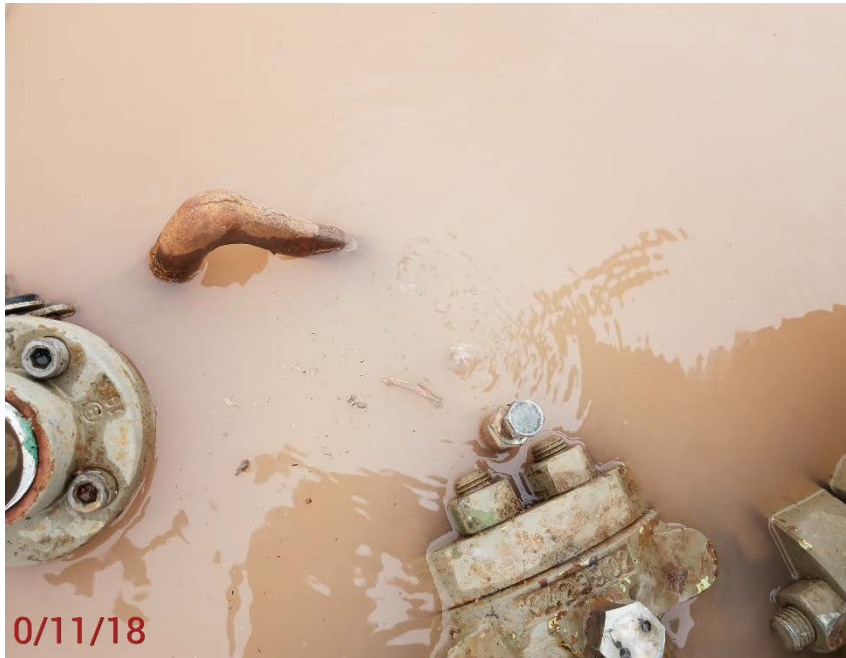
Location Photo #5, Leaking casing valve

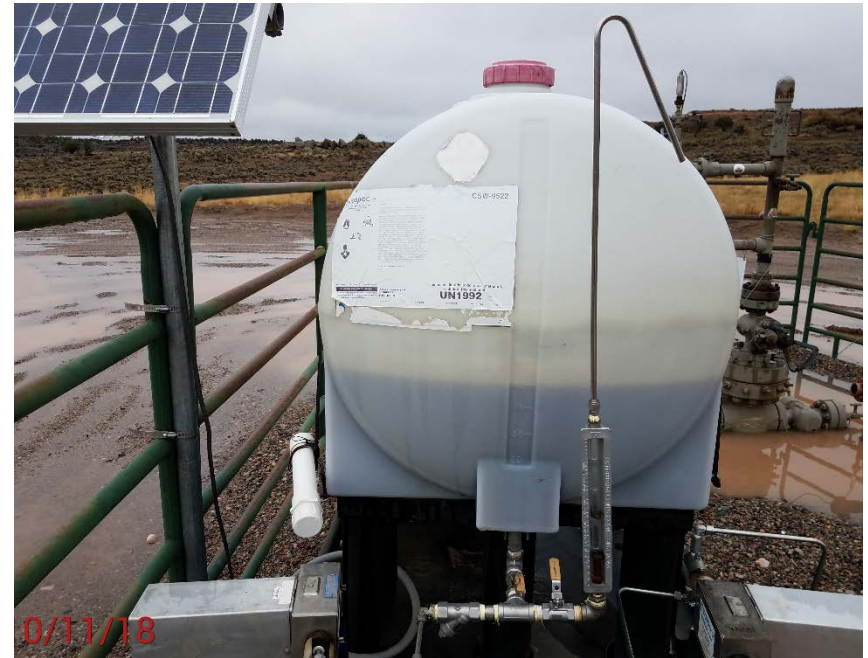
Location Photo #6, Non-legible label

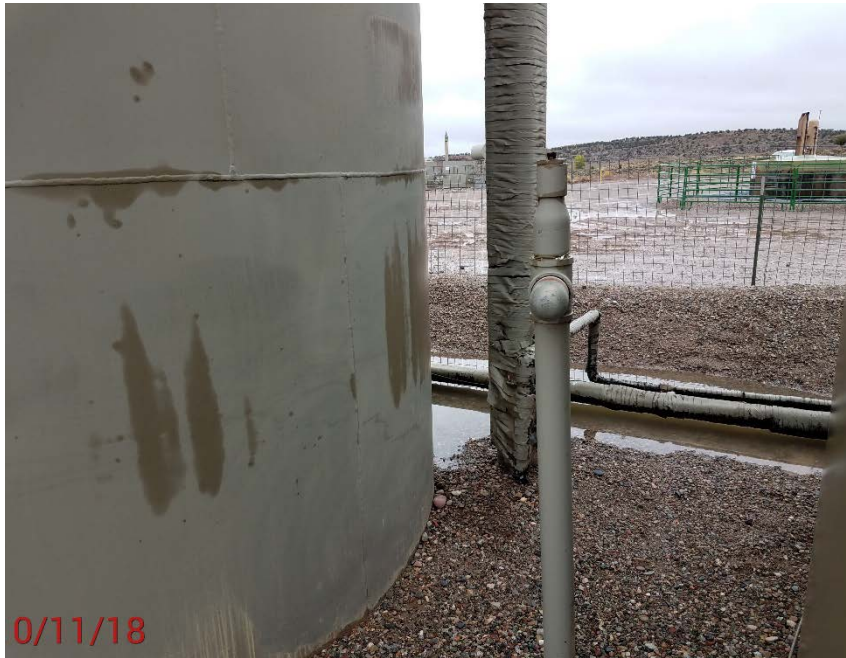
**Location Photo #7, unused/unmarked
flowline riser**

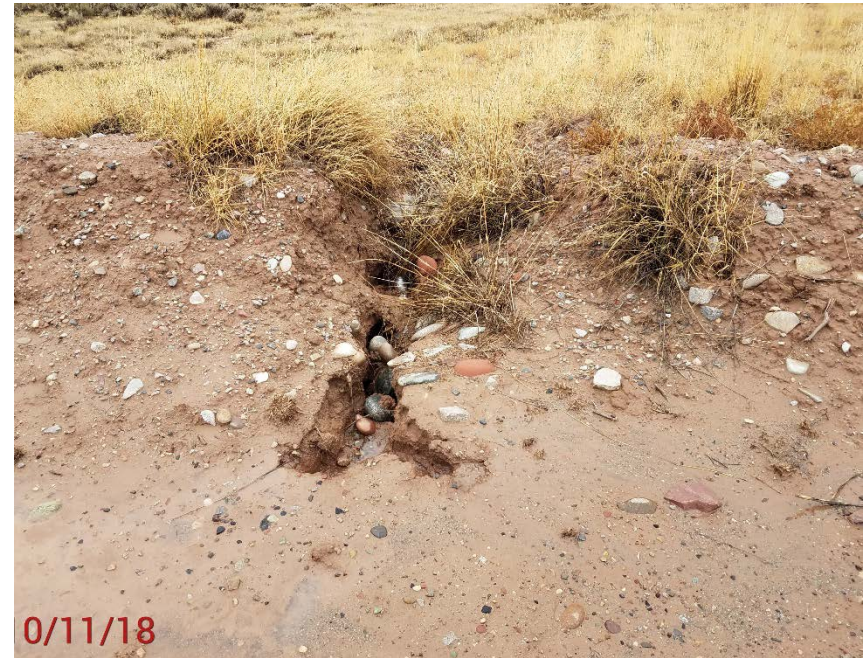
**Location Photo #8, Storm water issue,
sediment being moved off location.**

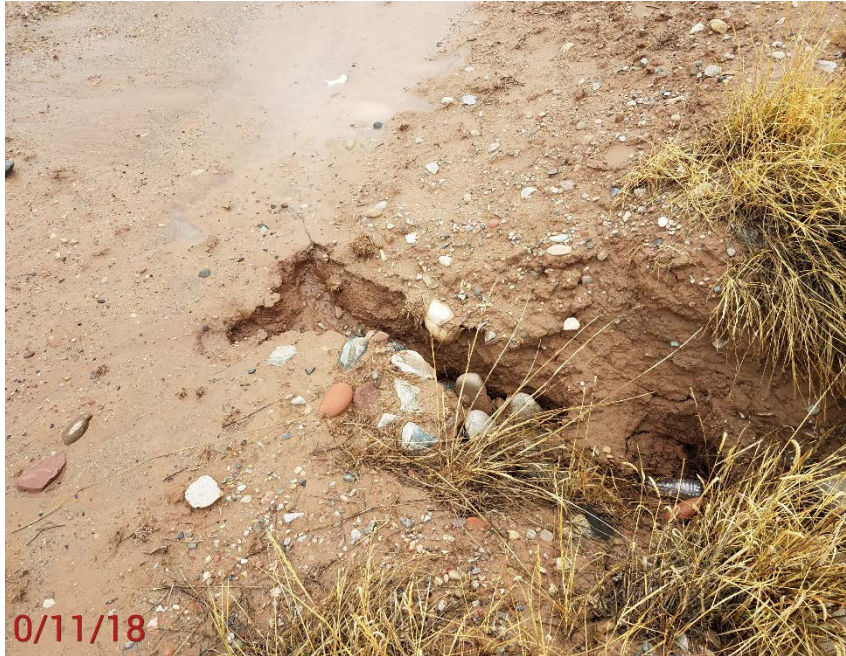
**Location Photo #9, storm water issue,
Sediment being moved from location**
