# Inspection Photos

Operator: PDC ENERGY INC - 69175

Location ID: 322636

Inspection Doc. Number: 682504024

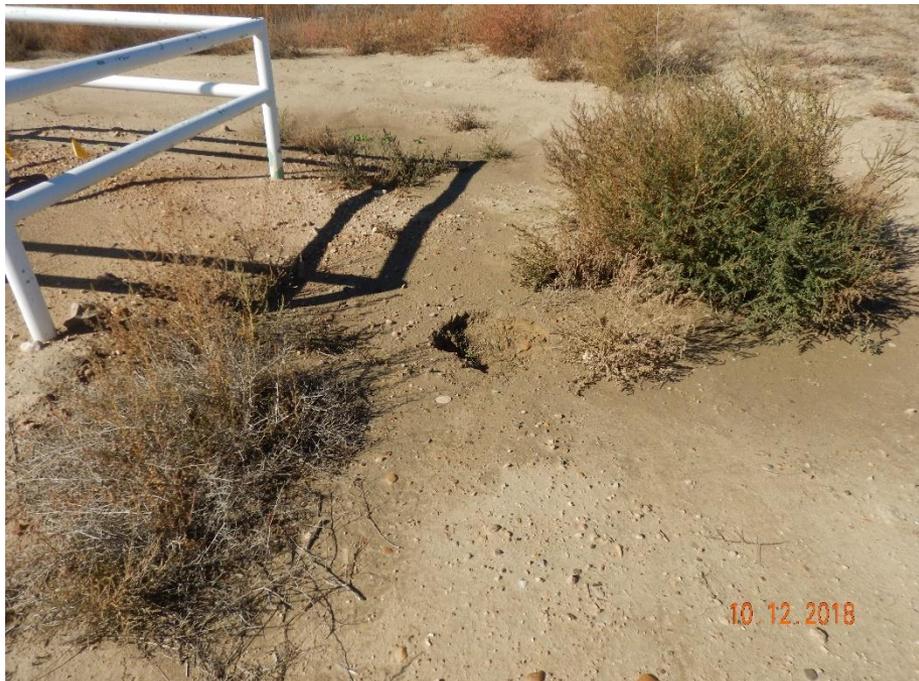
**Photo 1:** Photo taken from the battery location, facing west. Previous inspections documented subsidence concerns at the battery location and required operator to repair. Photo shows subsidence concerns remain.

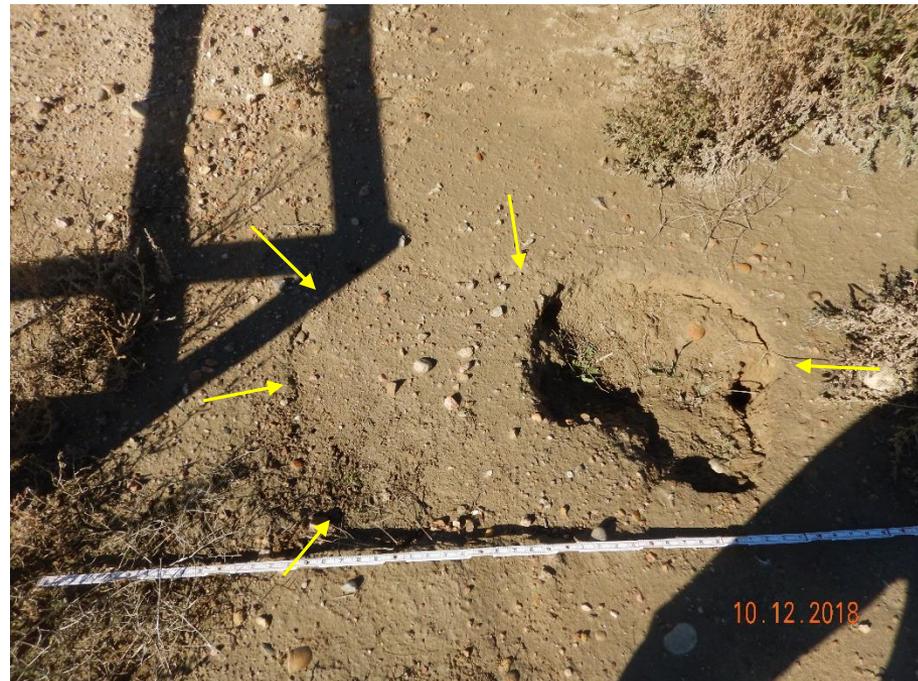
**Photo 2:** Photo taken from the battery location, facing west. Previous inspections documented subsidence concerns at the battery location and required operator to repair. Photo shows subsidence concerns remain and appear to be expanding. 6 foot measuring stick for reference.

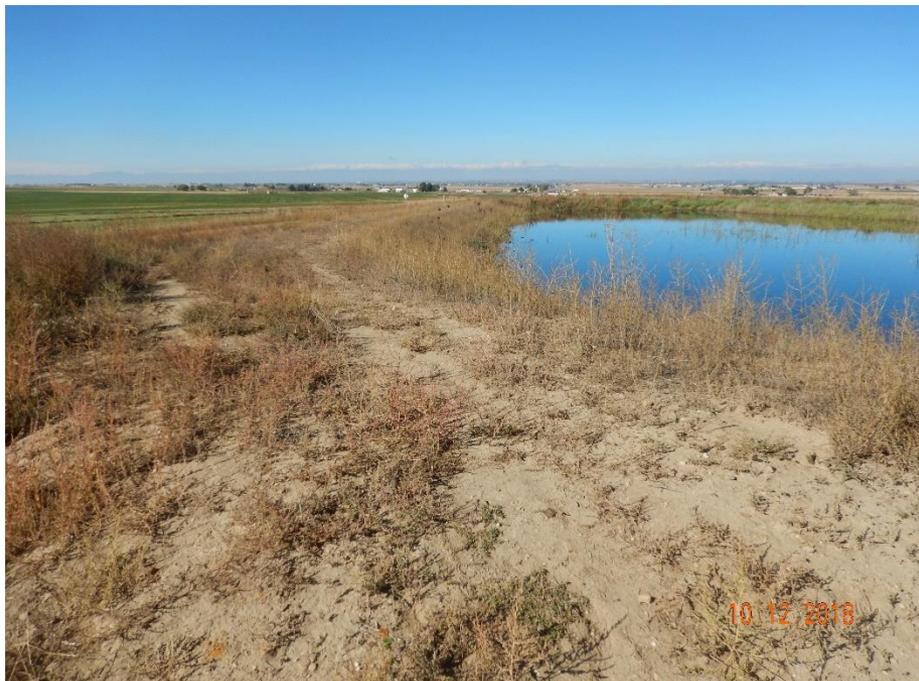
**Photo 3:** Photo taken from the battery location, facing west. Photo shows inspector irrigation pond. Surface owner has expanded irrigation pond incorporating the western half of the production facility.

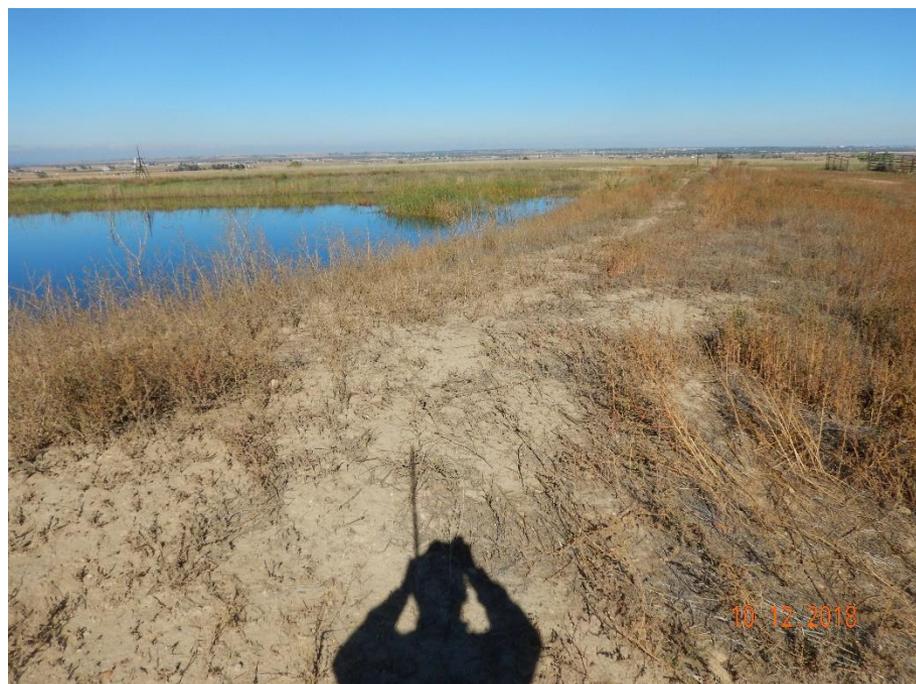
**Photo 4:** Photo taken from the battery location, facing north. Photo shows inspector irrigation pond. Surface owner has expanded irrigation pond incorporating the western half of the production facility.

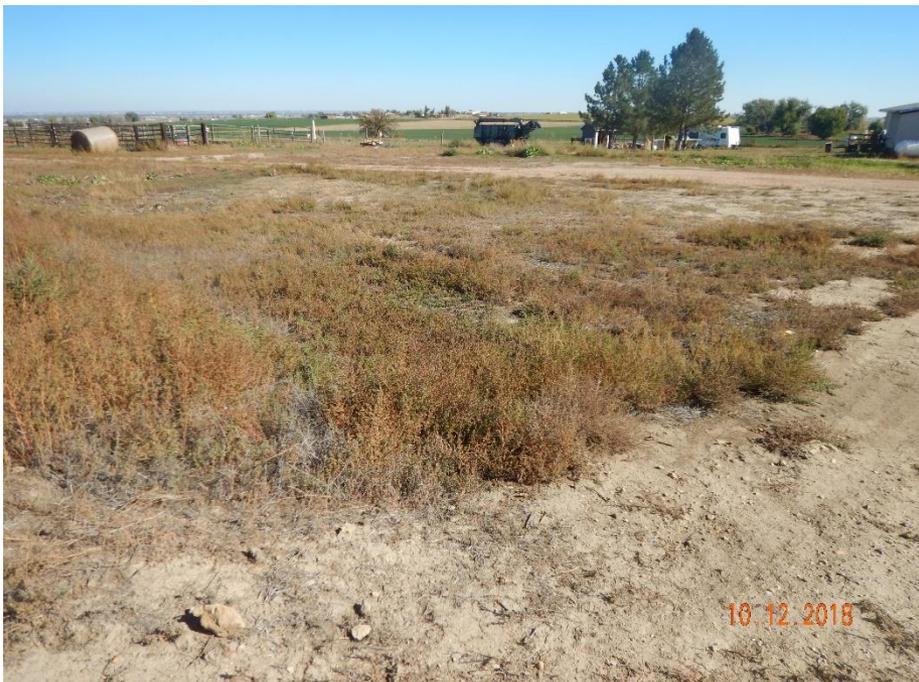
**Photo 5:** Photo taken from the battery location, facing northeast. Photo shows former production facility.

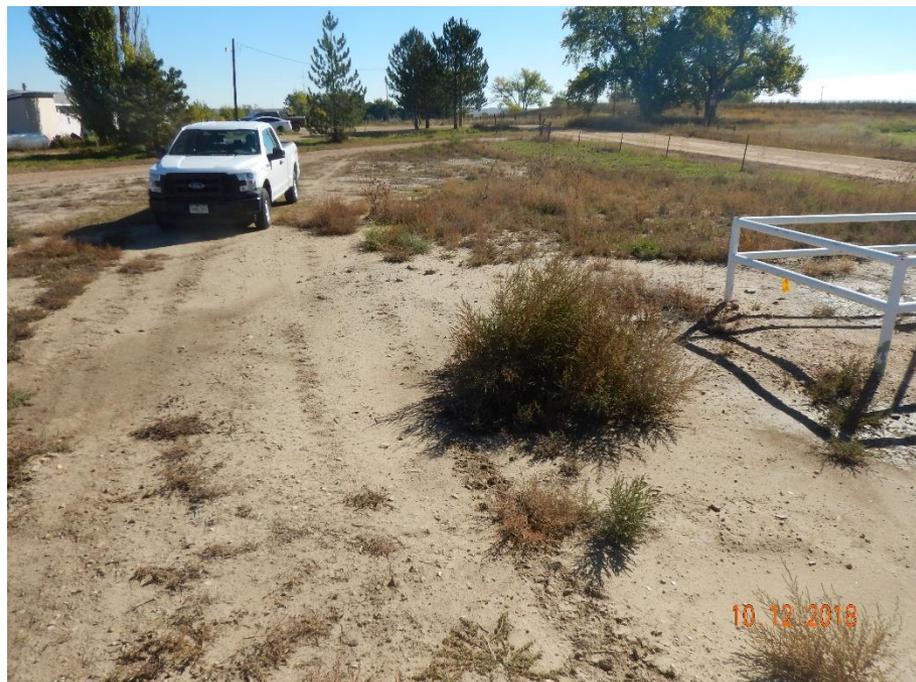
**Photo 6:** Photo taken from the battery location, facing east. Photo shows former production facility.

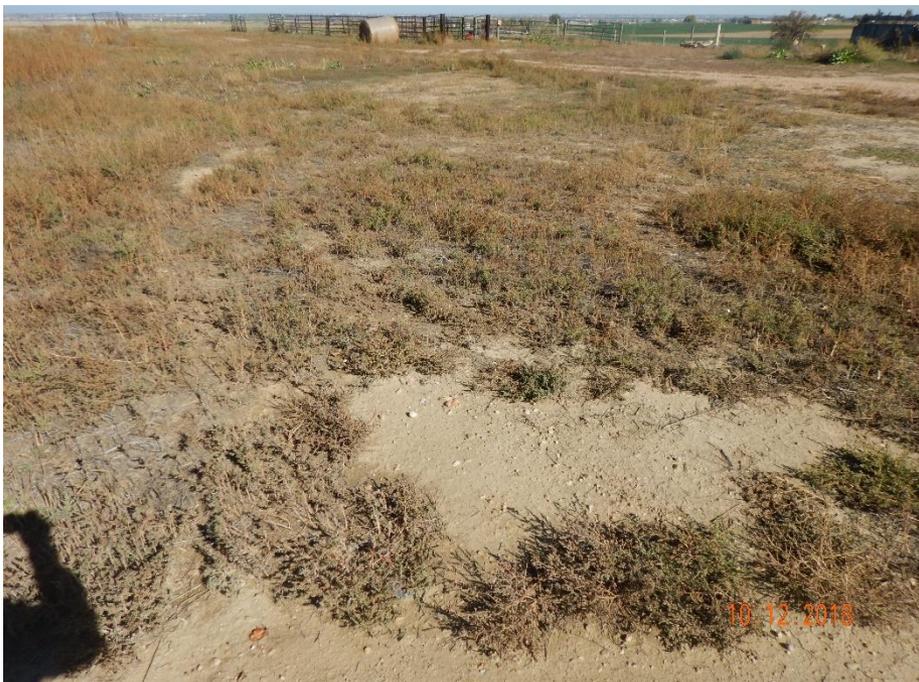
**Photo 7:** Photo taken from the battery location, facing northeast. Photo shows former production facility is either bare and exposed soil, or predominantly undesirable weedy plant species such as kochia and Russian thistle.

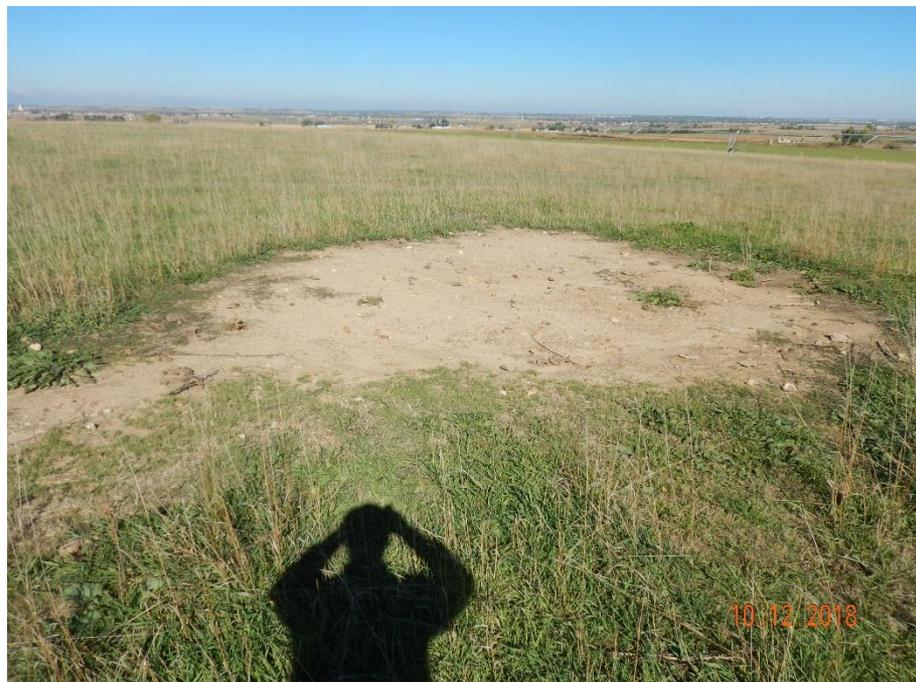
**Photo 8:** Photo taken from the well location, facing north. Photo shows well remains predominantly bare and exposed soil.

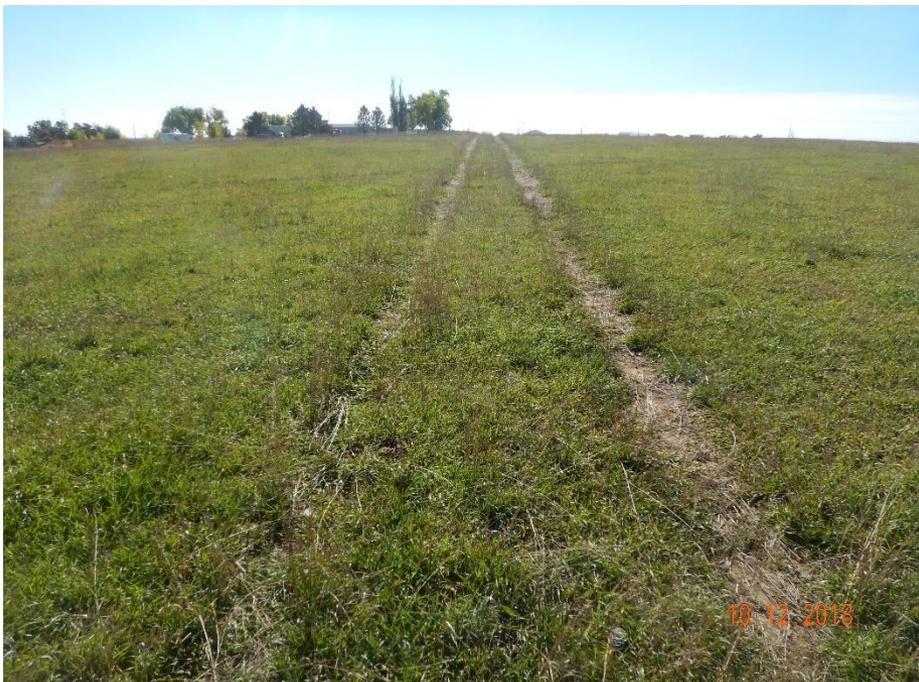
**Photo 9:** Photo taken from the well location, facing south. Photo shows access road.

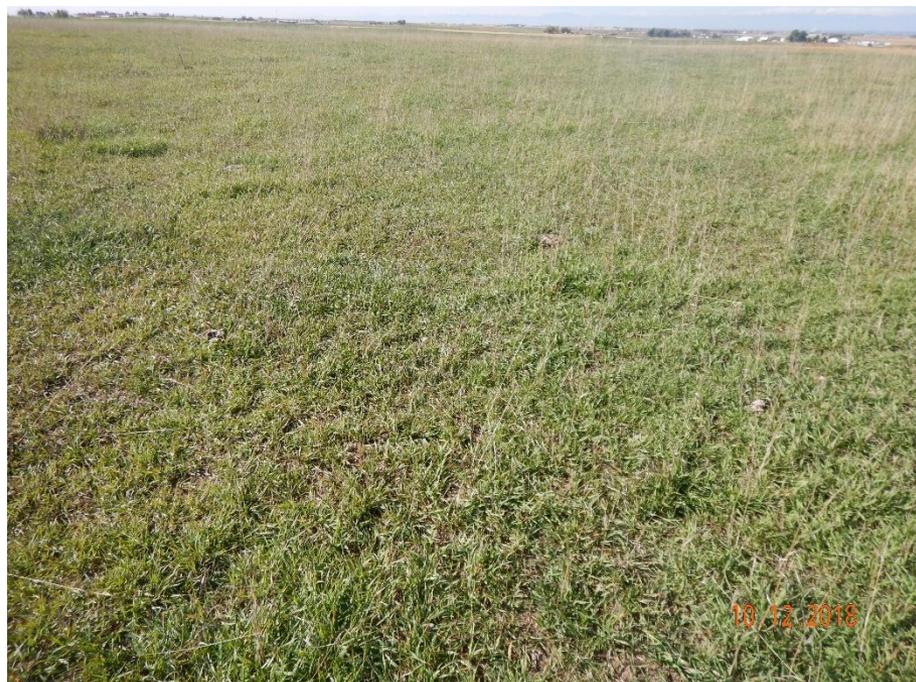
**Photo 10:** Photo taken from the adjacent reference area. Photo shows vegetation in reference area. Reference area is an irrigated perennial grassland crop.

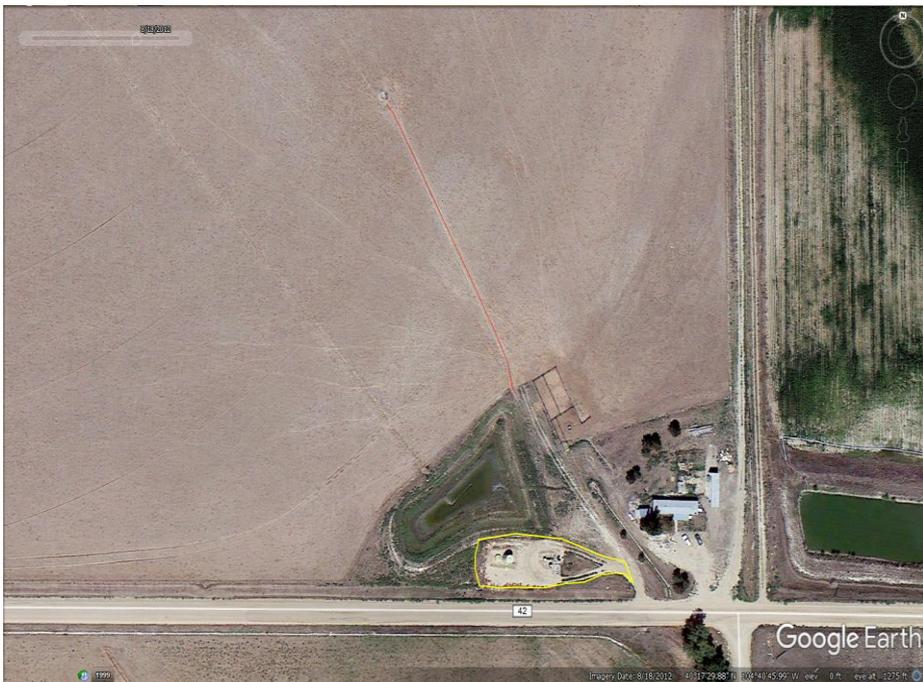
**Photo 11:** 2012 aerial imagery. Photo shows aerial of the well location, access road and production facility subject to the SOVR.

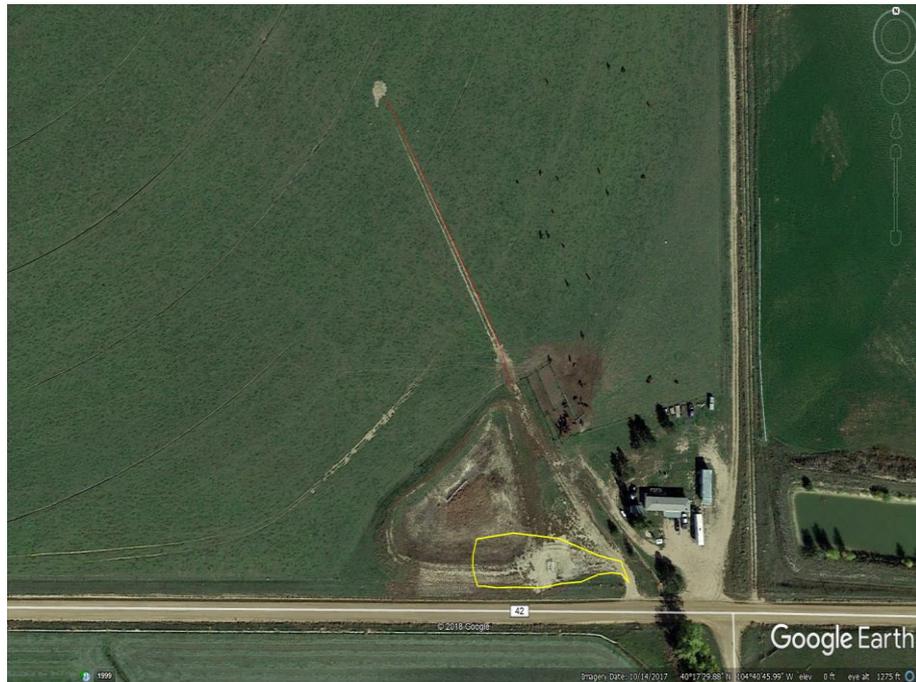
**Photo 12:** Most current available aerial imagery (2017). Photo shows surface owner has expanded the irrigation pond to include a portion of the battery facility.
