## Inspection Photos

Location Name: Watson Ranch B Pad

Location ID: #440705

Inspection Date: October 1, 2018

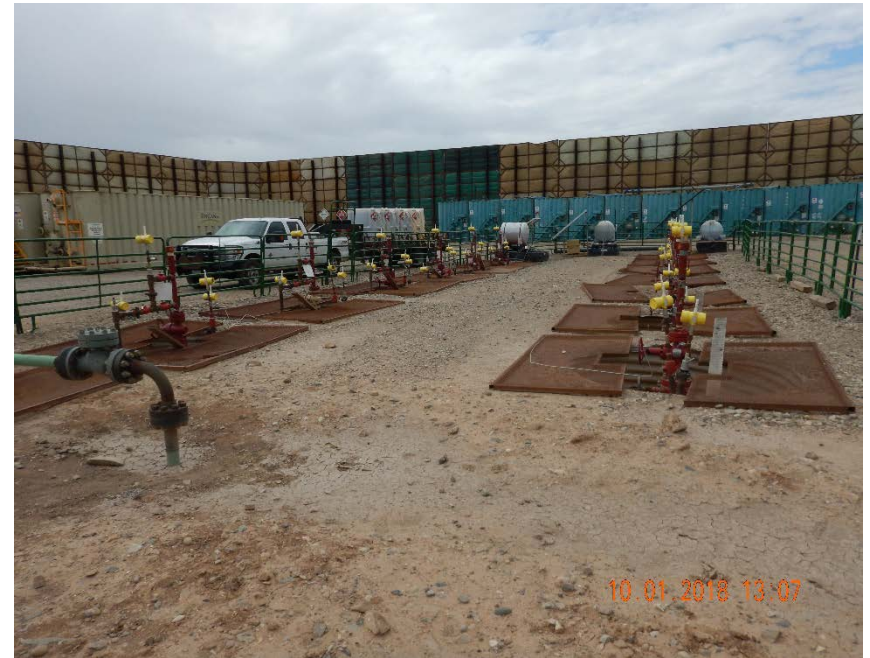
Photo #2 – View of wellheads from NE corner.

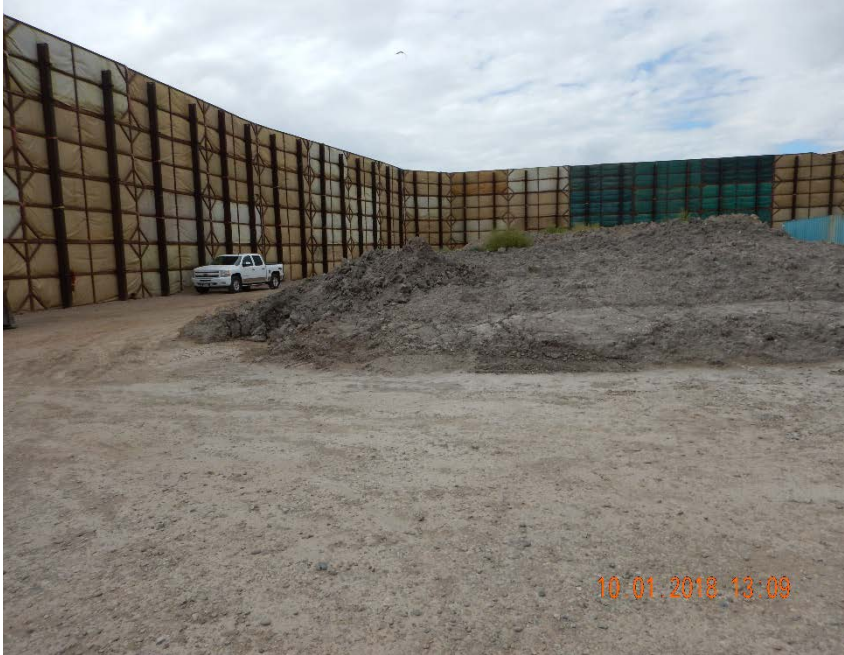
**Photo #3 – Cuttings stockpile located at SW corner of pad.**

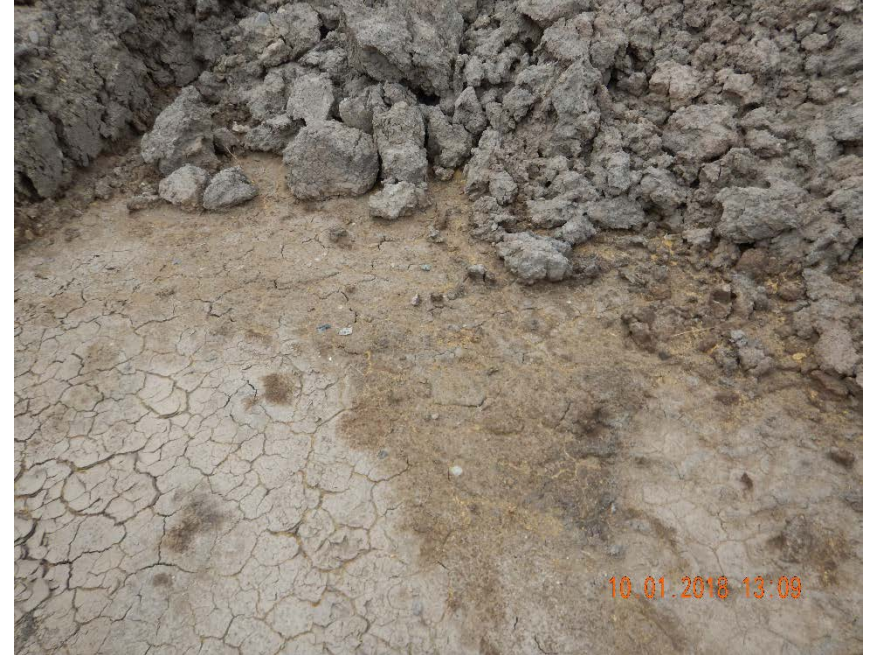
**Photo #4 – Evidence of stormwater runoff and sediment transport at SE corner of cuttings stockpile.**

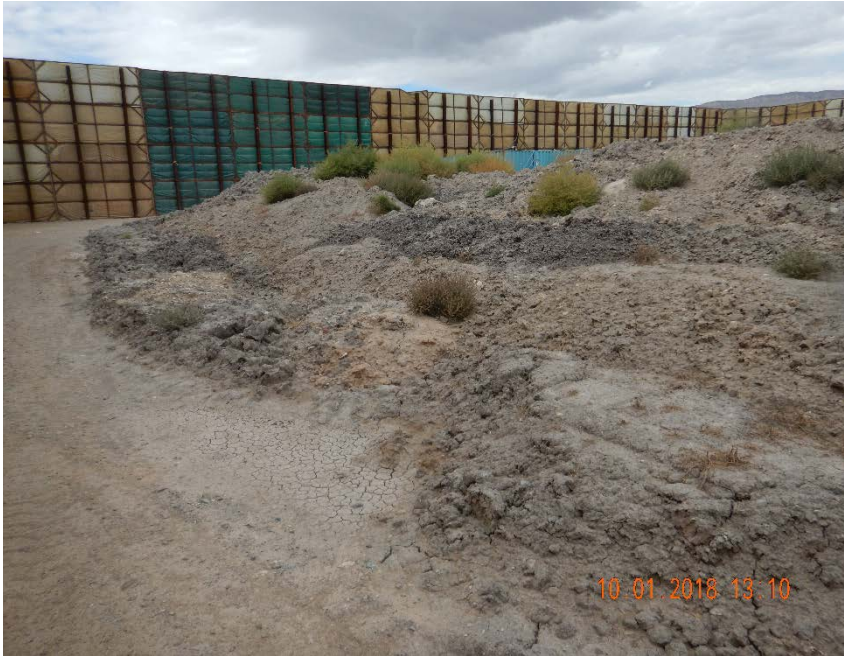
**Photo #5 – Vegetation growth and lack of stormwater control at SW cuttings stockpile.**

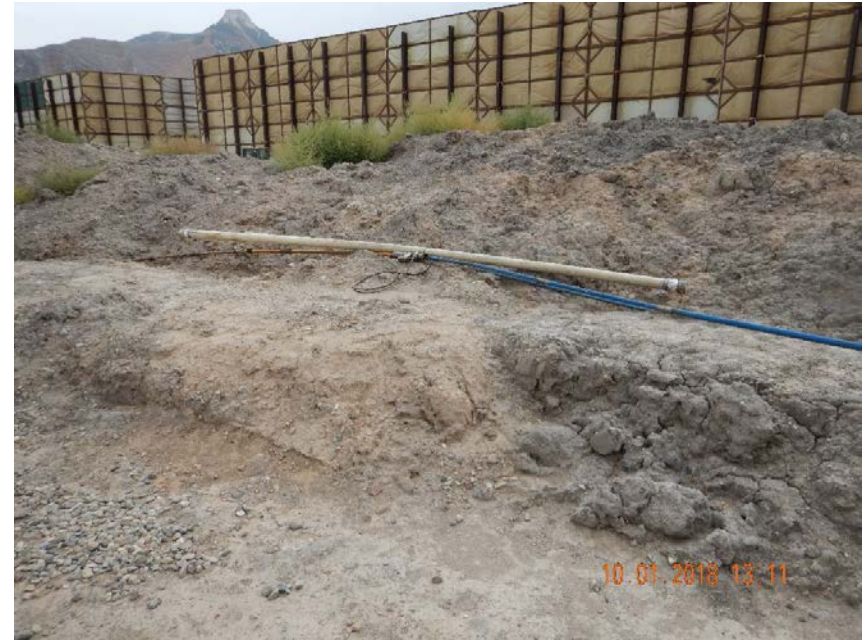
**Photo #6 – Unused equipment storage on SW cuttings stockpile.**

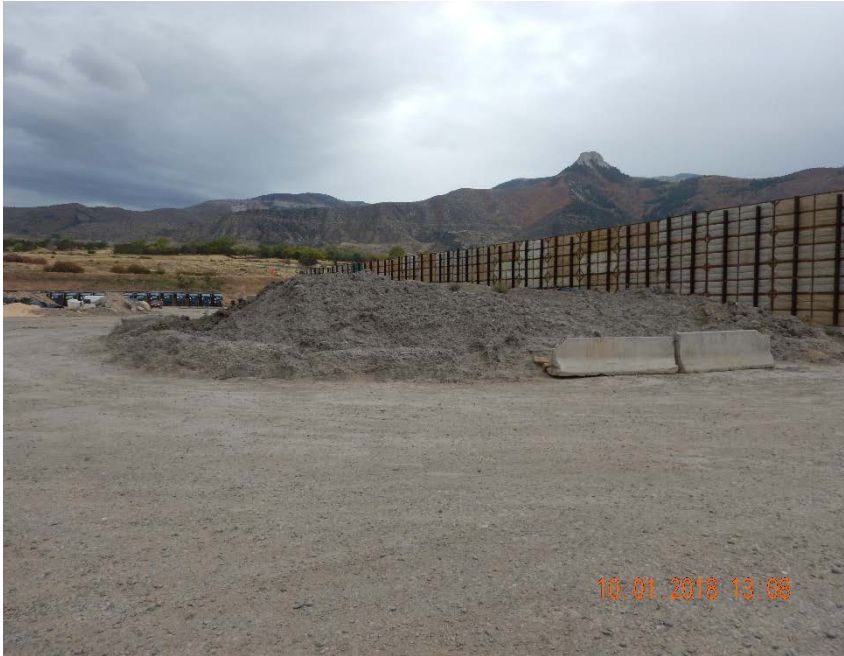
**Photo #7 – View of SE cuttings stockpile from west.**

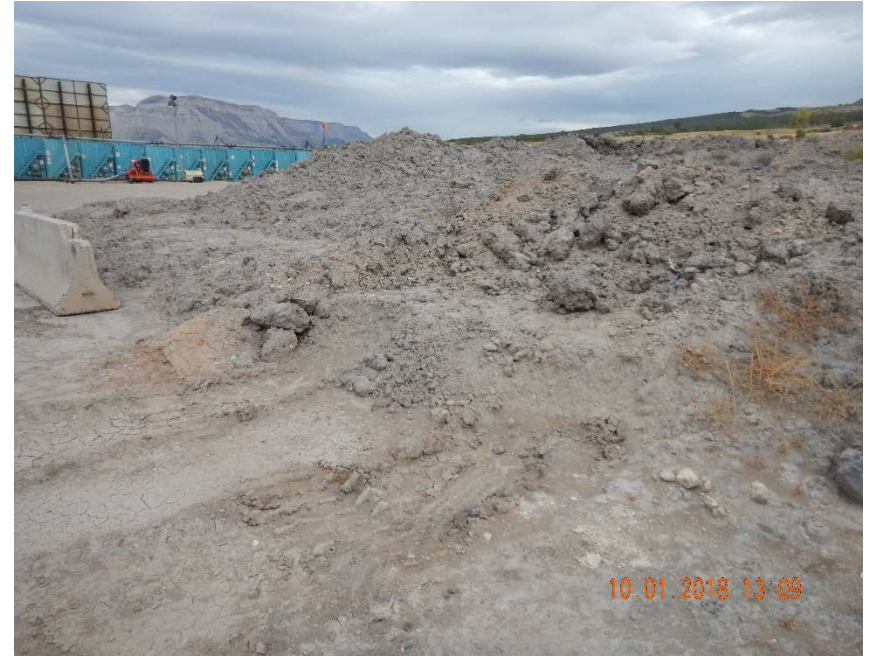
**Photo #8 – Vegetation growth and lack of stormwater control at SE cuttings stockpile.**

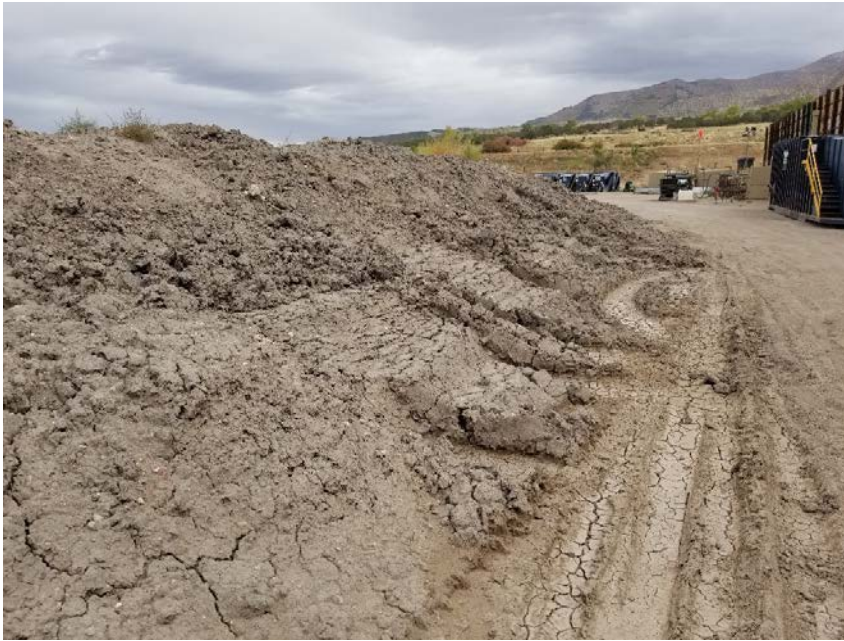
**Photo #9 – View along south side of SE cuttings stockpile. Note lack of stormwater control and presence of tire tracks along stockpile.**

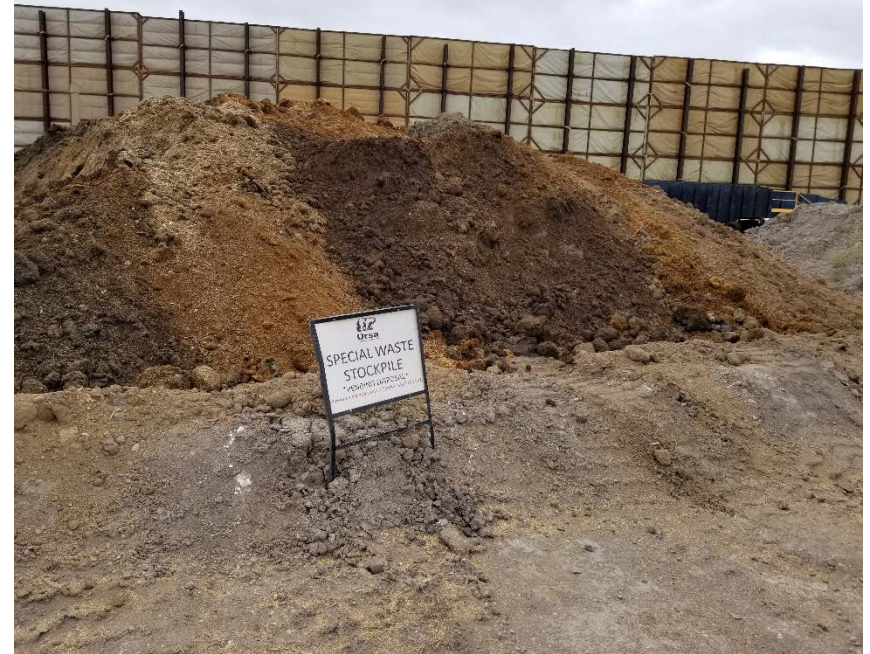
**Photo #10 – Special Waste stockpile located east of SE cuttings stockpile. Hydrocarbon odor detected from stockpiled material on inspection date. Note that this stockpile has earthen berm on three sides.**

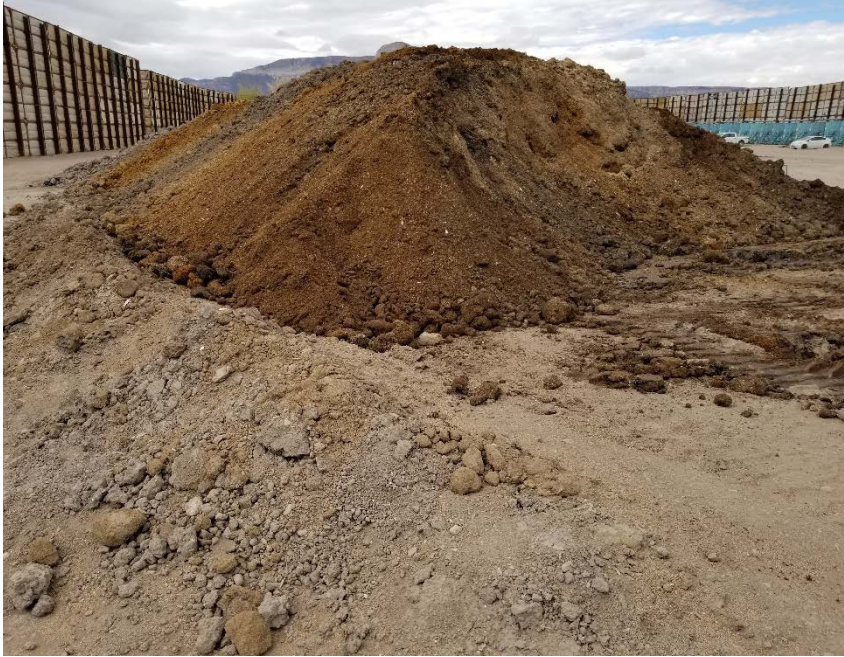
**Photo #11 – View of SE Special Waste stockpile from east side. Note absence of earthen berm and presence of equipment tracks on this side of stockpile.**

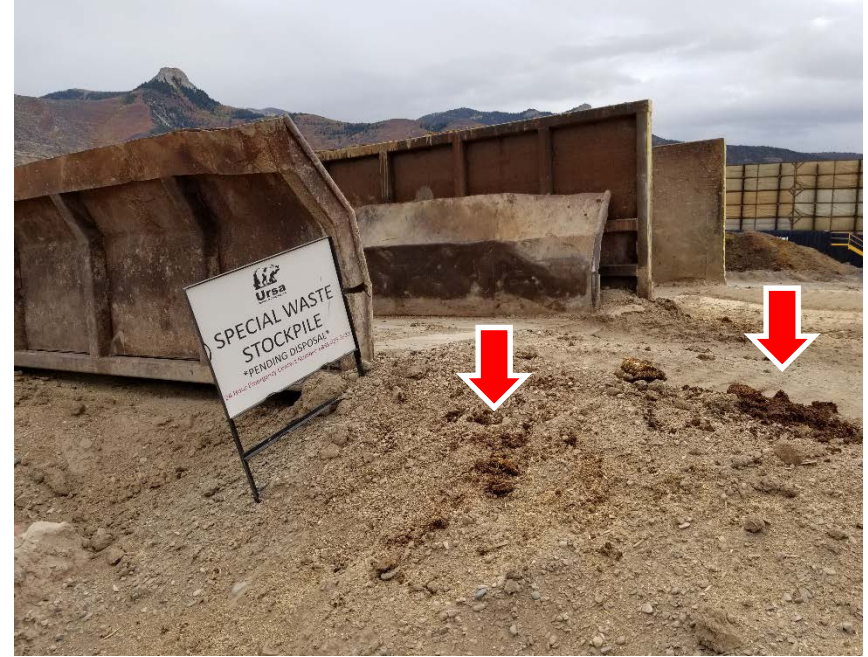
**Photo #12 – Special Waste stockpile sign located in NE corner of pad outside of metal container. Note localized accumulations of oil-stained soil on ramp leading into container (red arrows).**

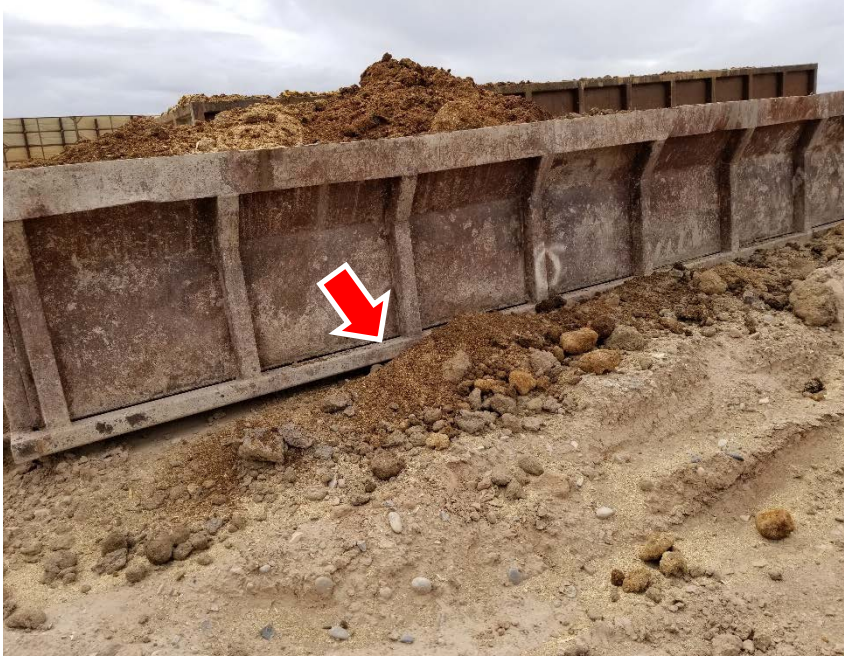
**Photo #13 – View of NE Special Waste stockpile from north side. Hydrocarbon odor detected from stockpiled material on inspection date. Note stockpiled material accumulation outside of metal container (red arrow). Operator was instructed to remove this impacted material during inspection.**

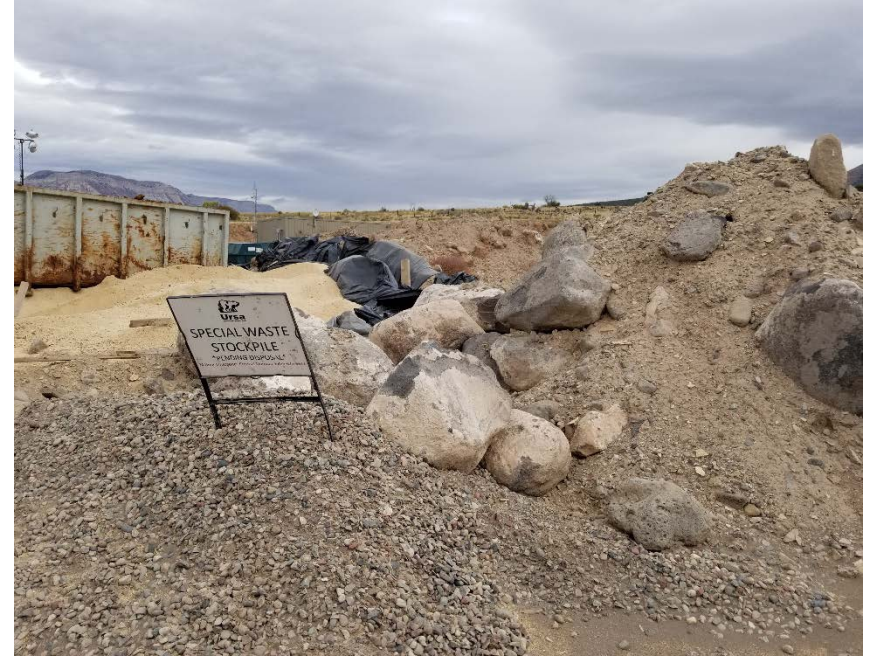
**Photo #14 – Additional Special Waste stockpile located in NE corner of pad did not appear to contain hydrocarbon-impacted material. Note presence of soil, boulders, road base, sawdust, wooden debris, black plastic, and vegetation. Pile also lacks stormwater control.**

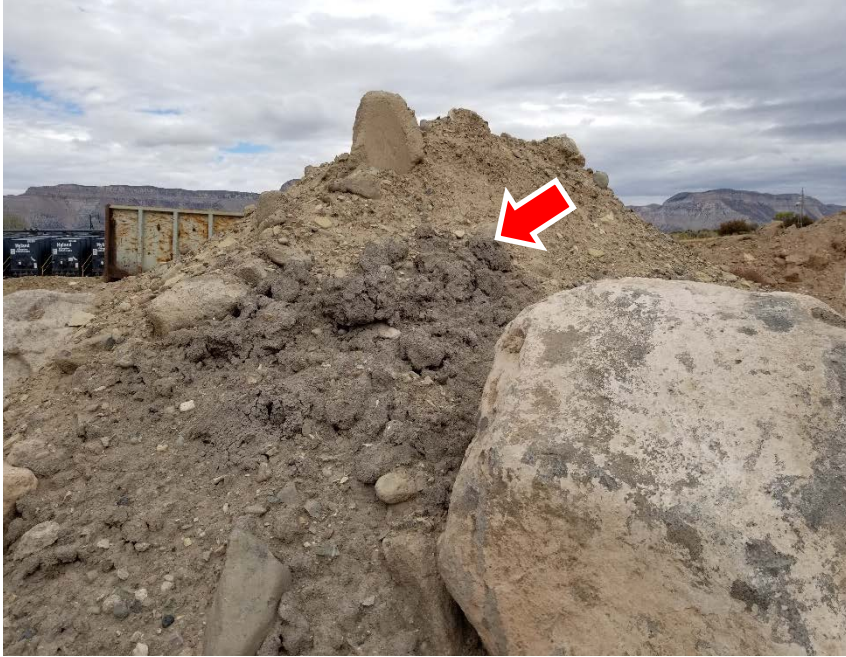
**Photo #15 – Cuttings were also present in NE Special Waste stockpile (red arrow).**

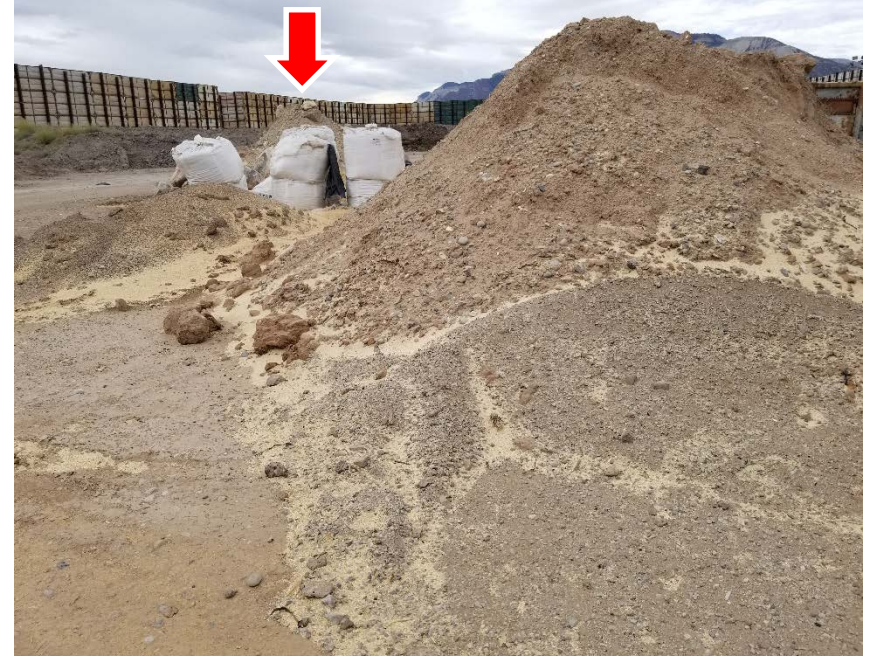
**Photo #16 – View of NE Special Waste stockpile from the east. Note white materials storage containers within stockpile (red arrow) and absence of stormwater control on this side of stockpile.**

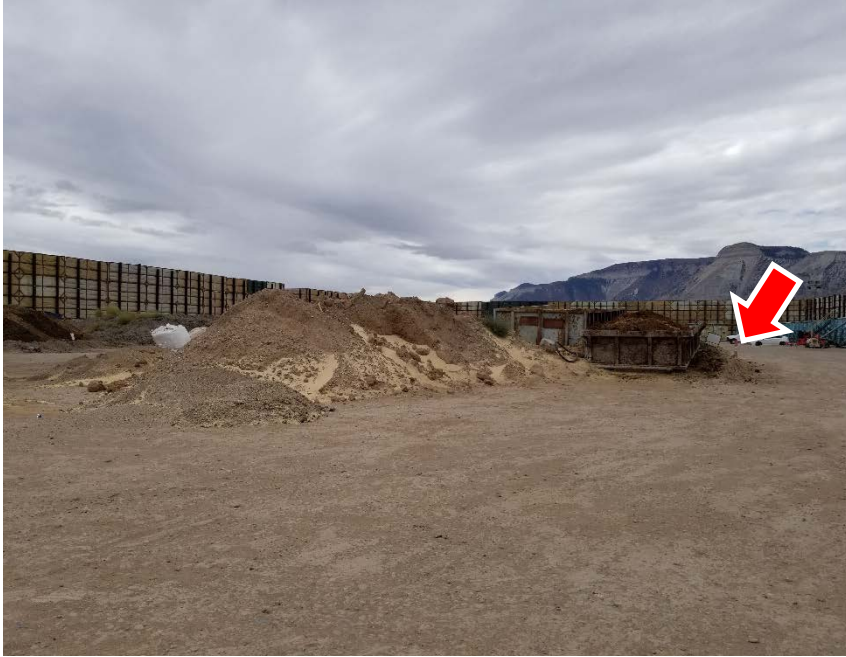
**Photo #17 – Overview of NE Special Waste Stockpiles from NE corner of pad. Note lack of stormwater control and presence of stained soil outside of metal container (red arrow).**

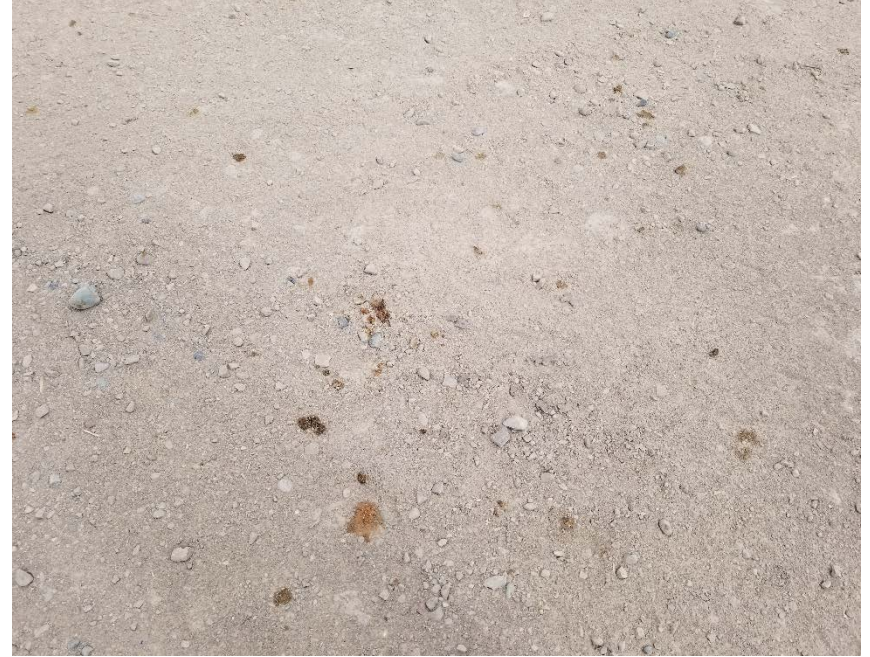
**Photo #18 – Localized accumulations of oil-stained soil on pad surface.**

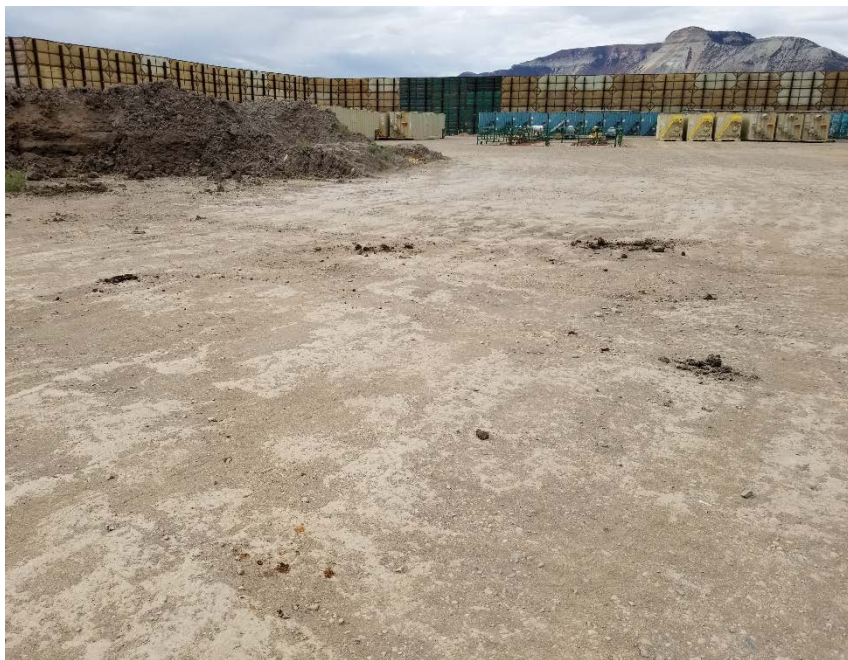
**Photo #19 – Localized accumulations of stained soil on pad surface.**

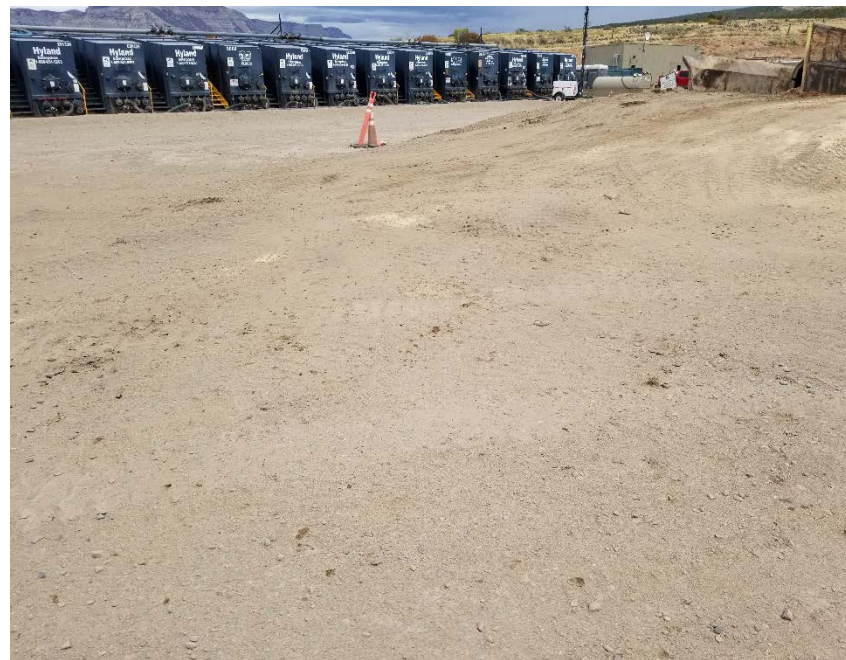
**Photo #20 – Localized accumulations of stained soil on pad surface.**
