Inspection Photos

Operator: Hilcorp Energy Co.

API: 05-067-07550

Date: 10/03/2018

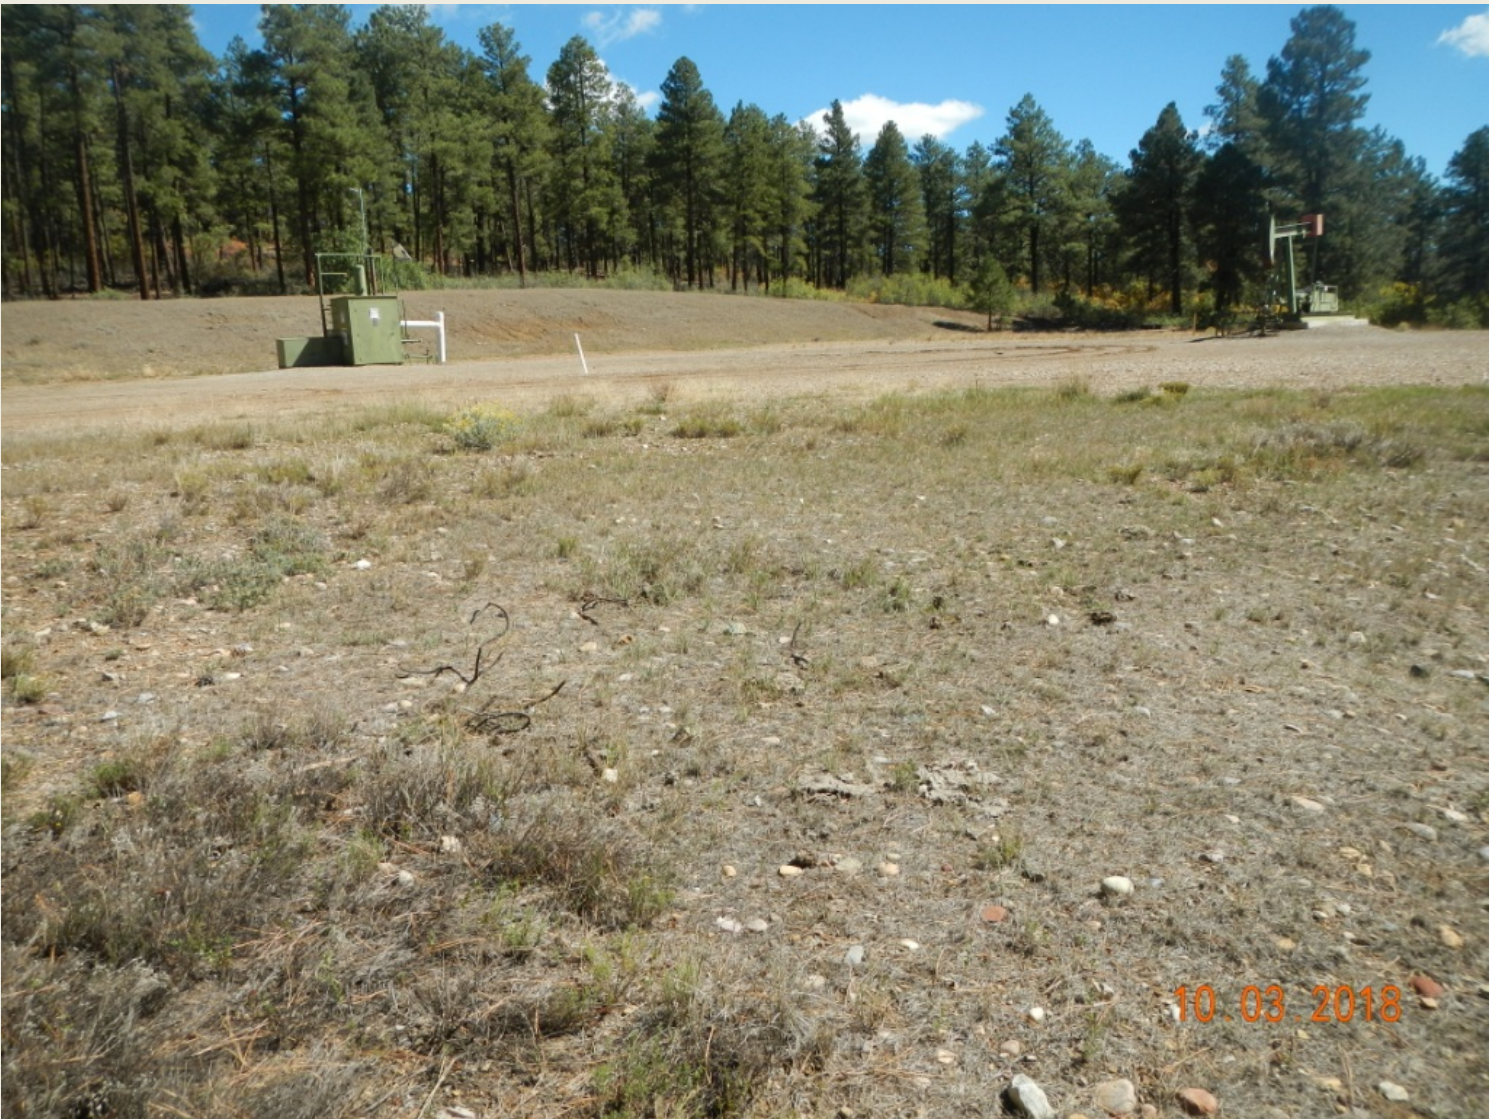
Photo 1. View of the project area from the northwestern corner facing center.

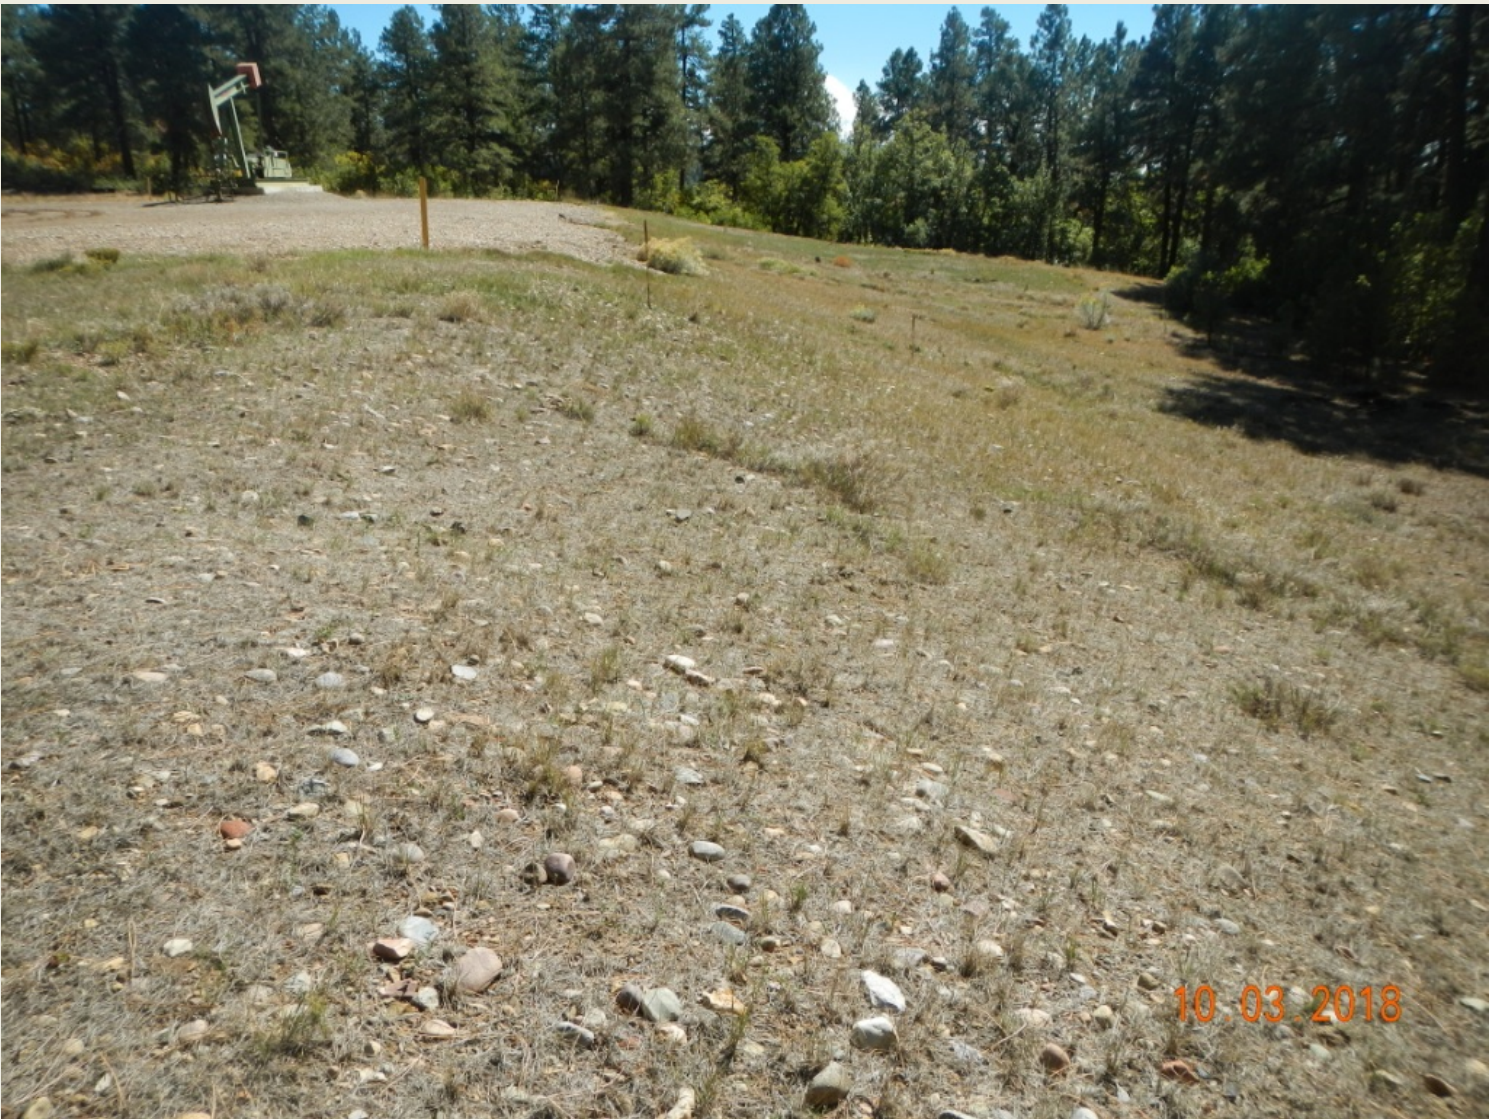
Photo 2. View of the western project area from the northwestern corner facing southward. Vegetation is becoming established with grasses such as western wheatgrass (*Pascopyrum smithii*), sand dropseed (*Sporobolus cryptandrus*), and forbs such as hairy goldenaster (*Heterotheca villosa*).

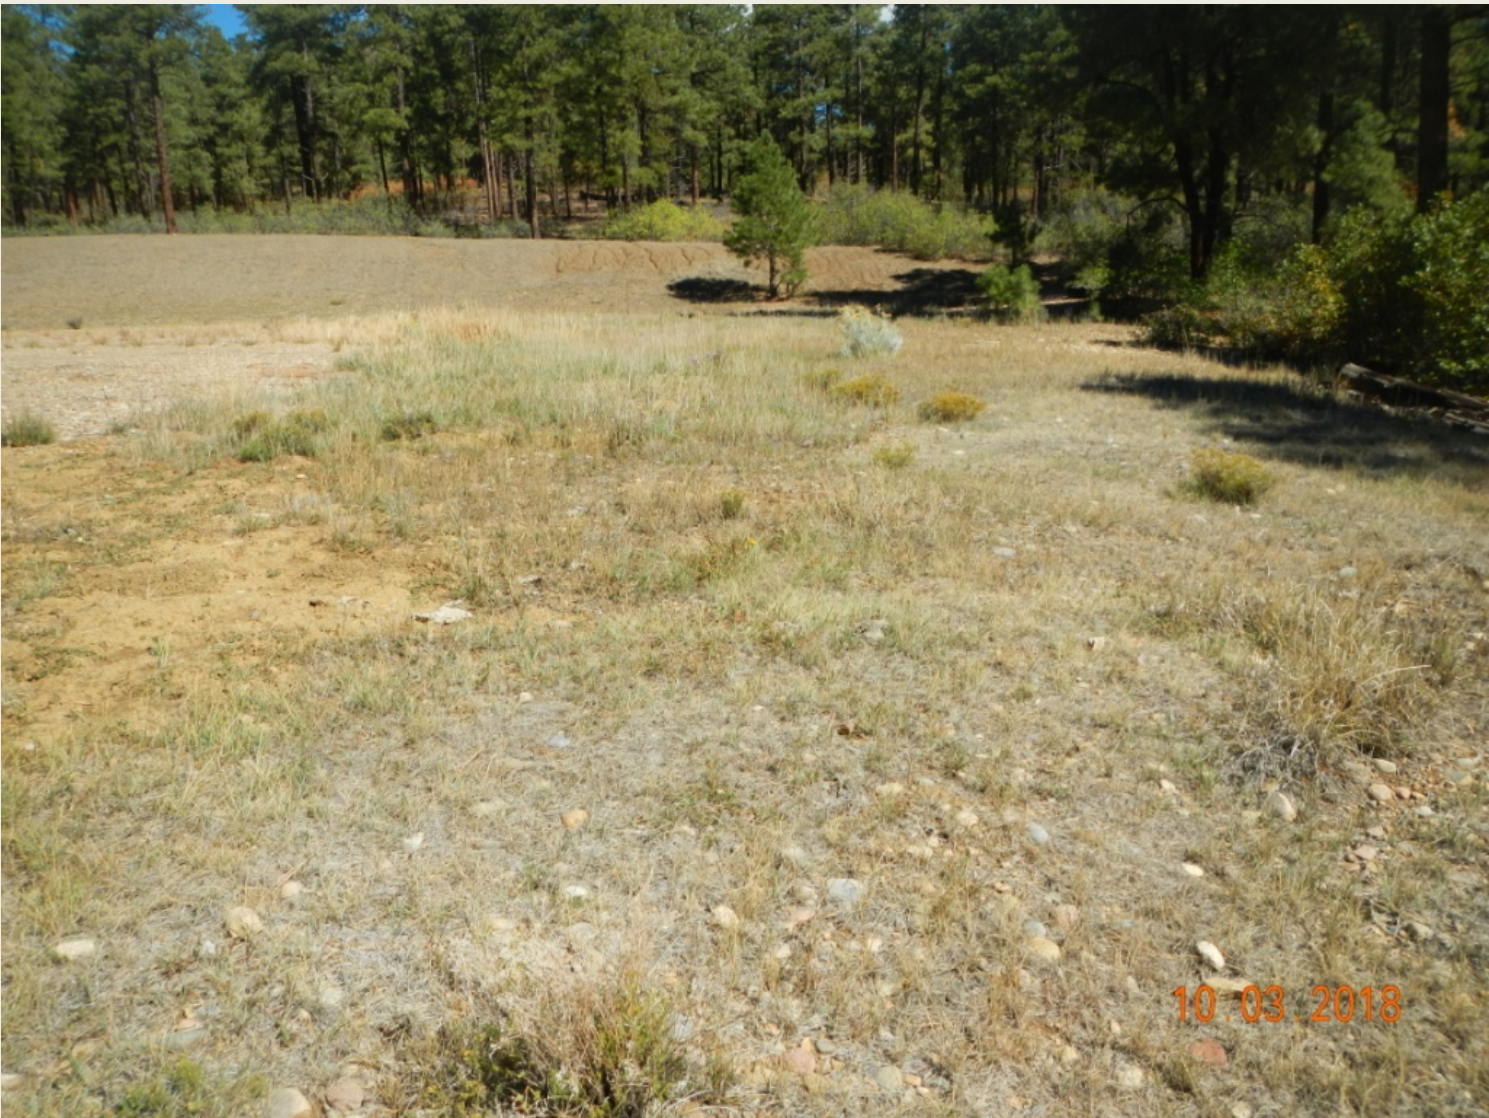
Photo 3. View of the southern project area from the southwestern corner facing eastward.

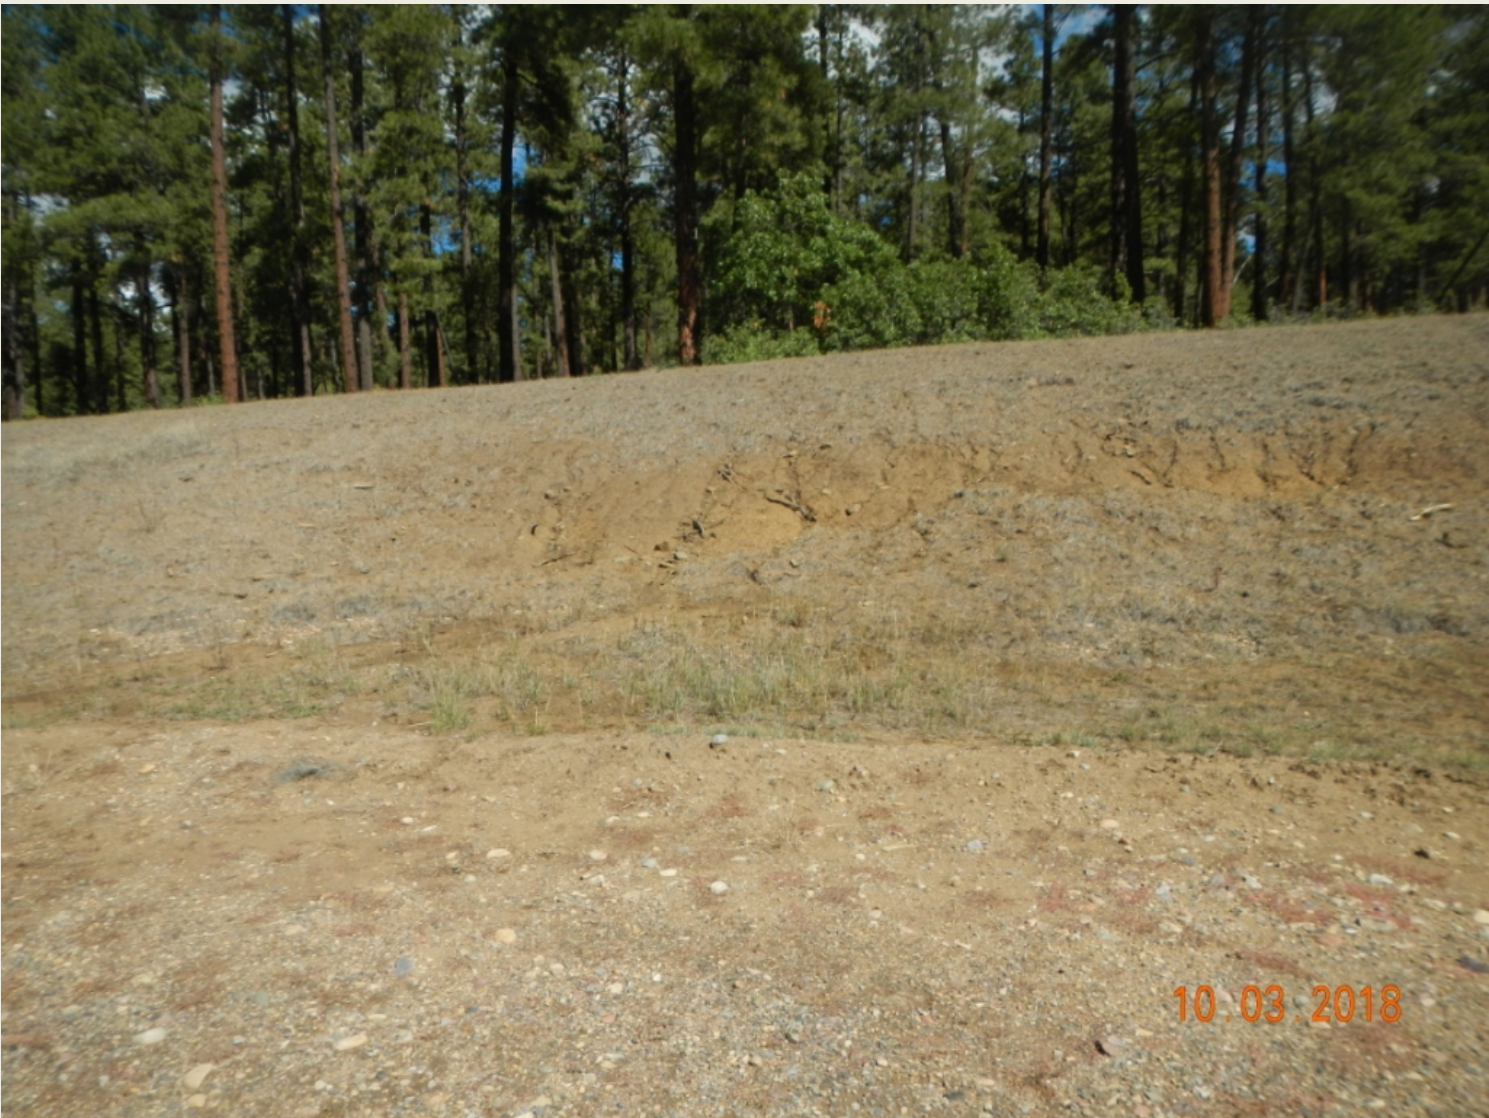
Photo 4. View of area in the eastern cut-slope where rilling is occurring on sparsely vegetated slope.
