# Inspection Photos

Operator: BP America

API: 05-067-08323

Date: 10/03/2018

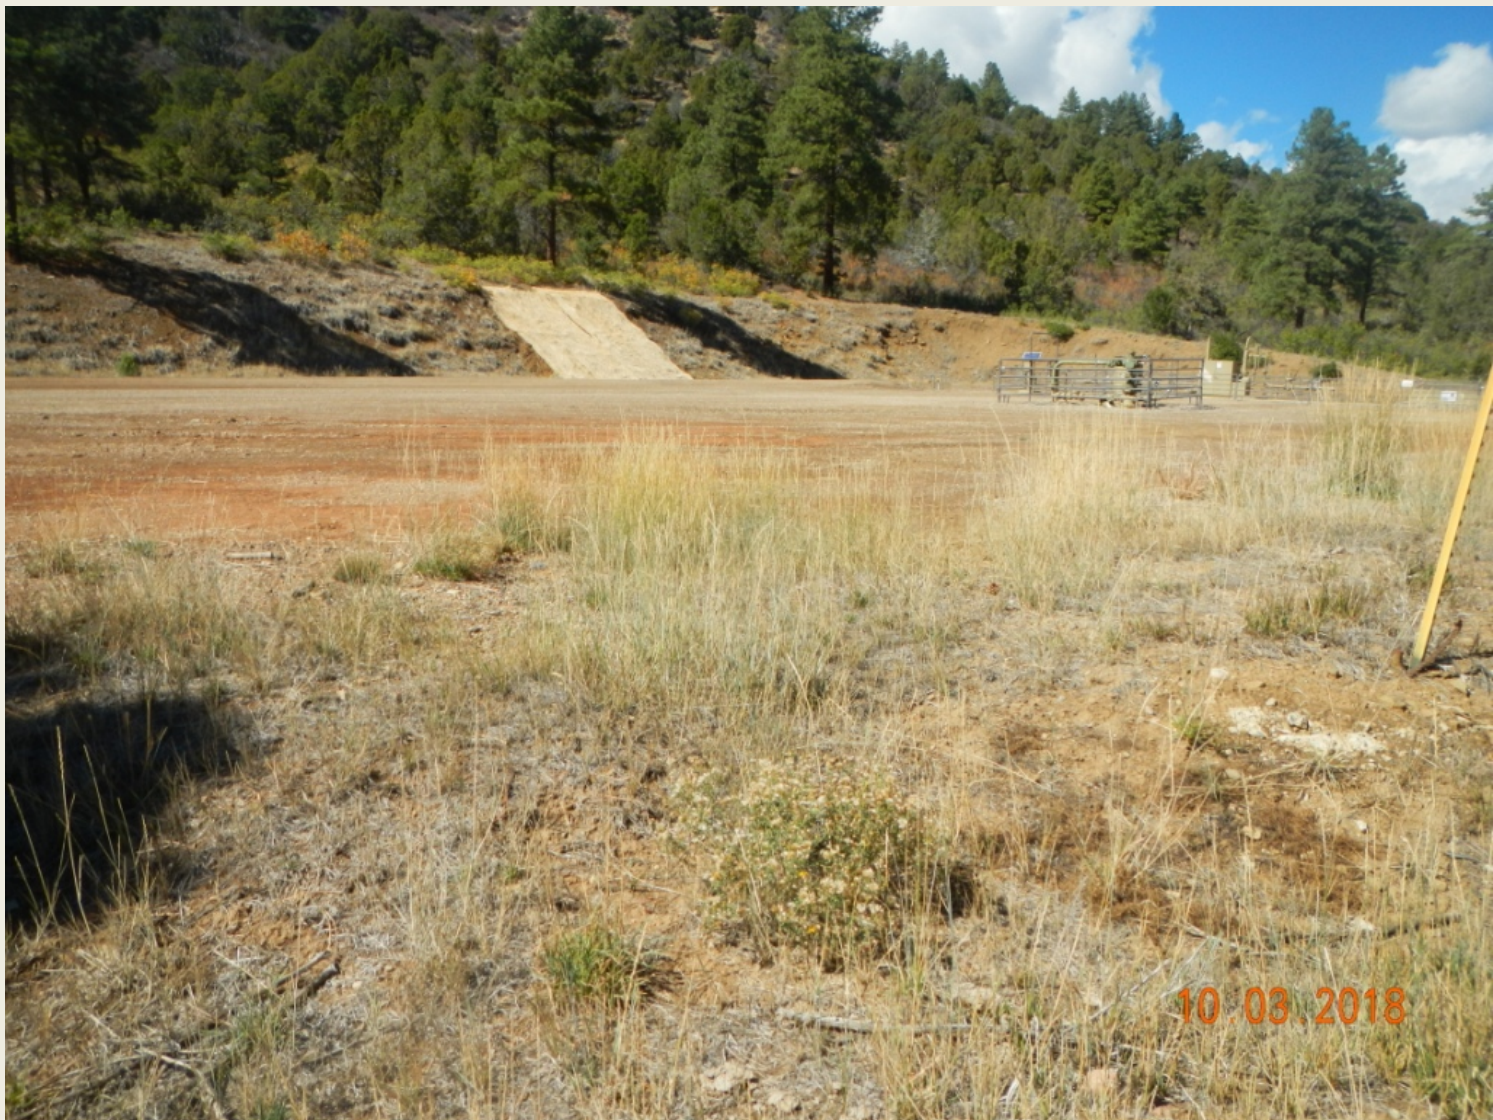
**Photo 1. View of the project area from the southeastern corner facing center.**

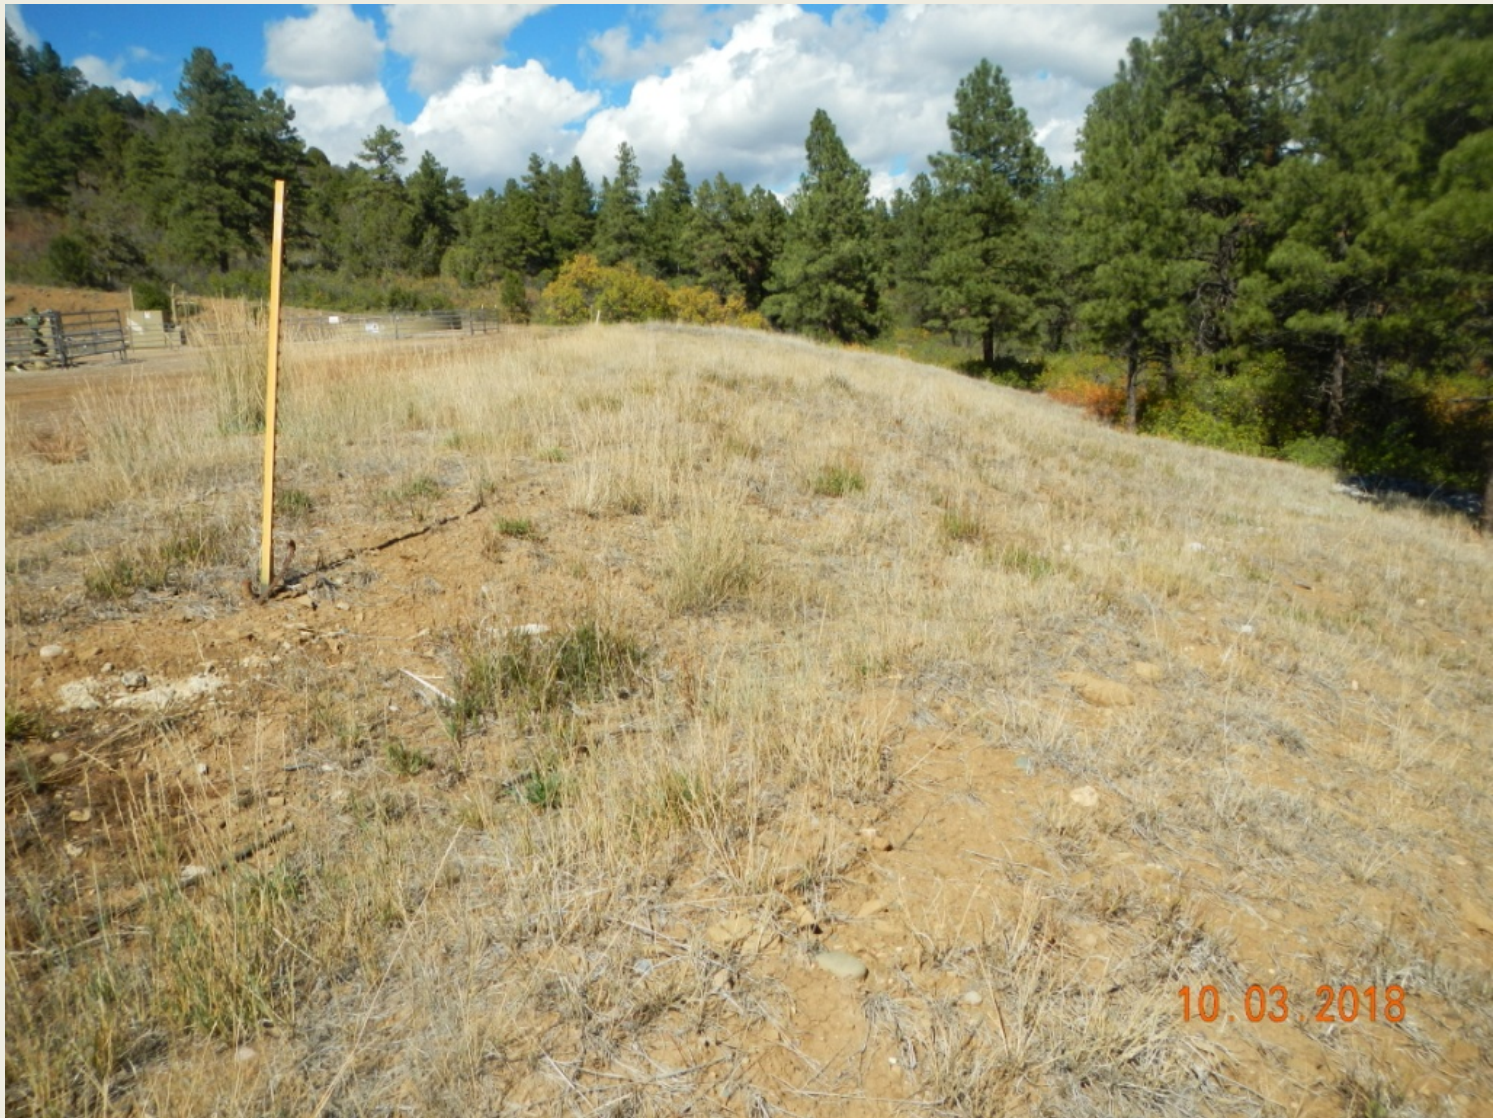
Photo 2. View of the eastern project area from the southeastern corner facing northward. Vegetation is becoming established with grasses such as western wheatgrass (*Pascopyrum smithii*) and intermediate wheatgrass (*Thinopyron intermedium*).

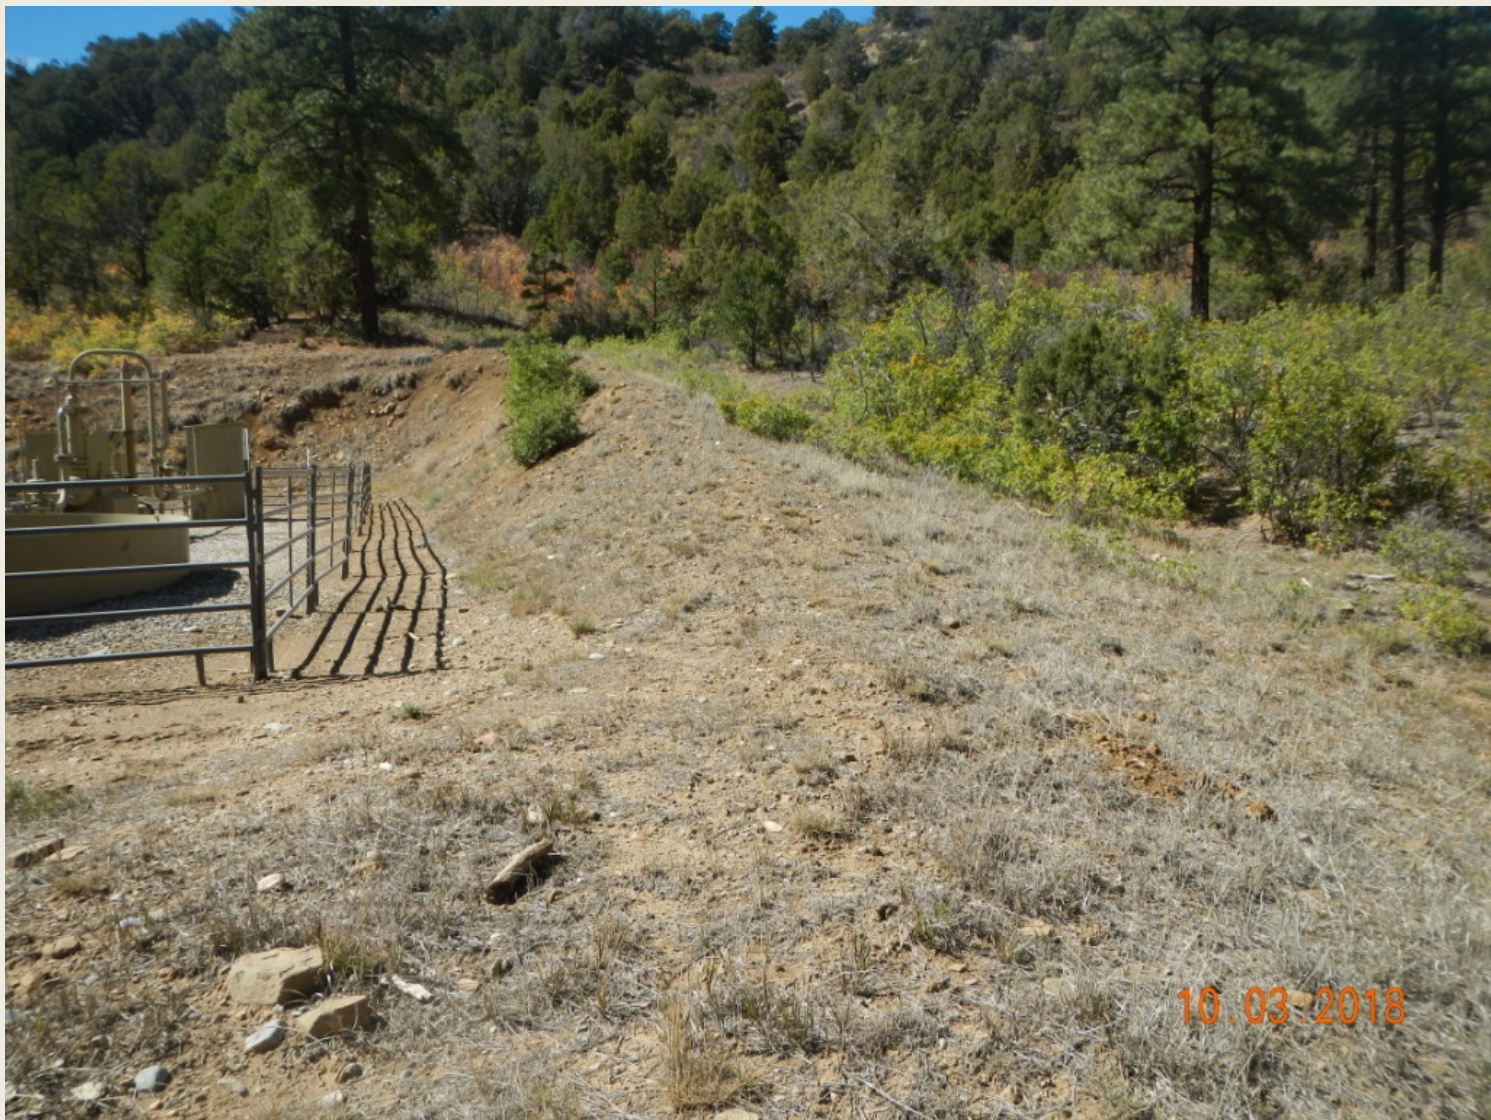
**Photo 3. View of the northern project area from the northeastern corner facing westward.**

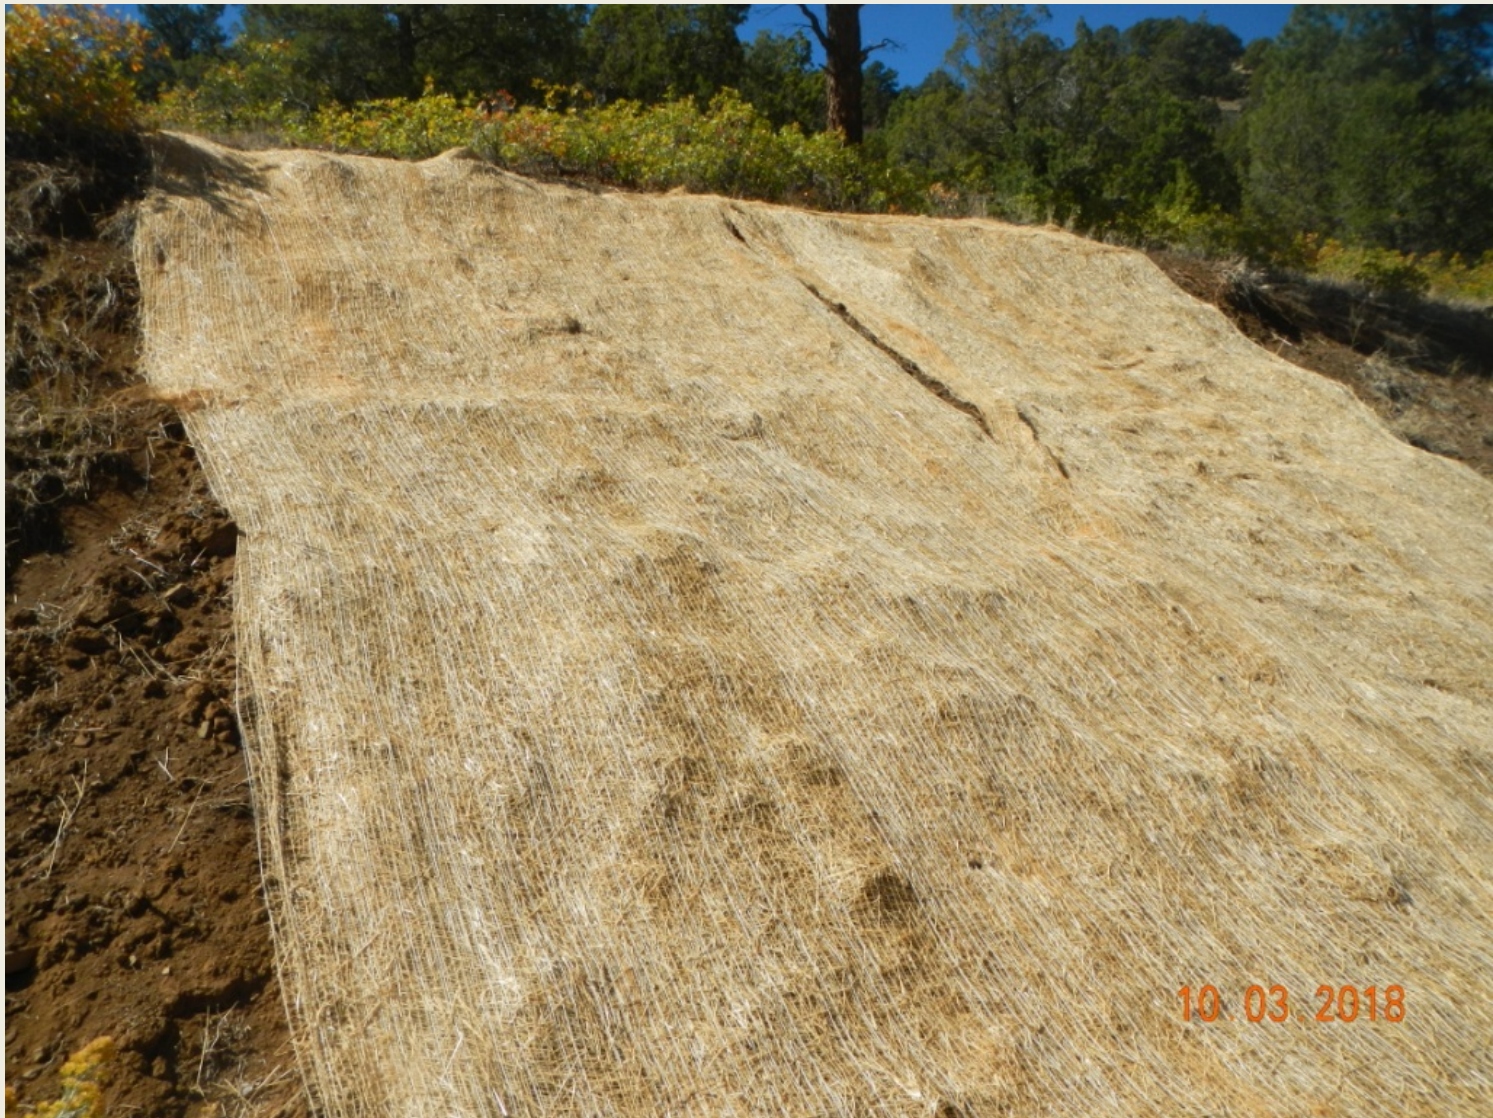
**Photo 4. View of area in the western cut-slope where straw blanket was recently installed for erosion control.**

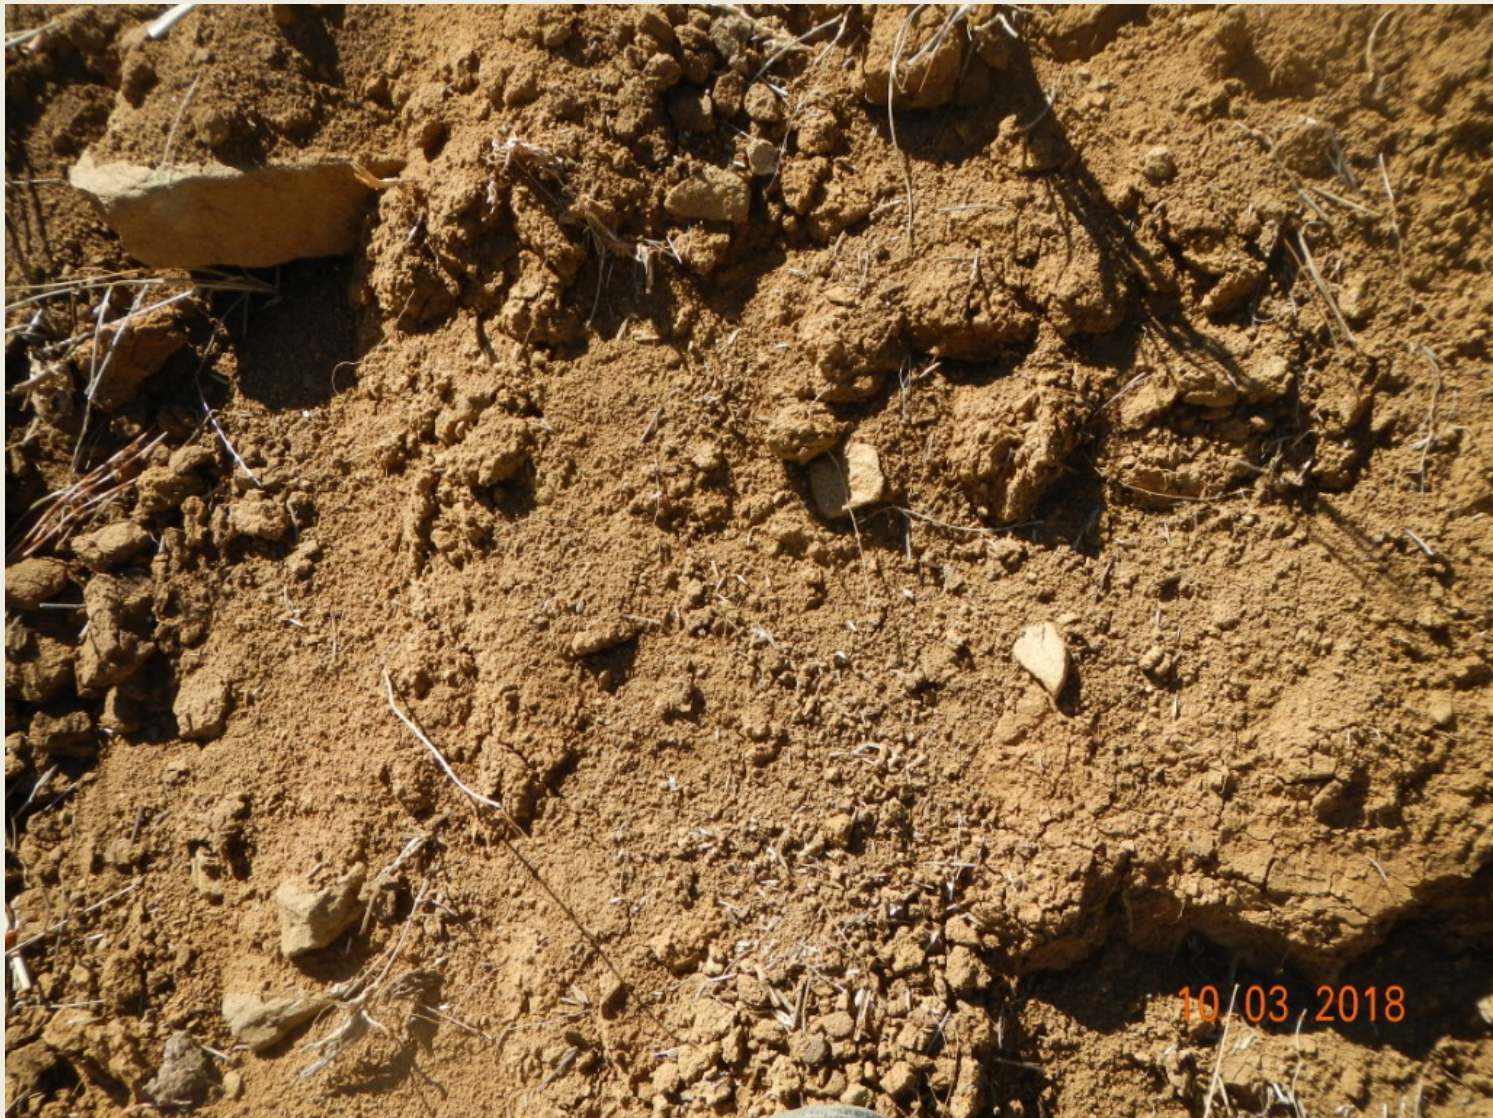
**Photo 5. Closeup view of disturbed soil in the western project area with visible seed on soil surface.**

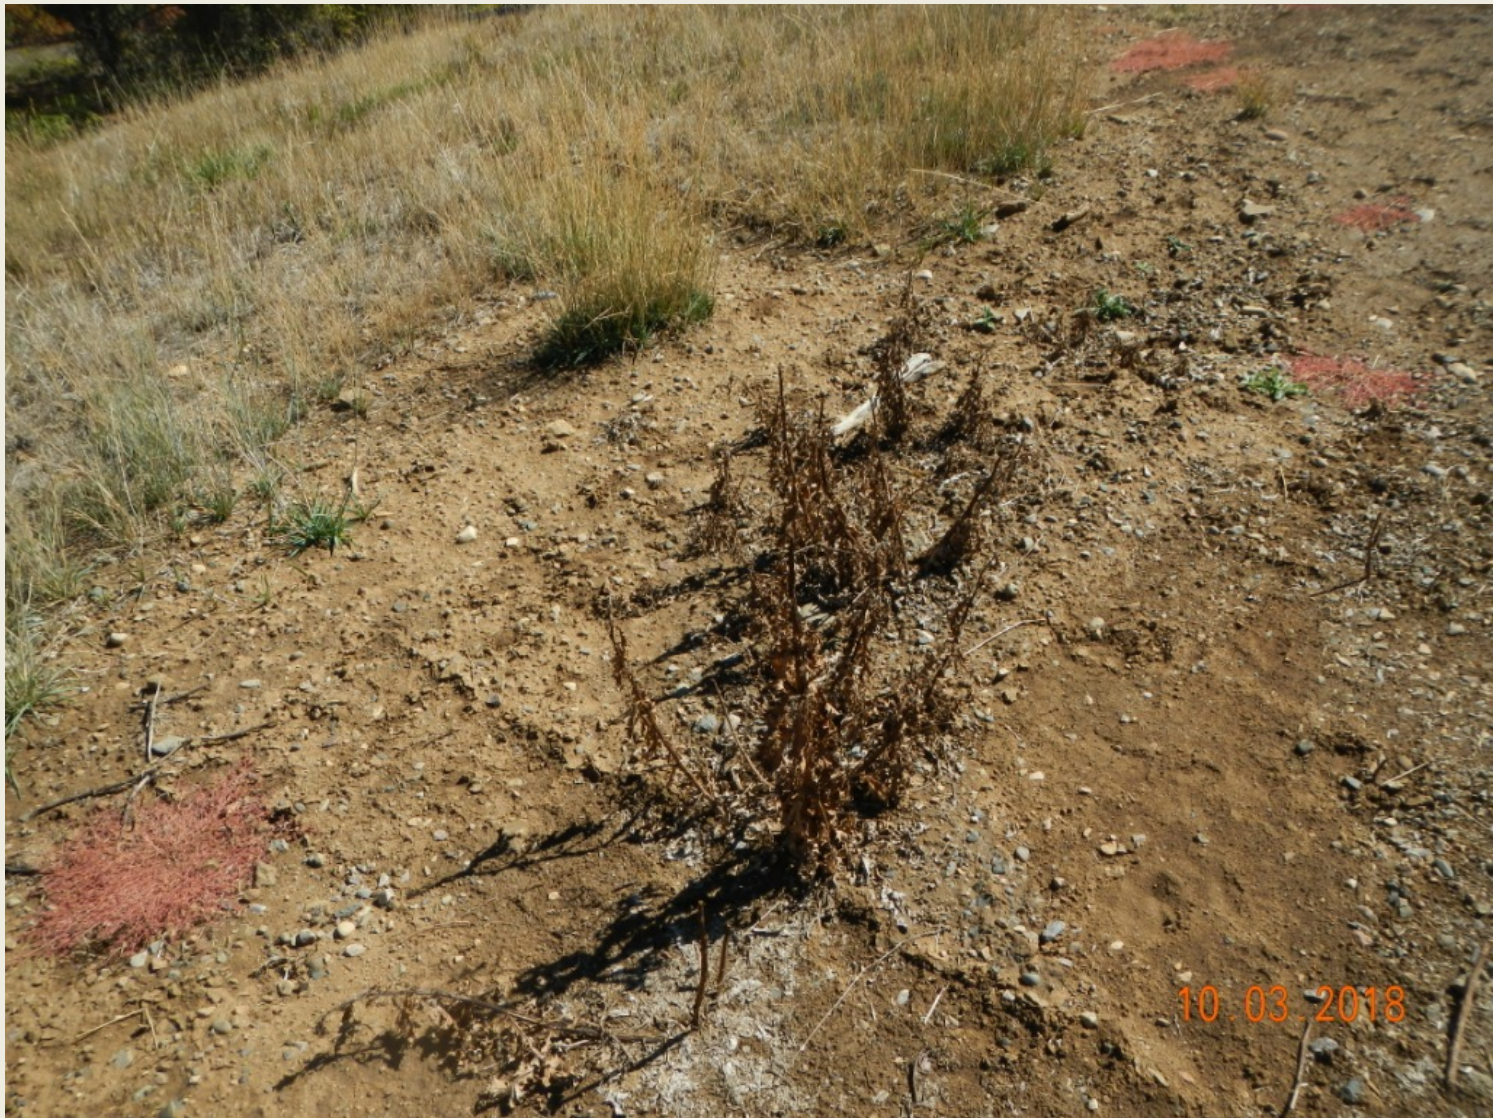
**Photo 6. View of weeds in eastern project area that appear to be treated.**
