Inspection Photos

Operator: BP America

API: 05-067-07158

Date: 10/03/2018

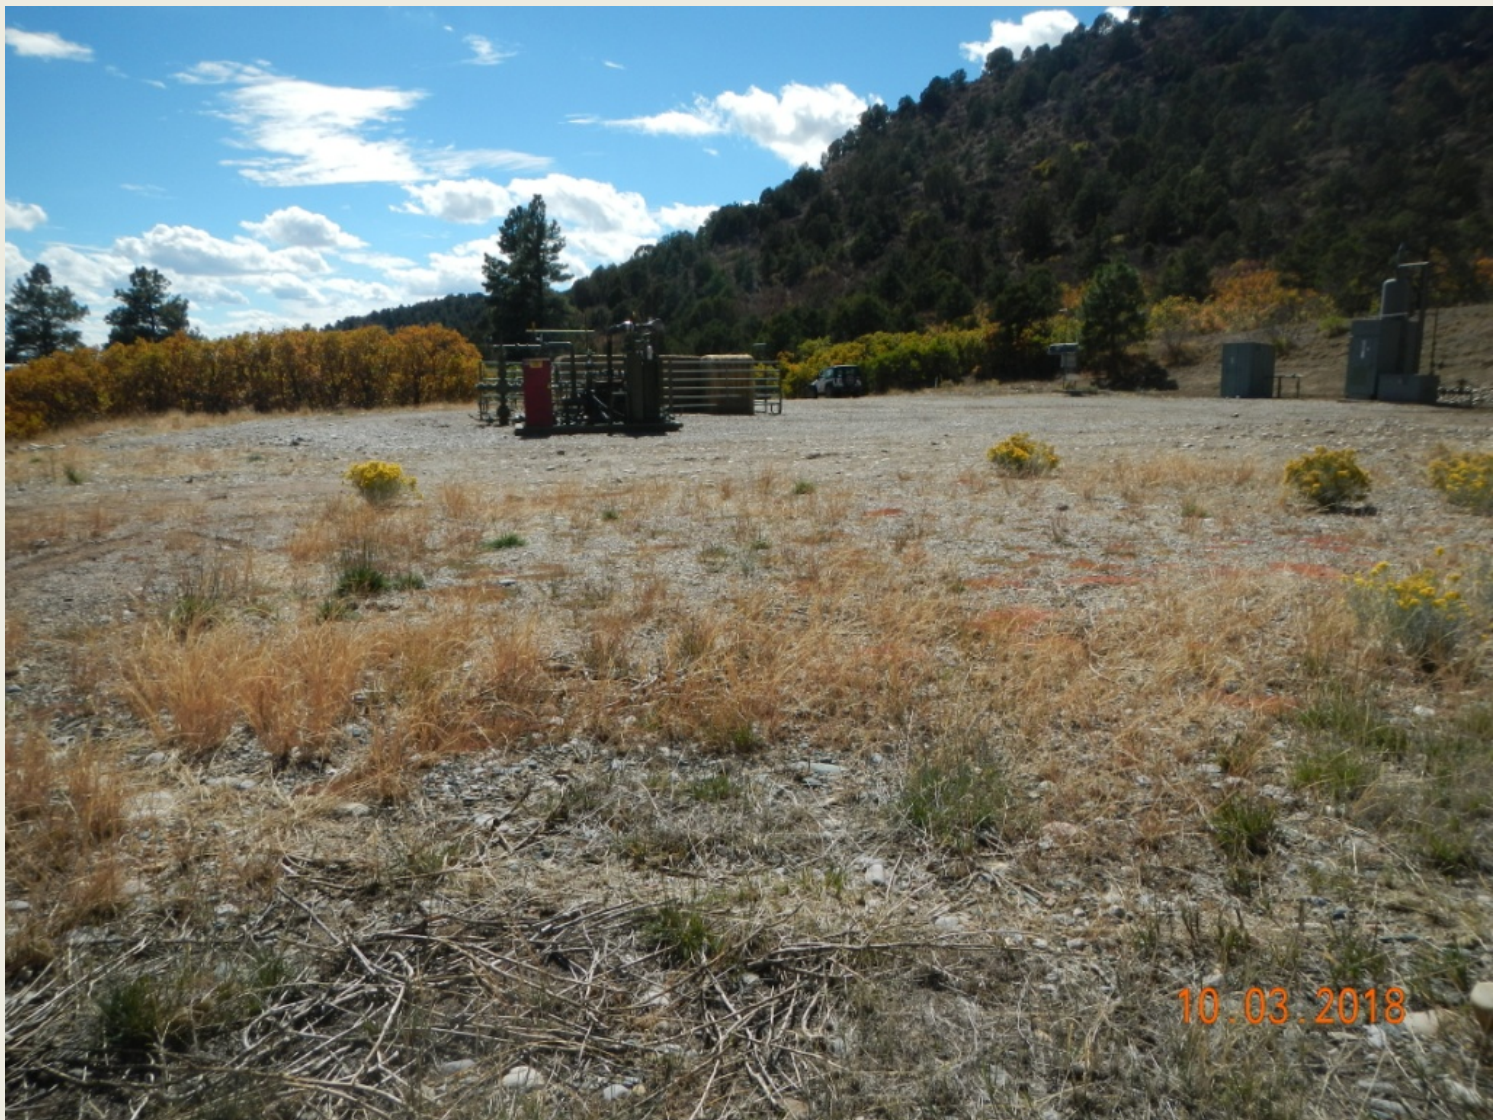
Photo 1. View of the project area from the northeastern corner facing center.

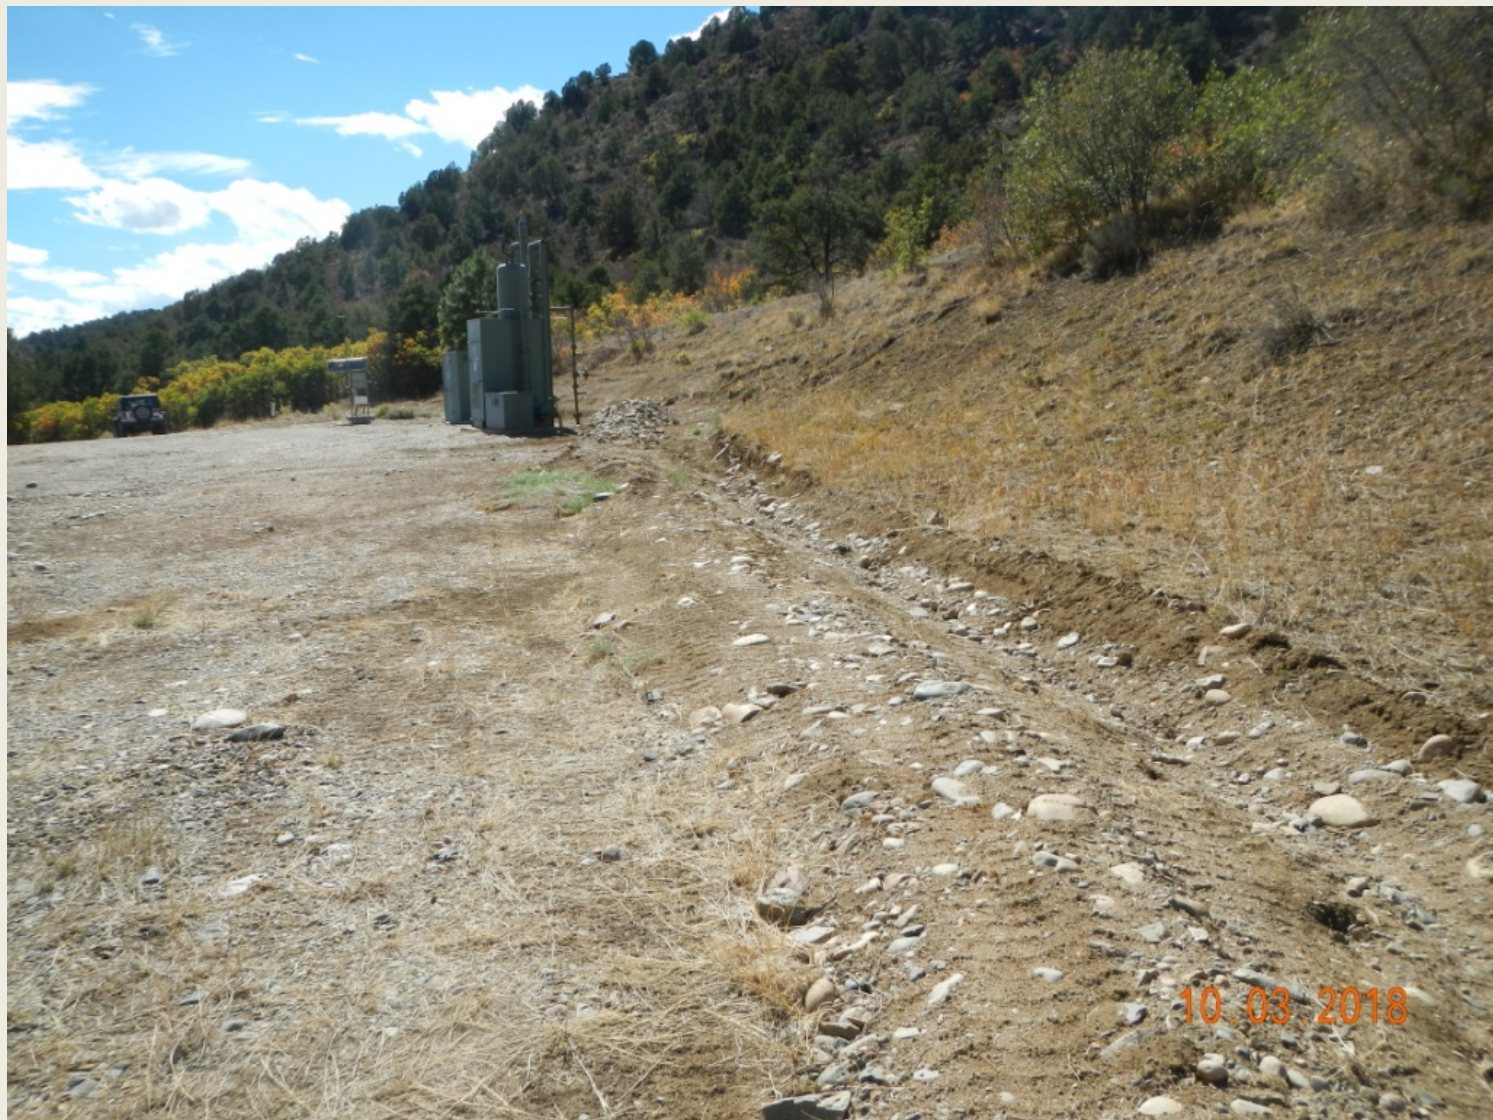
Photo 2. View of the western project area from the northwestern corner facing southward. Vegetation is becoming established with grasses such as western wheatgrass (*Pascopyrum smithii*), smooth brome (*Bromus inermis*), and sand dropseed (*Sporobolus cryptandrus*).

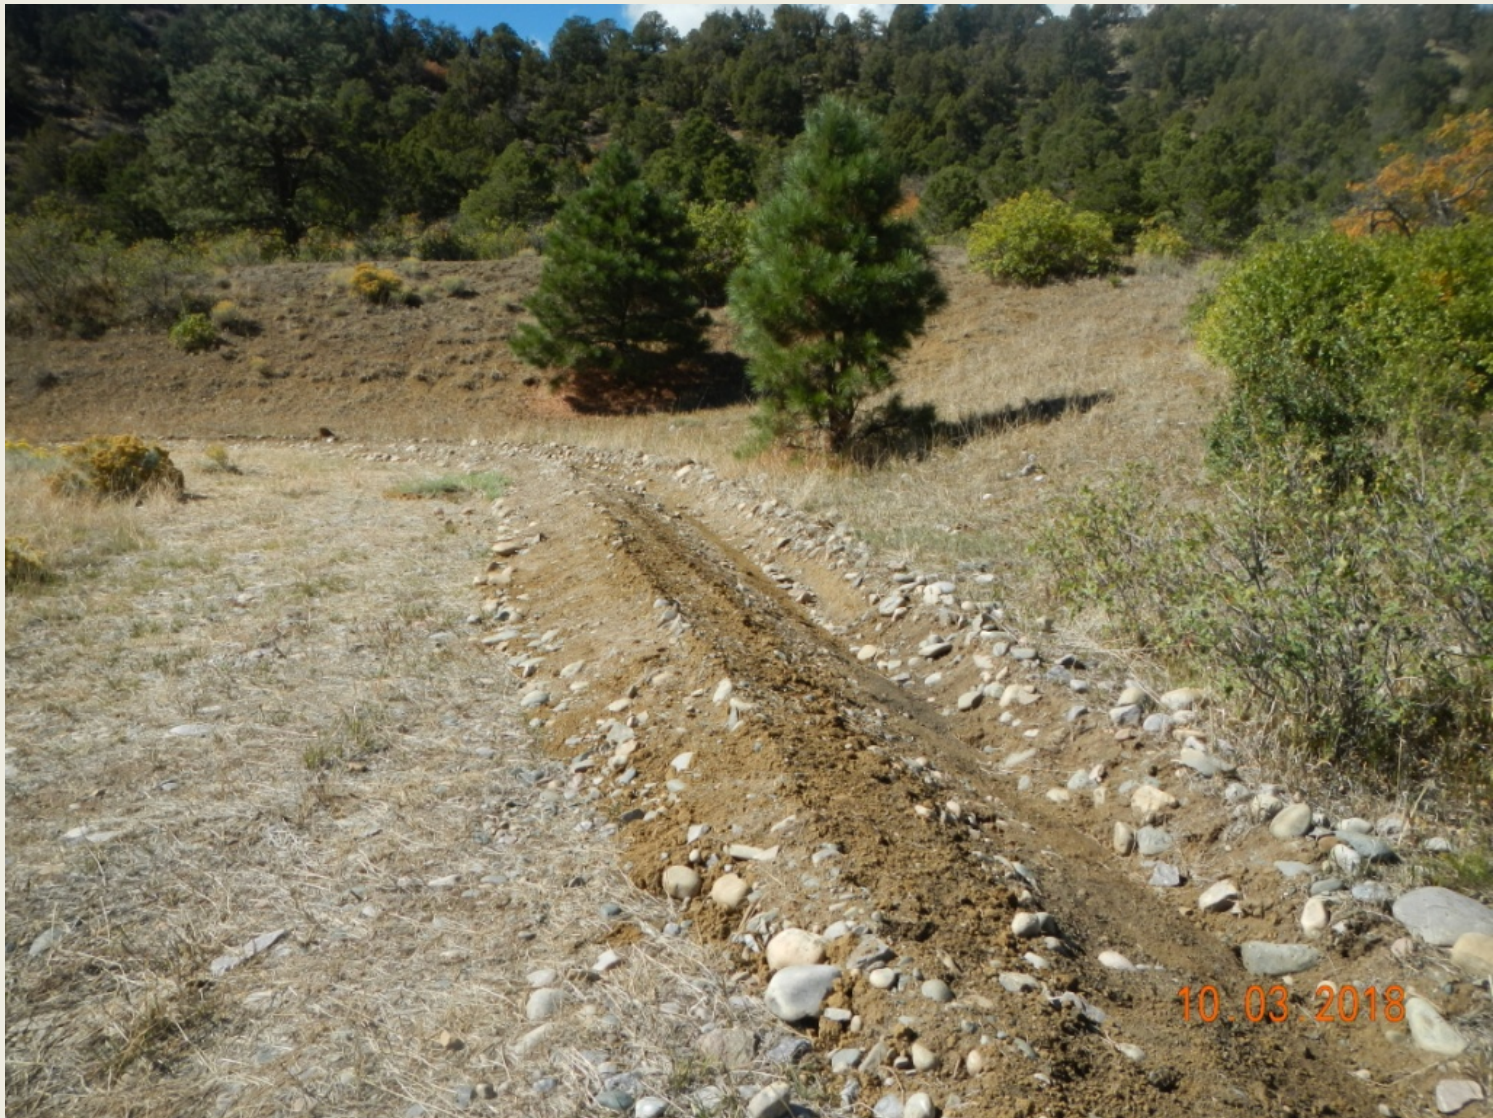
Photo 3. View of the northern project area from the northeastern corner facing westward. Stormwater diversion is recently graded.

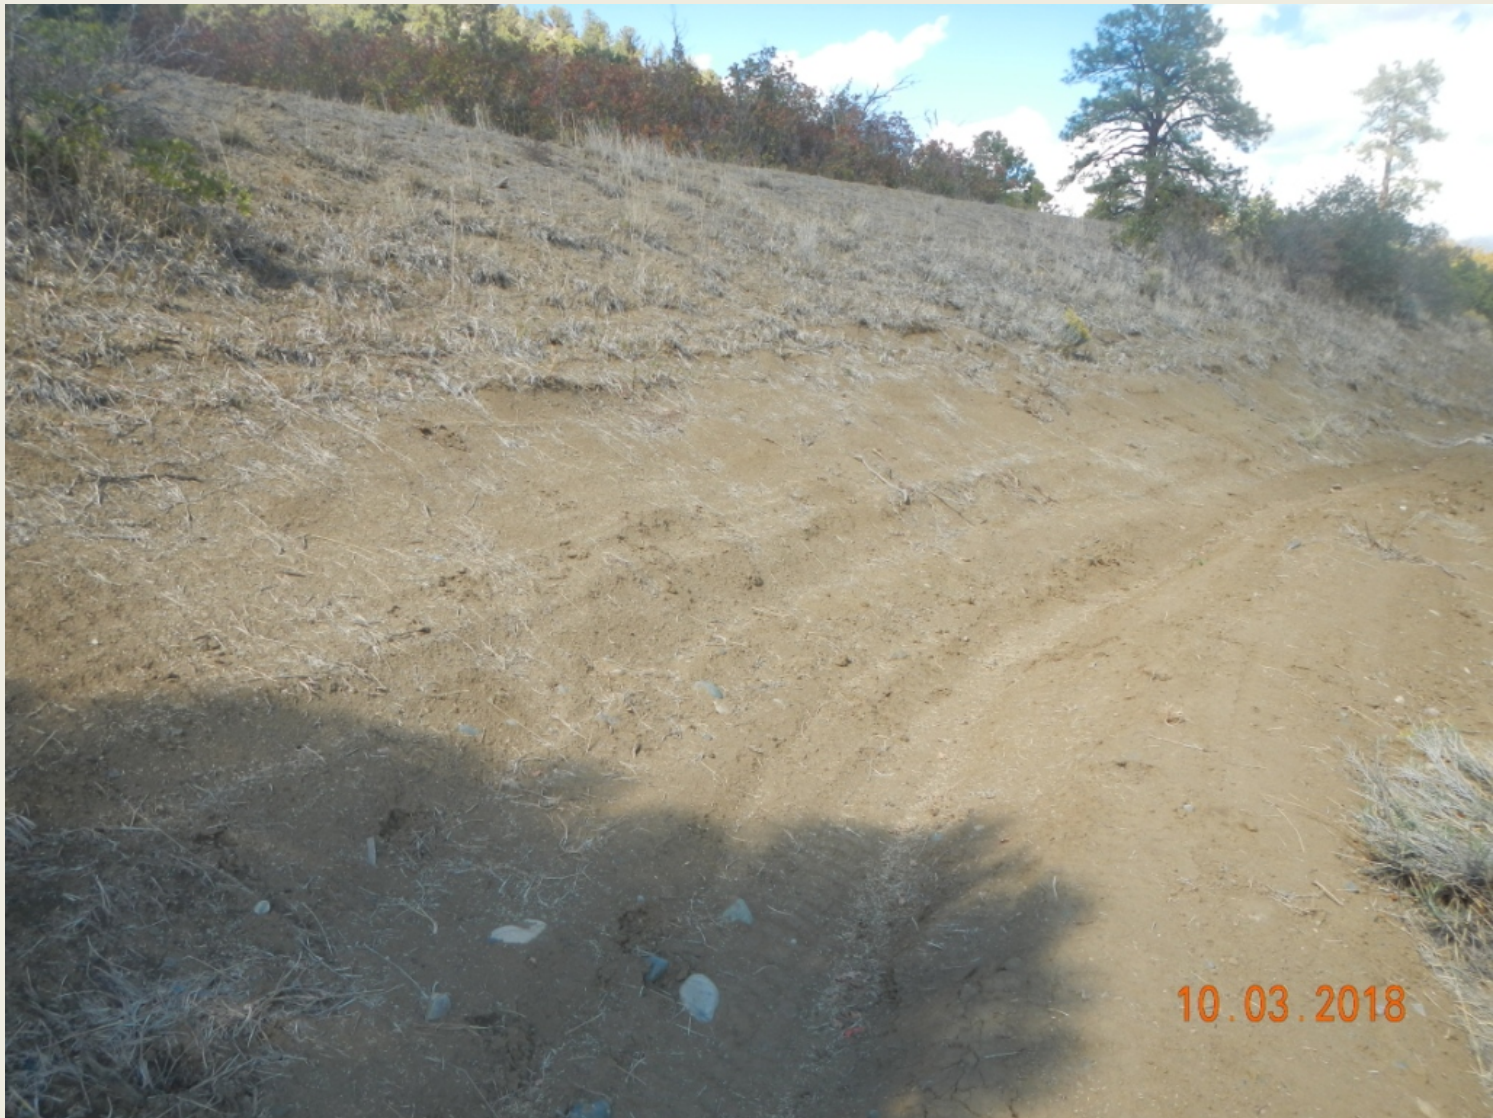
Photo 4. View of the southwestern project area from the southwestern corner facing northward. Berm and lower project area was recently graded and seeded.

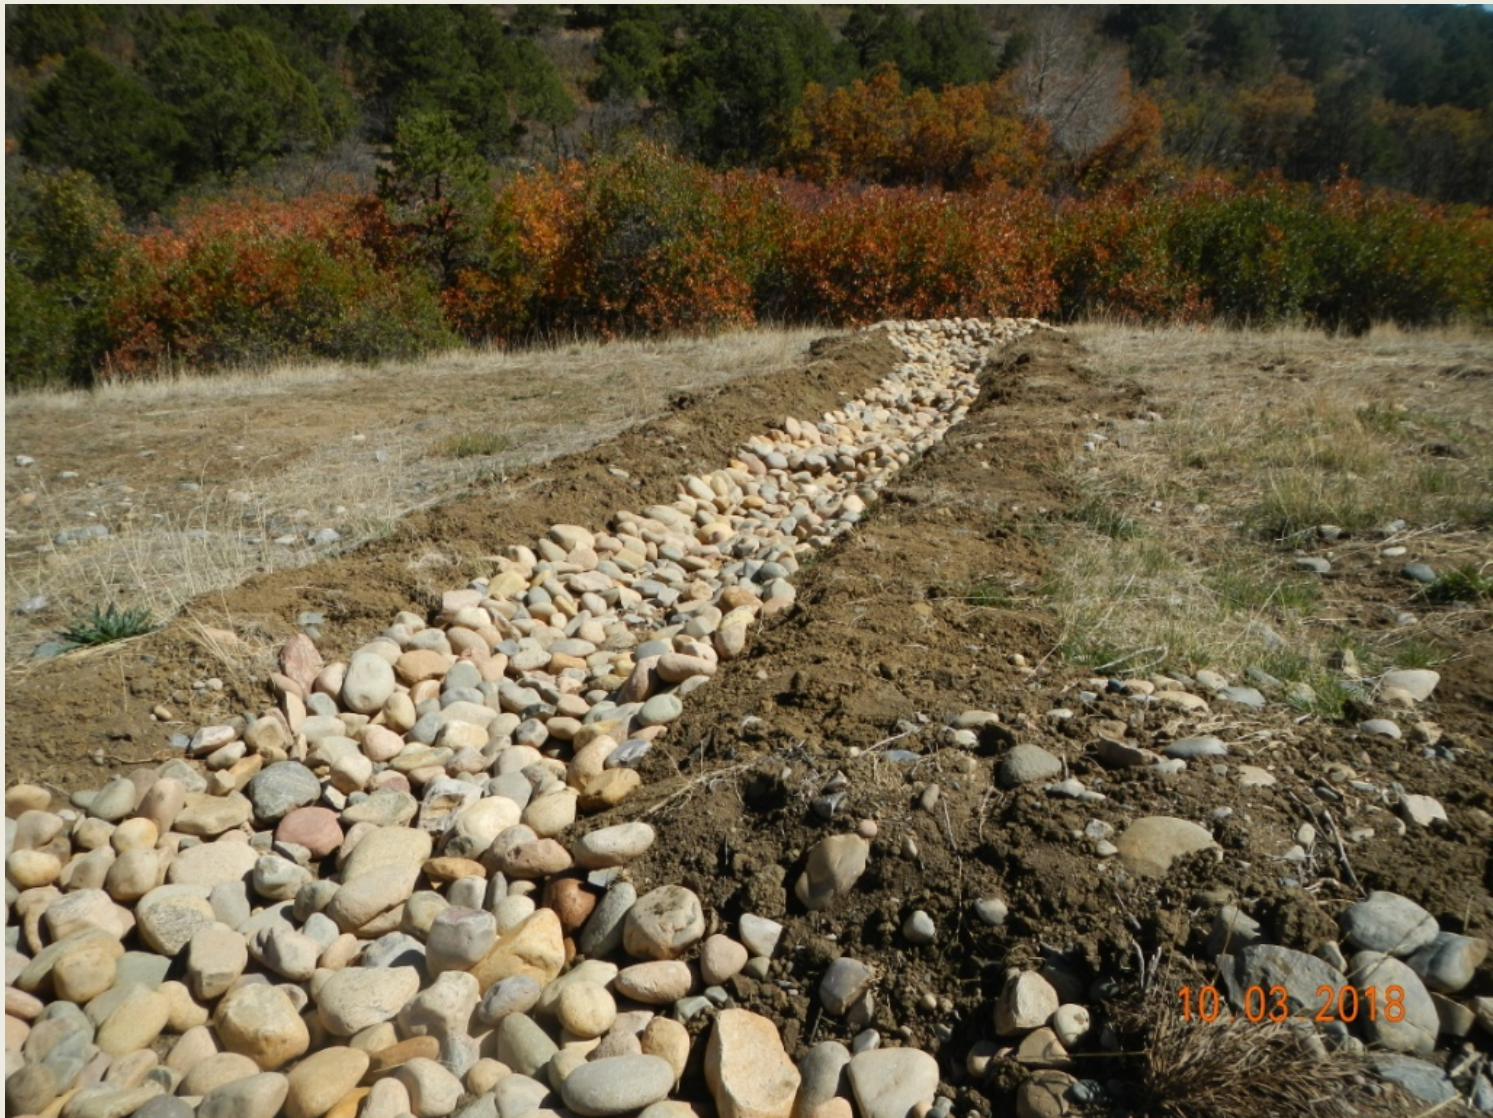
Photo 5. View of cobble run-down and silt trap within the eastern project area.

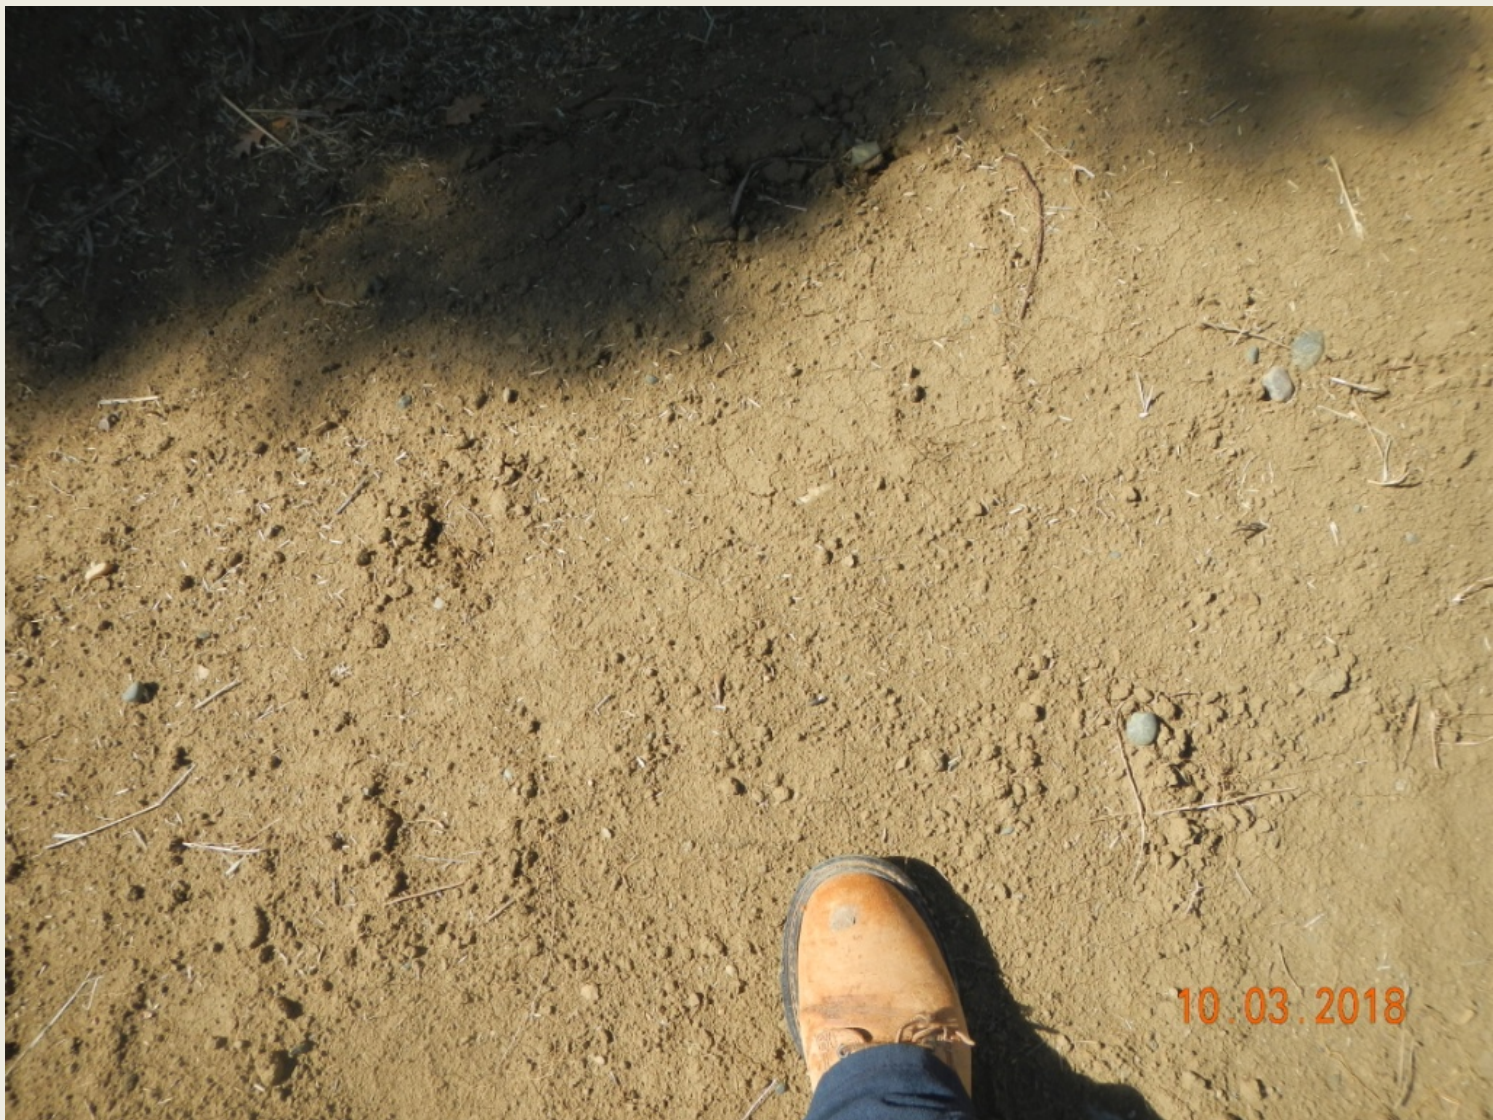
Photo 6. Closeup view of seed apparent on disturbed soil surface.
