Inspection Photos
Location Name: Walker Ann #2
Location ID: 320177

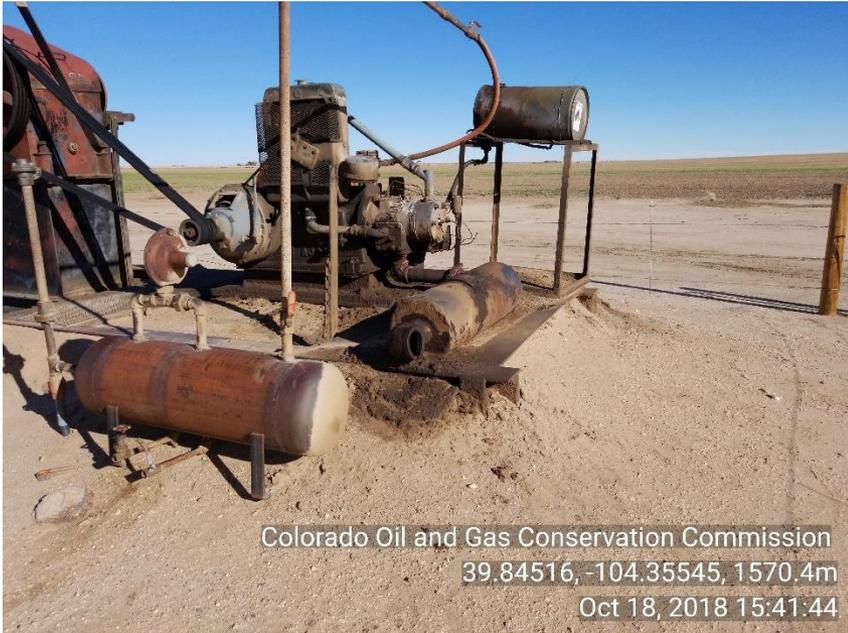
Photo 3 Stained soil exhaust

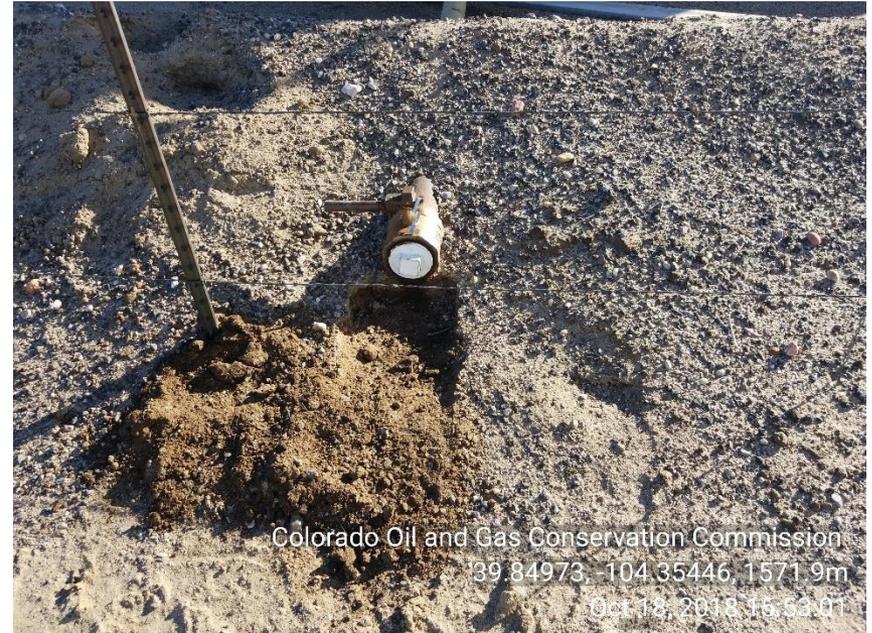
Photo 4 Stained soil crude oil load out line

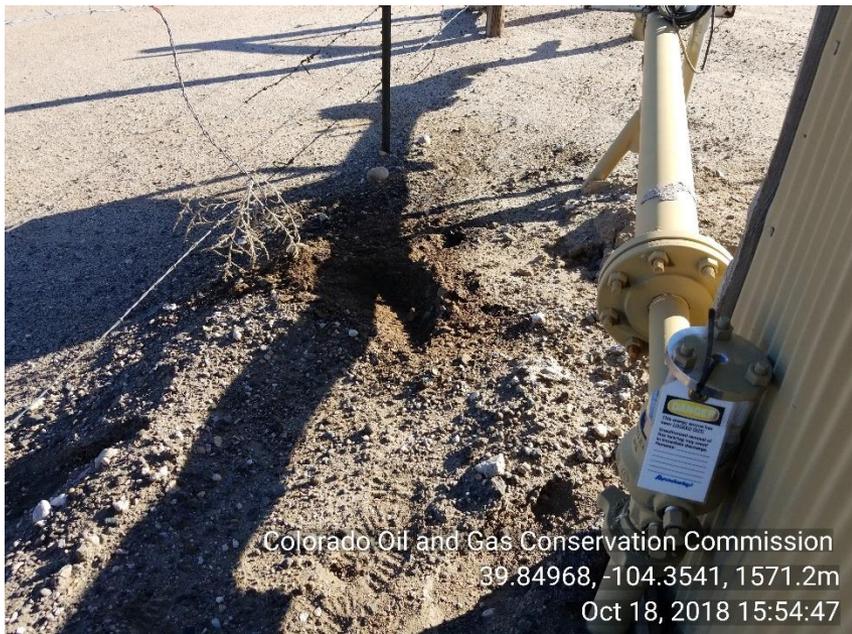
Photo 5 Stained soil by meter run. Meter run locked out tagged out
