**Inspection Photos**  
**Location Name: UPRR 23 Pan AM D2**  
**Location ID: 319939**

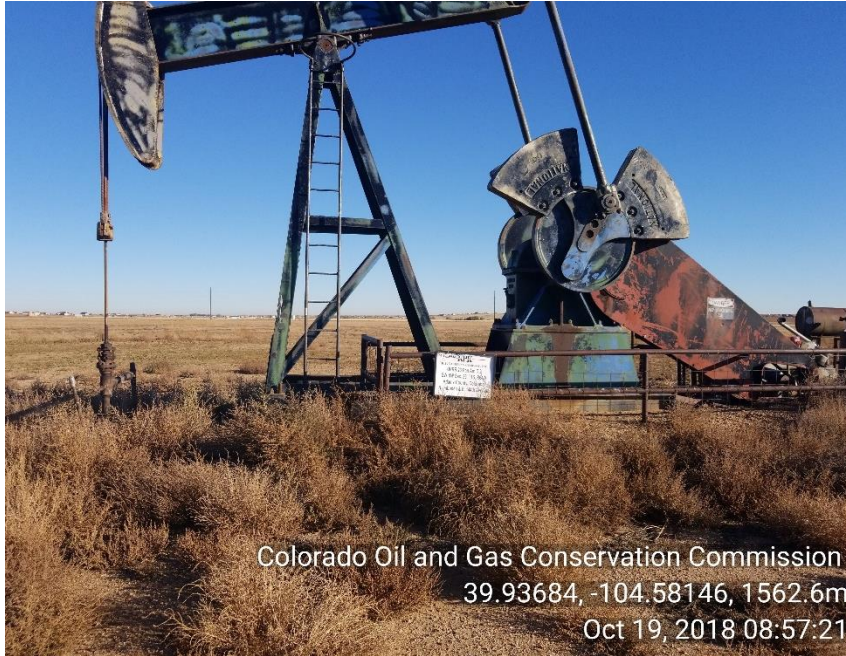
**Photo 1 WH WEEDS**

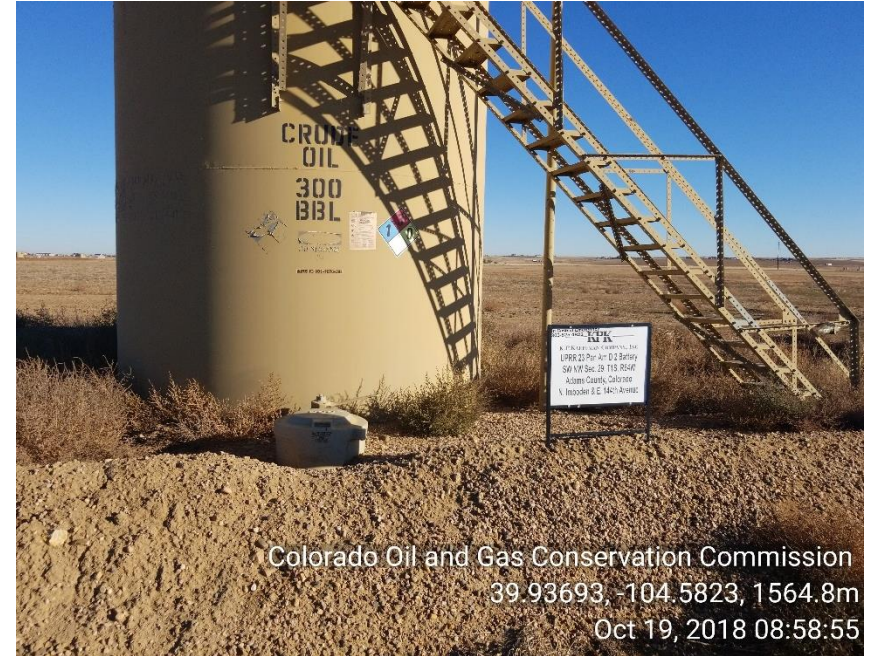
**Photo 2 TNK BTRY WEEDS**

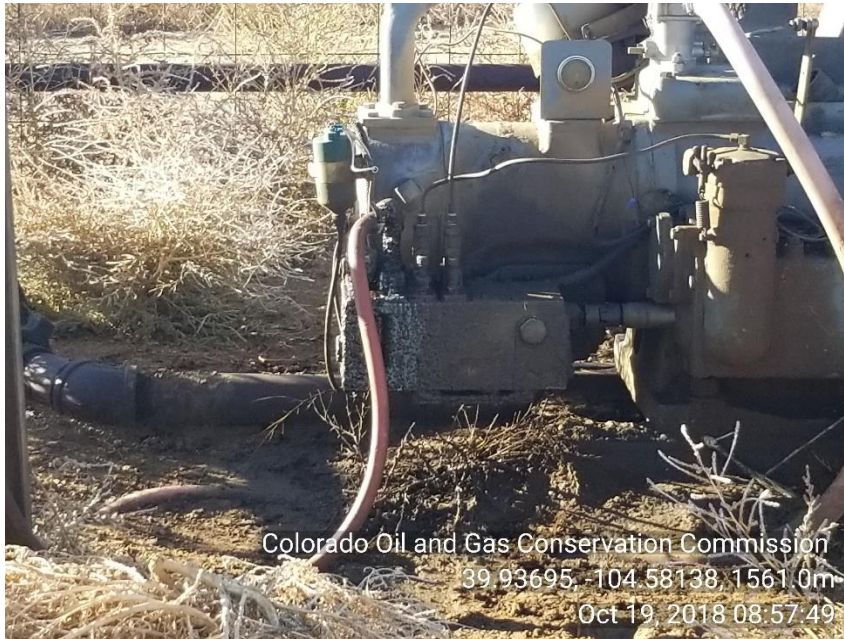
**Photo 3 Stained soil under motor of PU**

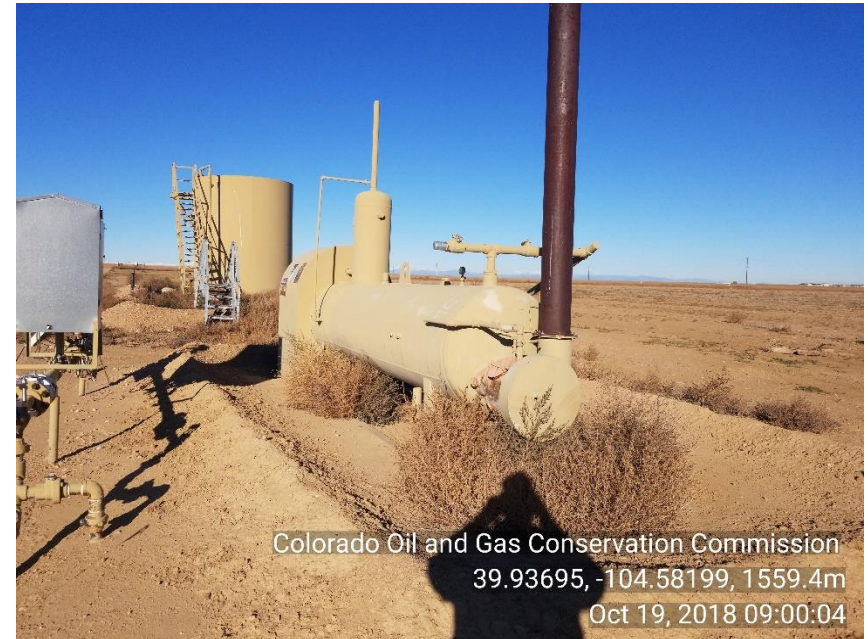
**Photo 4 Sep WEEDS under burner and sep**
