## Inspection Photos

Location Name: 05-045-09361 (FIGURE FOUR 8009B I25 498)

Location ID: 324242

Inspection: 679701195

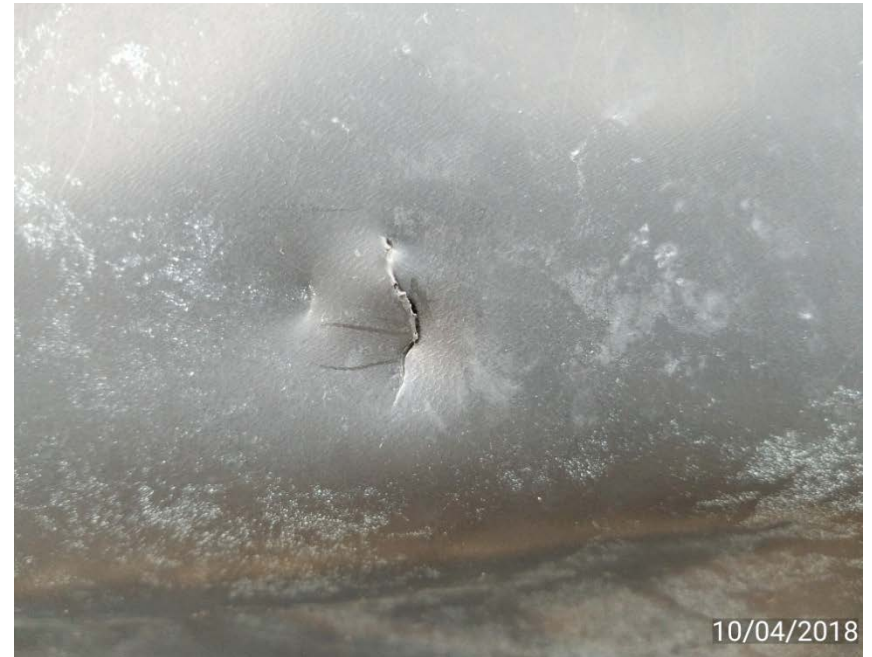
**Tear in tank liner**
