# Inspection Photos

Operator: BP Production

API: 05-067-07842

Date: 10/05/2018

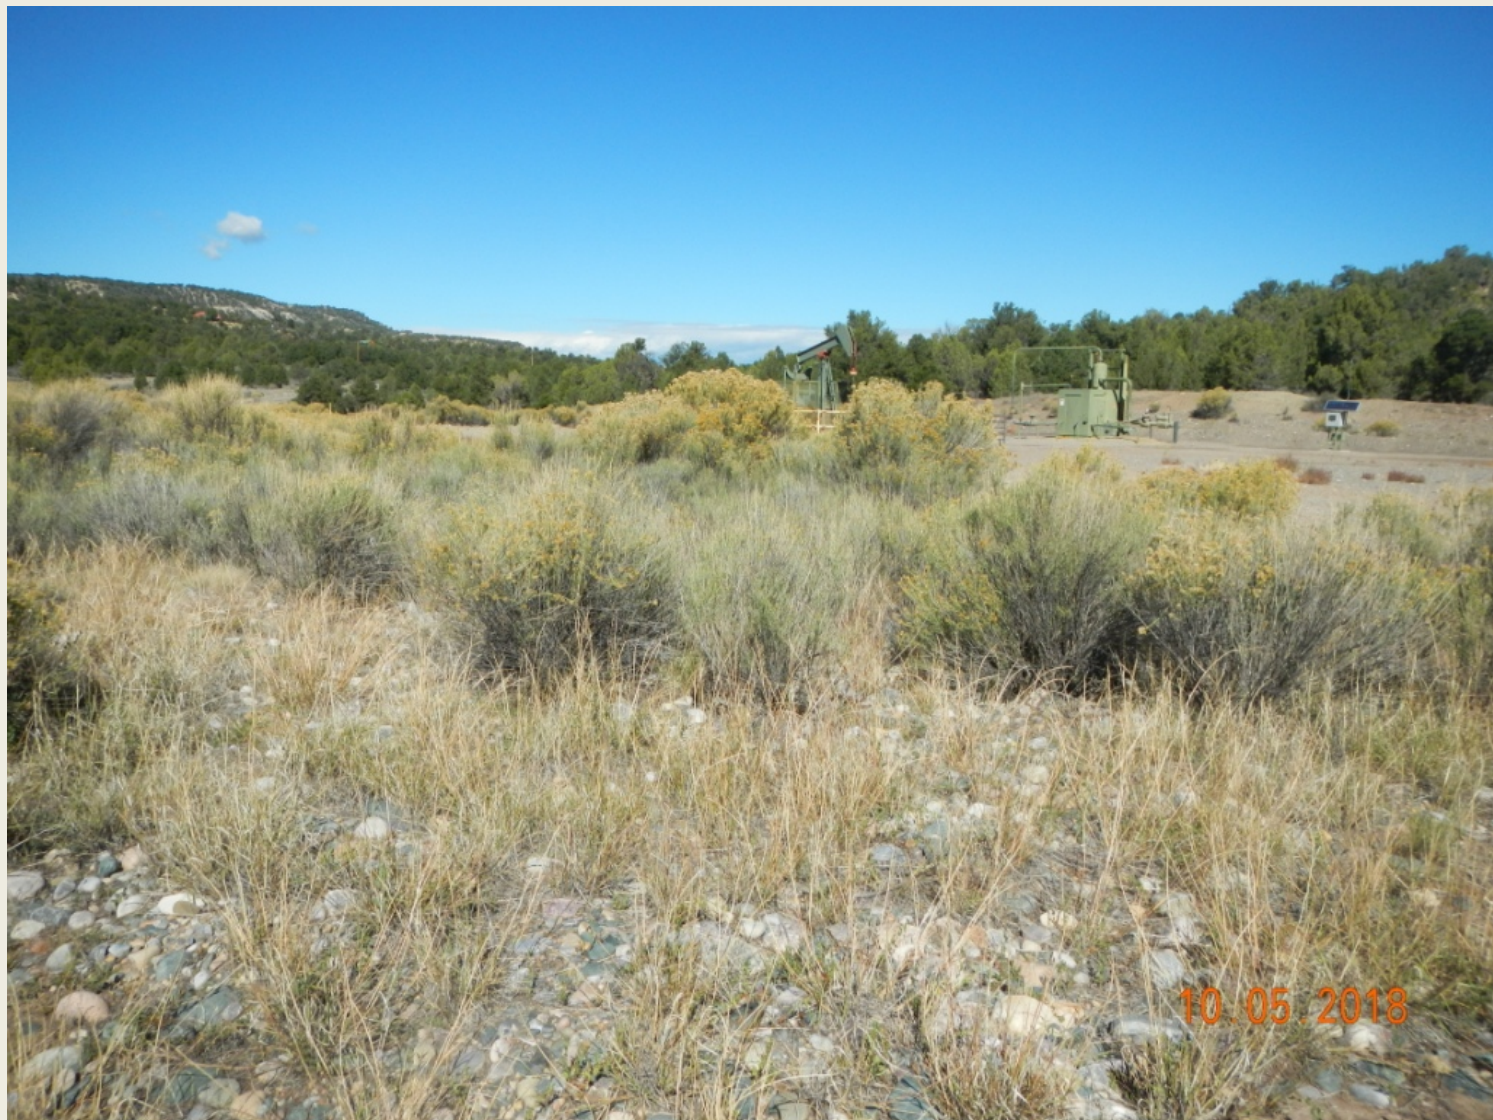
**Photo 1. View of the project area from the eastern edge facing northwestward toward the 067-07842 well.**

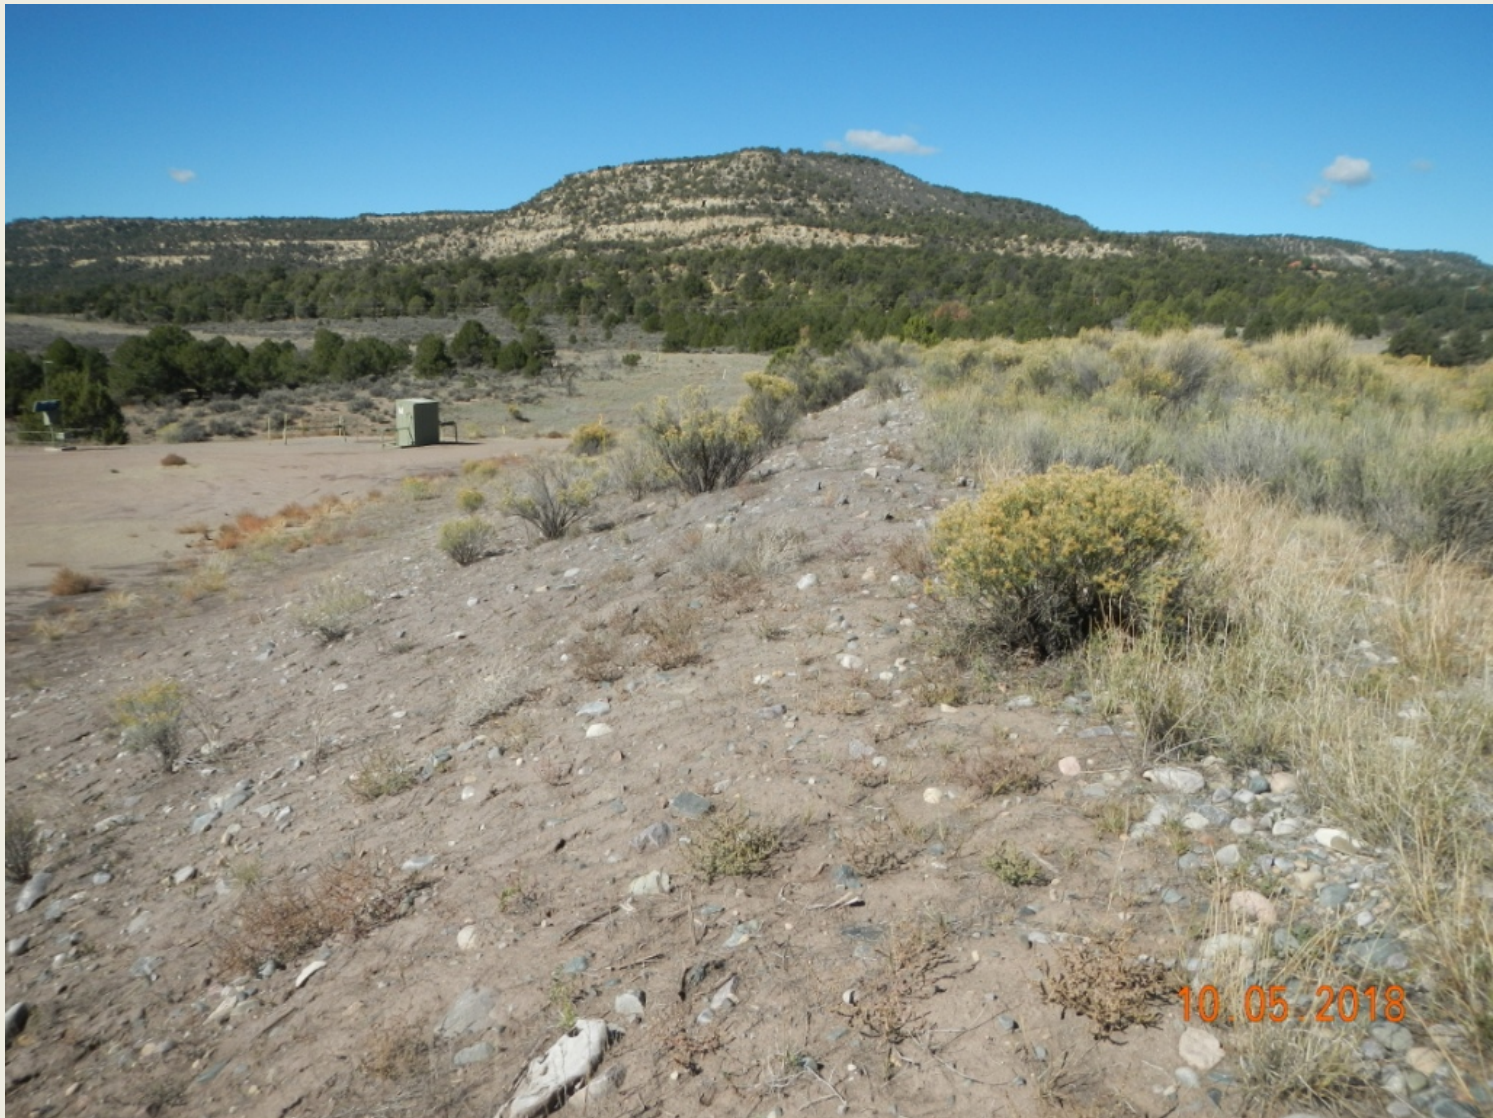
**Photo 2. View of the fill slope within the central portion of the project area from the eastern edge facing westward. Rilling is occurring on the fill slope from the northern portion of the well pad.**

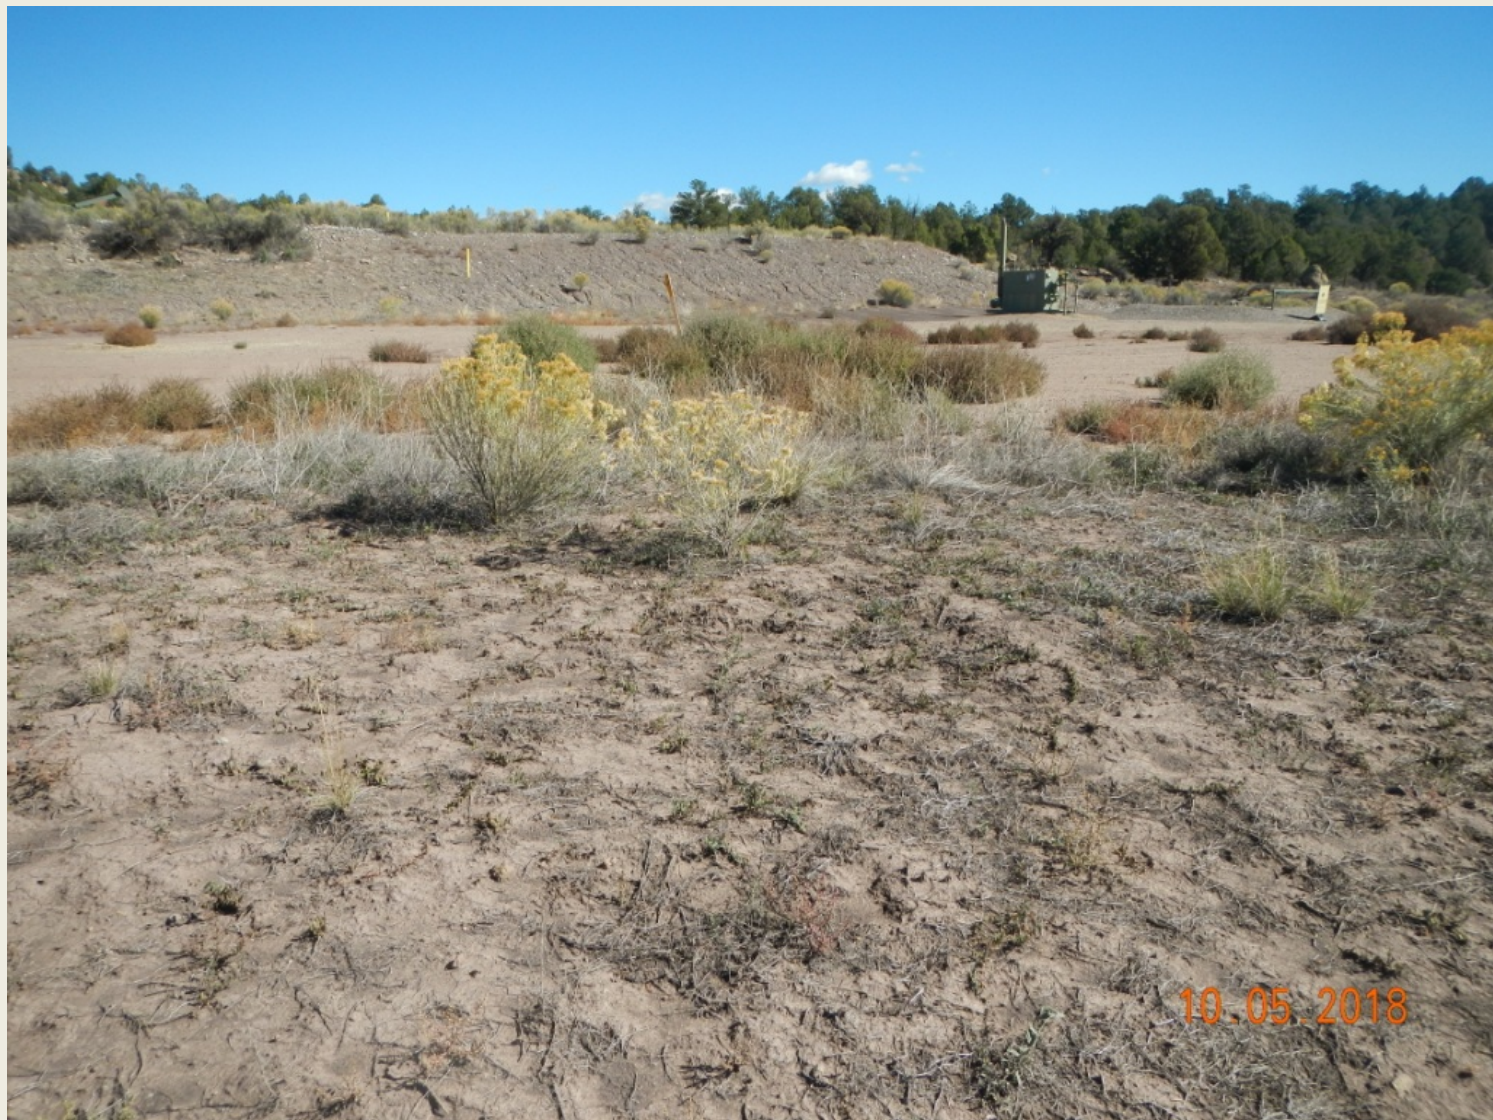
**Photo 3. View of the southern portion of the project area from the southwestern corner facing northeast toward the 067-05076 well.**

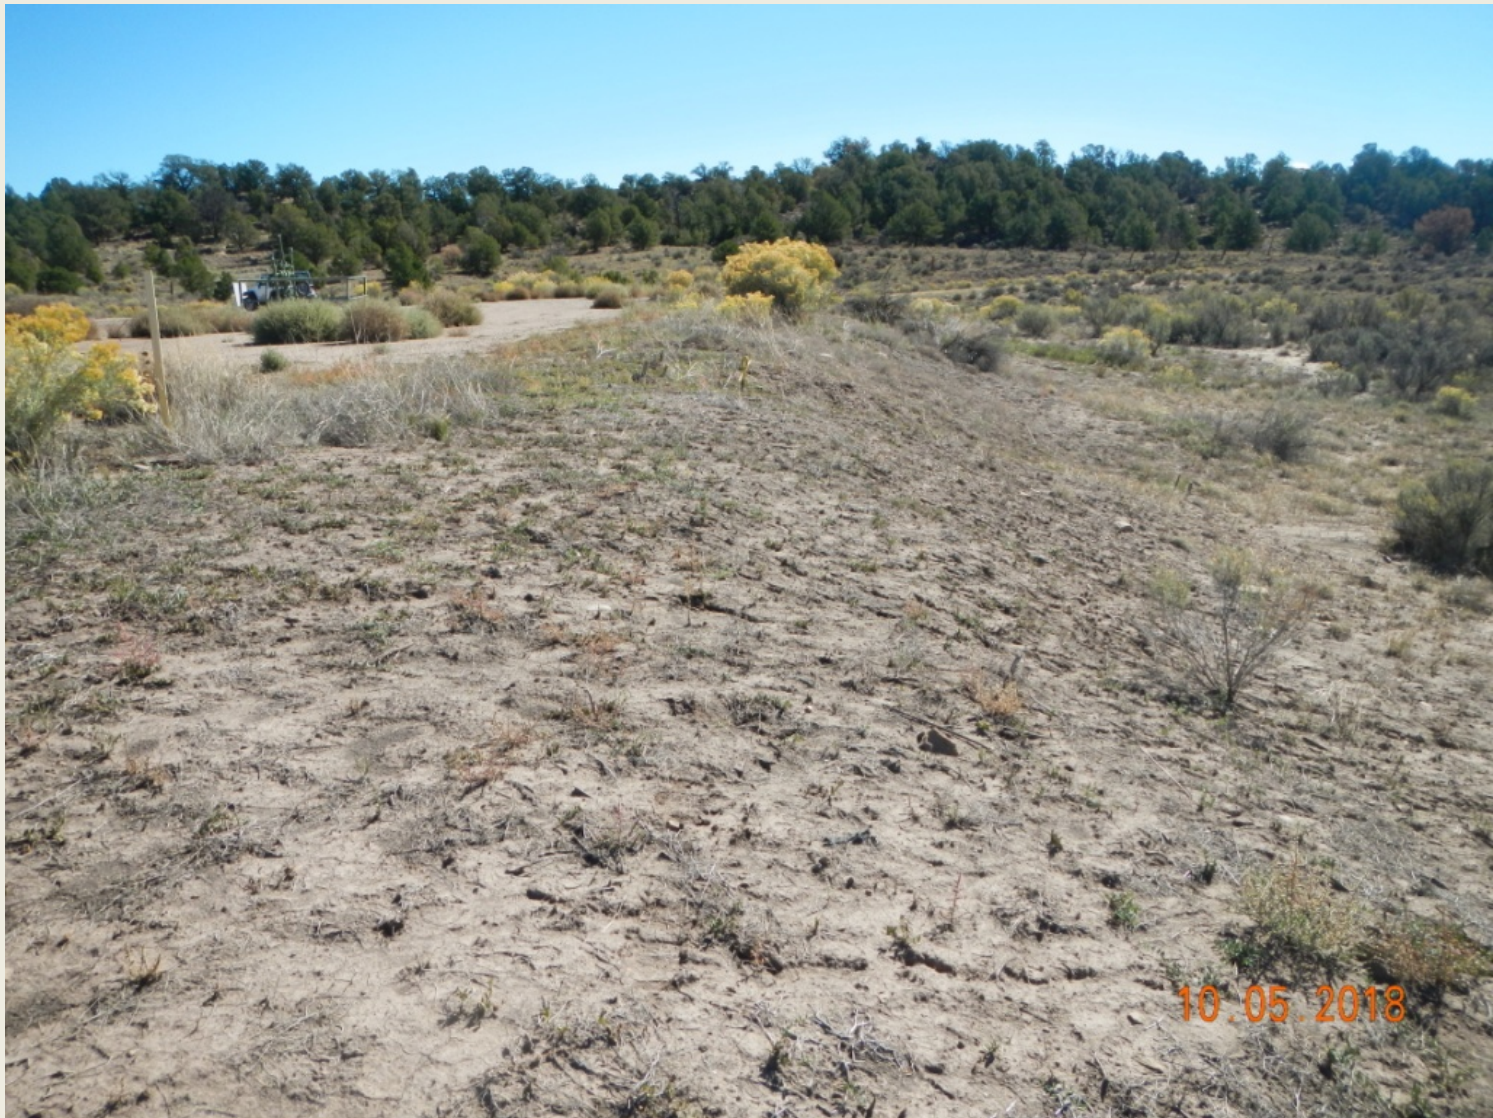
**Photo 4. View of the southern portion of the project area from the southwestern corner facing eastward. Vegetation on the southern fill slope appears drought stressed and sparse.**

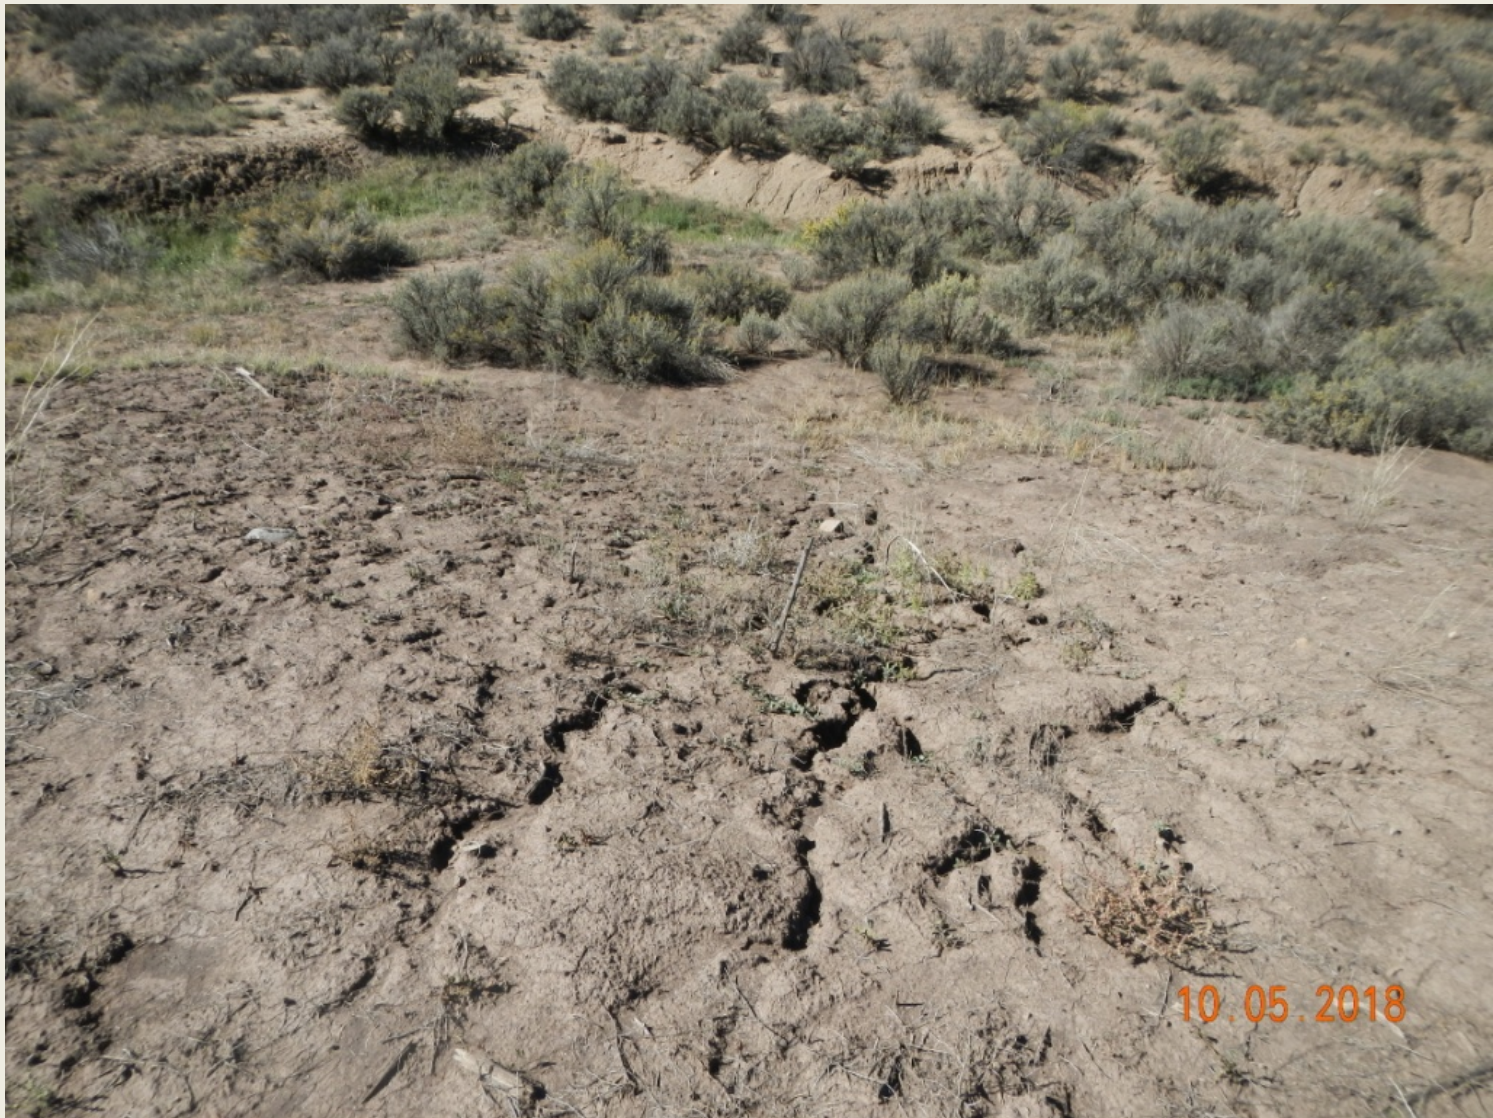
**Photo 5. View of rilling in the southeastern fill slope. Erosion control measures are needed to stabilize erosion on fill slopes.**

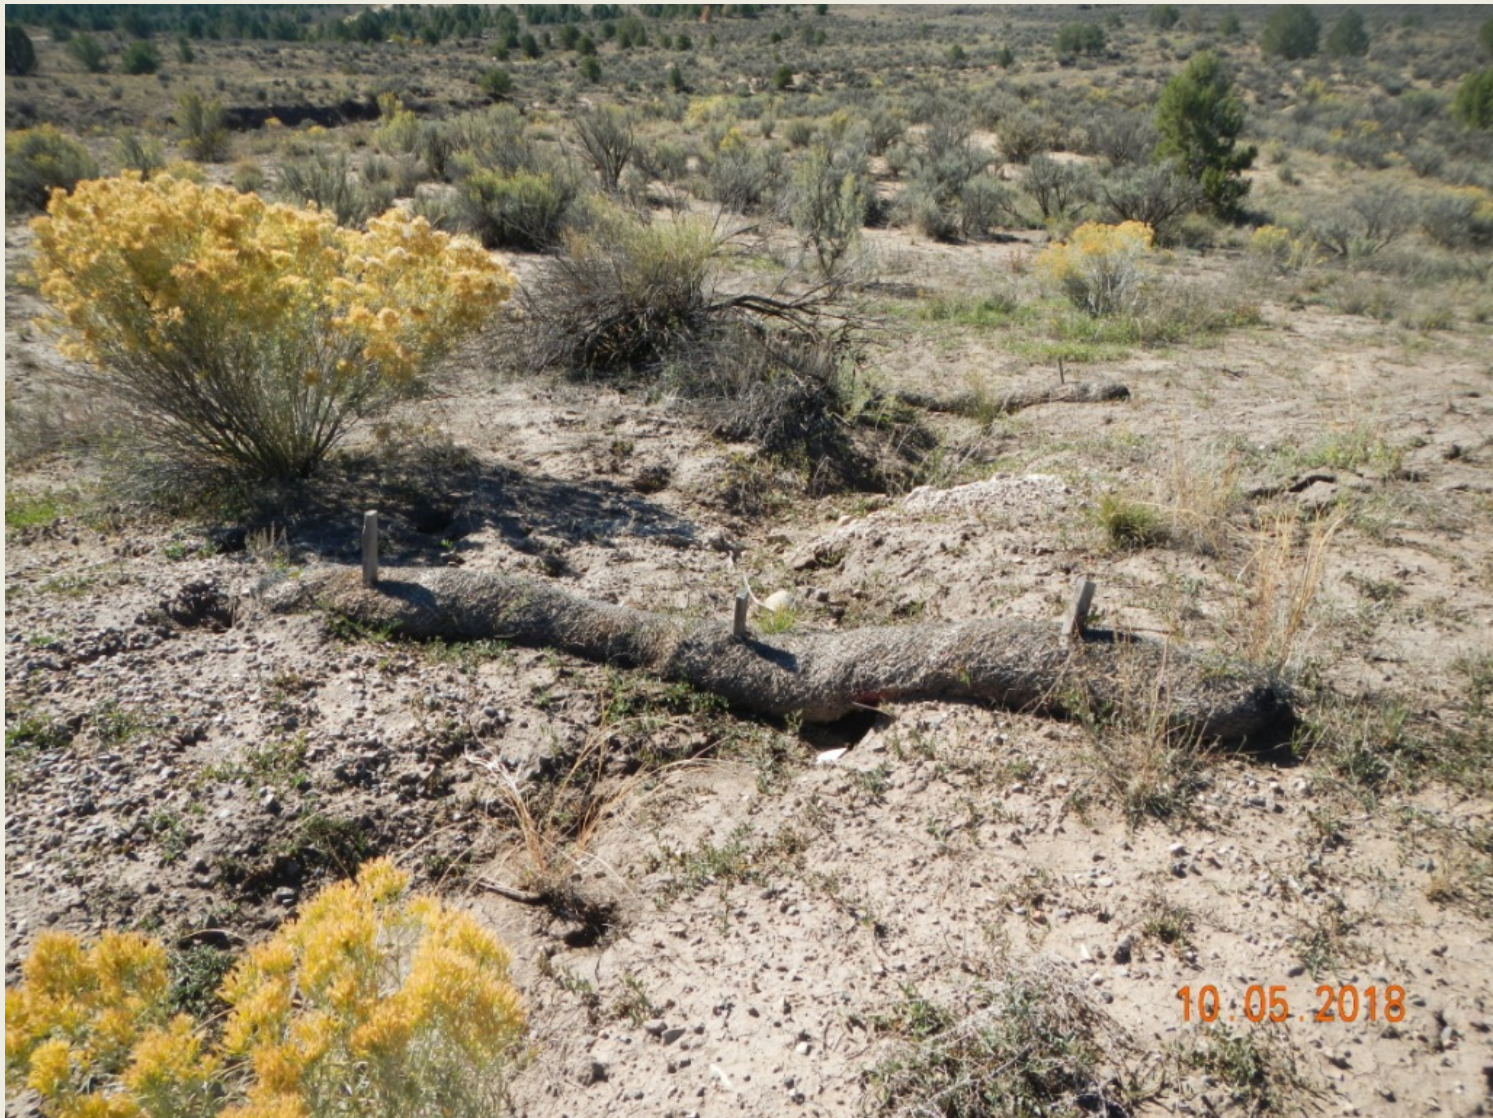
**Photo 6. View of wattle in the southern project area that is no longer functioning. Soils are not stabilized.**

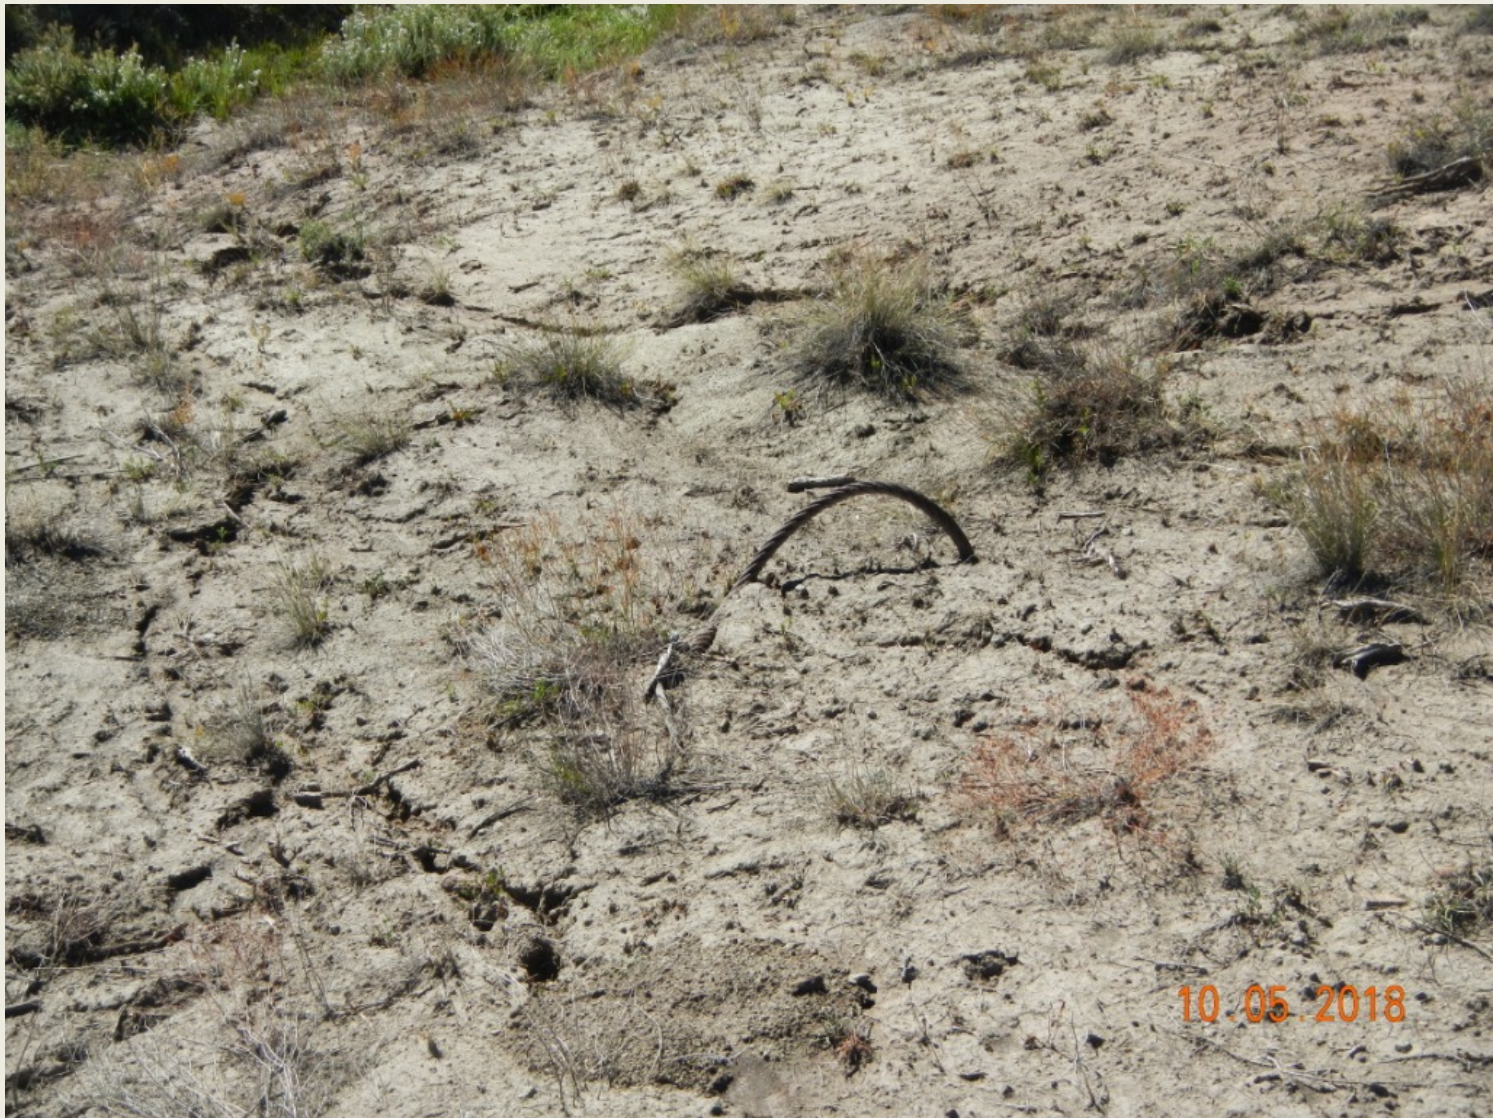
**Photo 7. View of cable within the southern project area.**

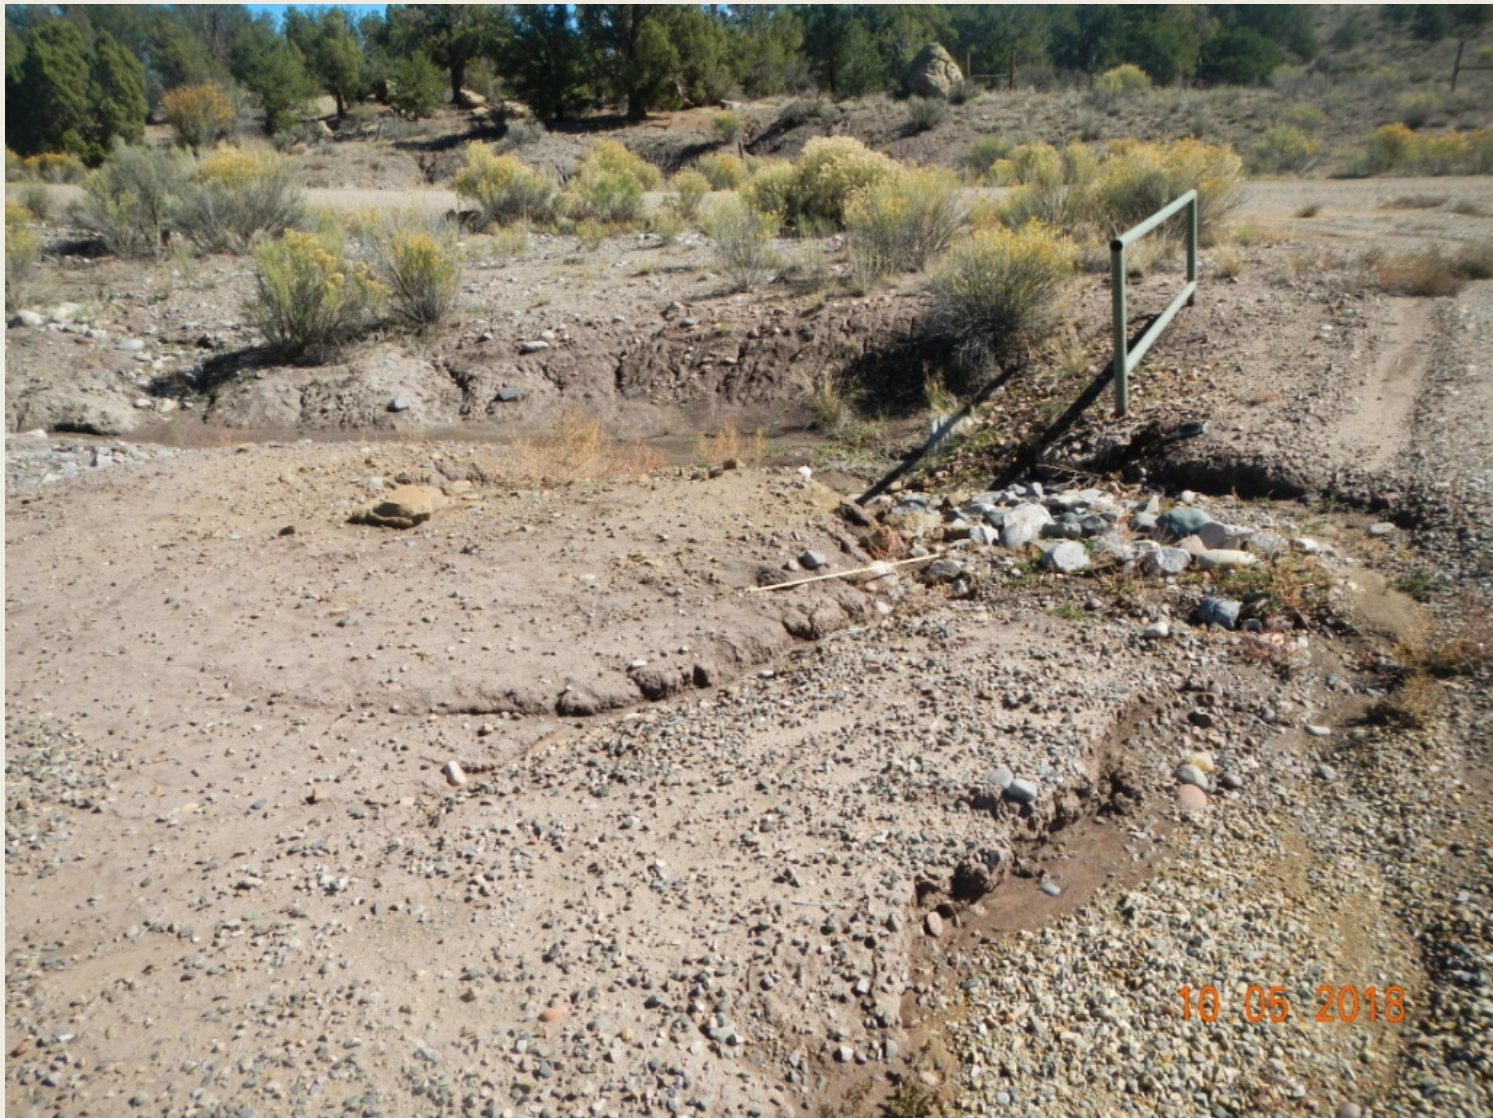
**Photo 8. View of erosional channeling at southeastern entrance to southern portion of the well pad. Stabilization measures are needed here.**

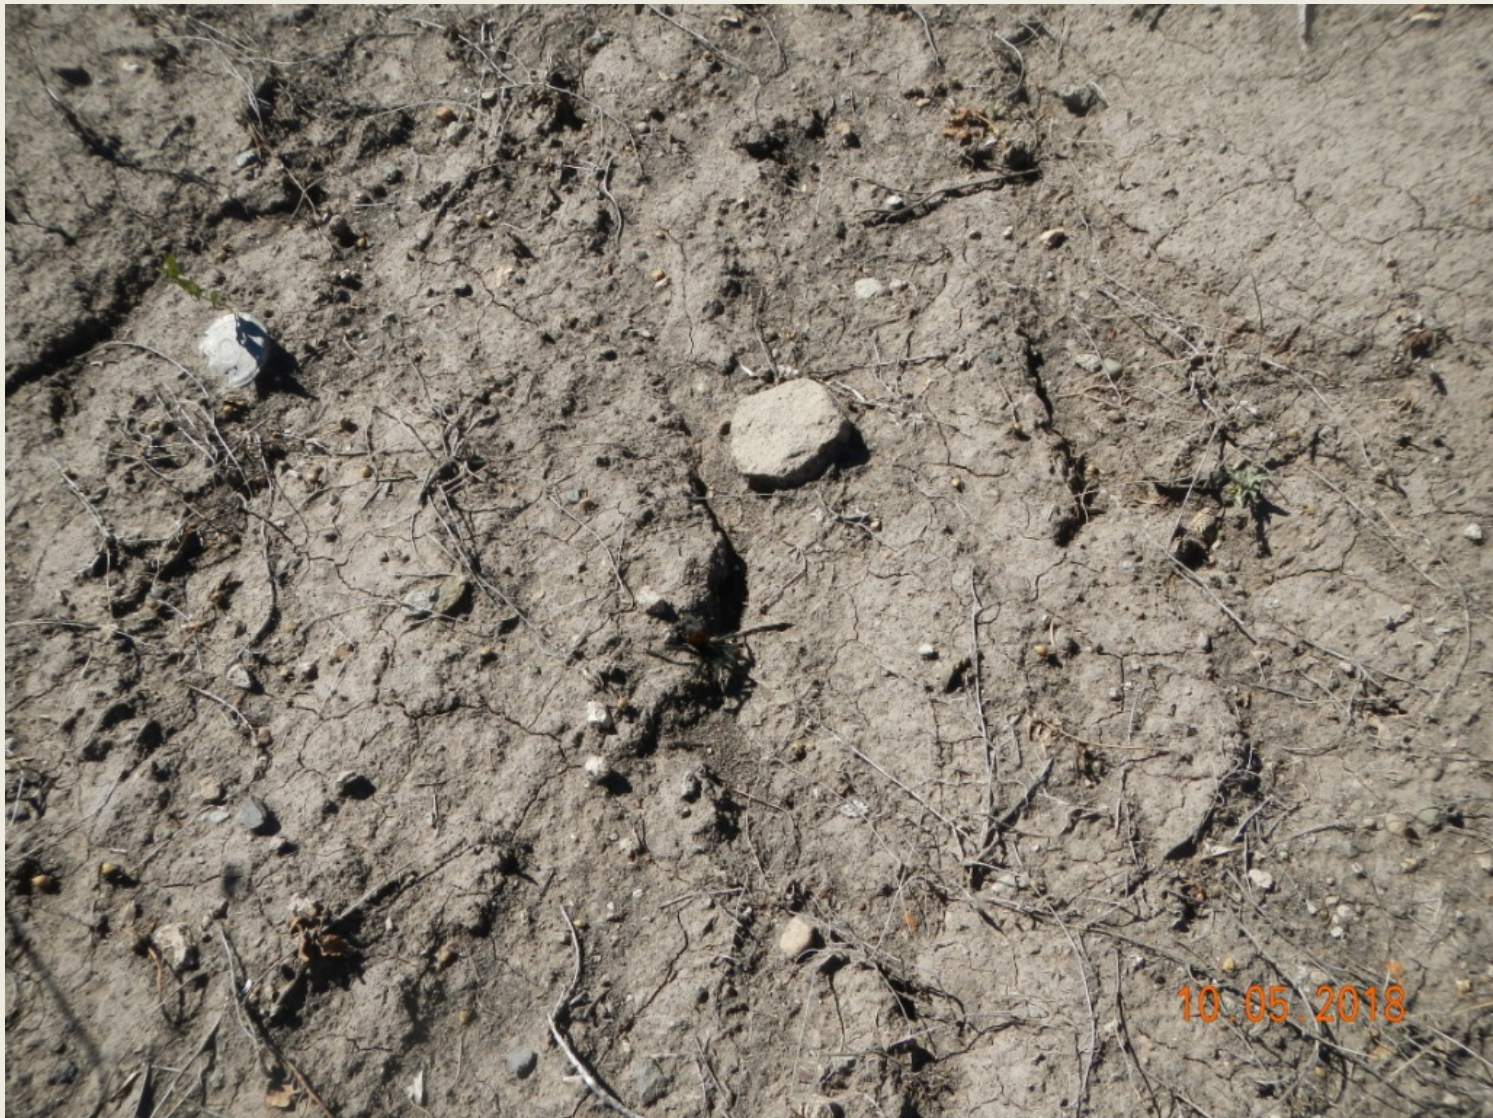
**Photo 9. View of typical vegetation cover within the southern project area. A few volunteer species are established, but overall cover is sparse and not approaching revegetation standards.**
