Inspection Photos

Location Name: Gunderson 0993-21-05

Location ID: #452797

Inspection Date: October 18, 2018

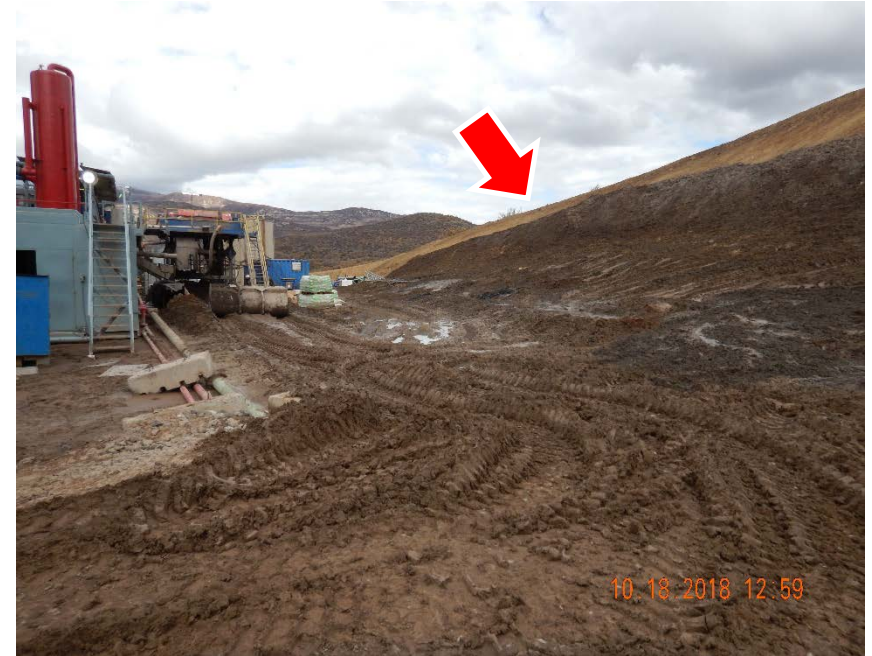
Photo #2 – View of cuttings pile (red arrow) from the south. Note absence of secondary containment berms and stormwater BMPs to isolate sediment and stormwater runoff from cuttings or to prevent tracking of material throughout pad.

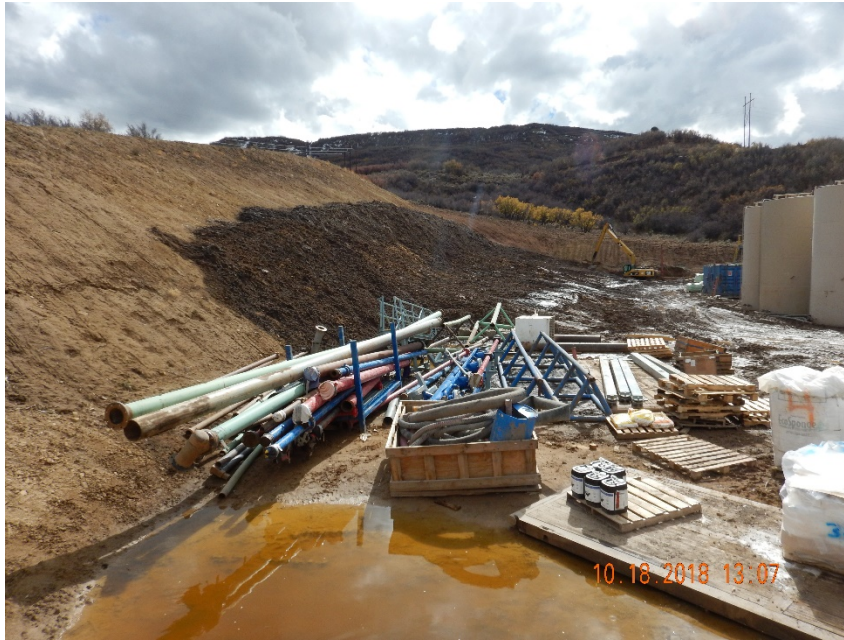
Photo #3 – View of cuttings pile (dark material) from NE corner of pad. Note storage of chemicals and equipment at NE corner of pad identical to Photo #9 included in 10/16/2018 Field Inspection Report (doc #692400233) photo log.

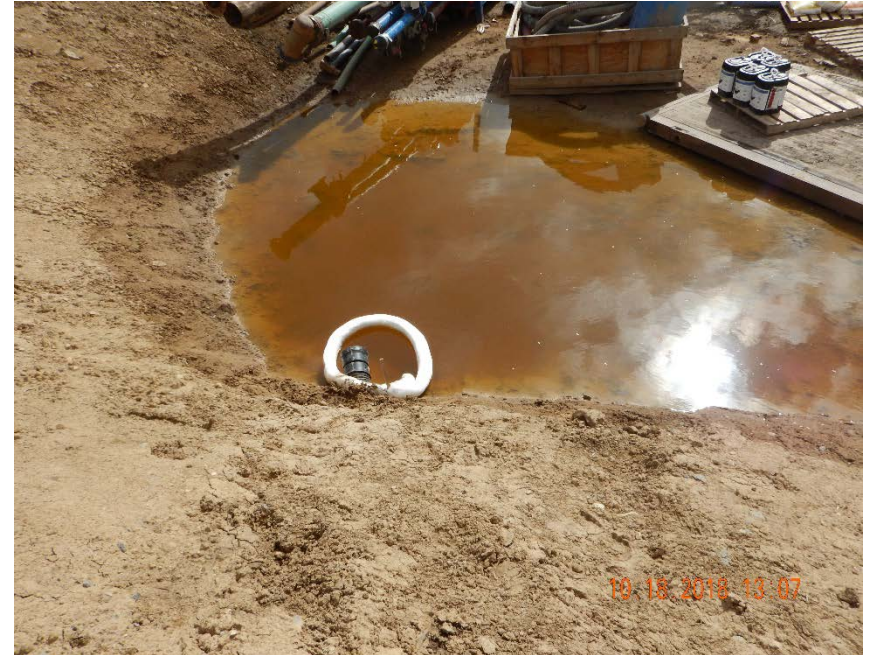
Photo #4 – Stormwater drain located at NE corner of pad. Note that there were no stormwater BMPs or secondary containment devices in place to prevent commingling of fluids from cuttings management pile with this area of the pad.

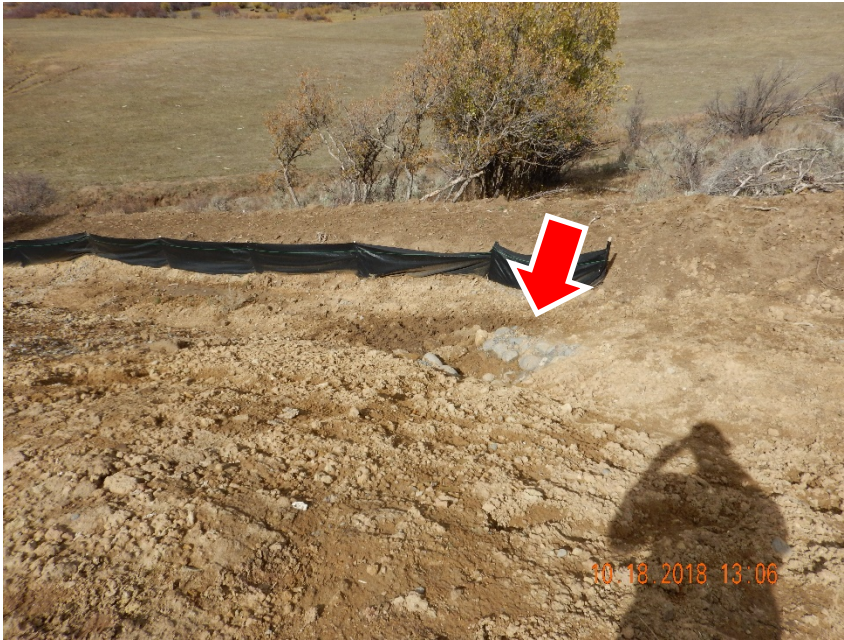
Photo #5 – Outlet of stormwater drain from previous photo (red arrow) and silt fence located north of pad.

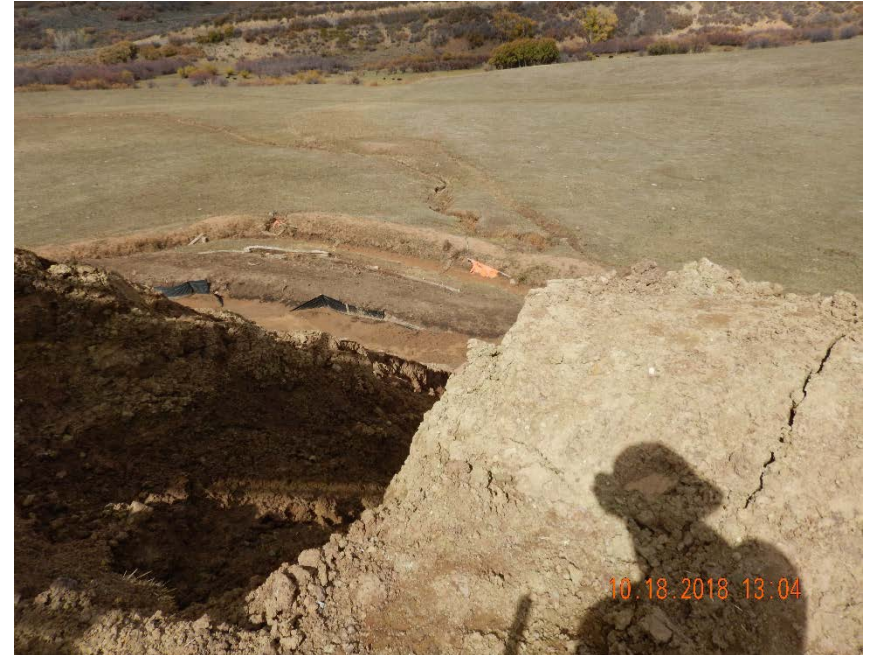
Photo #6 - Collapsed section of pad containment berm and fill slope located on north side of pad.
