Inspection Photos

Operator: Enervest

API: 05-067-09377

Date: 10/05/2018

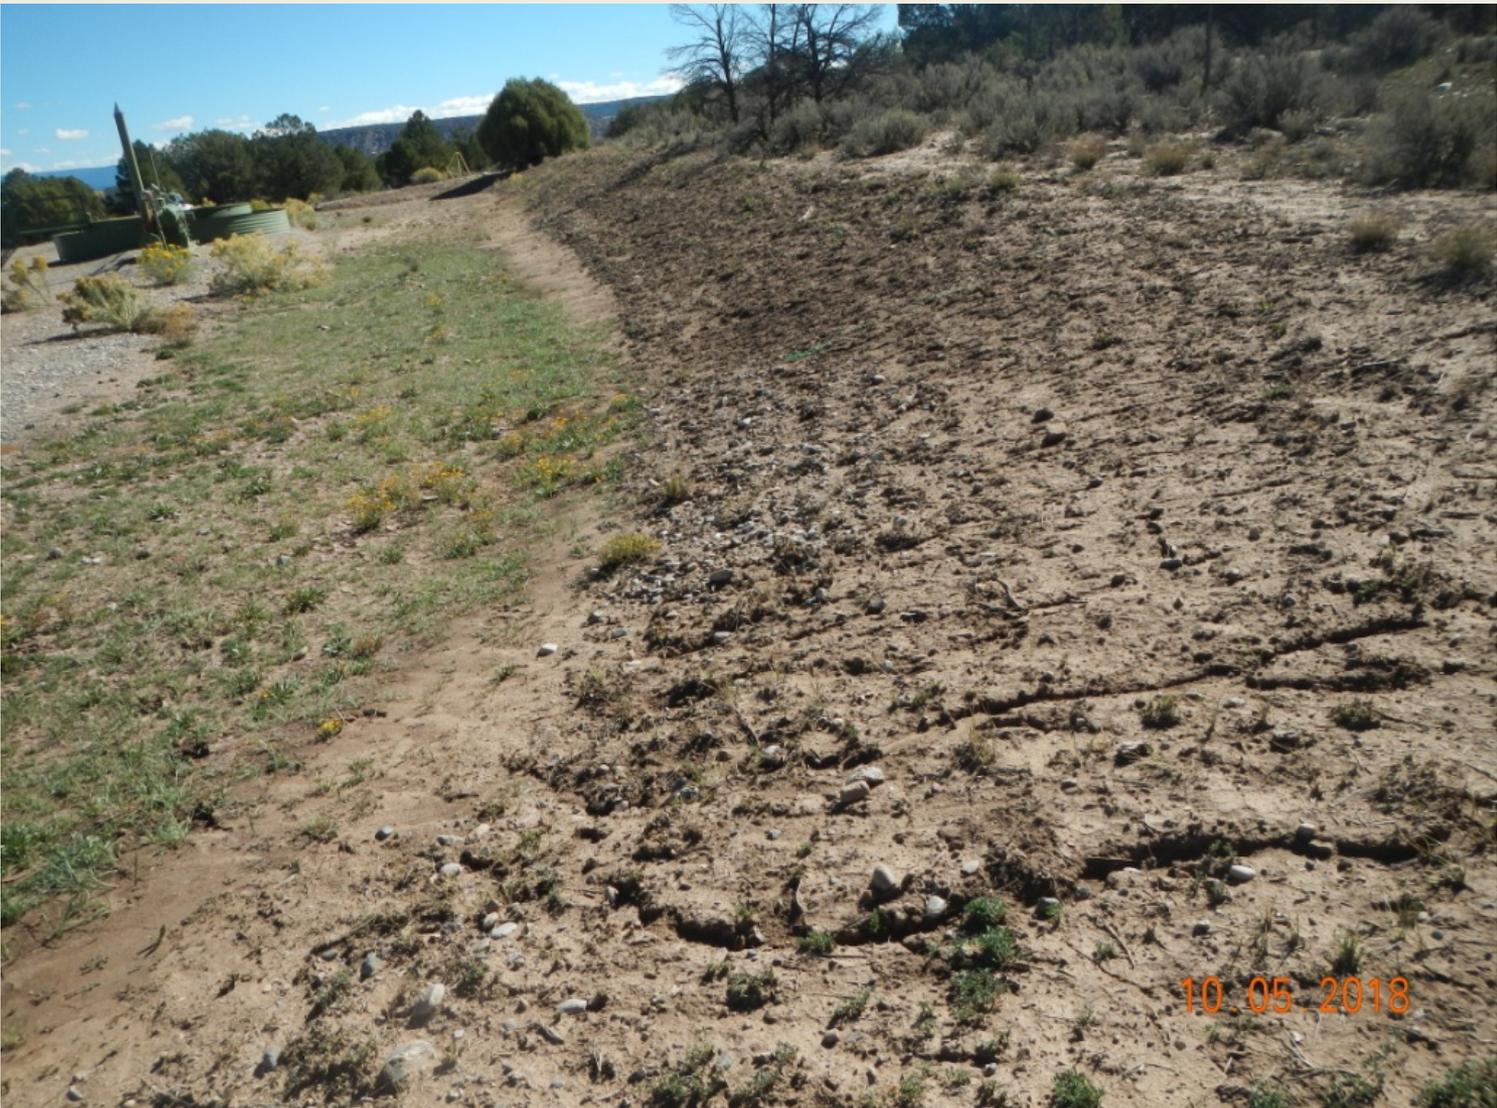
Photo 1. View of the southern portion of the project area from the southwestern corner facing eastward. Revegetation on well pad cut and fill slopes is sparse and appears to be drought stressed. This needs to be monitored and re-vegetation efforts conducted if vegetation is not increasing during the 2019 growing season. Rilling is occurring on the cut-slope.

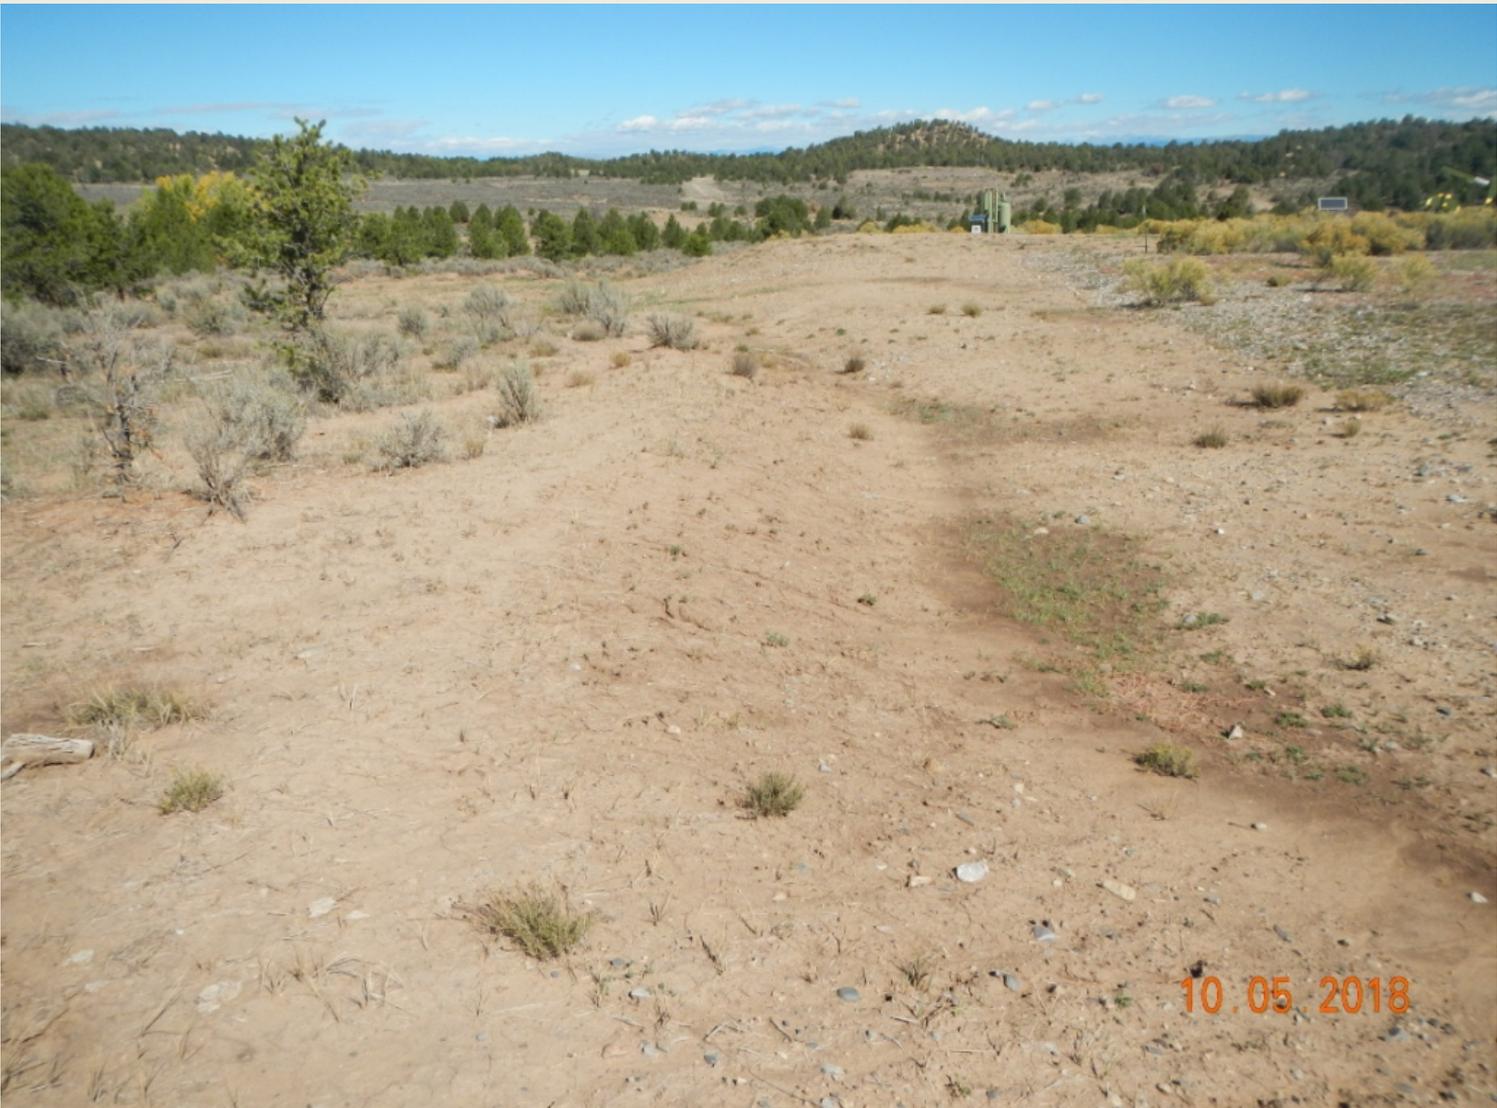
Photo 2. View of the southwestern portion of the project area from the southwestern corner facing northward. Revegetation is also sparse here.

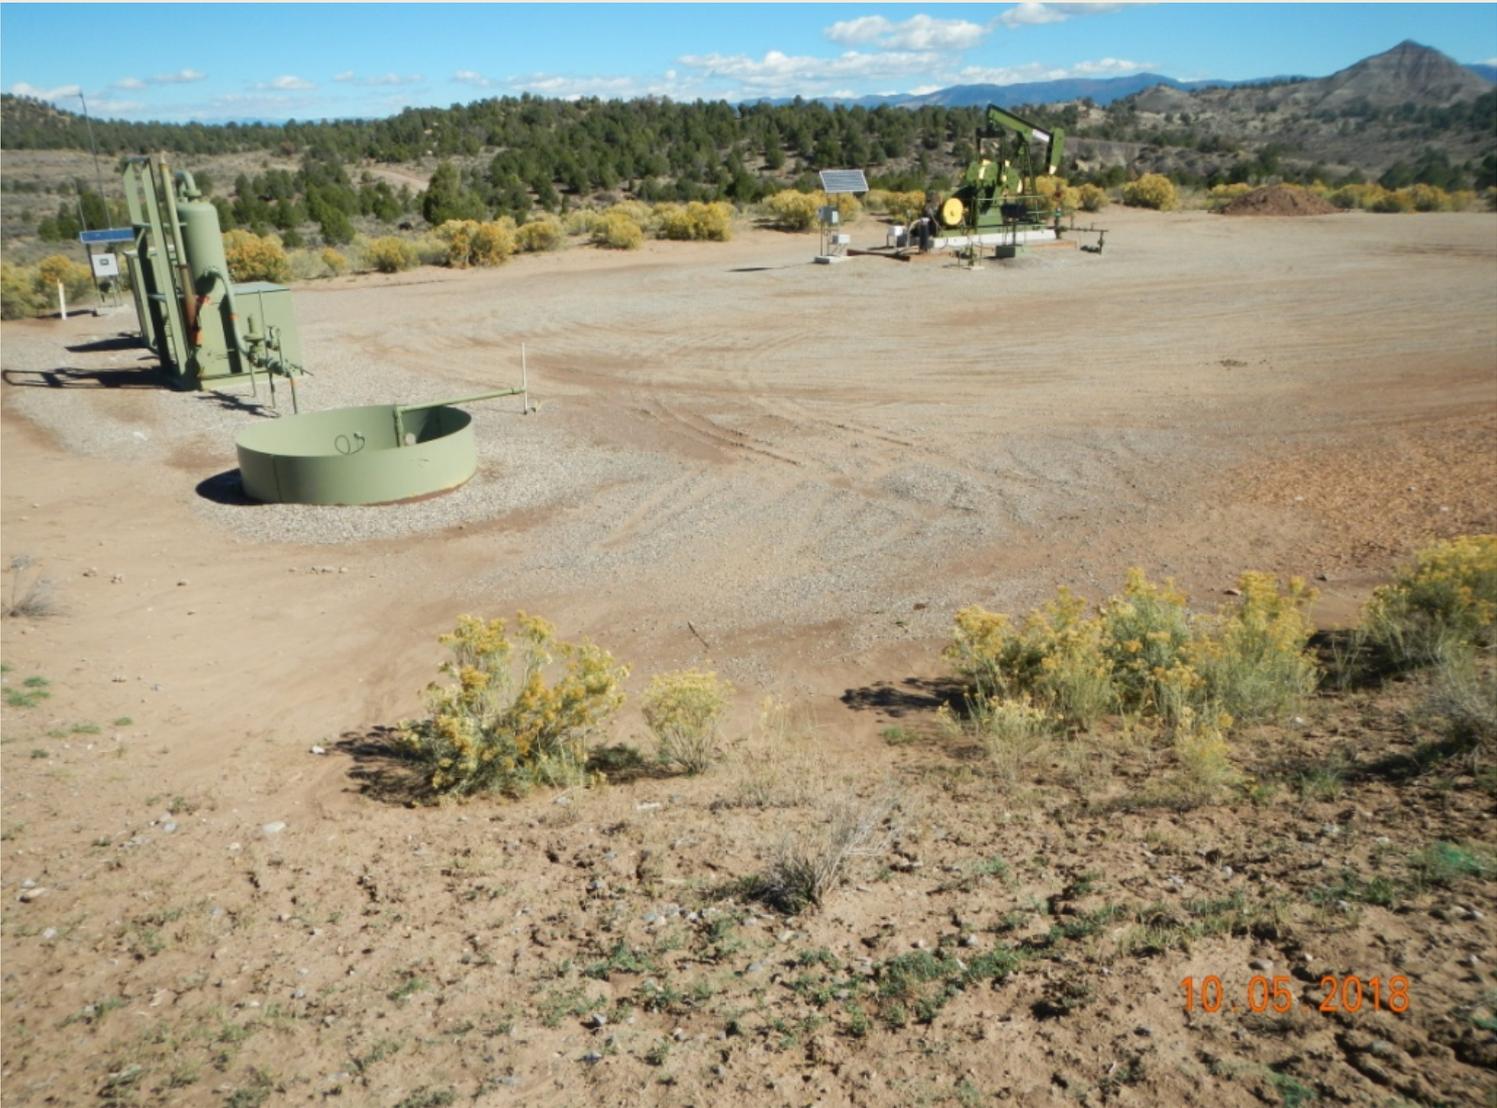
Photo 3. View of the northern project area from the mid-western edge facing center.

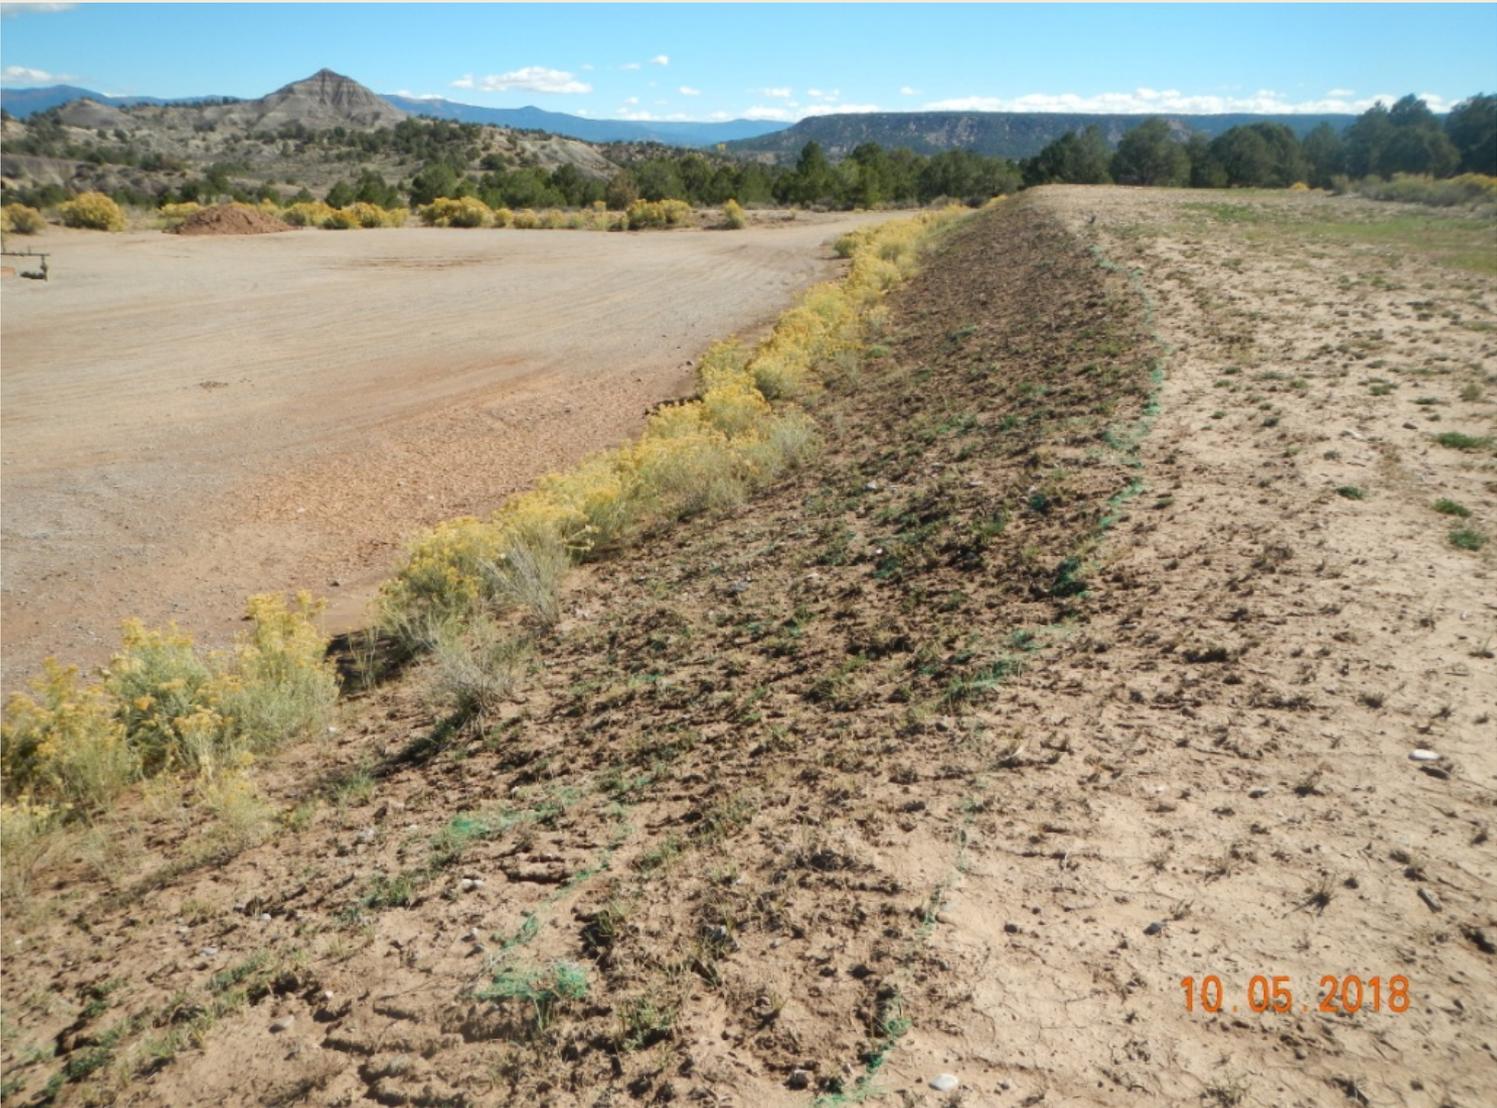
Photo 4. View of middle fill slope from the western edge facing eastward. Green plastic debris needs to be cleaned.

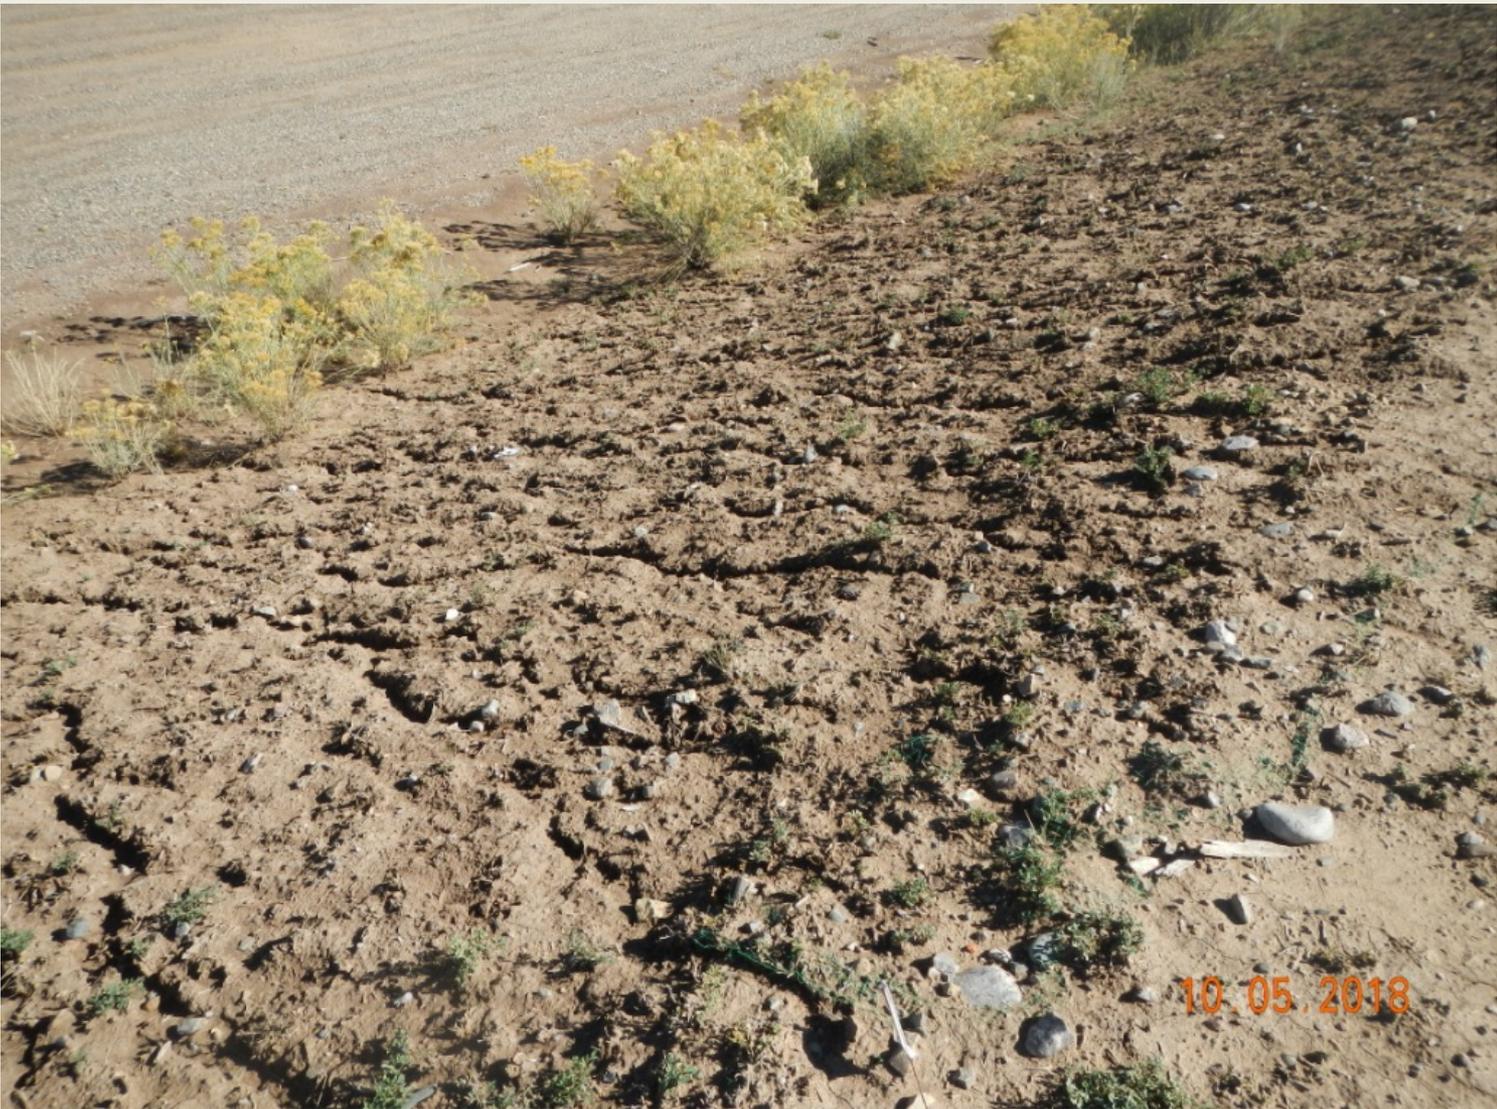
Photo 5. View of rilling in the central fill slope and poor revegetation facing down-slope.

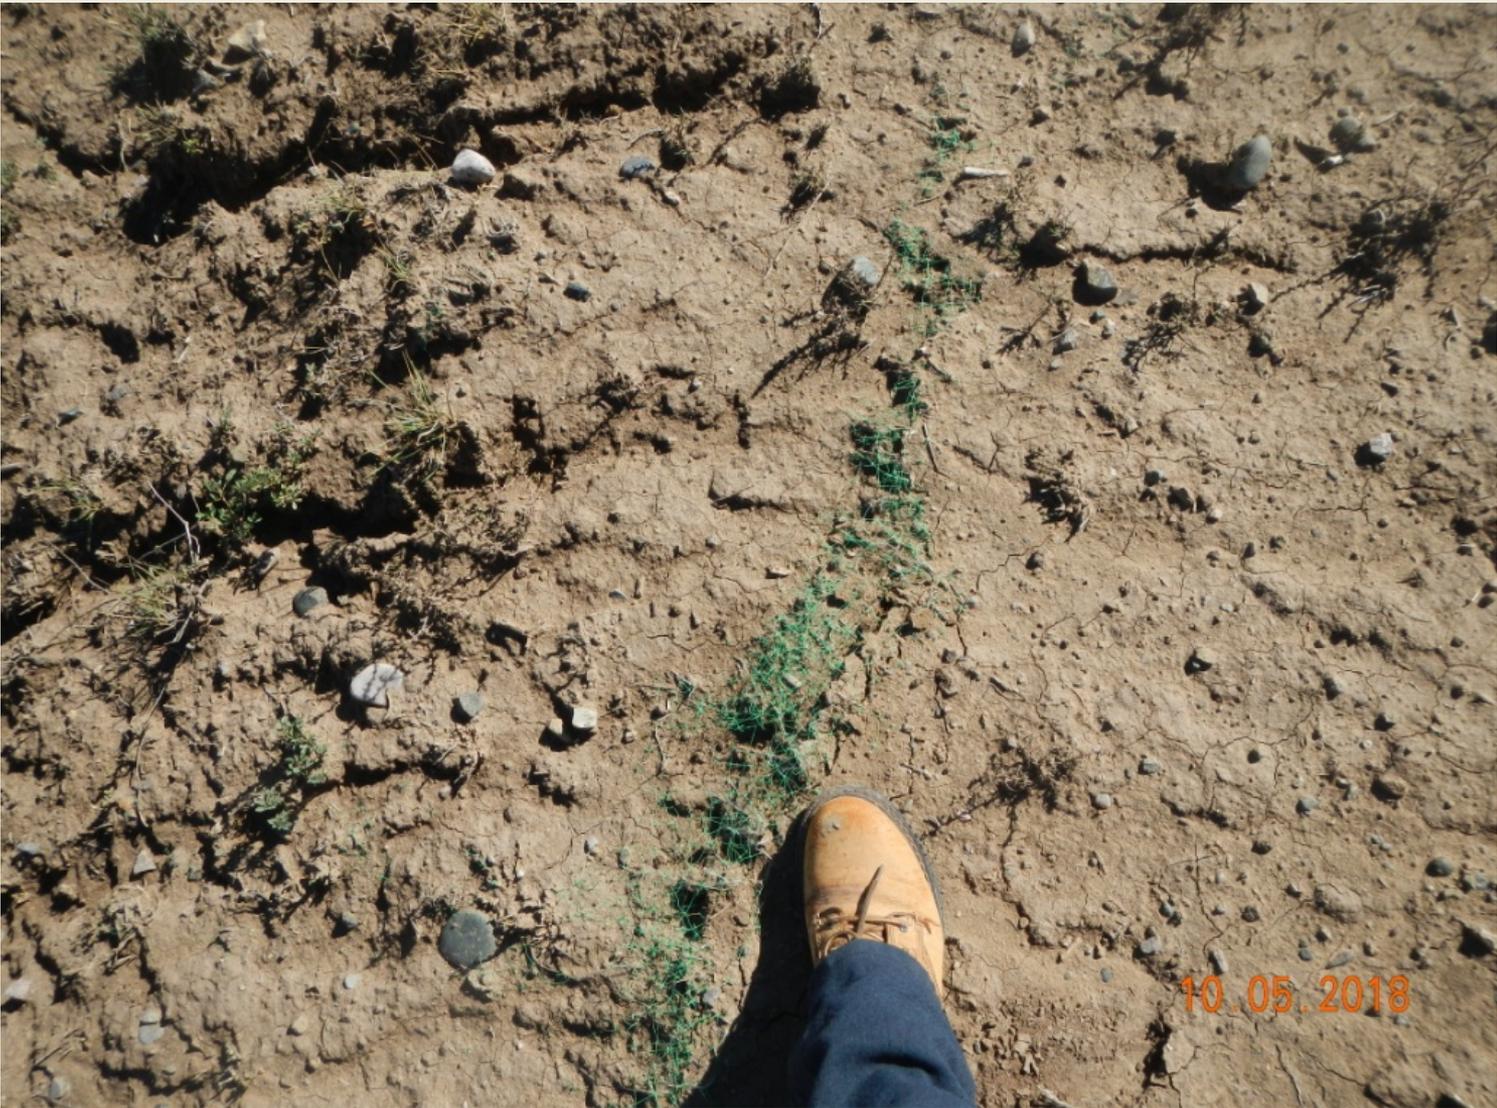
Photo 6. Close-up view of green plastic debris in the central fill slope.

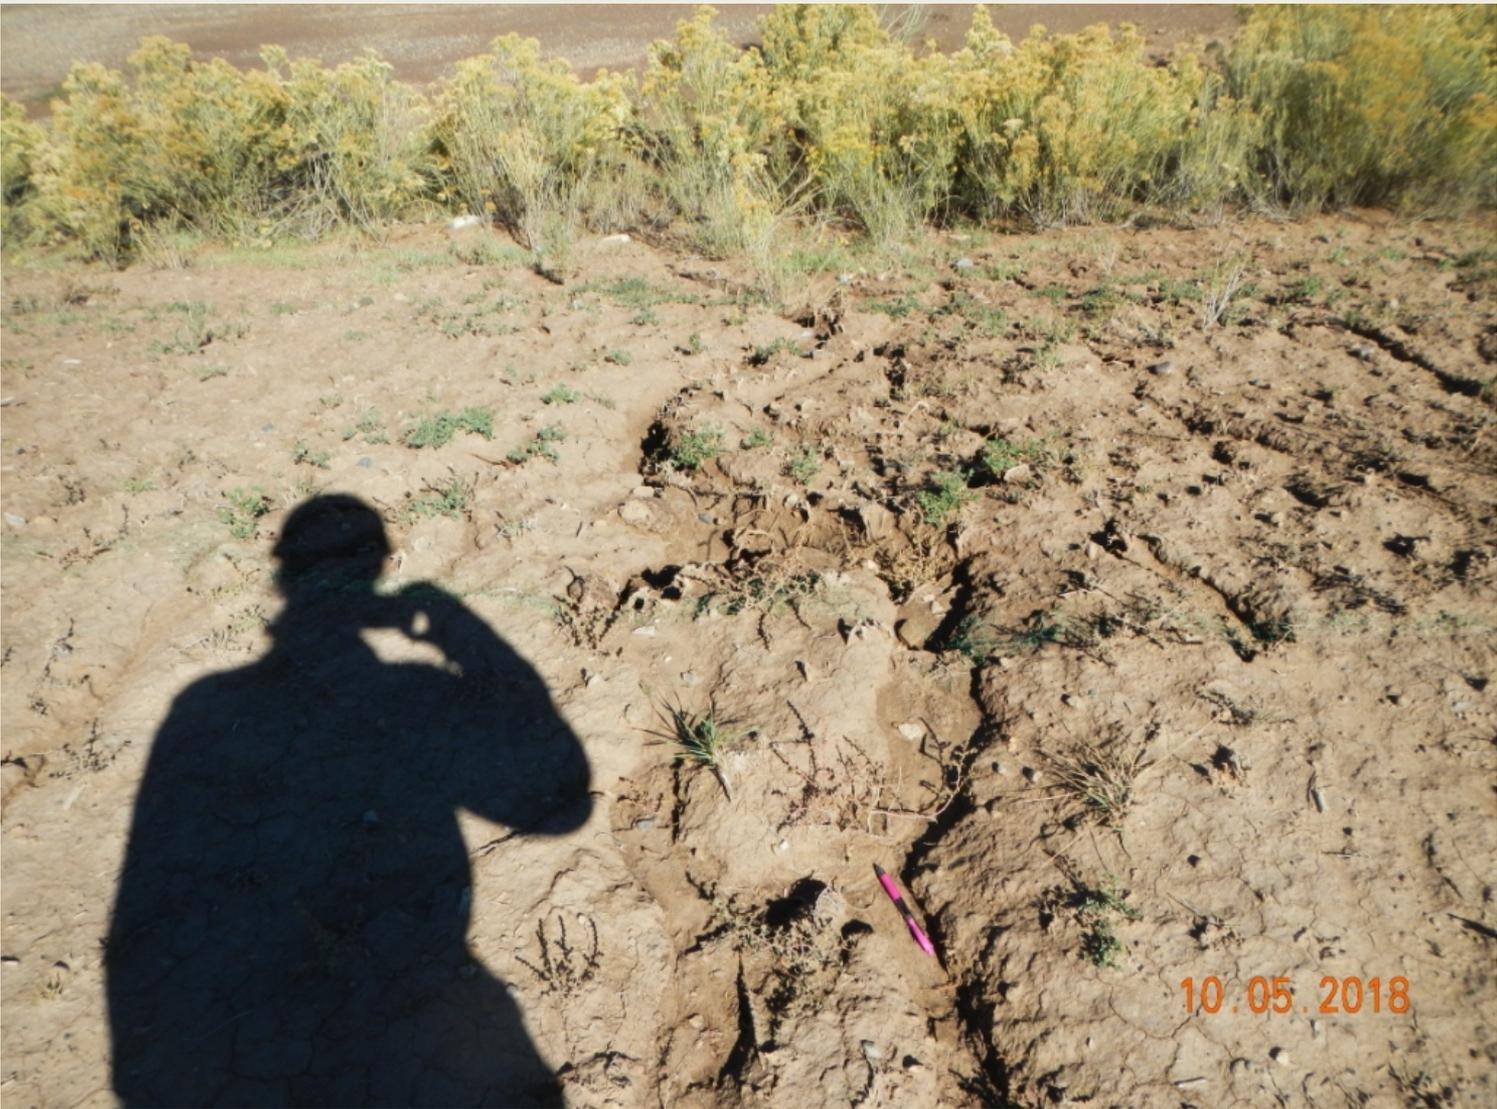
Photo 7. View of more rilling up to 12 inches deep in the central fill slope.

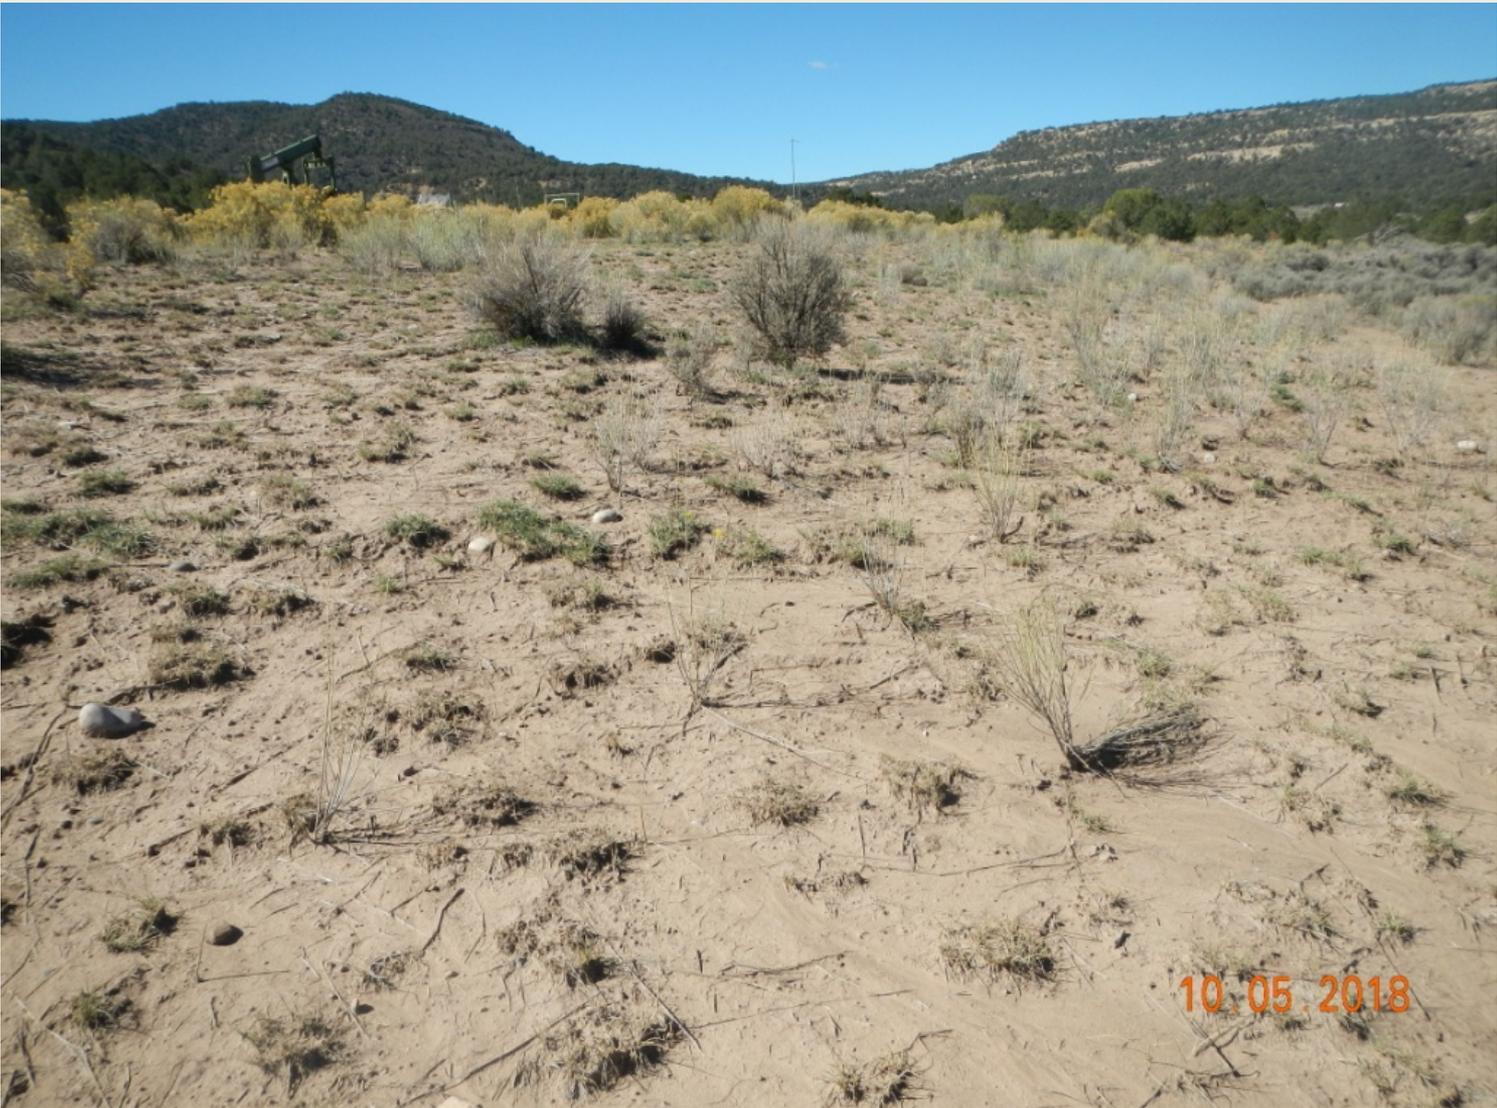
Photo 8. View of the northern project area from the northeastern corner facing westward.
