Inspection Photos

10/01/2018

Operator: SWN PRODUCTION COMPANY LLC -
10396

Inspection Doc. Number: 682504013
Adams County, CO

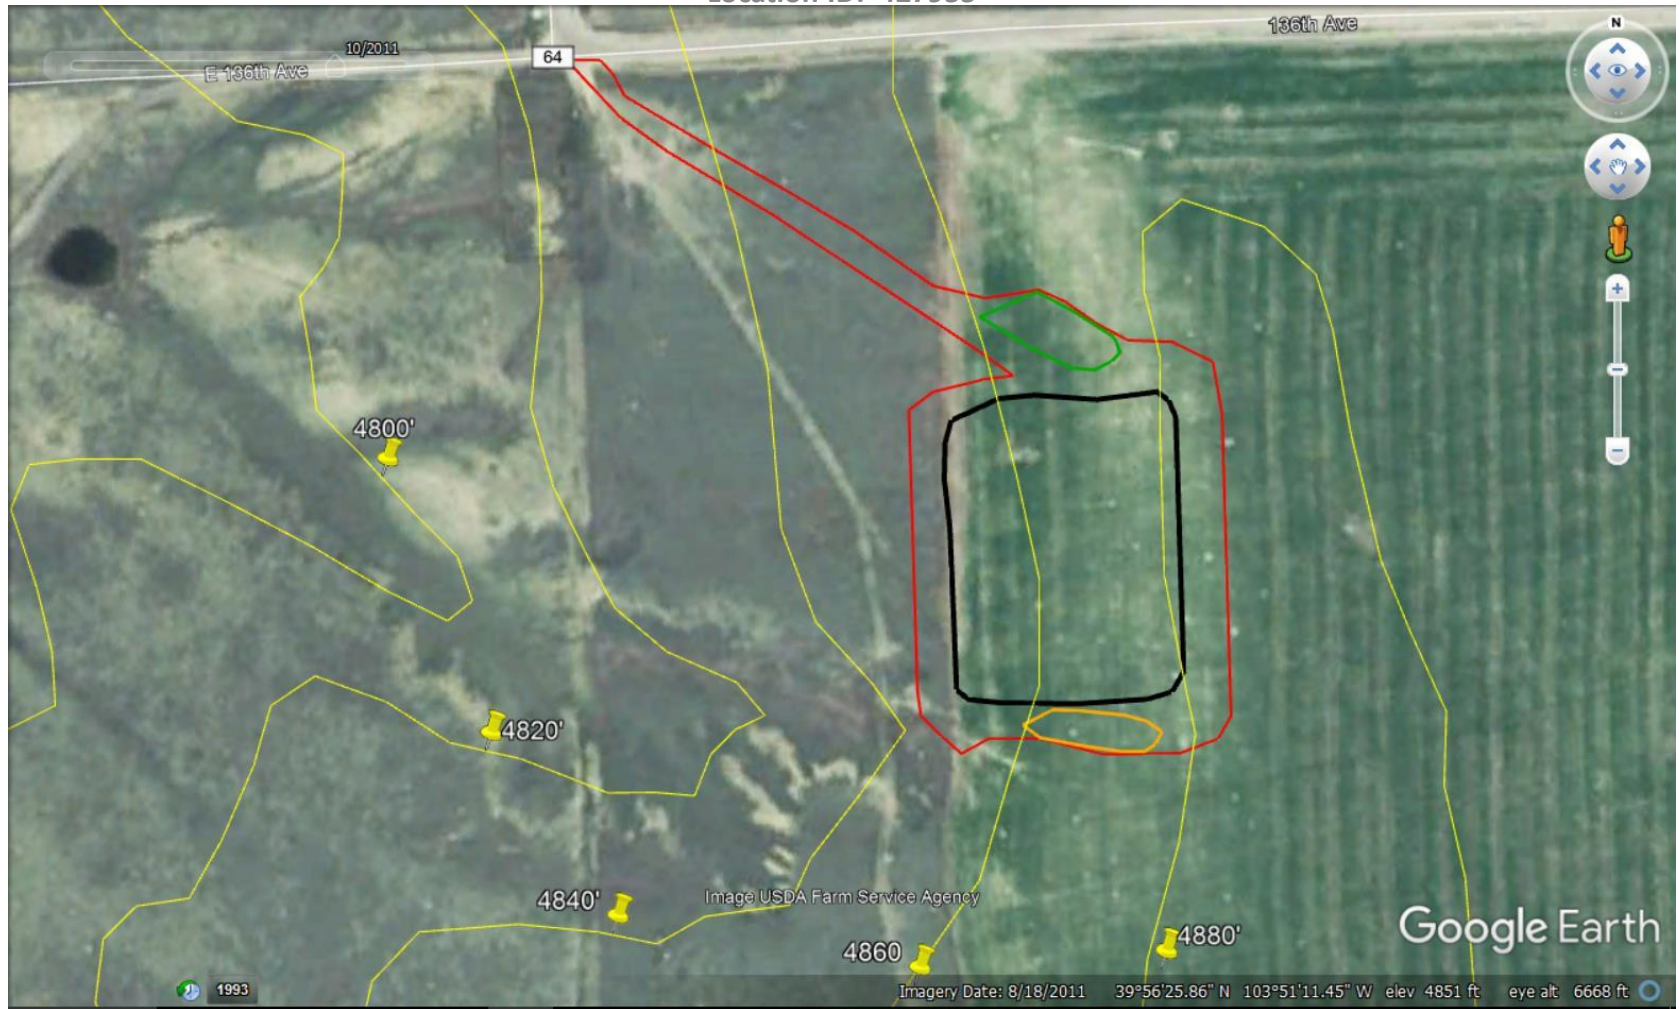
Photo 1: 2011 aerial imagery. Photo shows the location prior to oil and gas disturbances. Yellow lines indicate elevation/topography. Red polygon represents total disturbance (location+access road). Total disturbance is ~4.9 acres (4.5 acres excluding access road). Black polygon represents pad/production area size. Pad size is ~2.43 acres. Green polygon represents area of the topsoil stock pile and orange polygon represents area of “spoils” stockpile based on location drawing, “Exhibit A”, of document #401313989.

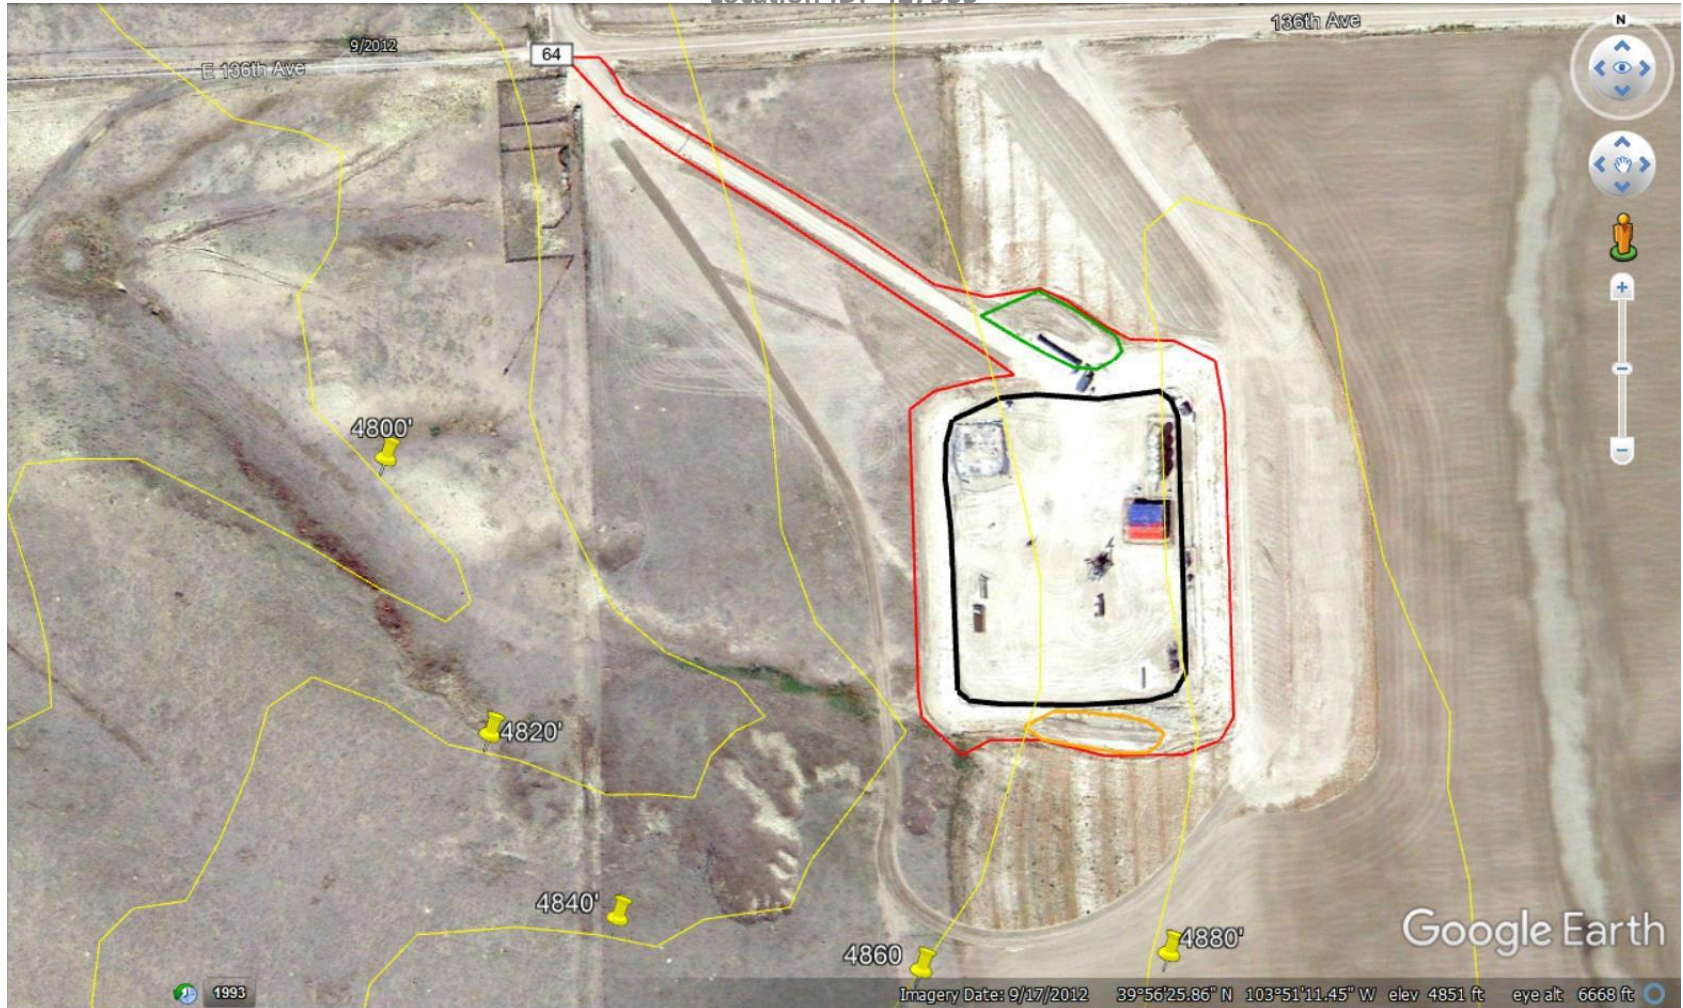
Photo 2: 9/17/2012 Aerial imagery. Well was SPUD 4/11/2012. COGCC records show first production date on 07/2012. COGCC 1003 reclamation rules require operator to perform interim reclamation (IR) on areas no longer reasonably needed for production to occur no later than three (3) months on cropland after drilling operations. Date IR would need to have been conducted is 10/2012. Photo shows location prior to when IR would need to have been conducted. 2A doc. # 400252948 states disturbance size during construction is 3.67 acres. Total disturbance size is ~4.5 acres (4.92 with access road).

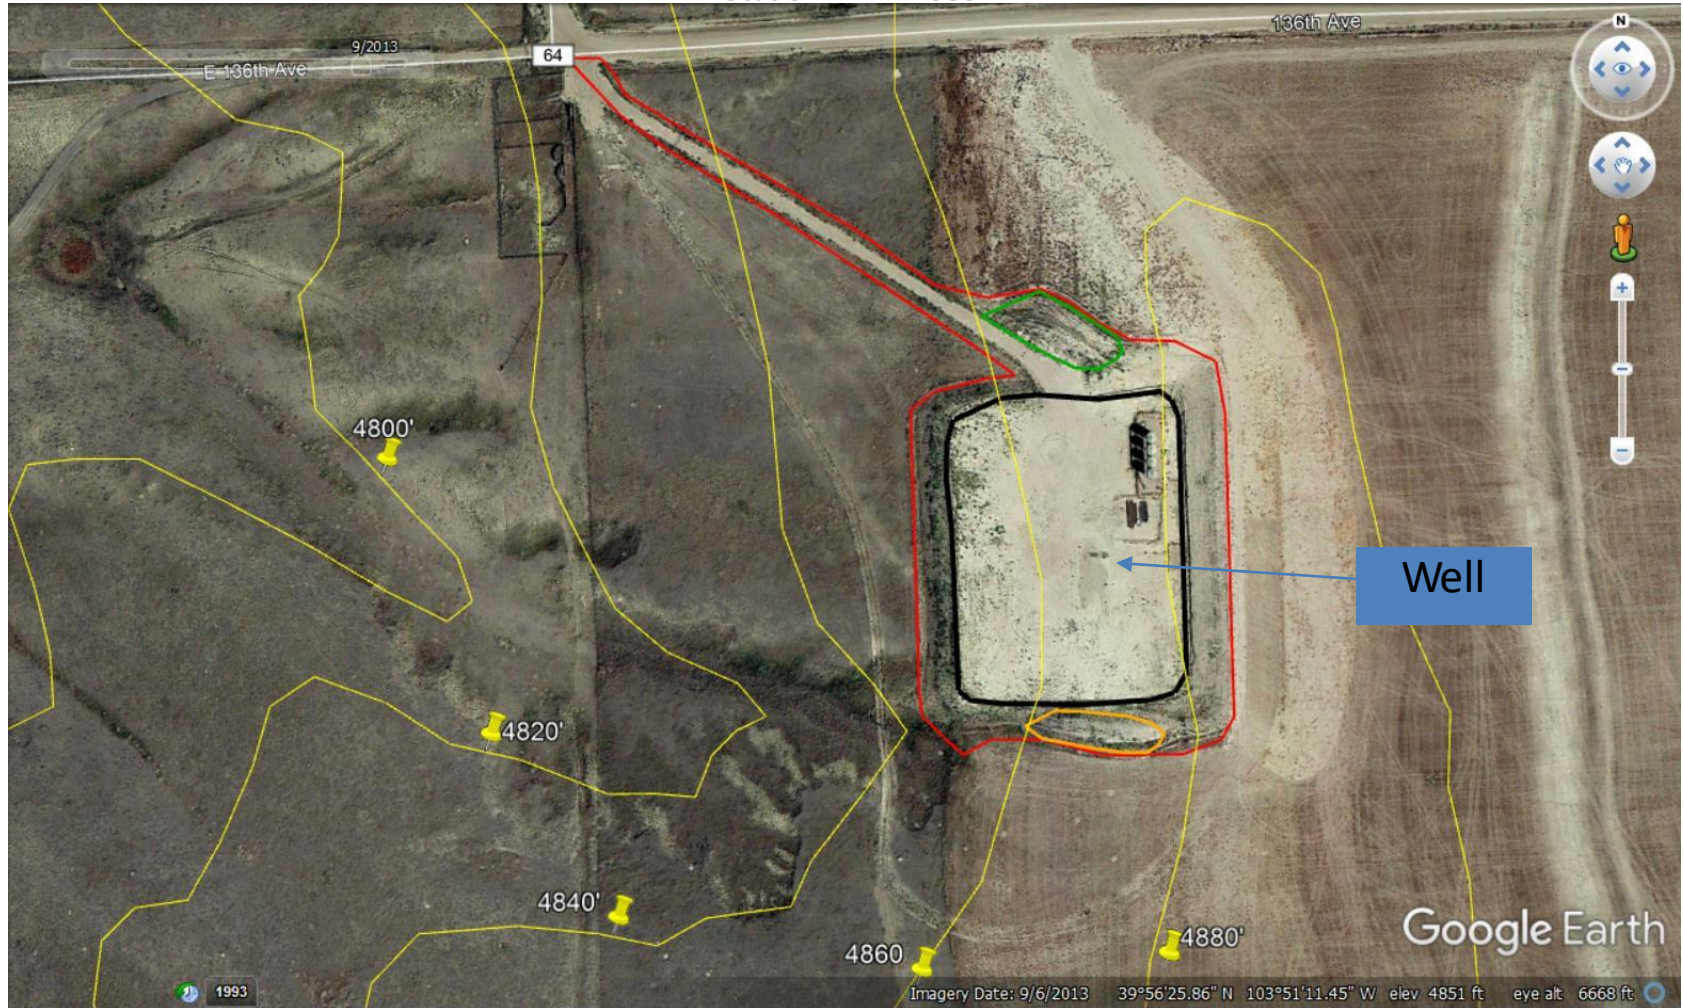
Photo 3: 9/06/2013 aerial imagery. 2A doc. #400252948 states size of location after IR is 0.92 acres, with IR estimated to begin on 9/1/2012. Based on production records, interim reclamation (IR) on areas no longer reasonably needed for production should have occurred no later than 10/2012. Photo image date is 11 months after when IR should have occurred. Photo shows location does not appear to have been reduced in size; IR does not appear to have been conducted. Total disturbance remains ~4.9 acres with pad/production area ~2.43 acres.

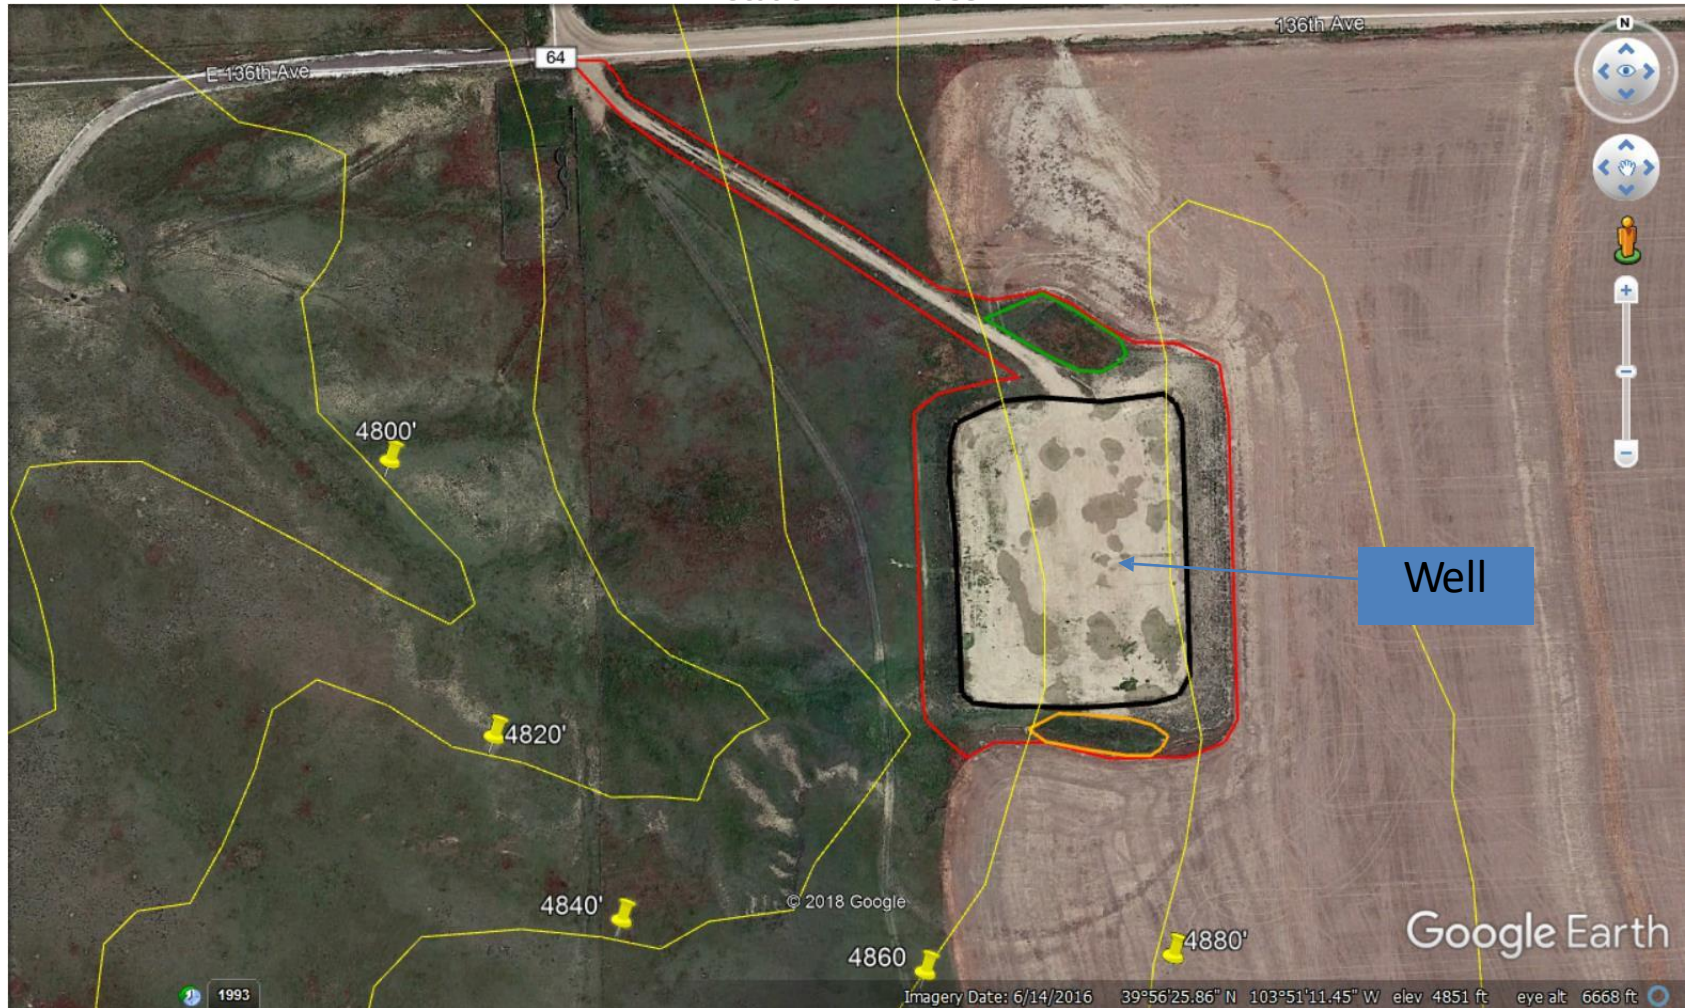
Photo 4: Current available aerial imagery dated 06/14/2016. 6(s) doc. #400900611 states well was PA'd on 8/28/2015. Photo shows well and equipment appear to have been removed. Location would now have been subject to 1004 reclamation rules which require final reclamation to be completed within 3 months on crop land after plugging a well. Final reclamation should have been completed by 11/28/2015. Photo shows location/disturbance size

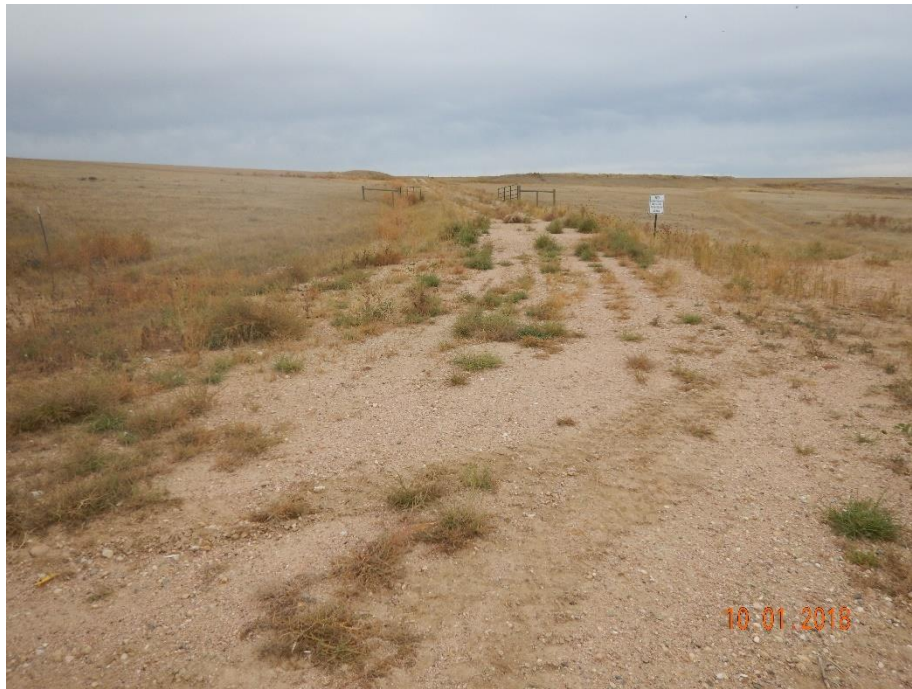
Photo 5: Photo from where the access road meets 136th avenue, facing southeast towards the location. Photo shows access road.

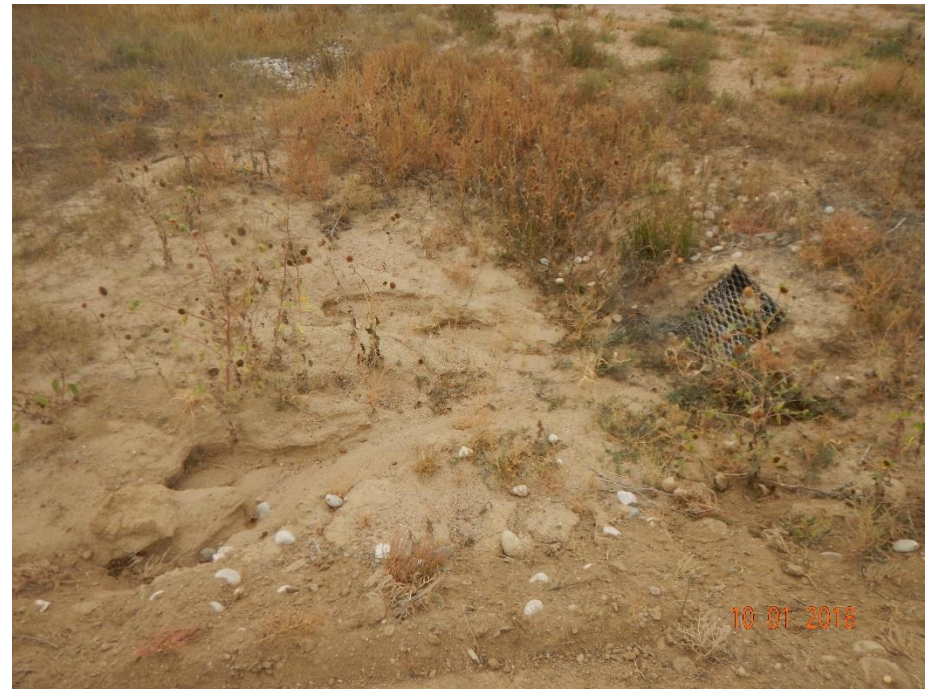
Photo 6: Photo of the eastern end of the culvert at the access road.

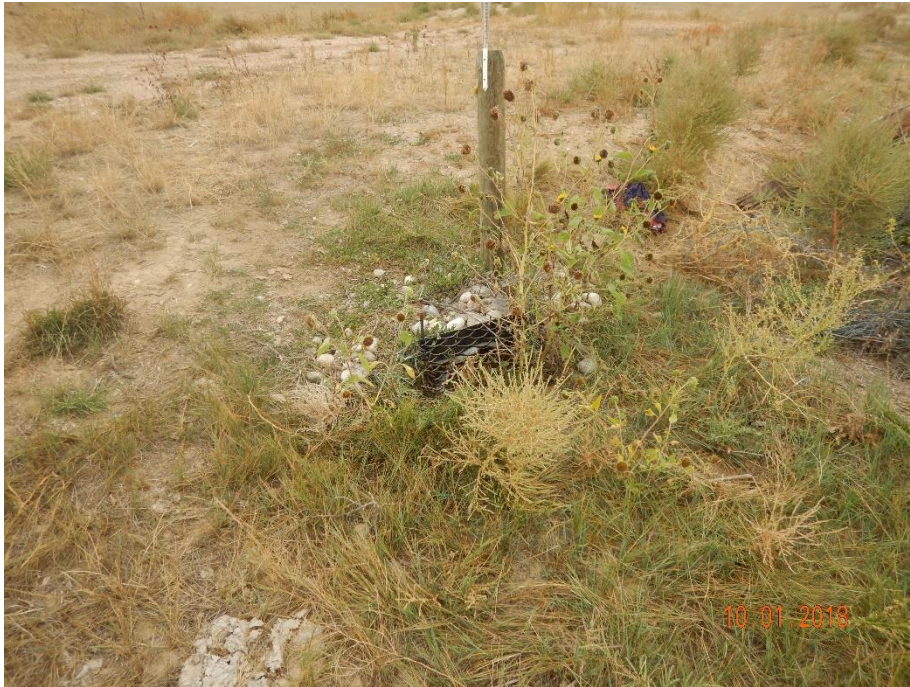
Photo 3: Photo of the western end of the culvert at the access road.

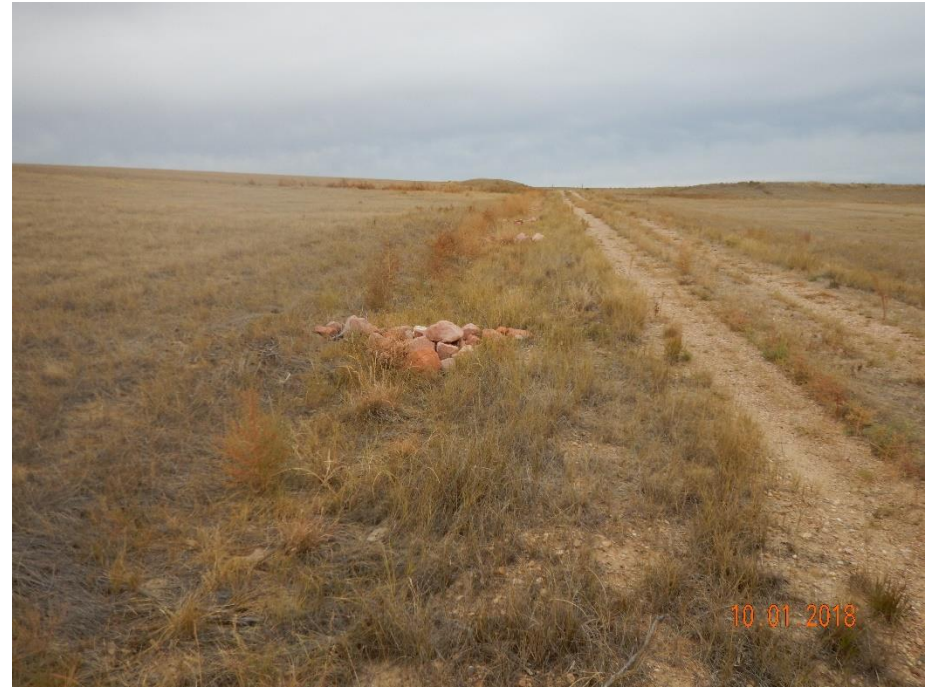
Photo 4: Photo taken from the access road, facing southeast. Photo shows velocity checks and ditch along access road. BMPs appear to be in proper functioning condition.

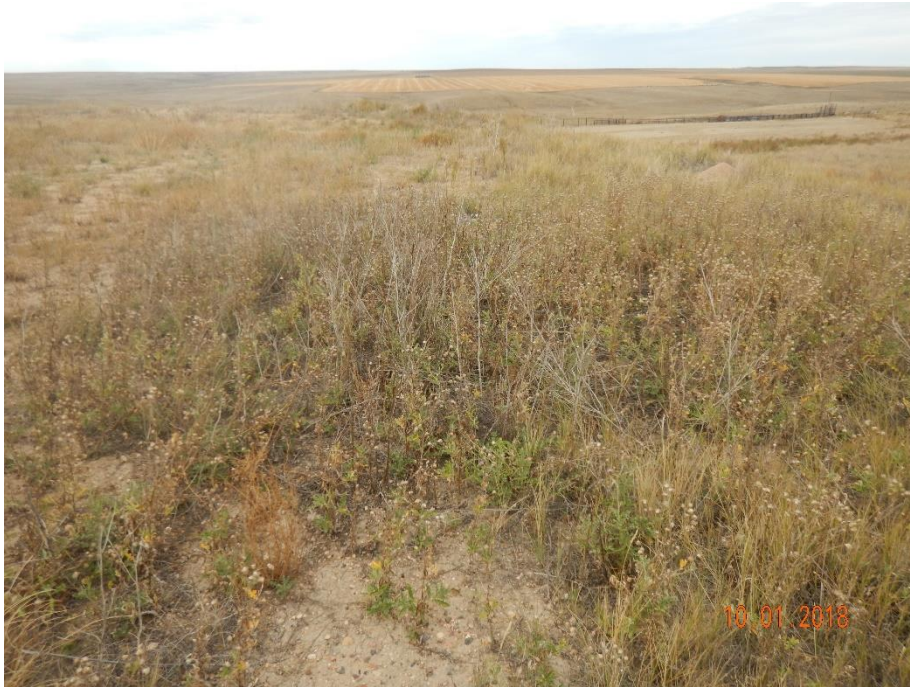
Photo 9: Photo from the northwest end of the pad, facing west. Photo shows patch of Canada thistle observed on location. This is a Colorado state listed noxious weed that needs to be managed.

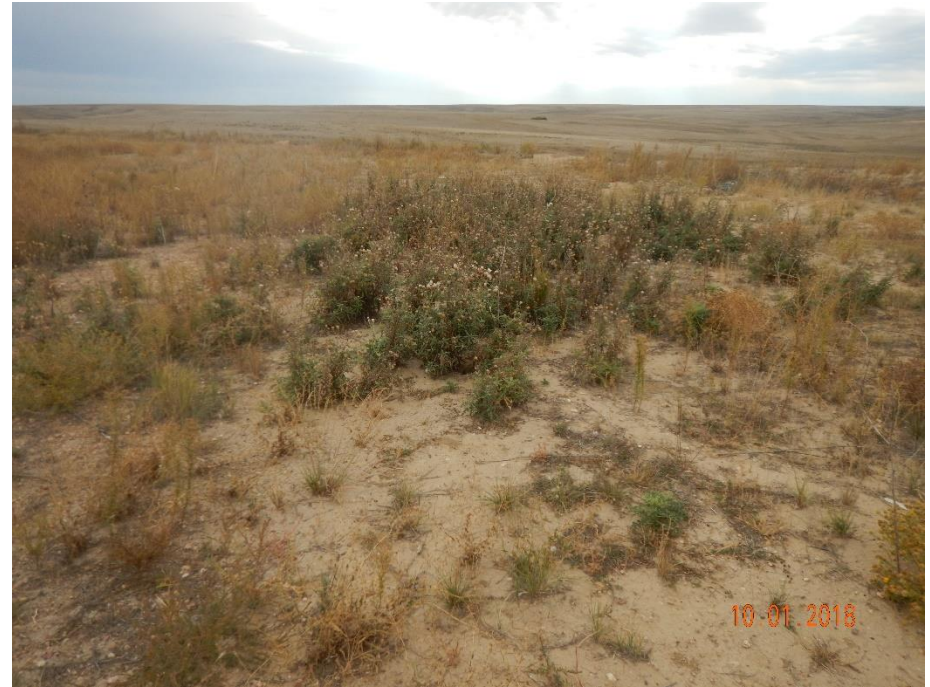
Photo 10: Photo from the northwest end of the pad, facing southwest. Photo shows a second patch of Canada thistle observed on the location. This is a Colorado state listed noxious weed that needs to be managed.

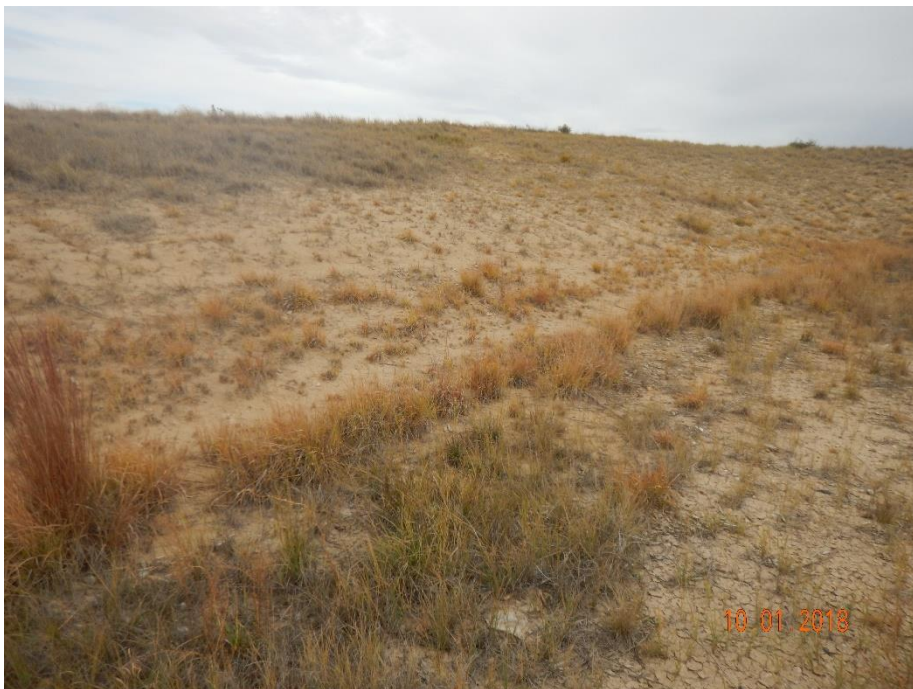
Photo 11: Photo from the northeast corner of the location, facing northeast. Photo shows cut slopes on the location do not appear to be stabilized; vegetation has not achieved a uniform establishment and stormwater erosion degradation is forming rill/gully erosion on the slopes. These areas remain predominantly bare and exposed soil and are at risk for further erosion degradation.

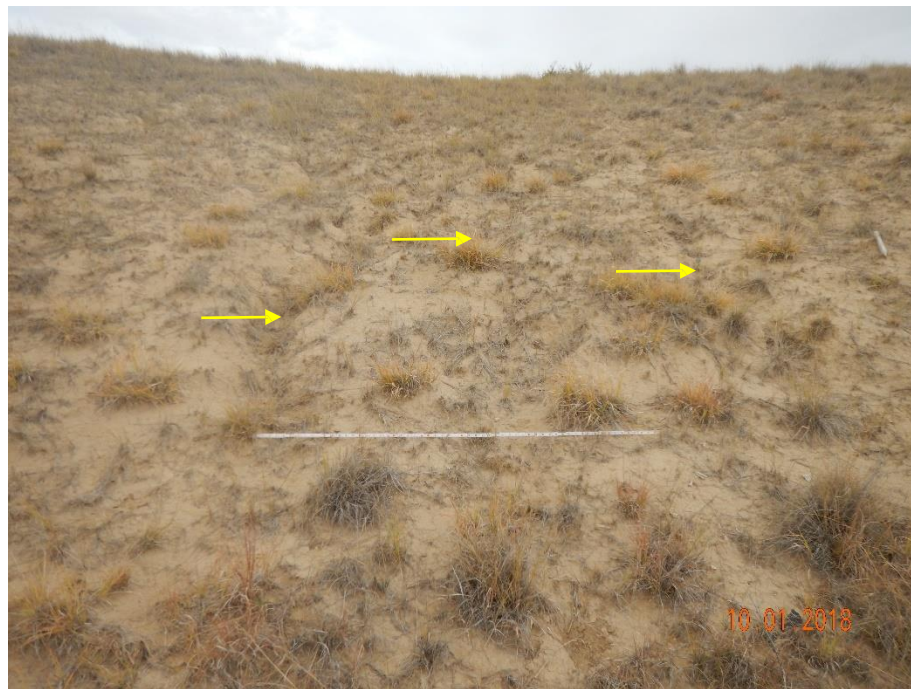
Photo 12: Continued from photo 11. Photo shows closer image of stormwater erosion occurring on the cut slopes of the location

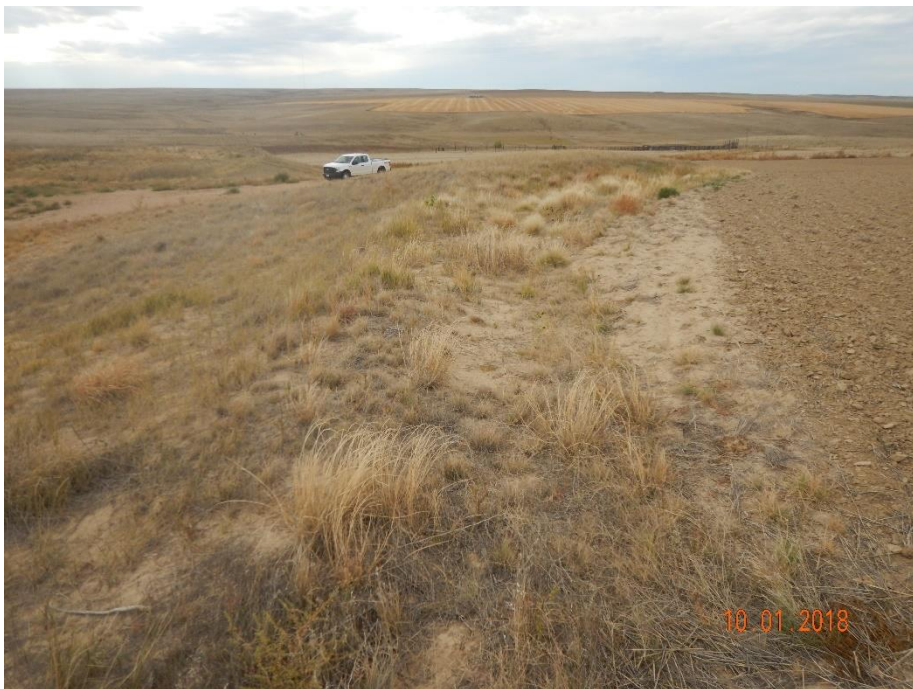
Photo 13: Photo taken from the north end of the location, facing west. Photo shows area designated as the “topsoil stockpile” based on location drawing, “Exhibit A”, of document #401313989. Photo also shows stormwater ditch on the north end of the stockpile.

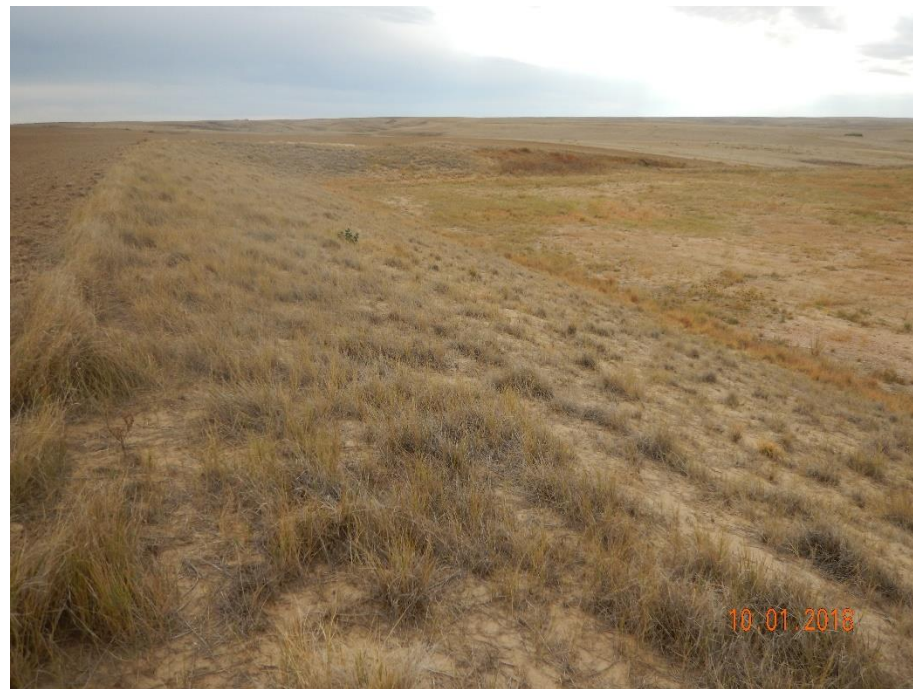
Photo 14: Photo from the east end of the location, facing south. Photos 14-16 provide an overview of the location from south, to west, and north. Photos also show that large areas of the pad is predominantly undesirable weedy plant species, or bare and exposed soil, and is not graveled/stabilized.

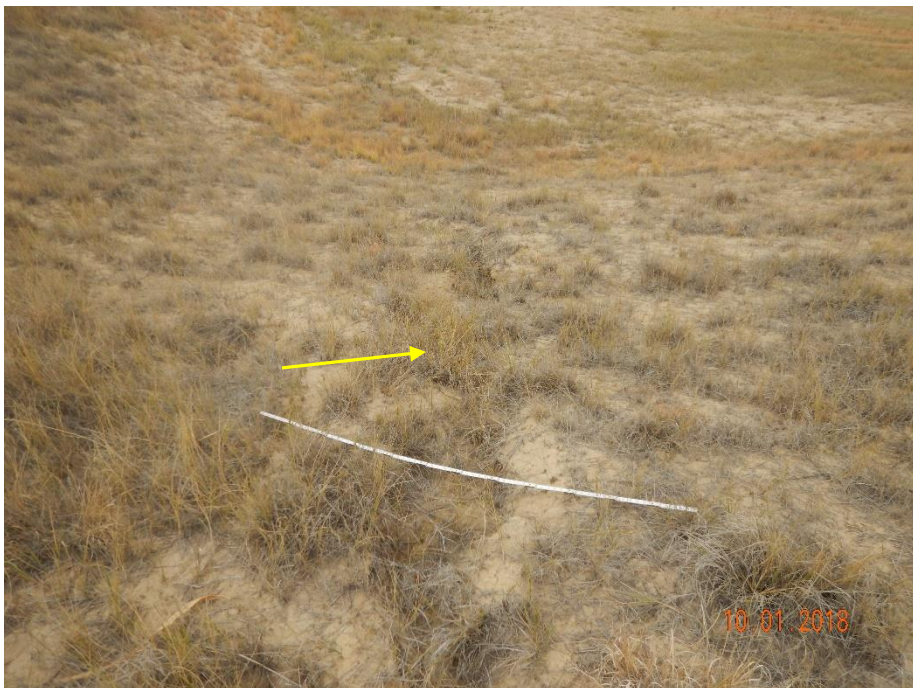
Photo 17: Photo taken from the southeast end of the location. Photo shows cut slopes on the location do not appear to be stabilized; stormwater erosion degradation is forming rill/gully erosion on the slopes and creating pedestal formations around what vegetation has established. 6 foot measuring stick for reference.

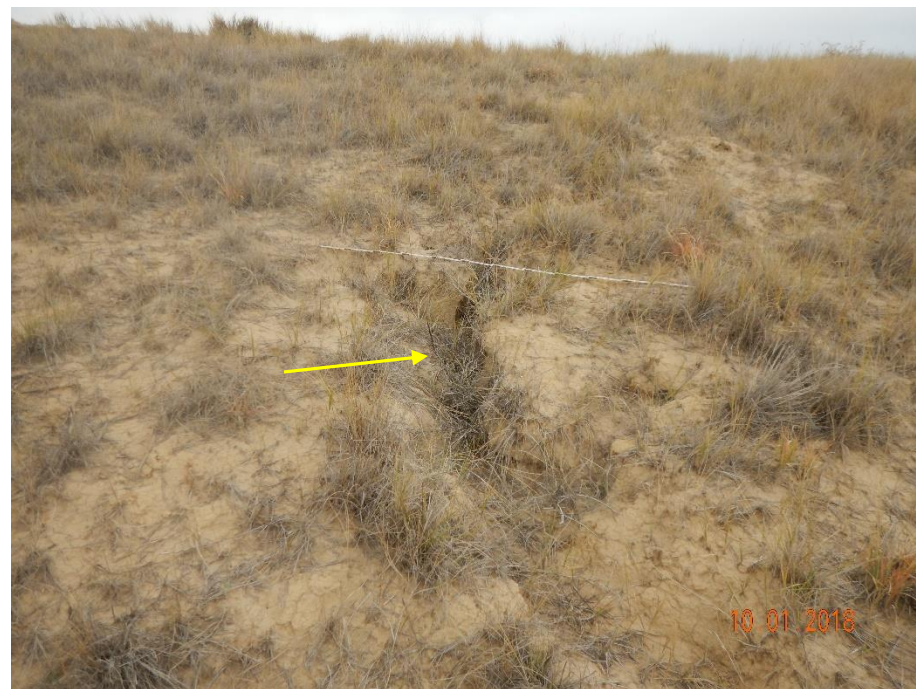
Photo 18: Photo taken from the southeast end of the location, facing east. See comments under photo 17.

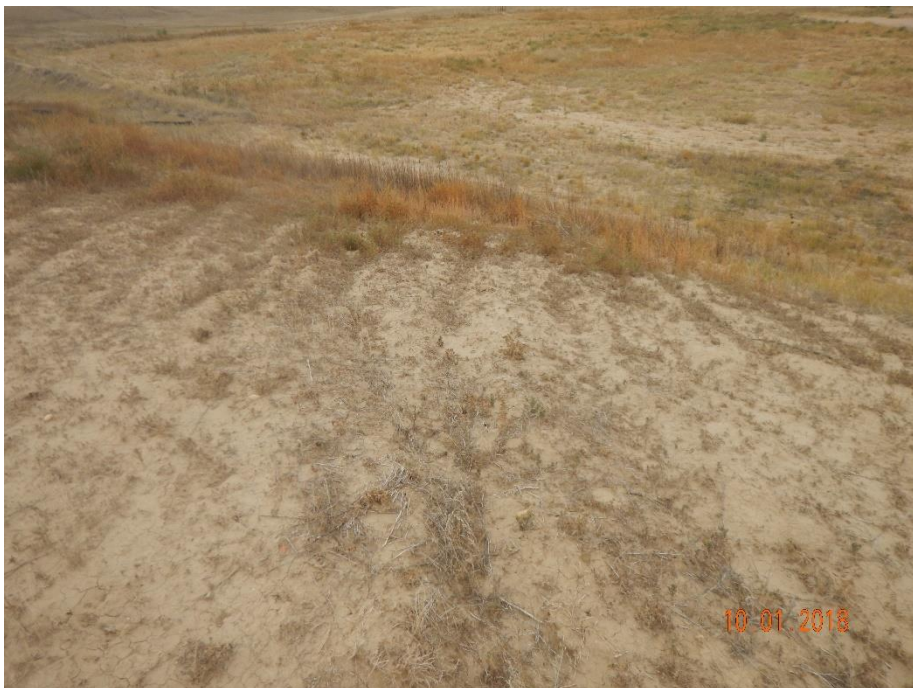
Photo 19: Photo taken from area of the “spoils” stockpile on the south end of the location, facing northwest. Photo shows areas of bare and exposed soil with large furrows. These furrows are similar to those seen after a ripper has roughened soils. This surface roughening has not been performed along the contour of the slope and has created channels to promote stormwater gully erosion degradation. Stockpile is not sufficiently stabilized.

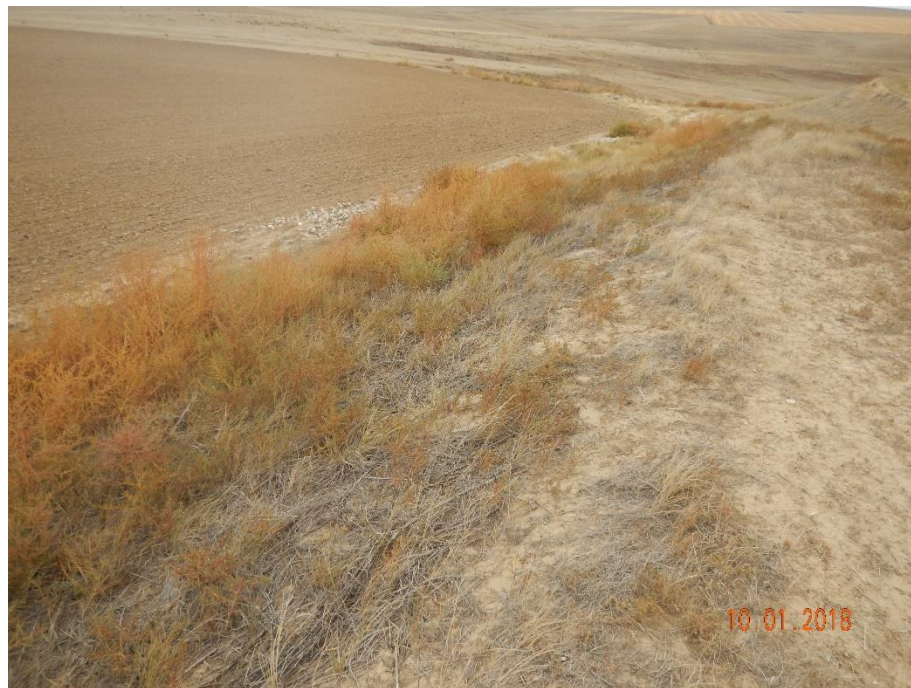
Photo 20: Photo taken from the south end of the location, facing west. Photo shows slopes on the south of the location appear to be largely bare and exposed soil, or predominantly undesirable weedy plant species.

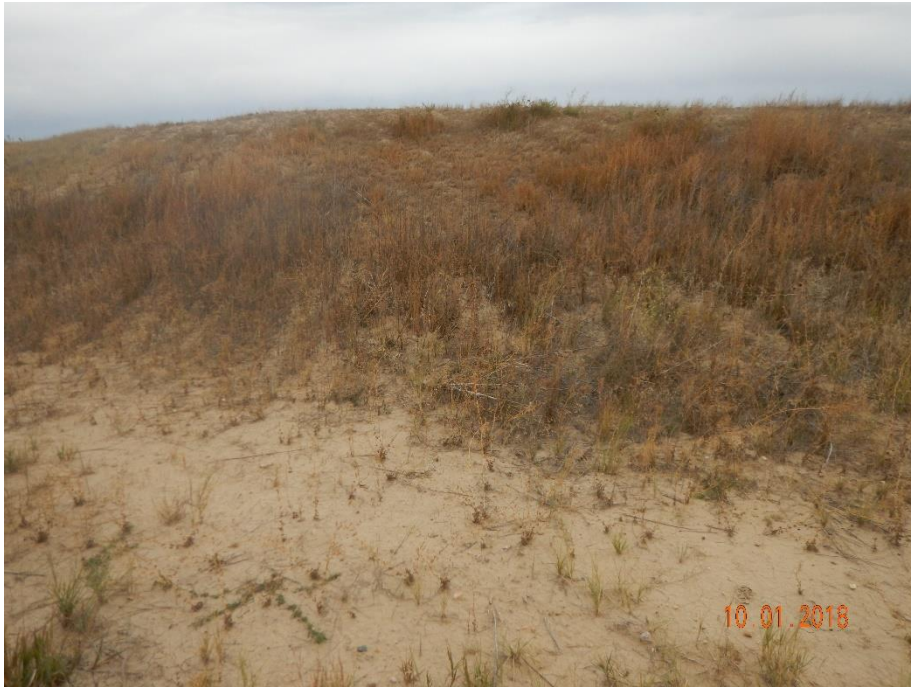
Photo 21: Photo taken from the south end of the location, facing south. See comment under photo 19. Vegetation seen in photo is predominantly undesirable weedy plant species.

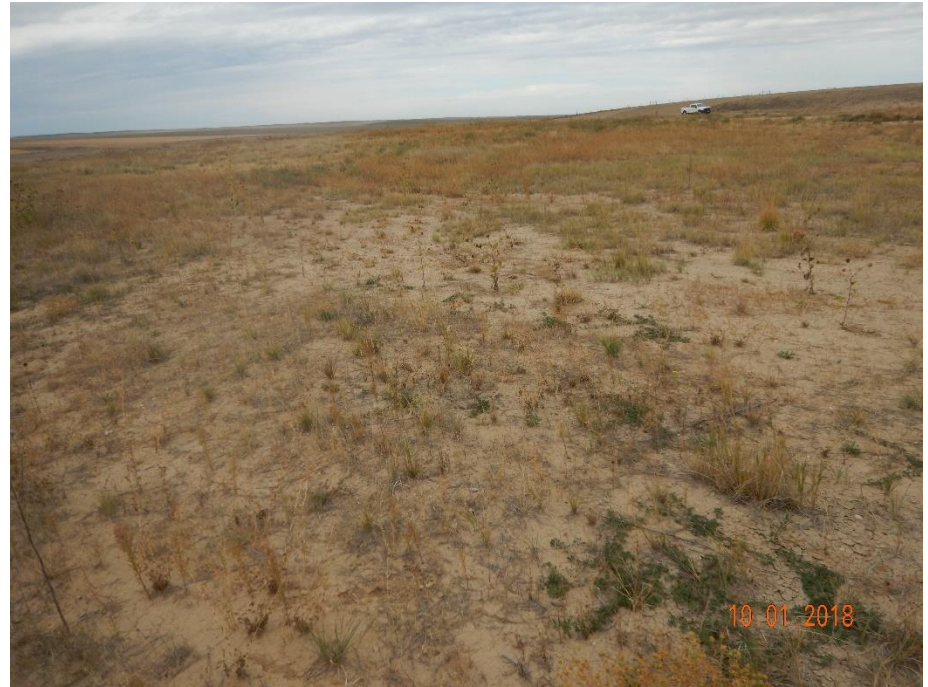
Photo 22: Photo from the south end of the location, facing northwest. Photos 22-24 provide an overview of the location from northwest, northeast, to east. Photos also show that large areas of the pad is predominantly undesirable weedy plant species, or bare and exposed soil, and is not graveled/stabilized.

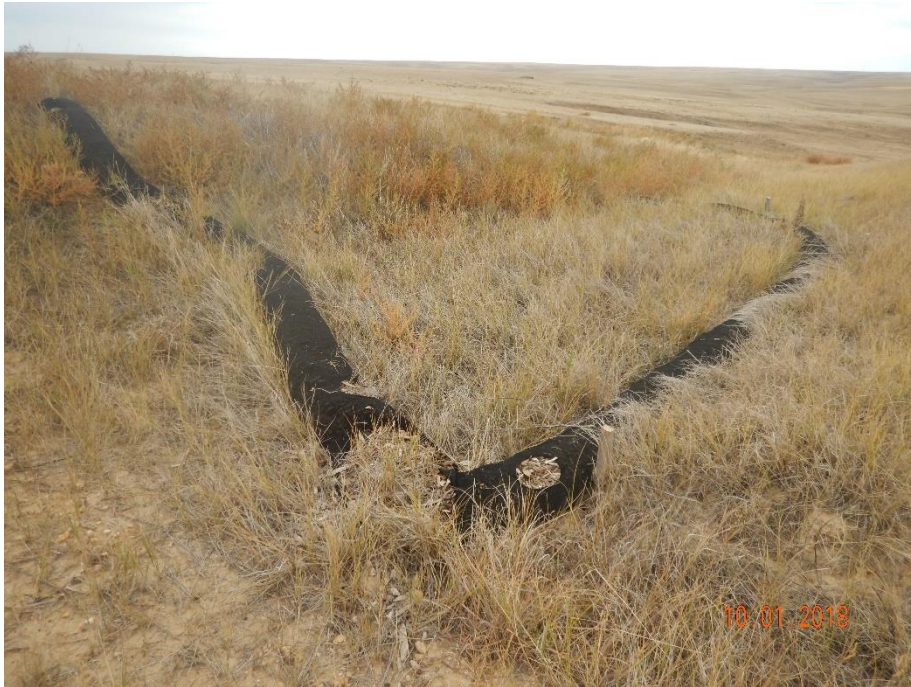
Photo 25: Photo taken from the south end of the location, facing southwest. Photo shows wood-mulch wattle stormwater ponding BMP. BMP showing signs of degradation,

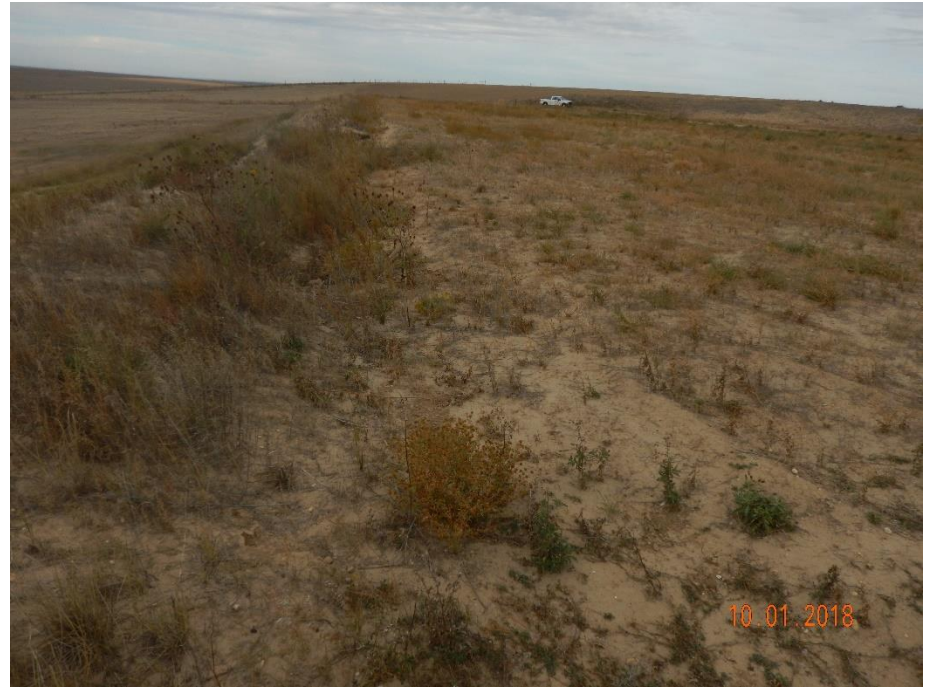
Photo 26: Photo from the southwest end of the location, facing north. Photos 22-24 provide an overview of the location from north, northeast, to east. Photos also show that large areas of the pad is predominantly undesirable weedy plant species, or bare and exposed soil, and is not graveled/stabilized.

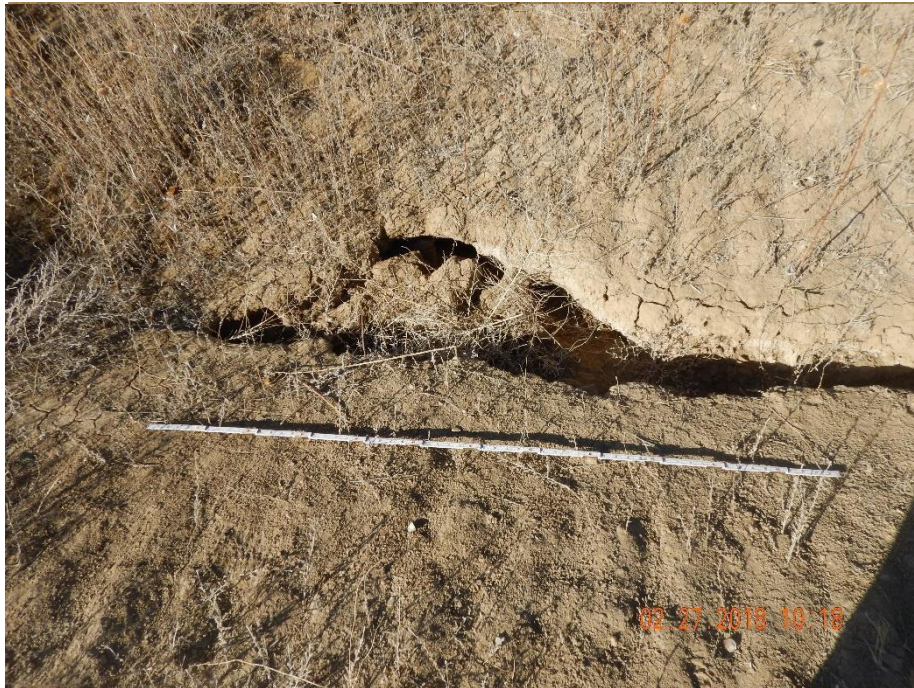
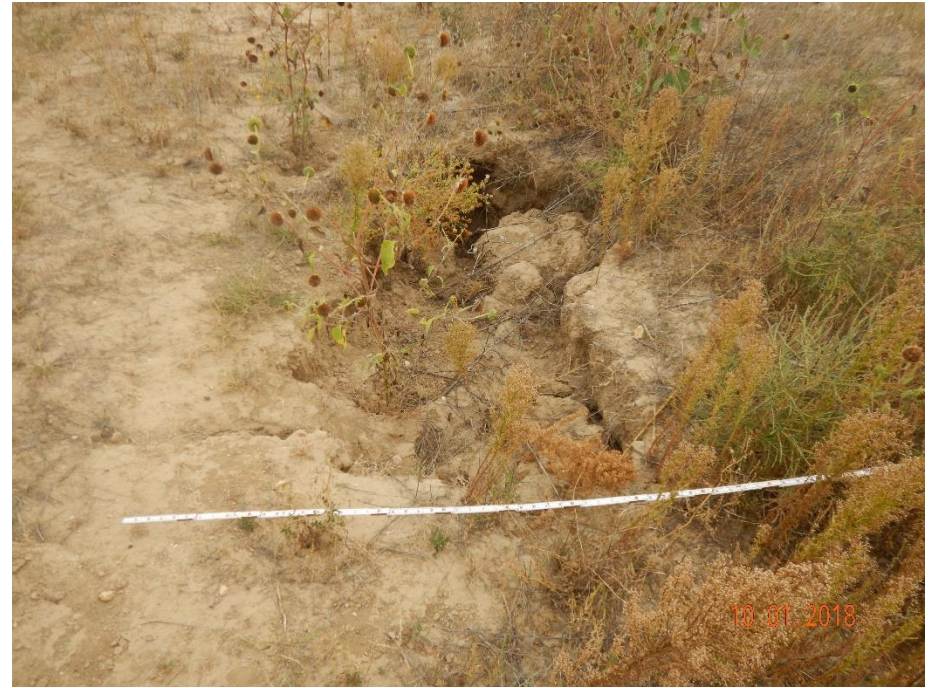
Photo 29: Photos taken from the stormwater ditch on the west end of the location. Photos shows stormwater runoff has incised the ditch along the west end of the pad. Photo on left (facing west) taken during a site visit 2/27/2018. Photo on right (facing north) shows progression of the degradation since February 2018. 6 foot measuring stick for reference.

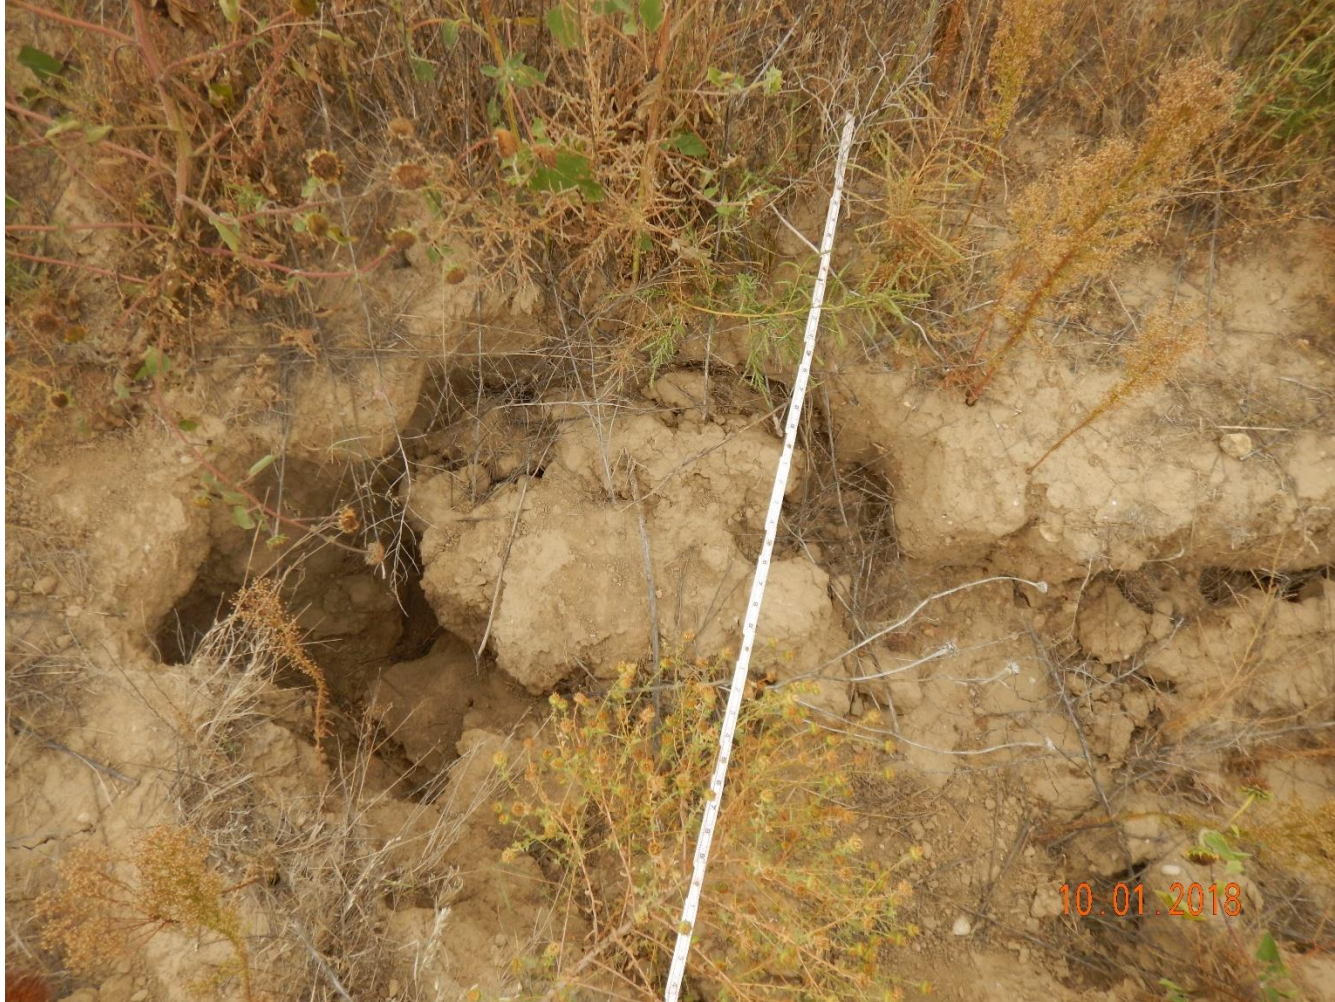
Photo 30: Continued from photo 29. 6 foot measuring stick for reference.
