Inspection Photos

10/01/2018

Operator: SWN PRODUCTION COMPANY LLC -
10396

Inspection Doc. Number: 682504013
Adams County, CO

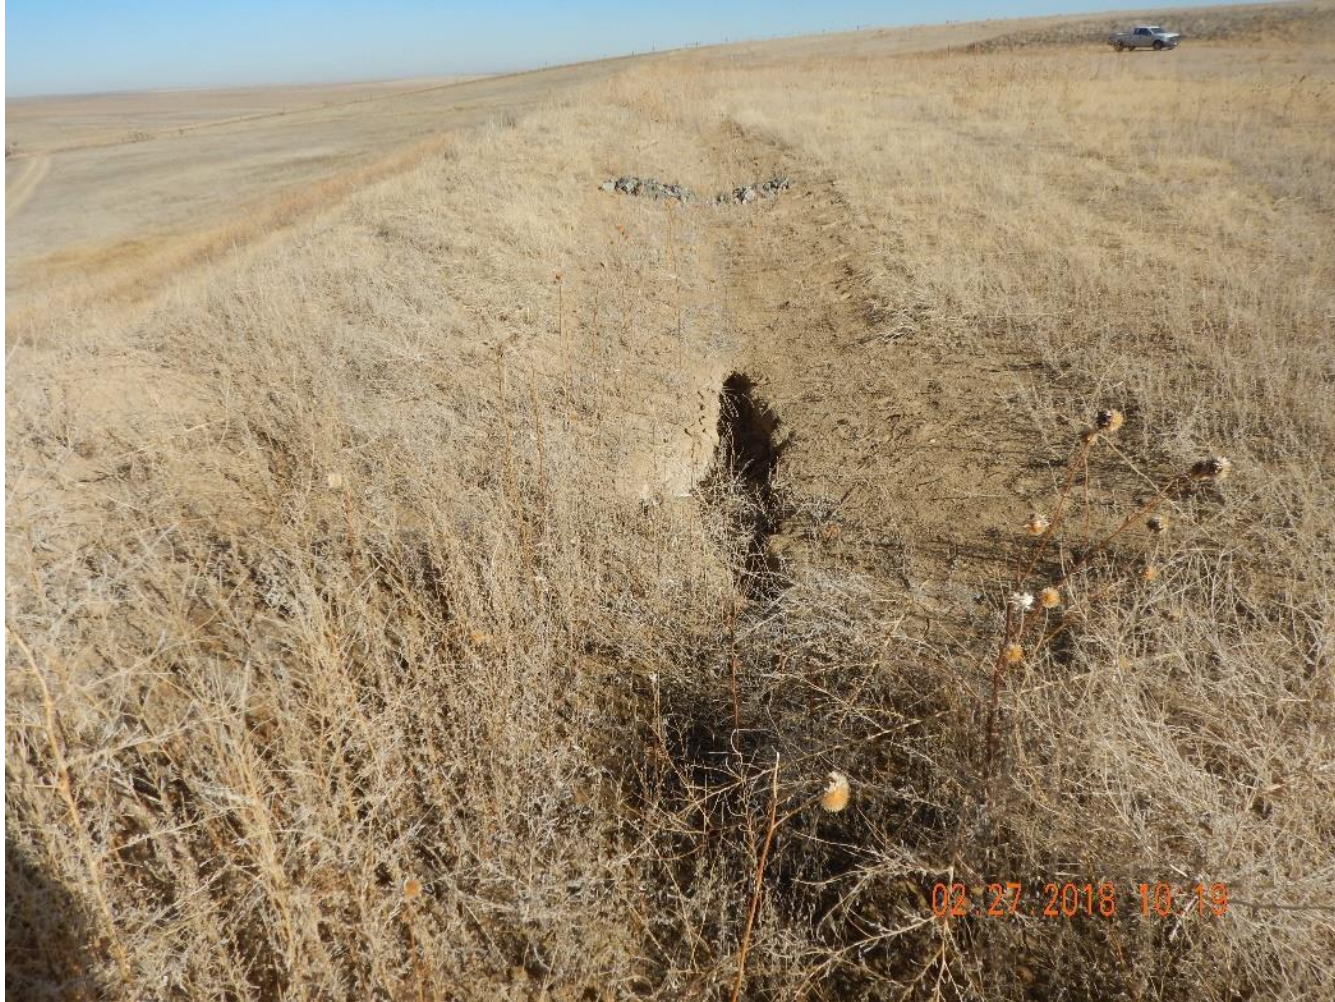
Photo 31: Photo date 2/27/2018. Photo taken from the west end of the location, facing north. Photo shows stormwater incision within the ditch.

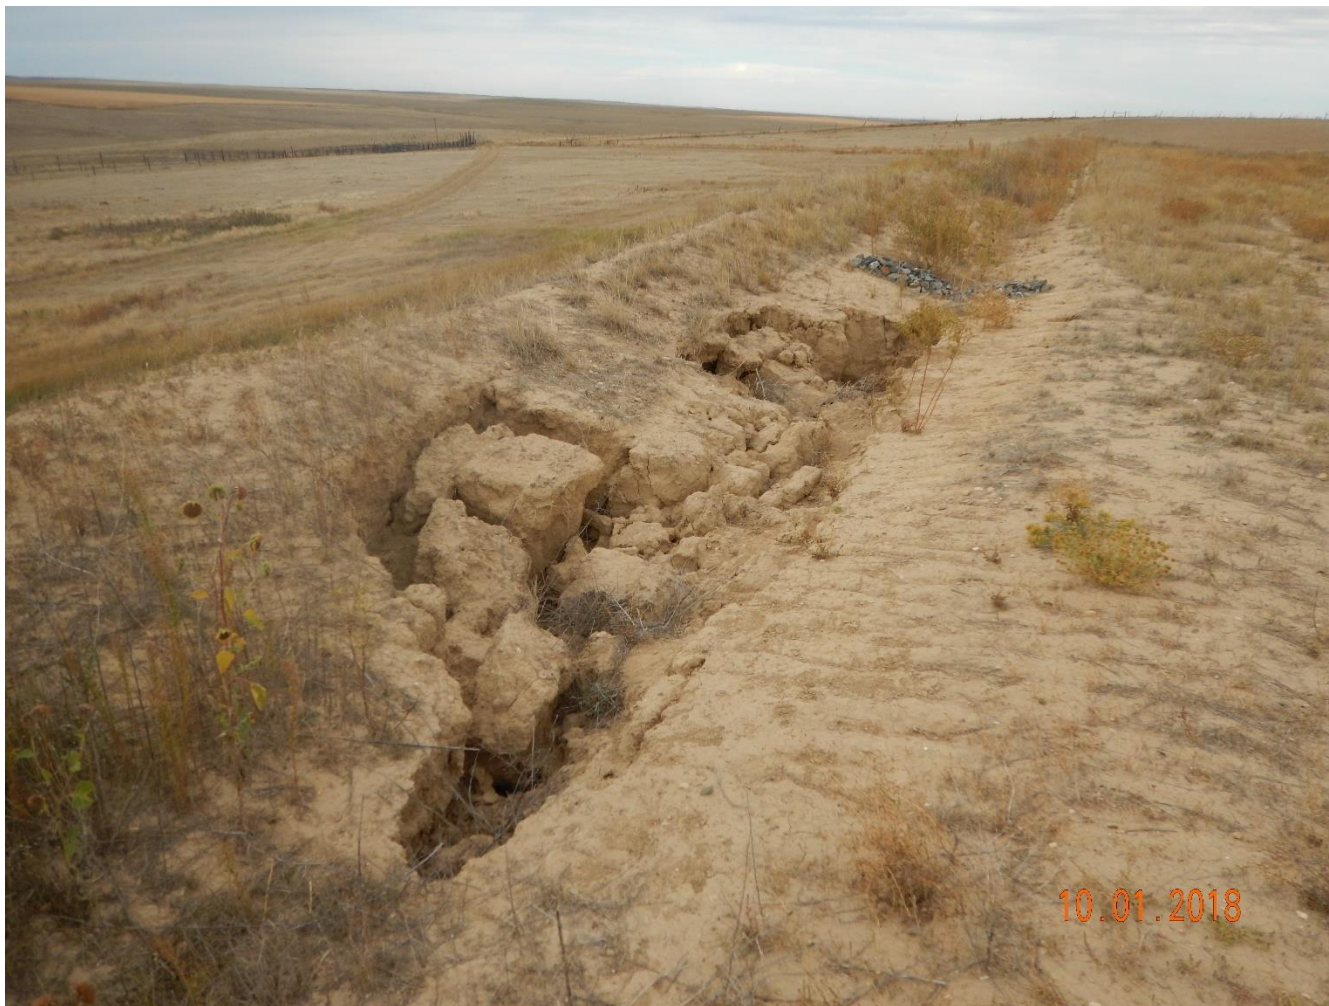
Photo 32: Continued from photo 31. Photo shows progression of the stormwater degradation since February 2018. Please note: water appears to be focusing within this area of the ditch. There is not evidence to suggest stormwater is flowing out of the ditch onto the pad, or off the location. Water appears to be traveling sub-gradient into what appears to be a sinkhole. Pad does not appear to be stable.

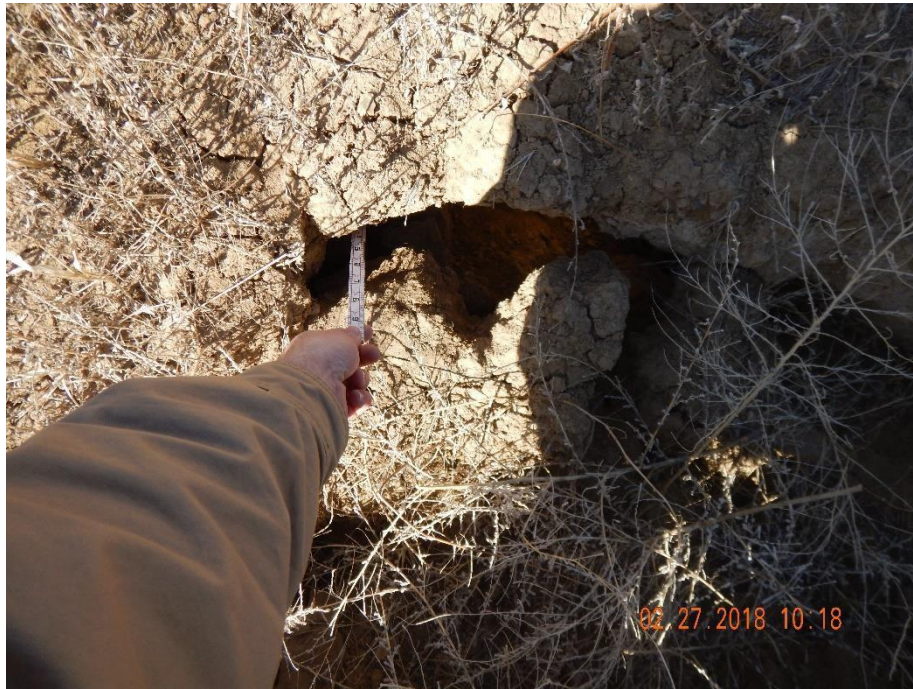
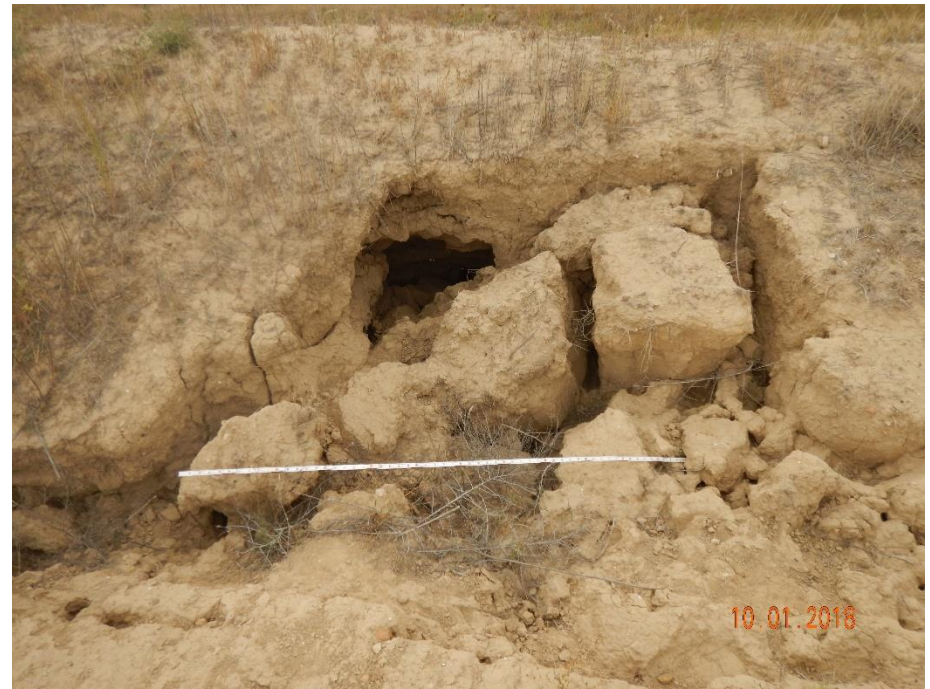
Photo 33: Continued from photo 31. Photos shows stormwater incision within the ditch has cut underneath the pad itself. Photo on left dated 2/27/2018 shows inspector inserted a 6 foot measuring stick to determine how far/deep the stormwater sinkhole has undercut into the pad. The sinkhole exceeded the length of the measuring stick and it was unclear how deep the undercut went at this time. The photo on the right shows the progression of the degradation since February, 2018. The depth at which the sinkhole has cut under the pad appears to exceed 10 feet down at this point.

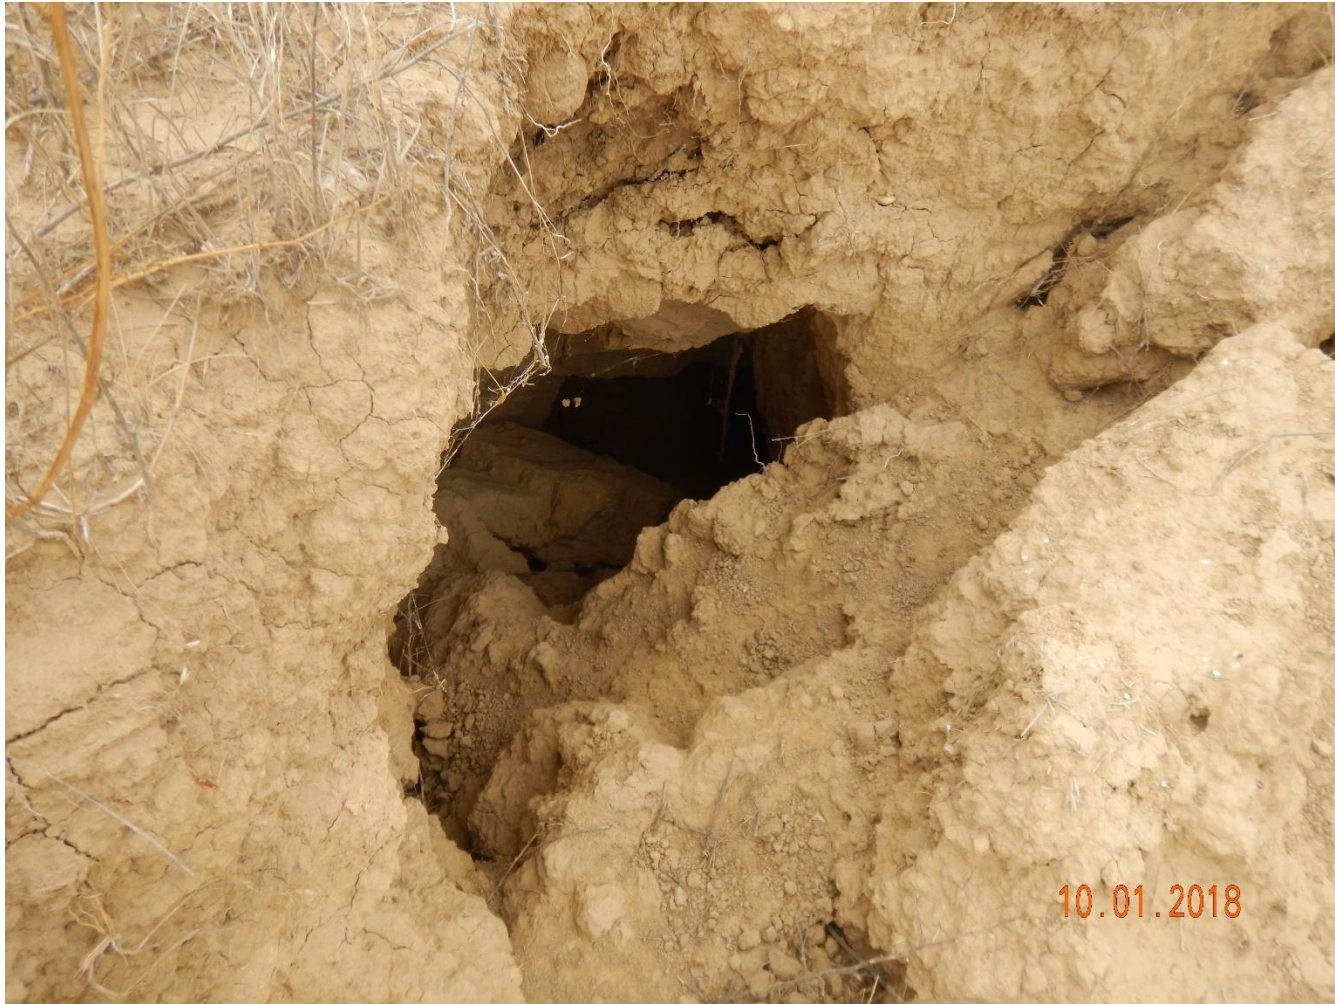
Photo 34: Continued from photo 33. Photo shows depth at which stormwater has created a sinkhole and cut under the pad, appears to exceed 10 feet down.

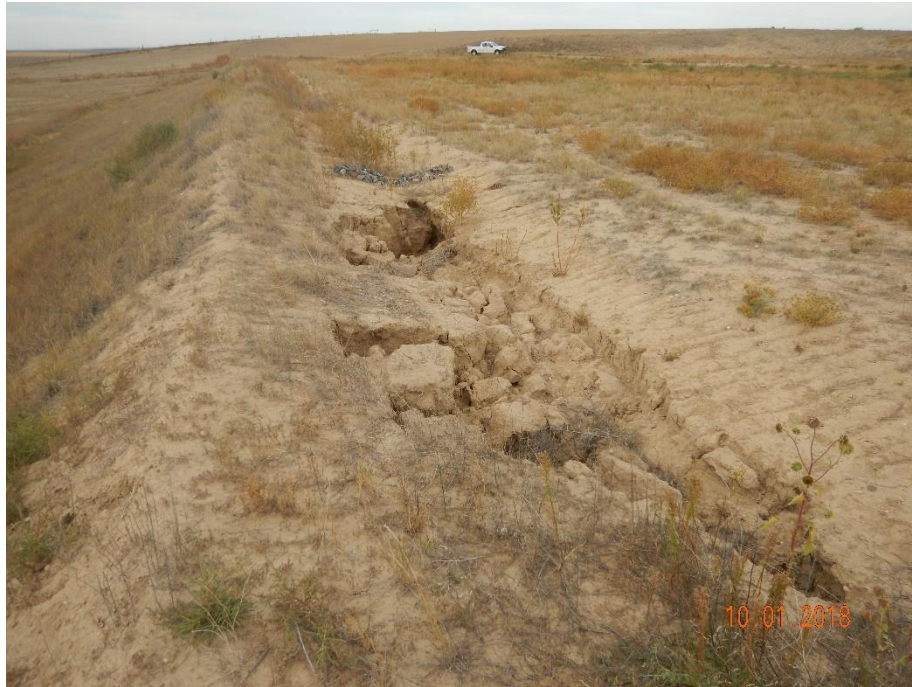
Photo 35: Continued from photo 32. Photo shows erosion degradation occurring, and sinkhole forming within the ditch on west end of the pad.

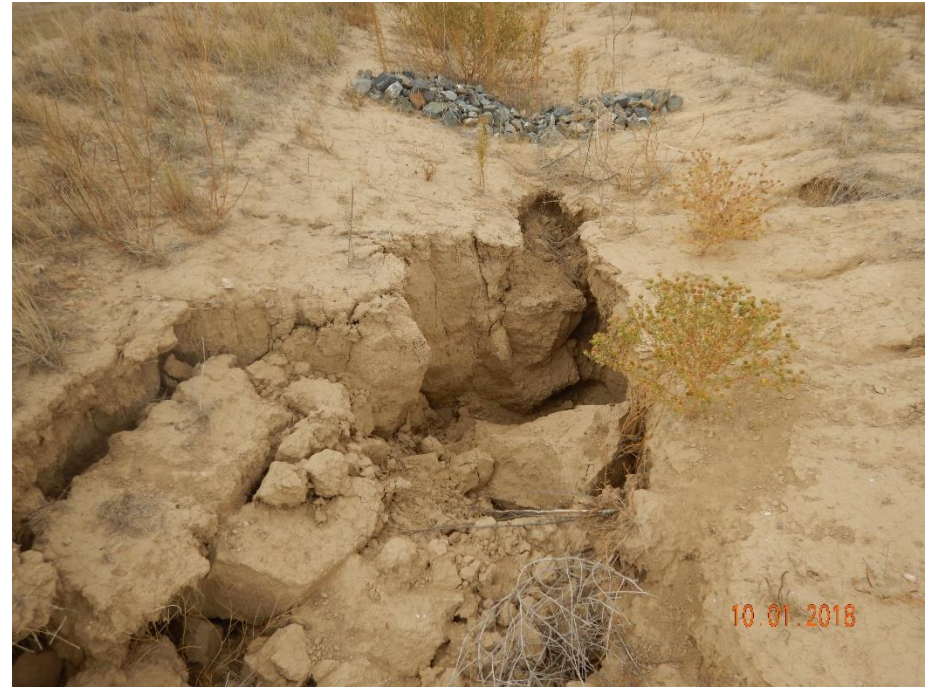
Photo 36: Continued from photo 32. Photo shows erosion degradation occurring, and sinkhole forming within the ditch on west end of the pad.

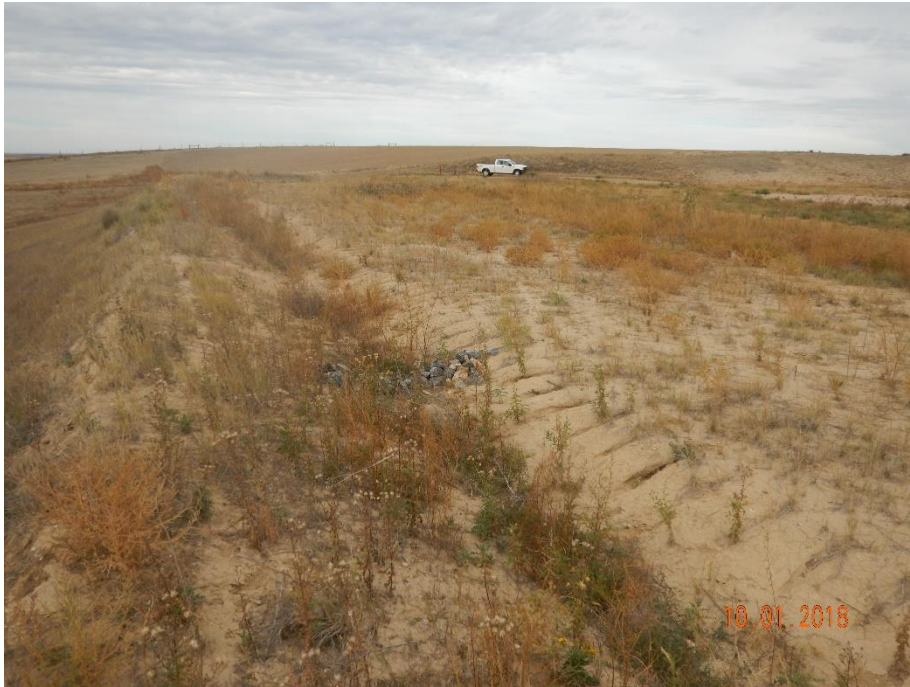
Photo 37: Photo taken from the west end of the pad, facing north. Photos 37-40 provide an overview of the location from north, east, so south. Photos also show stormwater runoff from the pad into the ditch has created rill formations on the slopes of the ditch.

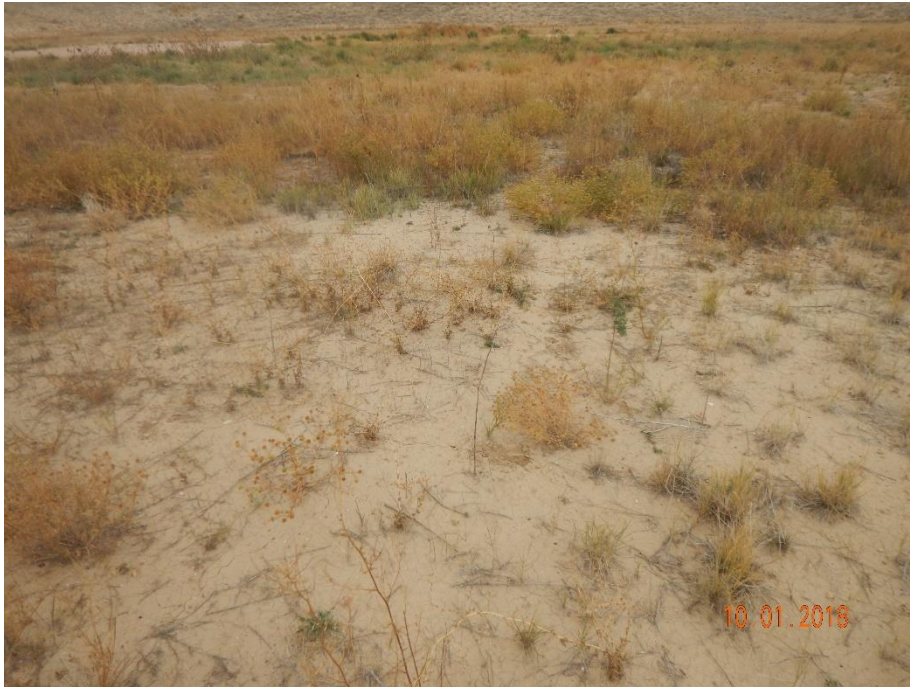
Photo 41: Photo taken from the west end of the location, facing east. Photo shows areas of the pad that do not appear to have been stabilized with gravel or vegetation.

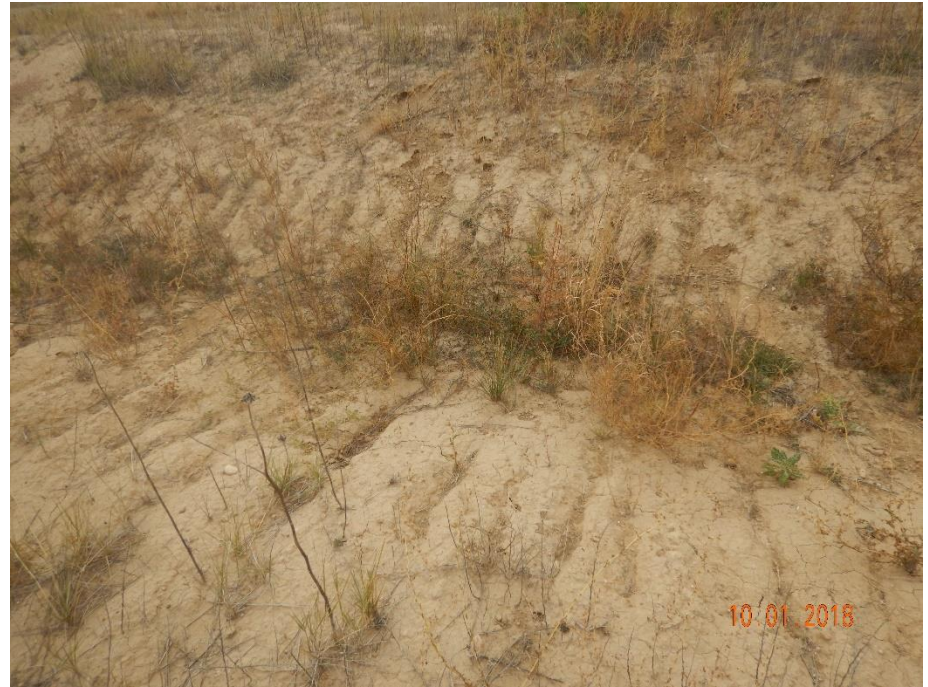
Photo 42: Photo taken from the ditch on the west end of the pad. Photos show stormwater runoff from the pad into the ditch has created rill erosion.

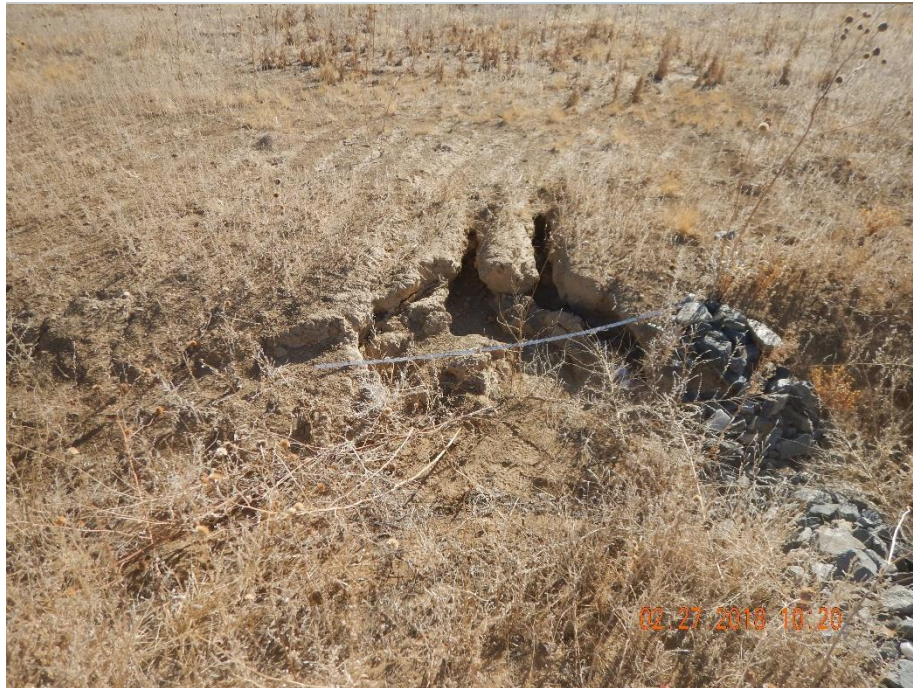
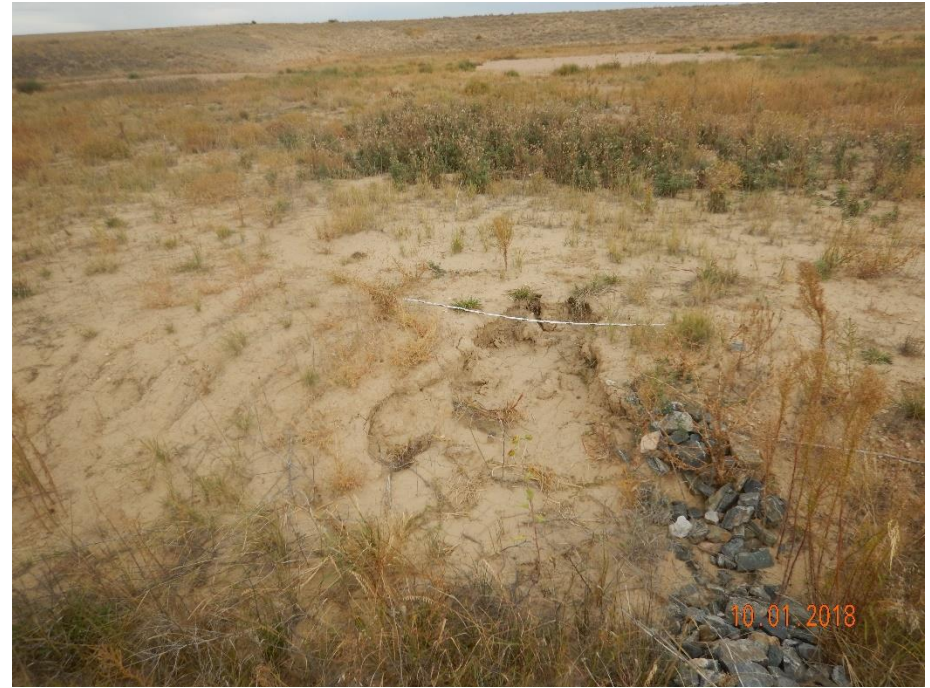
Photo 43: Photos taken from the stormwater ditch on the west end of the pad. Photo on the left dated 2/27/2018 shows stormwater runoff from the pad was creating rill and gully erosion that was beginning to cut eastward into the pad. Photo on the right shows erosion degradation has progressed further into the pad. 6 foot measuring stick for reference.

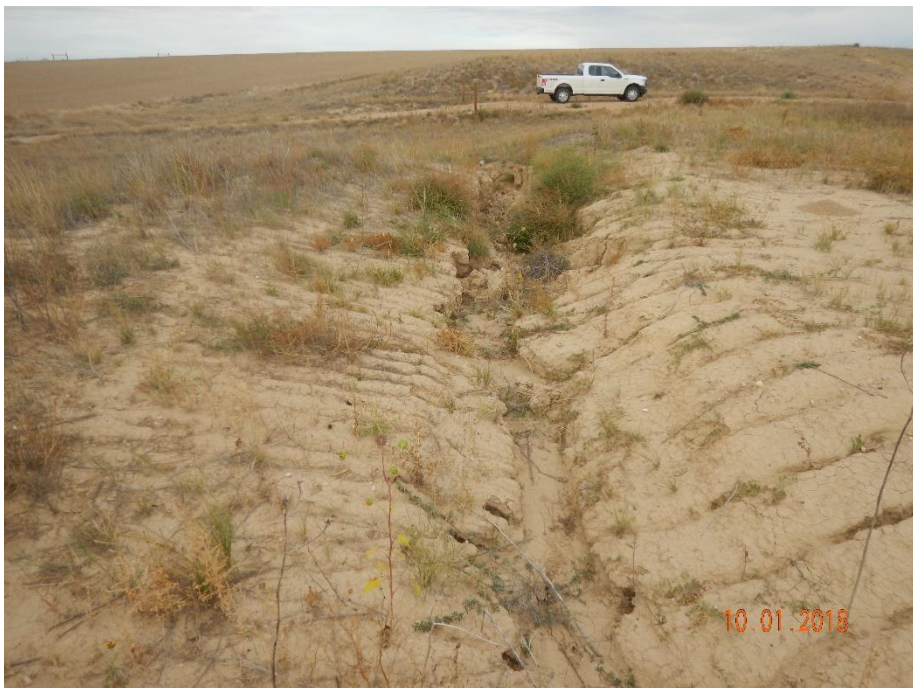
Photo 44: Photo taken from the northwest corner of the pad, facing east. Photo shows erosion degradation within the ditch. Stormwater runoff has blown out controls (erosion blanket, velocity checks) and has created a large gully on the north end of the pad.

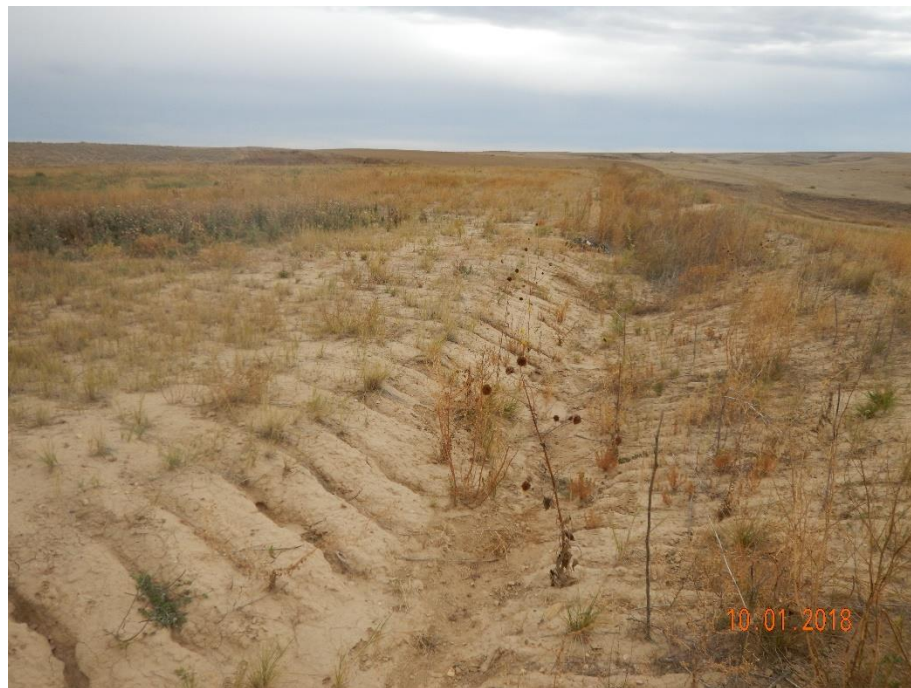
Photo 45: Photo taken from the northwest corner of the pad, facing. Photo shows erosion degradation within the ditch.

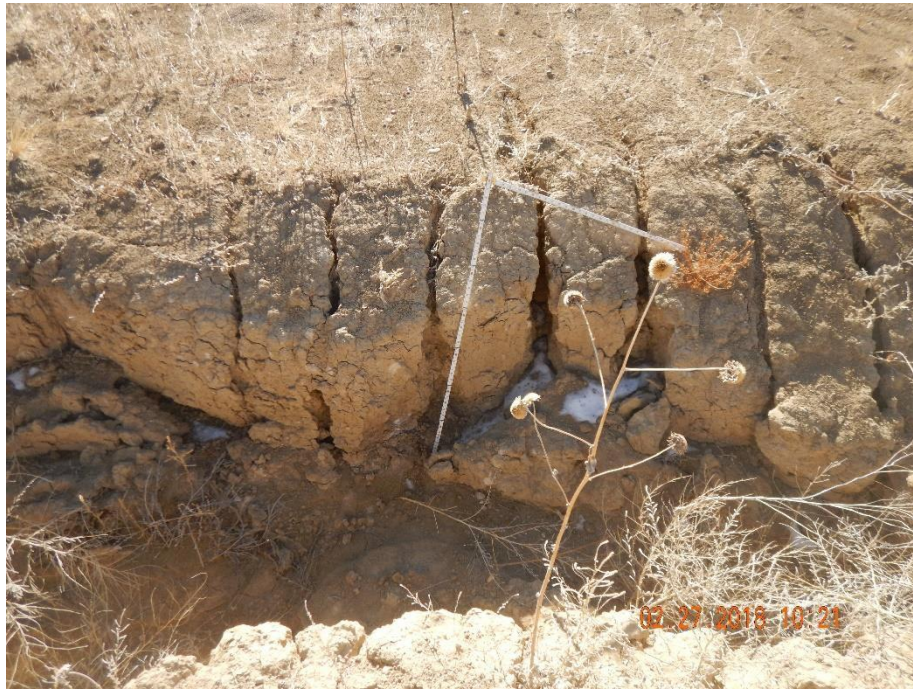
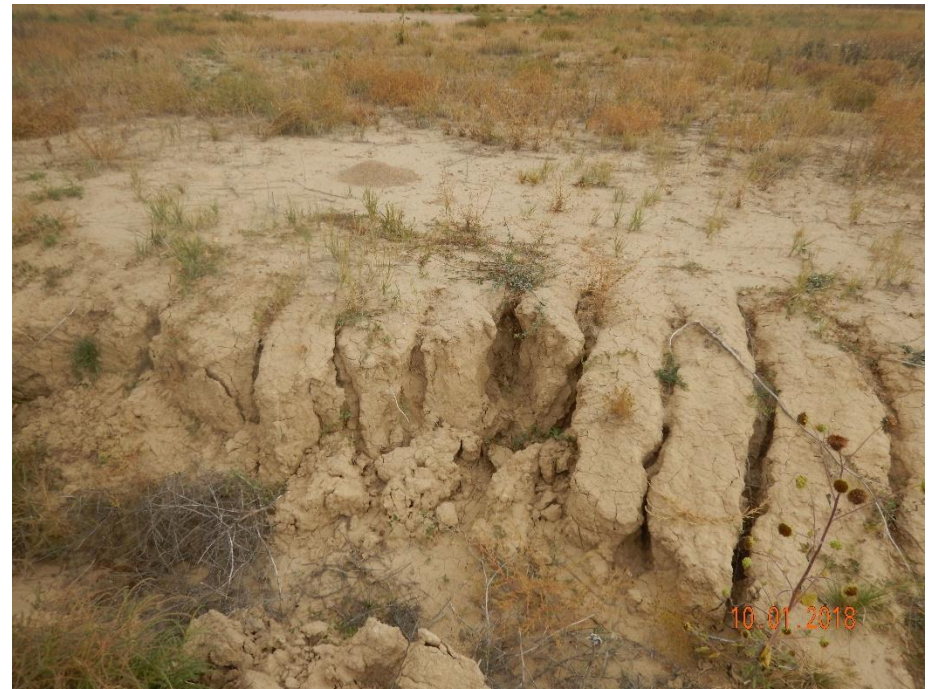
Photo 46: Photos taken from the gully erosion on the northwest end of the pad. Photo to left dated 2/27/2018 shows rill/gully erosion beginning to cut eastward into the pad. Photo on the right shows erosion degradation has progressed further into the pad. 6 foot measuring stick for reference.

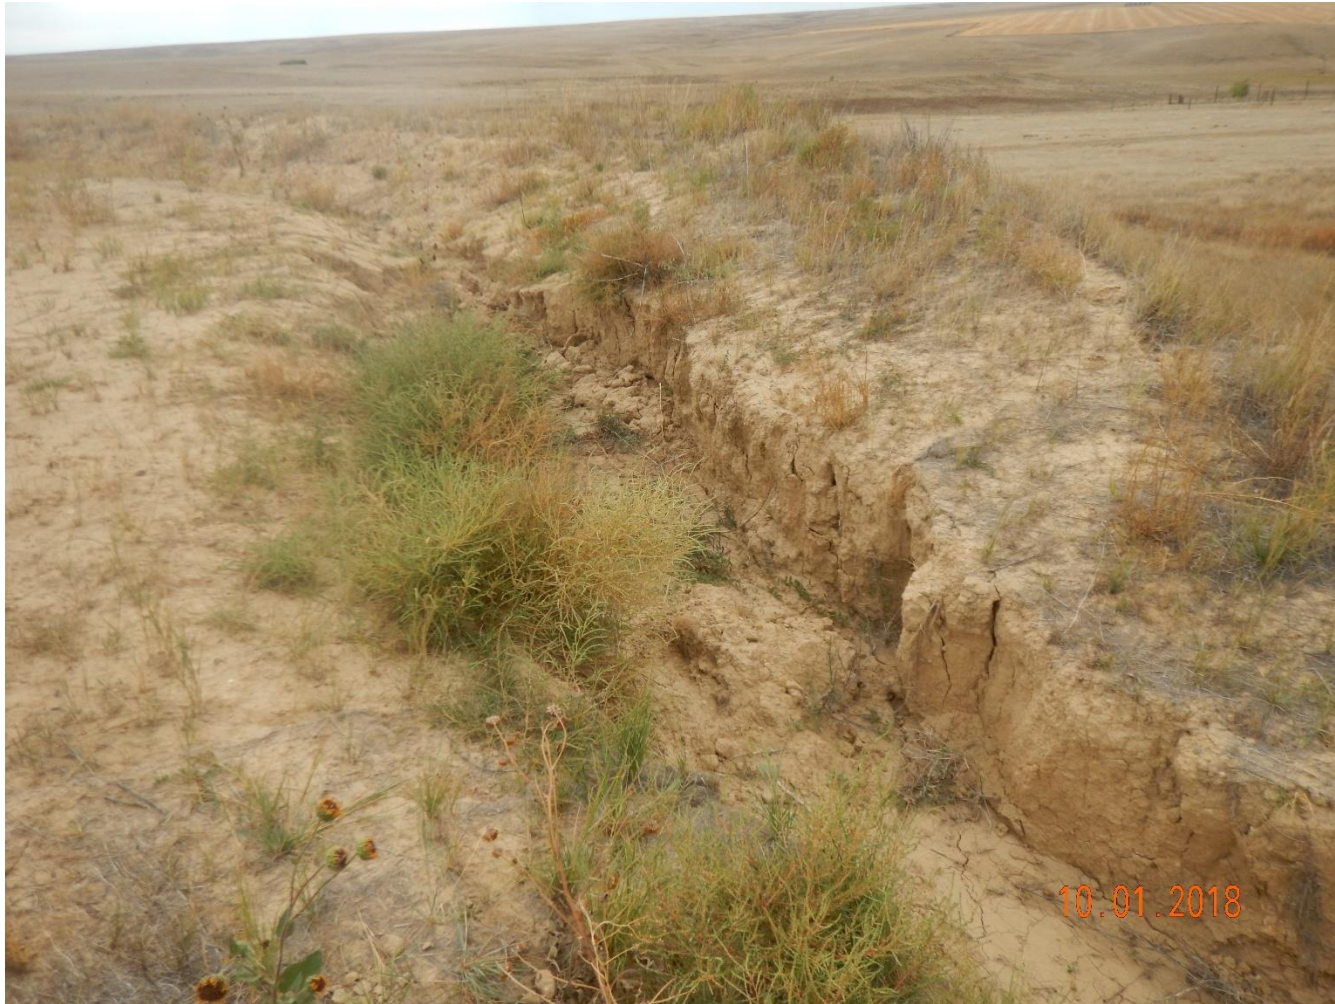
Photo 47: Photo taken from the northwest end of the pad, facing west. Photo shows stormwater runoff from the pad has blown out the ditch, velocity checks and erosion control blanket, creating a large gully.

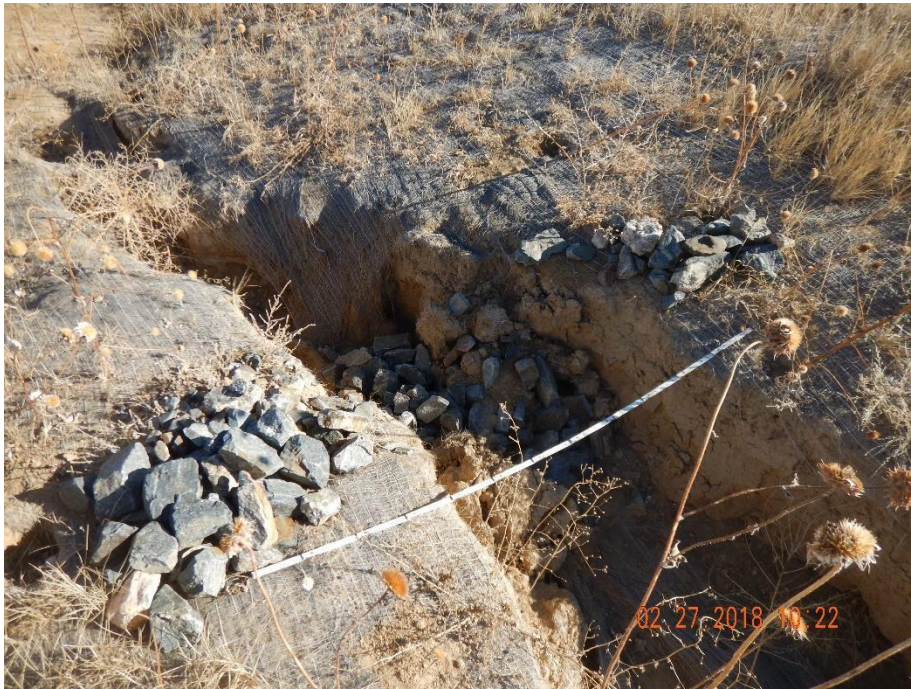
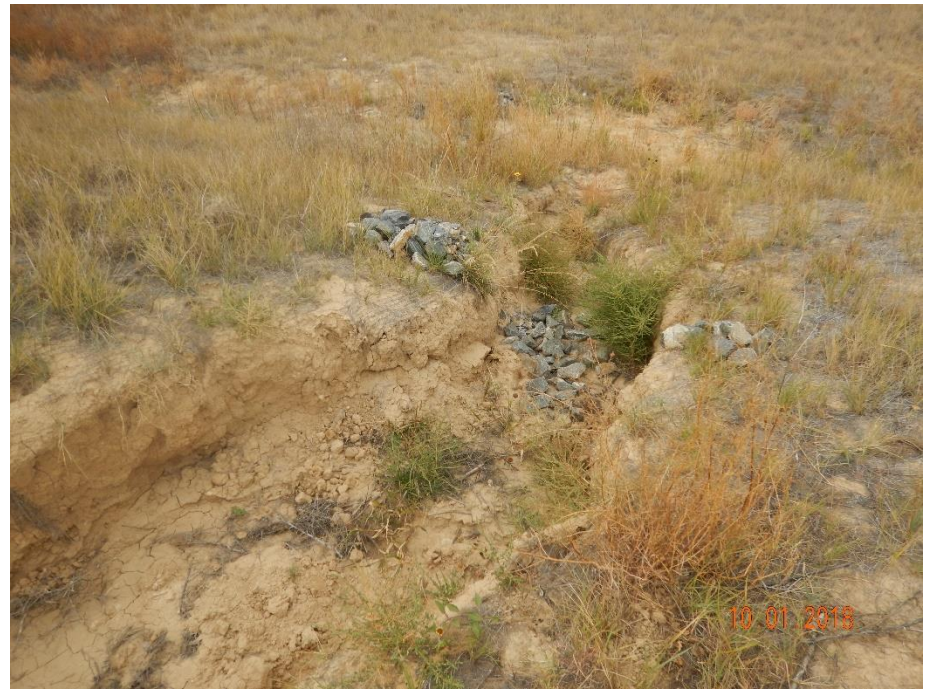
Photo 48: Photos taken from the gully erosion on the northwest end of the pad. Photo to left dated 2/27/2018 shows stormwater runoff erosion from the pad has blown out the ditch, velocity checks and erosion control blanket, creating a large gully. Photo on the right shows progression of the erosion degradation. 6 foot measuring stick for reference.

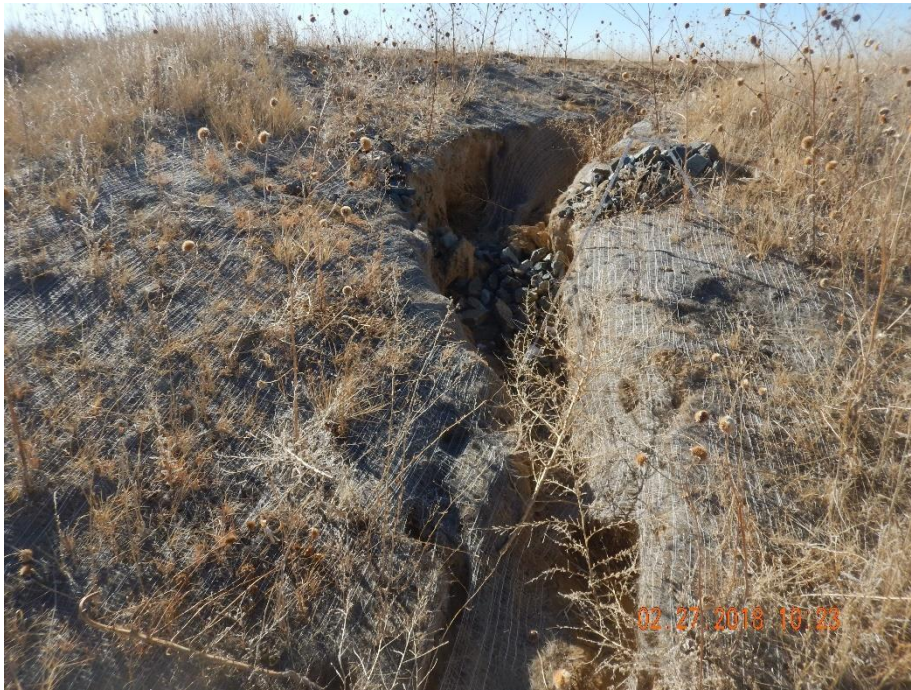
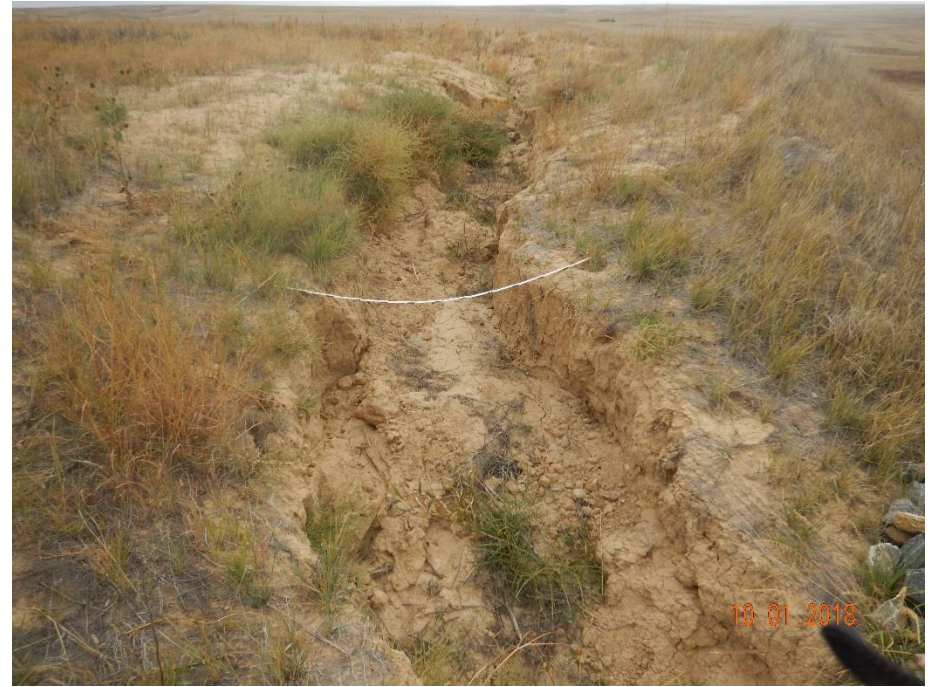
Photo 49: Photos taken from the gully erosion on the northwest end of the pad, facing south. Photo to left dated 2/27/2018 shows stormwater runoff erosion from the pad has blown out the ditch, velocity checks and erosion control blanket, creating a large gully. Photo on the right shows progression of the erosion degradation. 6 foot measuring stick for reference.

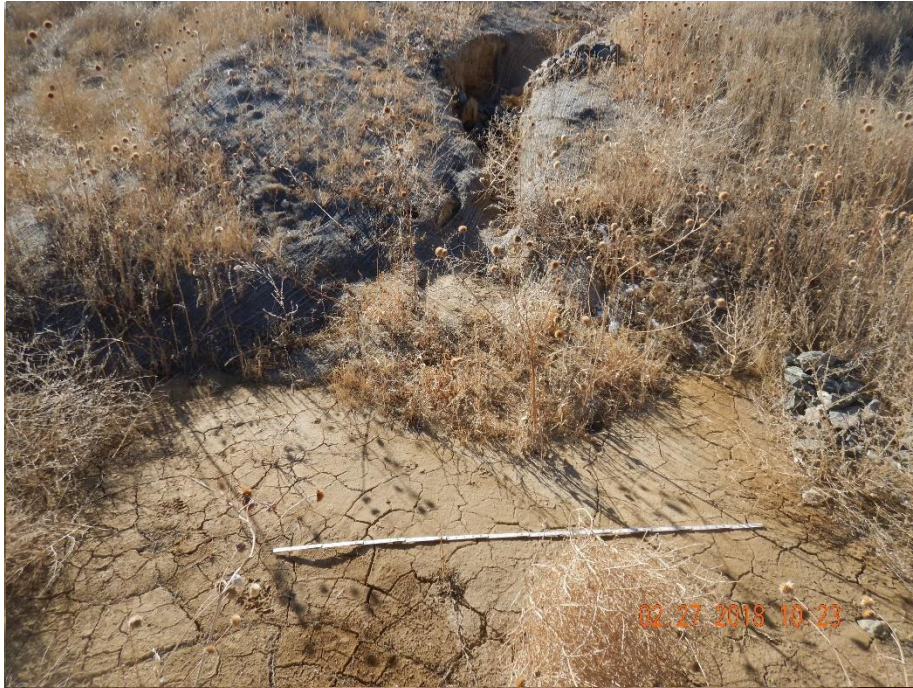
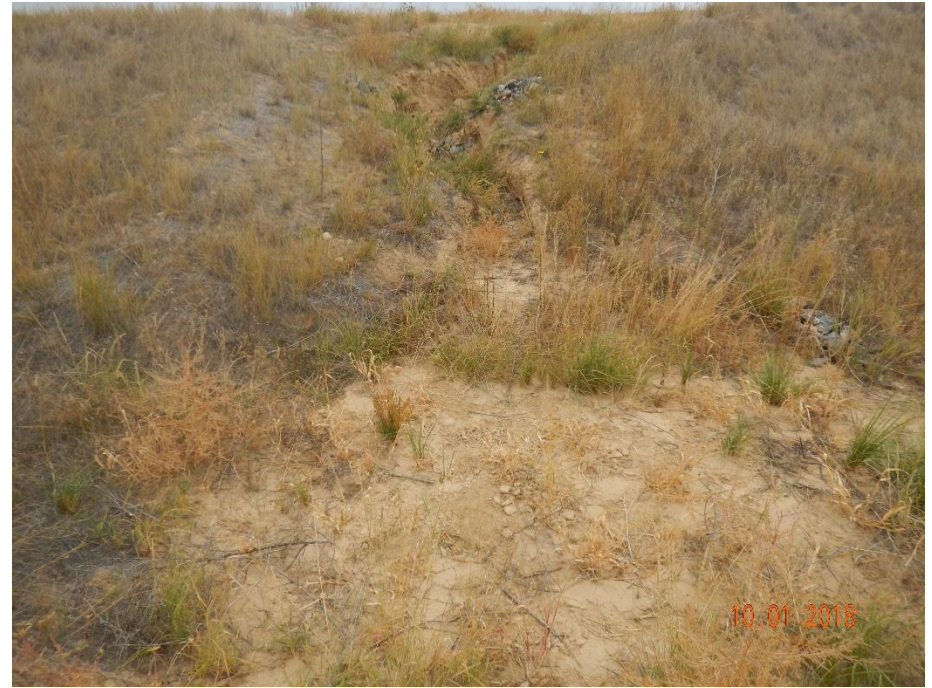
Photo 50: See comments under photo 49.

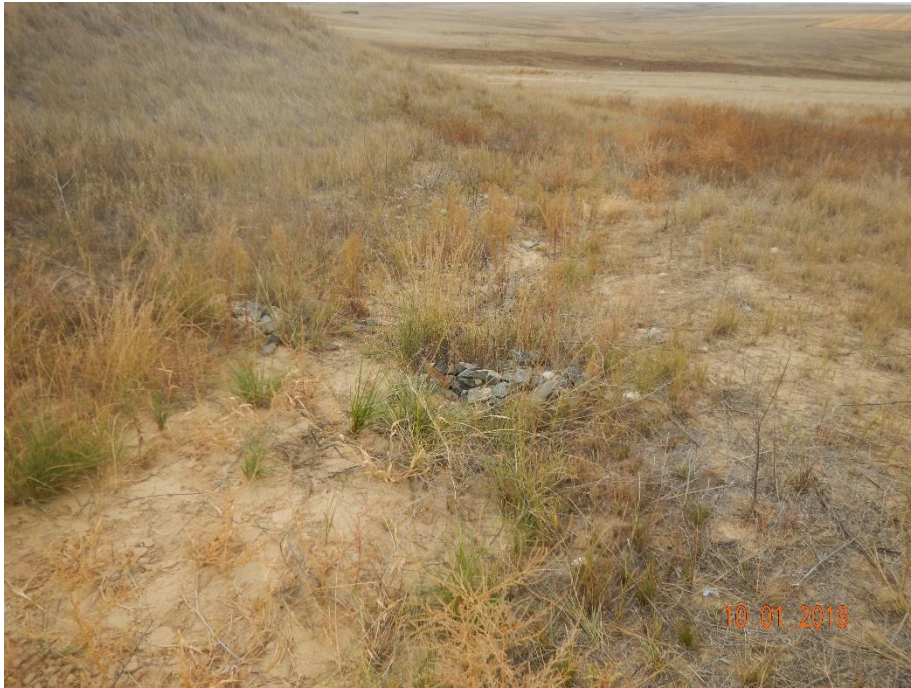
Photo 51: Photo taken from the north end of the location, facing west. Photo velocity check has filled with sediment and is not longer in proper functioning condition.

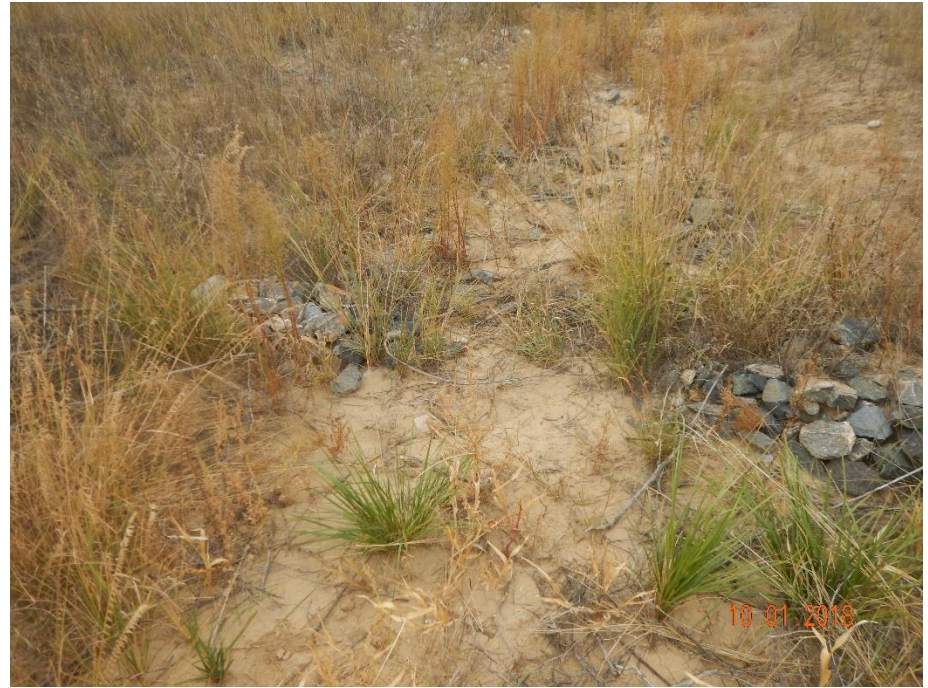
Photo 52: See comments under photo 51.

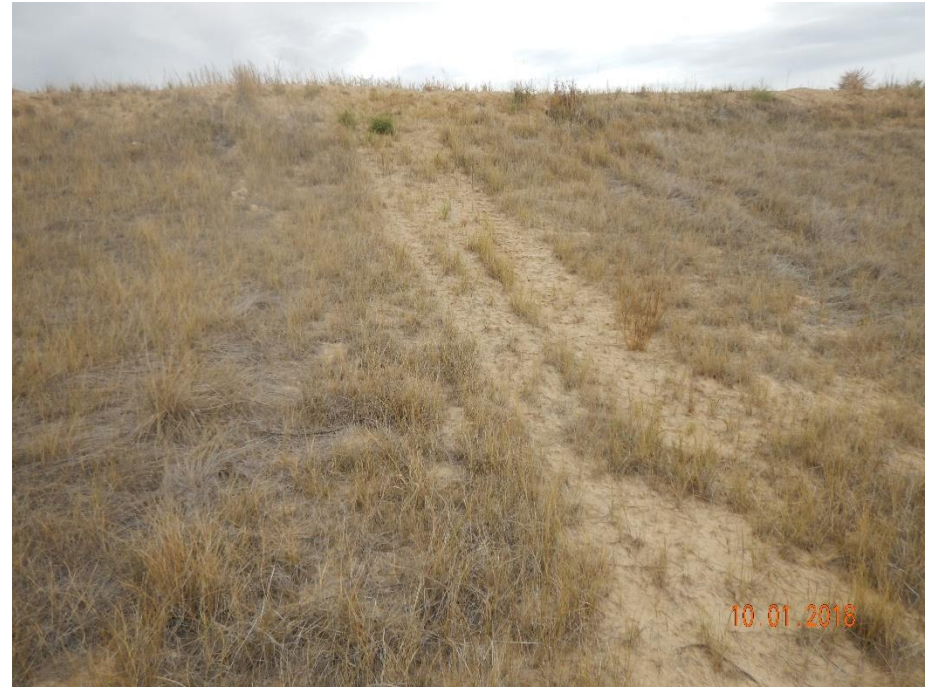
Photo 54: Photo taken from the west end of the location, facing east and upslope. Photo shows areas of the slope that remain predominantly bare and exposed soil. Operator has indicated that these areas had work conducted to repair erosion in 2016.

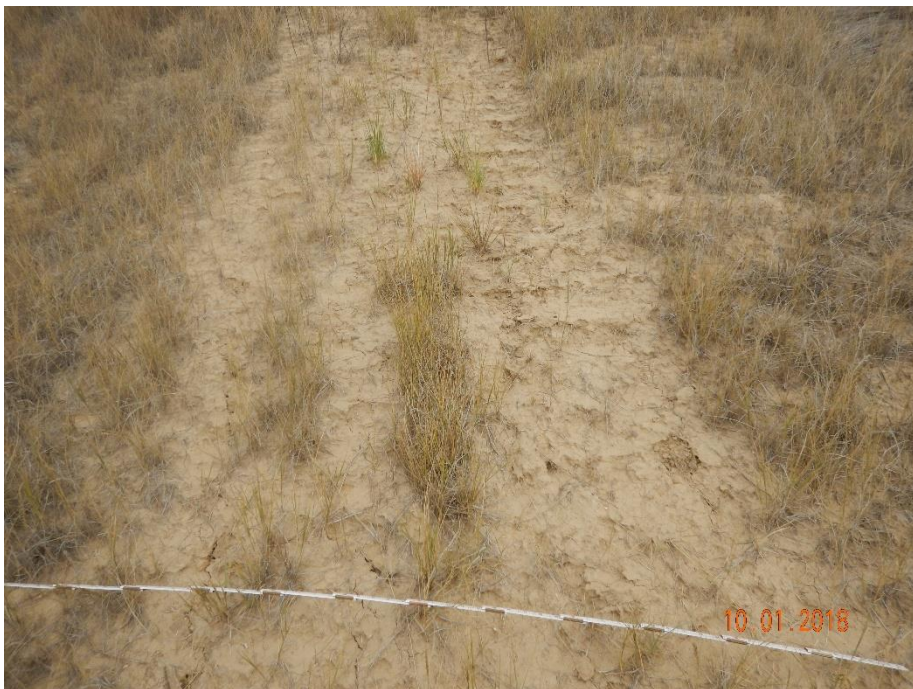
Photo 55: Continued from photo 54. Photo shows that though some vegetation has established on slope, areas remain predominantly bare and exposed soils. 6 foot measuring stick for reference.

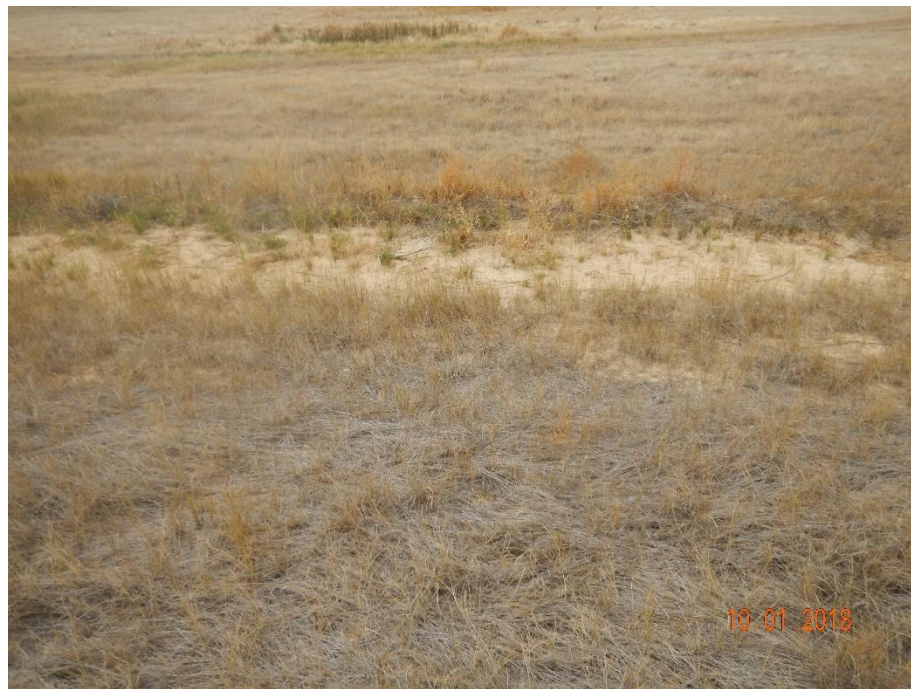
Photo 56: Photo taken from the west end of the location, facing west. Photo shows stormwater ditch along perimeter of location has filled with sediment and is no longer in proper functioning condition.

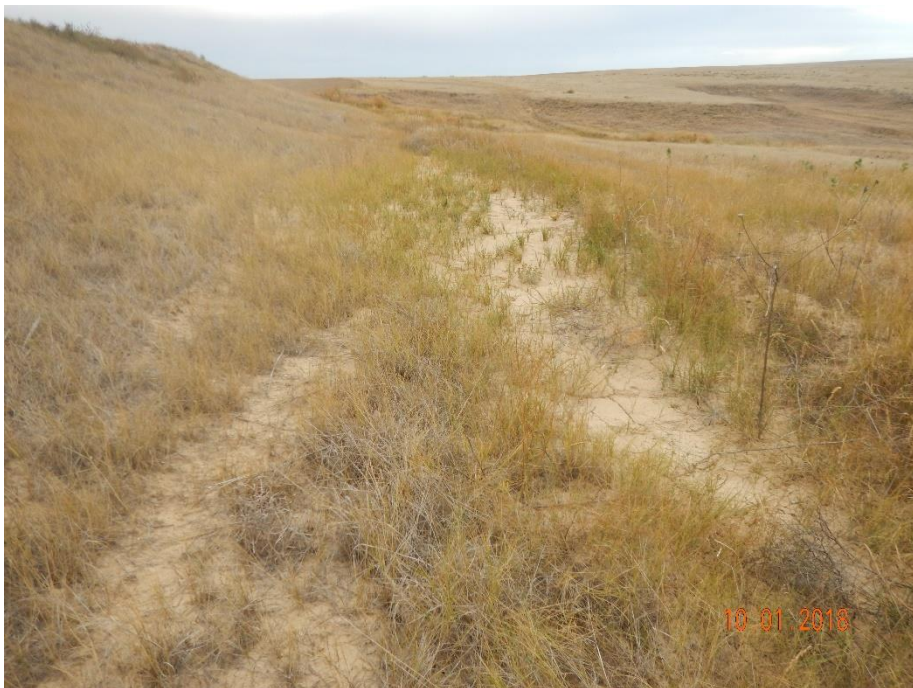
Photo 57: Photo taken from the west end of the location, facing south. Photo shows stormwater ditch along perimeter of location has filled with sediment and is no longer in proper functioning condition.
