Inspection Photos

10/01/2018

Operator: SWN PRODUCTION COMPANY LLC -
10396

Inspection Doc. Number: 682504013
Adams County, CO

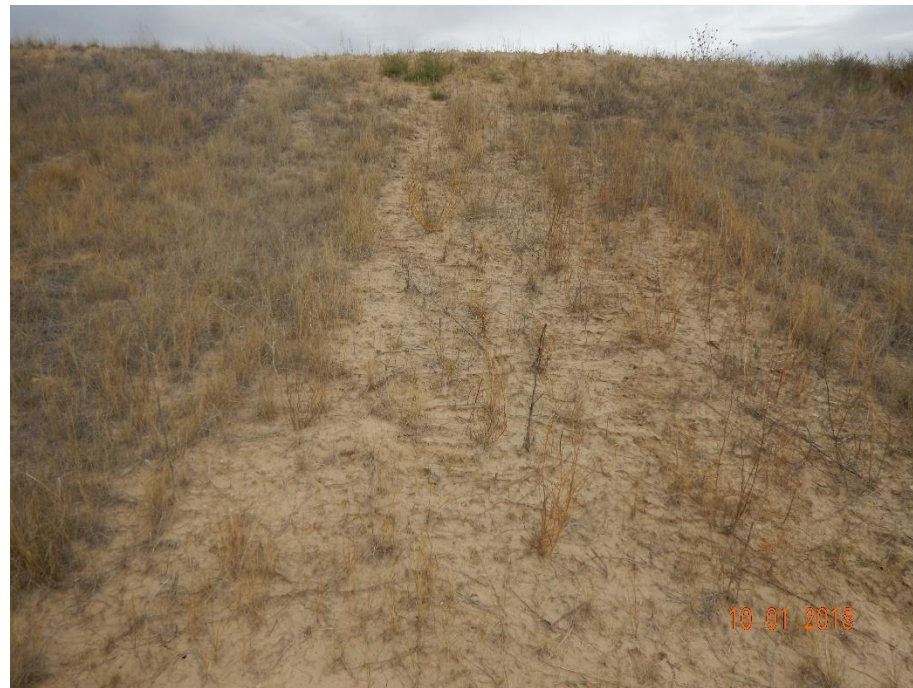
Photo 58: Photo taken from the west end of the location, facing east and upslope. Photo shows areas of the slope that remain predominantly bare and exposed soil. Operator has indicated that these areas had work conducted to repair erosion in 2016.

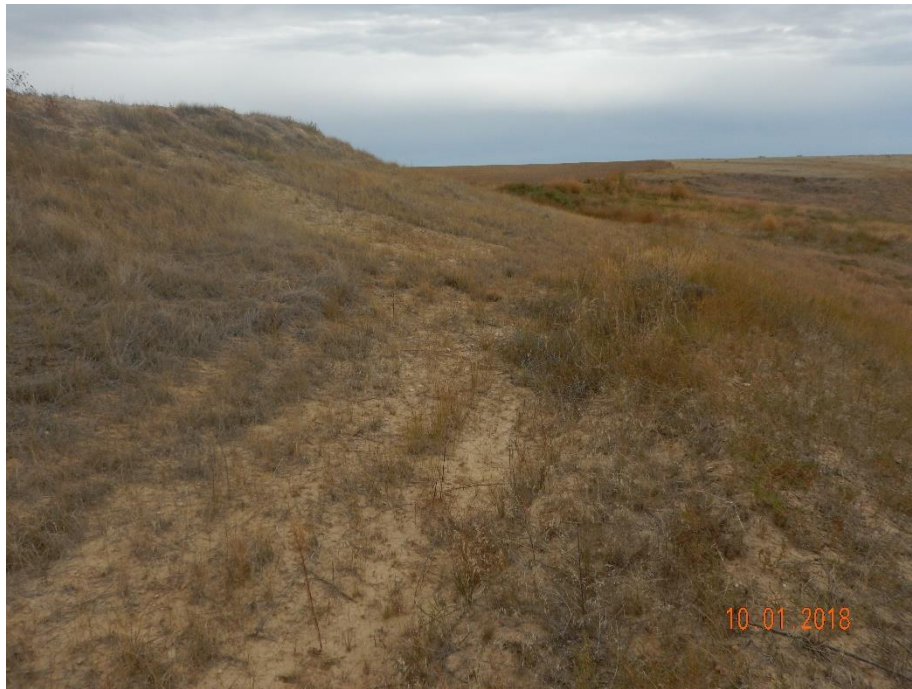
Photo 59: Photo taken from the southwest end of the location, facing south. Photo shows the corner of the location and a portion of the adjacent reference areas. There appears to be a drainage to the immediate north of the location.

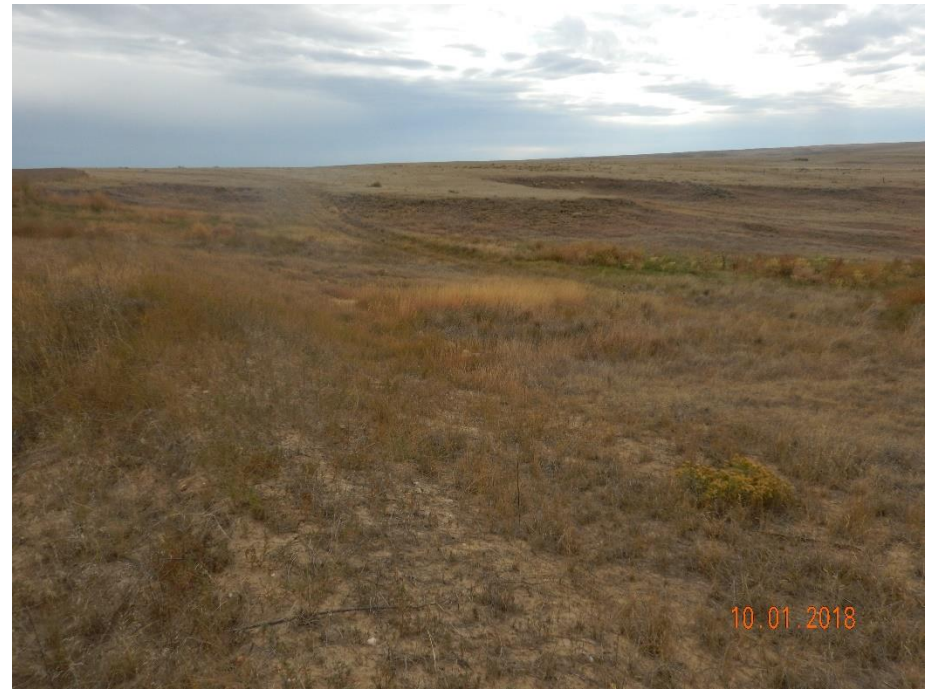
Photo 60: Photo taken from the southwest end of the location, facing southwest. Photo shows the corner of the location and a portion of the adjacent reference areas. There appears to be a drainage to the immediate north of the location.
