# Inspection Photos

Operator: BP Production

API: 05-067-07867

Date: 10/05/2018

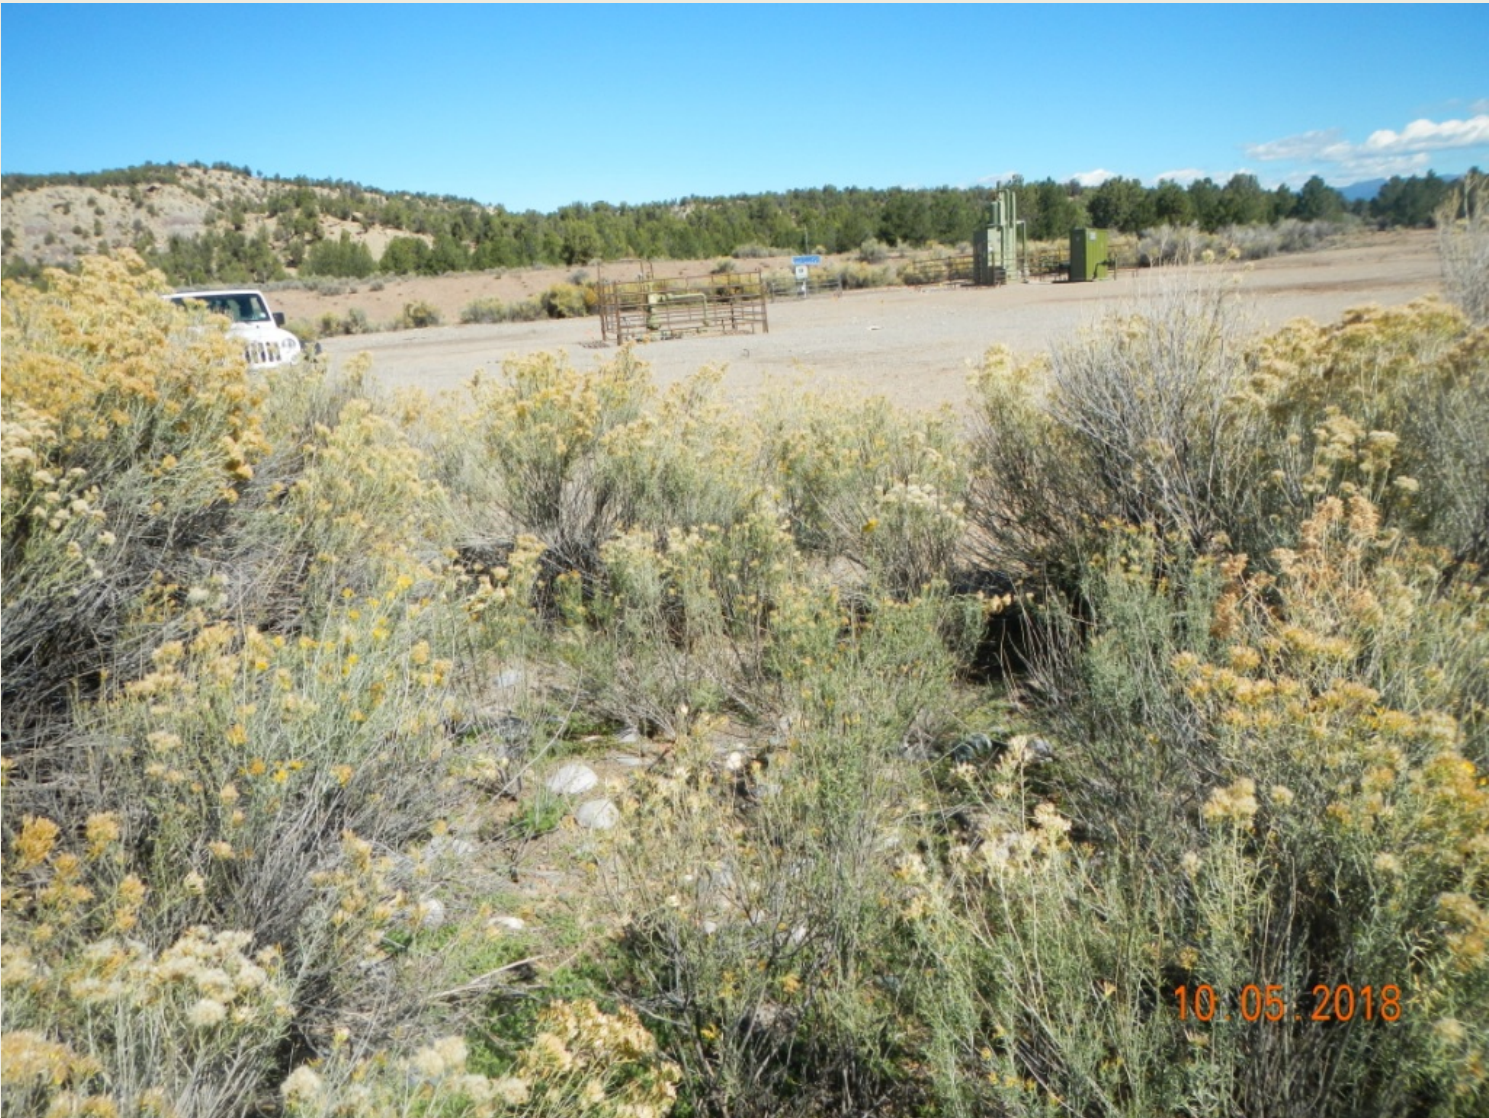
**Photo 1. View of the project area from the southwestern corner facing center.**

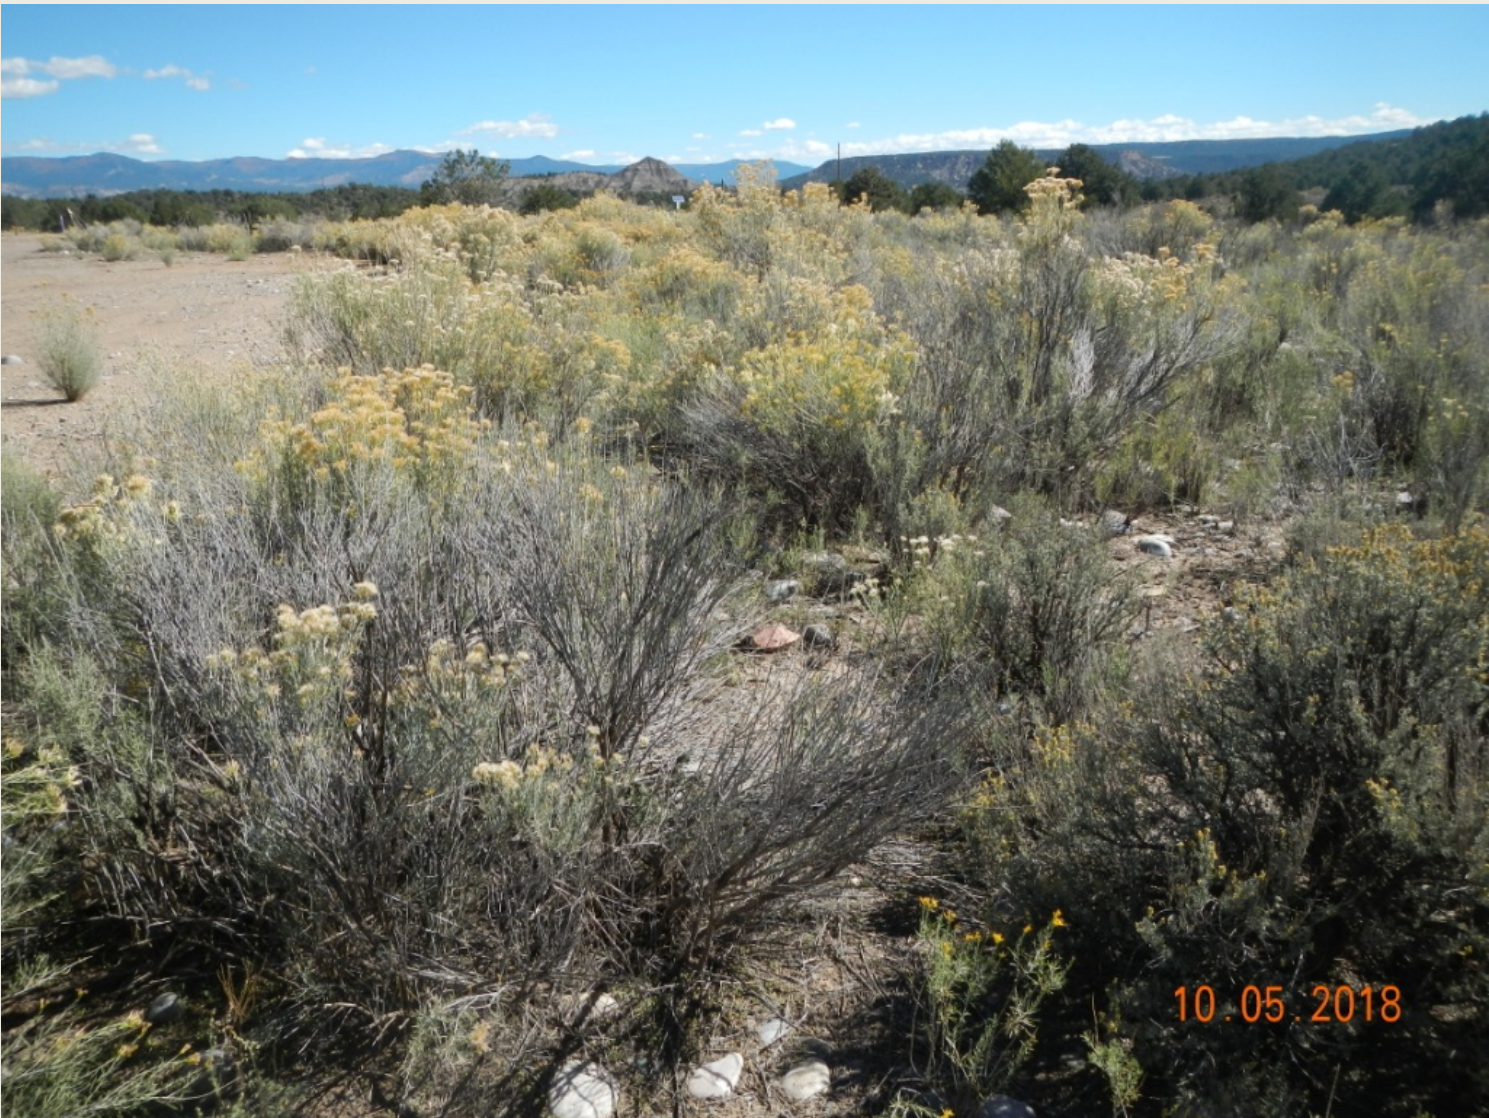
**Photo 2. View of the southern portion of the project area from the southwestern corner facing eastward. Revegetation is progressing with shrubs such as rubber rabbitbrush (*Chrysothamnus nauseosus*), fringed sage (*Artemisia frigida*), and grasses such as sand dropseed (*Sporobolus cryptandrus*).**

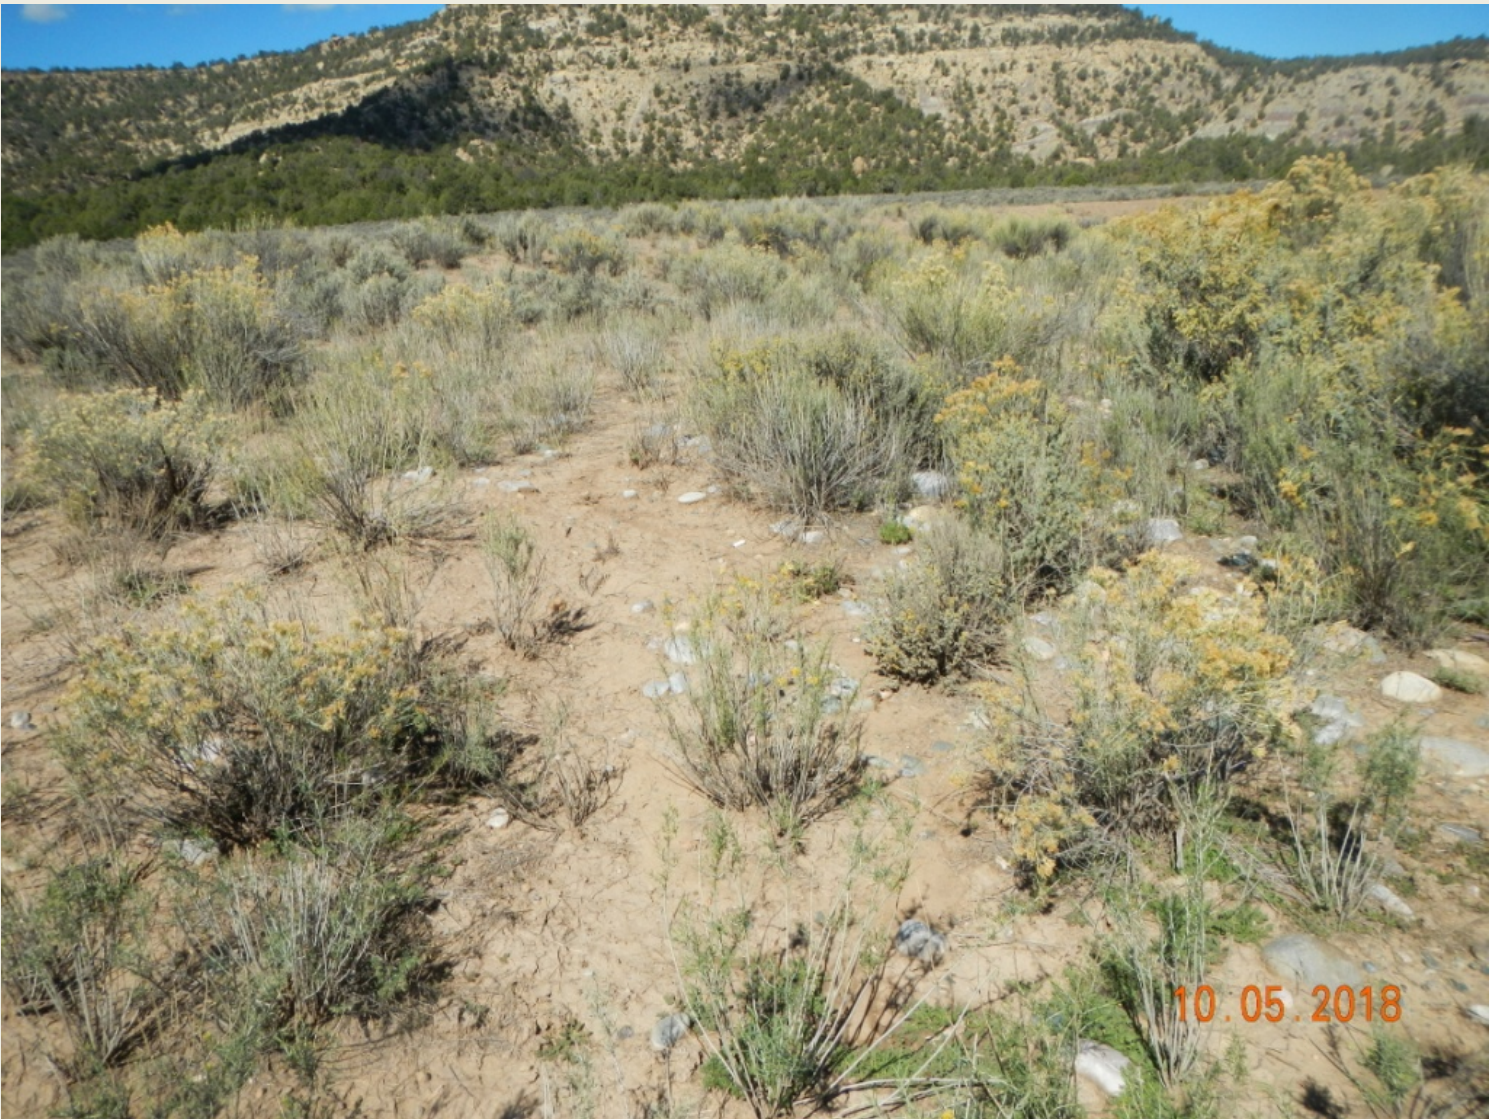
**Photo 3. View of the western project area from the southwestern corner facing northward.**
