Inspection Photos

Operator: Enervest Operating, LLC

API: 05-067-06026

Date: 10/05/2018

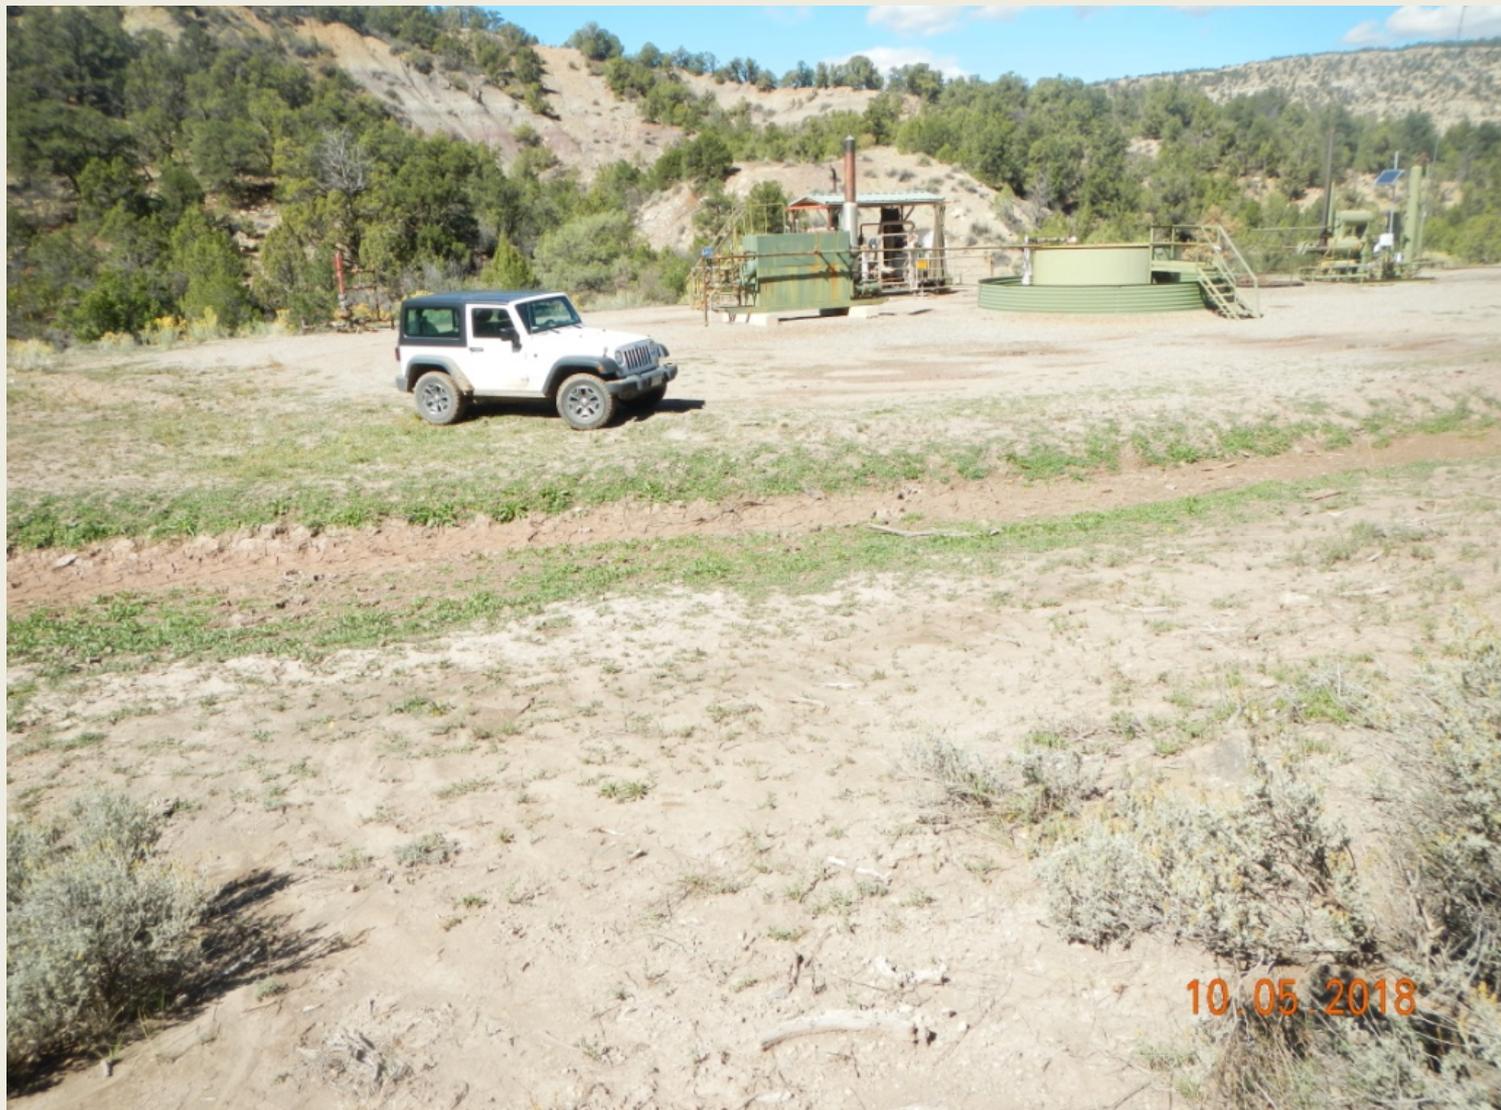
Photo 1. View of the project area from the southeastern corner facing center.

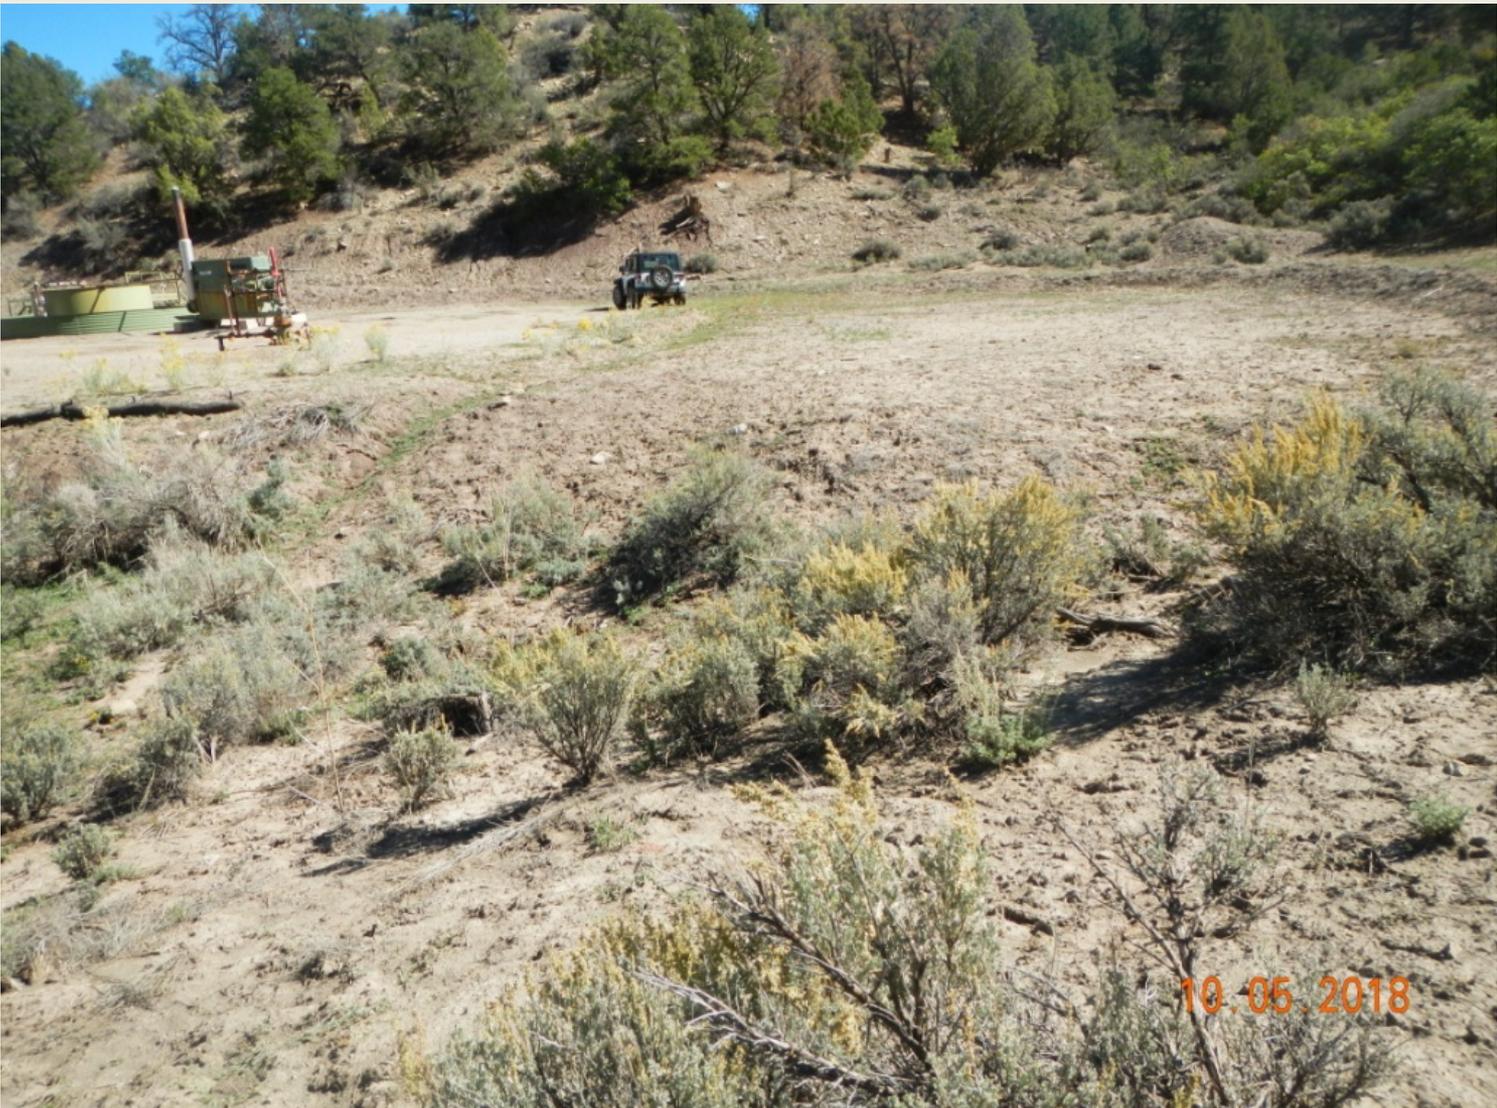
Photo 2. View of the southern portion of the project area from the southwestern corner facing eastward. Revegetation is largely comprised of shrubs such as rubber rabbitbrush (*Chrysothamnus nauseosus*) and big sagebrush (*Artemisia tridentata*), and weedy vegetation such as field bindweed (*Convolvulus arvensis*).

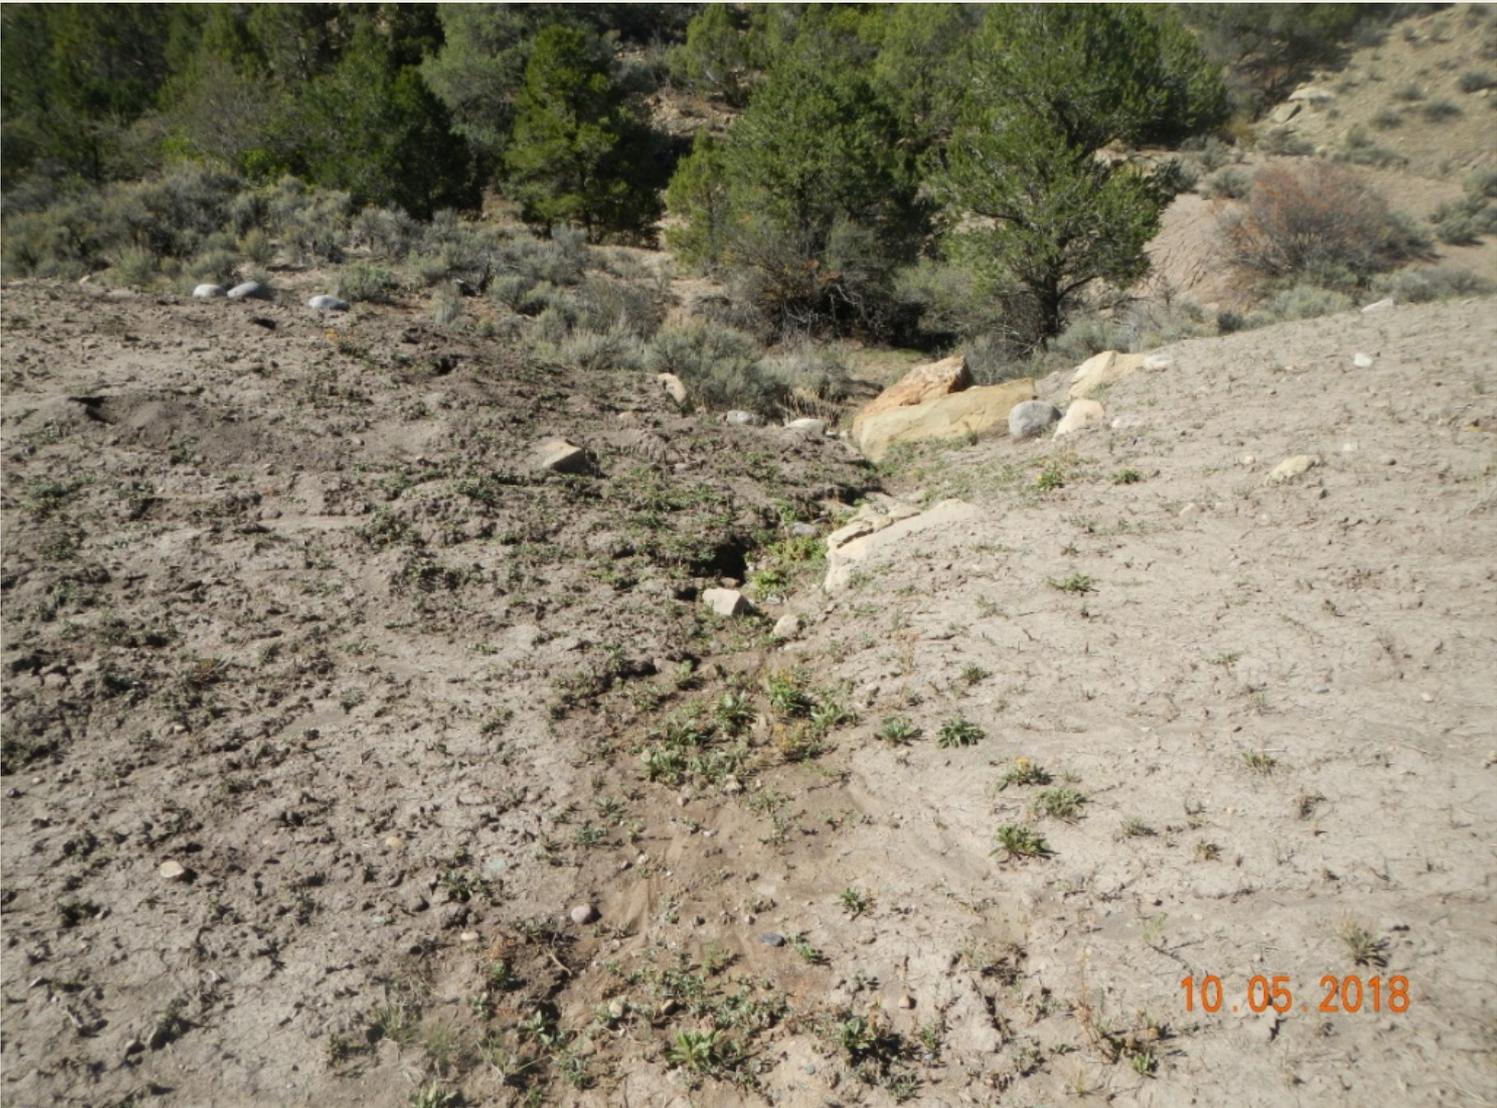
Photo 3. View of area in the southwestern project area where stormwater flows from the southwestern corner of the project area are diverted down slope resulting in soil erosion and sediment transport off of the project area.

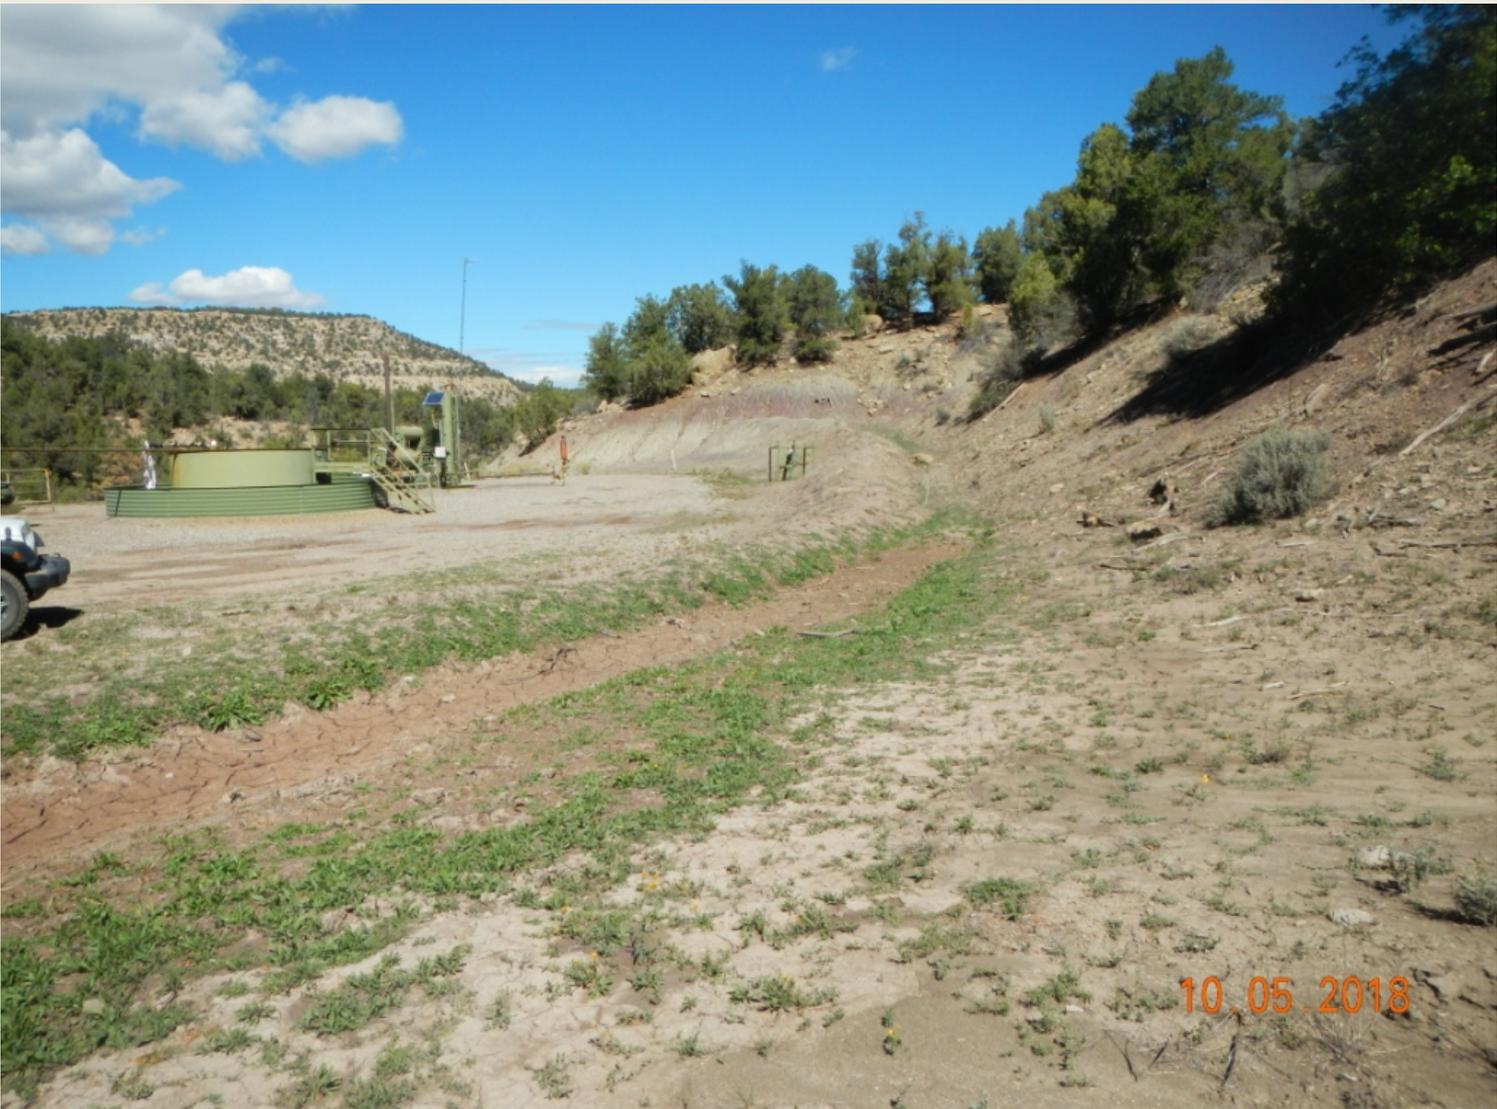
Photo 4. View of the eastern project area from the southeastern corner facing northward.

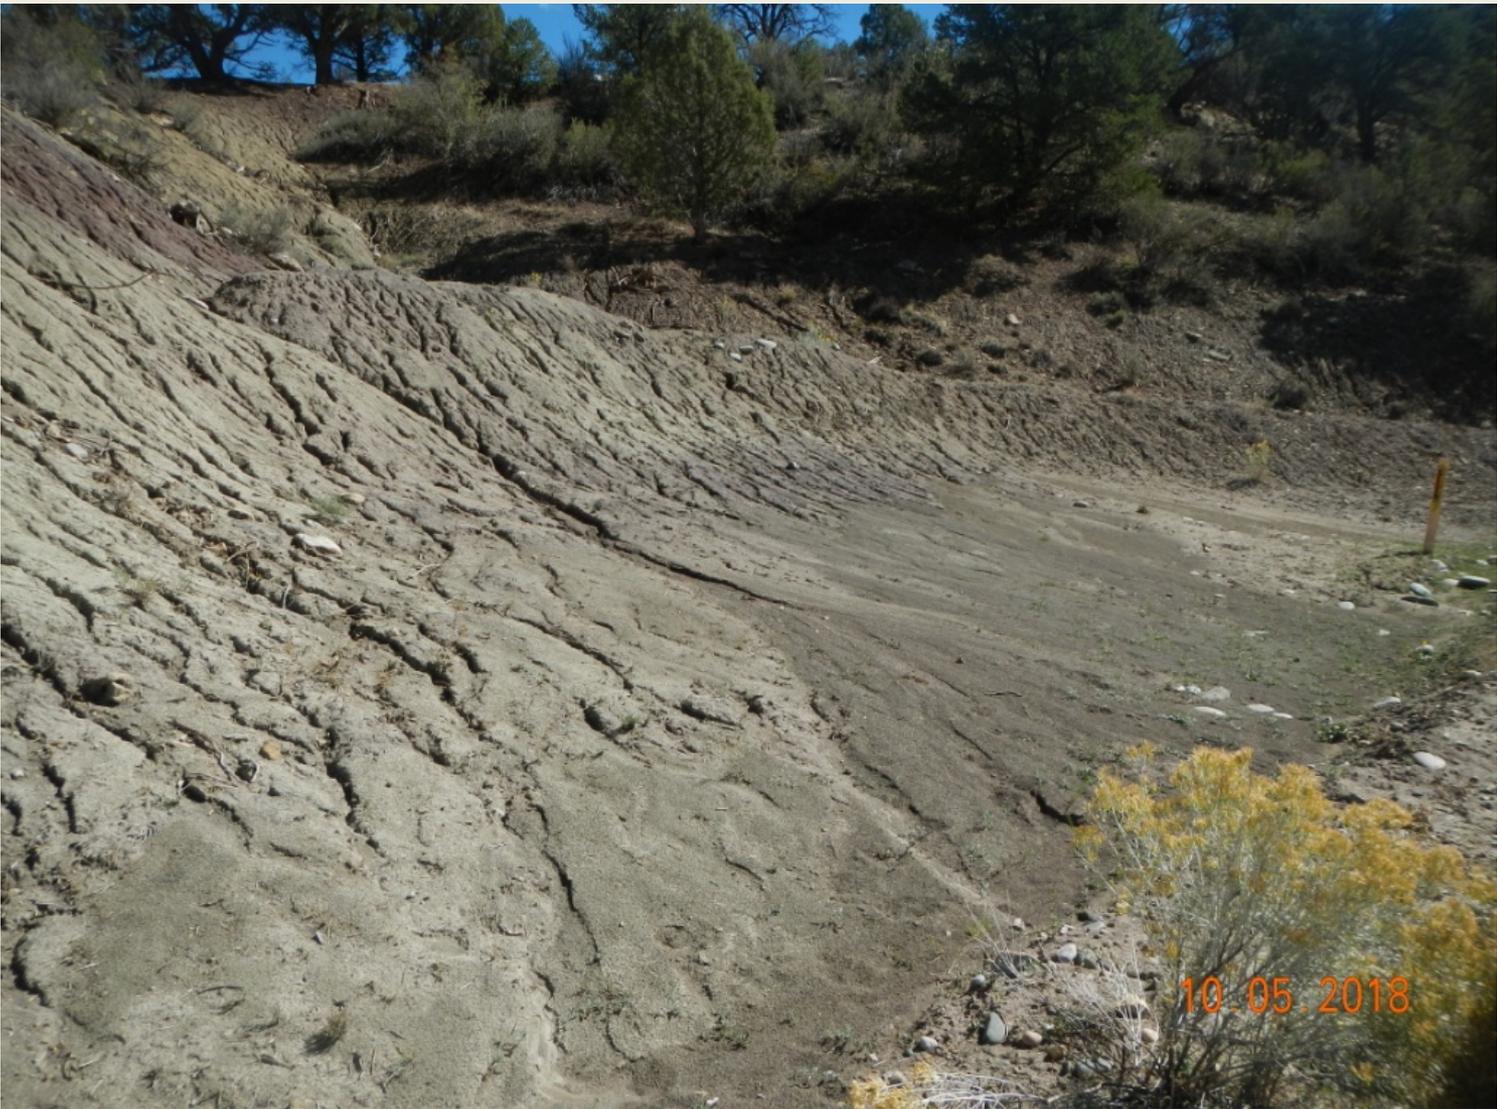
Photo 5. View of the northeastern project area where soils are not stabilized and berms/stormwater controls are not functioning properly.

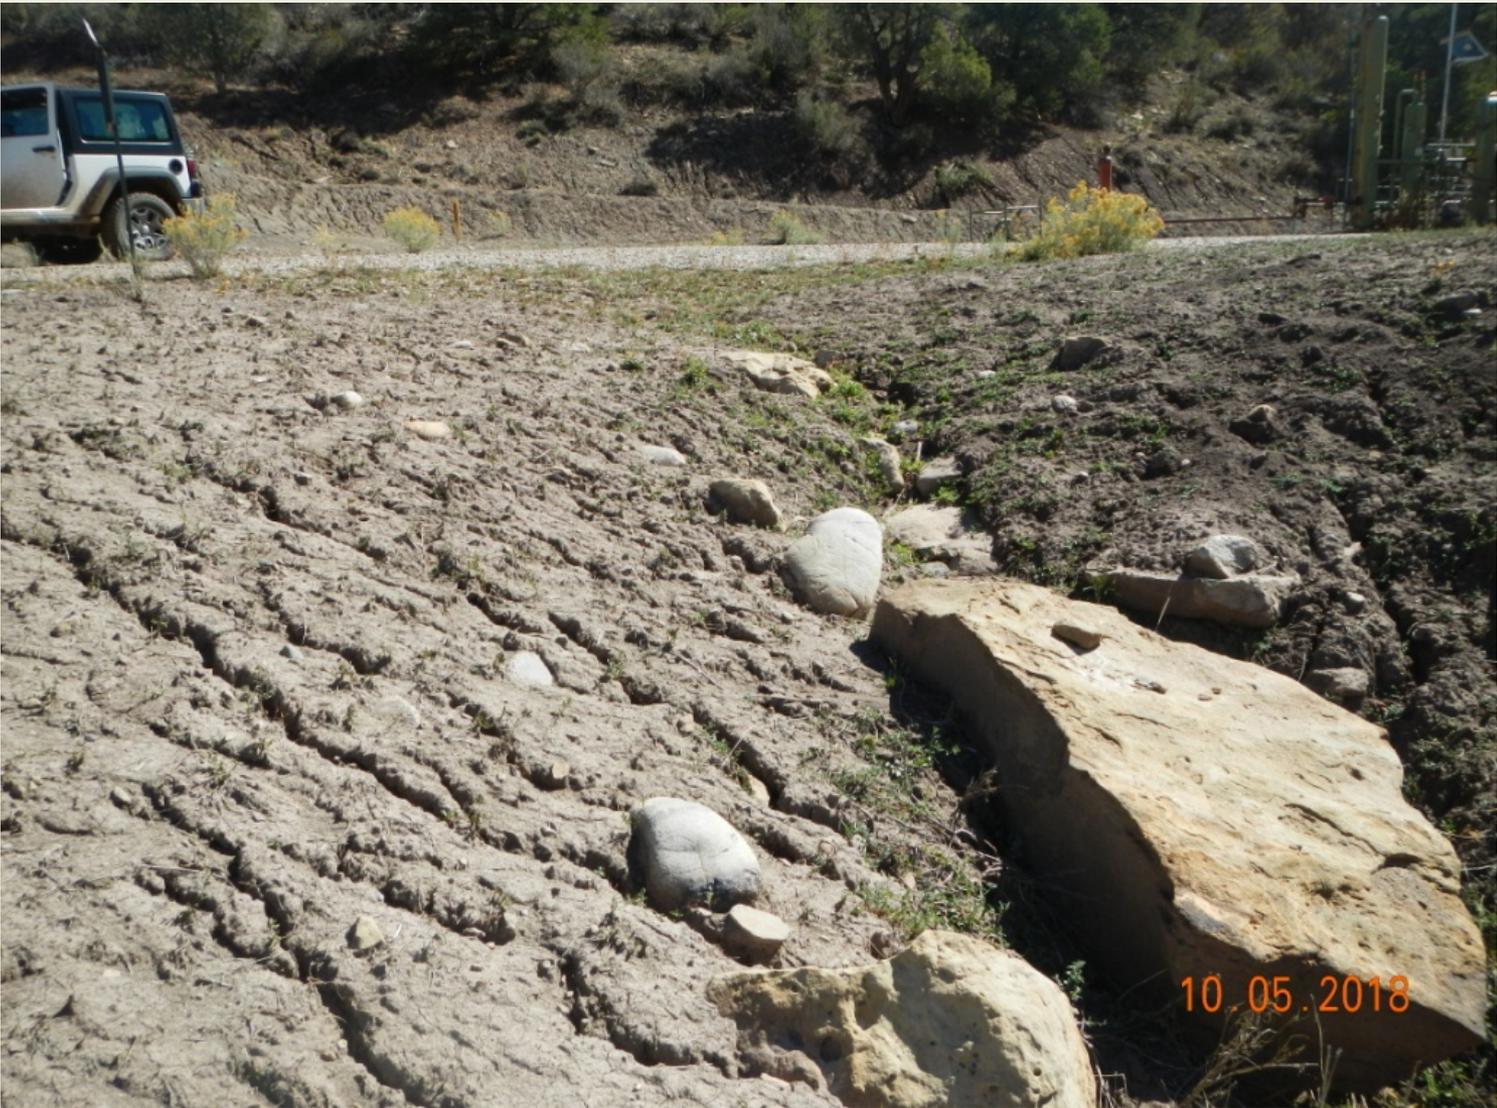
Photo 6. View of erosional channel in the northwestern project, facing upslope, area where adjacent soils are not stabilized and stormwater flows erode the slope toward the western drainage.

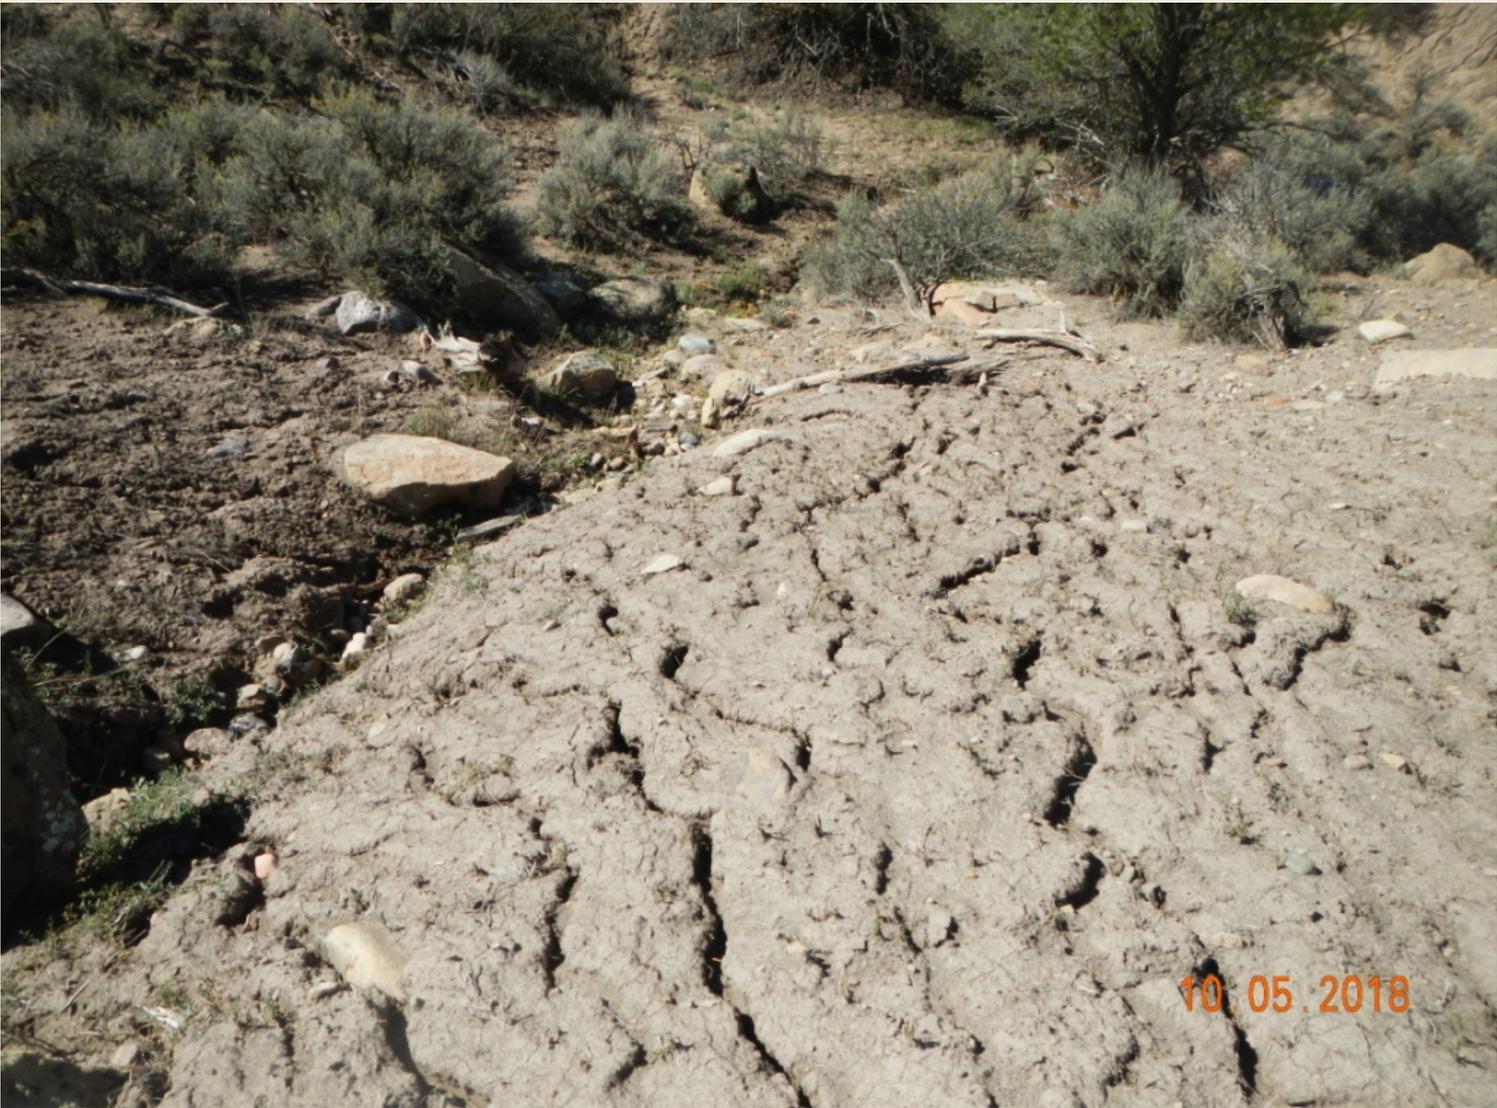
Photo 7. Downstream view from Photo 7, facing downslope, where erosional channeling and rilling is occurring in the northwestern project area.
