Stormwater Inspection Report

| Operator: | Laramie Energy, LLC |
| Project: | Cascade Creek Project Area |
| Location: | C.C. 608-41 Access Road and Pad |

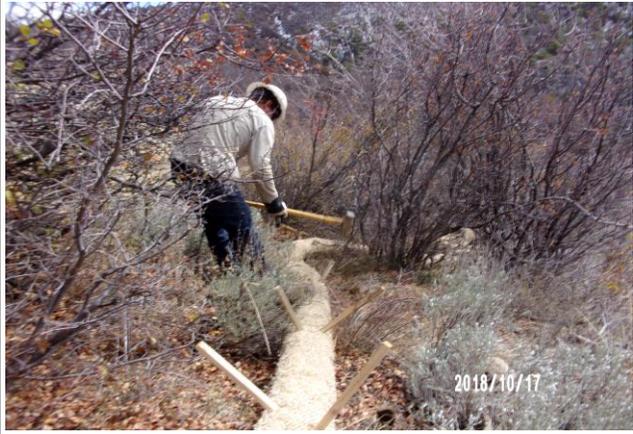
Photo 1

Wattle Installation on the C.C. 608-41 Pad

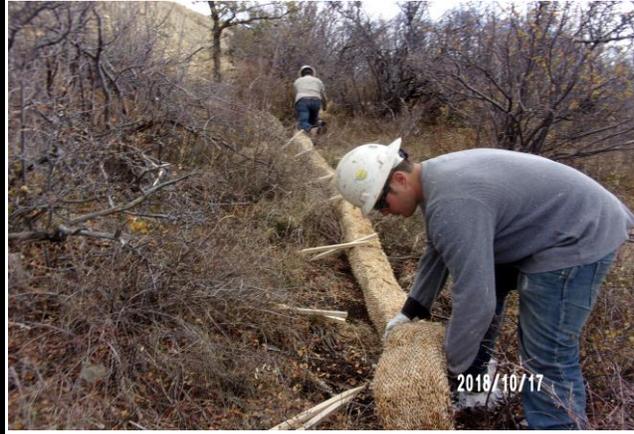
Photo 2

Wattle Installation on the C.C. 608-41 Pad

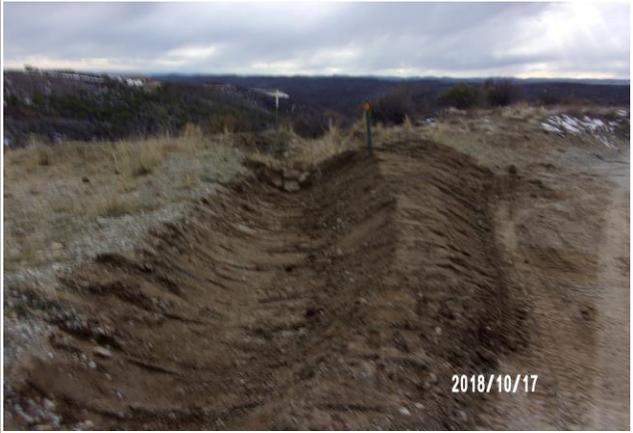
Photo 3

BMP Maintenance on the C.C. 608-41 Access Rd

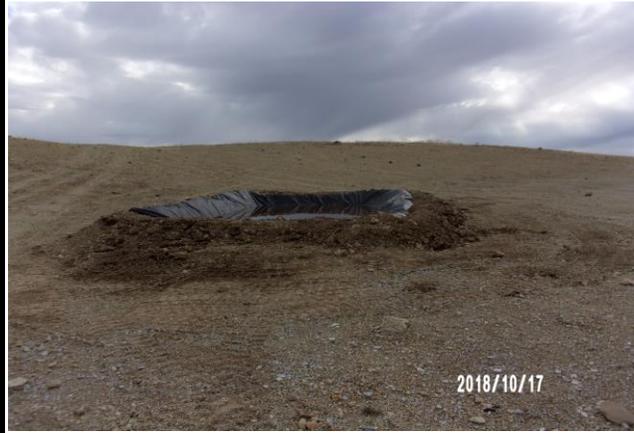
Photo 4

Containment Berm Repaired on the C.C. 608-41 Pad
