## Stormwater Inspection Report

<b>Operator:</b>	Laramie Energy, LLC
<b>Project:</b>	Cascade Creek Project Area
<b>Location:</b>	C.C. 608-41 Pad
<b>Date:</b>	Thursday, October 18, 2018
<b>Weather:</b>	Overcast, Light Winds, High 46° Lo 29°

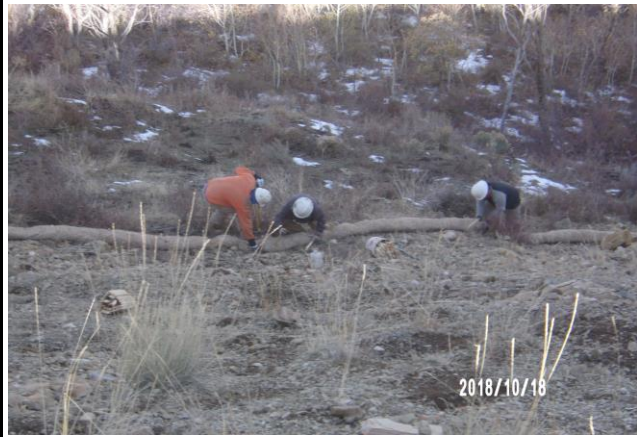
**Photo 1**

*Wattle Installation on the C.C. 608-41 Pad***Photo 2**

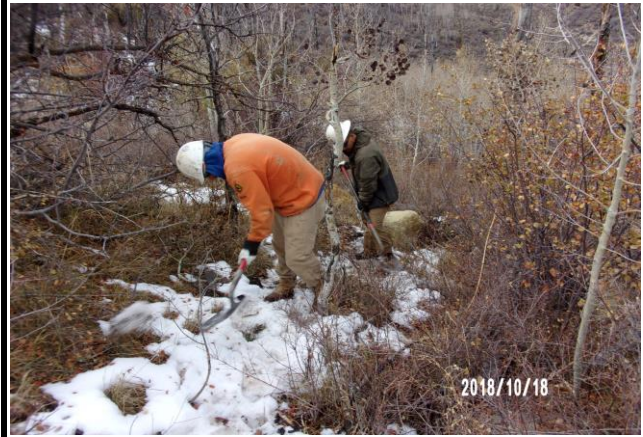
*Wattle Installation on the C.C. 608-41 Pad***Photo 3**

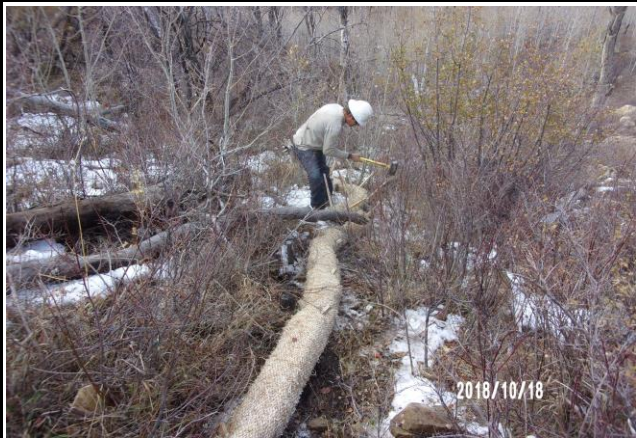
*Wattle Installation on the C.C. 608-41 Pad***Photo 4**

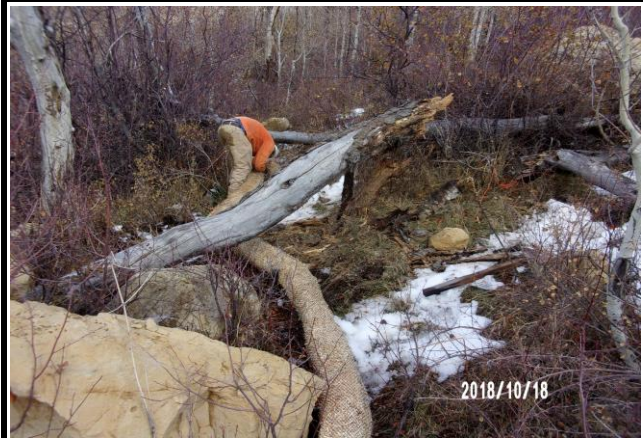
*Wattle Installation on the C.C. 608-41 Pad*
