**Inspection Photo
Miller 5-36
API # 045-09192
Inspection # 689302161**

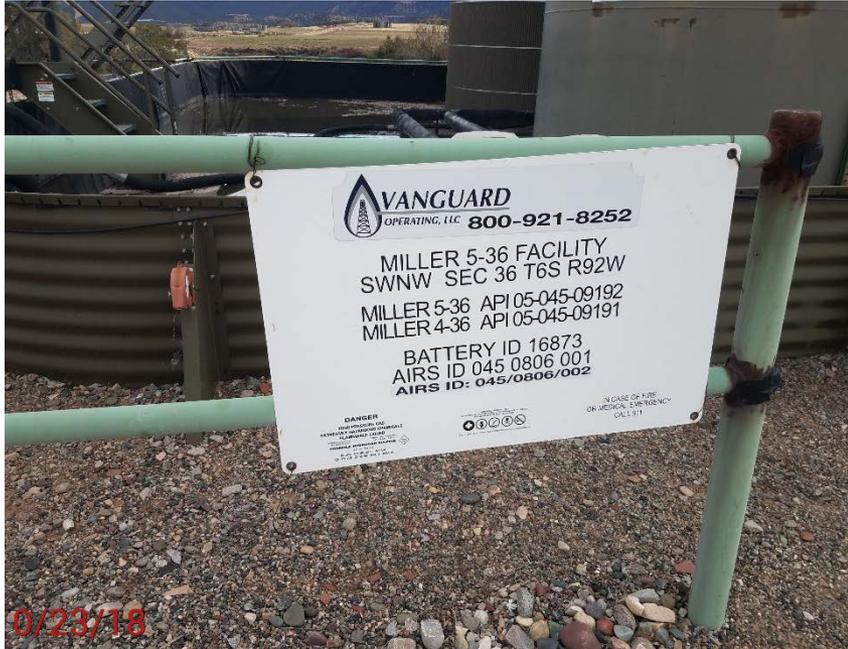
Location Photo #3, battery sign missing information.
