ROW Compliance Inspection		Case #: COC 61214 Holder: Maralex Disposal LLC	Project Name: Roan Creek Evaporation Pond
Twn: 8 S Rng: 98 W Sec 36: Qtr: NESE		County: Mesa County State: Colorado	
Inspection Date & Time: 9/27/2018 9:00am			
Inspector: Scott Hall		Office Time:	Total Time:
People/Affiliations at Inspection: COGCC		Steven Arauza	
Existing Conditions? 1.Construction, 2.Operation, 3.Reclamation; Disturbed Area Measurements; Facilities		Site was construction in the 1980's and was used until 2009. Pit has been in noncompliance since 2010 and has not been used since. The site is 285' by 505' and include a 24' x 245' access road and a 100' x 77' site for bioremediation of soils. Facilities include, pit, fence, 300 barrel tank with berm, and leak detection system.	
Conformance with ROW Terms & Conditions? Constructed to Specifications		ROW is not in compliance with the stipulations. ROW expired 8/30/2018.

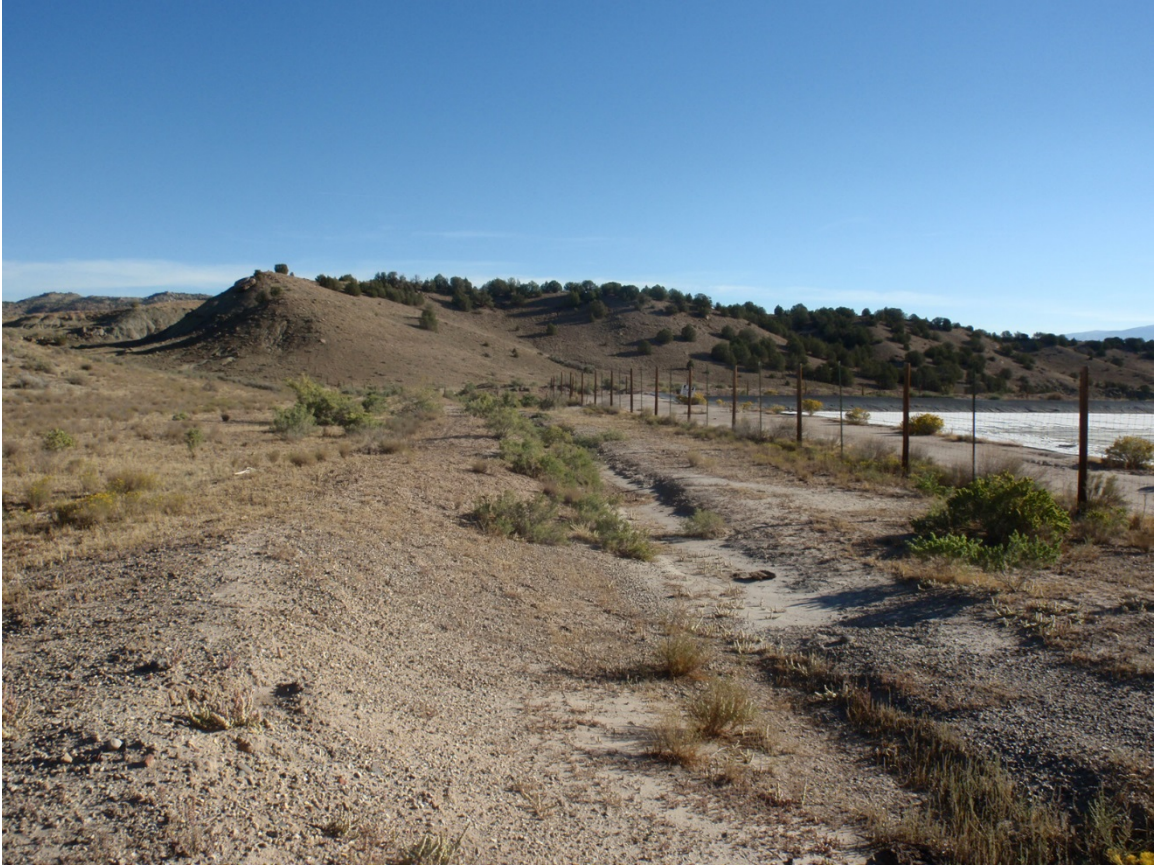
Photo 7. View of berm, storm water channel and fence along west side of facility

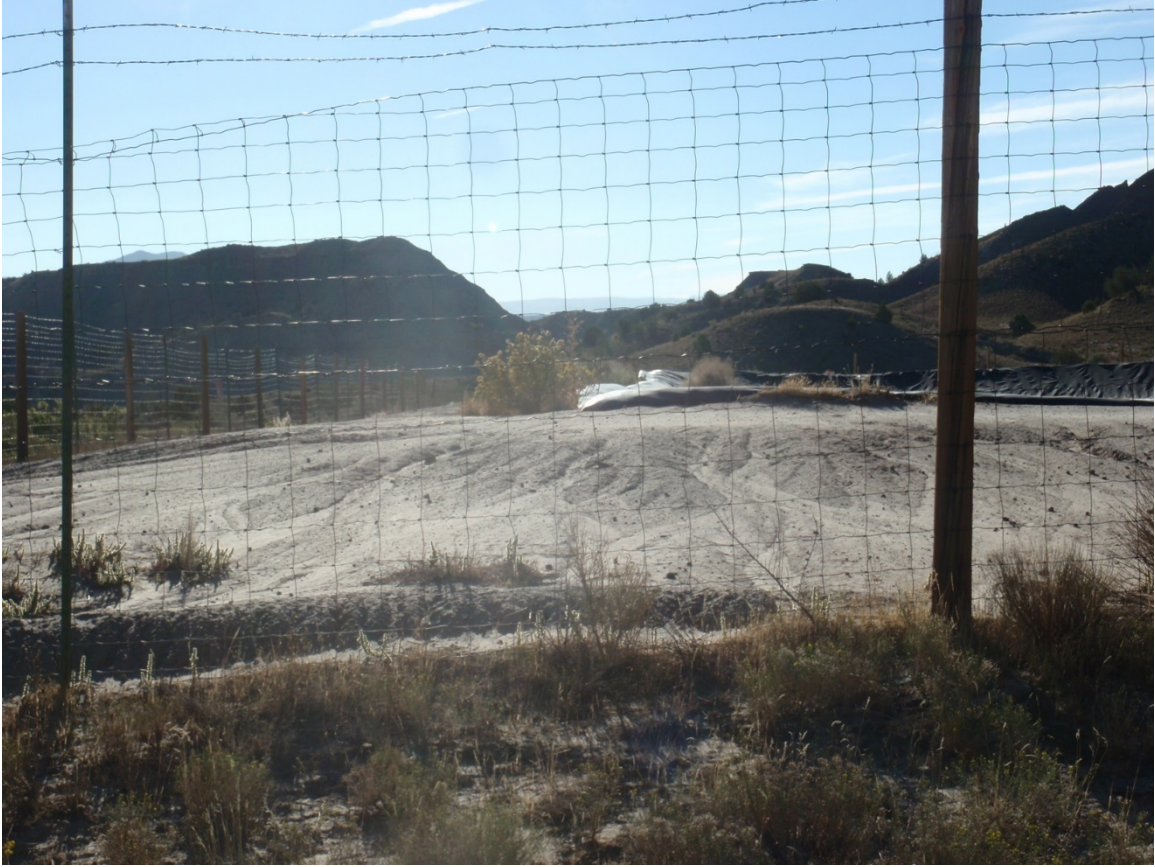
Photo 11. Northwest corner of pit. Berm eroding and soil piling up at bottom of fence

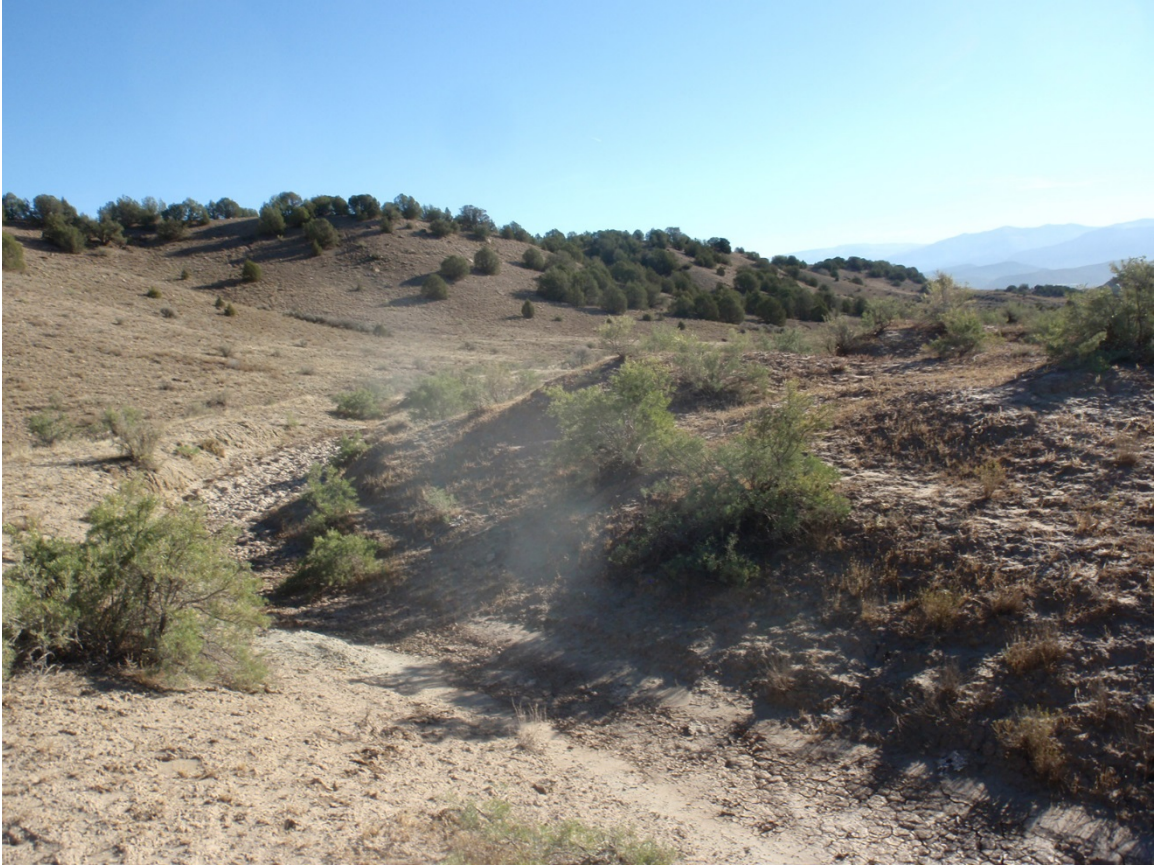
Photo 13. Sediment trap located northwest of facility in storm water channel.

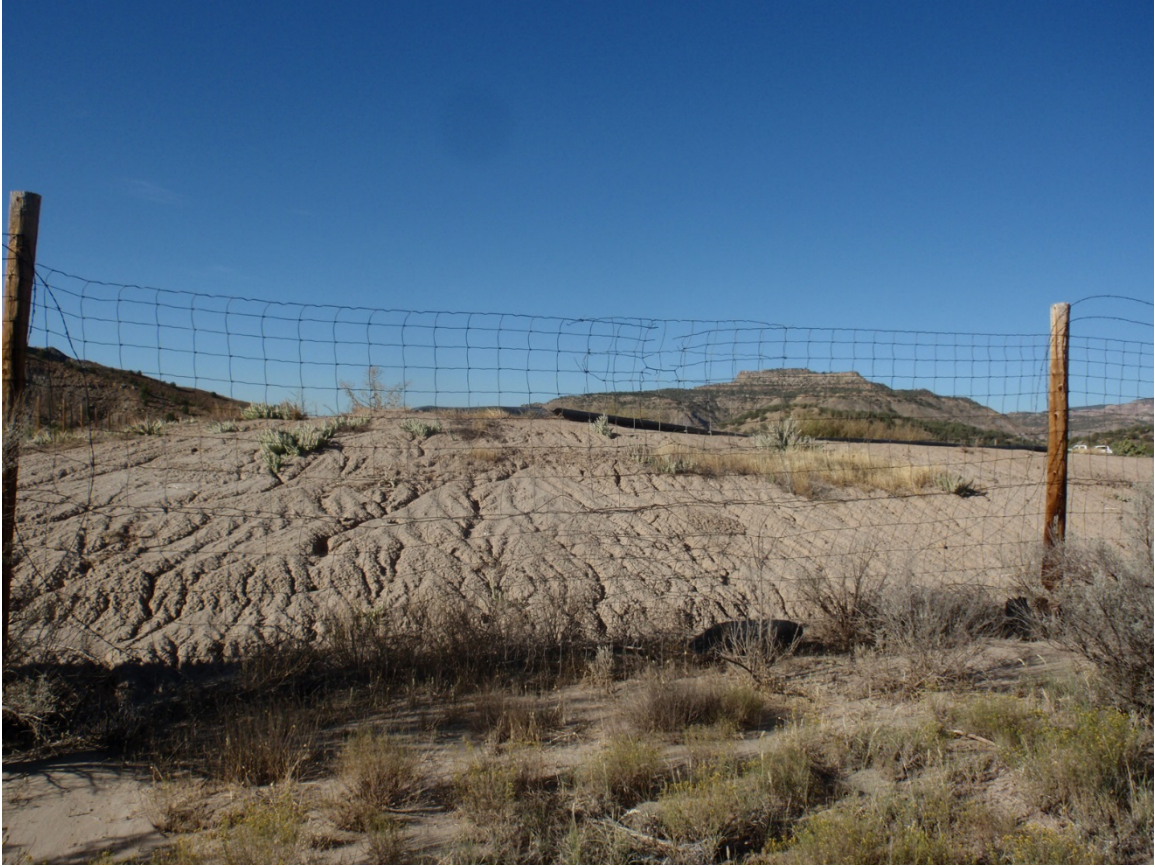
Photo 15. Erosional rills on north side of berm at facility. No vegetation to hold soil in place.

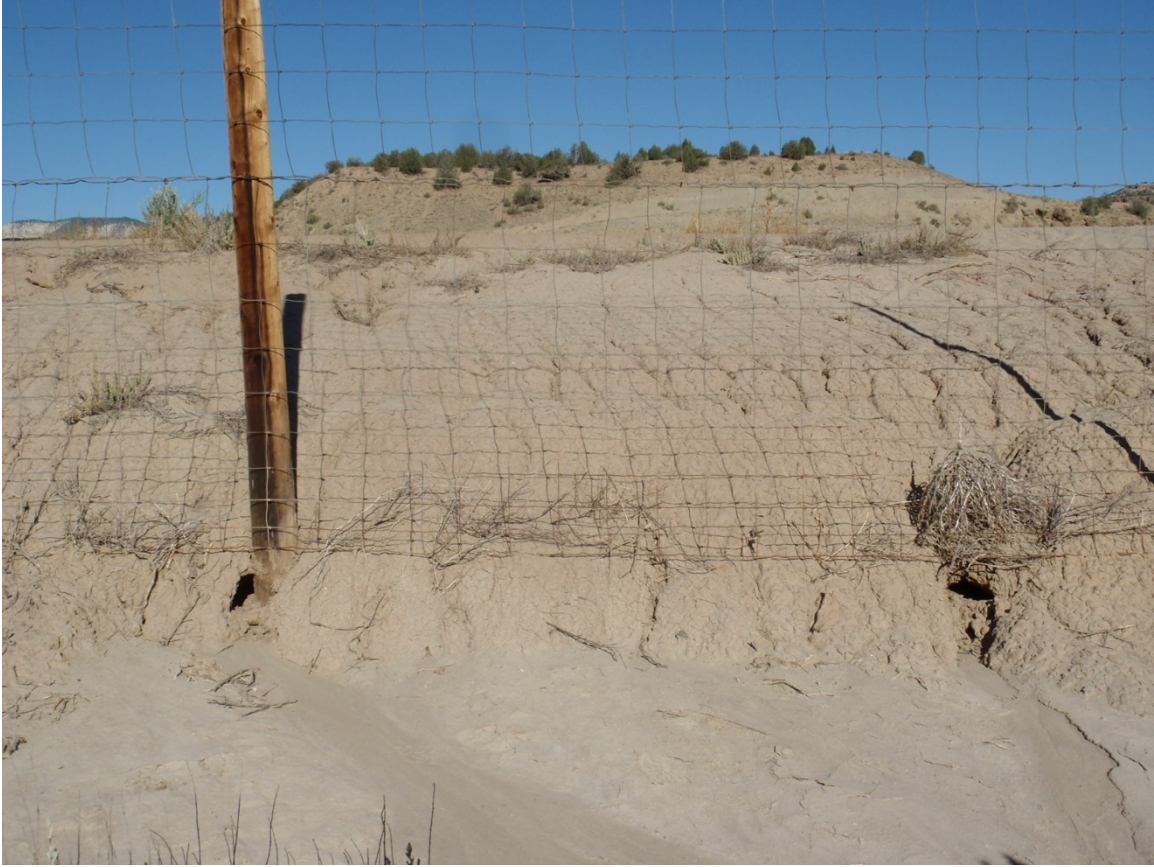
Photo 17. East side of facility looking west. Soil is migrating offsite and into drainage.

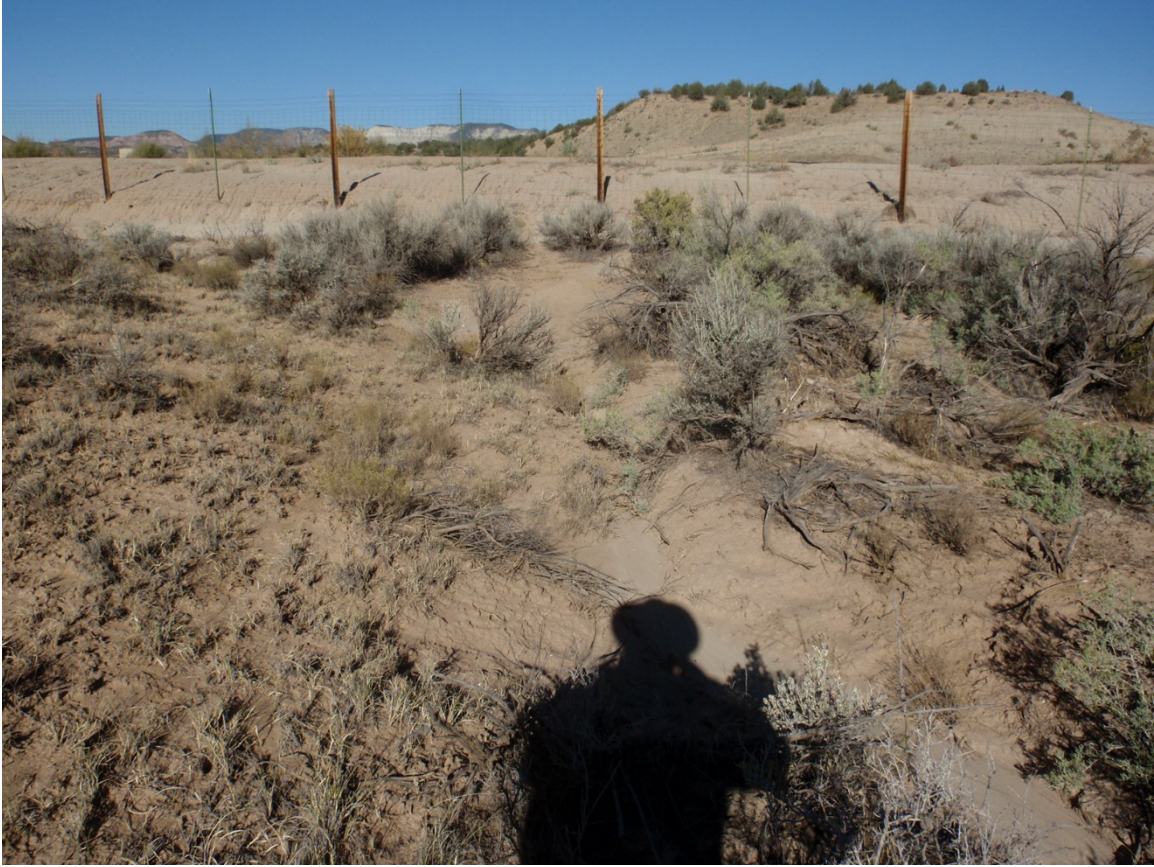
Photo 19. Erosion and offsite soil migration on east side of facility.

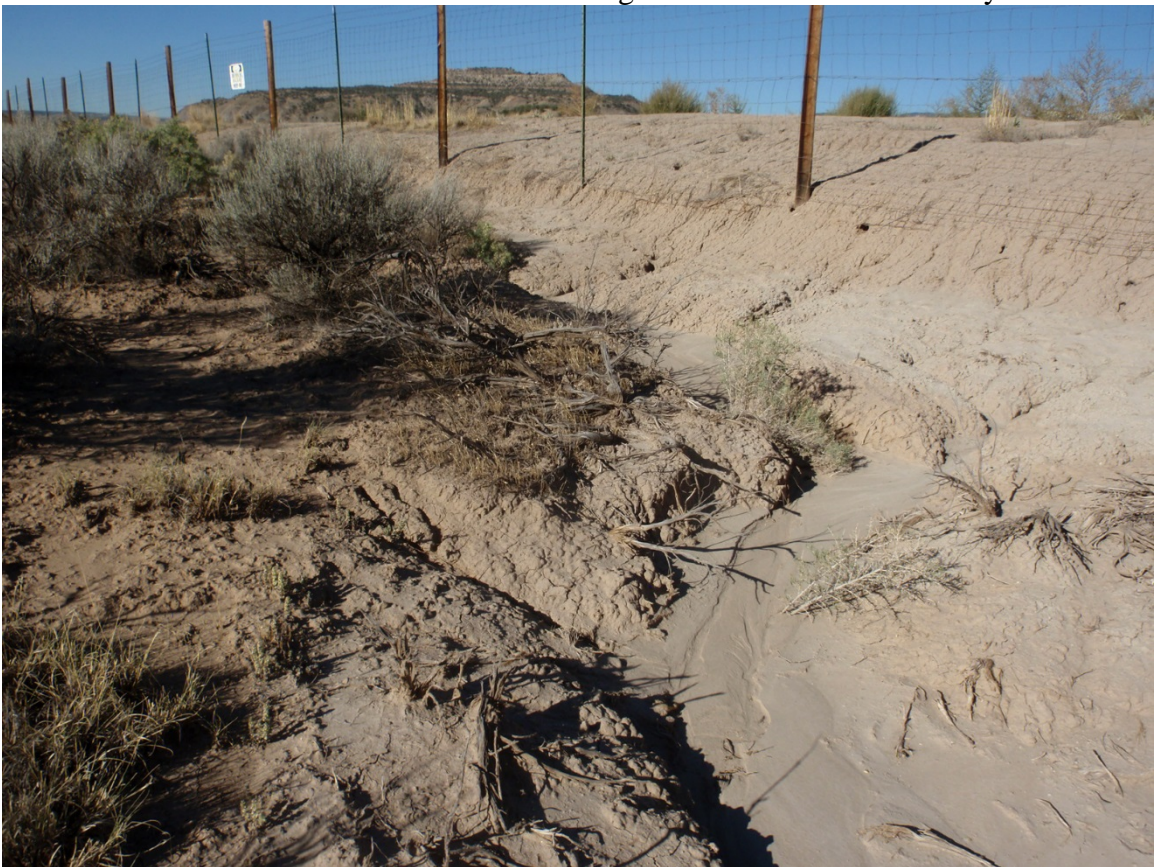
Photo 20. Erosion and offsite soil migration on east side of facility.

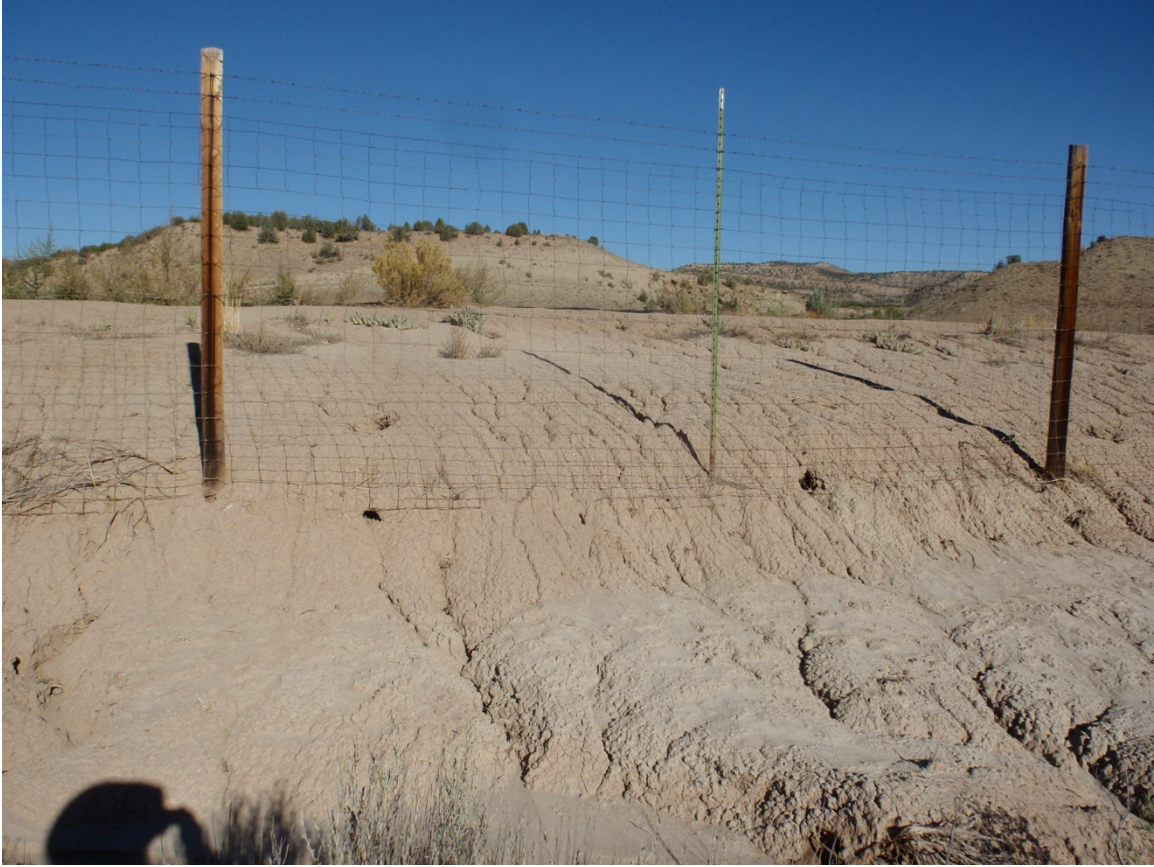
Photo 21. Erosion and offsite soil migration on east side of facility.

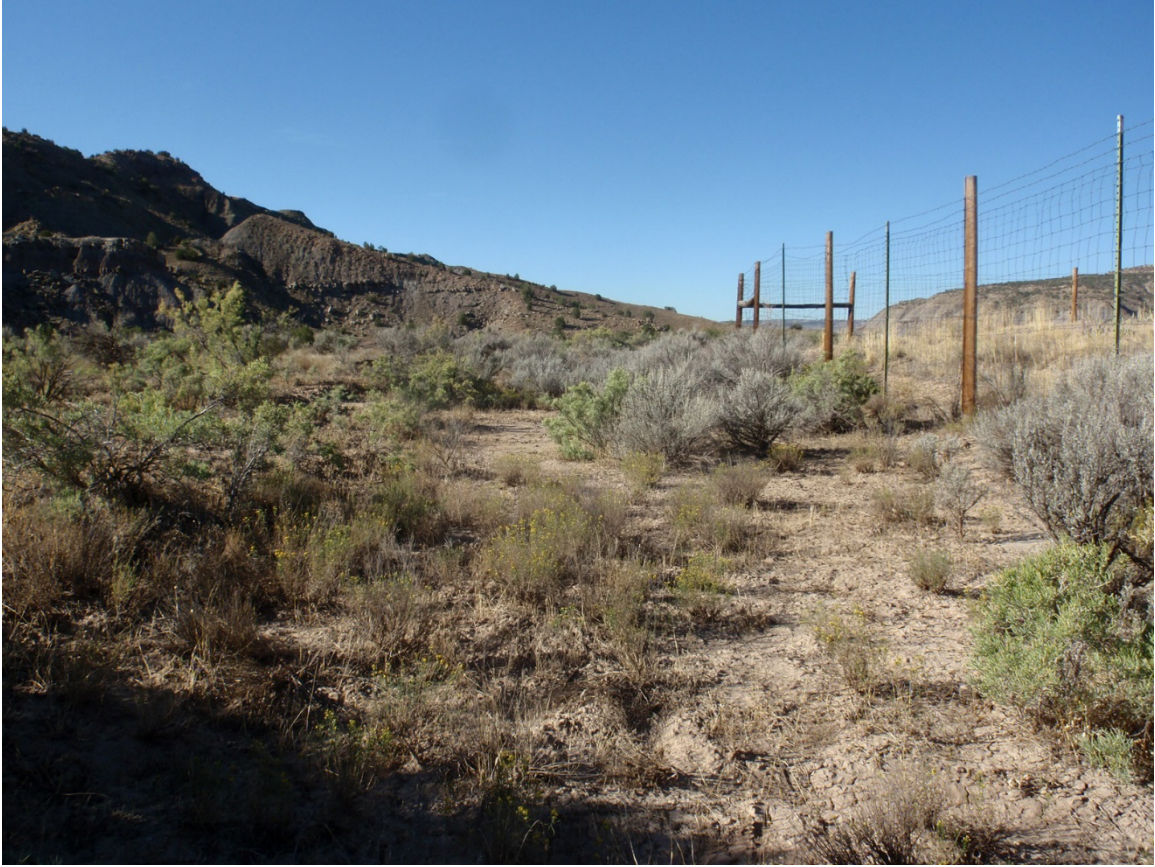
Photo 23. Erosion and offsite soil migration on east side of facility.

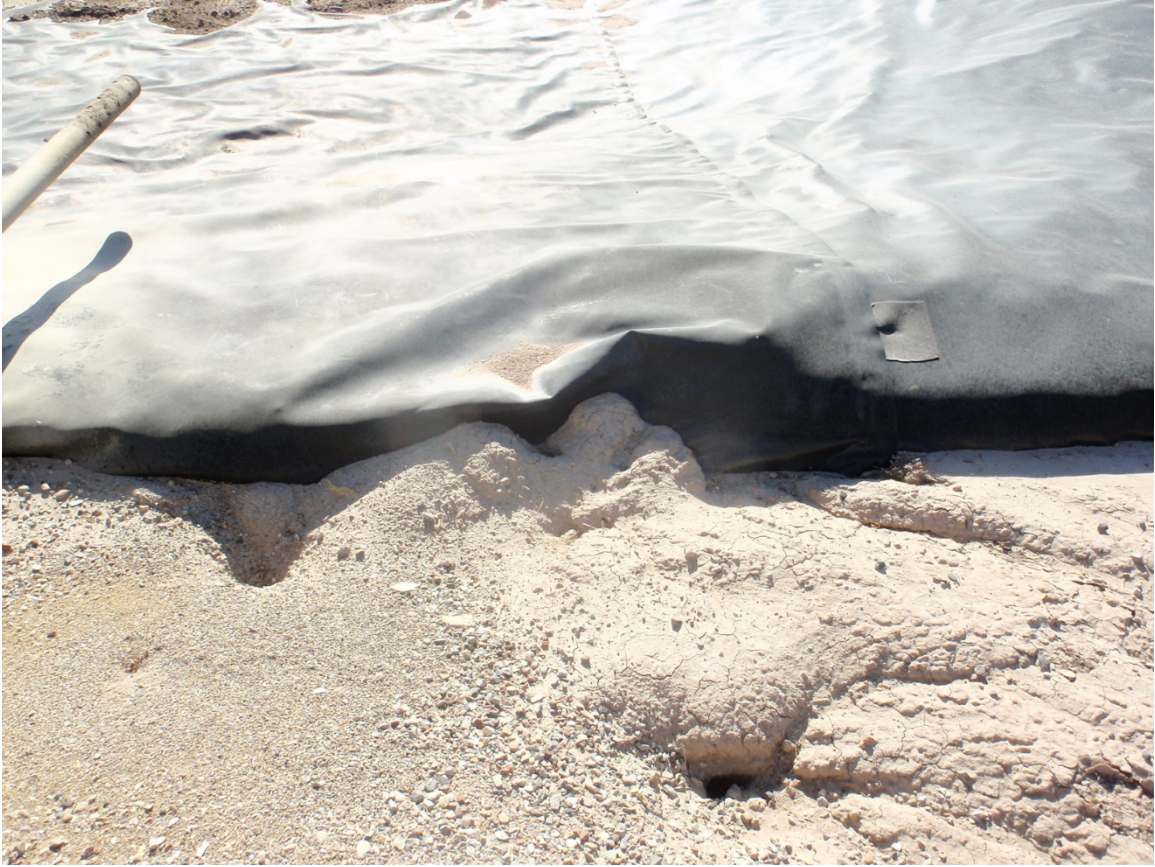
Photo 35. Erosion of soils under liner near tank liner not keyed into berm sufficiently.

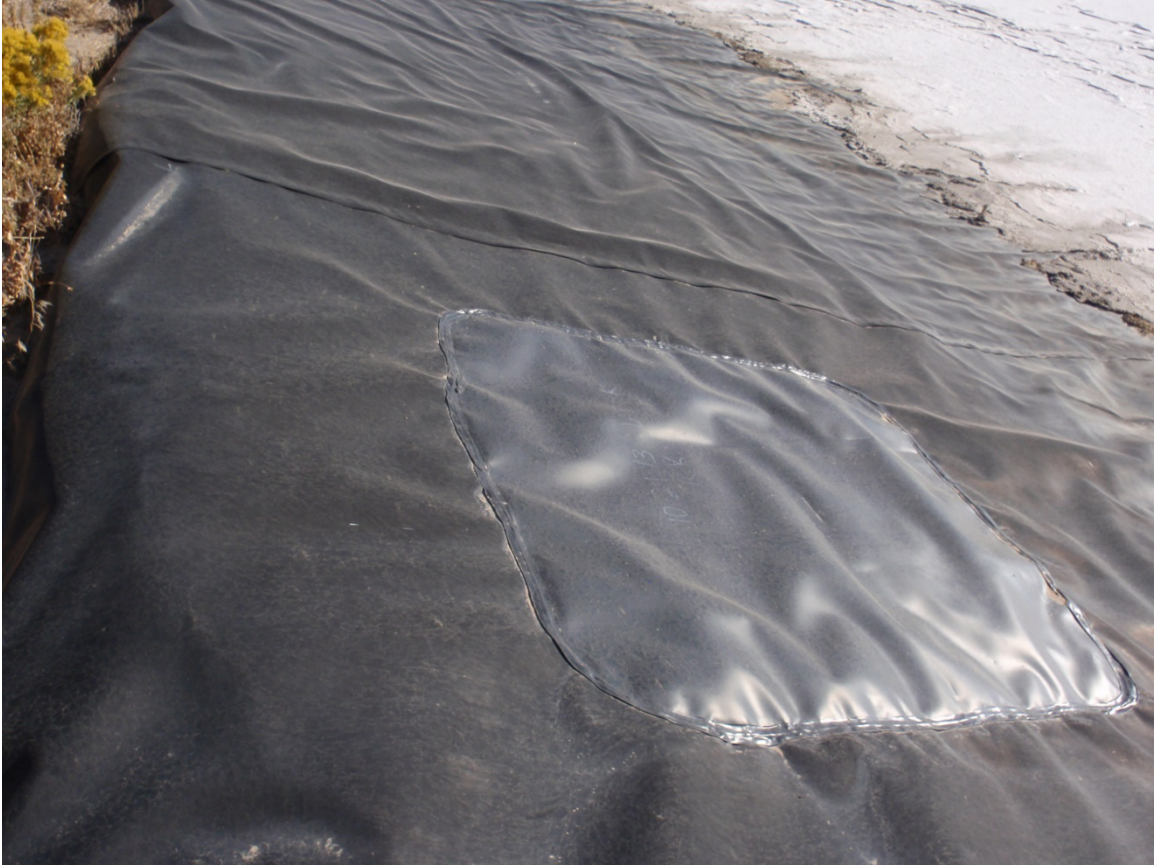
Photo 37. Older patch in liner on west side of pit.

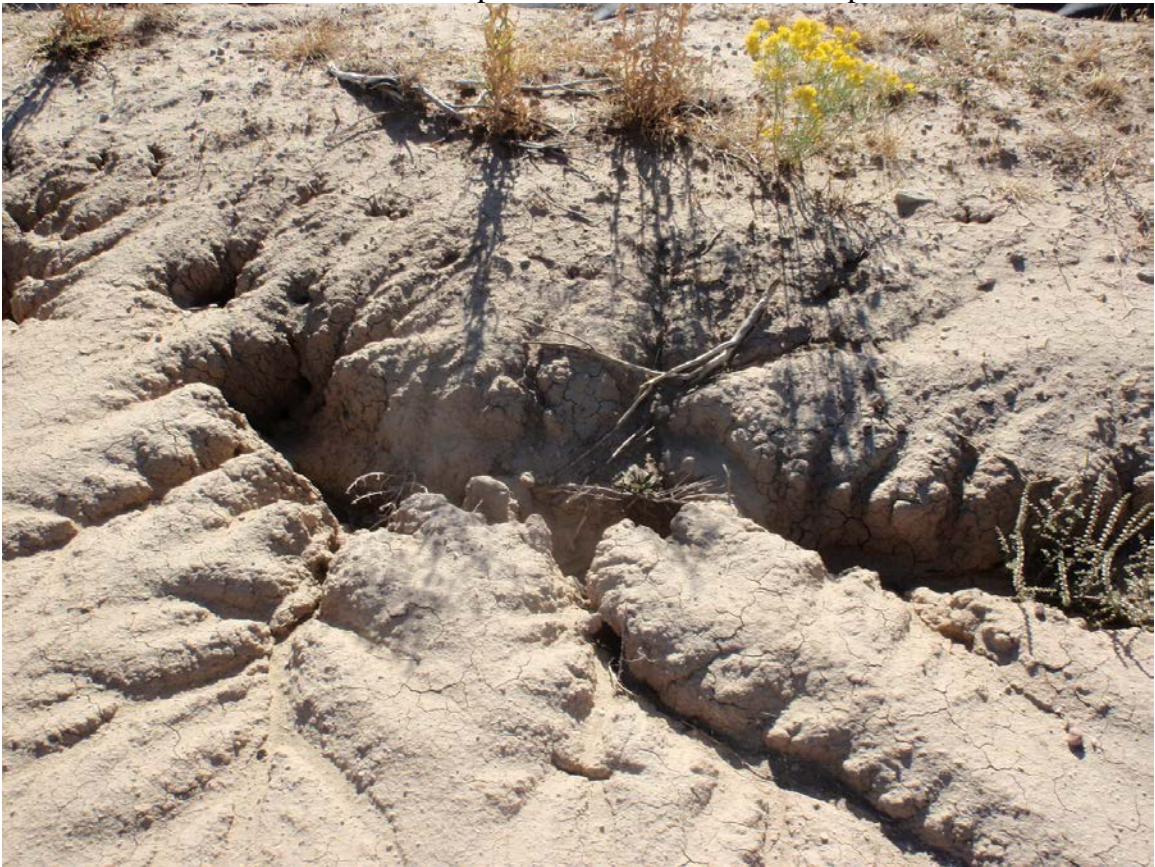
Photo 38. Erosion on berm on west side of pit

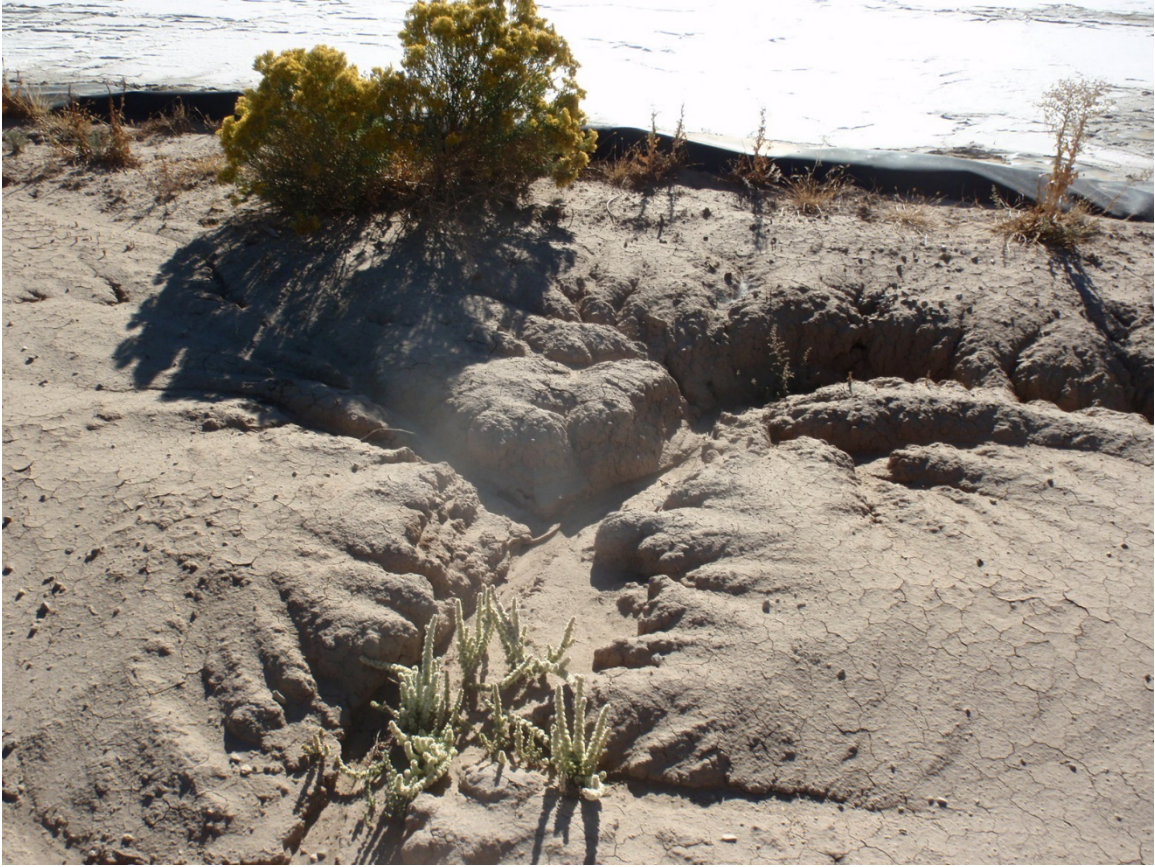
Photo 39. Erosion on berm on west side of pit, Halogeton in foreground.

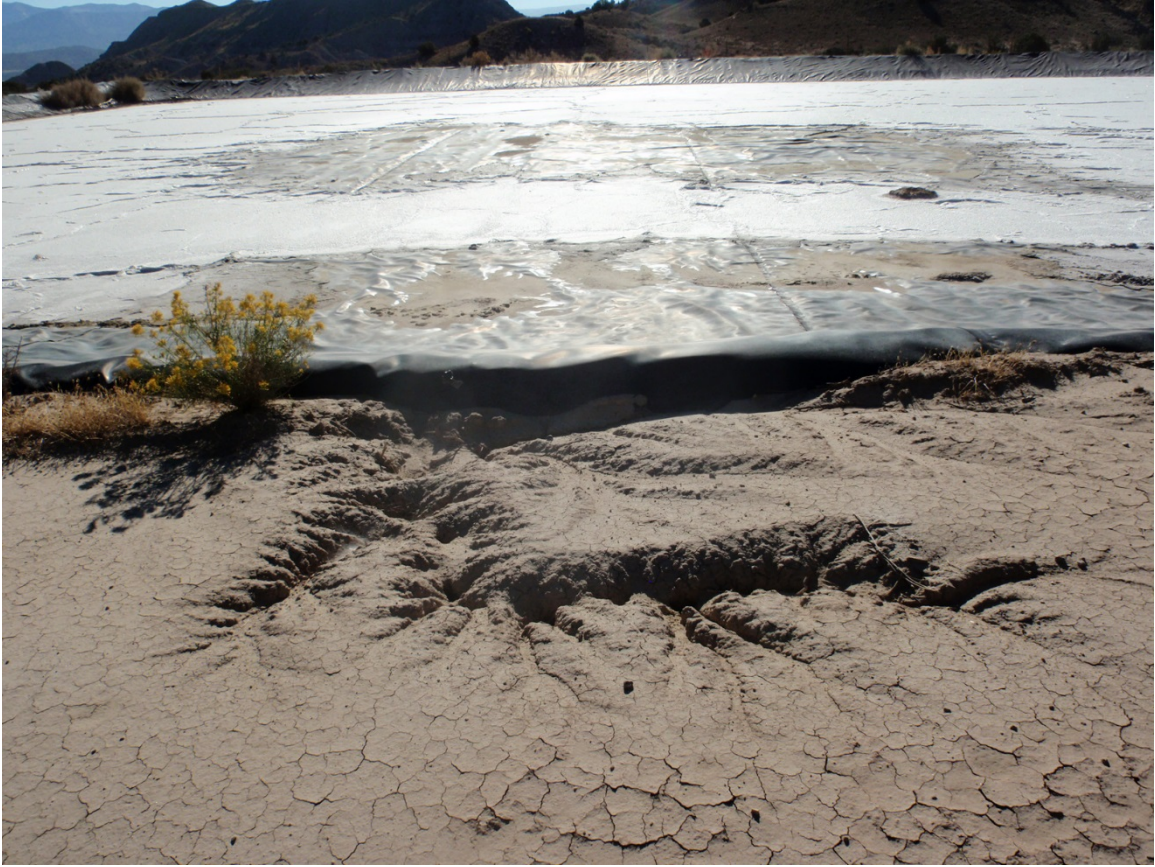
Photo 43. Erosion on berm on west side of pit

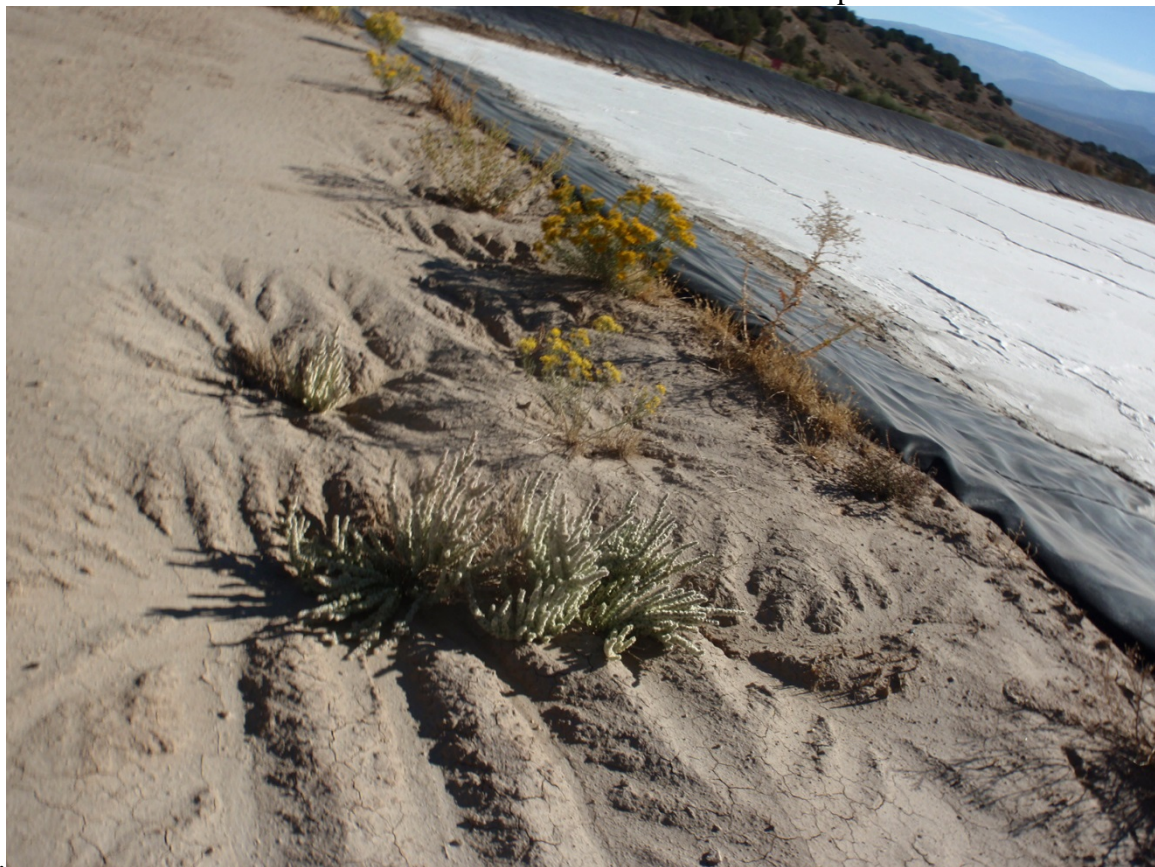
Photo 44. Erosion on berm on west side of pit

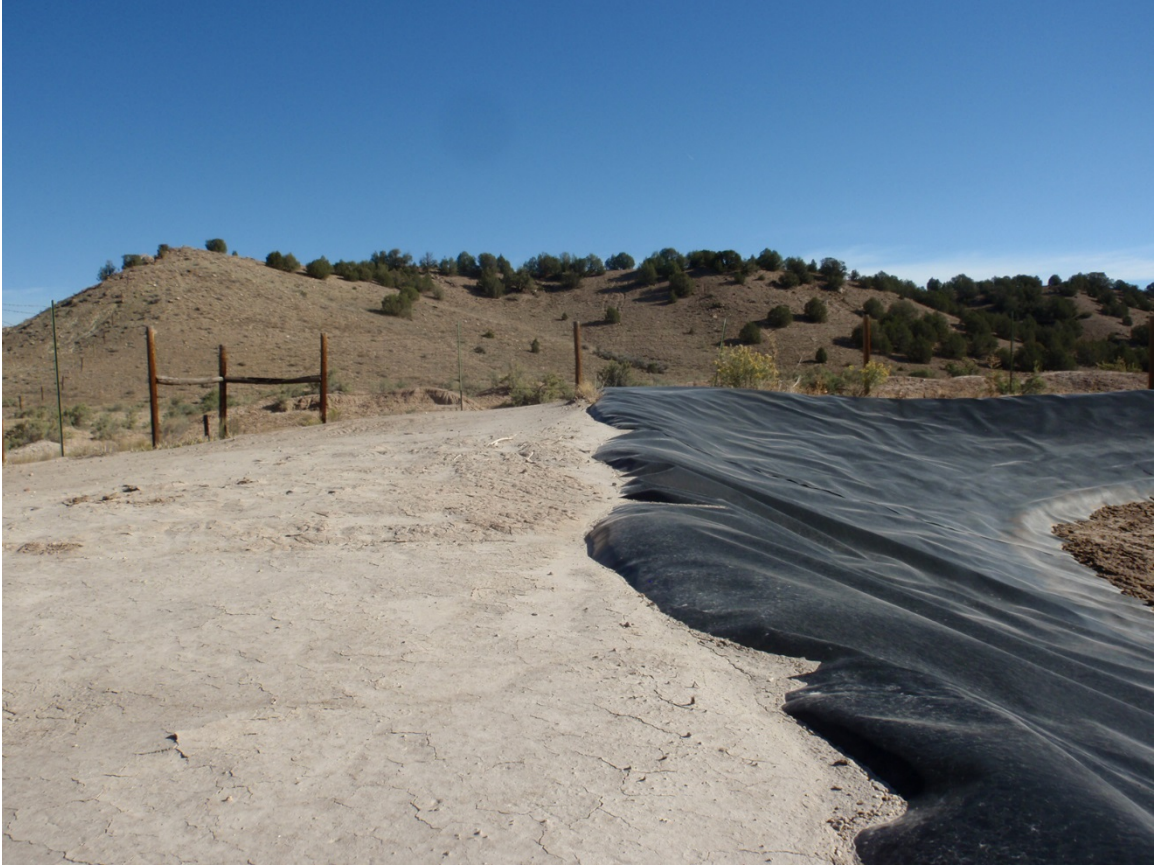
Photo 49. Erosion on northwest corner of pit

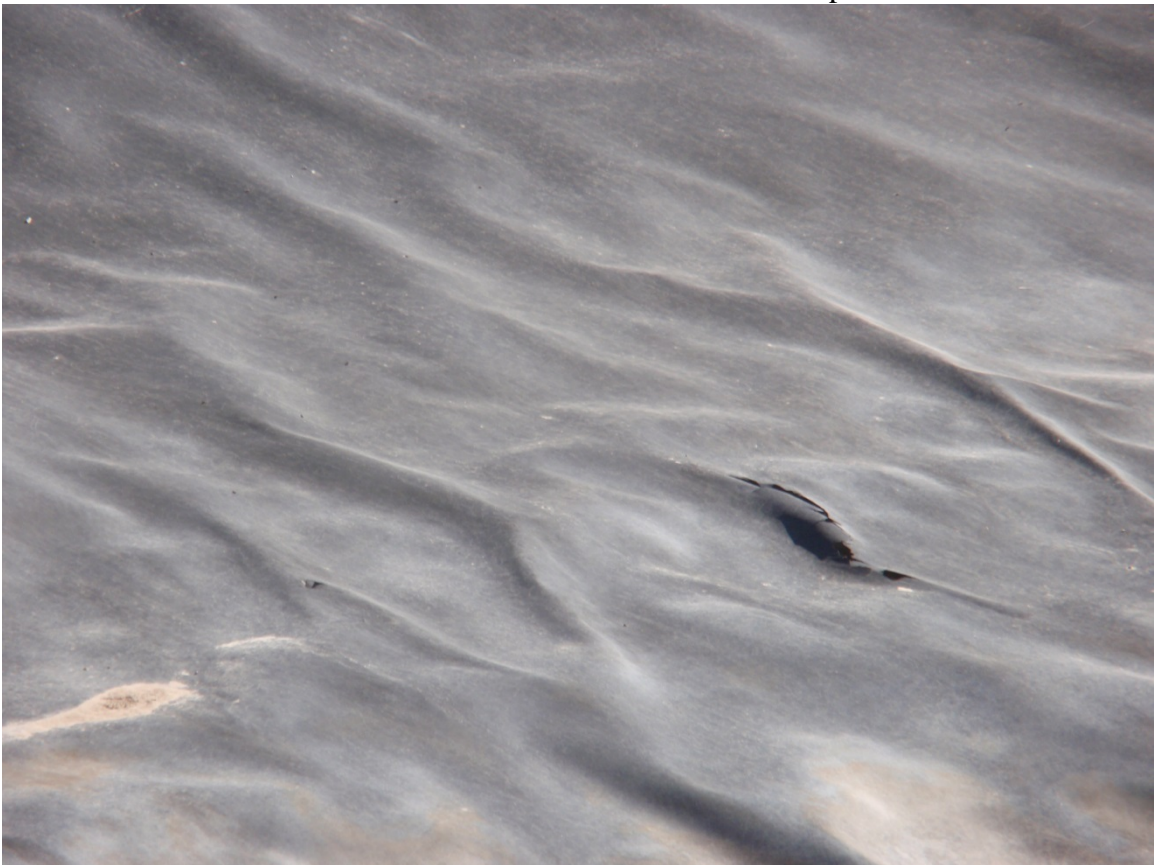
Photo 50. Visible crack in liner near northwest corner.

Maintenance Needs?		Berms need to be repaired and protected from erosion. Liner has numerous patches and 70 + holes were seen. Large hole in liner.	
Photos & Maps		See Attached	
Other Comments and Additional Actions Necessary: The ROW has expired and will not be renewed. The holder must submit a plan detail the removal of all facilities, and the reclamation and restoration of the site. This should include the testing and disposal of soils, contouring and reseeding of site. A joint inspection must be scheduled with BLM and Maralex to discuss the requirements for an acceptable termination and rehabilitation plan.			
DRAFT February 27, 2009 - Perry		Next Inspection date:

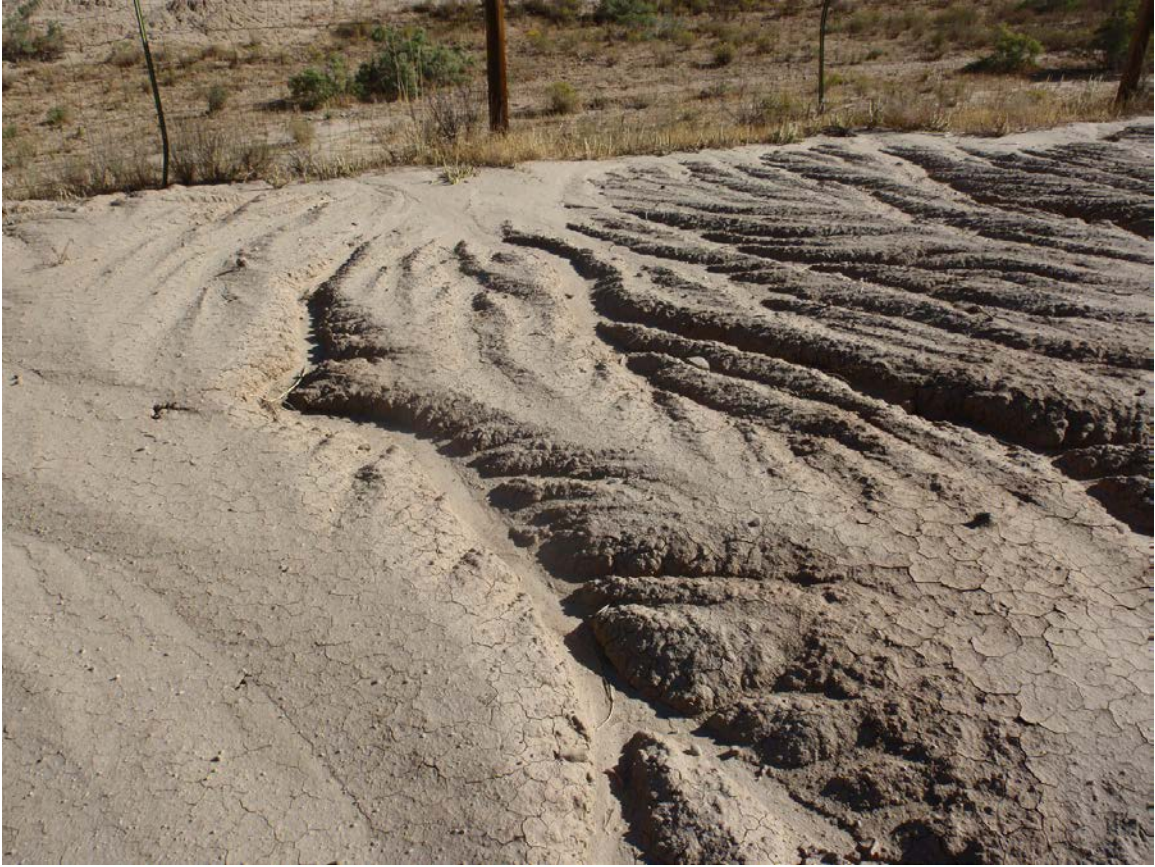
Photo 51. Erosional rills along the north side of pit.

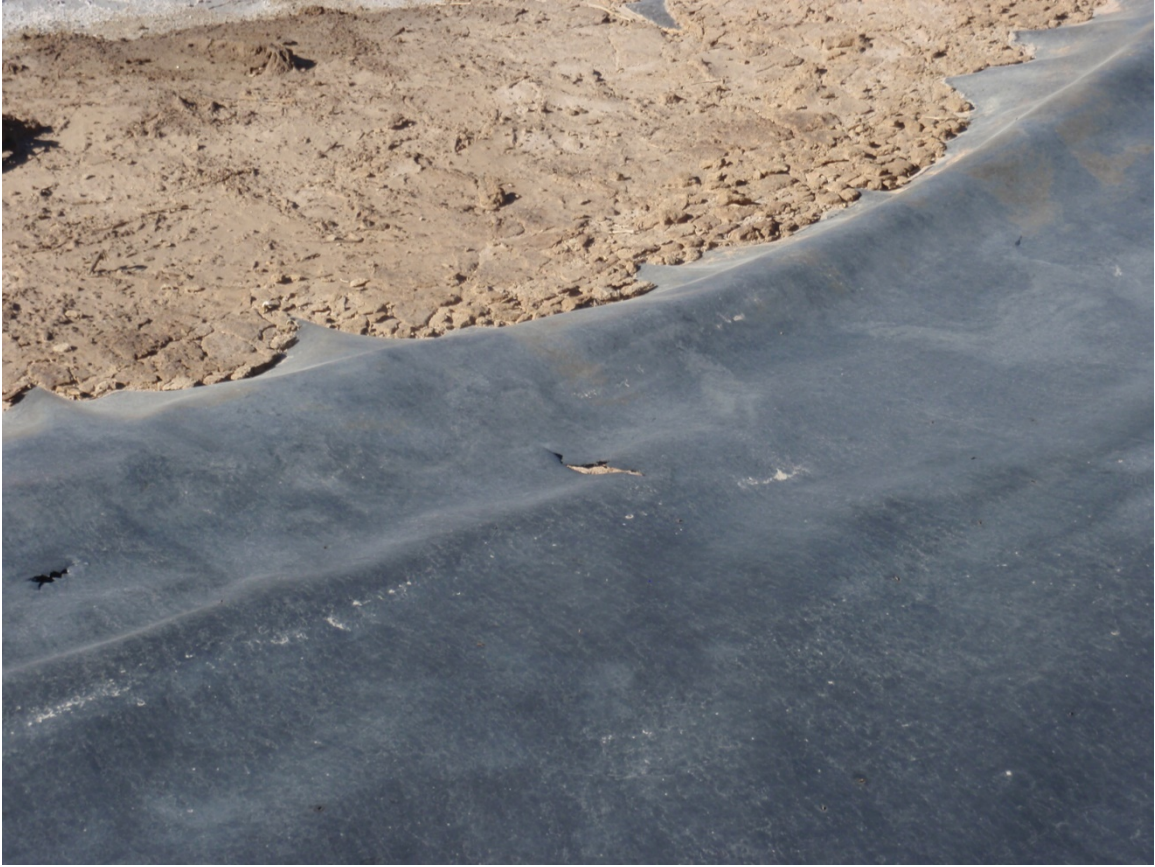
Photo 53. Damage to liner along north side of pit

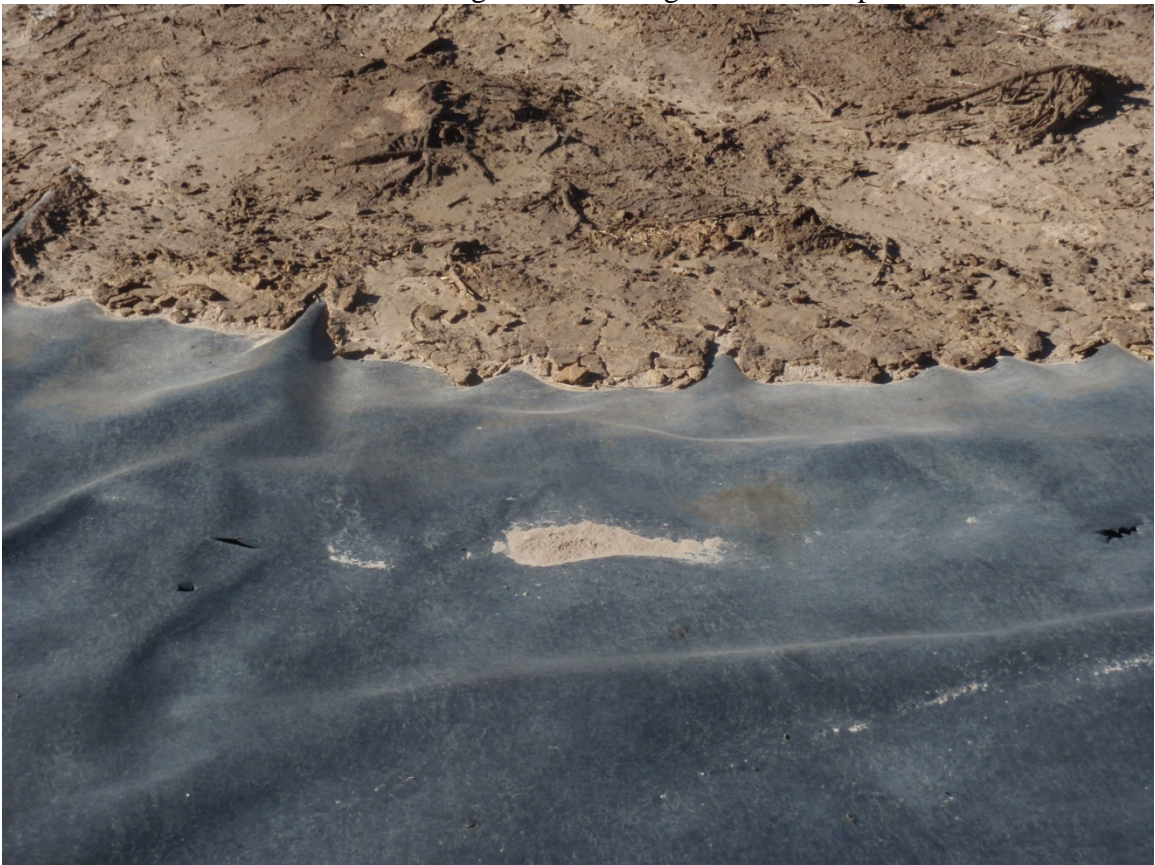
Photo 54. Damage to liner along north side of pit

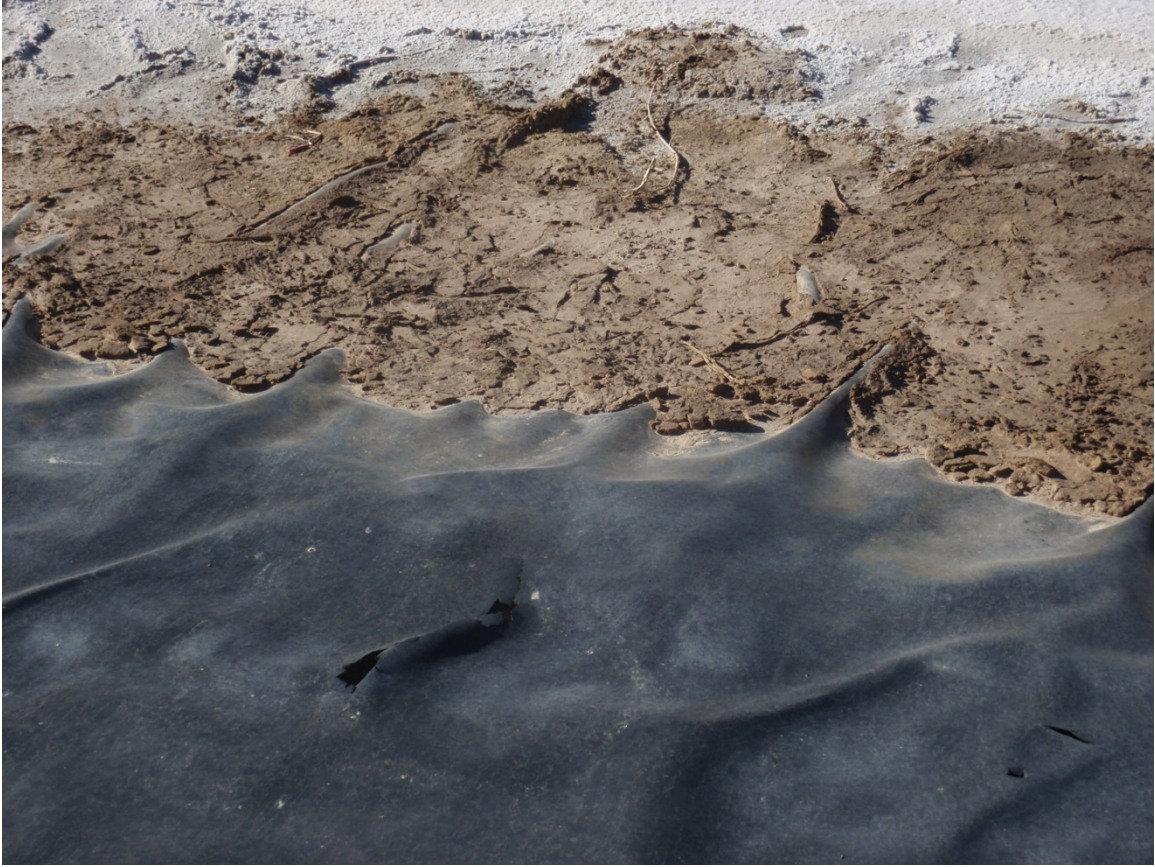
Photo 55. Damage to liner along north side of pit

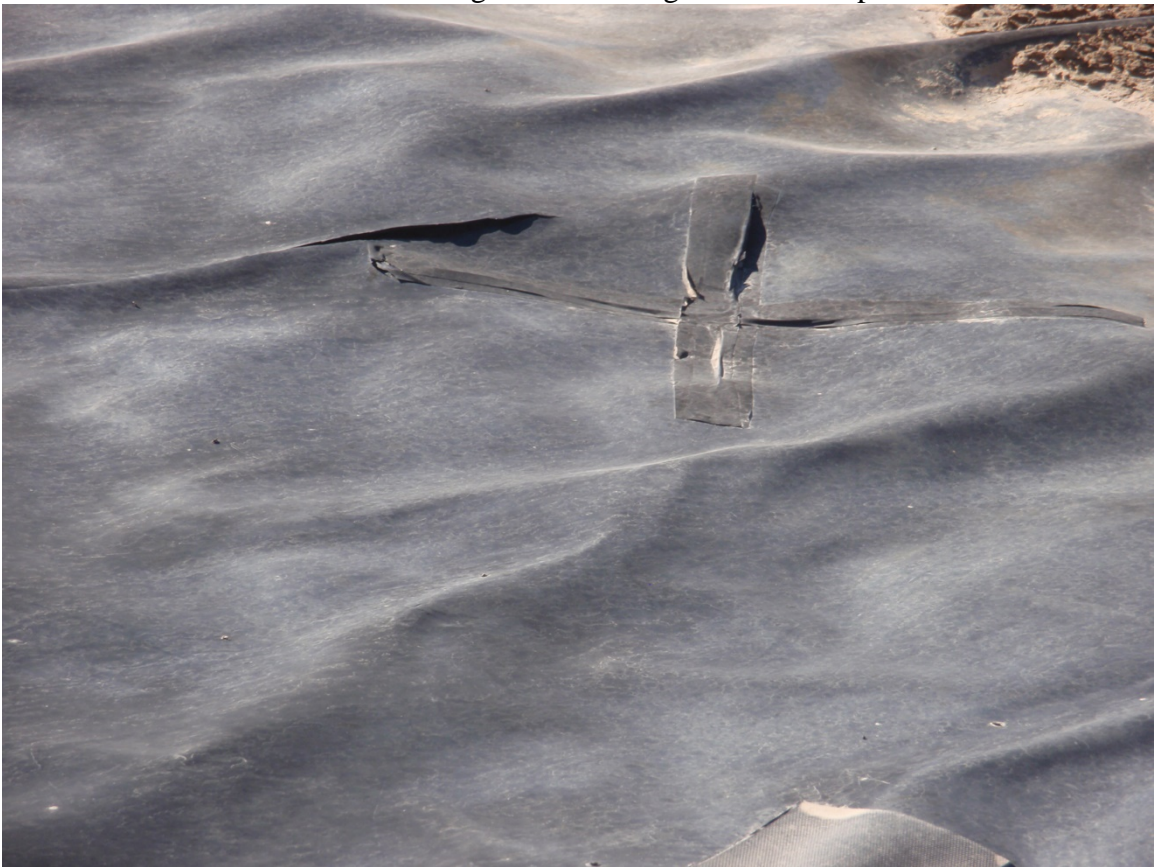
Photo 56. Damage to liner along north side of pit
