ROW Compliance Inspection		Case #: COC 61214 Holder: Maralex Disposal LLC	Project Name: Roan Creek Evaporation Pond
Twn: 8 S Rng: 98 W Sec 36: Qtr: NESE		County: Mesa County State: Colorado	
Inspection Date & Time: 9/27/2018 9:00am			
Inspector: Scott Hall		Office Time:	Total Time:
People/Affiliations at Inspection: COGCC		Steven Arauza	
Existing Conditions? 1.Construction, 2.Operation, 3.Reclamation; Disturbed Area Measurements; Facilities		Site was construction in the 1980's and was used until 2009. Pit has been in noncompliance since 2010 and has not been used since. The site is 285' by 505' and include a 24' x 245' access road and a 100' x 77' site for bioremediation of soils. Facilities include, pit, fence, 300 barrel tank with berm, and leak detection system.	
Conformance with ROW Terms & Conditions? Constructed to Specifications		ROW is not in compliance with the stipulations. ROW expired 8/30/2018.

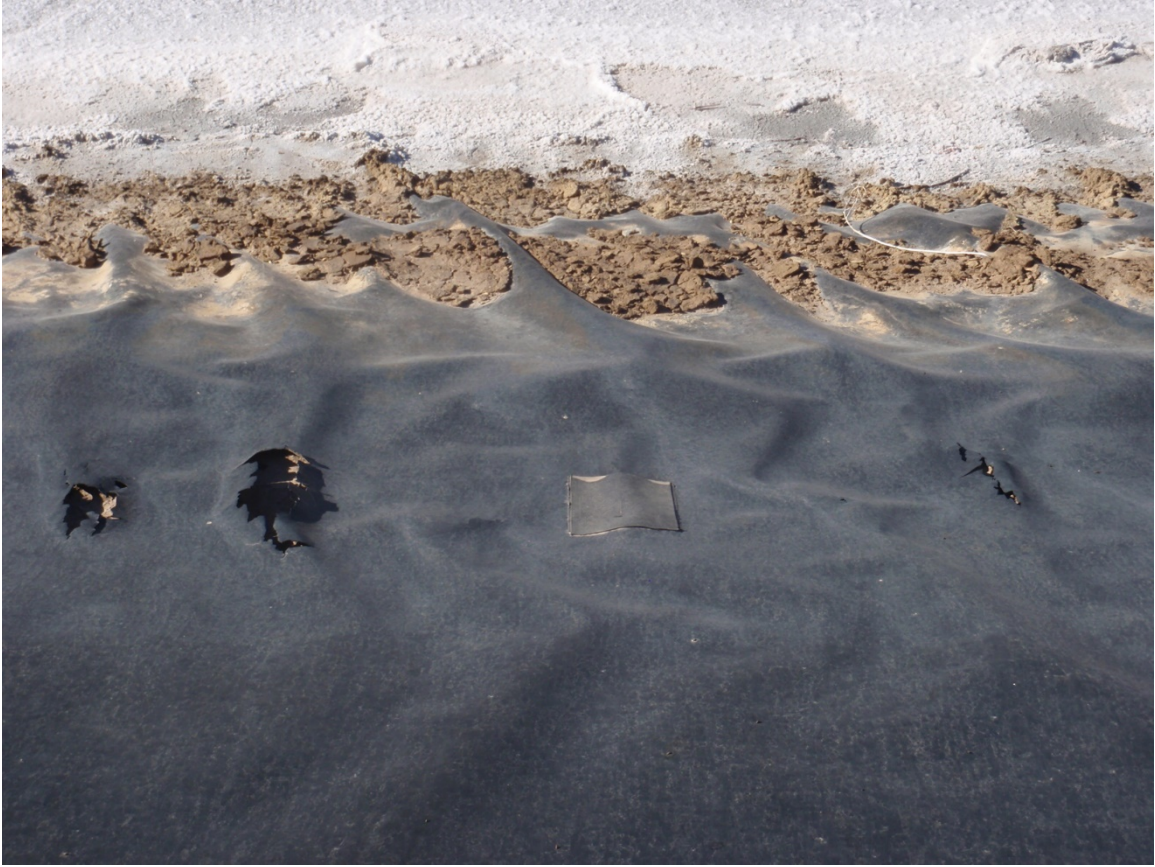
Photo 57. Damage to liner along north side of pit

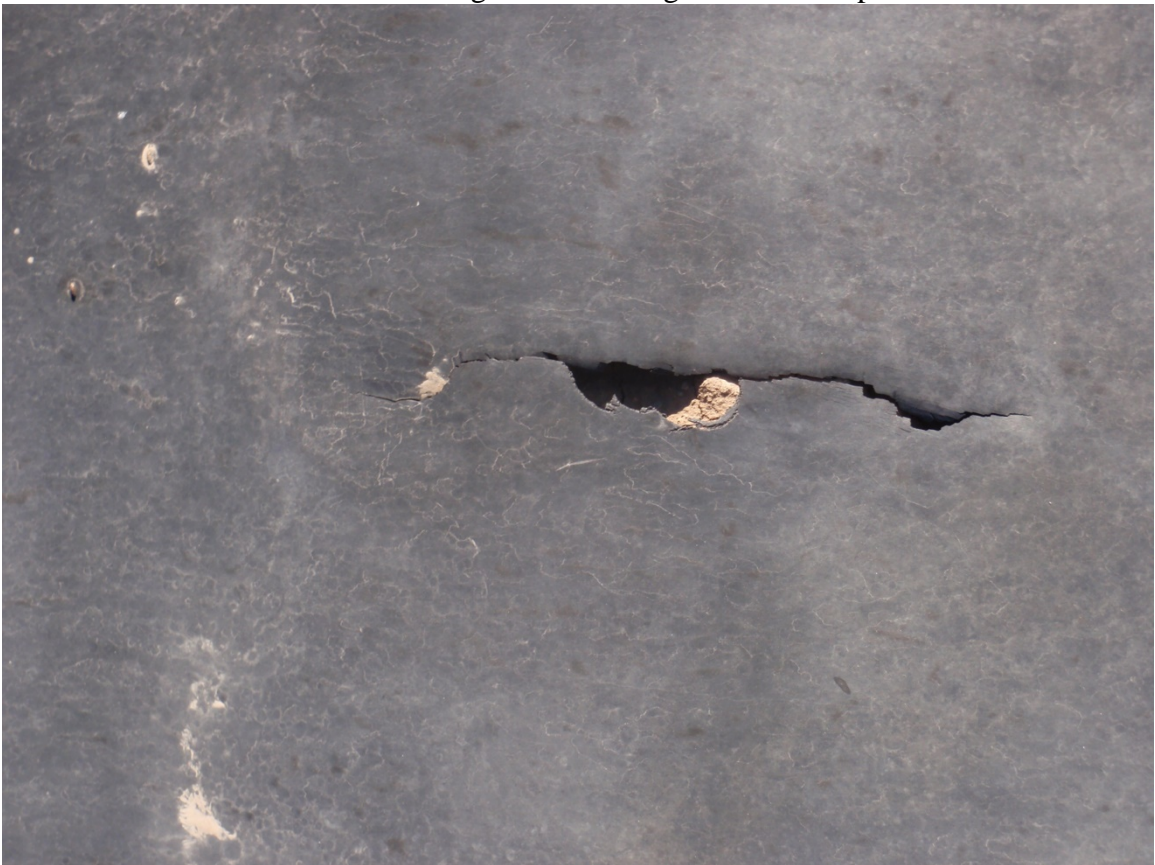
Photo 58. Damage to liner along north side of pit

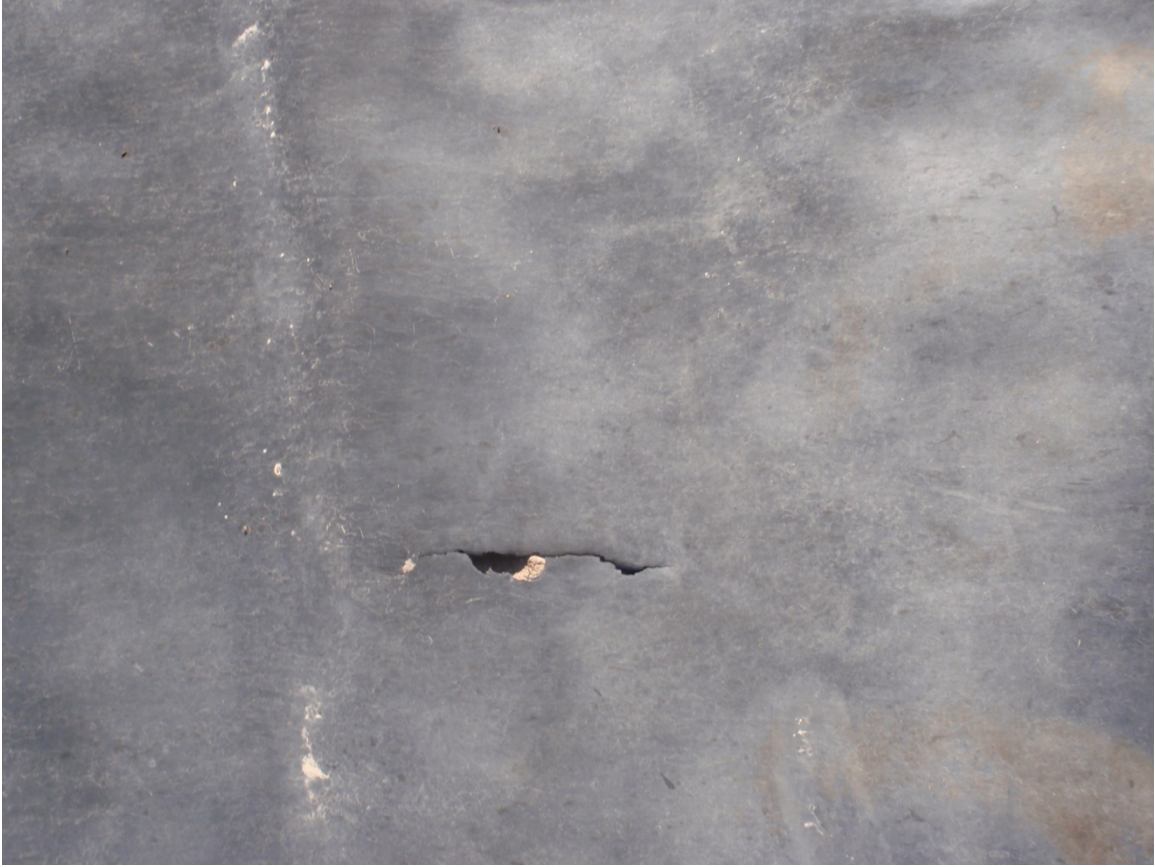
Photo 59. Damage to liner along north side of pit

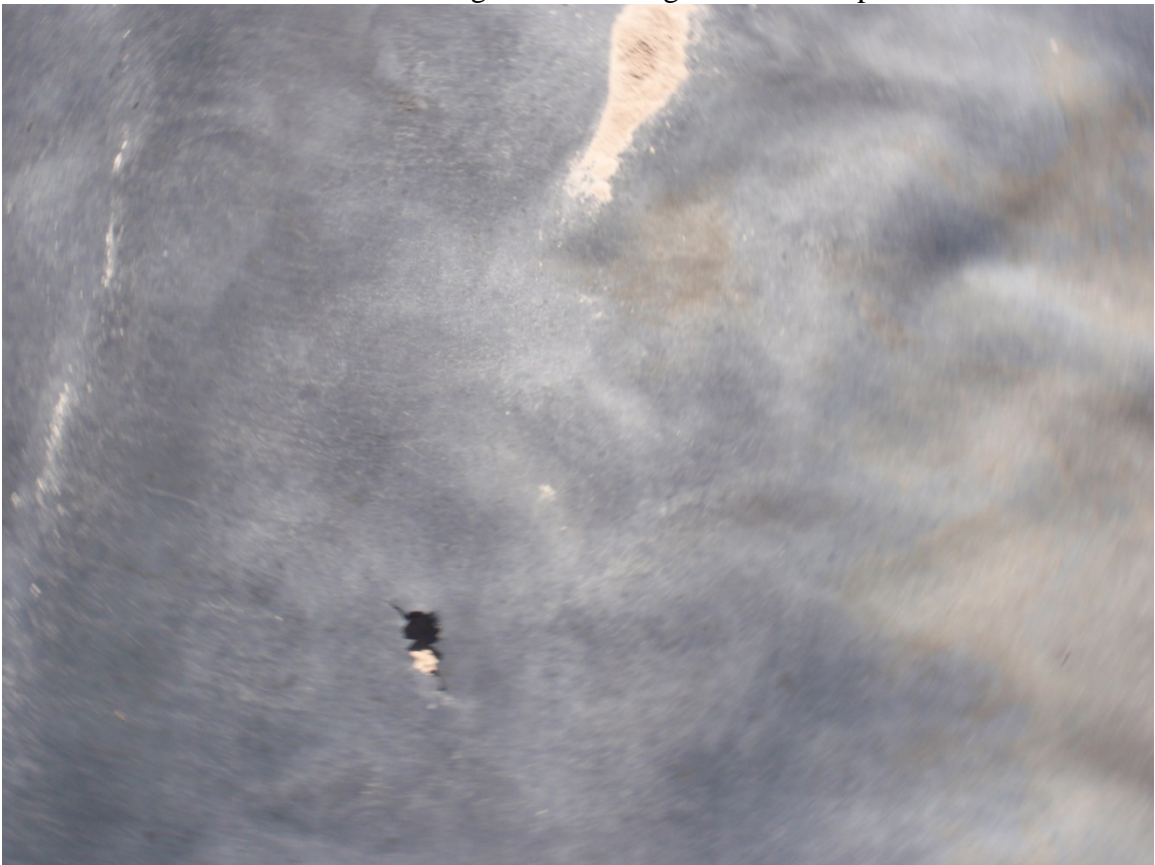
Photo 60. Damage to liner along north side of pit

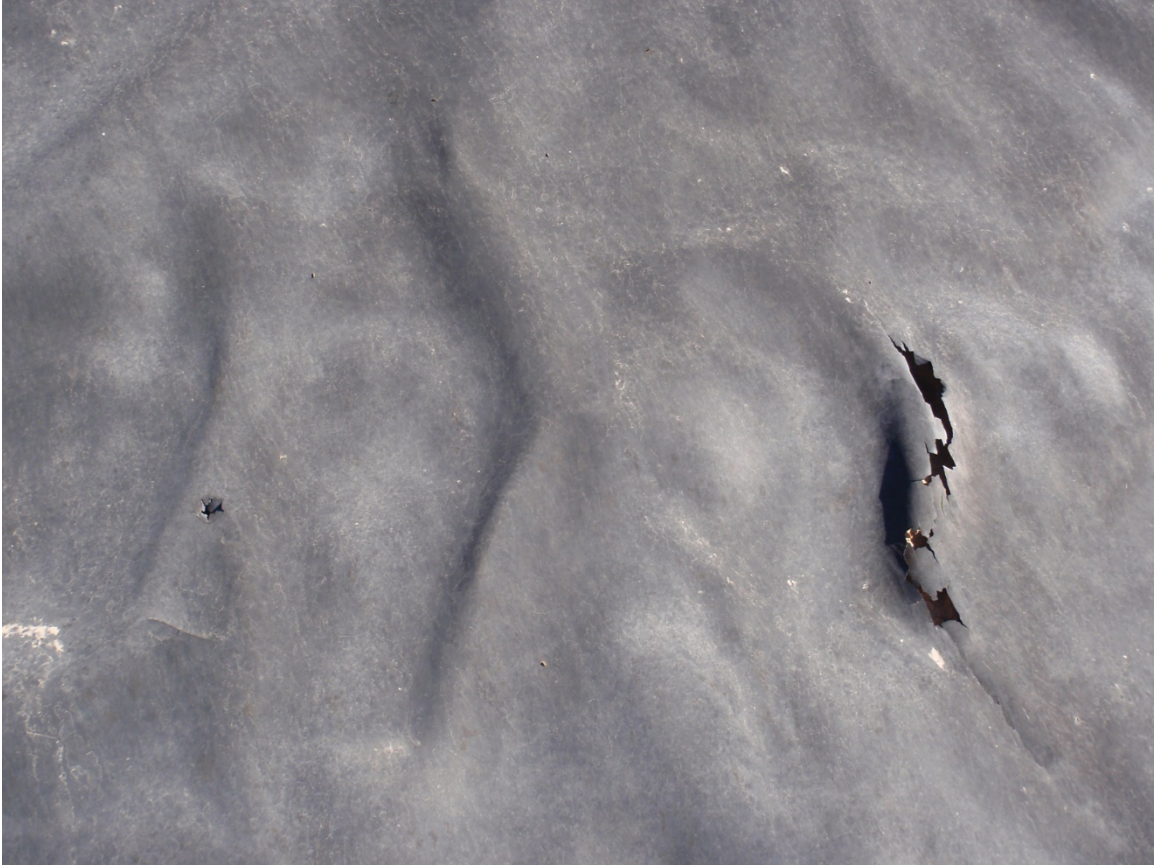
Photo 61. Damage to liner along north side of pit

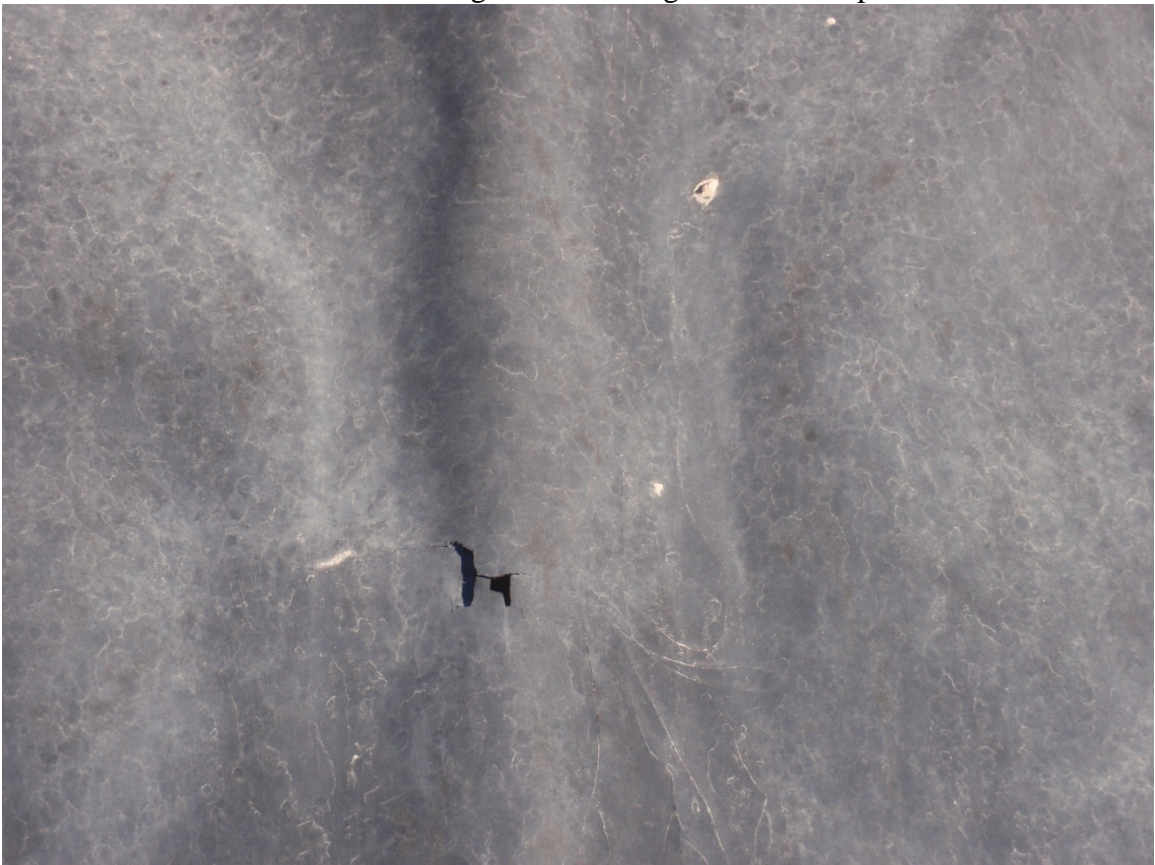
Photo 62. Damage to liner along north side of pit

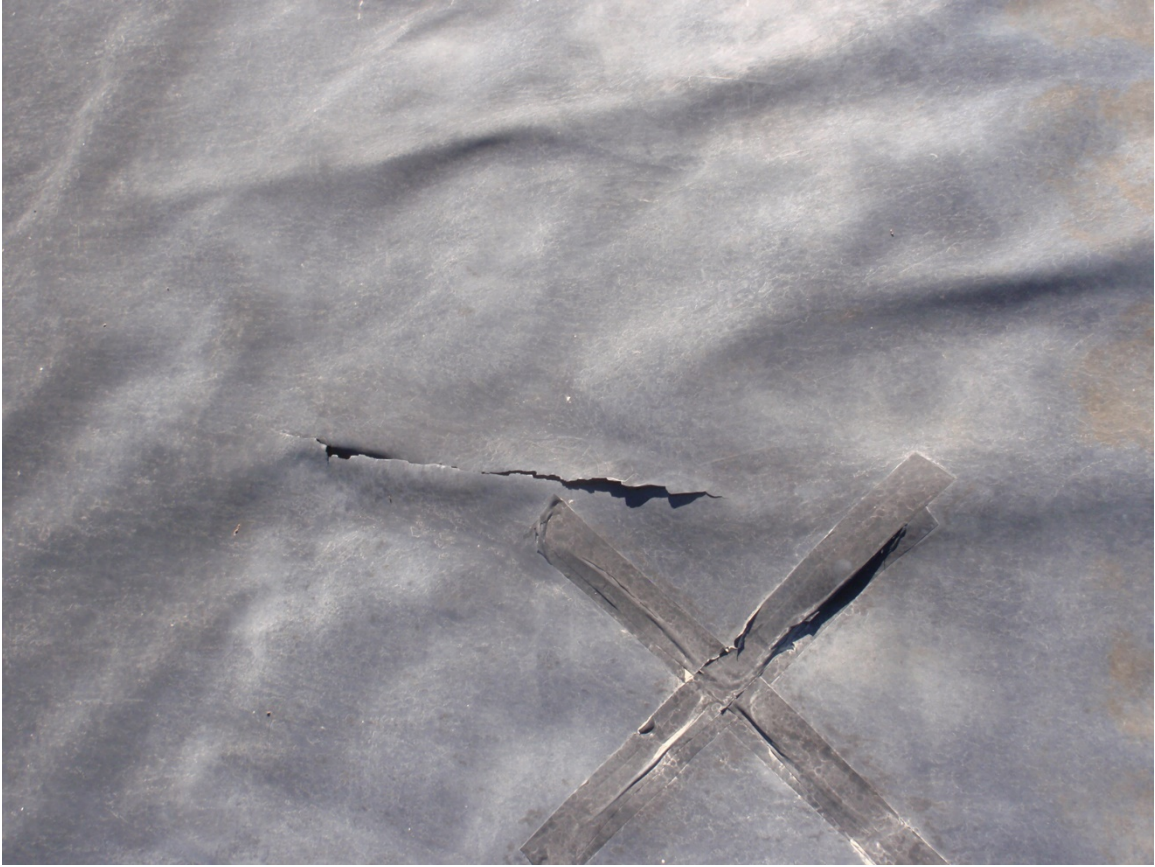
Photo 63. Damage to liner along north side of pit

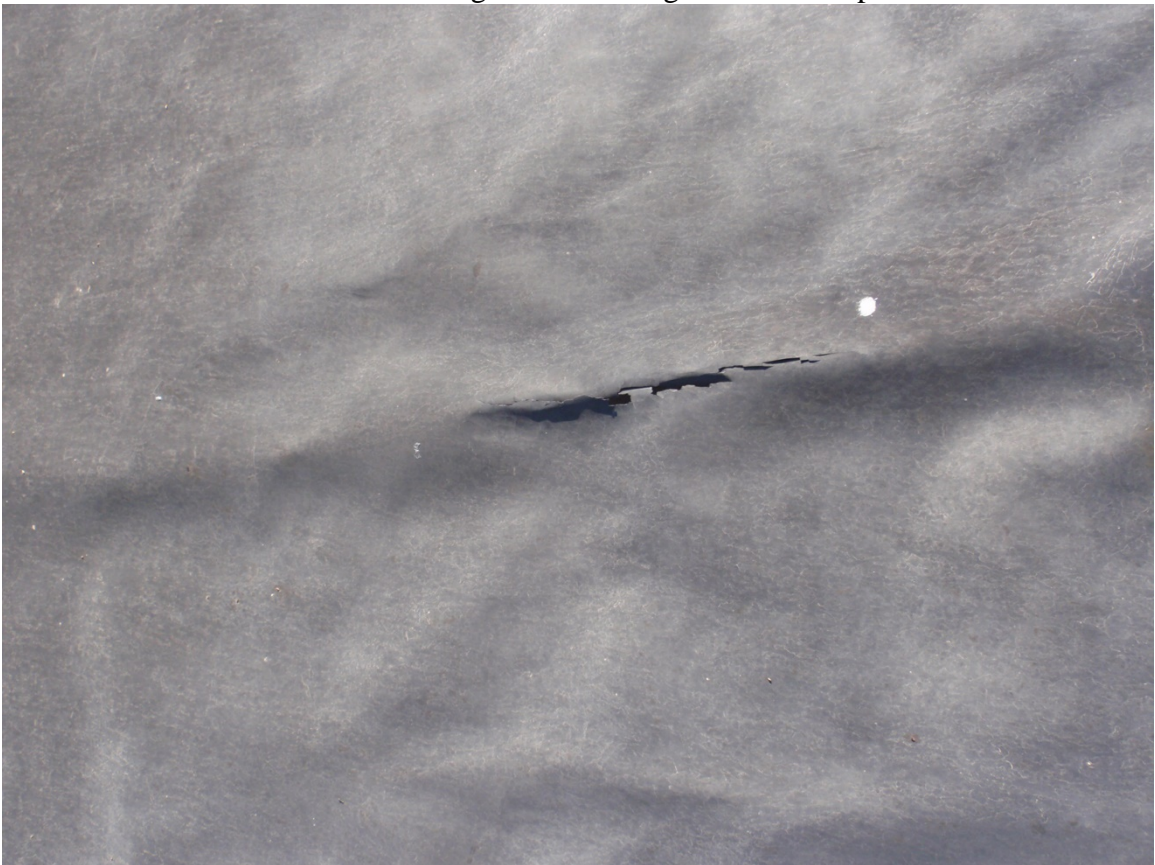
Photo 64. Damage to liner along north side of pit

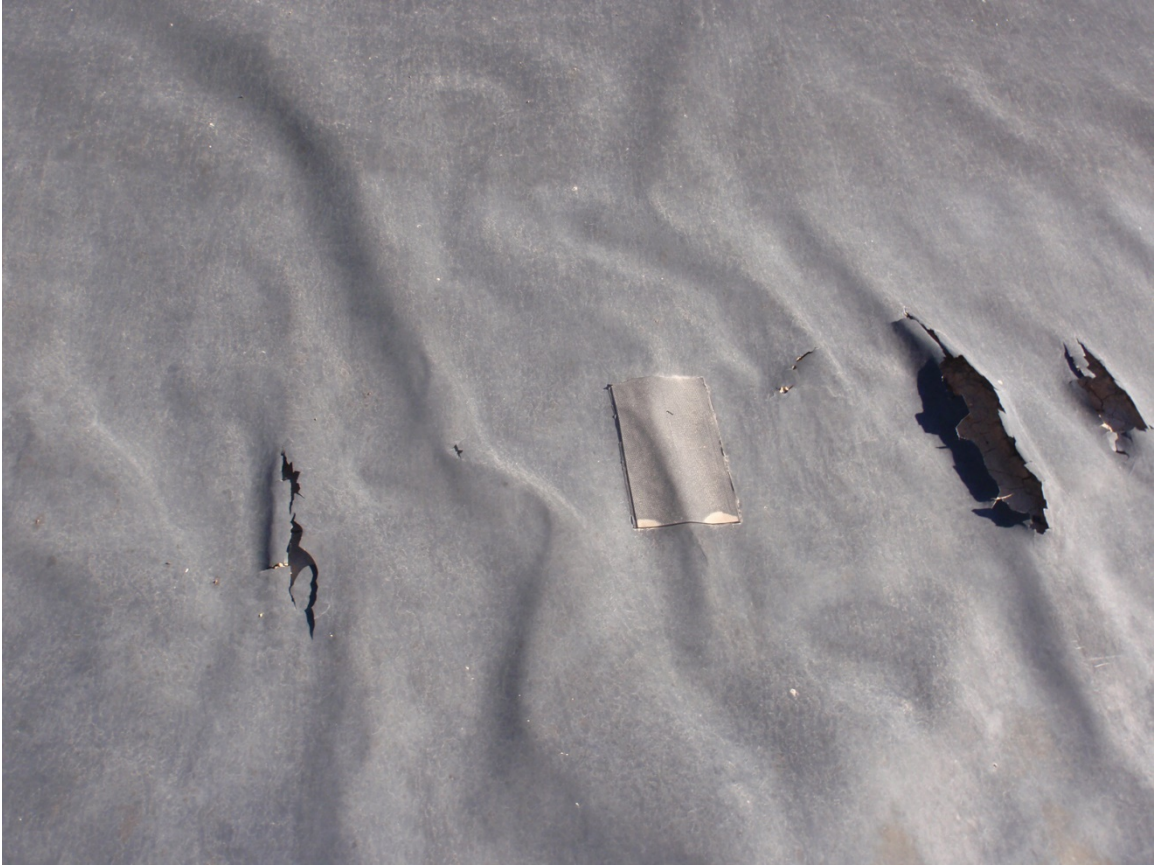
Photo 65. Damage to liner along north side of pit

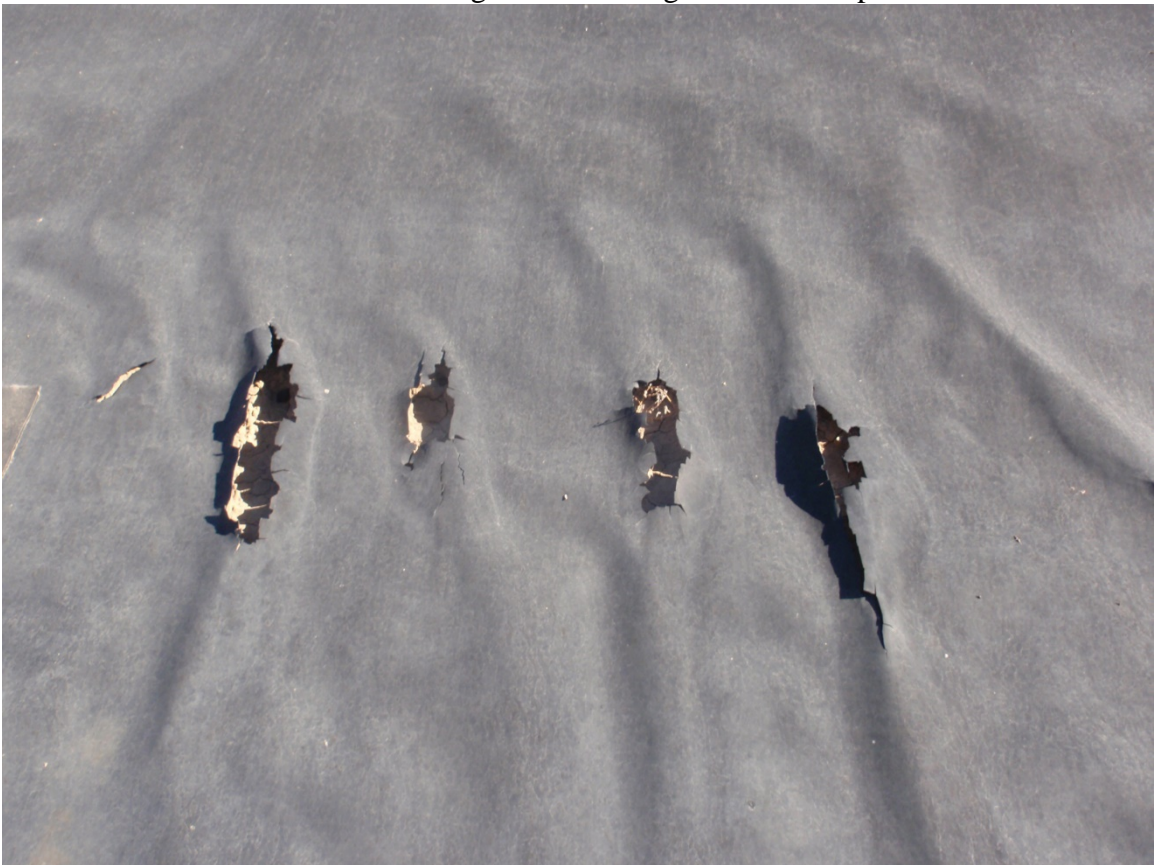
Photo 66. Damage to liner along north side of pit

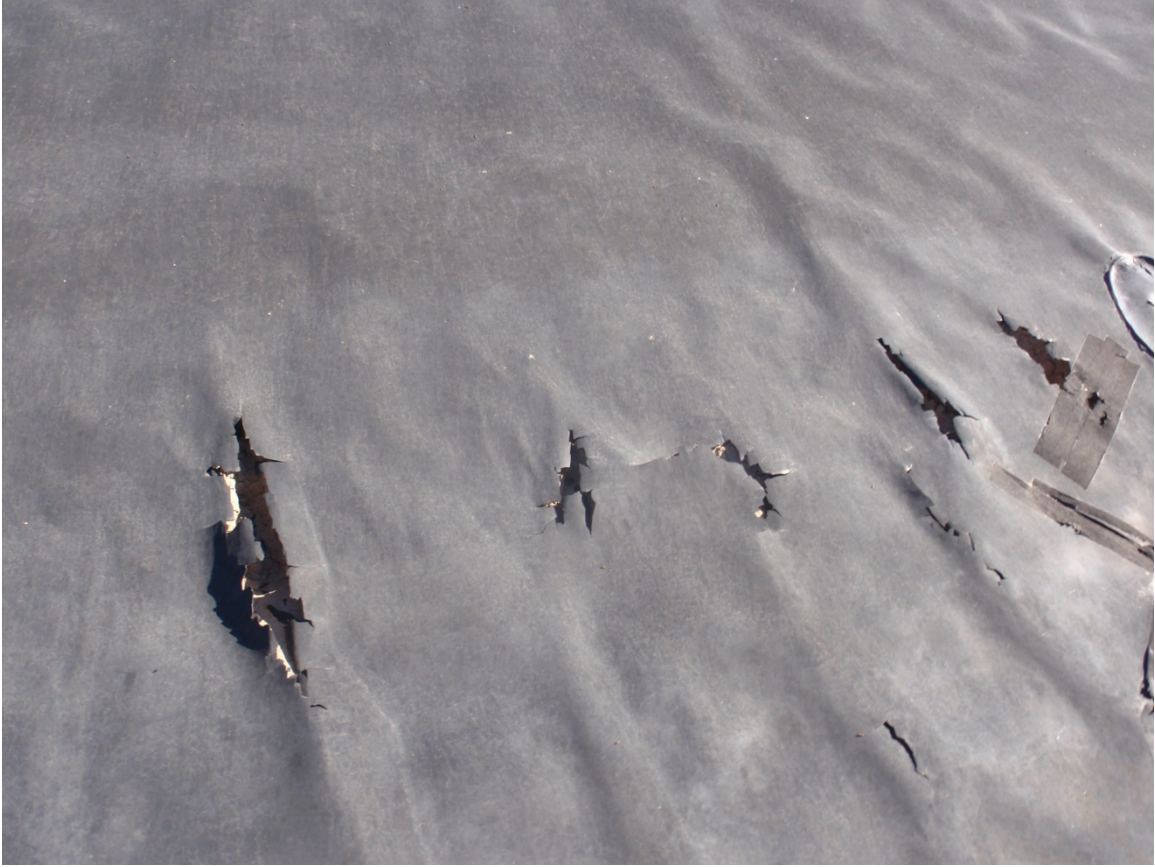
Photo 67. Damage to liner along north side of pit

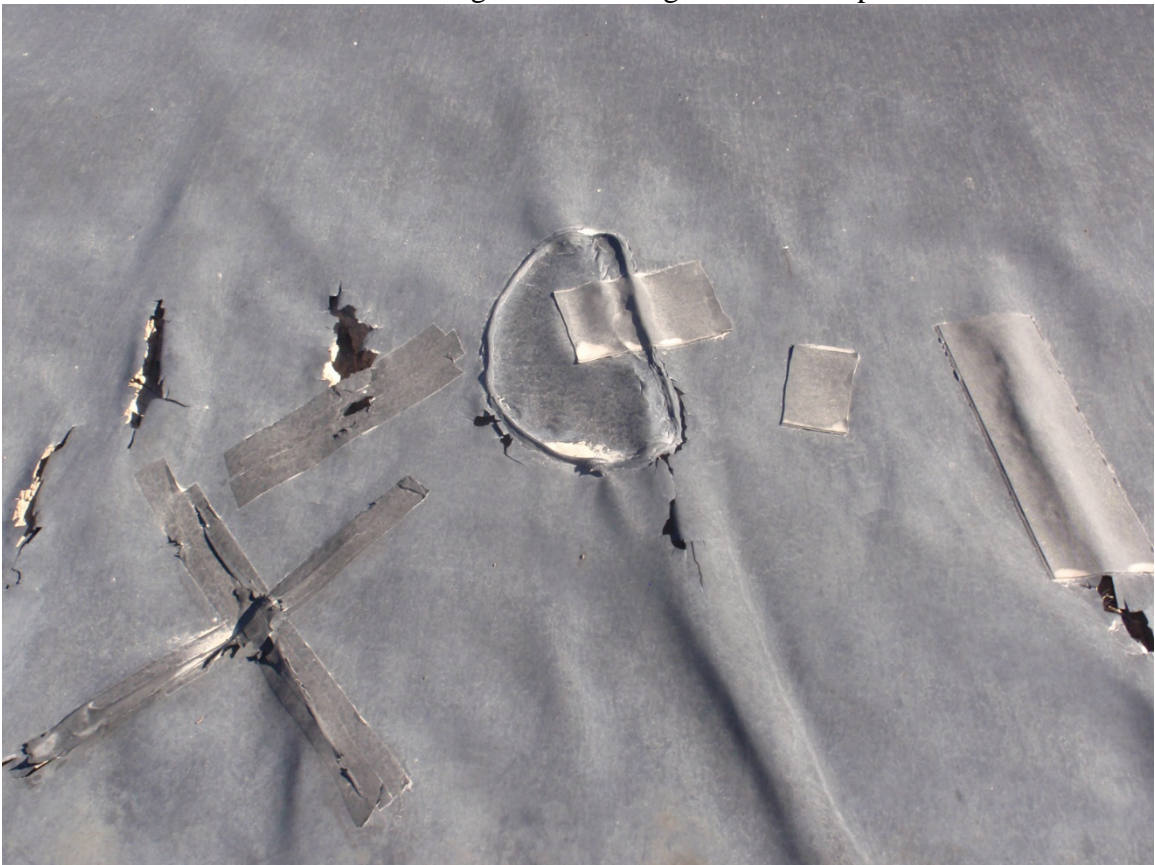
Photo 68. Damage to liner along north side of pit

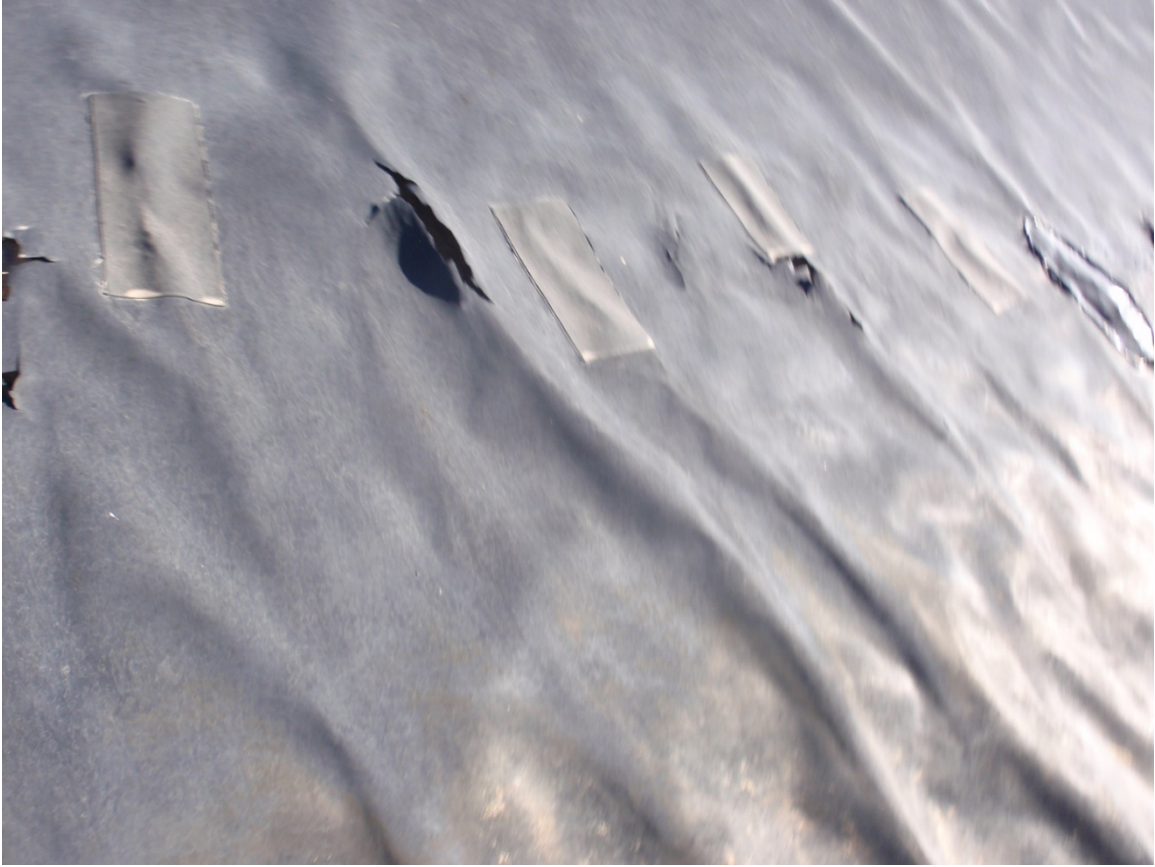
Photo 69. Damage to liner along north side of pit

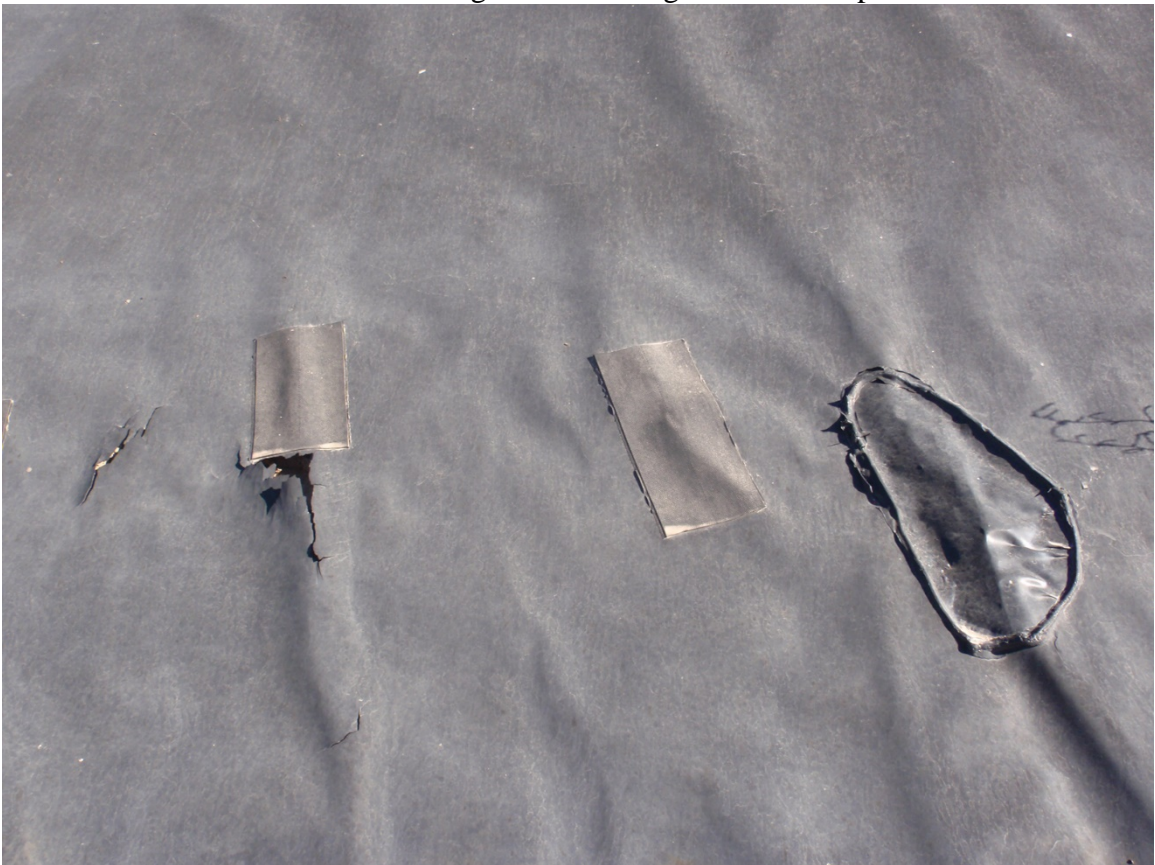
Photo 70. Damage to liner along north side of pit

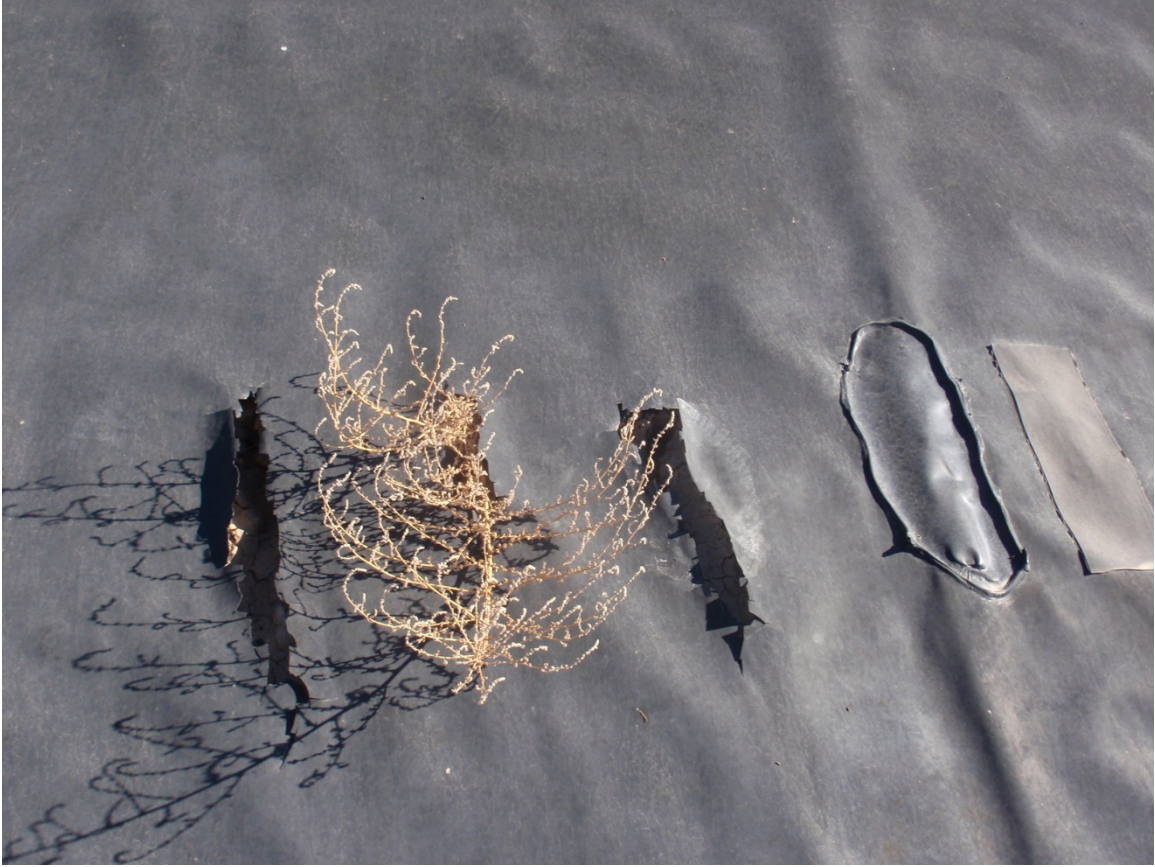
Photo 70. Damage to liner along north side of pit

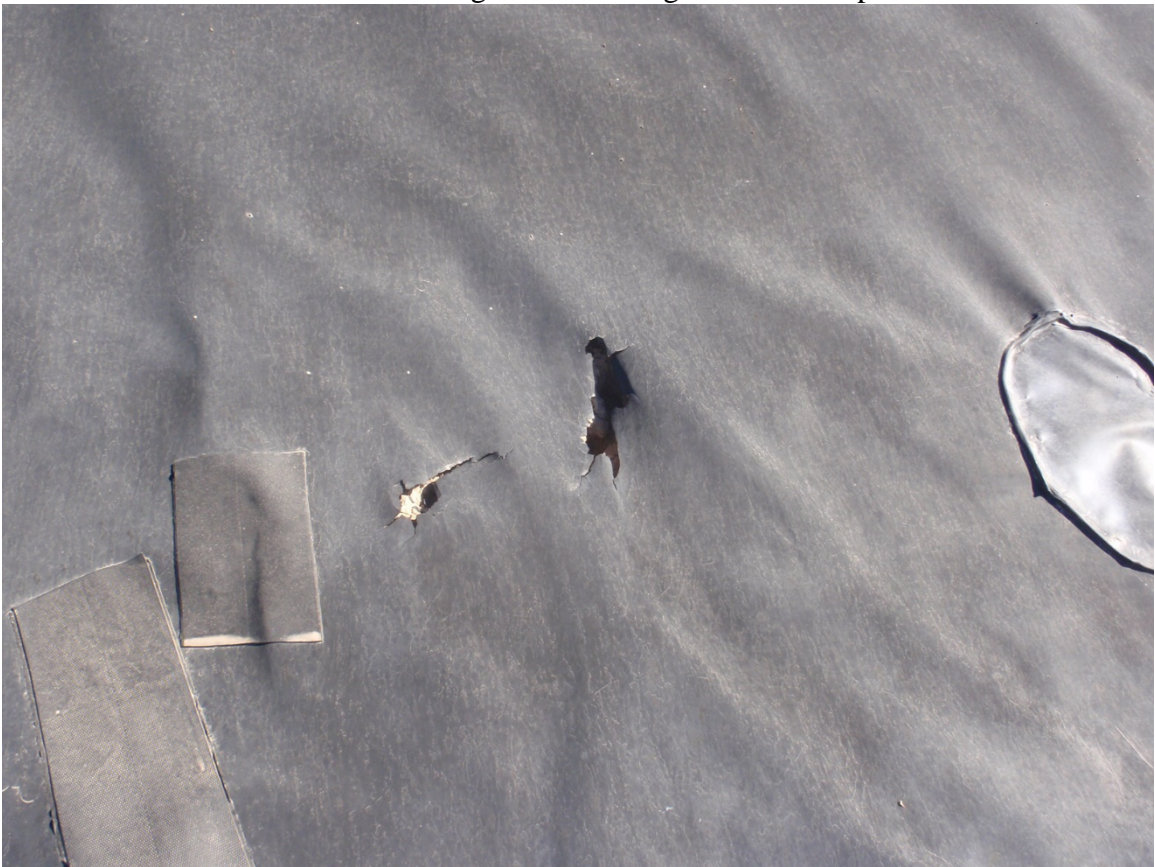
Photo 72. Damage to liner along north side of pit

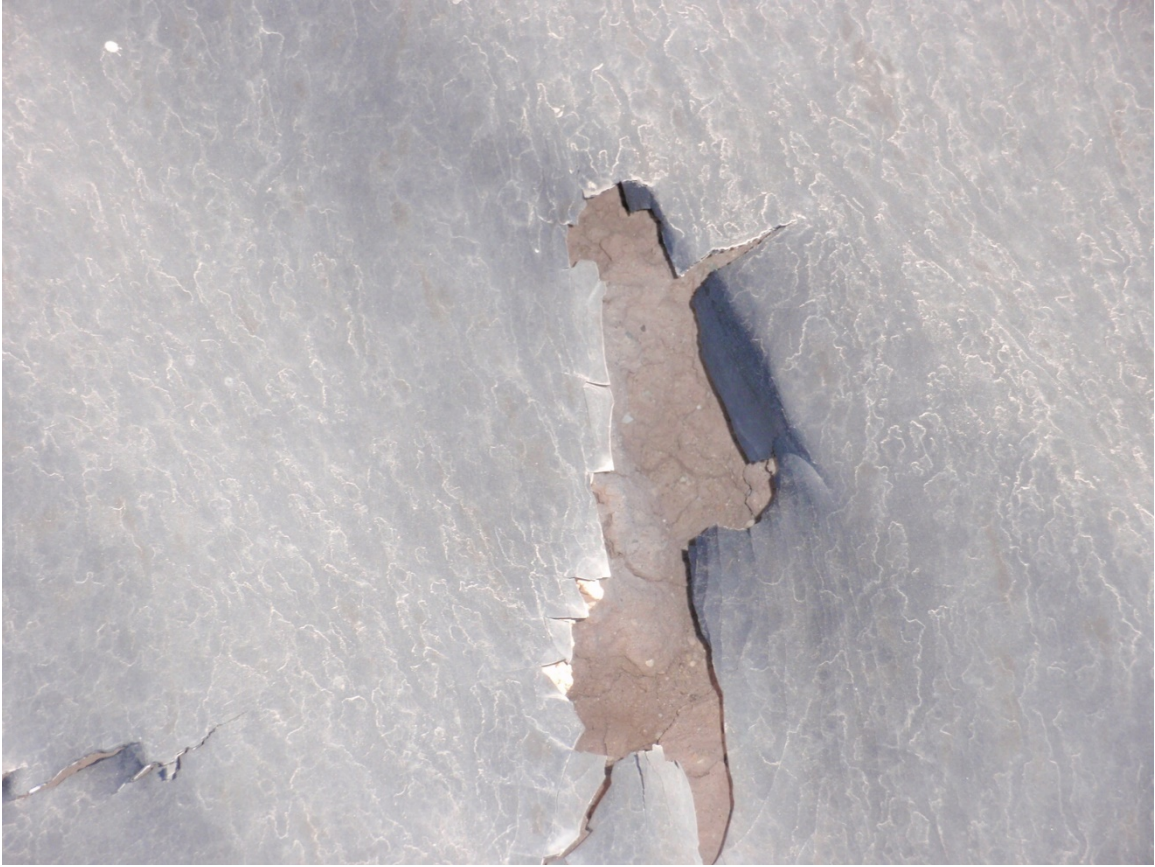
Photo 73. Damage to liner along north side of pit

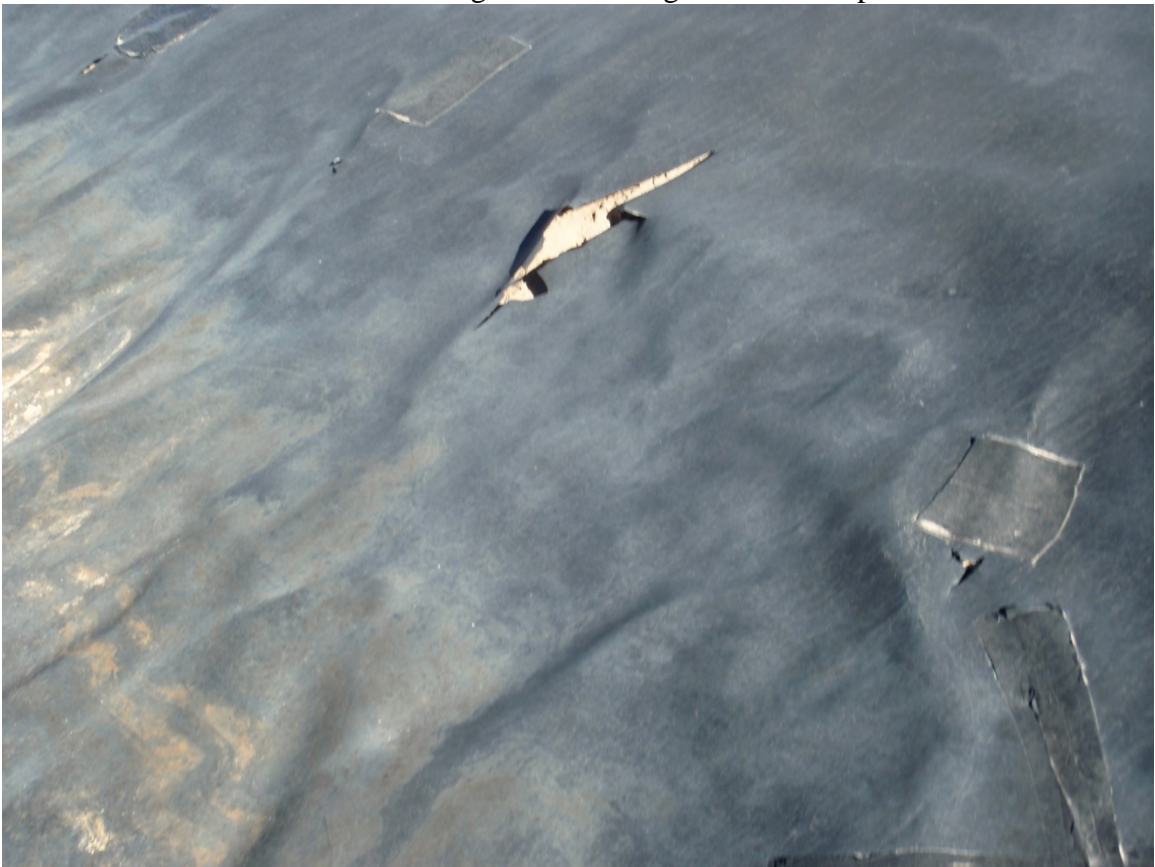
Photo 74. Damage to liner along north side of pit

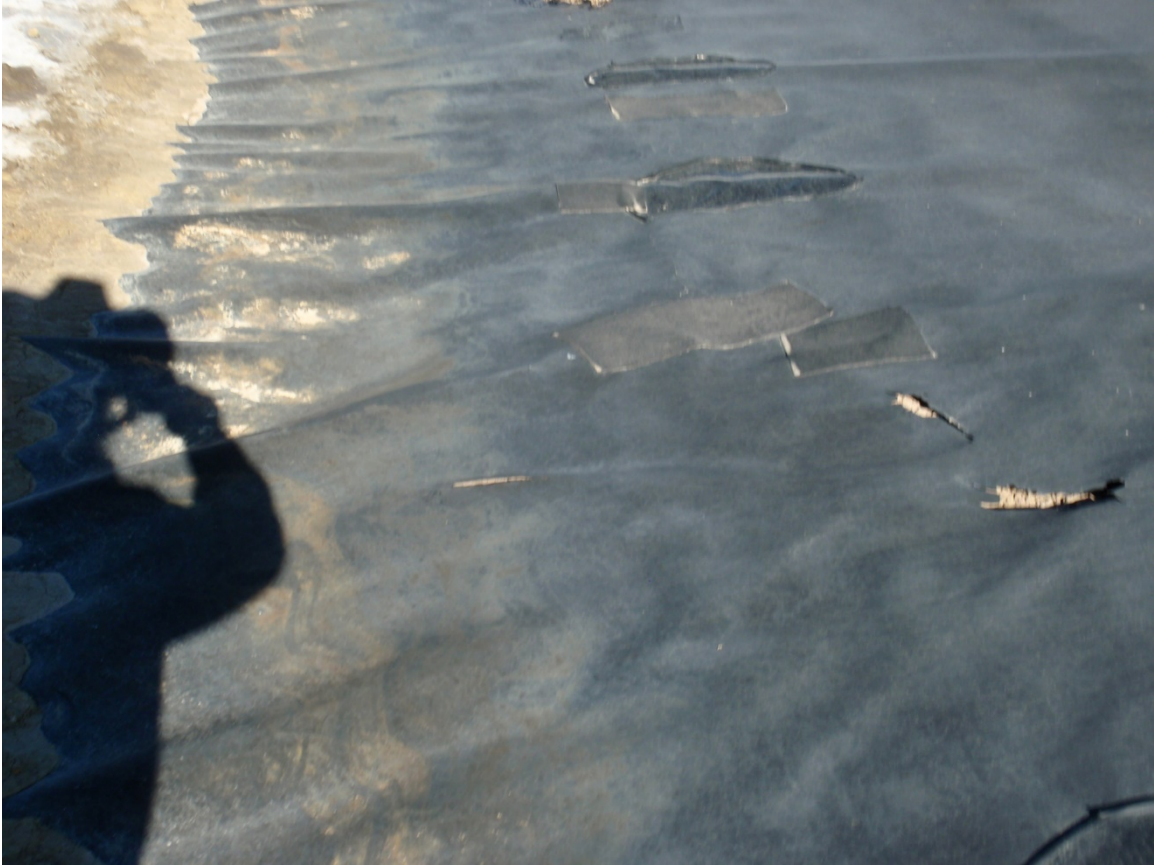
Photo 75. Damage to liner along north side of pit

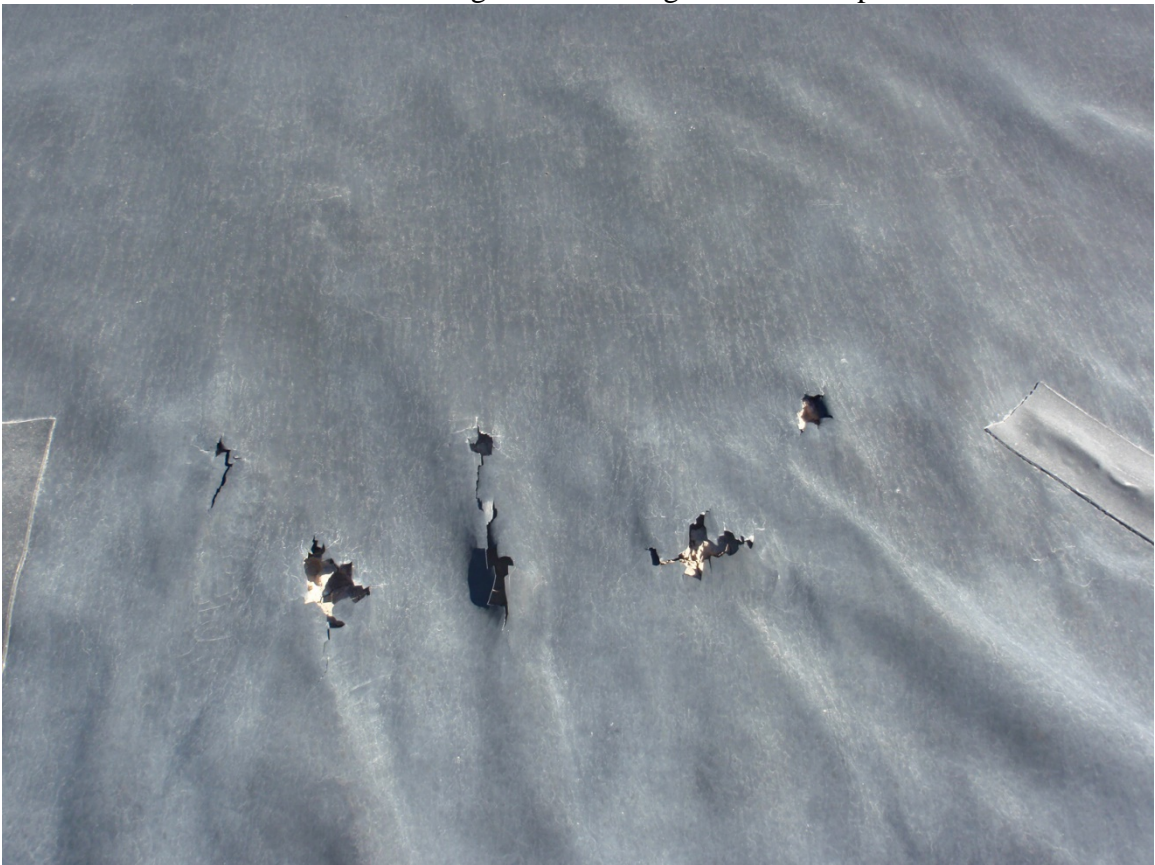
Photo 76. Damage to liner along north side of pit

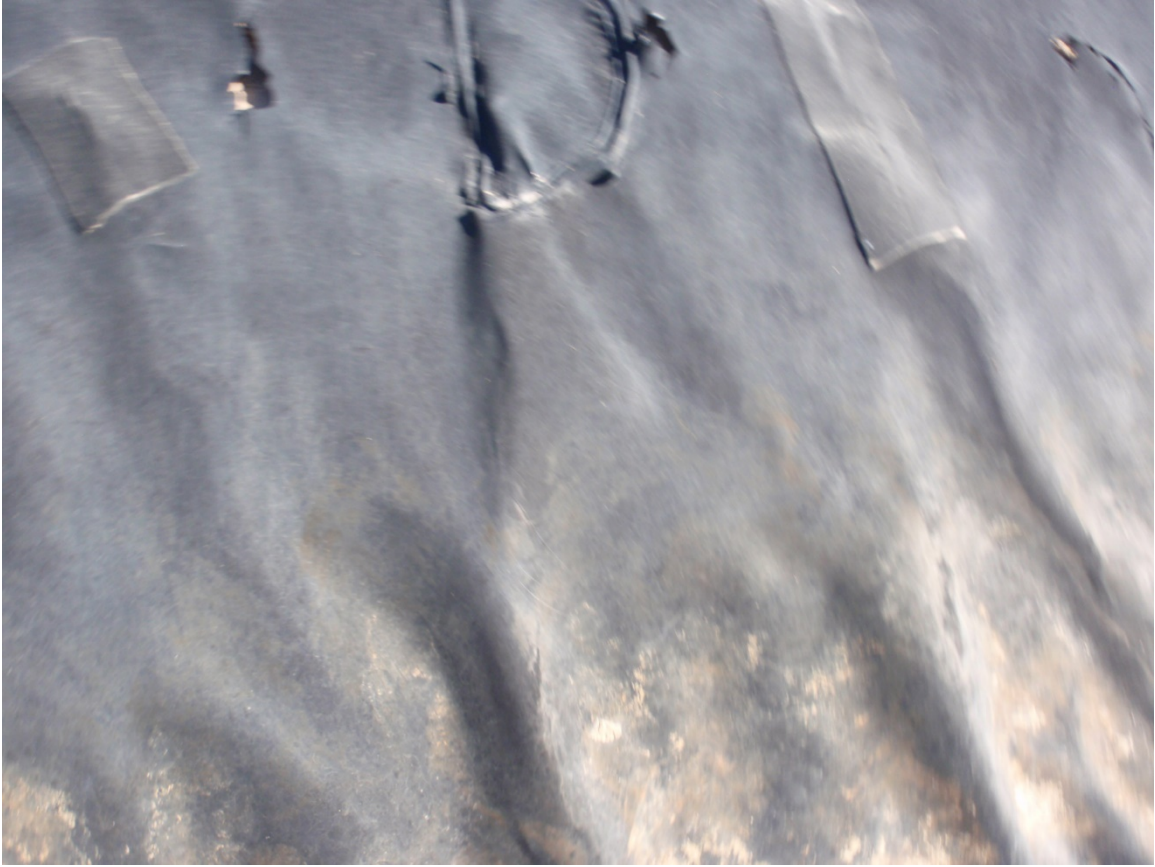
Photo 77. Damage to liner along north side of pit

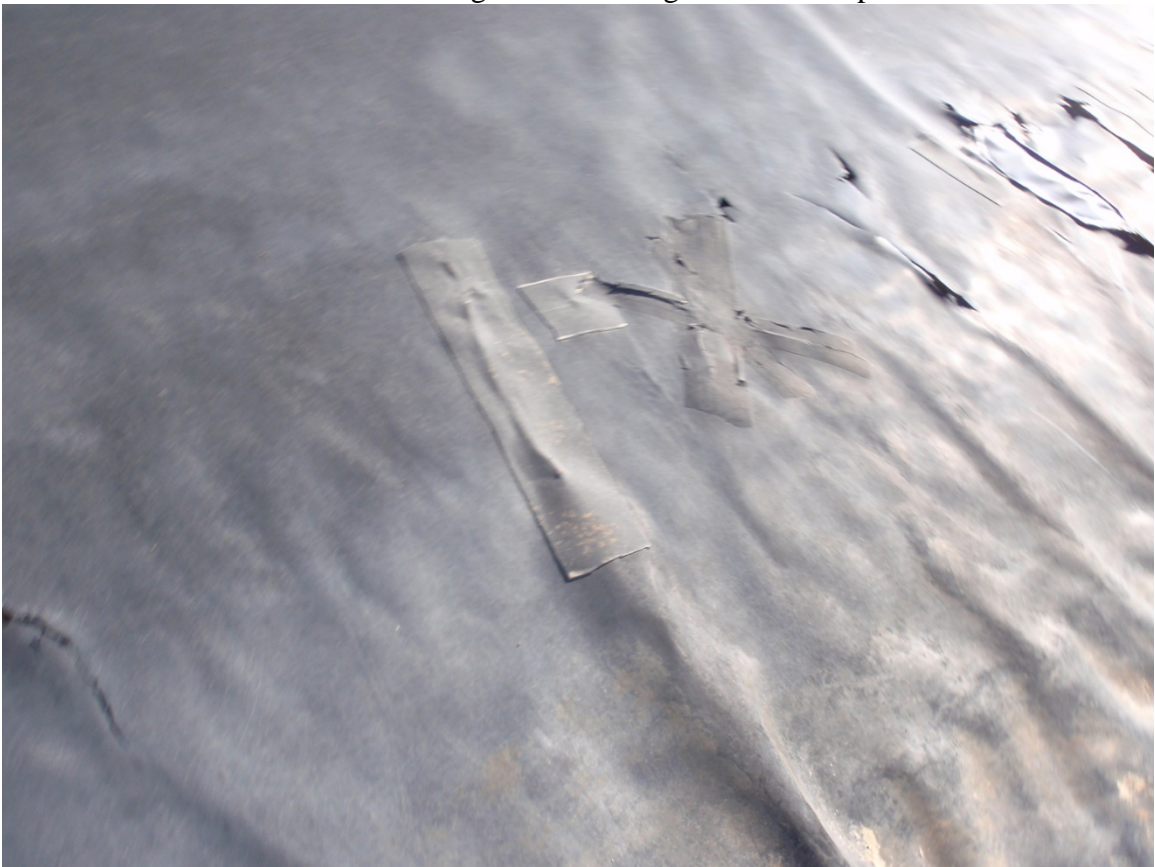
Photo 78. Damage to liner along north side of pit
