ROW Compliance Inspection		Case #: COC 61214 Holder: Maralex Disposal LLC	Project Name: Roan Creek Evaporation Pond
Twn: 8 S Rng: 98 W Sec 36: Qtr: NESE		County: Mesa County State: Colorado	
Inspection Date & Time: 9/27/2018 9:00am			
Inspector: Scott Hall		Office Time:	Total Time:
People/Affiliations at Inspection: COGCC		Steven Arauza	
Existing Conditions? 1.Construction, 2.Operation, 3.Reclamation; Disturbed Area Measurements; Facilities		Site was construction in the 1980's and was used until 2009. Pit has been in noncompliance since 2010 and has not been used since. The site is 285' by 505' and include a 24' x 245' access road and a 100' x 77' site for bioremediation of soils. Facilities include, pit, fence, 300 barrel tank with berm, and leak detection system.	
Conformance with ROW Terms & Conditions? Constructed to Specifications		ROW is not in compliance with the stipulations. ROW expired 8/30/2018.

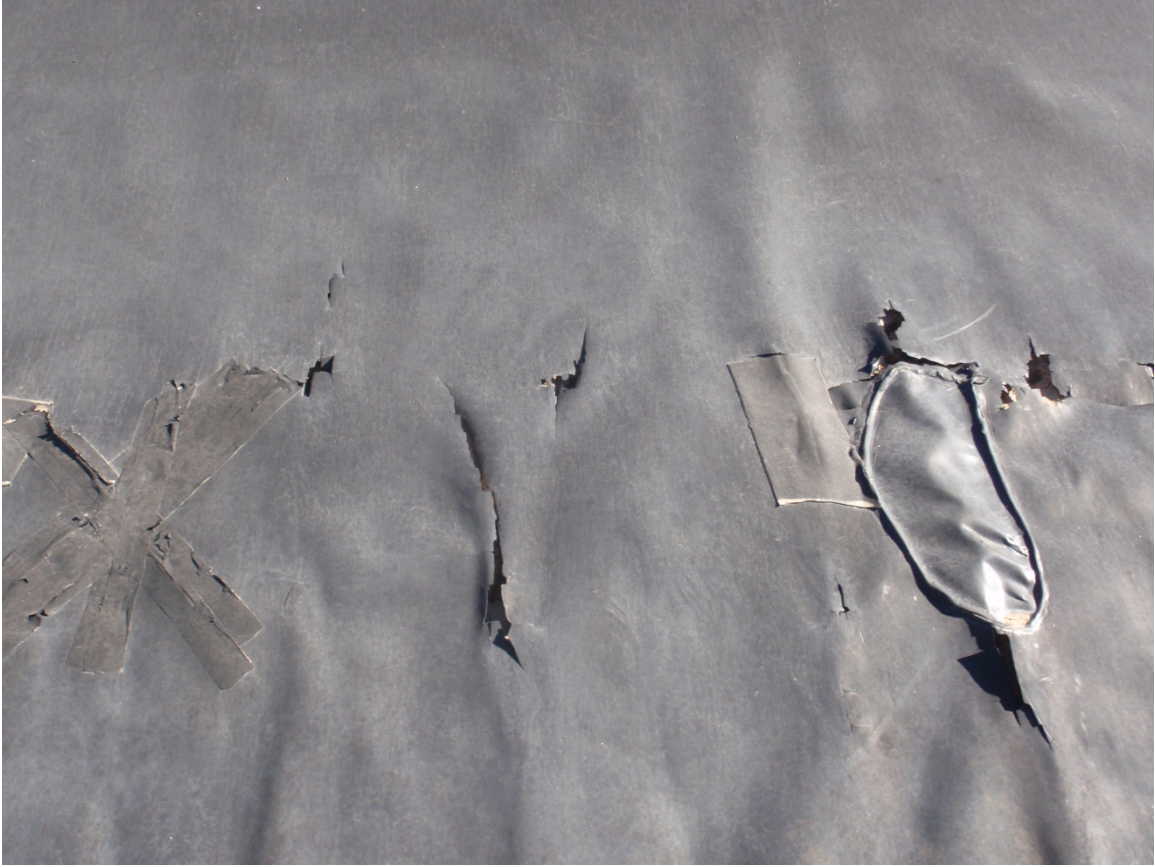
Photo 79. Damage to liner along north side of pit

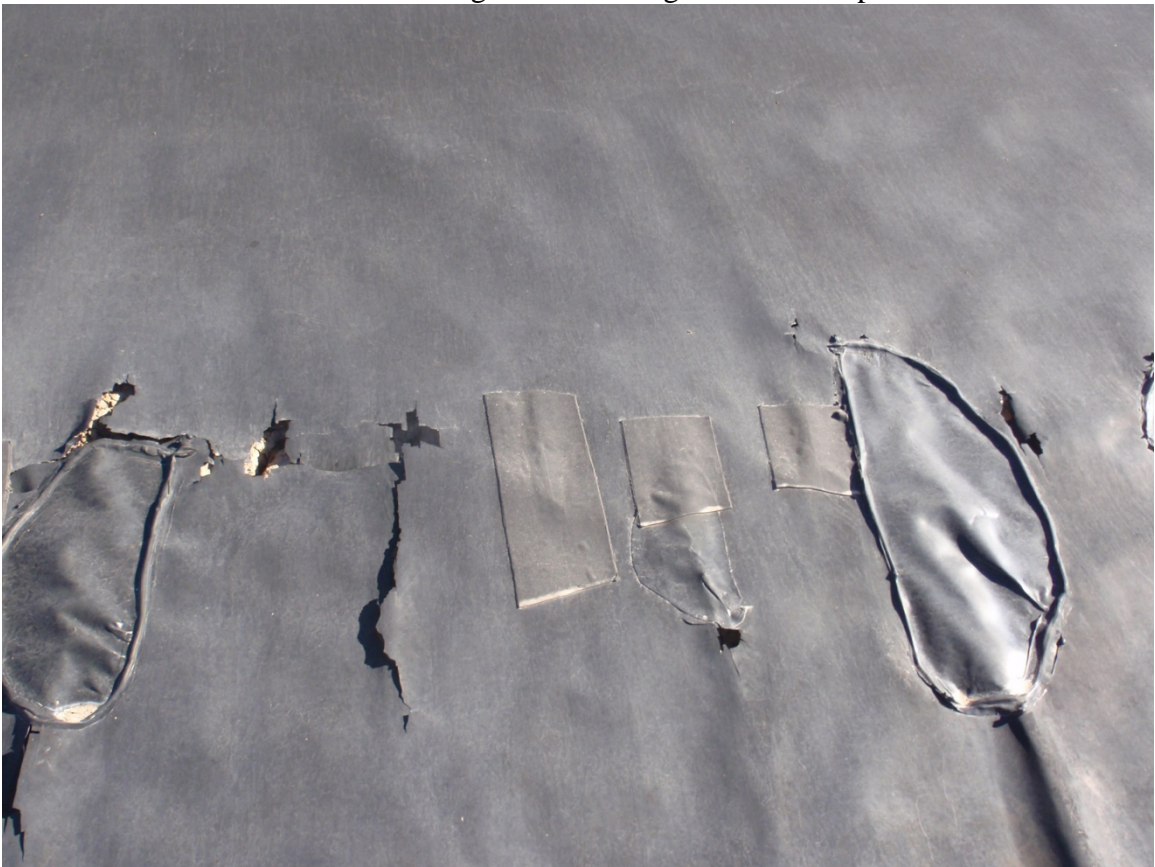
Photo 80. Damage to liner along north side of pit

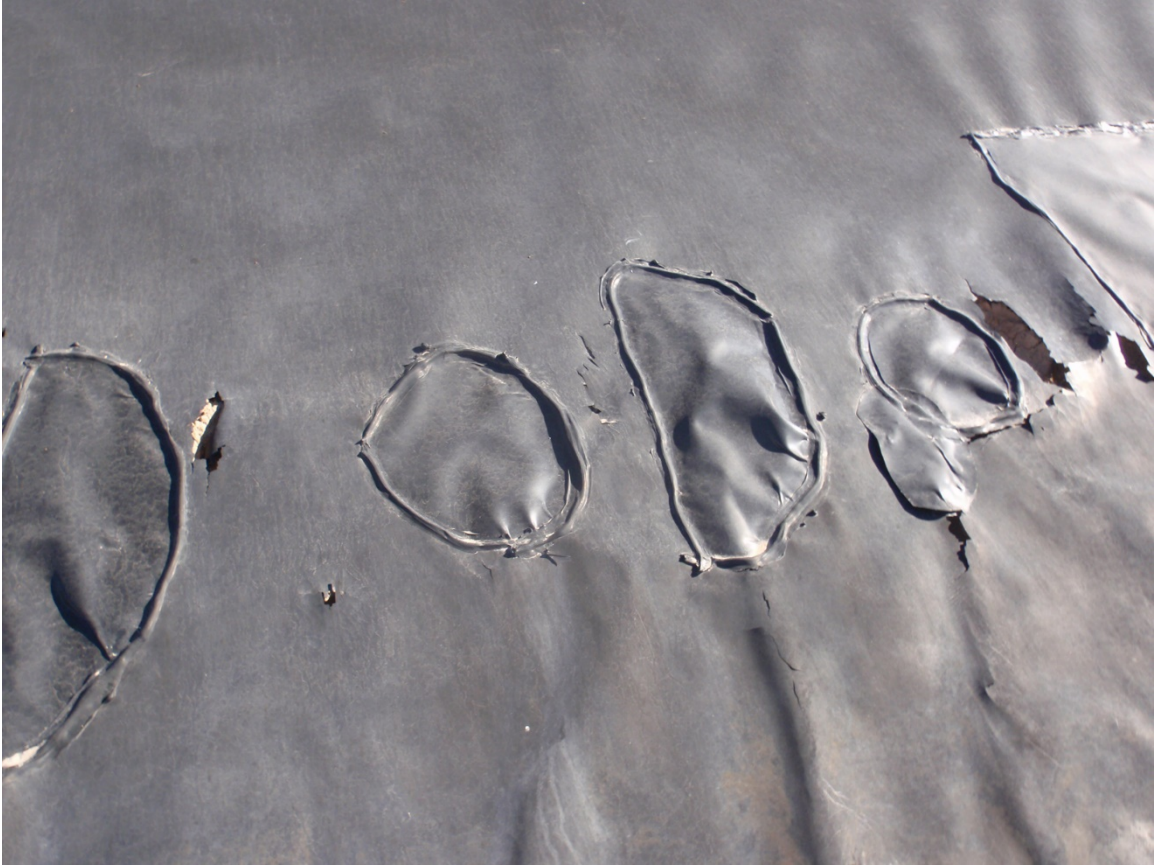
Photo 80. Damage to liner along north side of pit

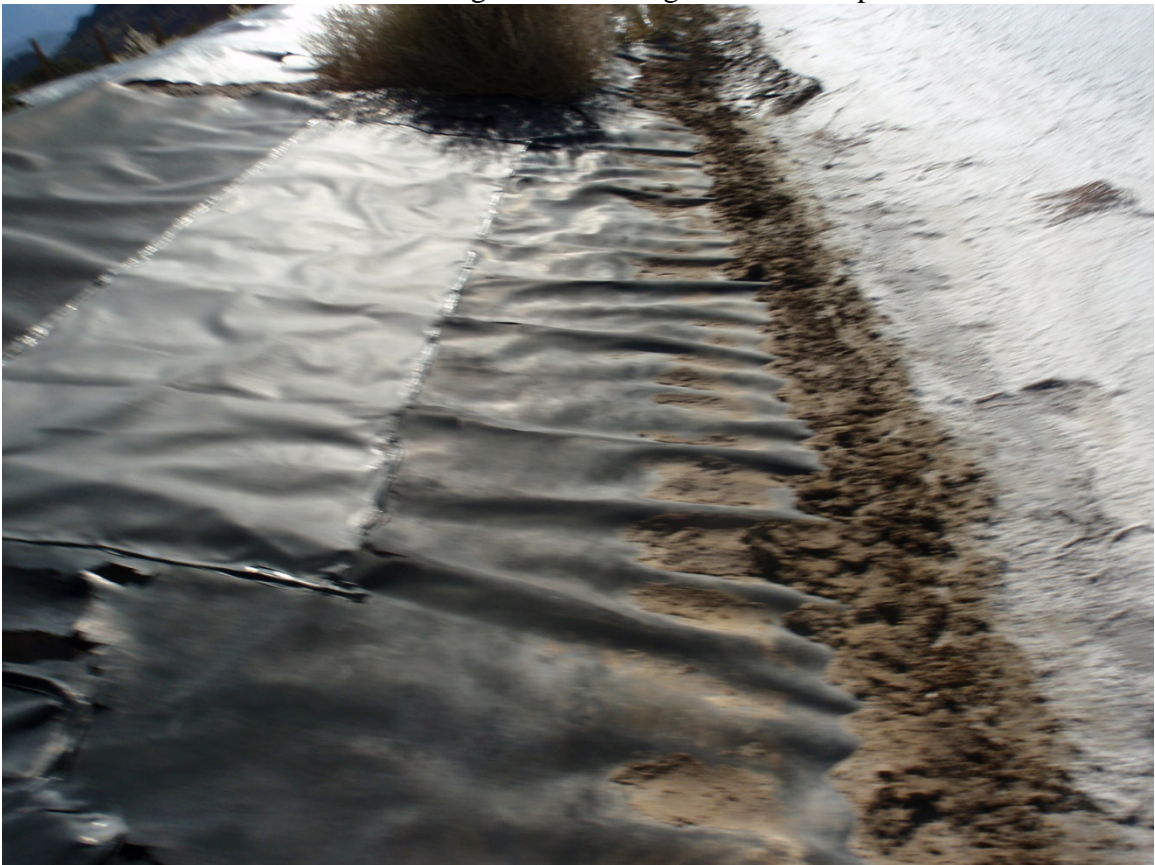
Photo 81. Damage to liner along north side of pit, accumulation of sediment in pit.

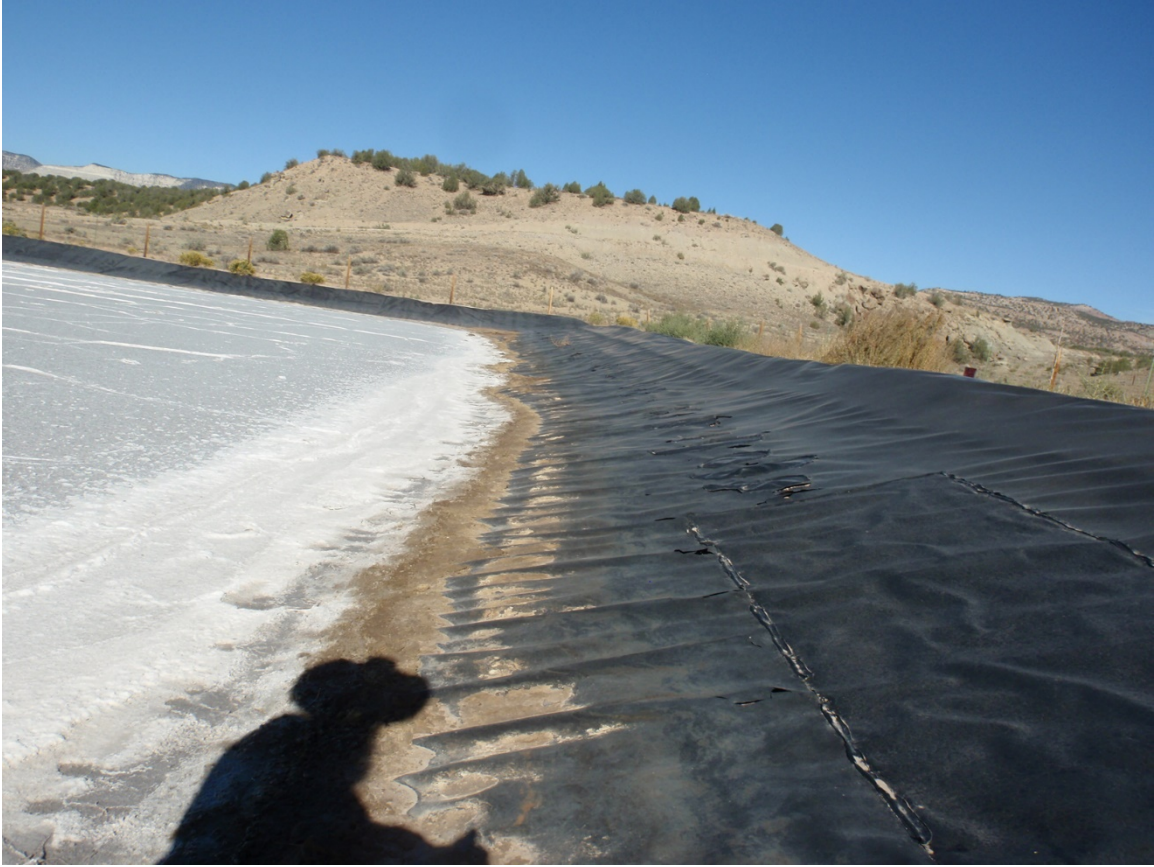
Photo 82. Damage to liner along north side of pit, accumulation of sediment in pit

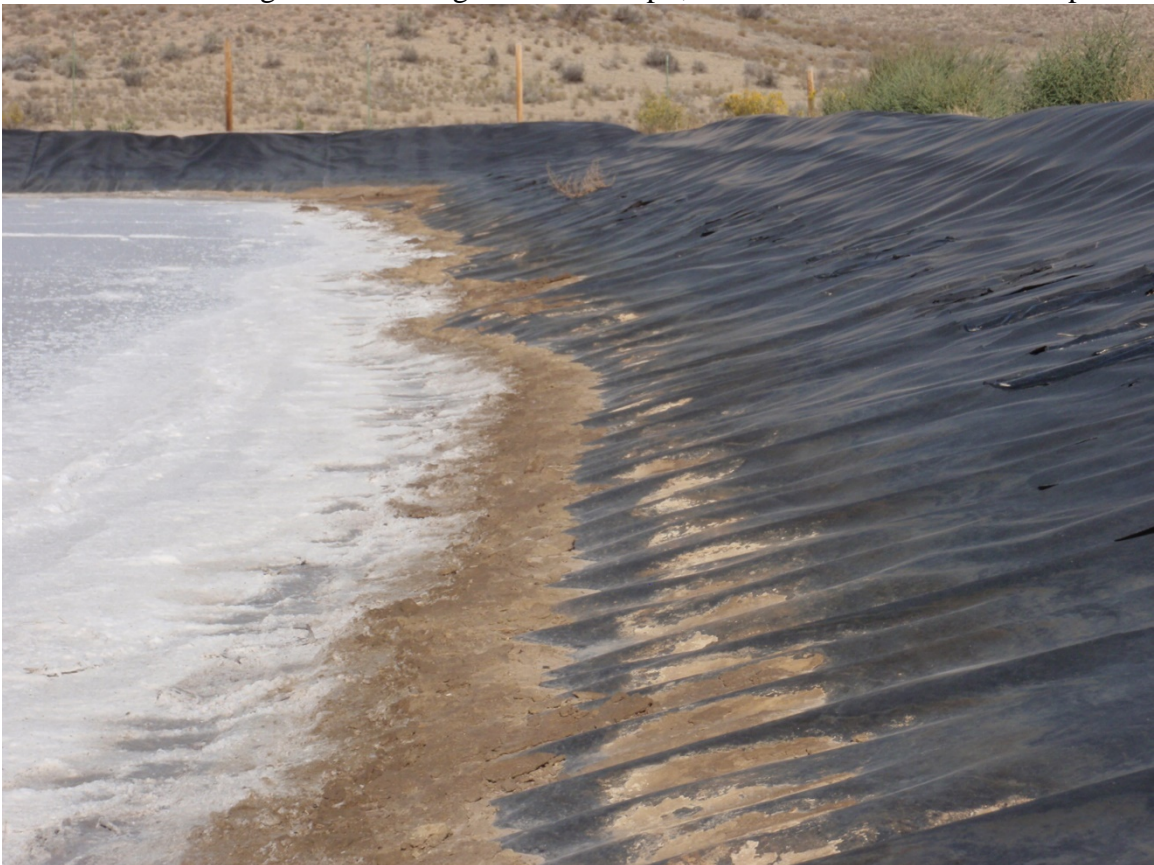
Photo 83. Damage to liner along north side of pit, accumulation of sediment in pit

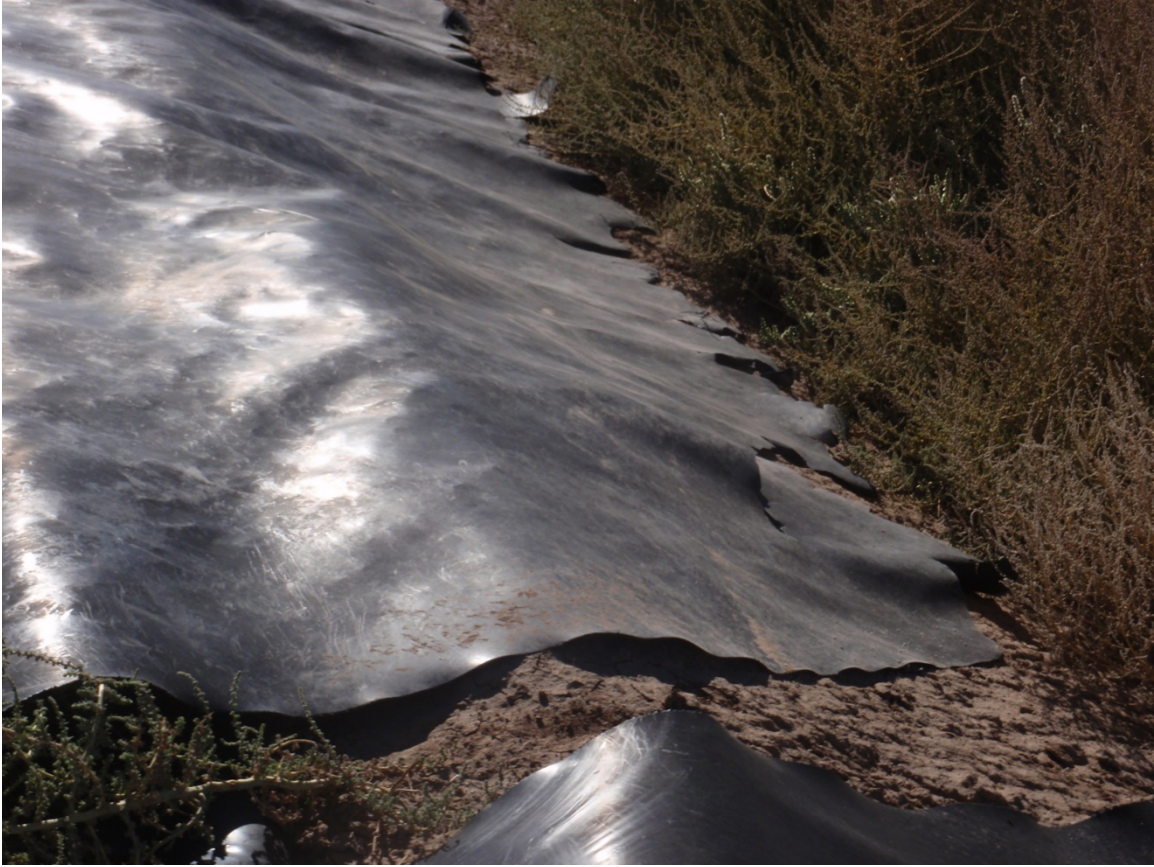
Photo 84. Large tear in liner at northeast side of pit.

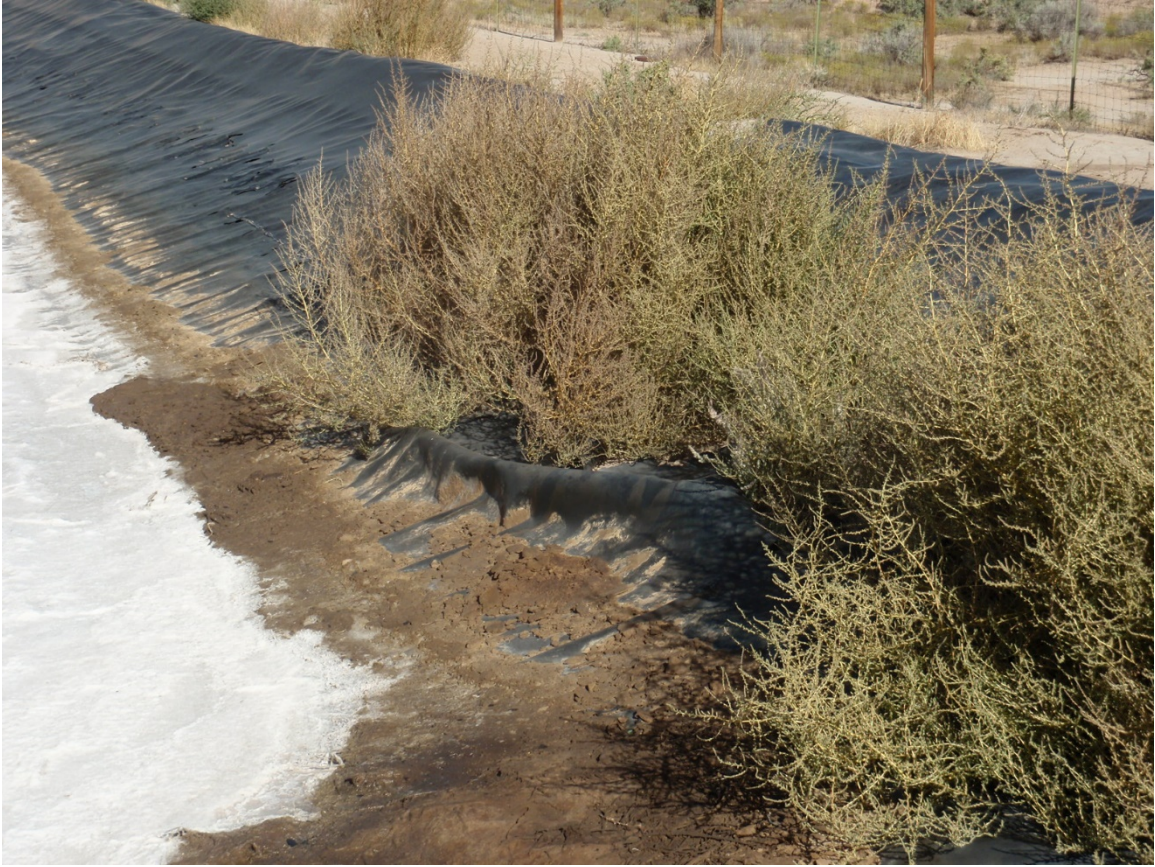
Photo 88. Large tear in liner at northeast side of pit

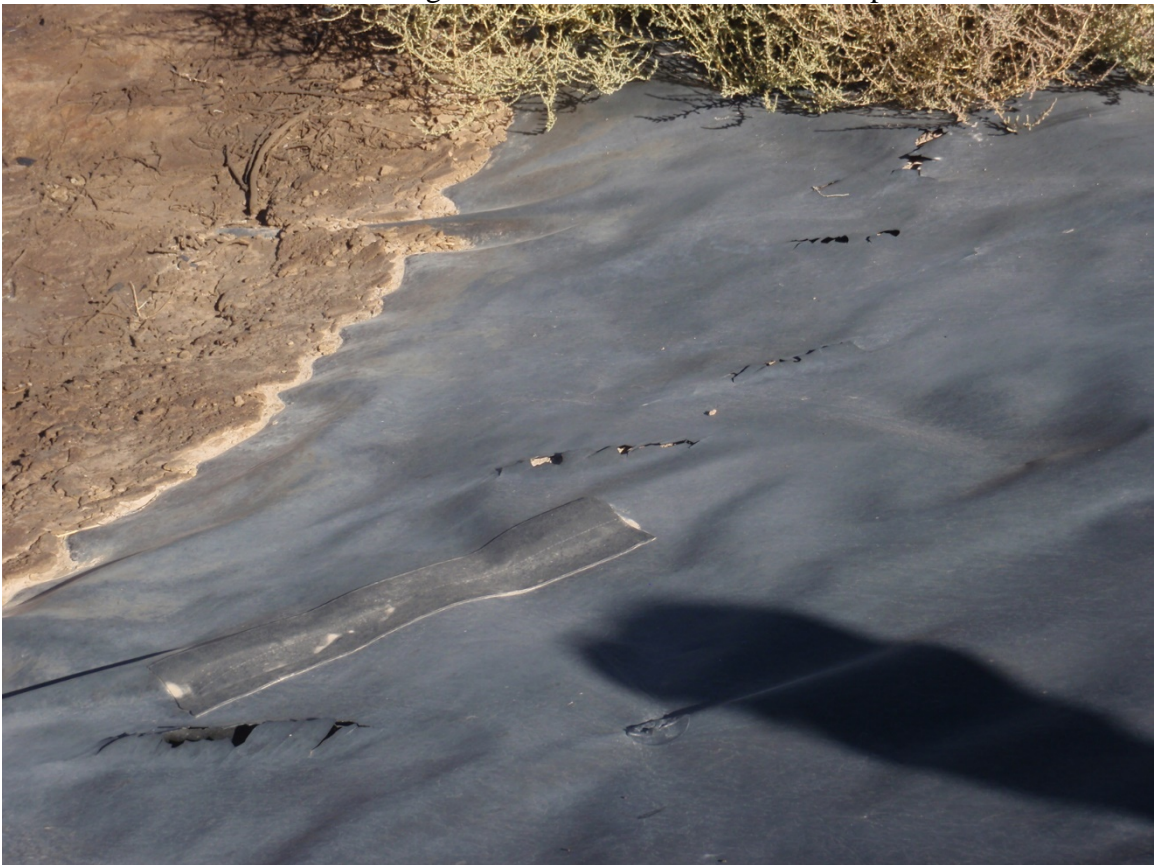
Photo 89. Damage to liner at northeast corner of pit.

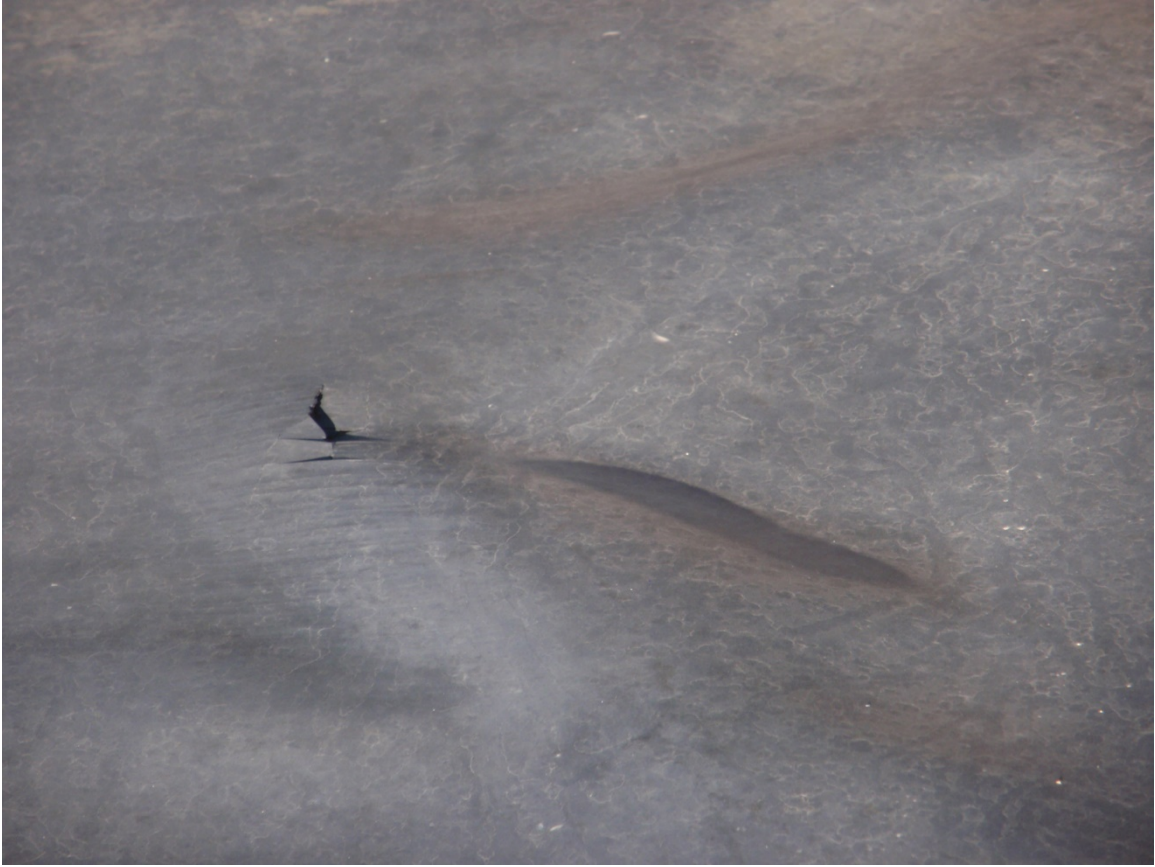
Photo 90. Damage to liner at northeast corner of pit.

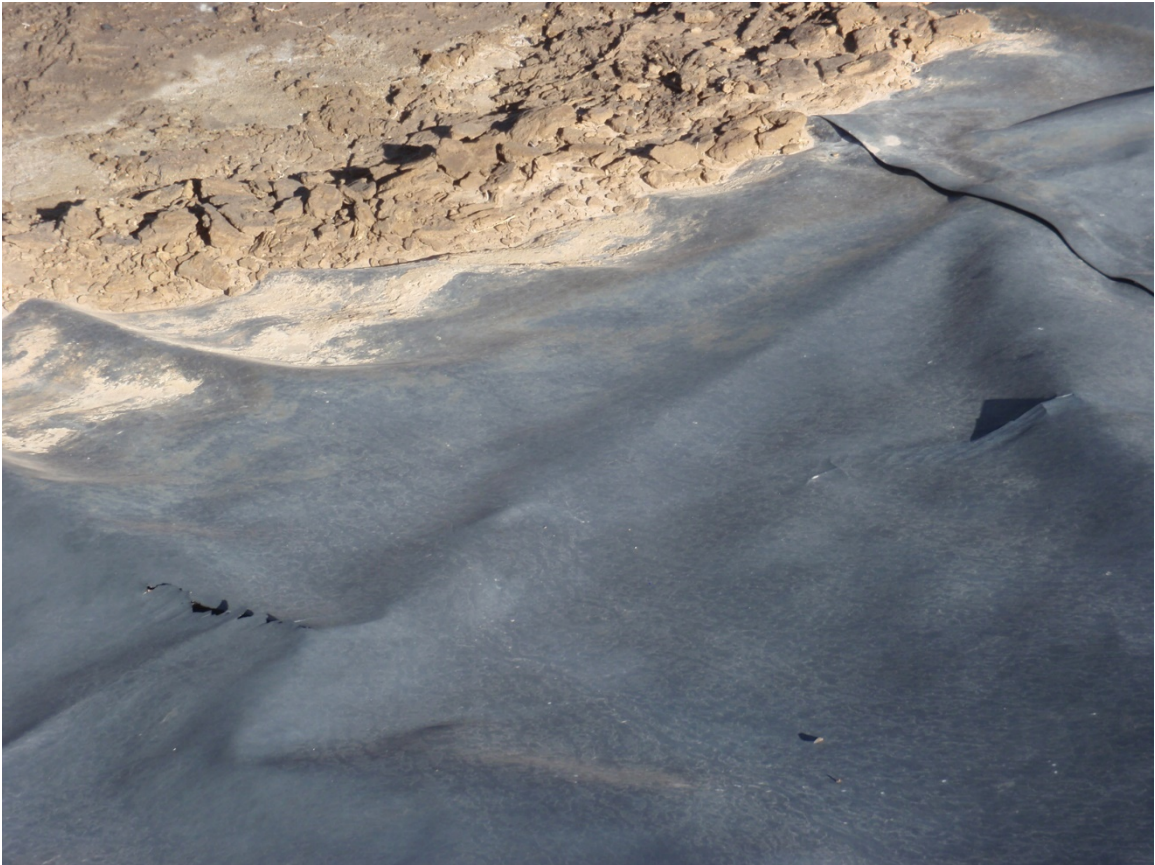
Photo 91. Damage to liner at northeast corner of pit.

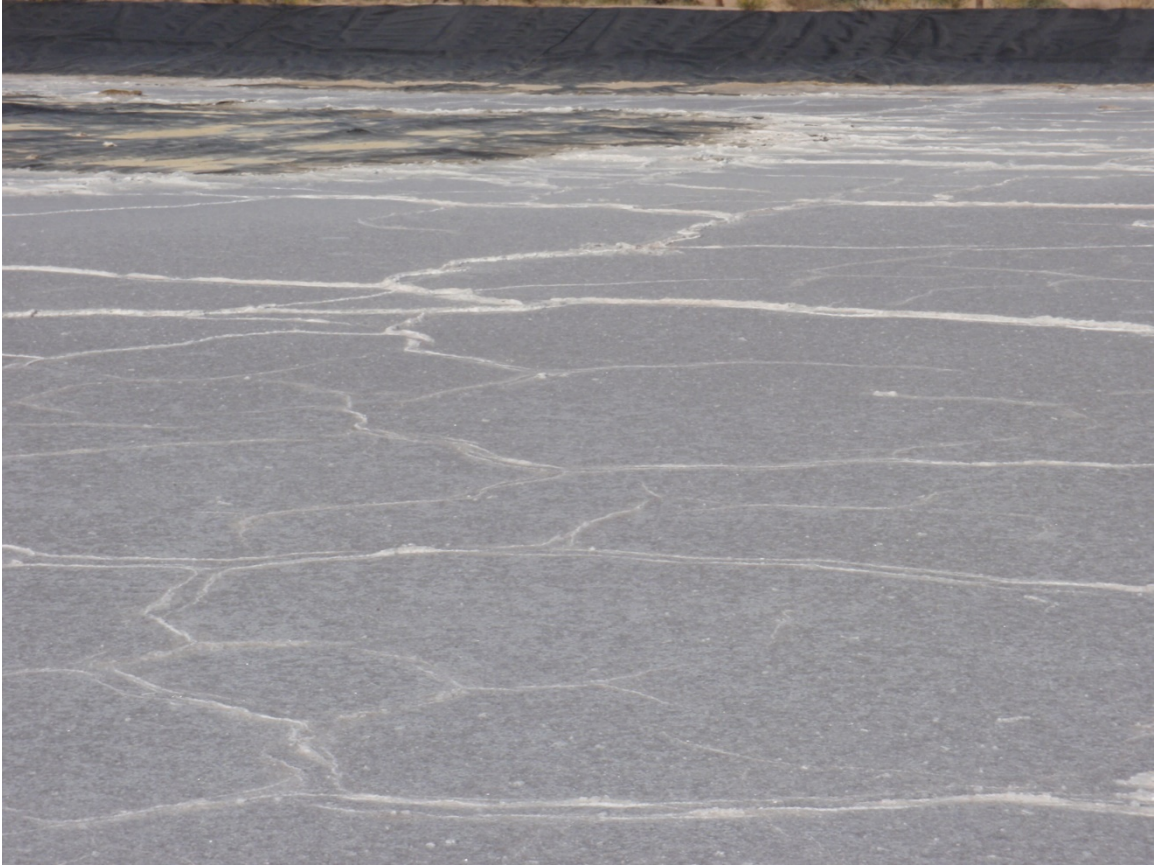
Photo 94. Accumulation of salts in pit

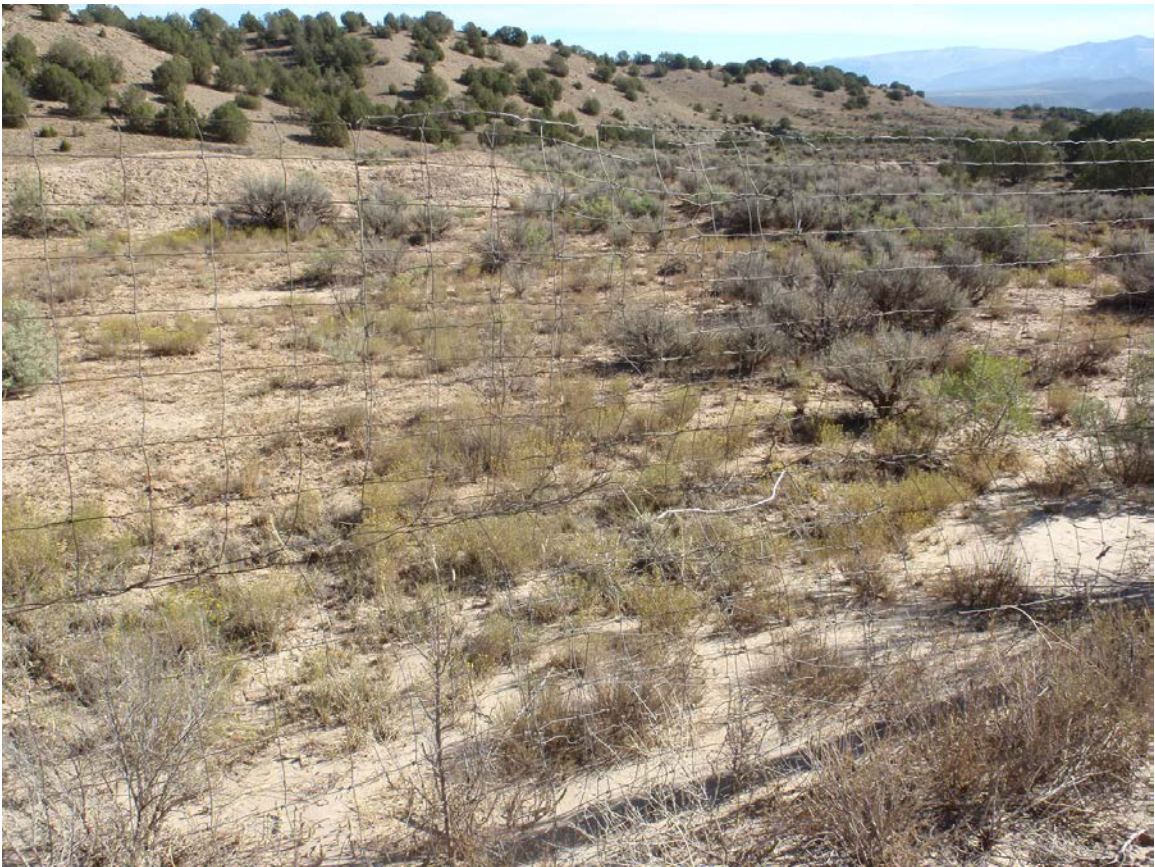
Photo 95. Repair to fence along north side of facility.

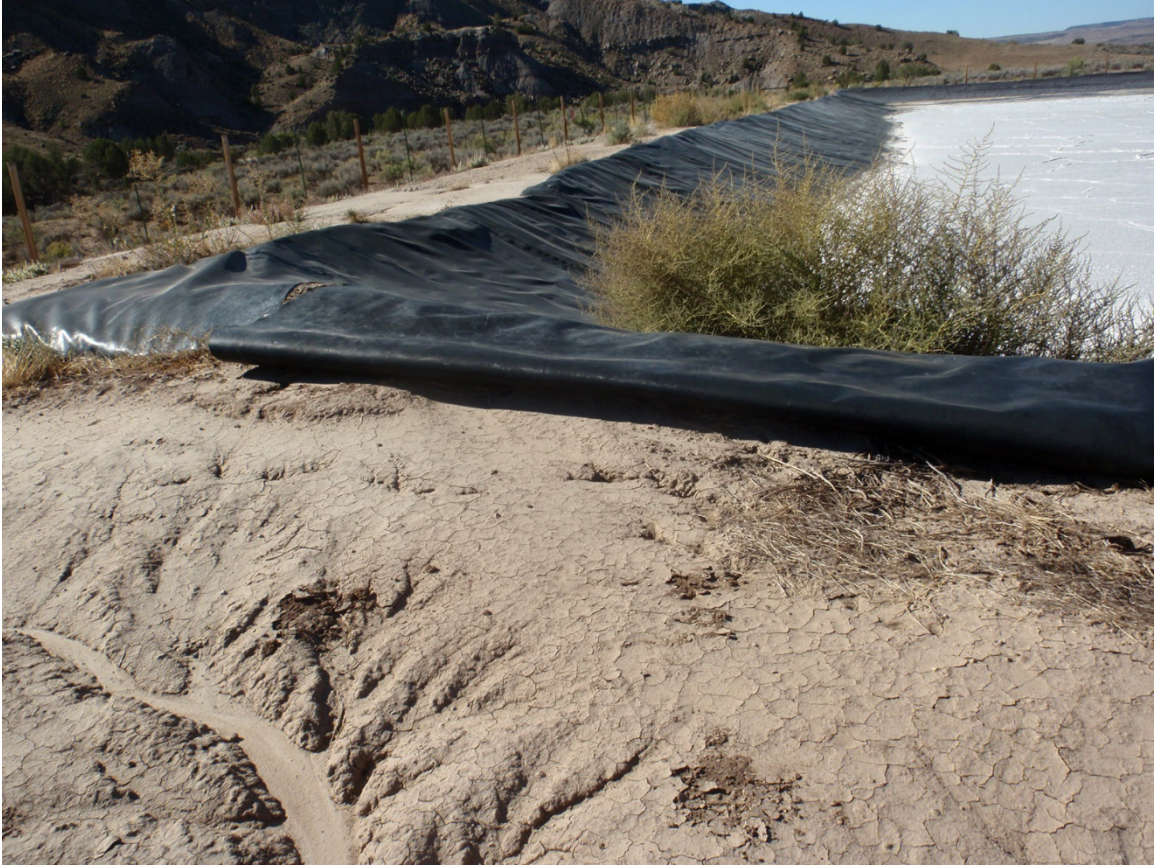
Photo 96. Damage to liner and erosion issues at northeast corner of pit.

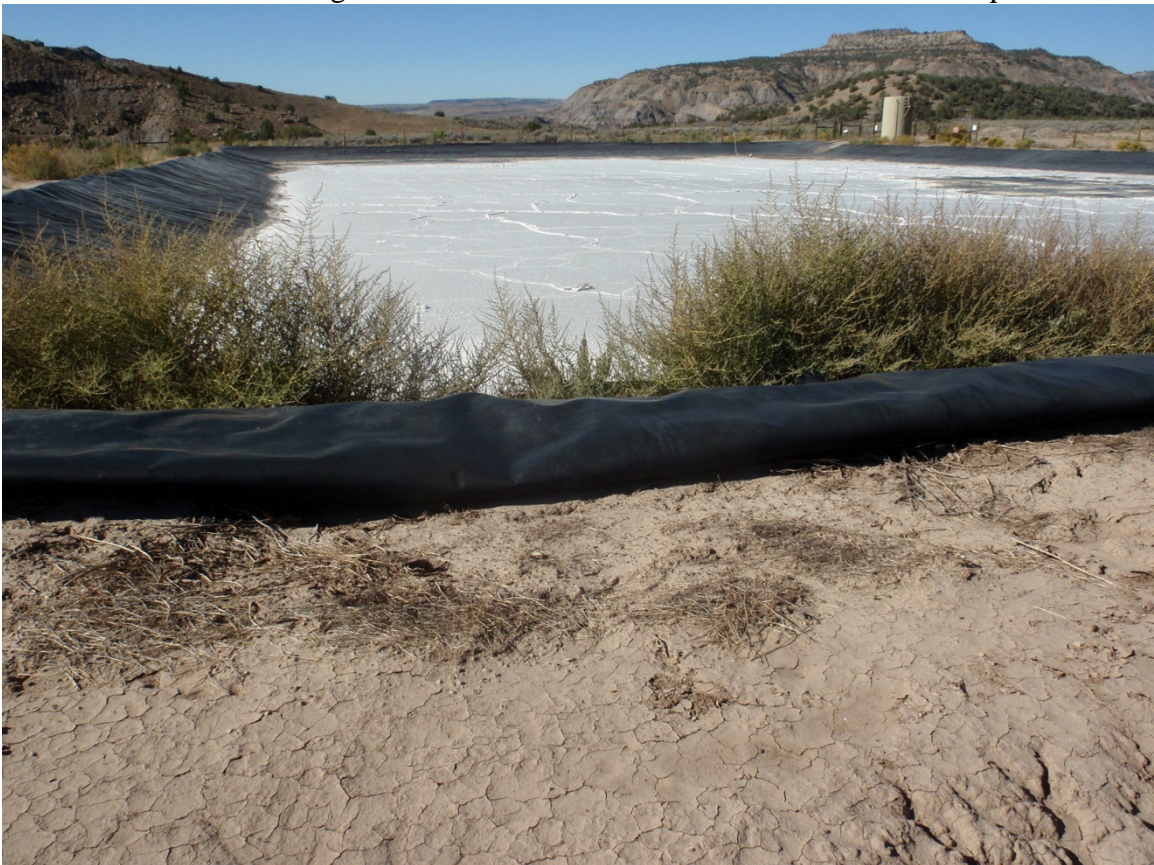
Photo 97. Damage to liner at northeast corner of the pit

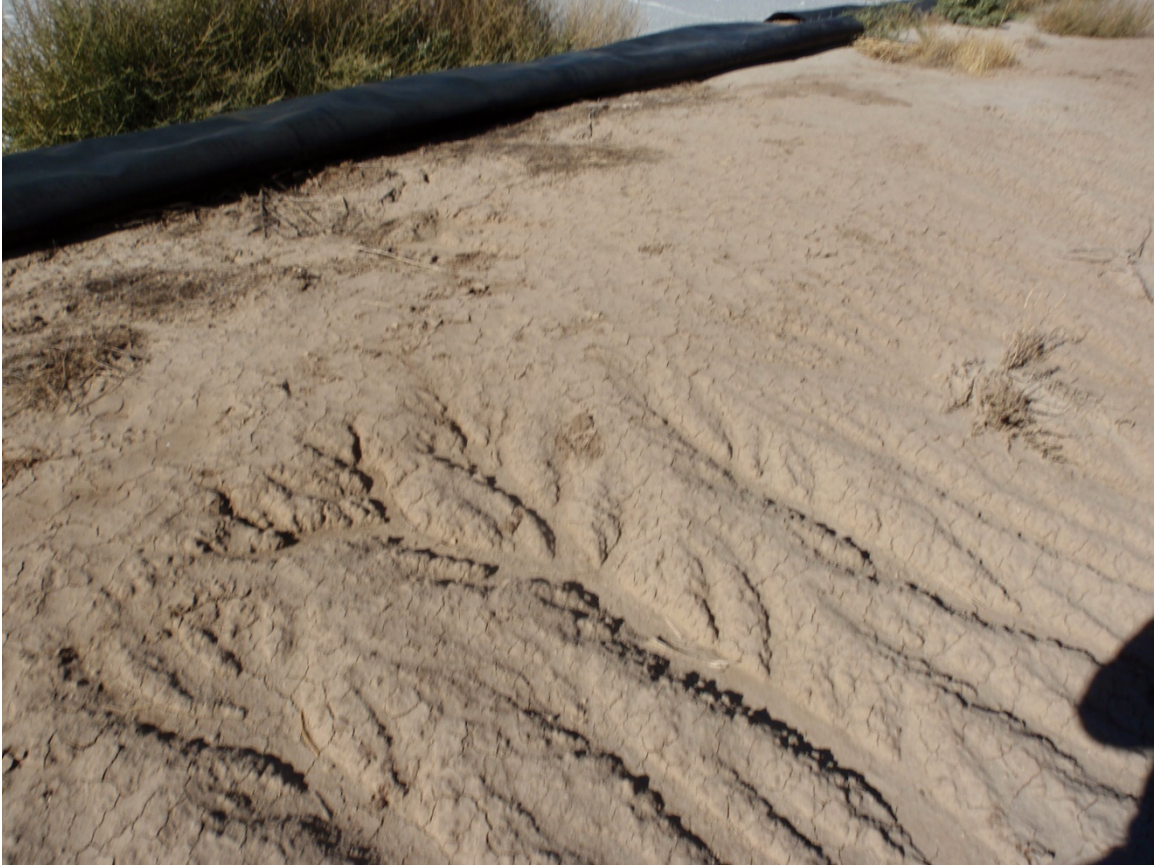
Photo 98. Damage to liner and erosion issues at northeast corner of pit.

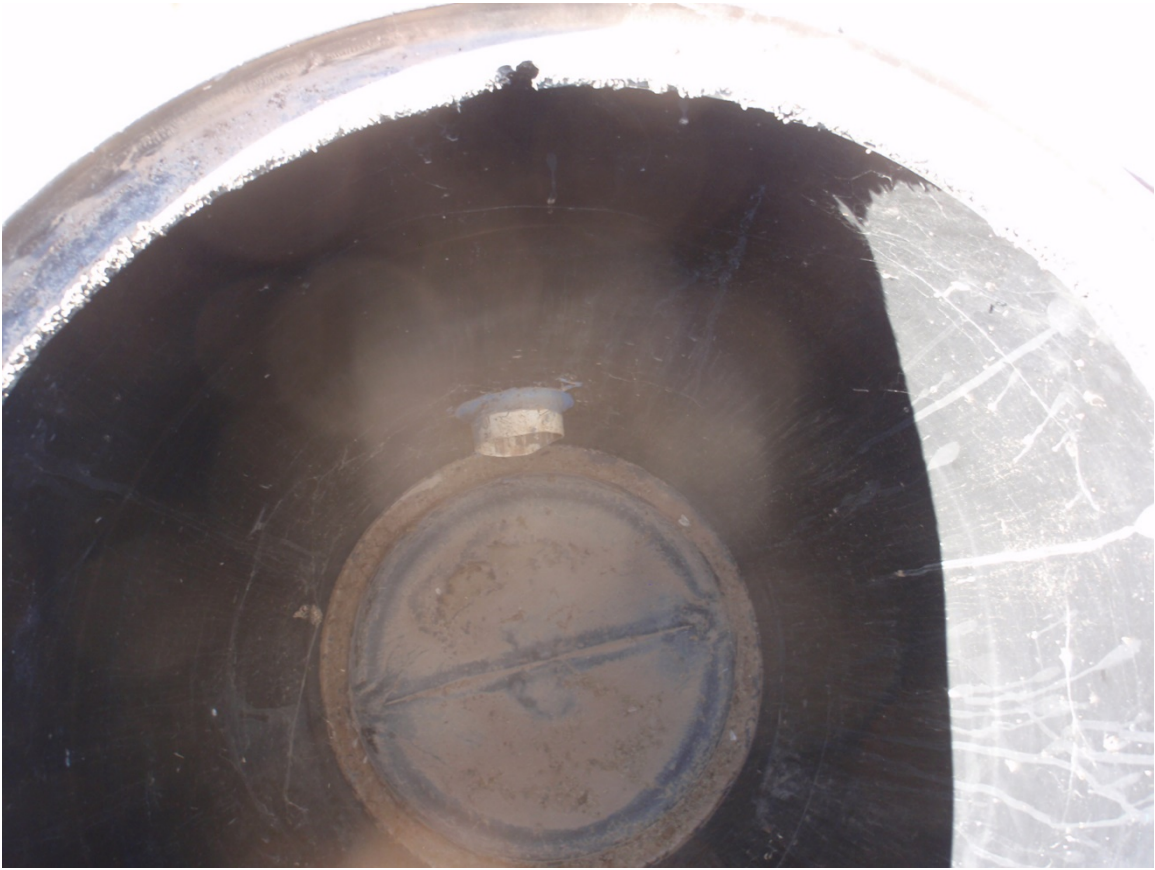
Photo 100. Leak detection system, no water present

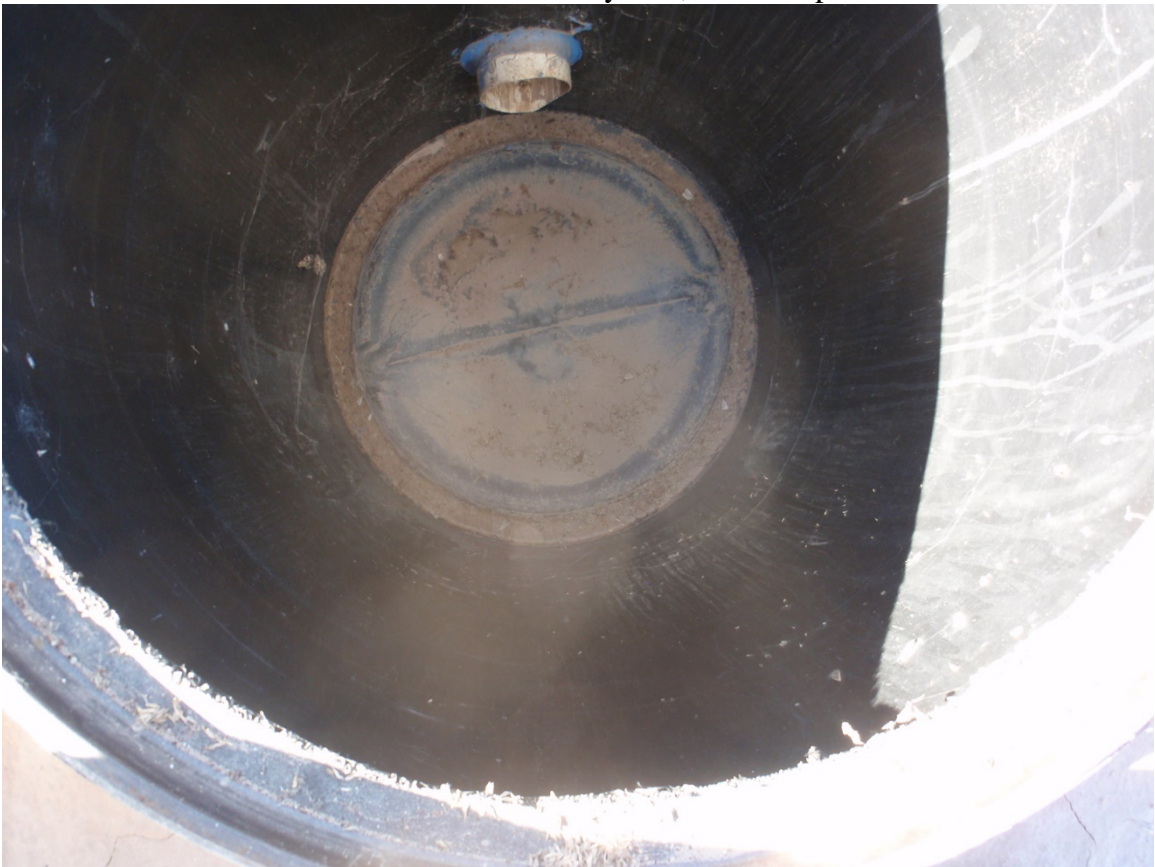
Photo 101. Leak detection system, no water present

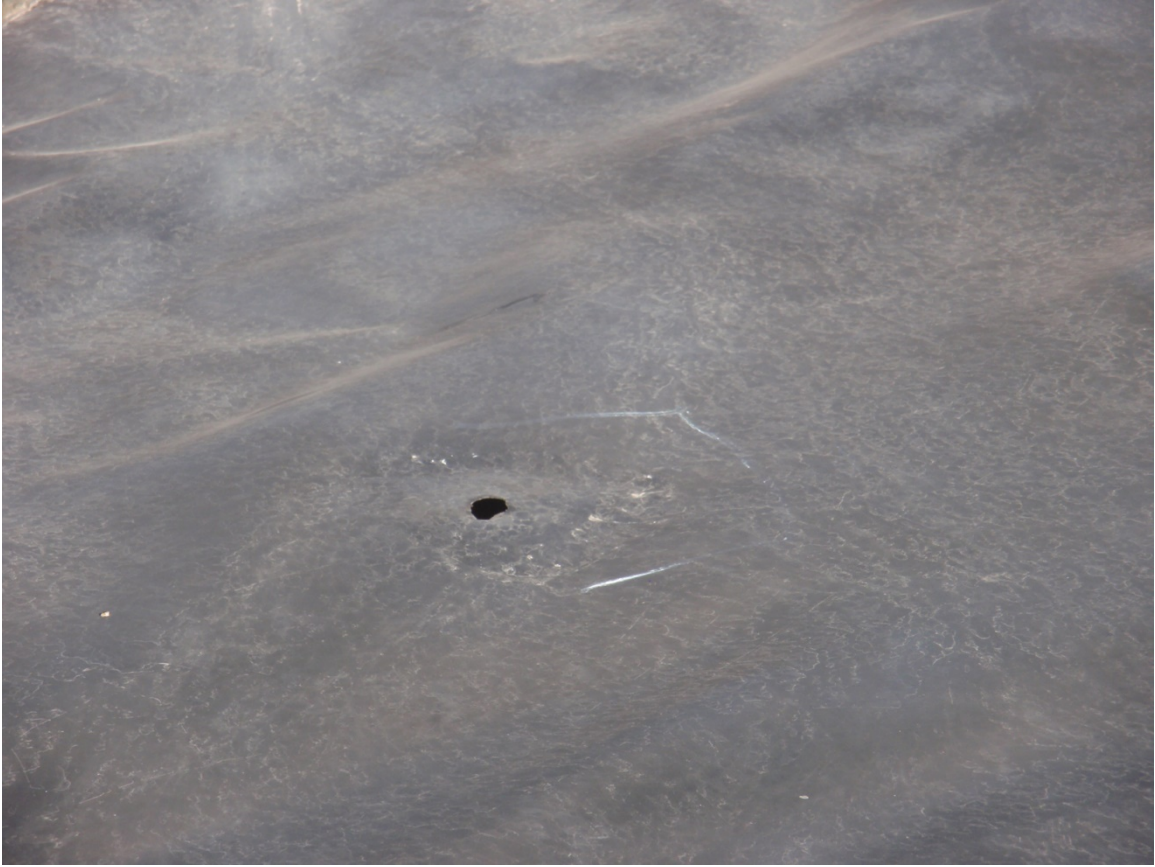
Photo 104. Small hole in liner on east side of pit

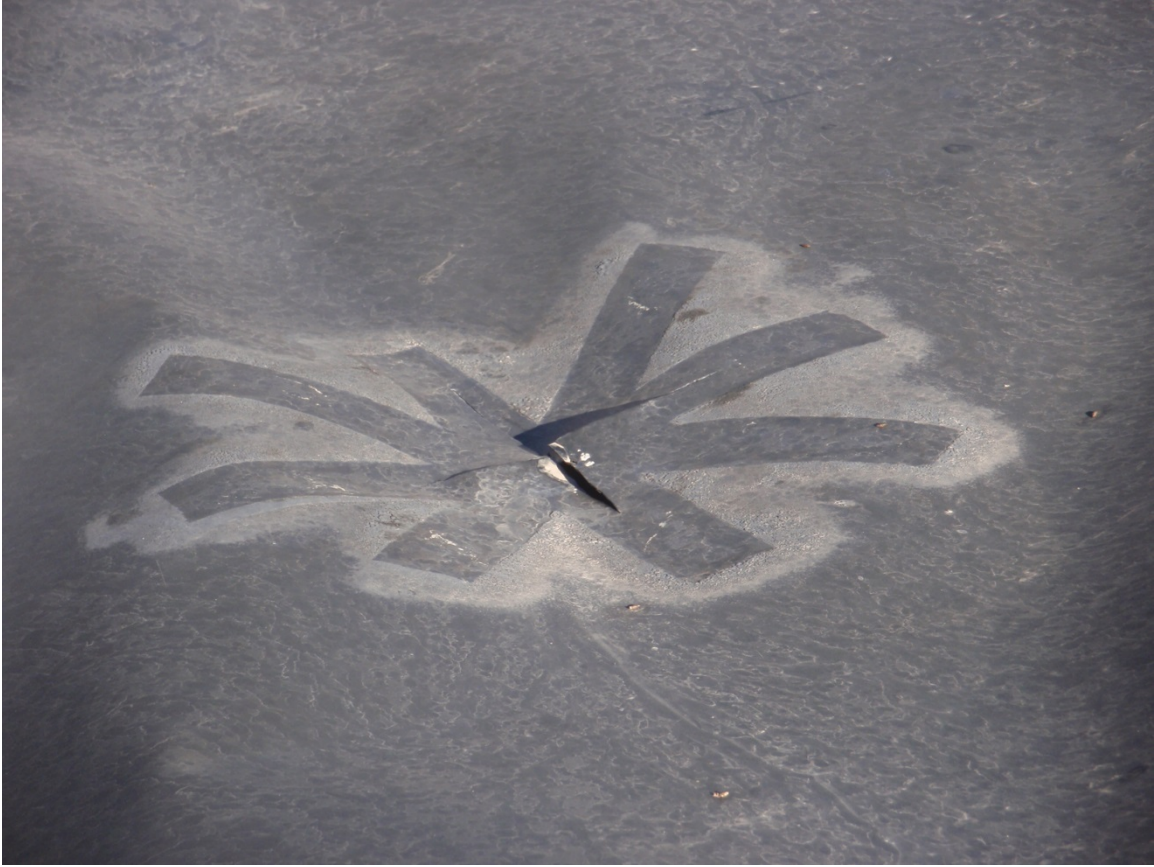
Photo 106. Damage to patch in liner near southeast corner

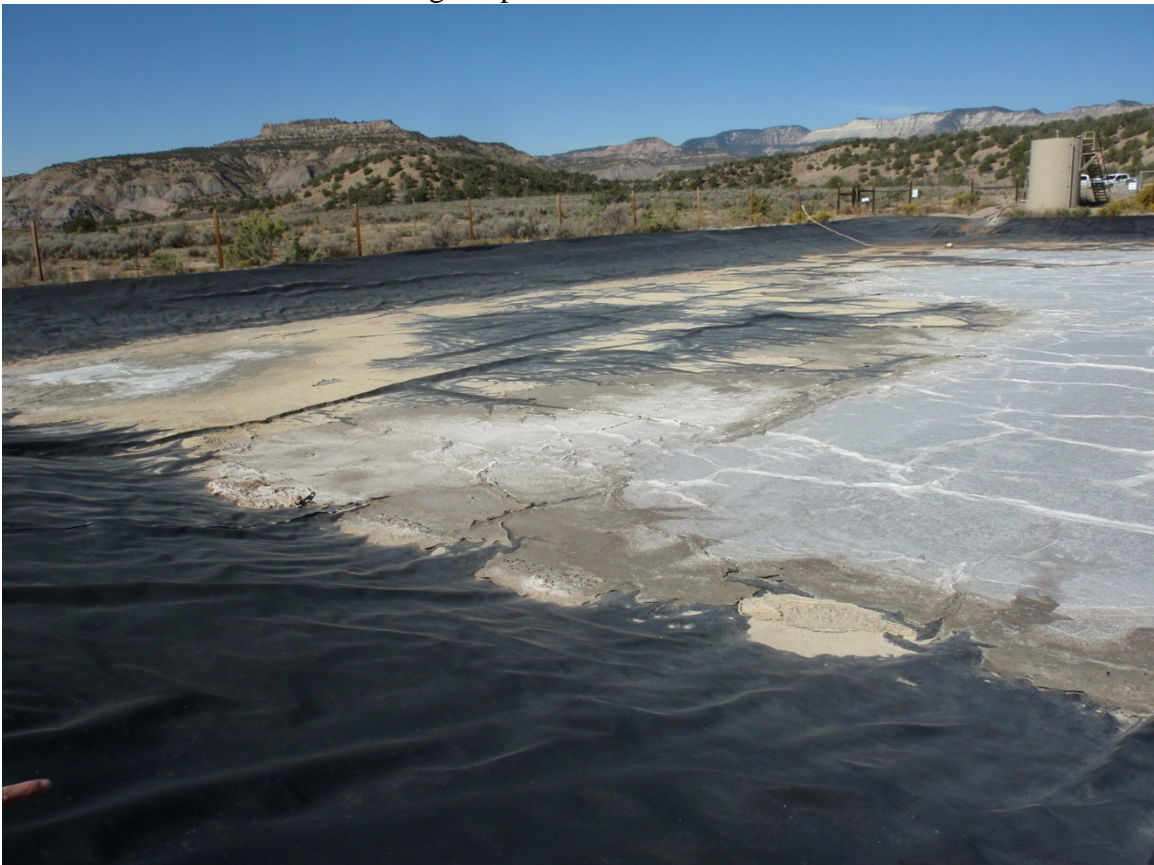
Photo 107. Sediment accumulating in pit possibly from berm erosion

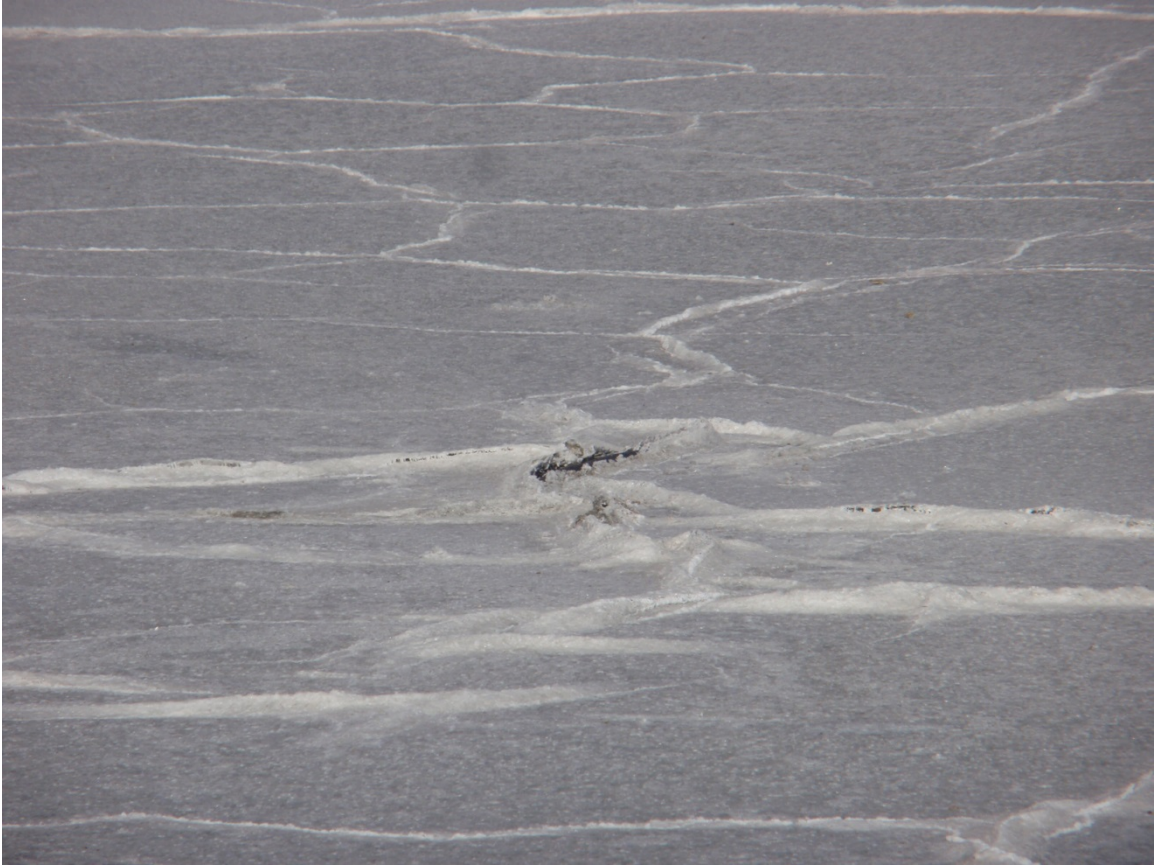
Photo 108. Accumulation of salts in pit
