Inspection Photos
Location Name: Thomson Price #2
Location ID: 320156

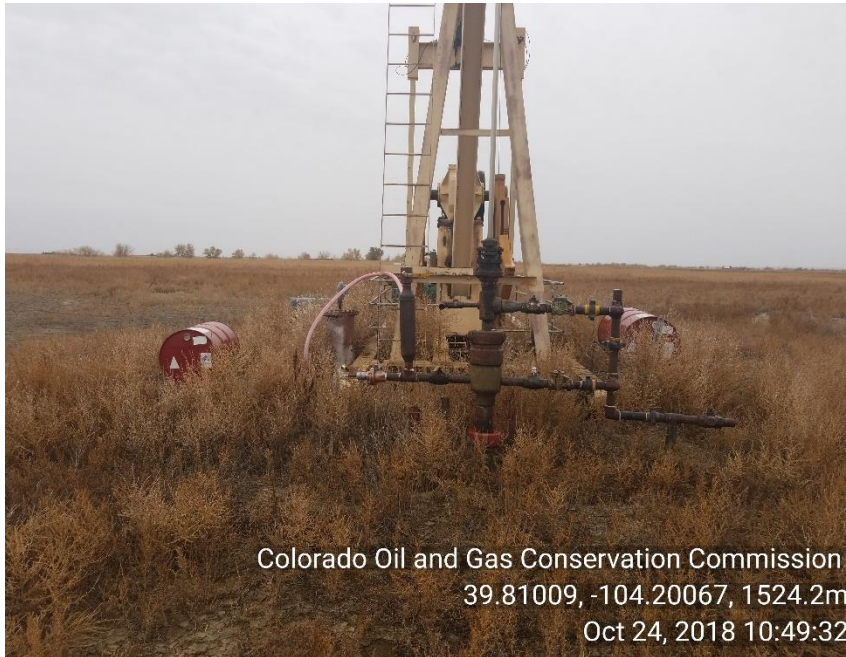
Photo 1 WH no Sign

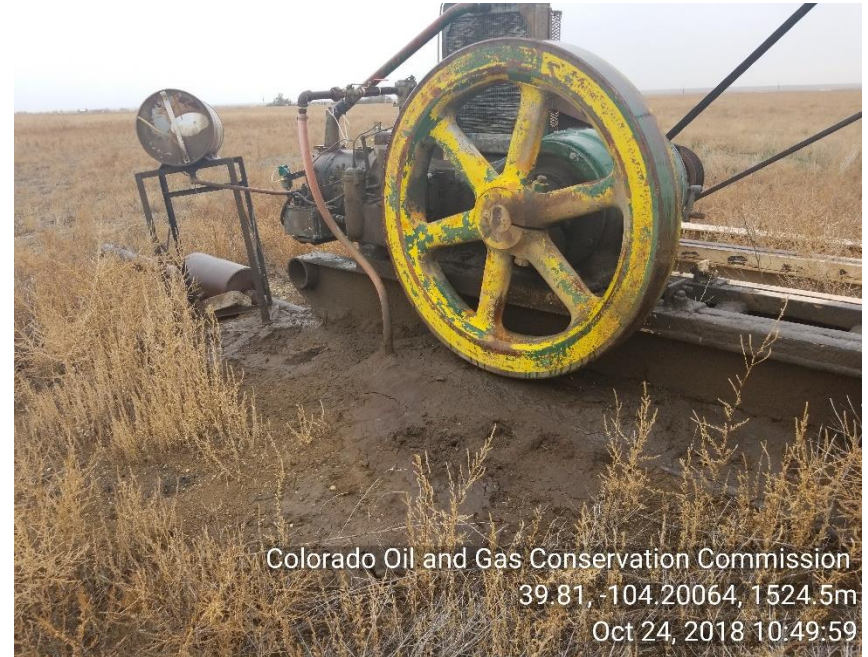
Phot 2 Stained soil around PU motor

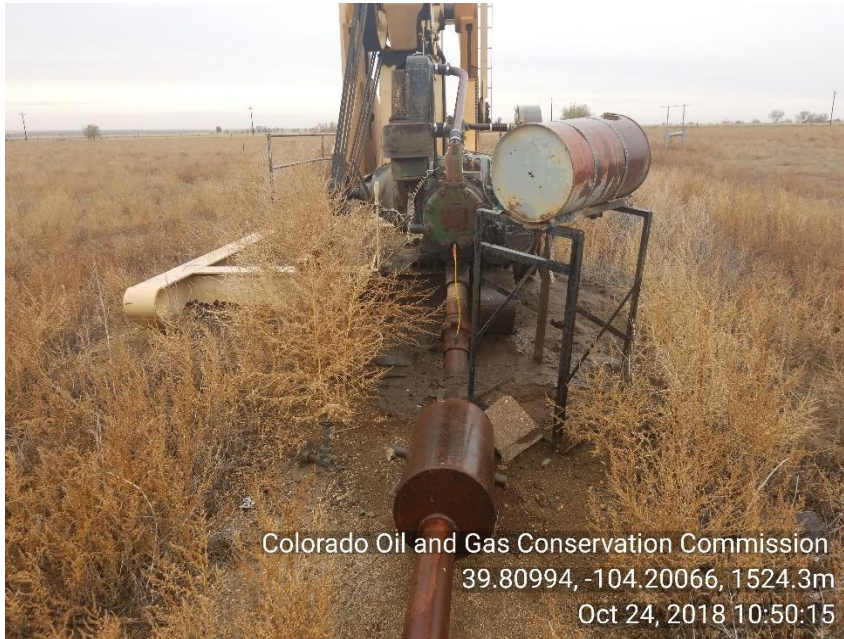
Photo 3 Stained soil PU exhaust

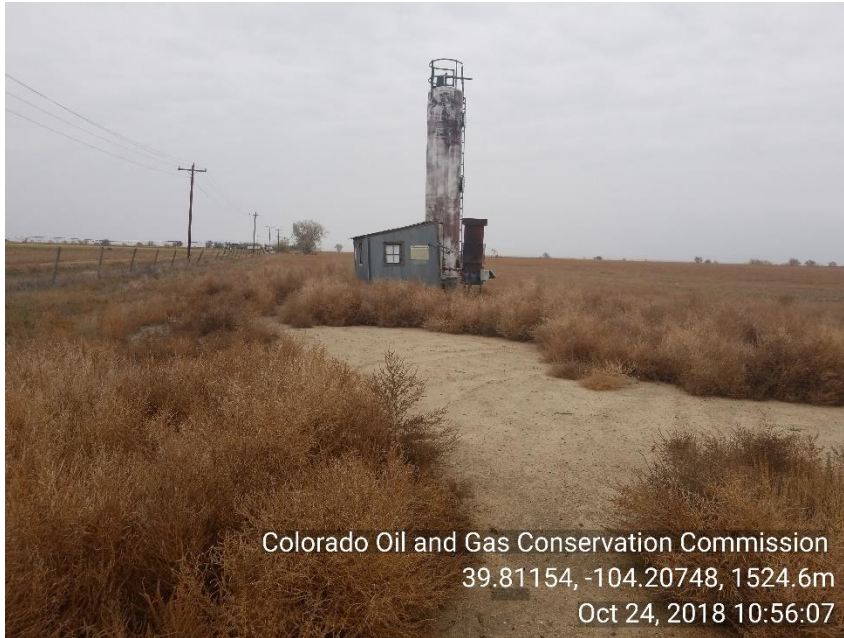
Photo 5 Weeds around SEP

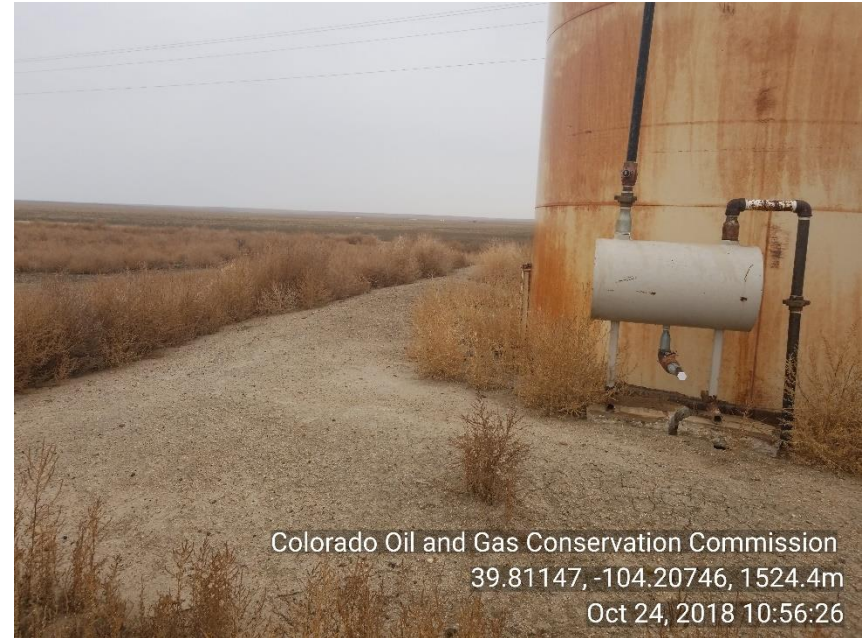
Phot 6 no berm around crude oil tank

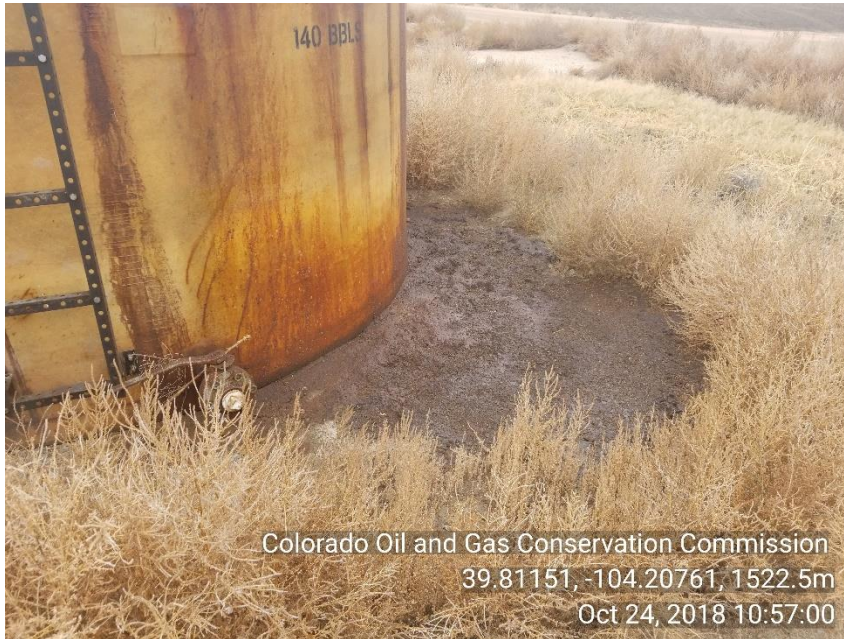
Photo 7 Stained soil around Pro water fiberglass tank

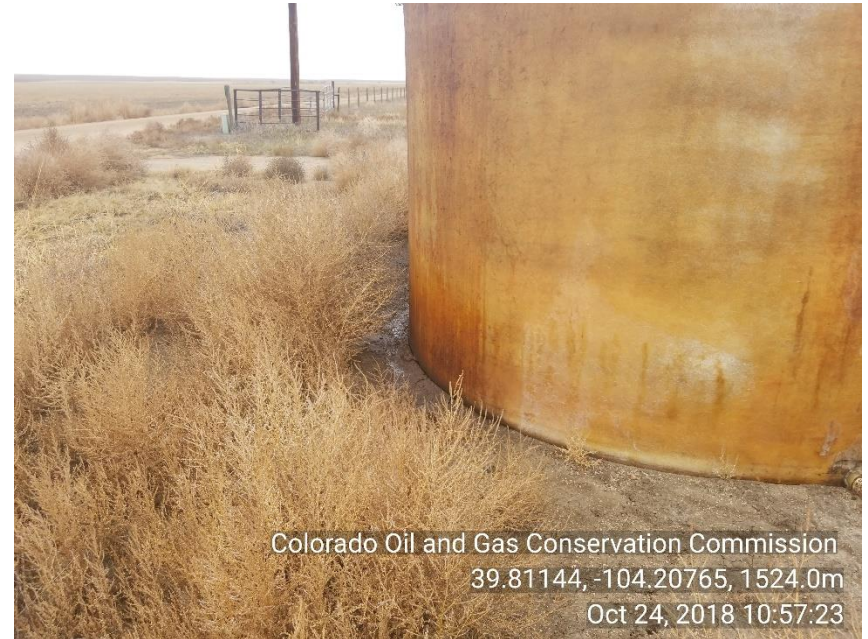
Phot 8 Stained soil around Pro water fiberglass tank

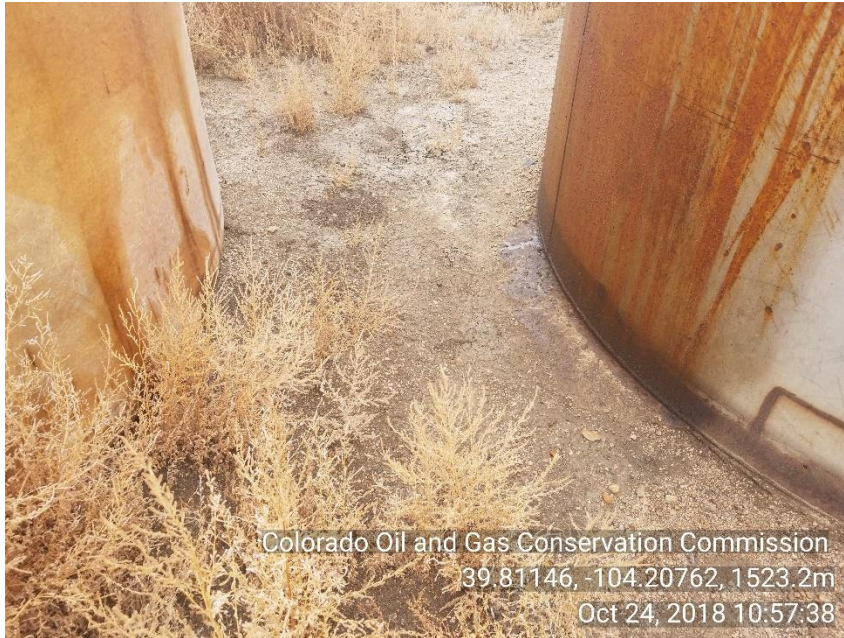
Photo 9 Stained soil around Produced water steel tank

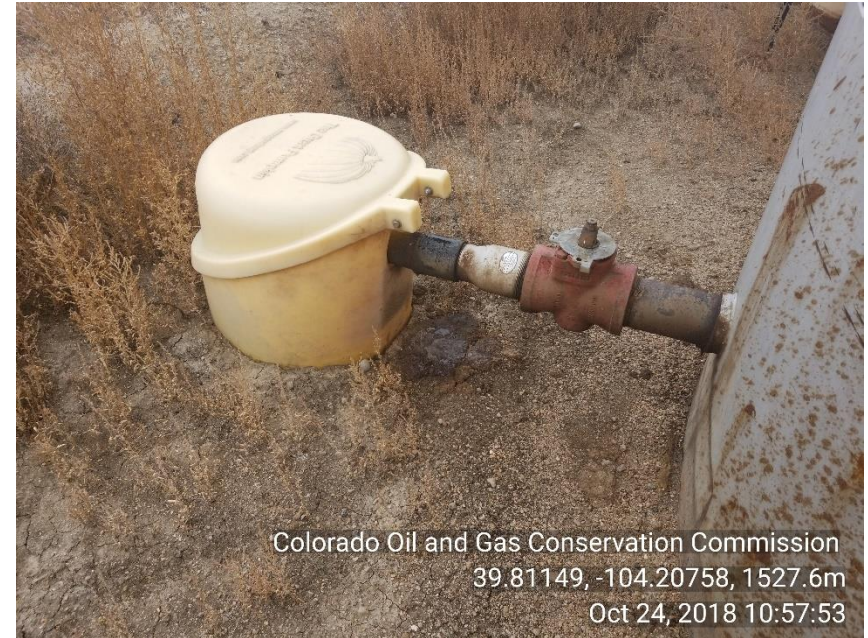
Phot 10 Stained soil under load out line to pro water tank

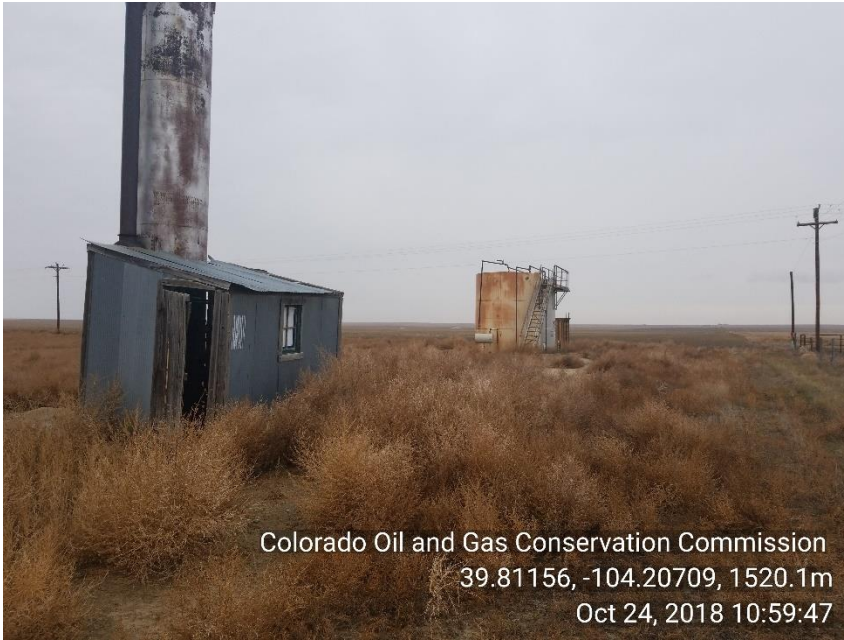
Photo 11 Weeds on location
