Inspection Photos

Operator: BP Production

API: 05-067-07843

Date: 10/05/2018

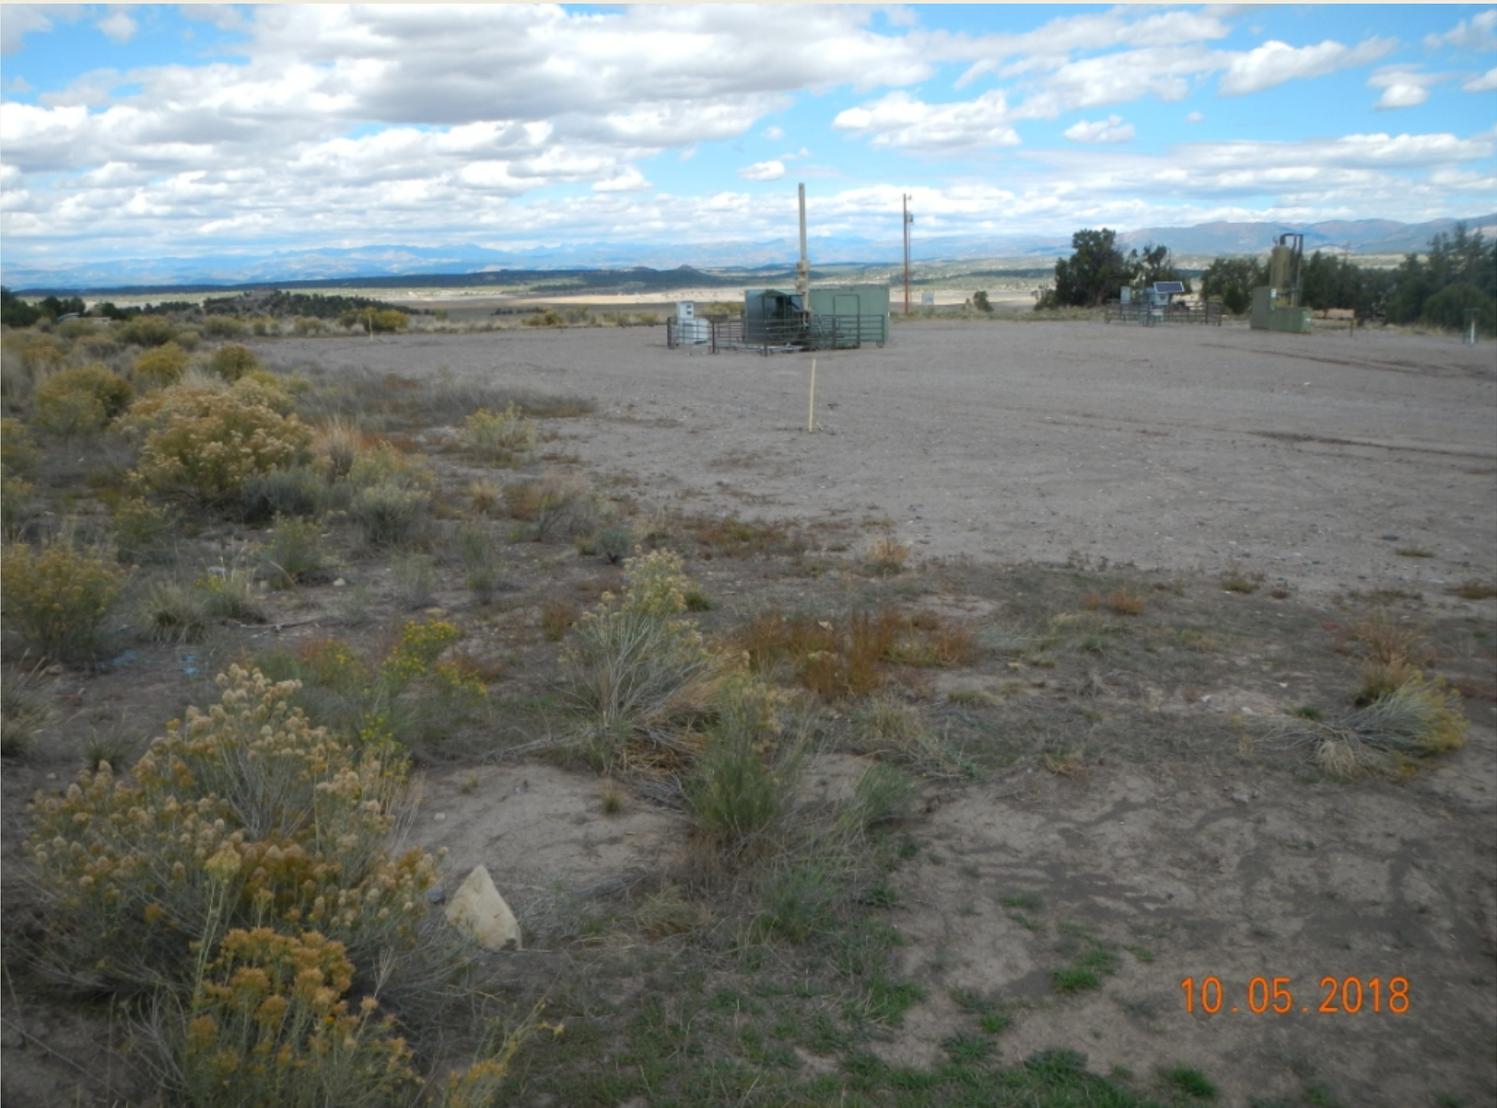
Photo 1. View of the project area from the southwestern corner facing center.

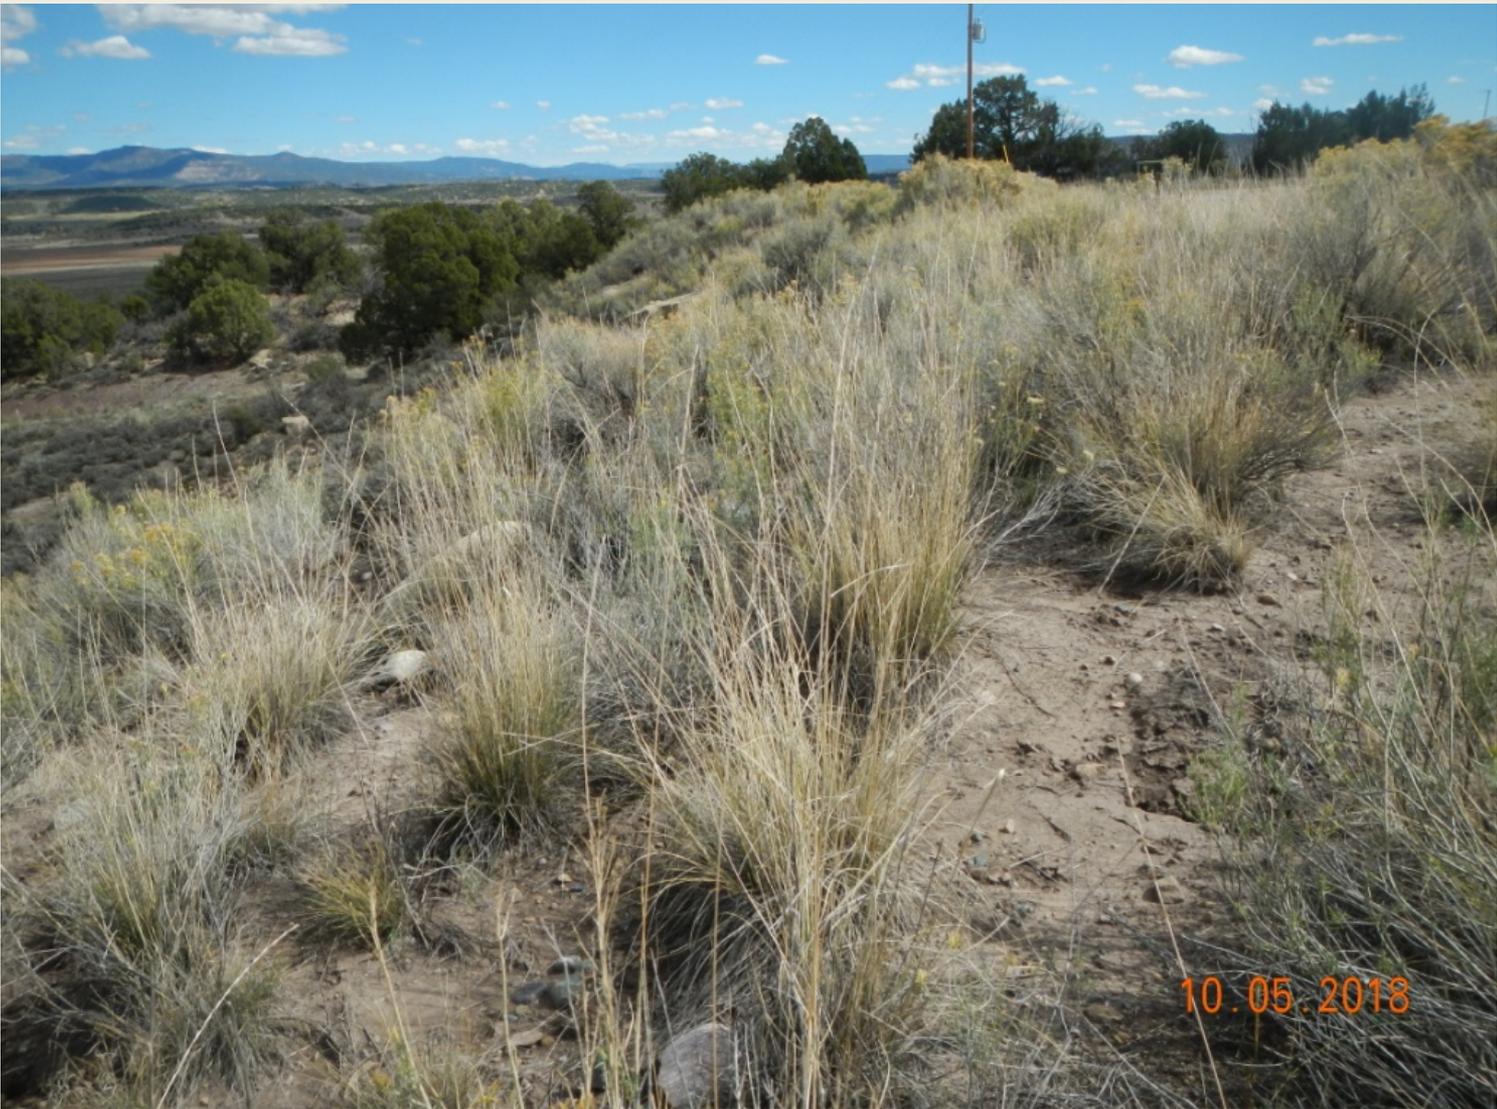
Photo 2. View of the northern project area from the northwestern corner facing eastward. Revegetation is progressing within the interim reclamation areas with shrubs such as rabbitbrush (*Chrysothamnus nauseosus*), and grasses such as intermediate wheatgrass (*Thinopyron intermedium*).

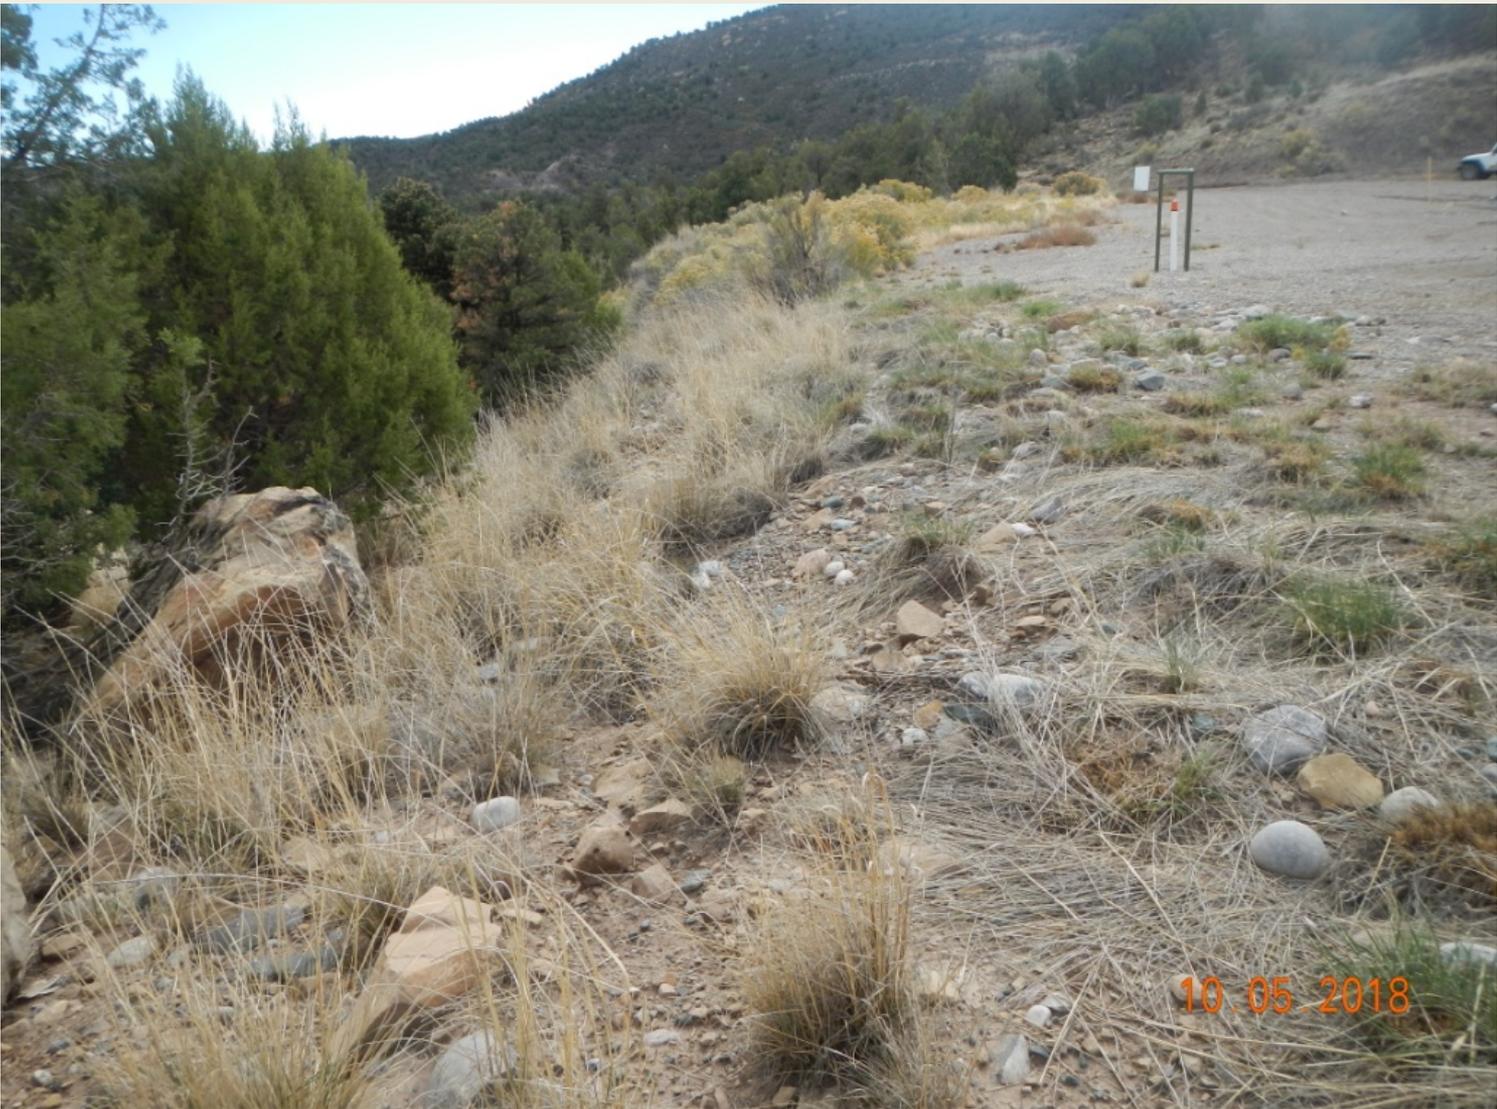
Photo 3. View of the eastern project area from the northeastern corner facing southward.

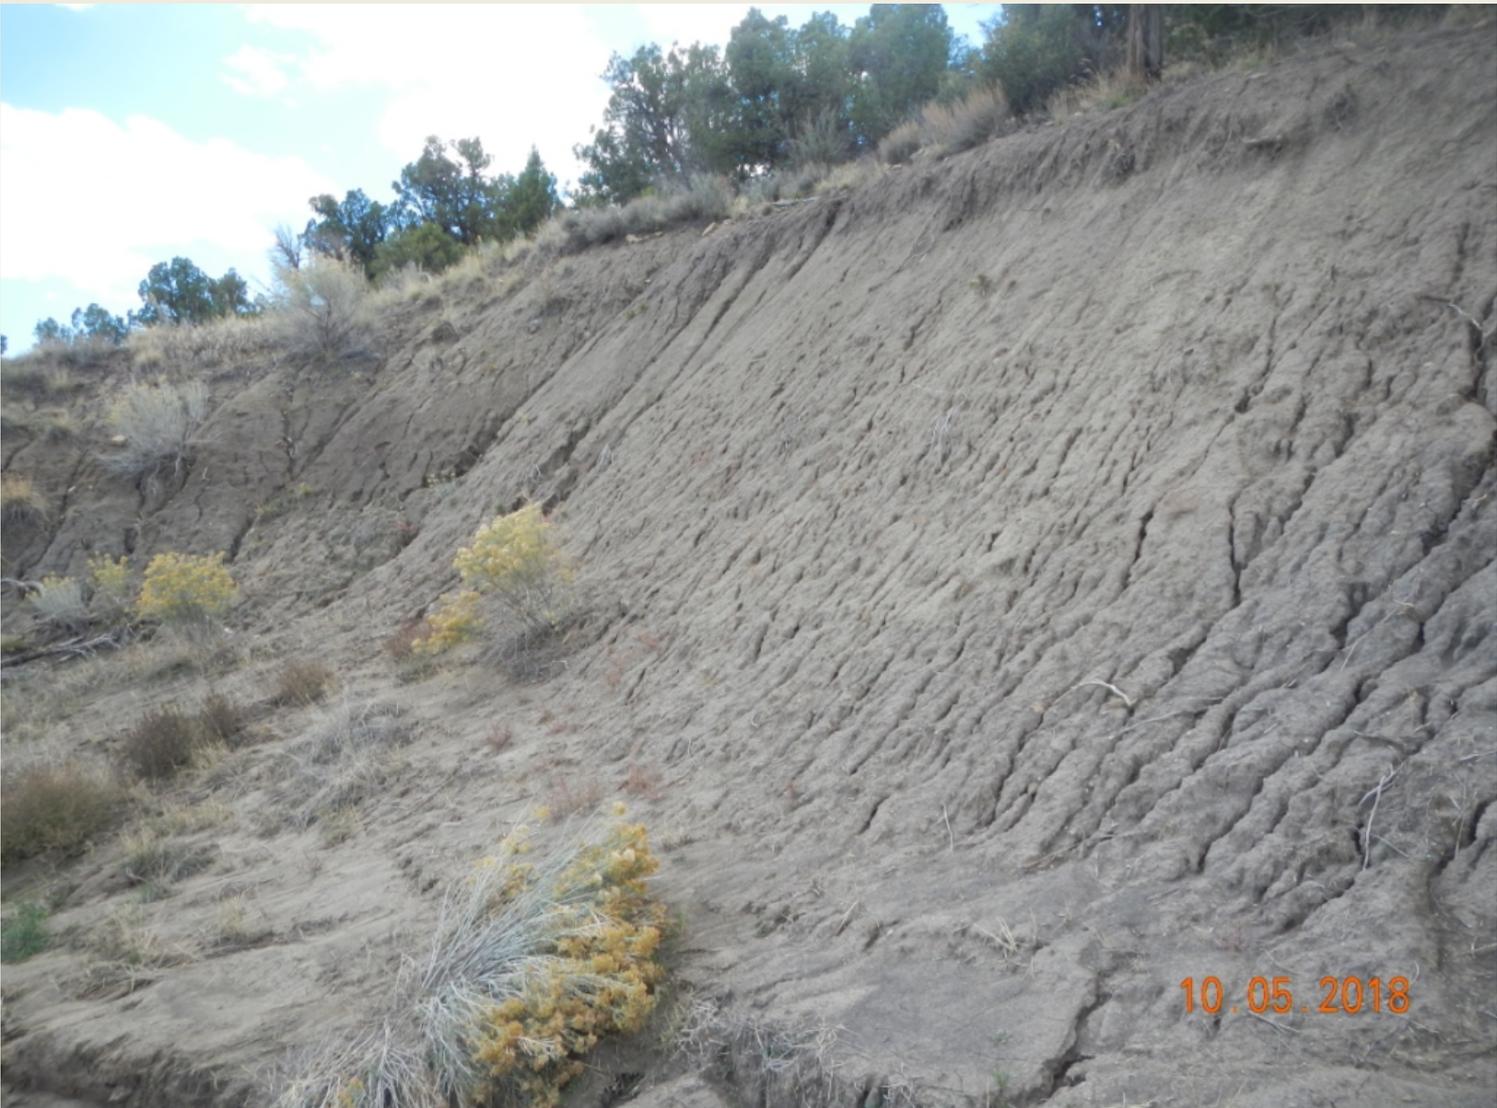
Photo 4. View of the southwestern portion of the project area. Erosional channels and deep rills are forming within the cut-slope. Exposed roots are visible.

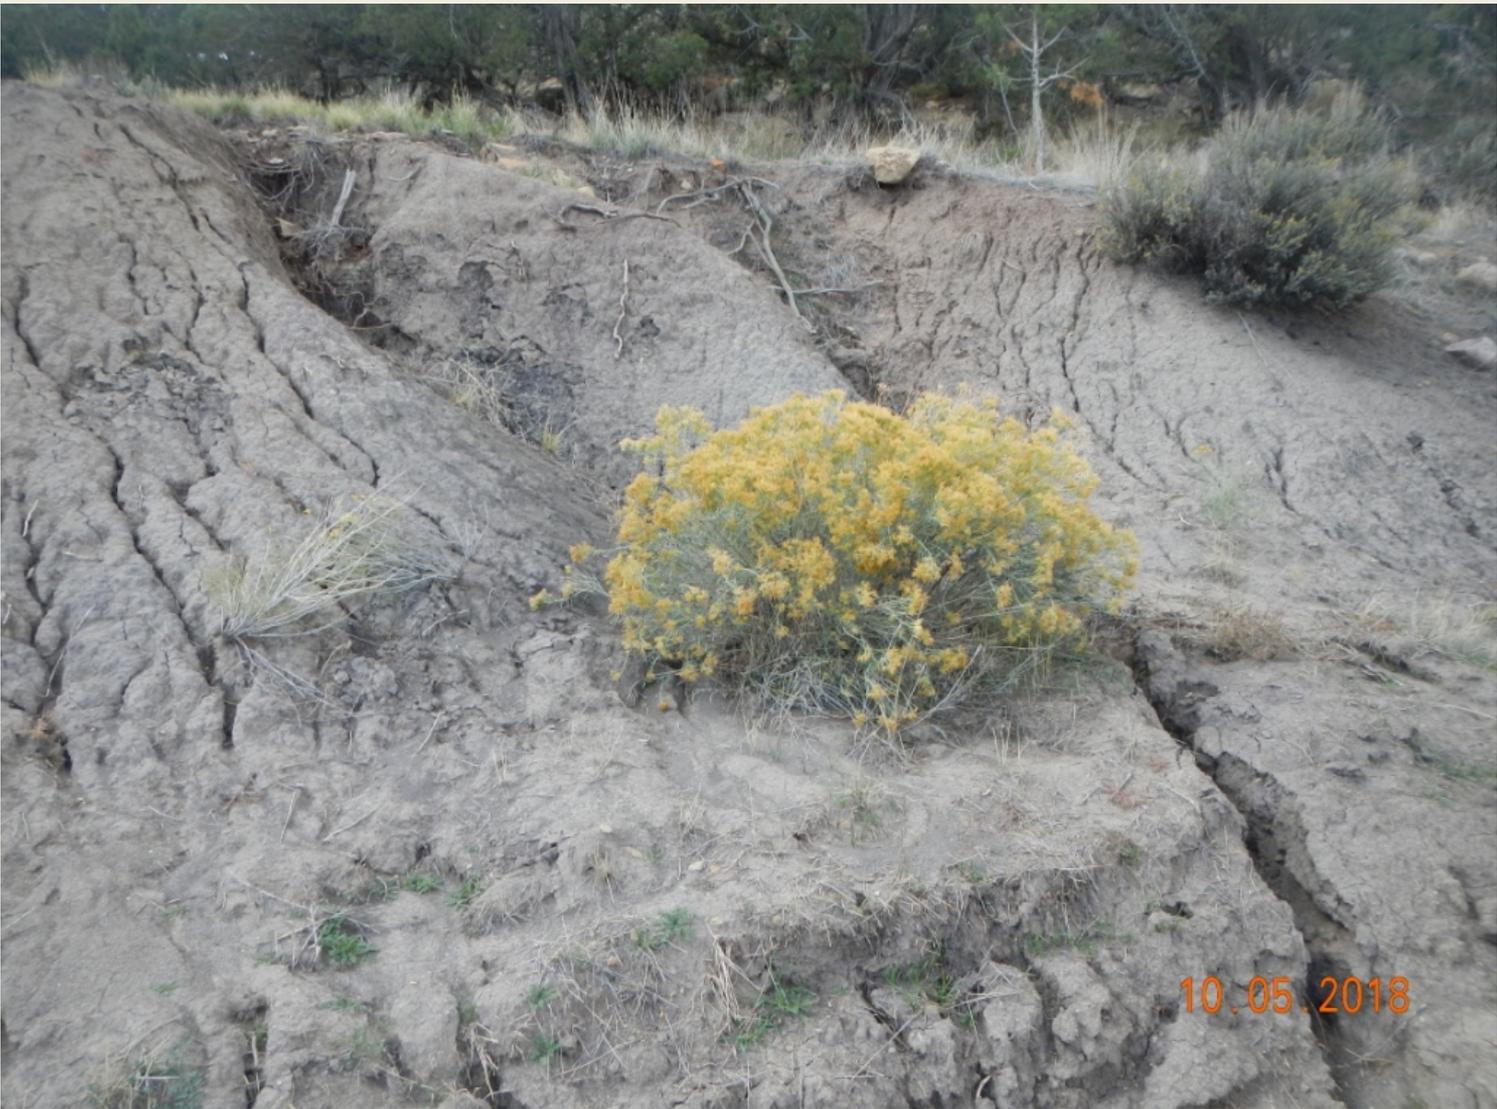
Photo 5. View of erosional channels in the southwestern cut-slope, approximately 2 to 3 feet wide and deep.

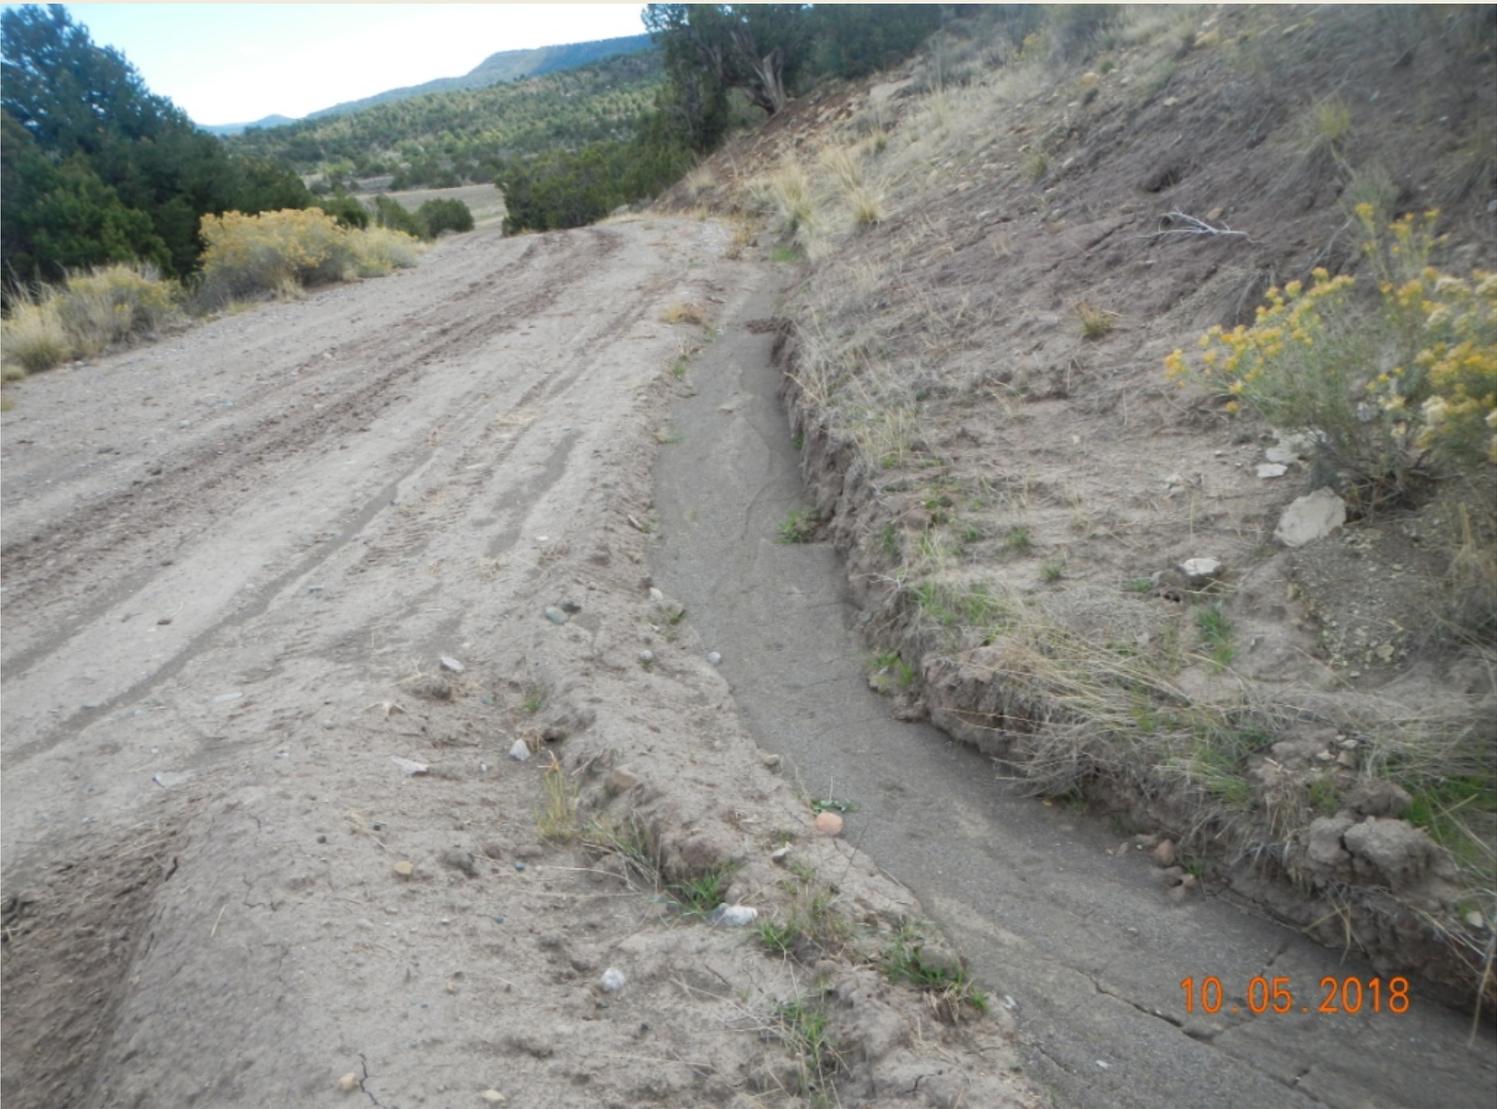
Photo 6. View of diversion ditch from western and southwestern cut-slope, full of sediment and not properly stabilized.

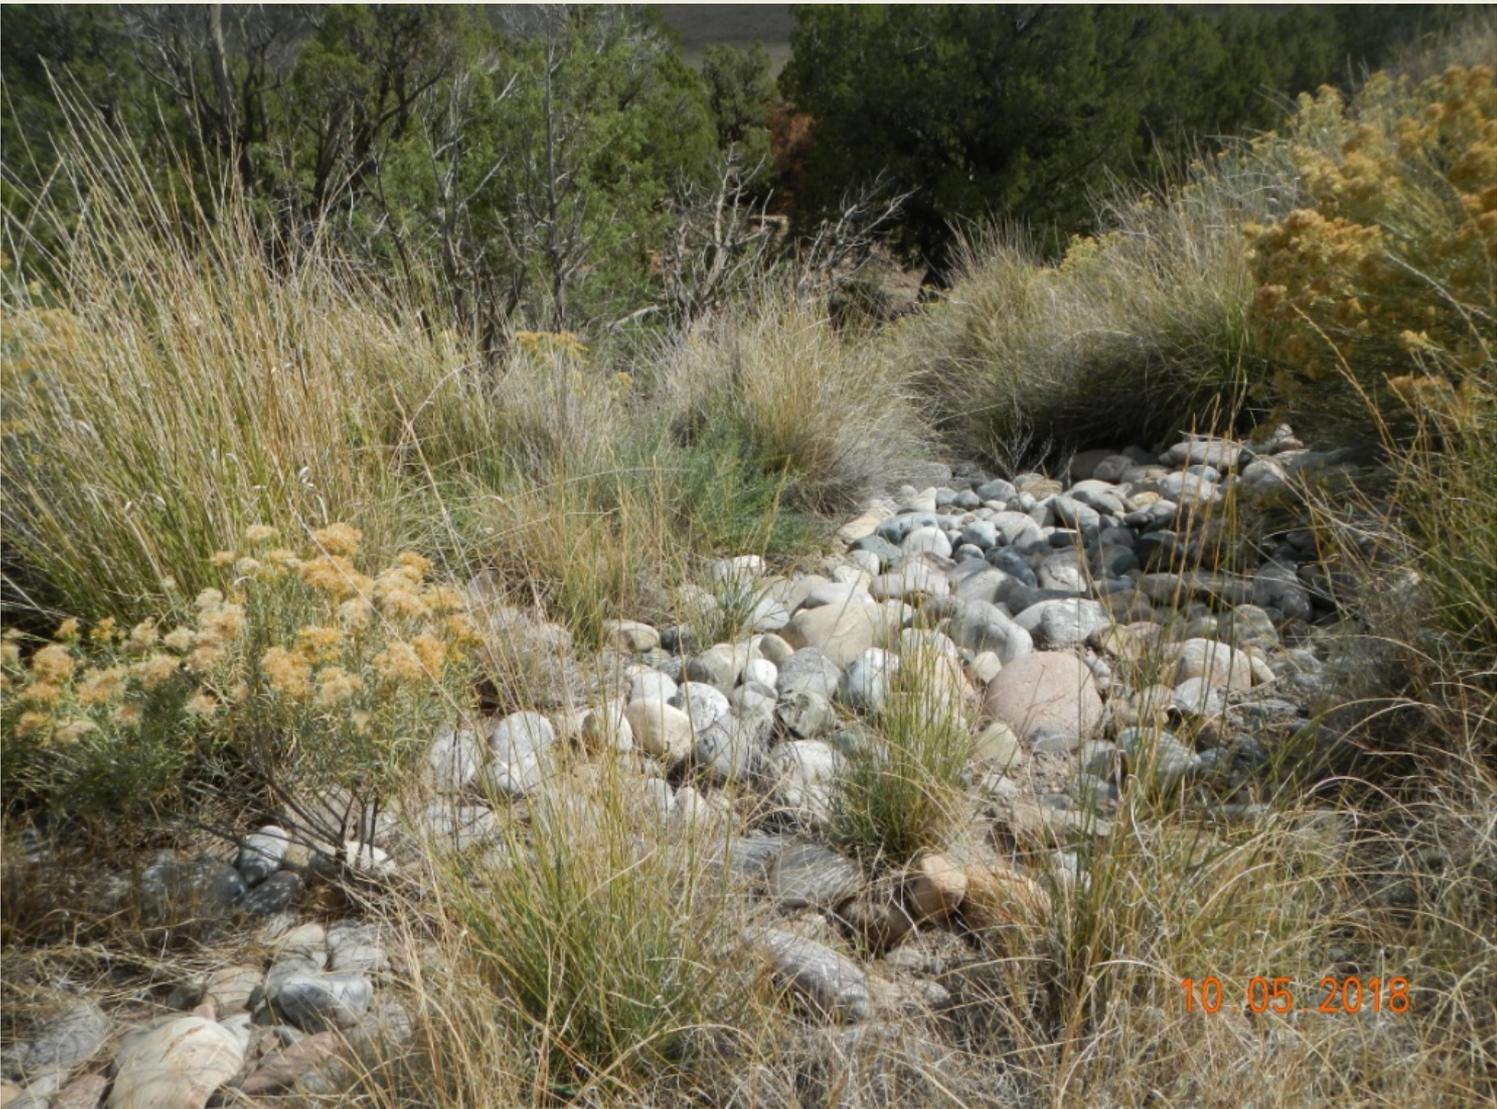
Photo 7. View of cobble run-down in the southeastern project area that appears to be functioning.
