## Inspection Photos

Location Name: Hunter Mesa Evaporation Pits

Facility ID: #454455

Inspection Date: October 18, 2018

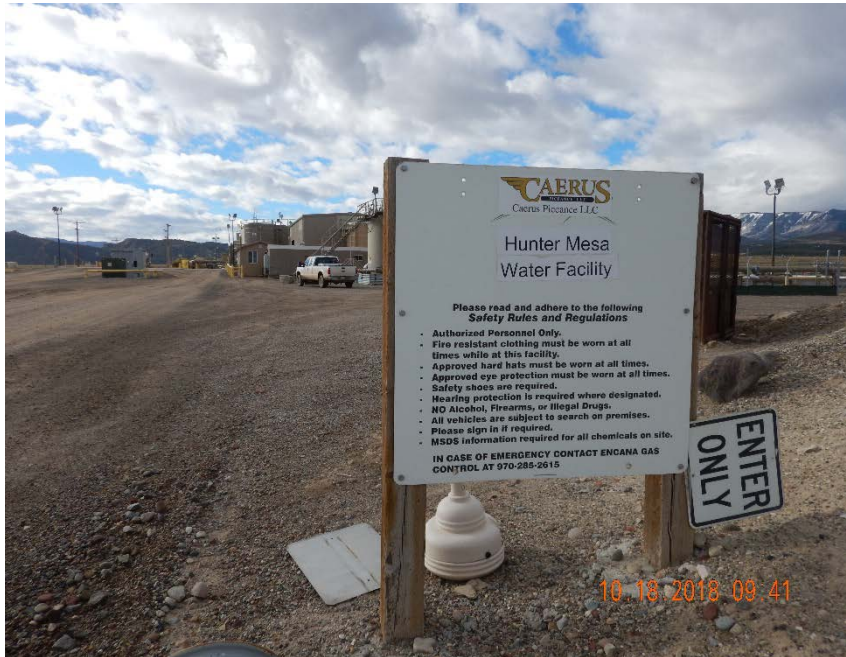
Photo #1 – Sign located at main point of access to facility.

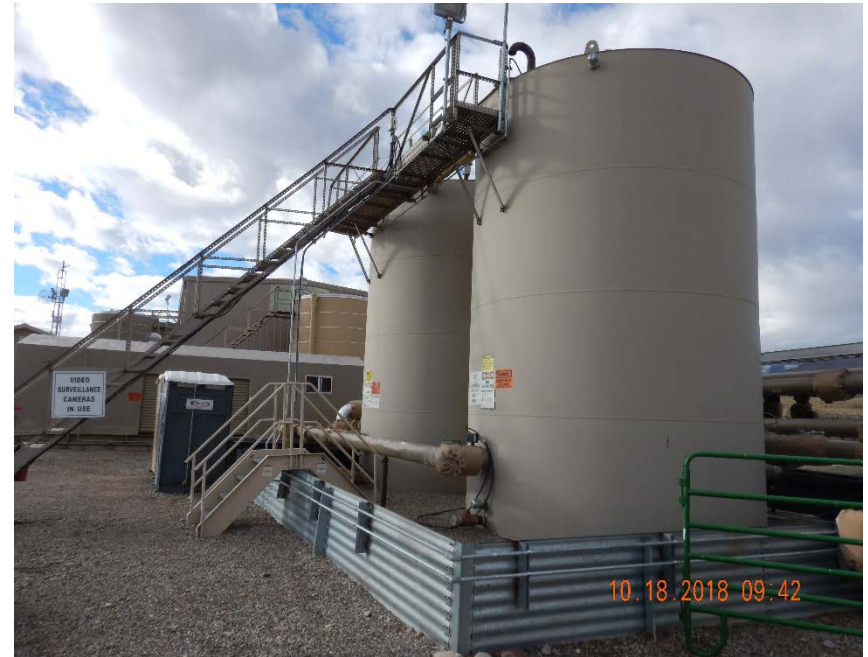
Photo #2 – View of 500 bbl produced water ASTs from northeast corner of SPCC.

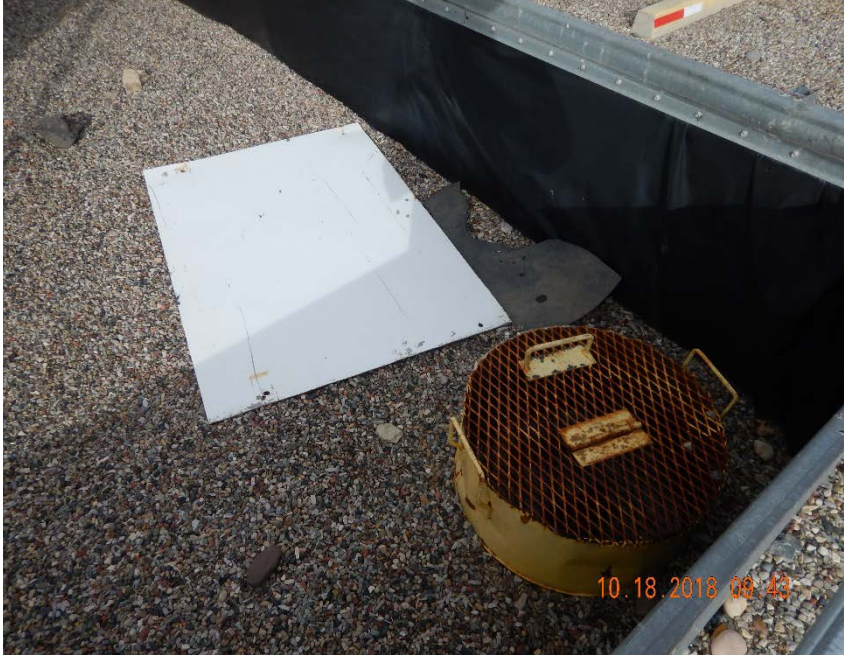
**Photo #3 – Metal sign and bucket stored inside of northeast corner of SPCC.**

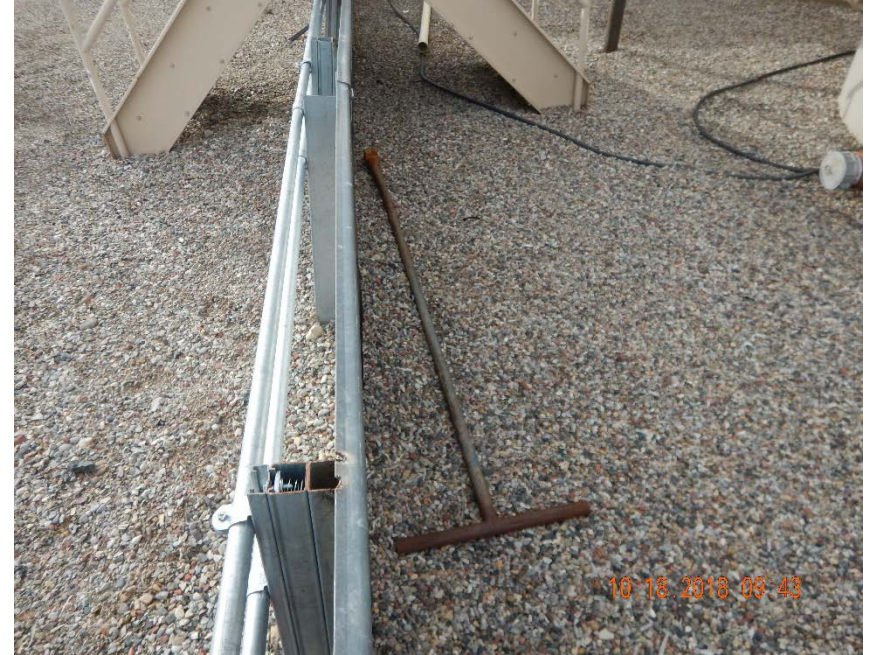
**Photo #4 – Metal post stored inside of SPCC.**

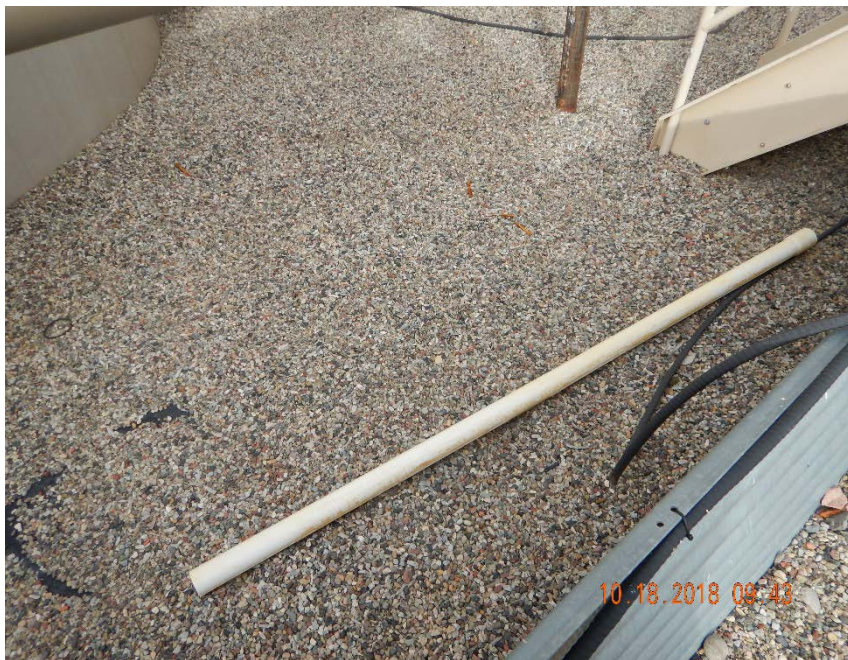
**Photo #5 – PVC pipe stored inside of SPCC.**

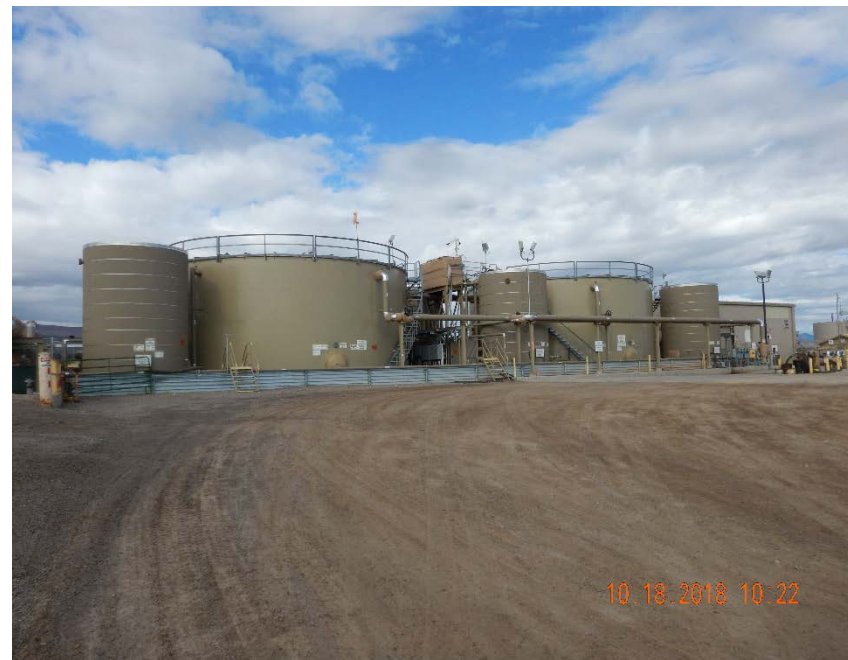
**Photo #6 – View of central tank battery from SE corner.**

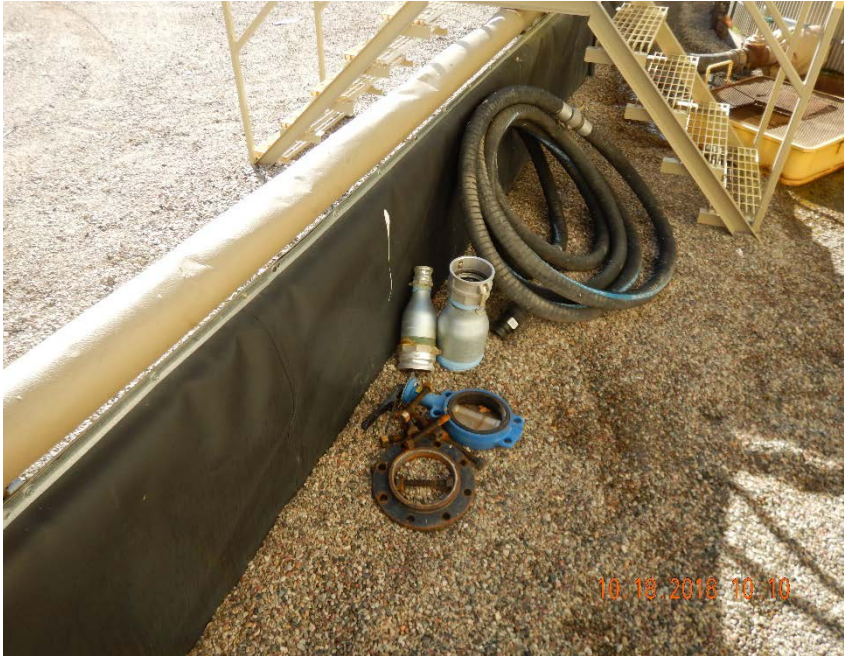
**Photo #7 – Equipment storage inside of SPCC at central tank battery.**

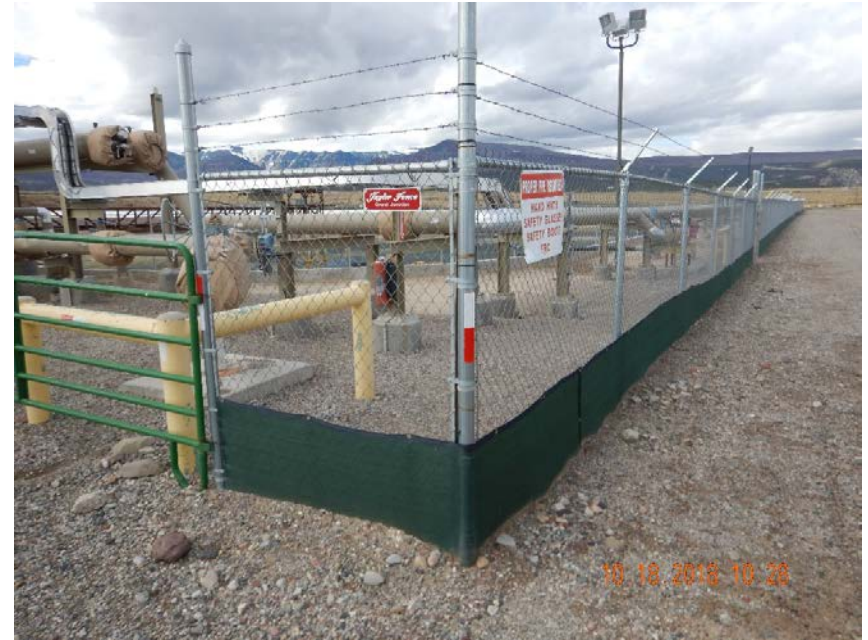
**Photo #8 – View of fence surrounding pit complex from NE corner. Note chain link fence with barbed wire on north side of pit complex (right side of photo) joins with steel panel fence on east side of pit complex (left side of photo).**

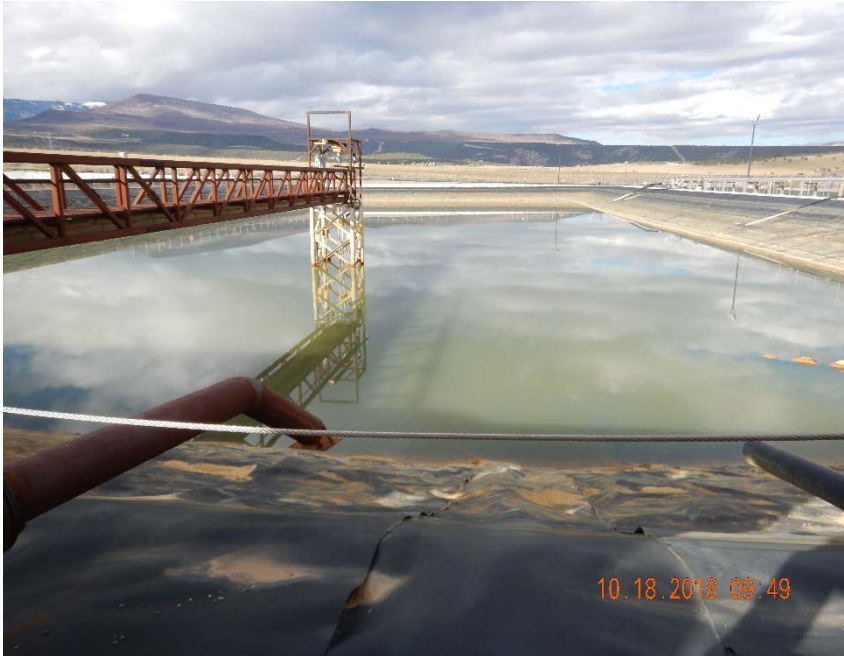
**Photo #9 – Overview of Pit Facility #435837 from east side.**

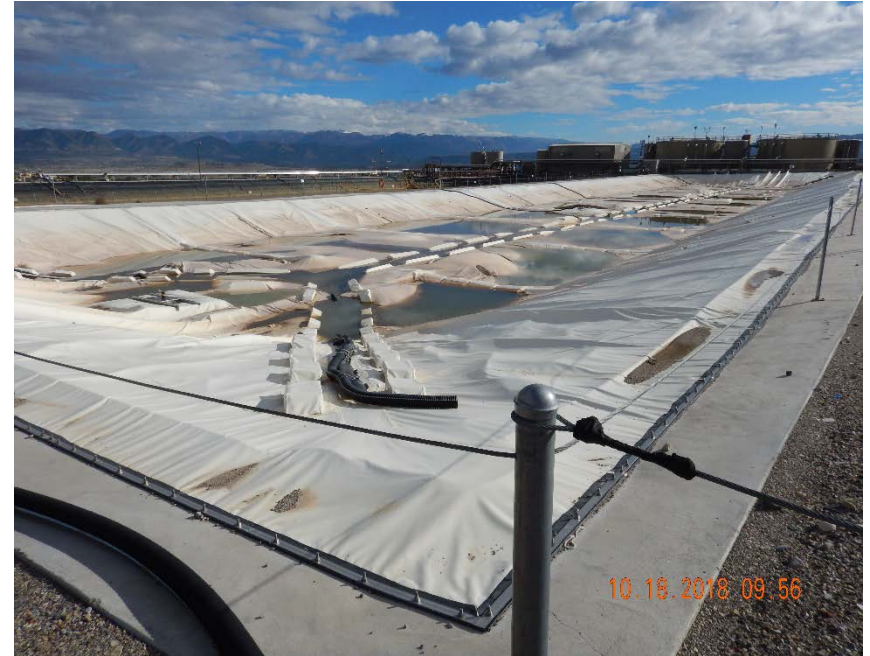
**Photo #10 – Overview of covered Pit Facility #435836 from SW corner.**

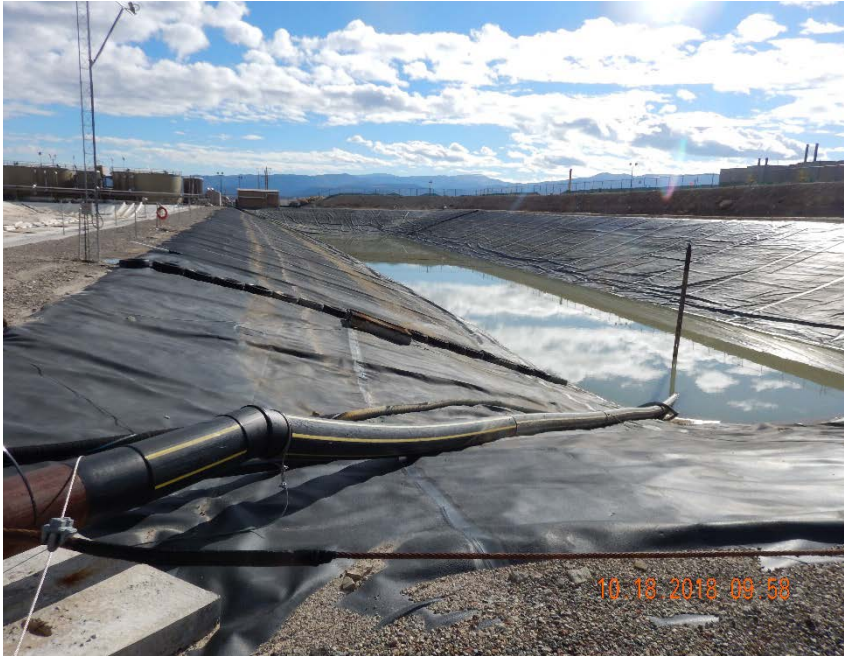
**Photo #11 – Overview of Pit Facility #435835 from NW corner.**

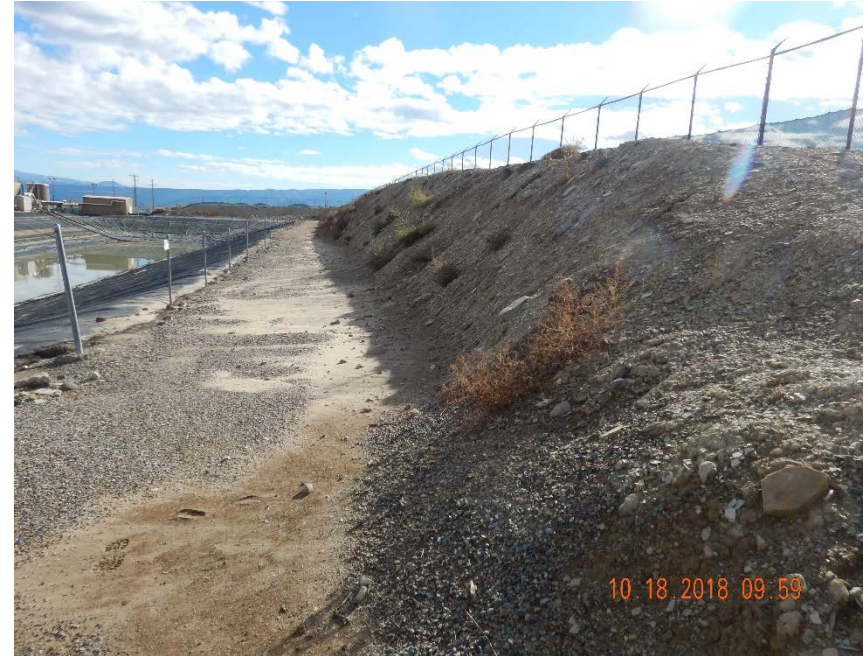
**Photo #12 – View of earthen berm along south and southeast sides of facility. Note visible sediment transport from berm approaching Pit Facility #435835.**

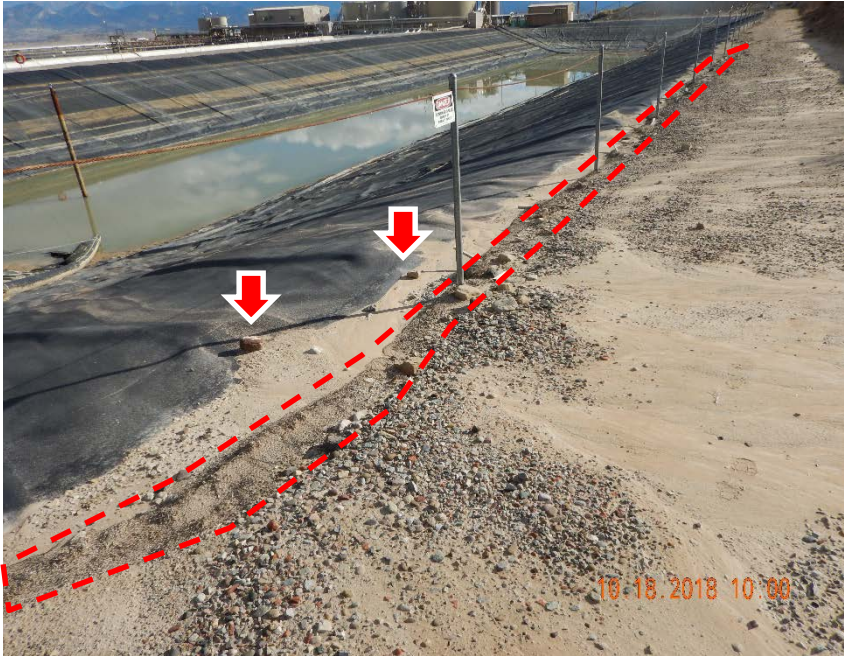
**Photo #13 – Straw wattle along south side of Pit Facility #435835 (red outline) needs repair or replacement. Note evidence of sediment transport and rocks (red arrows) on top of pit liner.**

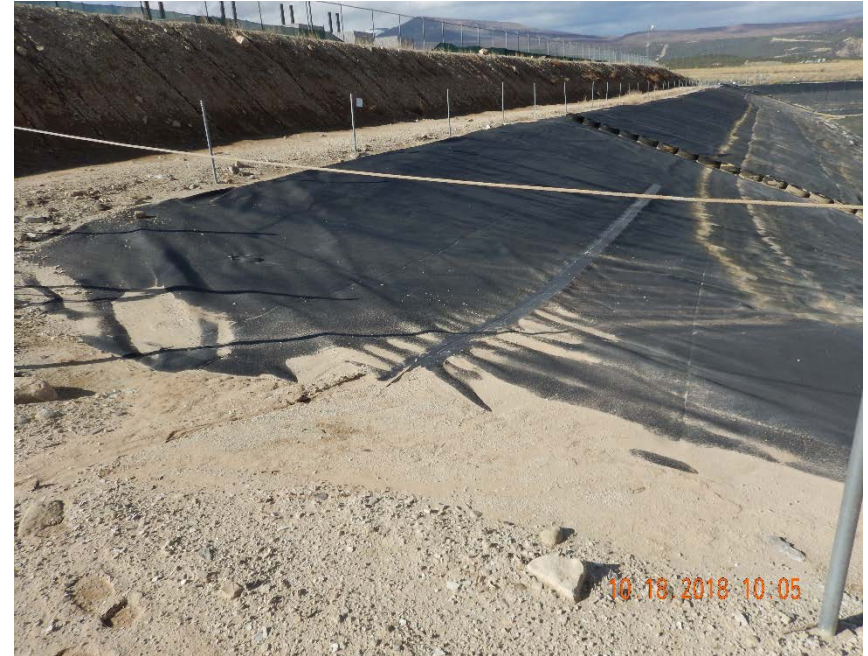
**Photo #14 – Sediment transport into Pit Facility #435835 from east side.**

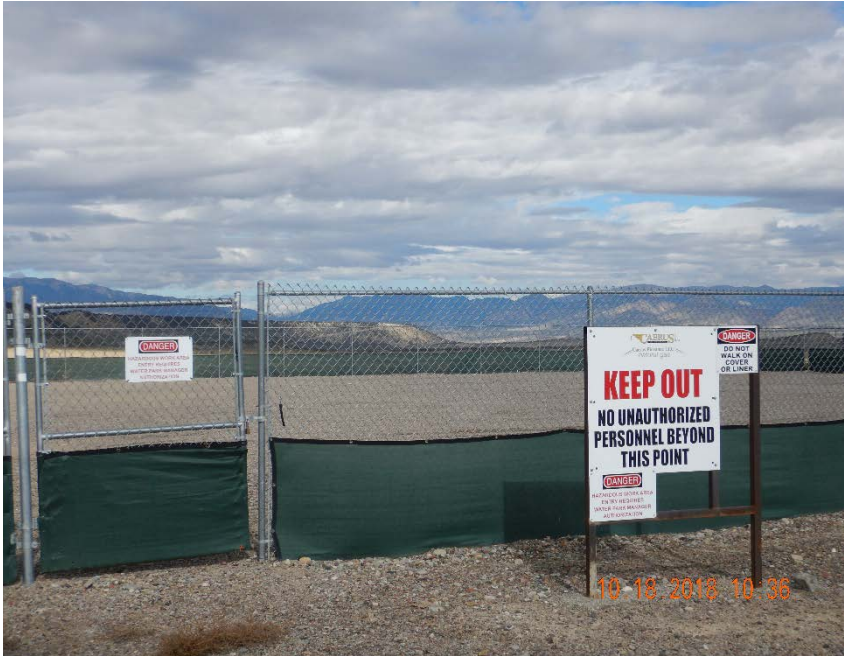
**Photo #15 – Chain link fence with wildlife mesh and controlled entry at Pit Facility #433571.**

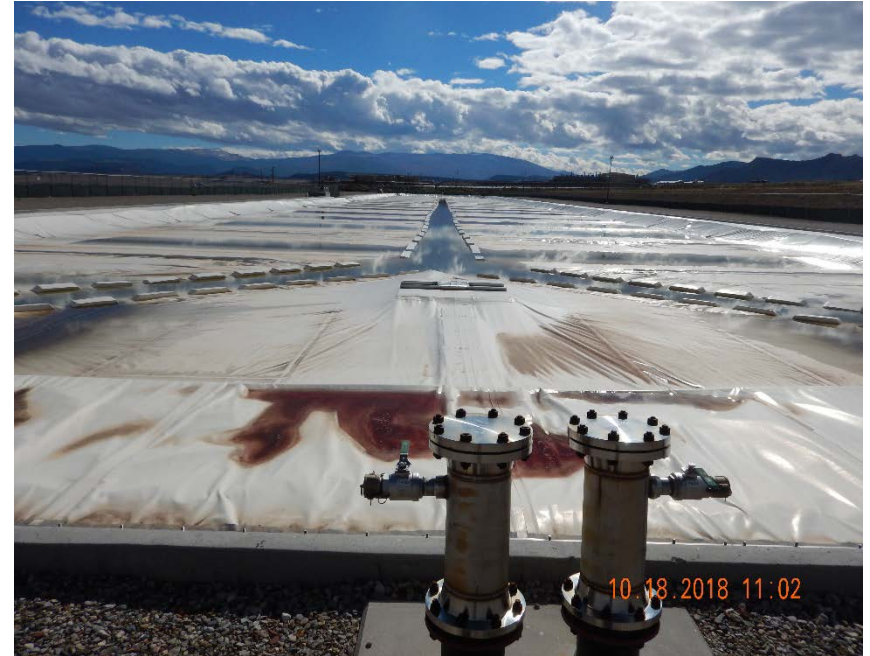
**Photo #16 – View of Pit Facility #433571 from NW side.**

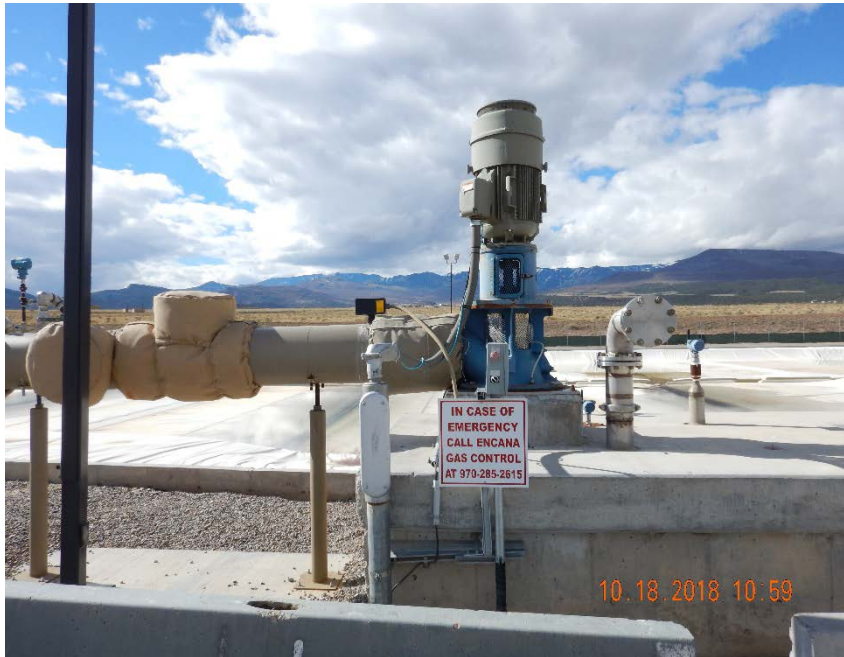
**Photo #17 – Sign on NE side of Pit Facility #433571 identifies previous operator. Emergency contact phone number (tested 10/24/2018) is valid for current operator.**

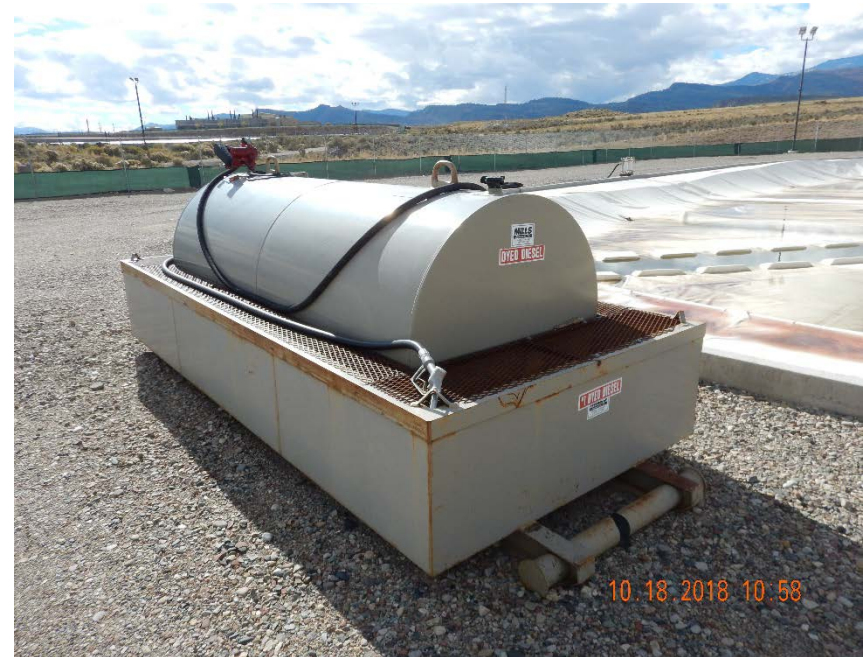
**Photo #18 – Diesel tank with secondary containment located at SE corner of Pit Facility #433571.**
