Inspection Photos

Operator: BP Production

API: 05-067-09700

Date: 10/05/2018

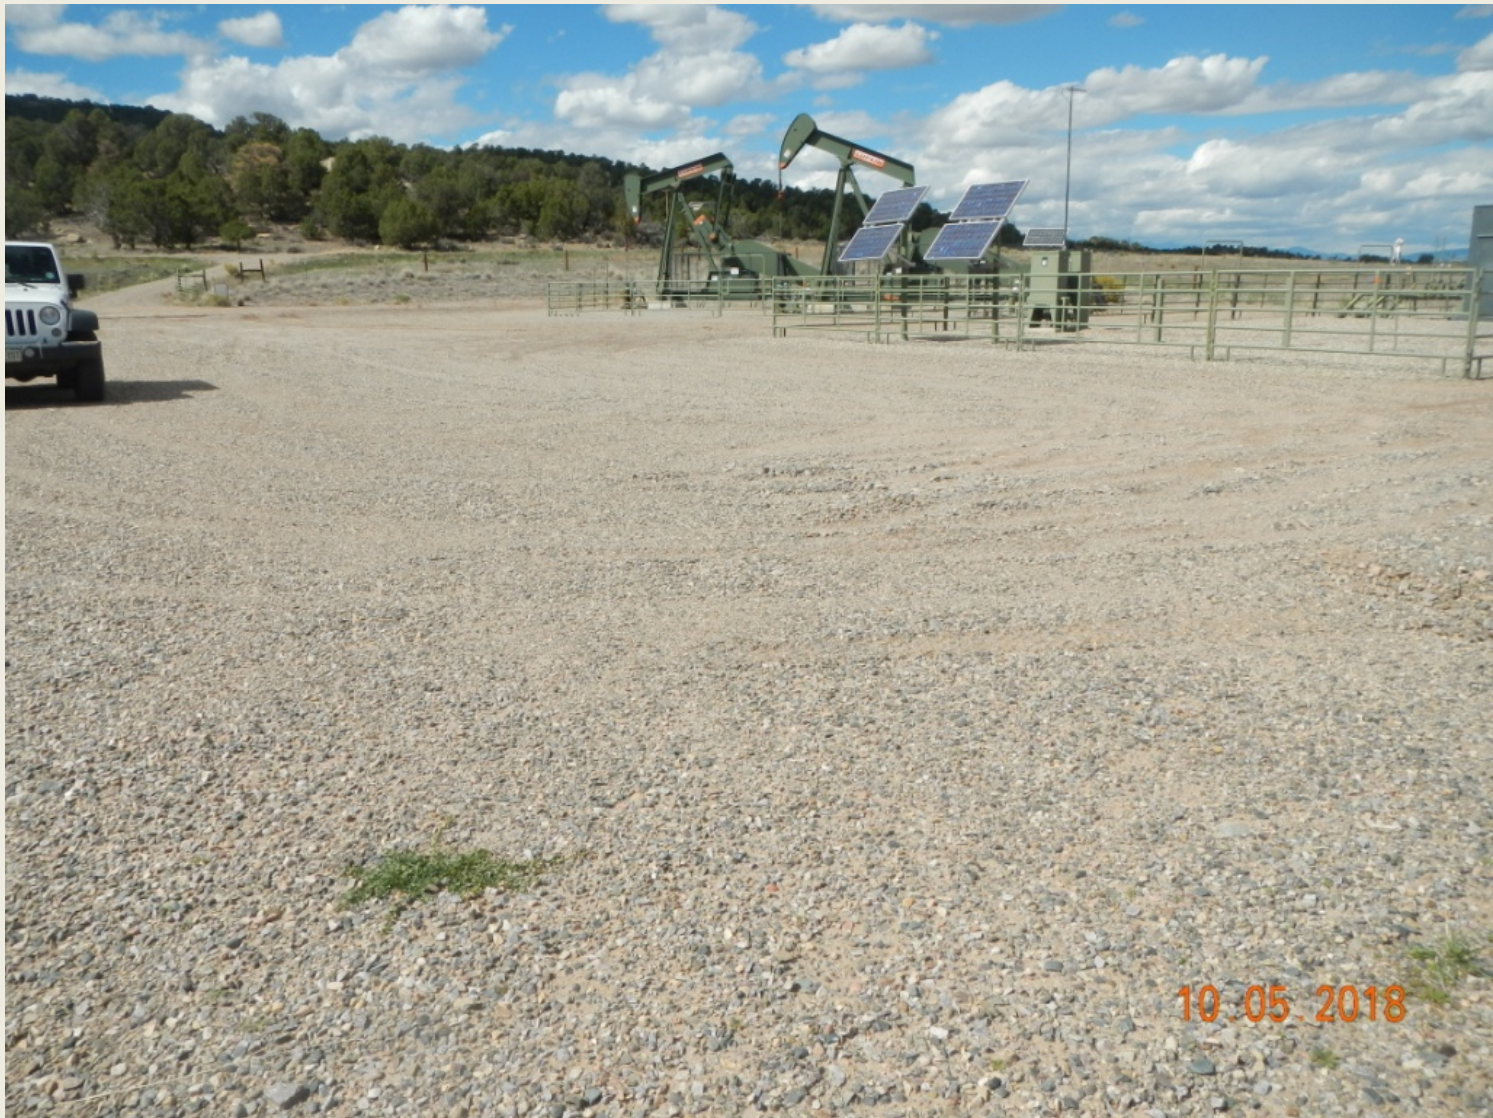
Photo 1. View of the project area from the southeastern corner facing center.

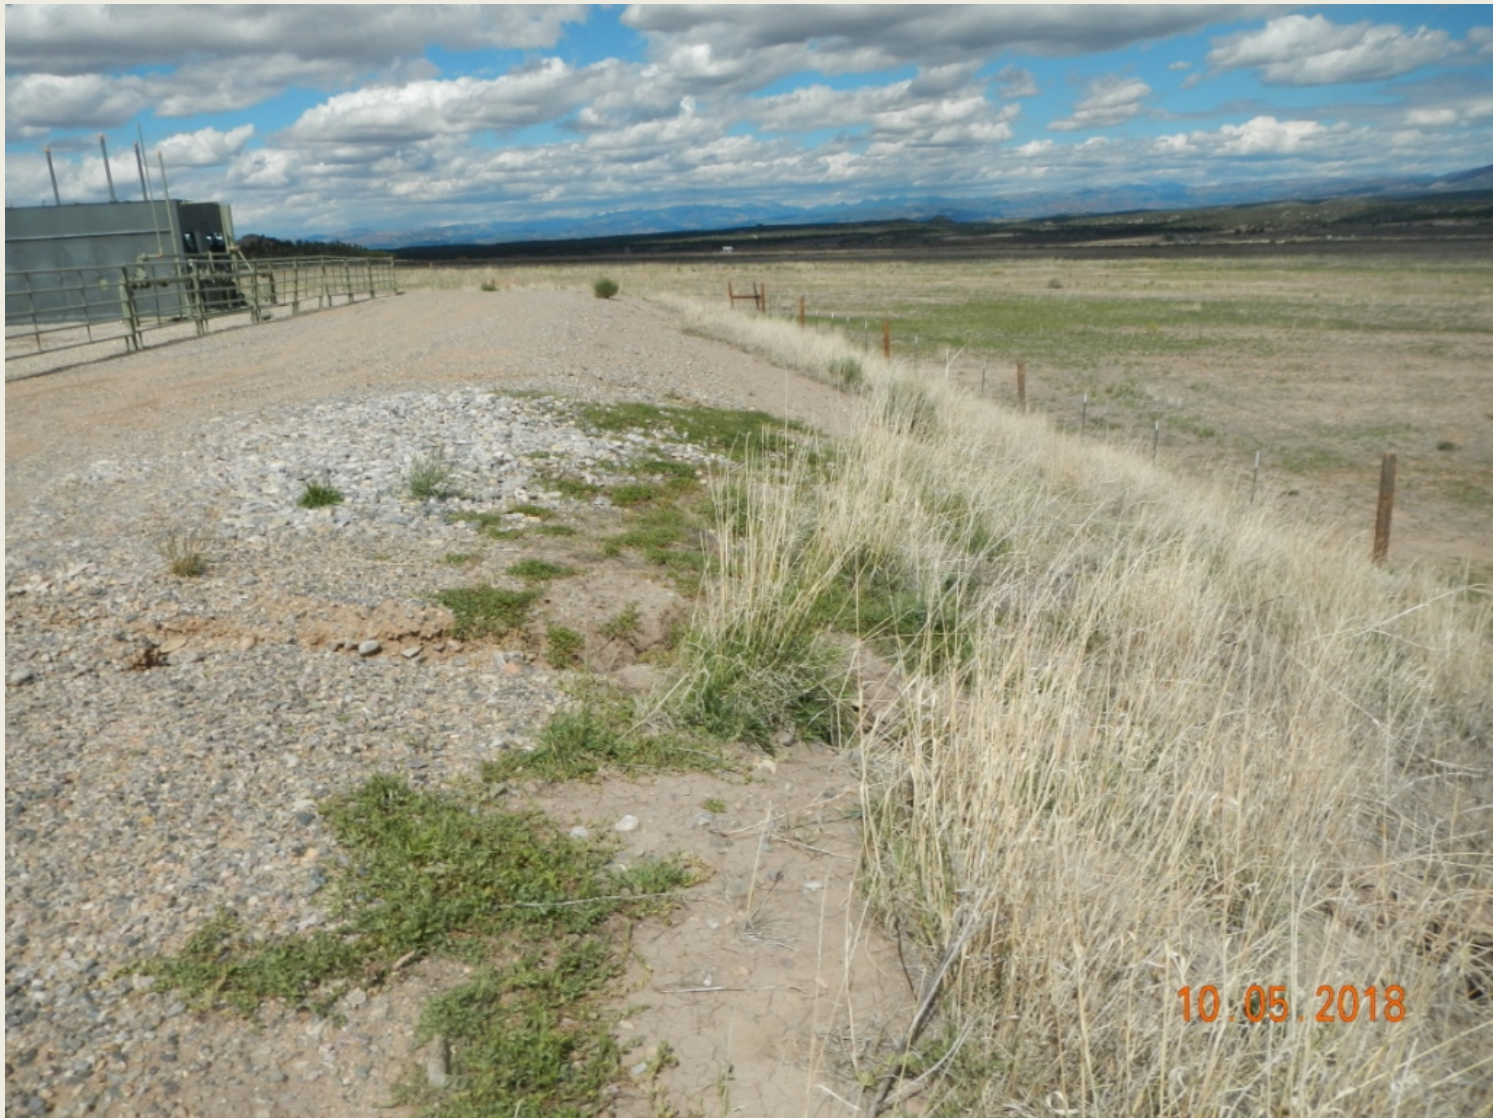
Photo 2. View of the eastern project area from the southeastern corner facing northward. Revegetation is progressing within the interim reclamation areas with grasses such intermediate wheatgrass (*Thinopyron intermedium*) .

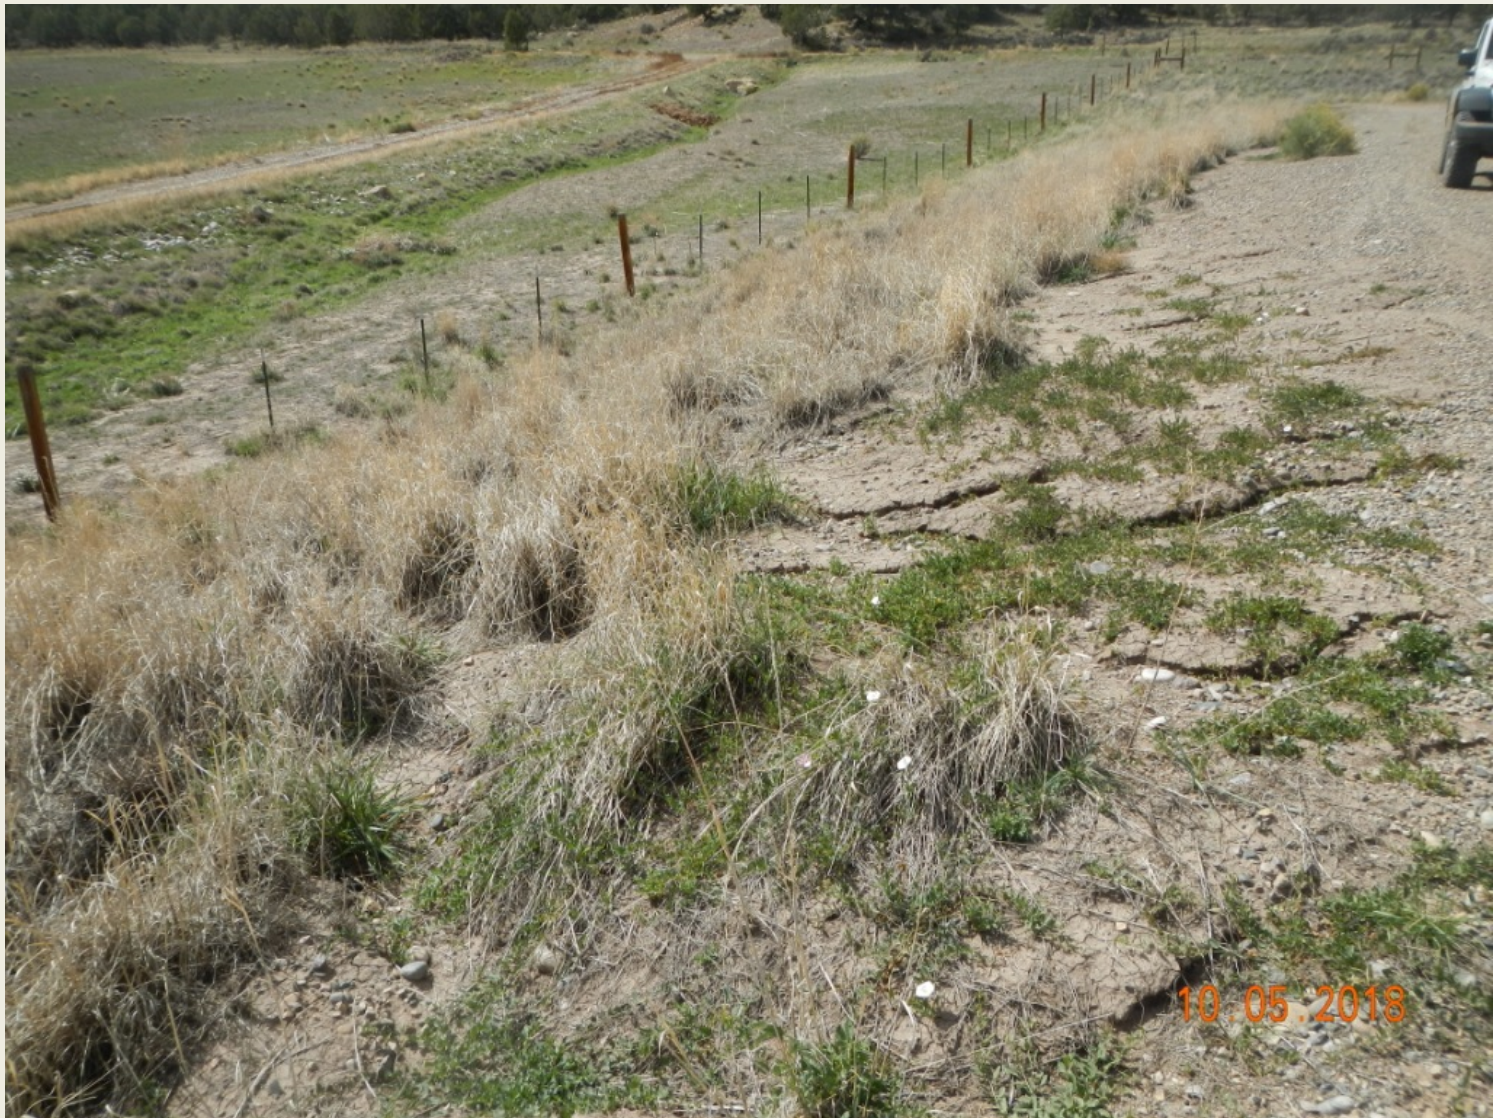
Photo 3. View of the southern project area from the southeastern corner facing westward.

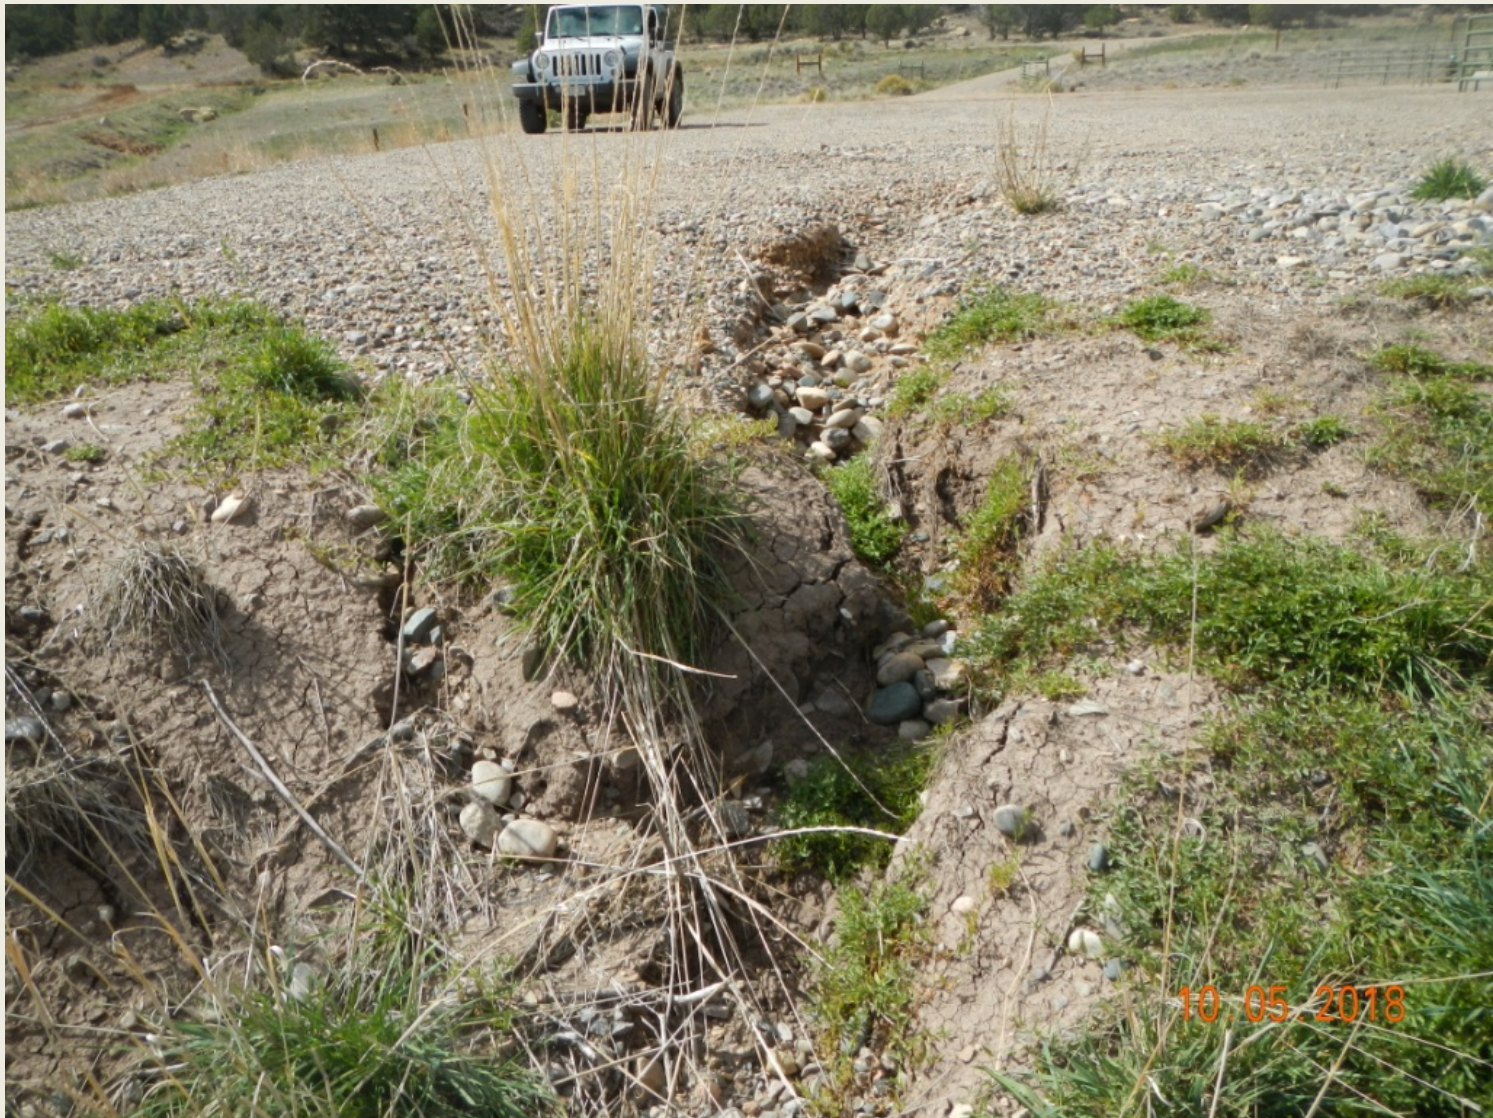
Photo 4. View of erosional channels up to 1 foot wide and deep forming within the southeastern project area.

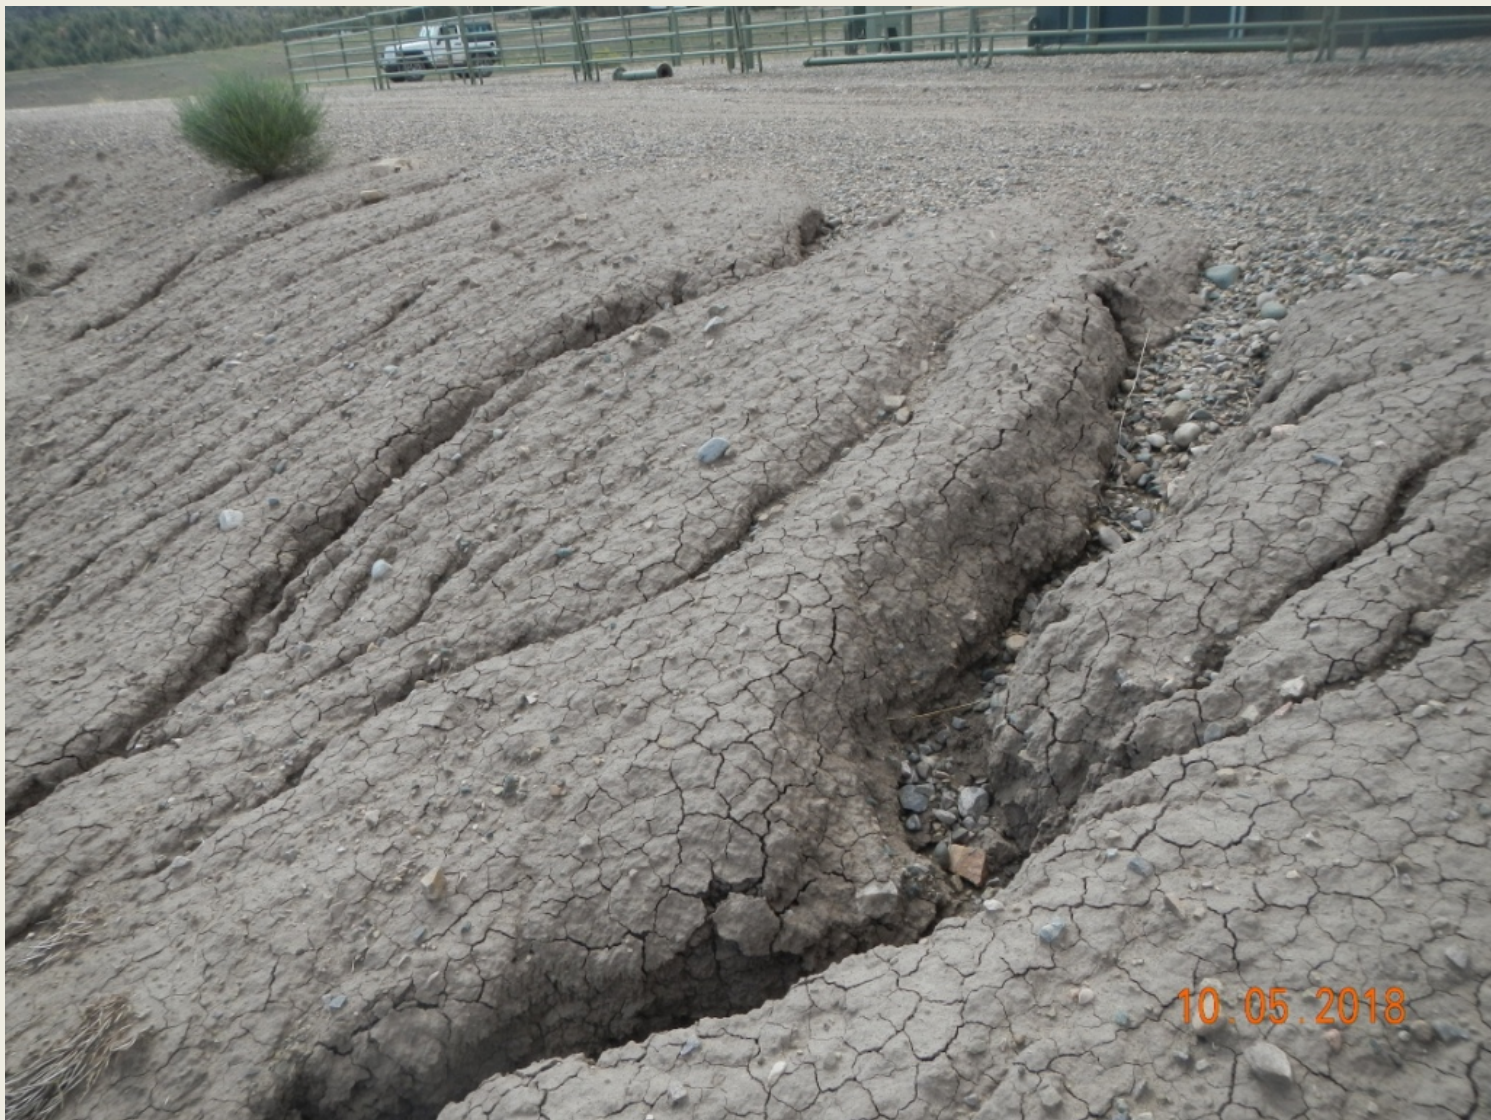
Photo 5. View of erosional channels in the northeastern portion of the project area.

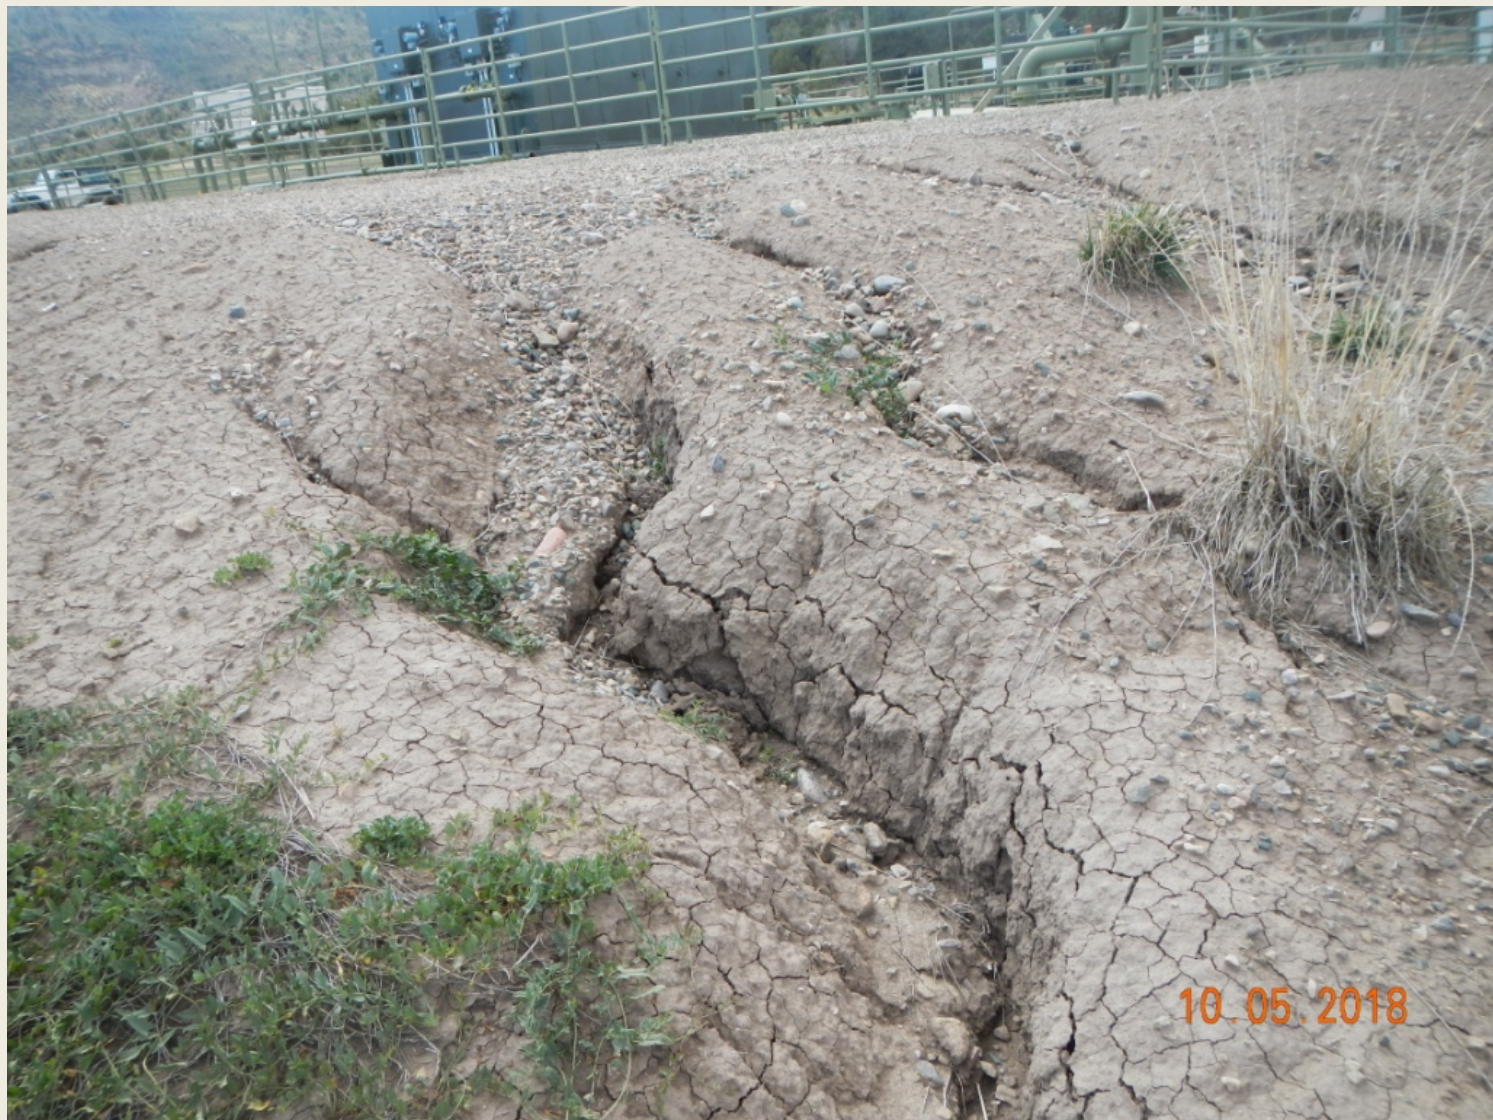
Photo 6. View of more erosional channels within the eastern project area.

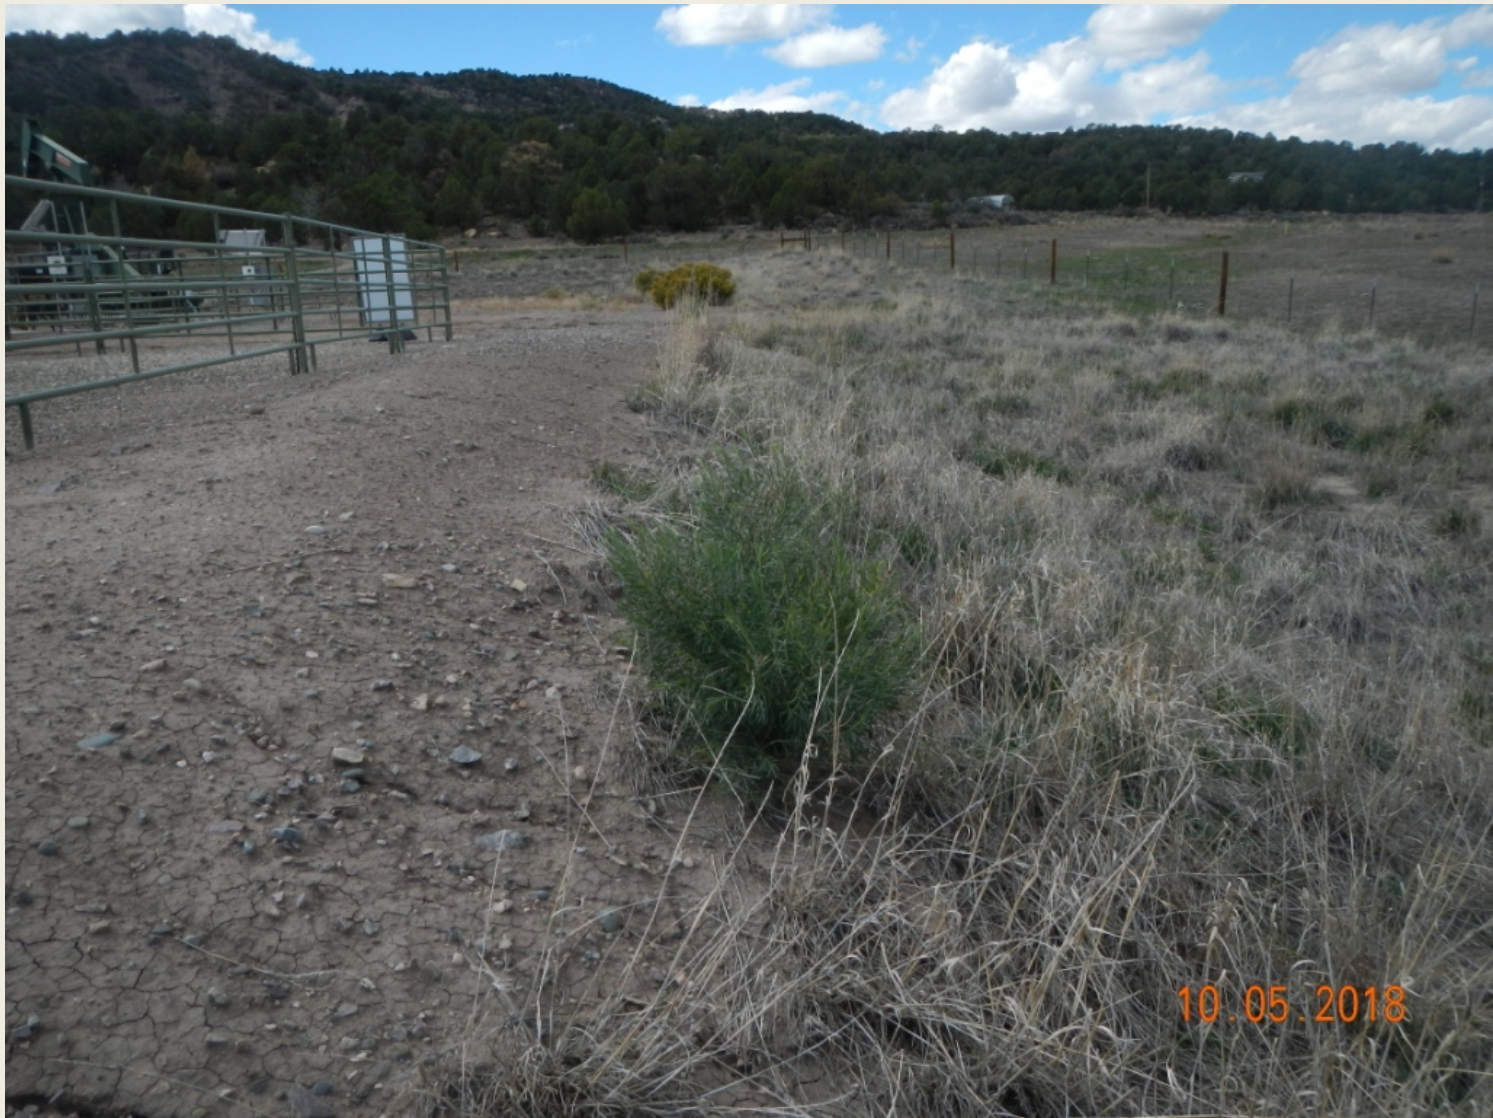
Photo 7. View of the northern portion of the project area from the northeastern corner facing westward.
