Inspection Photos  
Location Name: Schumacher 32-6 #13-3  
API: 05-007-06239

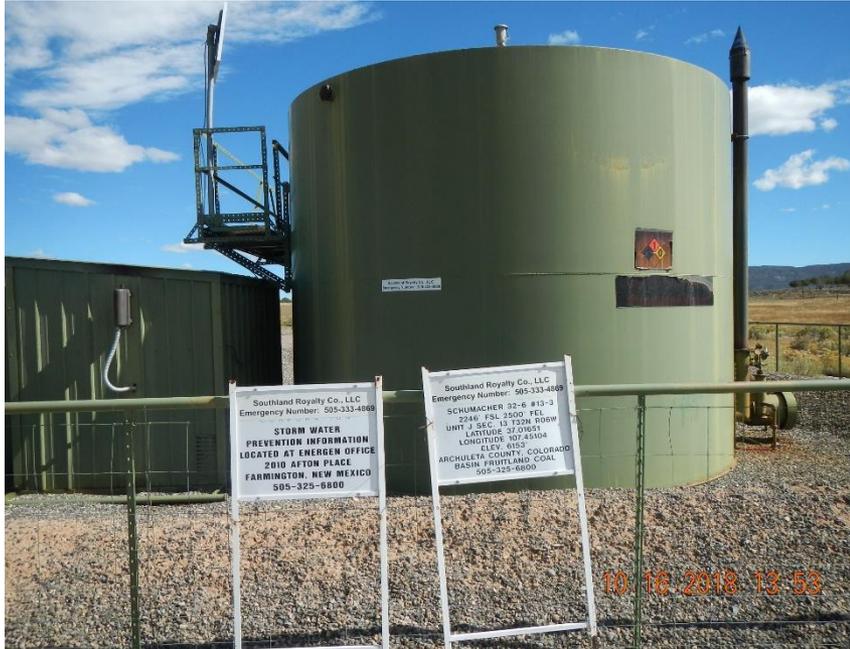
Schumacher 32-6 #13-3 location sign. Label and placard on western tank are illegible.

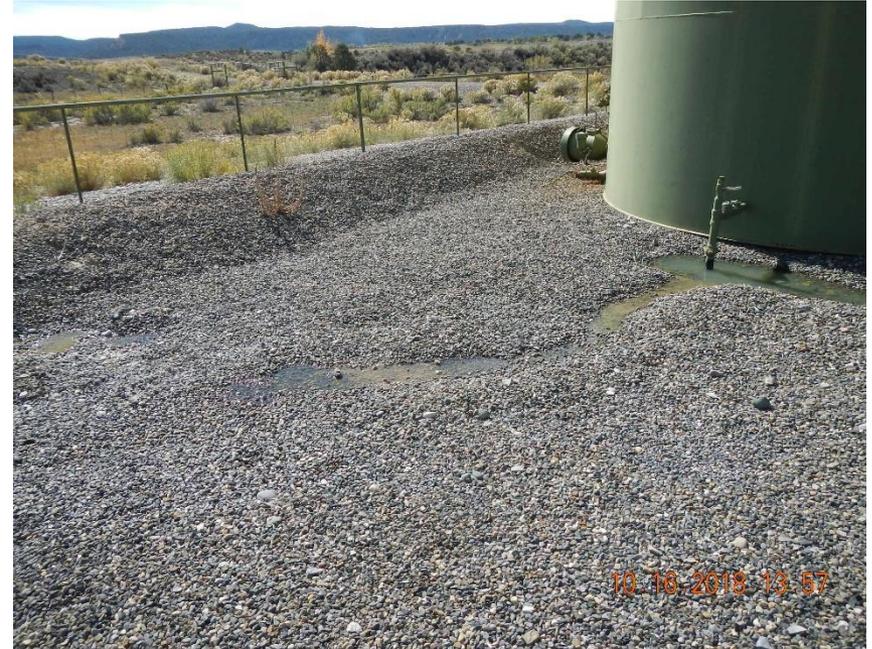
Fluid observed in secondary containment berm. Reportedly storm water.

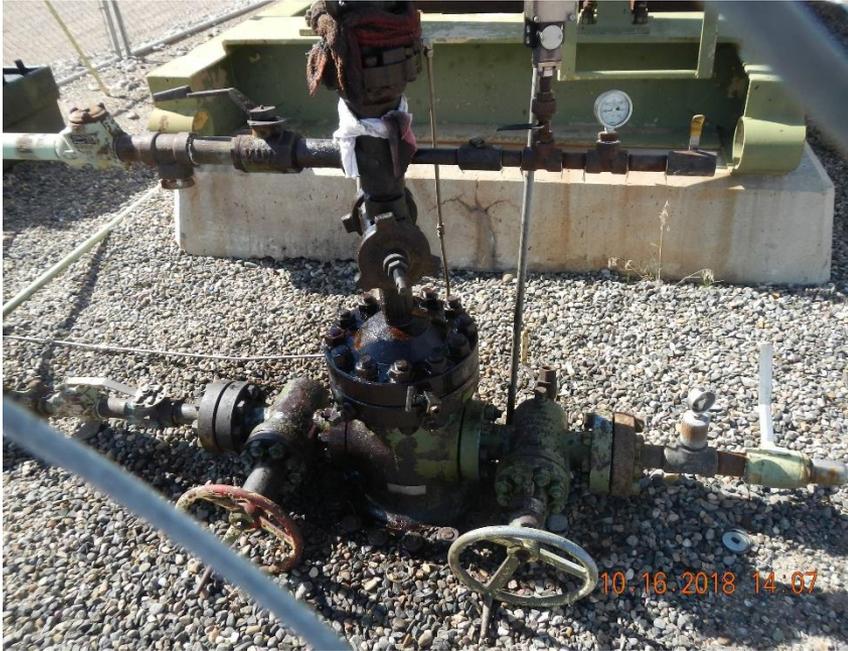
Well head is wet and stained.

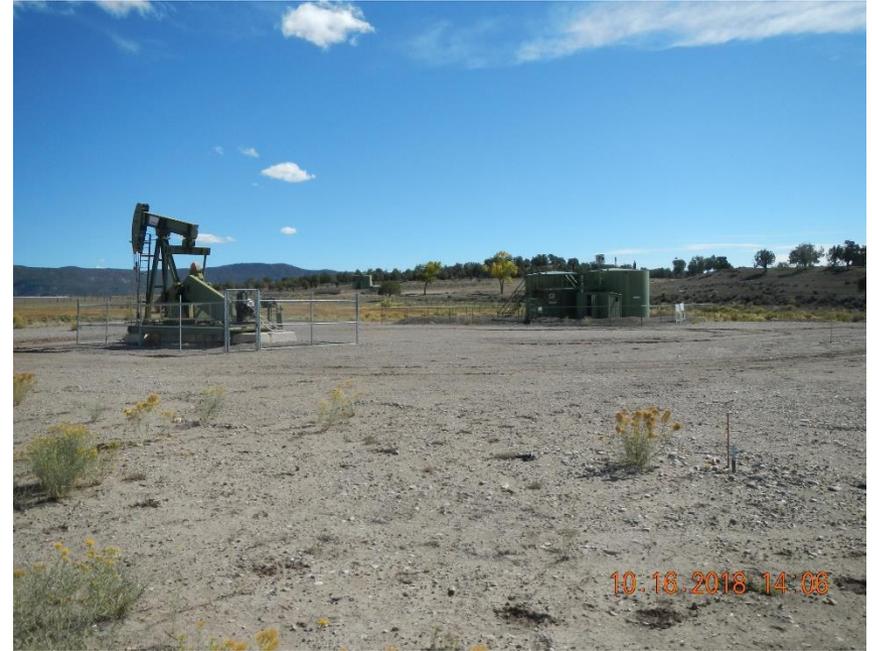
Schumacher 32-6 #13-3 location photo.
