Inspection Photos
Location Name: UPRR 60 Pan AM#1
Location ID: 320076

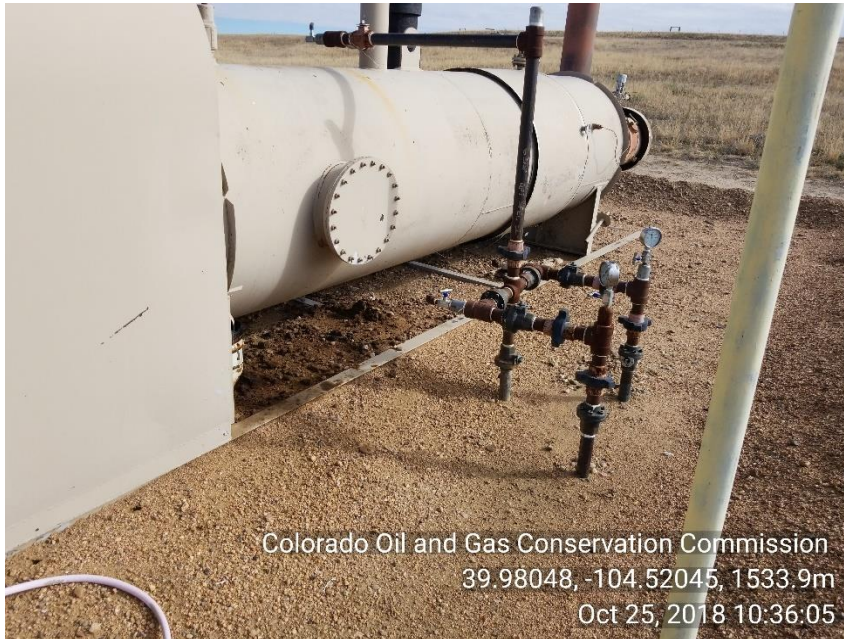
Photo 3 Stained soil under sep drain lines

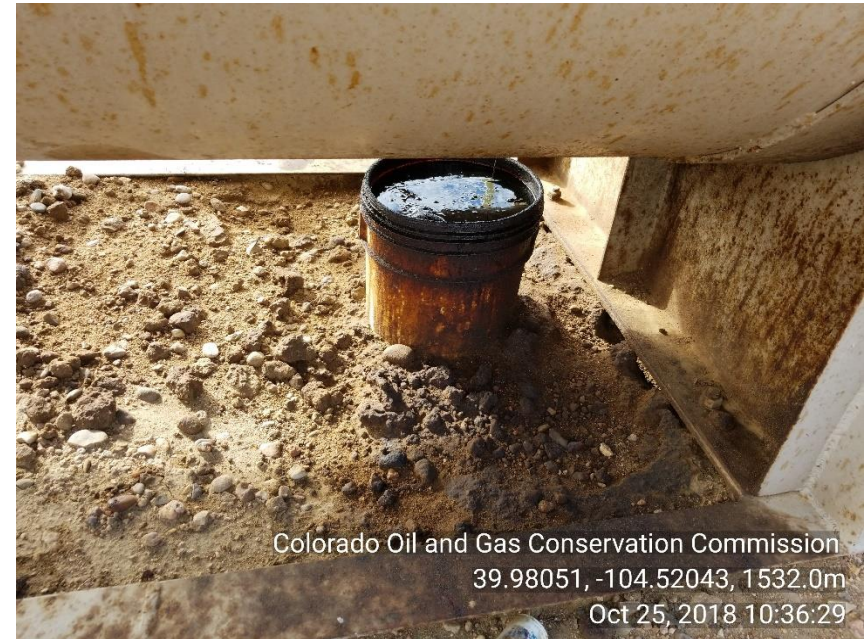
Photo 4 Stained soil under sep
