Inspection Photos
Location Name: Anderson 43-29
API: 05-081-07184

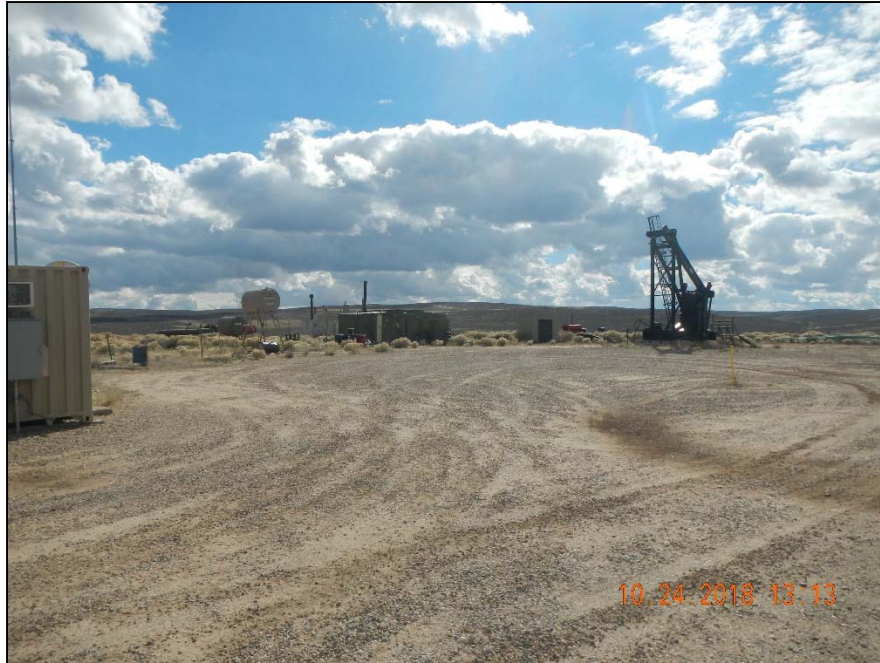
Photo 1. Overview of location taken at entrance facing southeast.

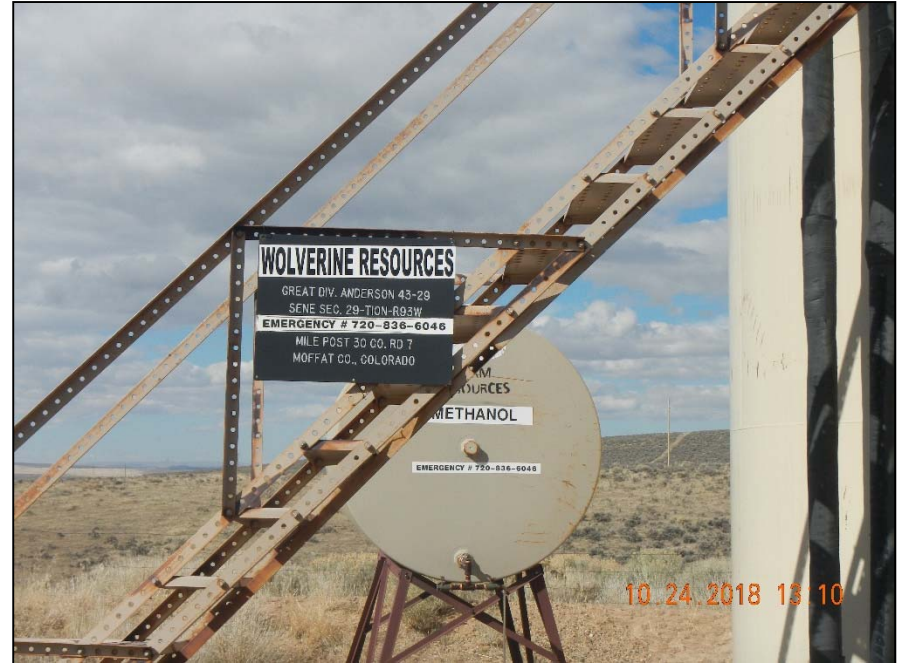
Photo 2. Previous operator emergency contact number on tank battery sign and labels.

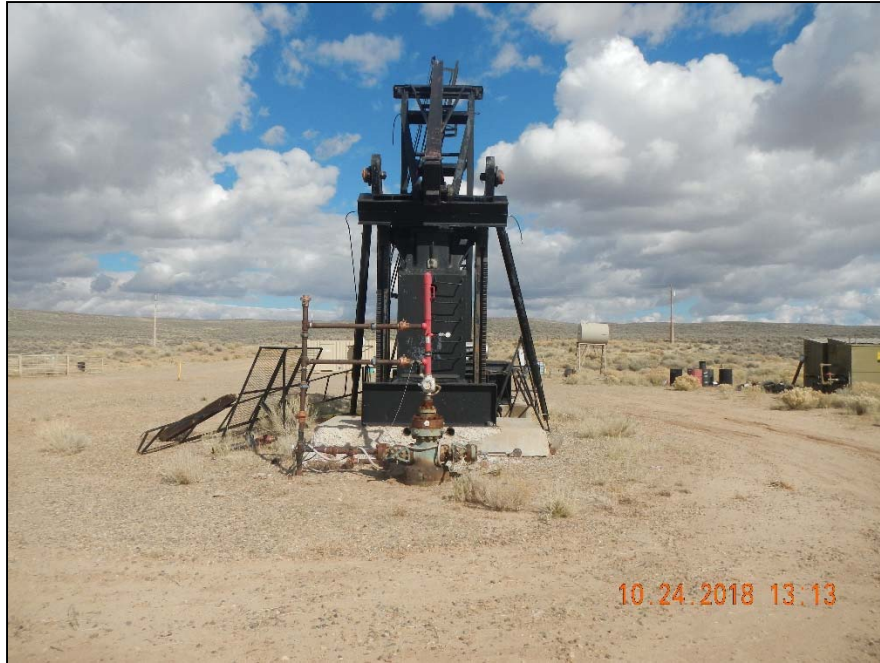
Photo 3. No wellhead sign.

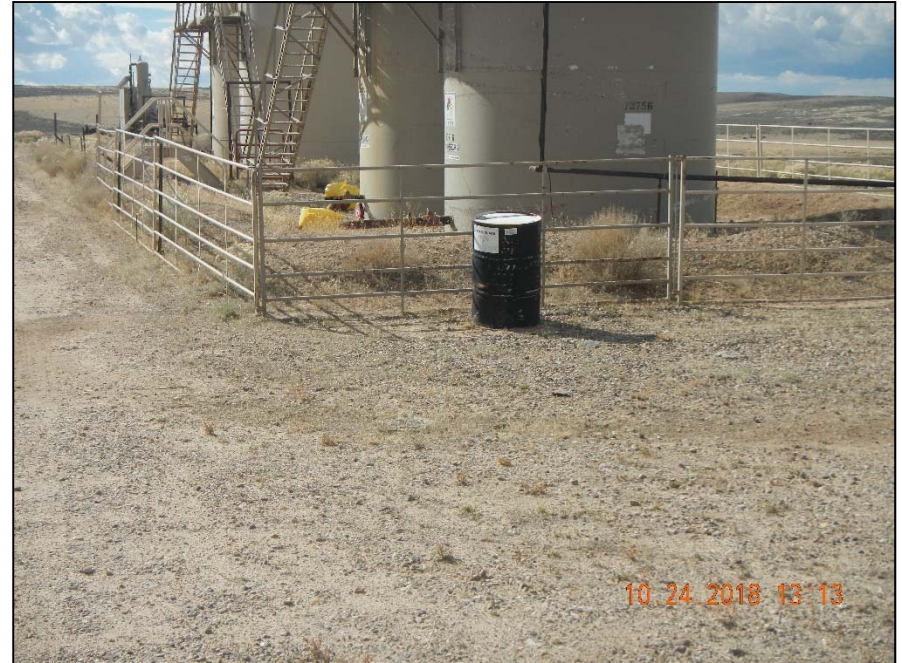
Photo 4. Barrel without secondary containment.

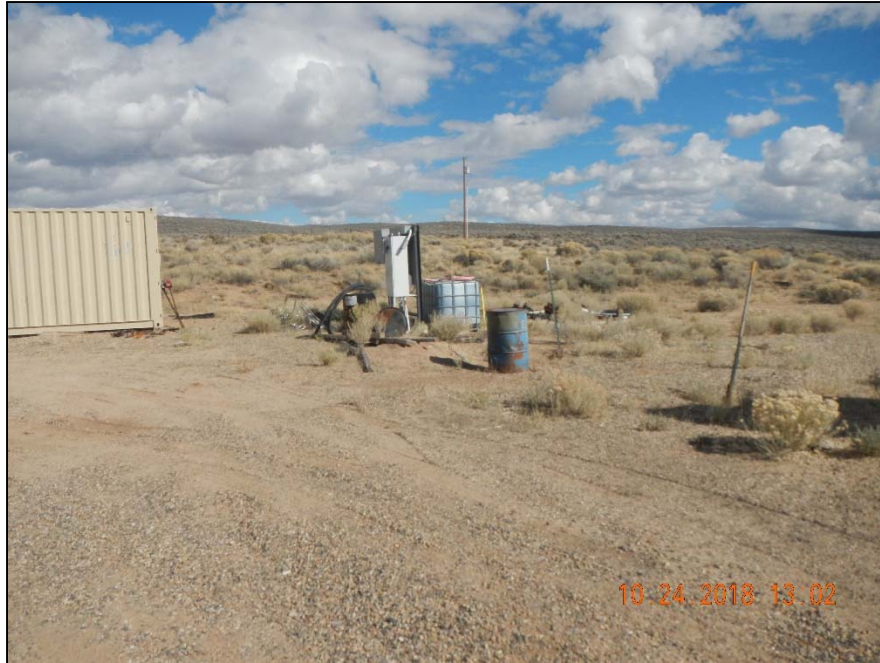
Photo 5. Equipment stored on location perimeter.

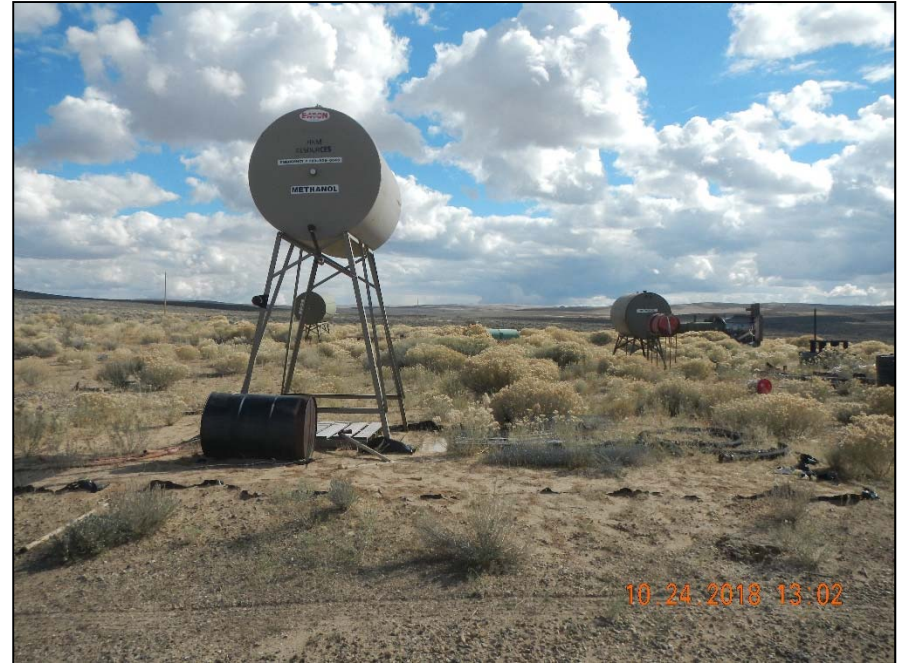
Photo 6. Equipment stored on location perimeter.

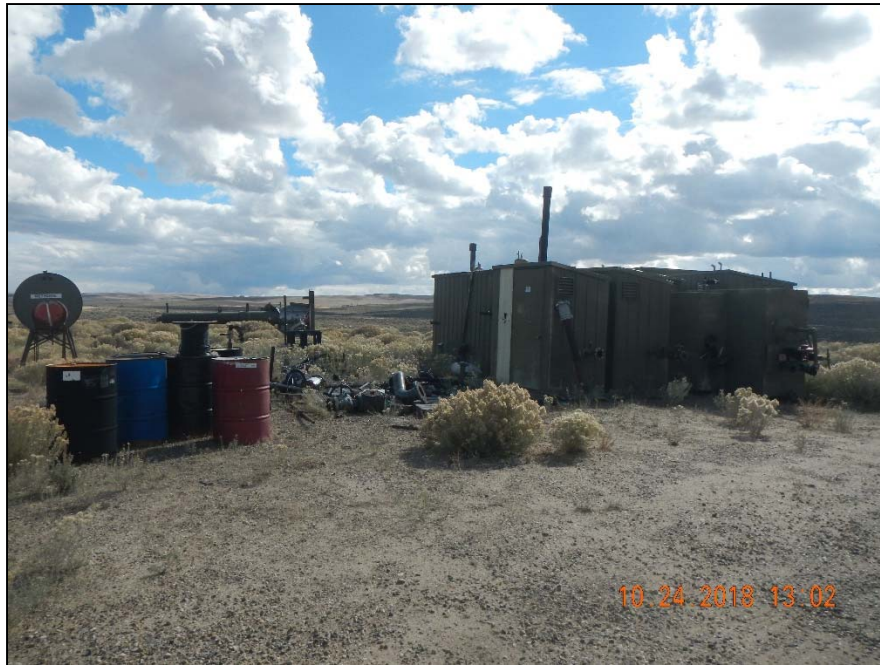
Photo 7. Equipment stored on location perimeter.

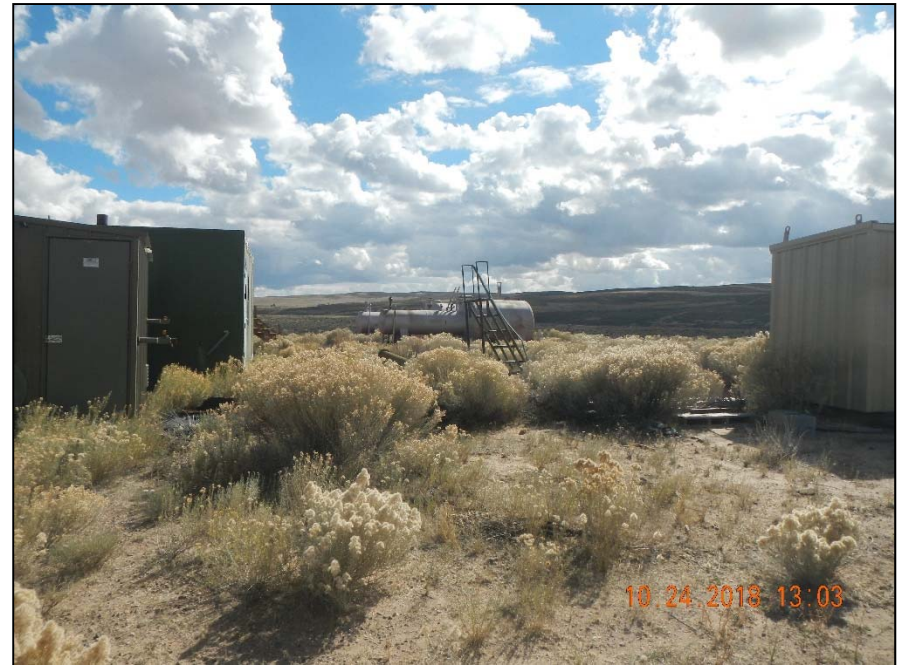
Photo 8. Equipment stored on location perimeter.

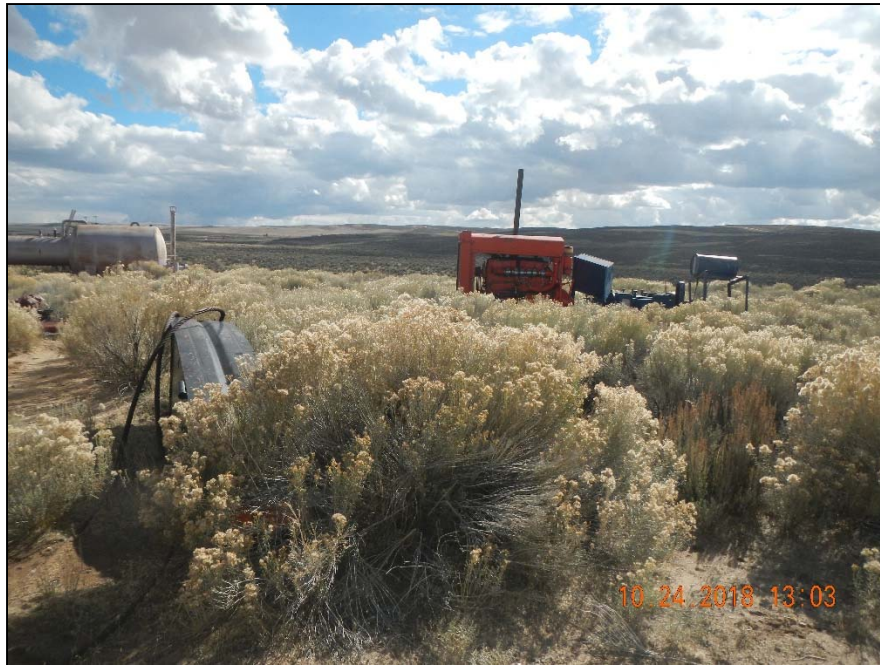
Photo 9. Equipment stored on location perimeter.

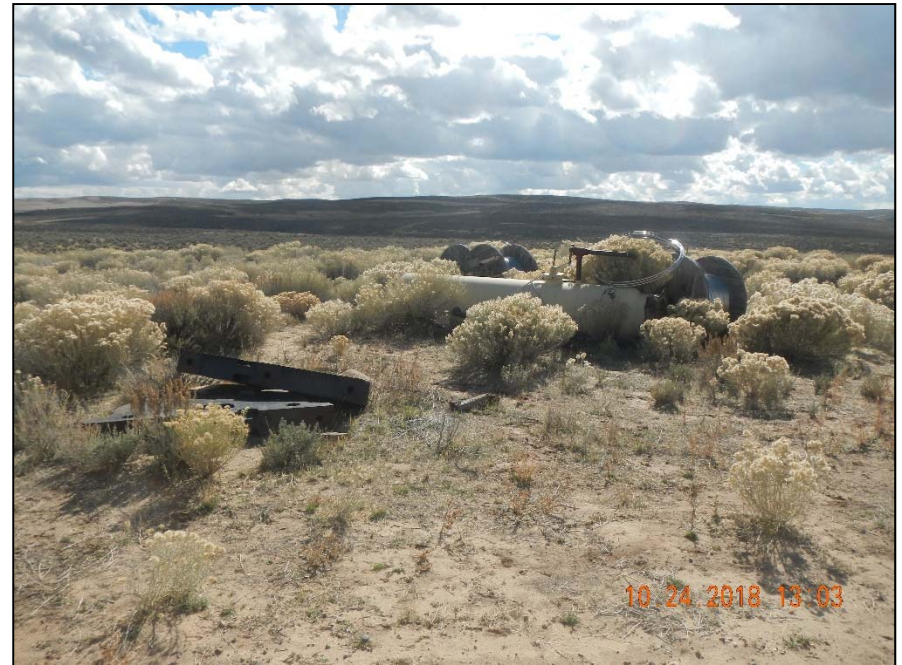
Photo 10. Equipment stored on location perimeter.

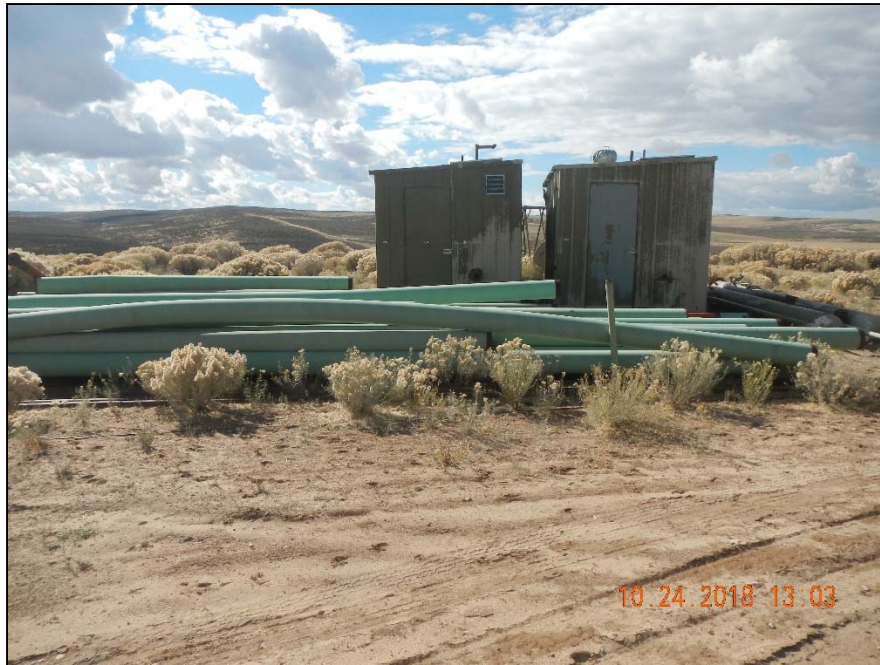
Photo 11. Equipment stored on location perimeter.

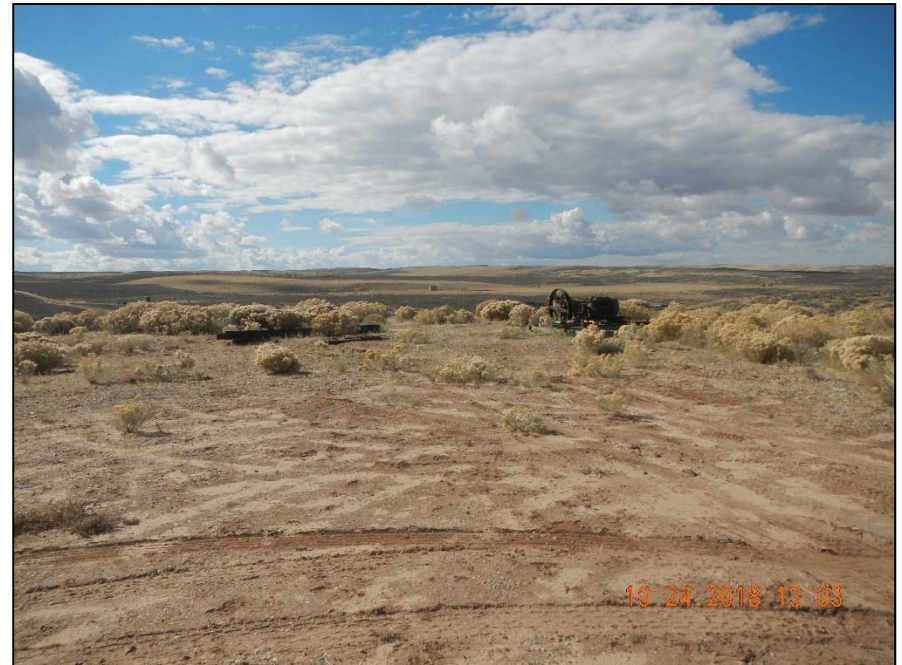
Photo 12. Equipment stored on location perimeter.
