# Inspection Photos

Operator: DJ Simmons Inc.

API: 05-033-06063

Date: 9/18/2018

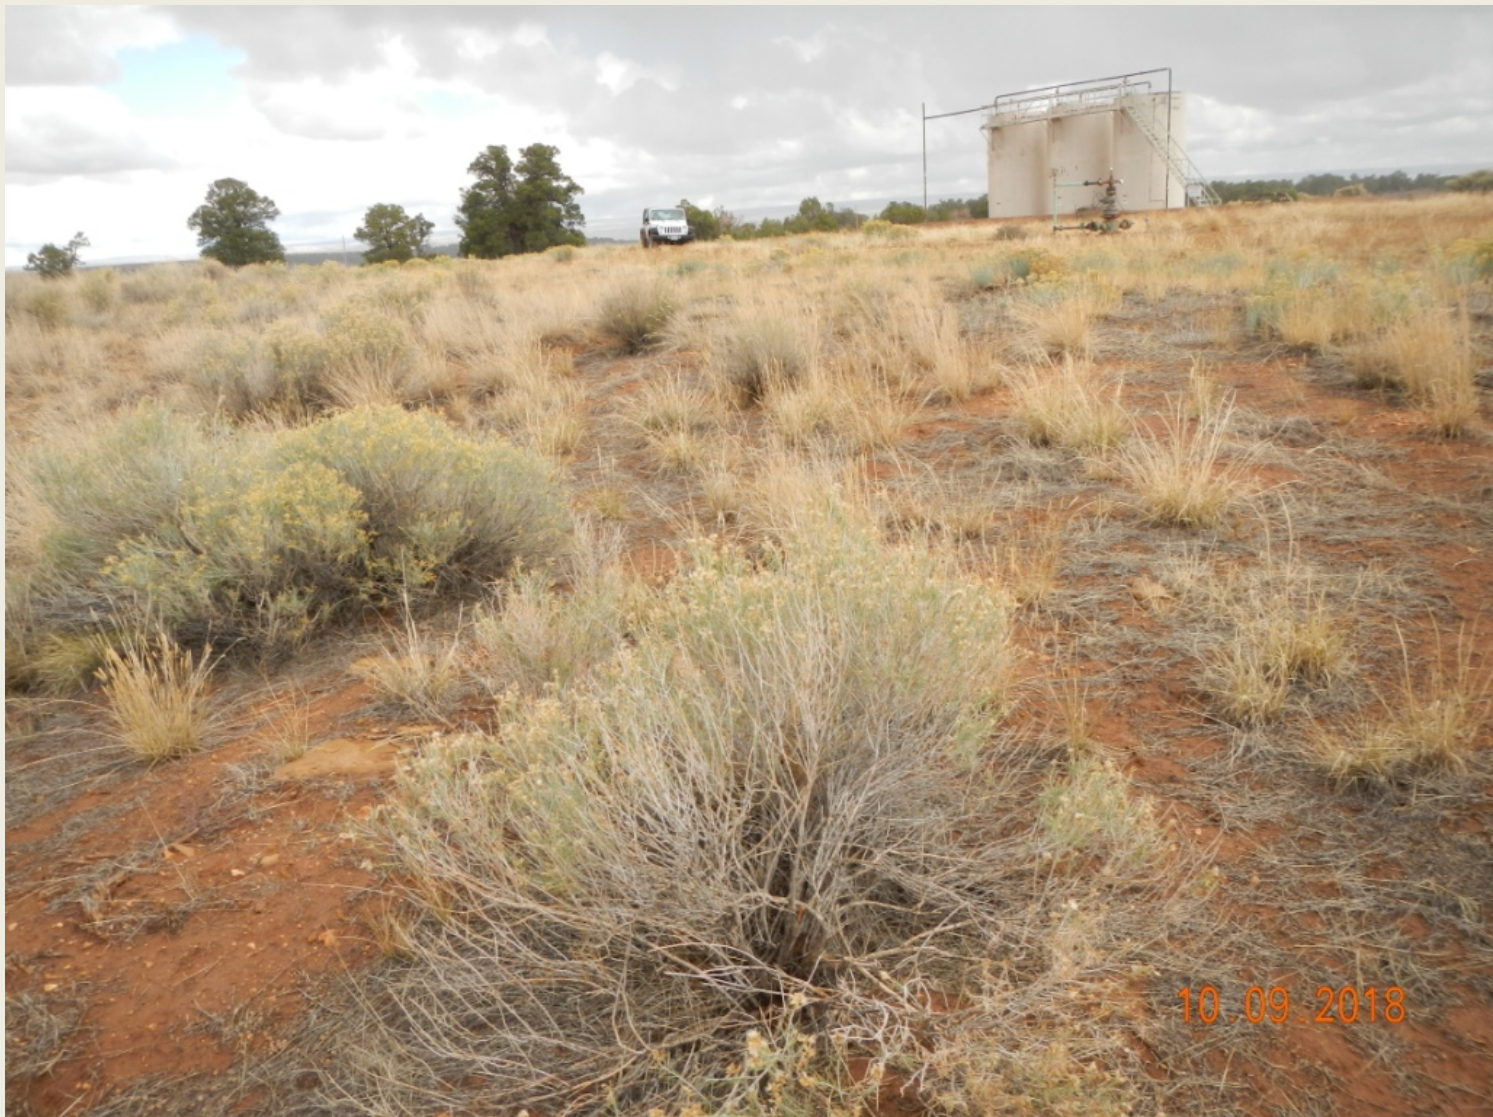
**Photo 1. View of the project area from the southwestern corner facing center.**

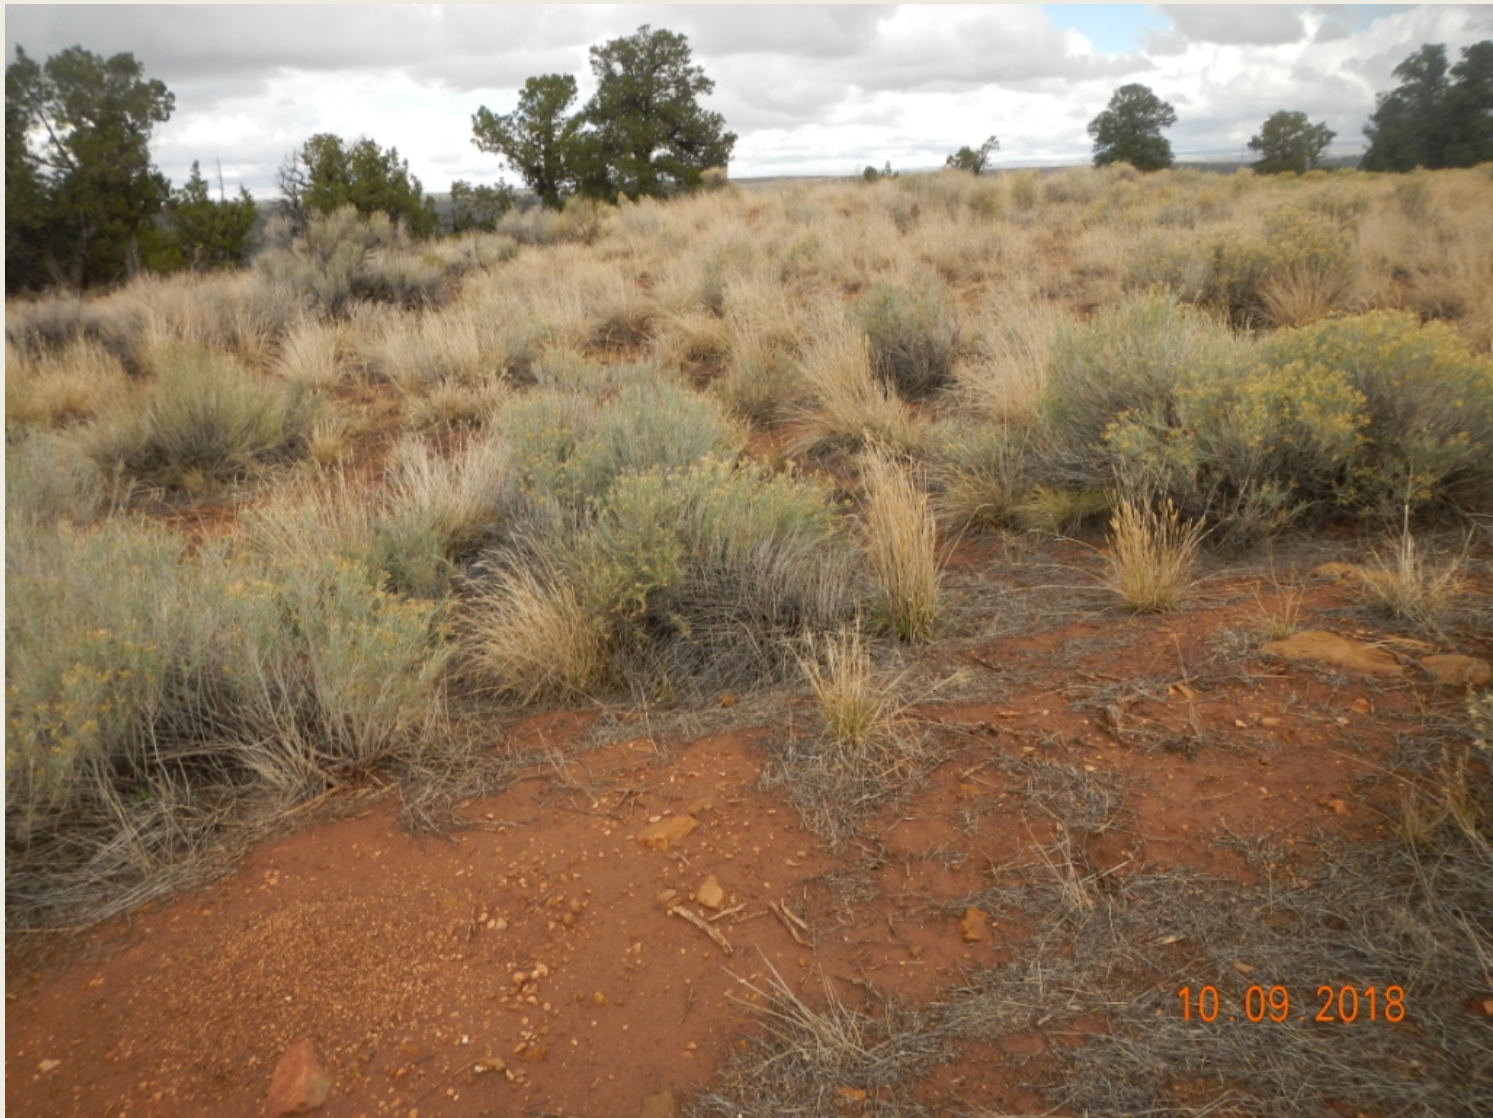
**Photo 2. View of the western portion of the project area from the southwestern corner facing northward. Revegetation is progressing within outer reclamation areas with grass such as crested wheatgrass (*Agropyron cristatum*) and shrubs such as rubber rabbitbrush (*Chrysothamnus nauseosus*).**

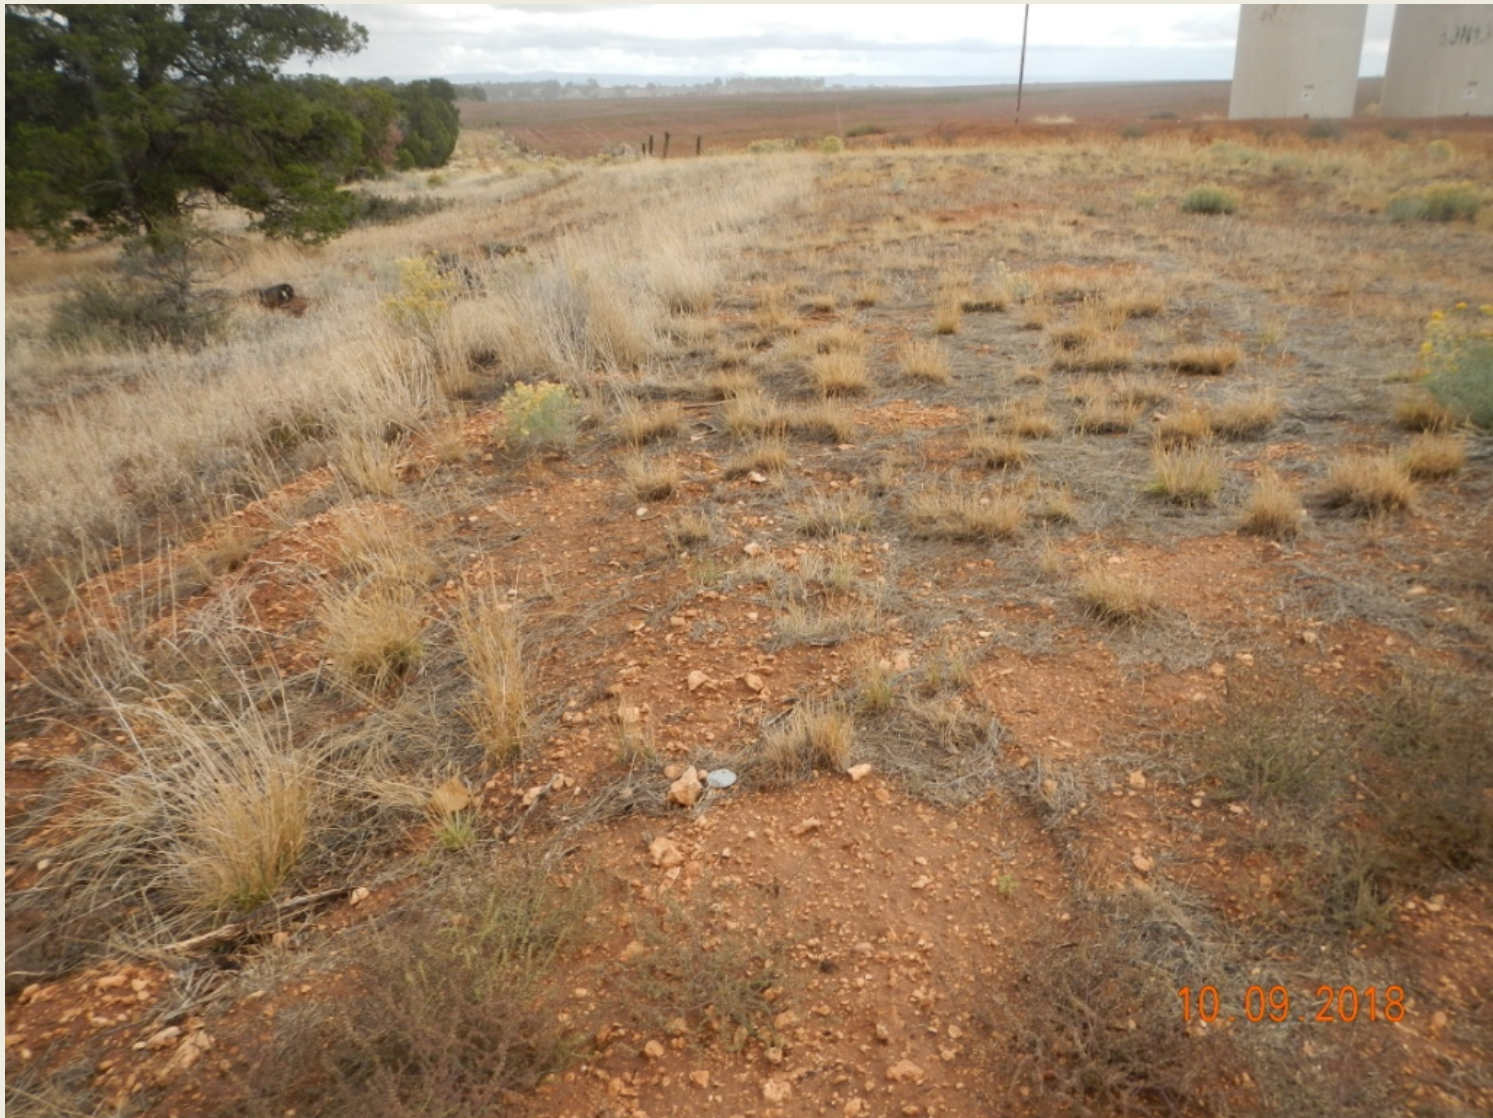
**Photo 3. View of the northern portion of the project area from the northwestern corner facing eastward.**
