Inspection Photos

Operator: BP Production

API: 05-067-08778

Date: 10/16/2018

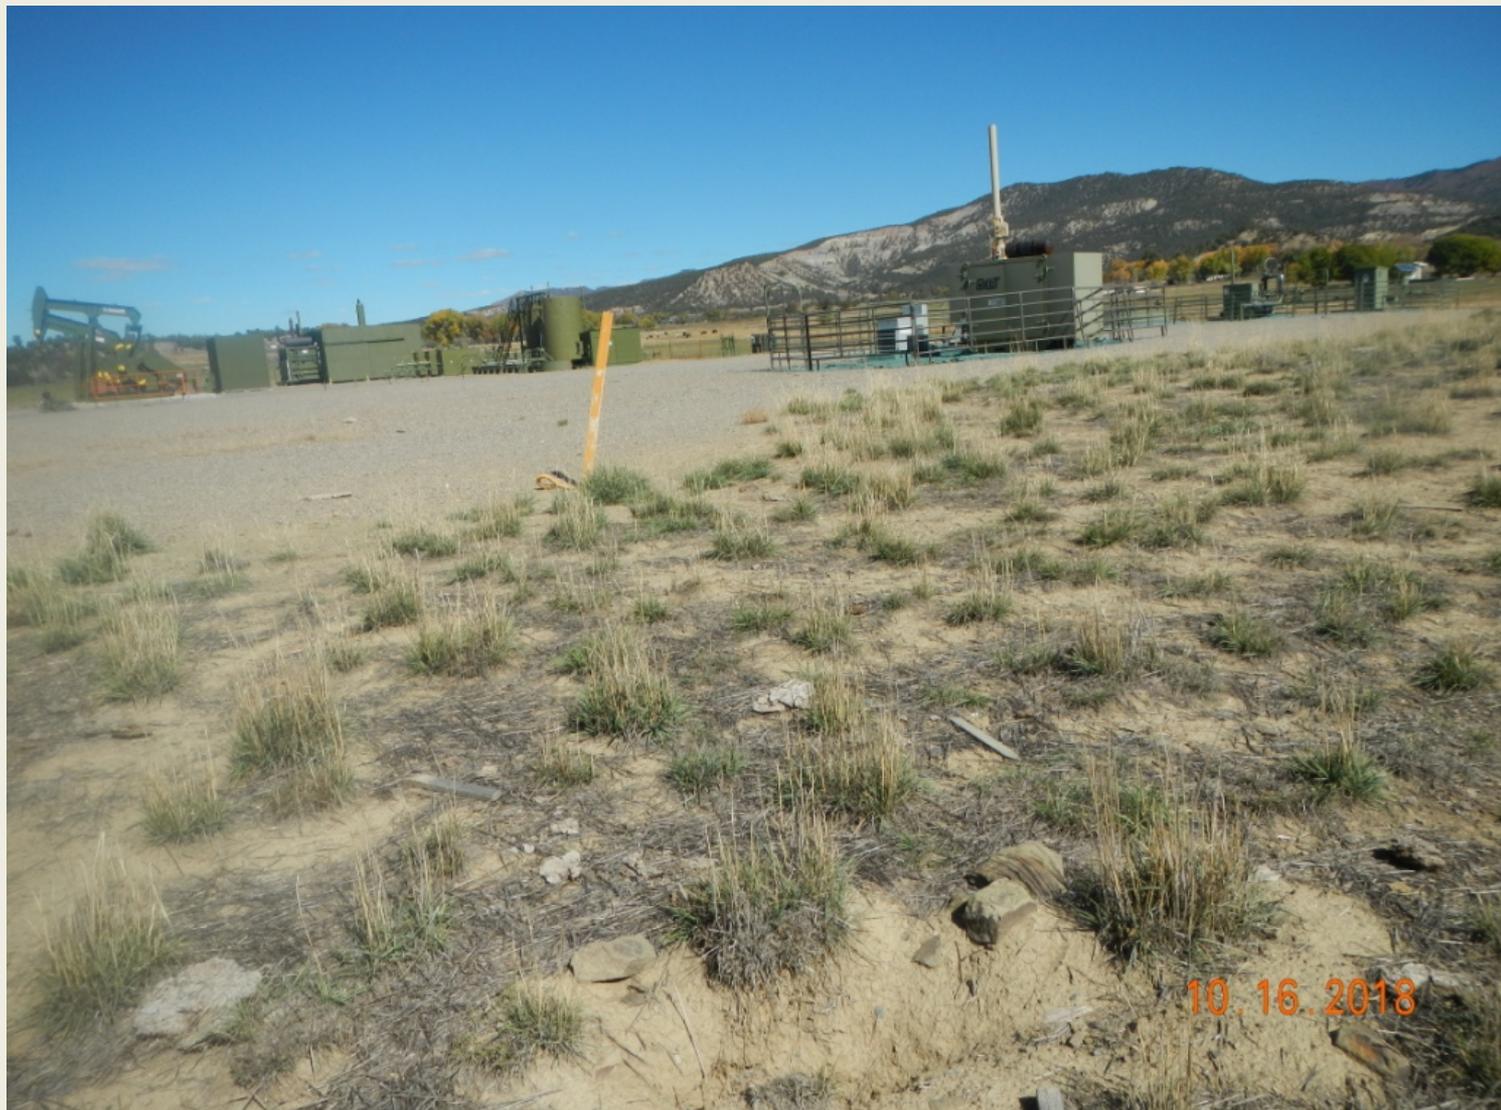
Photo 1. View of the project area from the southwestern corner facing center.

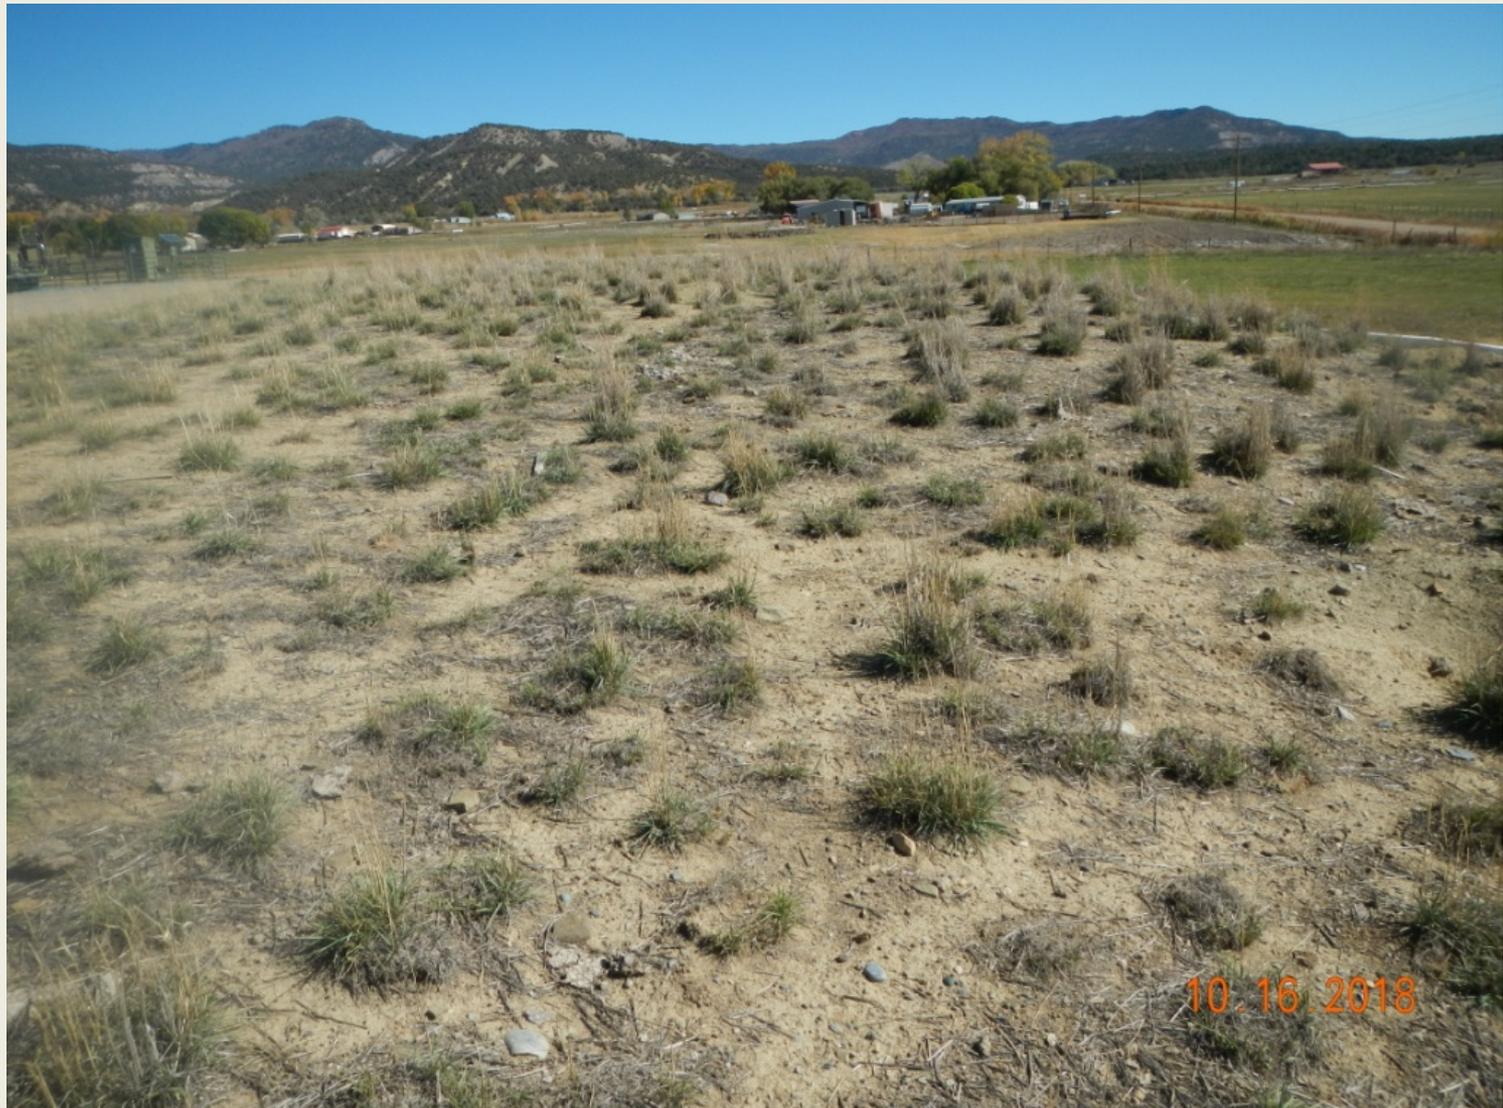
Photo 2. View of the southern project area from the southwestern corner facing eastward. Revegetation is progressing within the interim reclamation areas with grasses such as sand dropseed (*Sporobolus airoides*) and intermediate wheatgrass (*Thinopyron intermedium*).

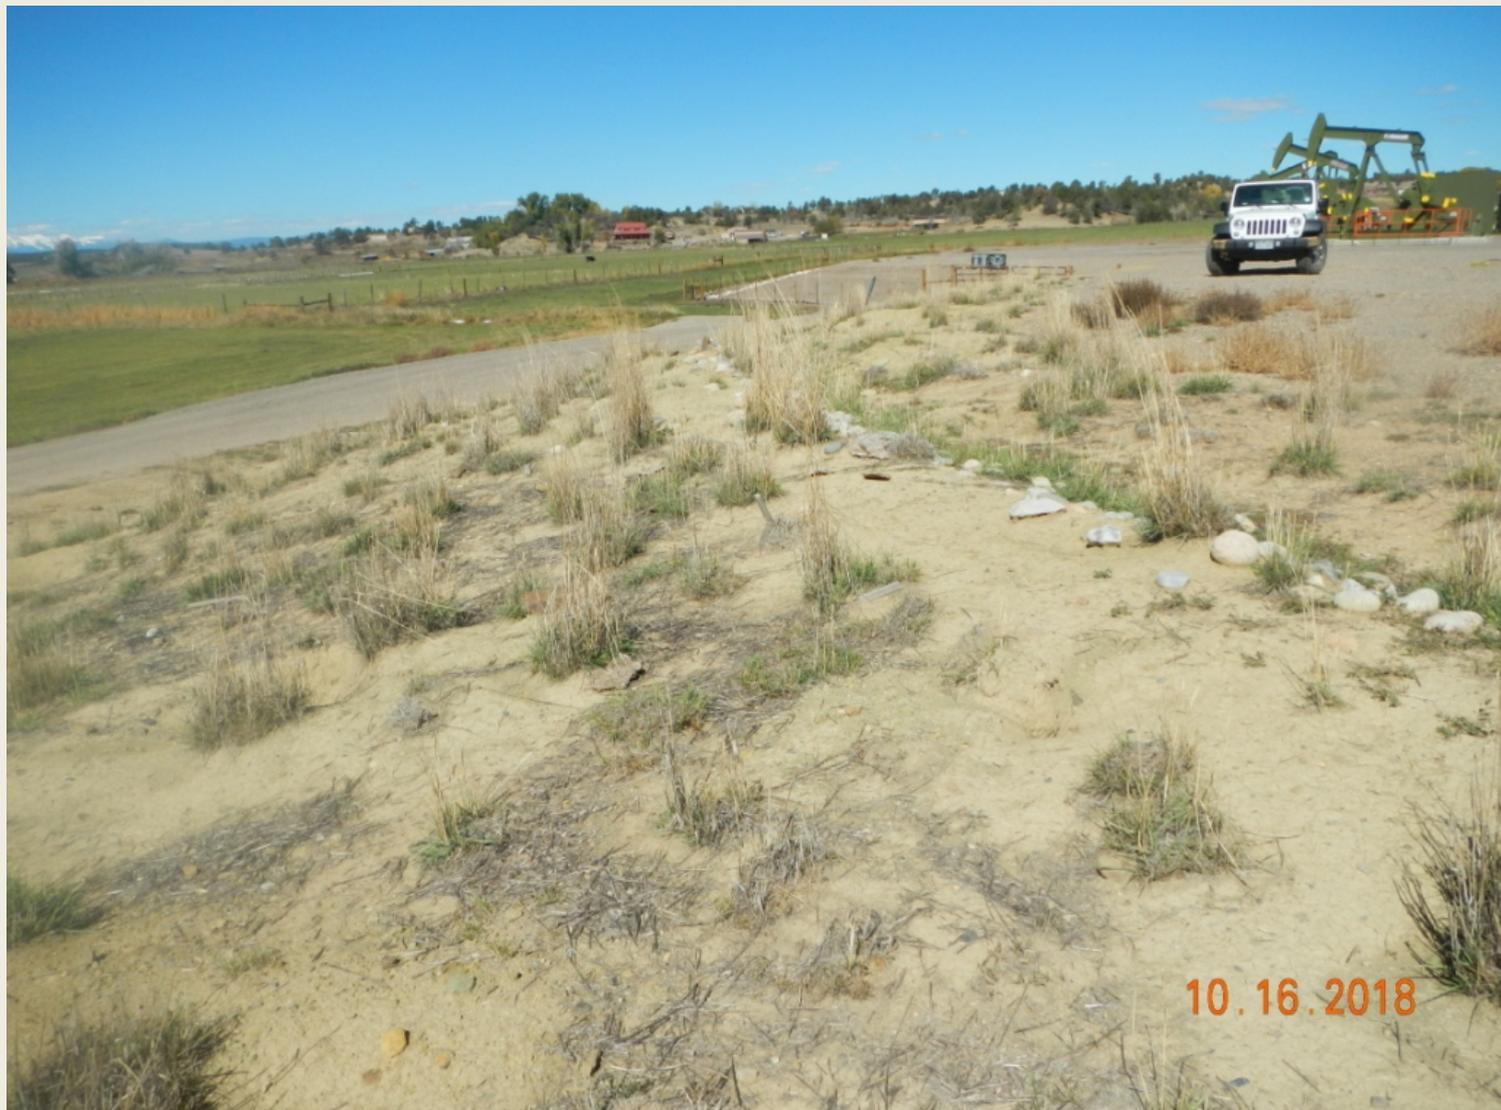
Photo 3. View of the southwestern project area from the southwestern corner facing northward.

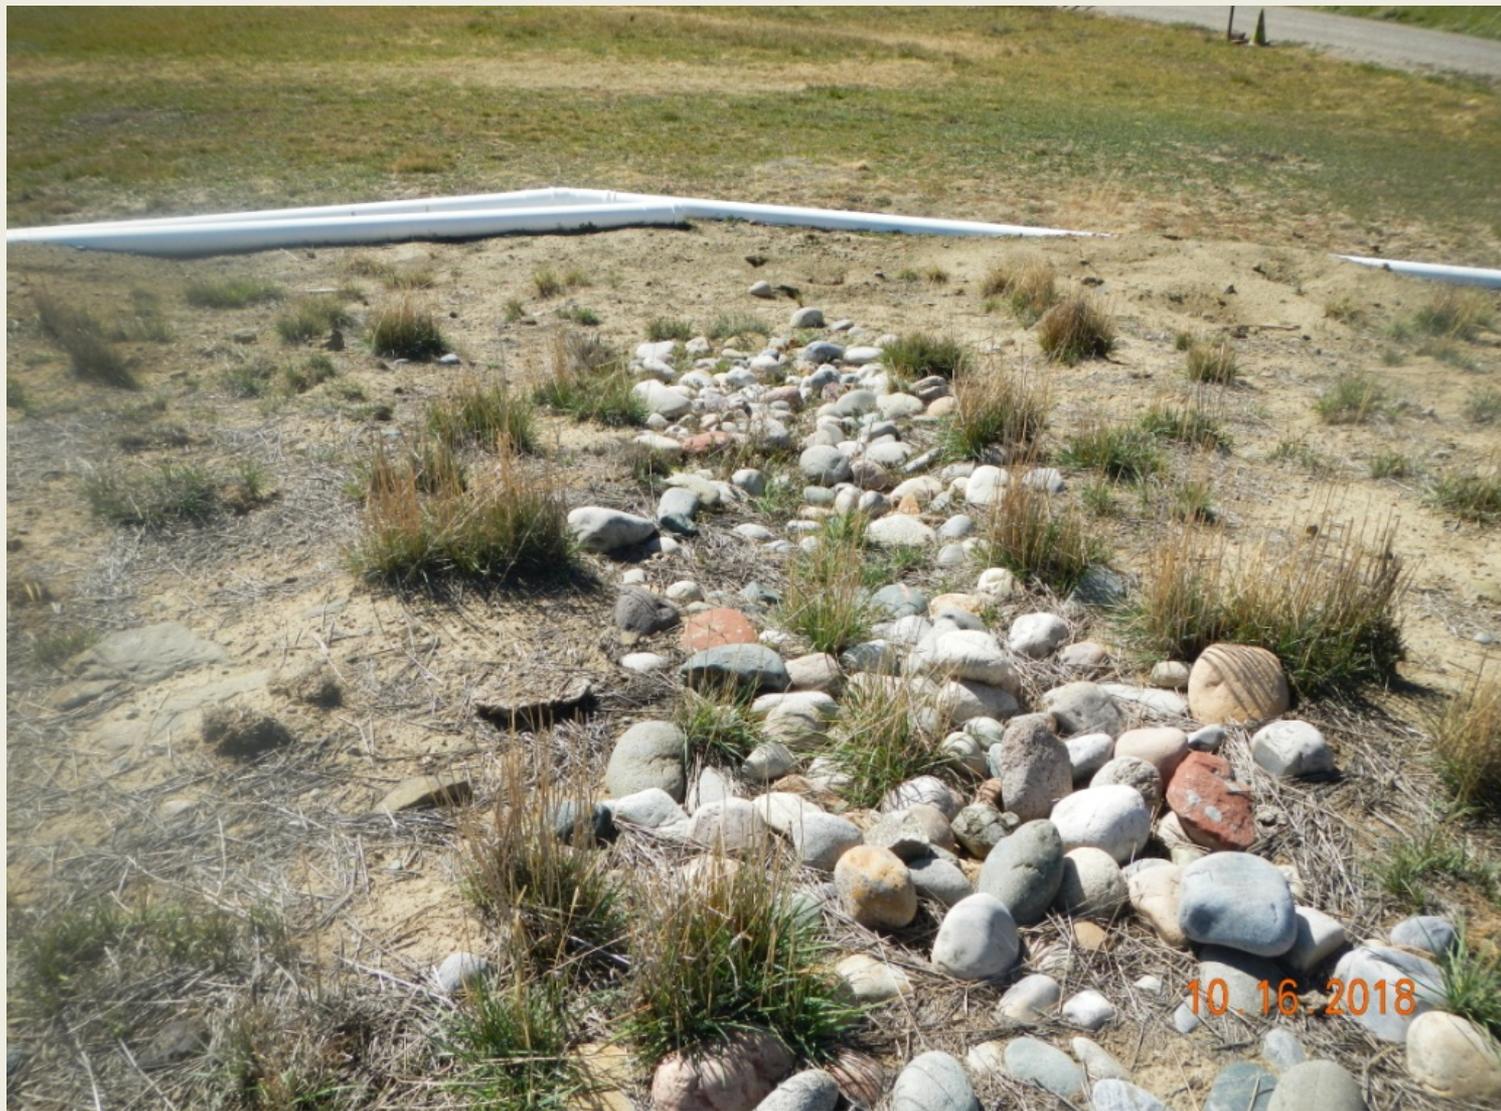
Photo 4. View of cobble rundown in the southwestern corner that appears to be functioning.

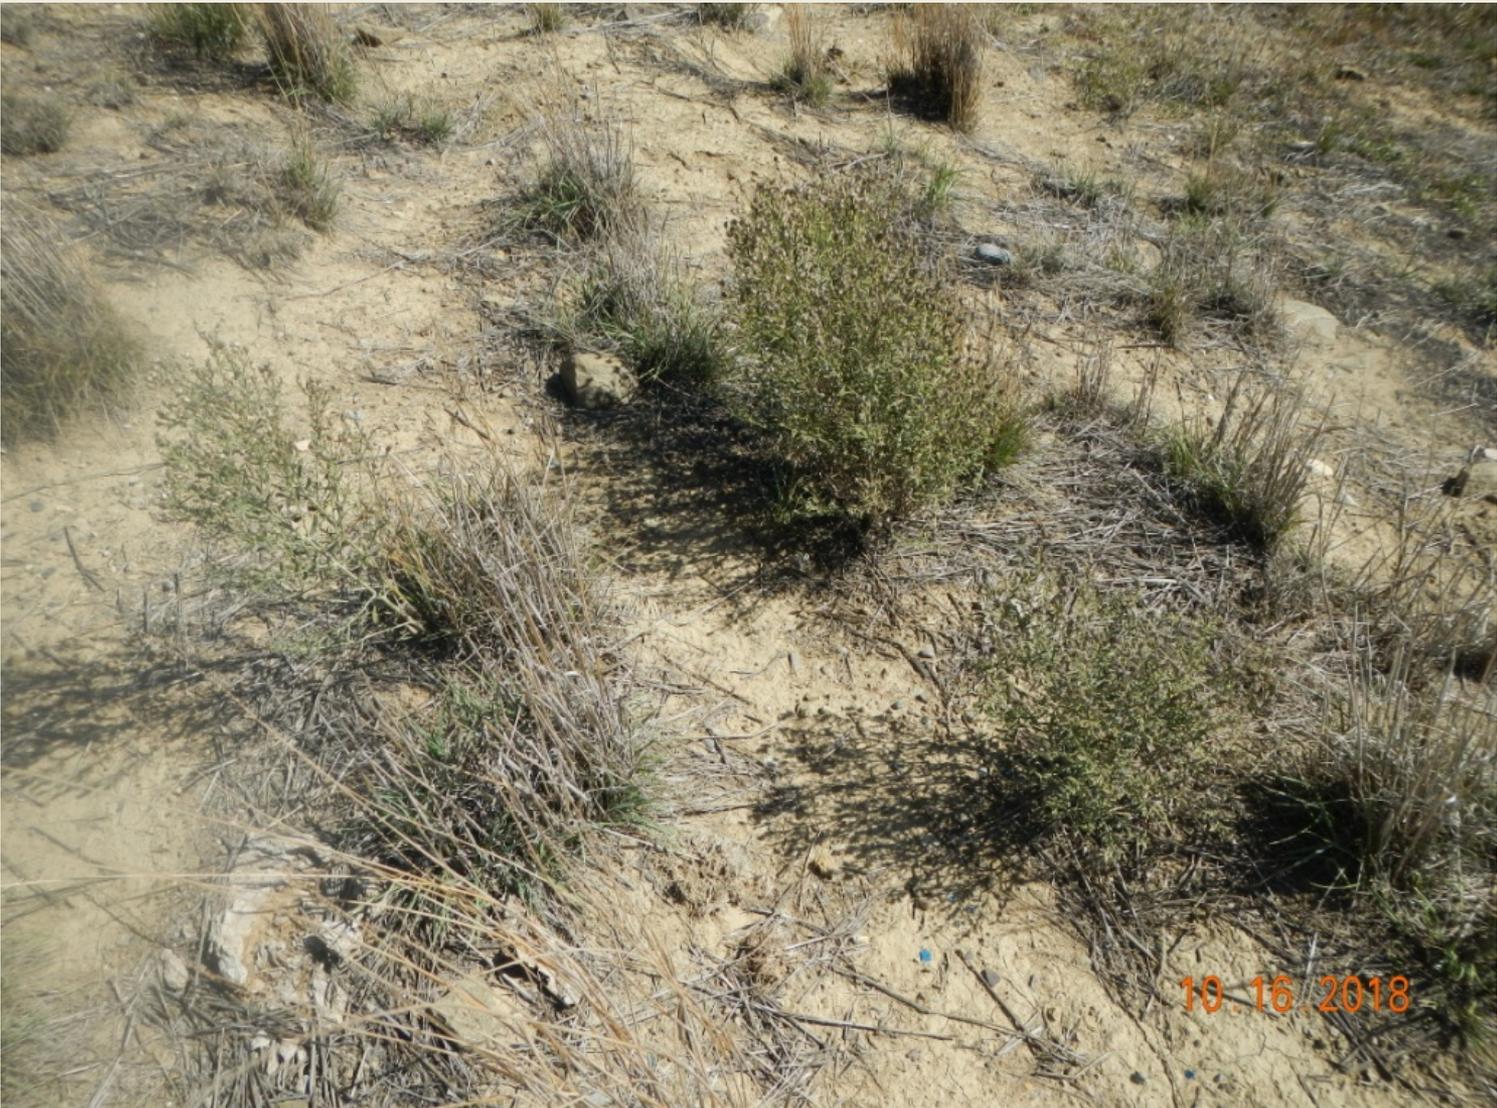
Photo 5. View of Russian knapweeds (*Acroptilon repens*) within the southeastern project area. Approximately 30 individuals observed.
