Construction and Stormwater Inspection

Operator: MALLARD EXPLORATION LLC- #10670

Location ID: 456368

Inspection Photos
Location Name: Khaki Campbell East /Pad
Location ID: 456368

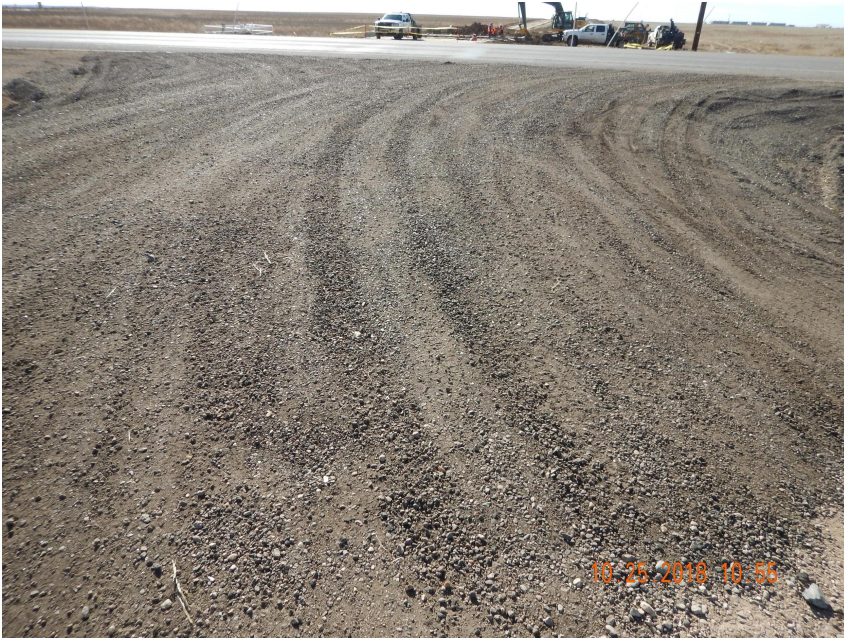
Photo 1. Photo taken from the entrance of location off Highway 14, facing South. Operator has installed a culvert along the roadside ditch and gravel at the entrance.

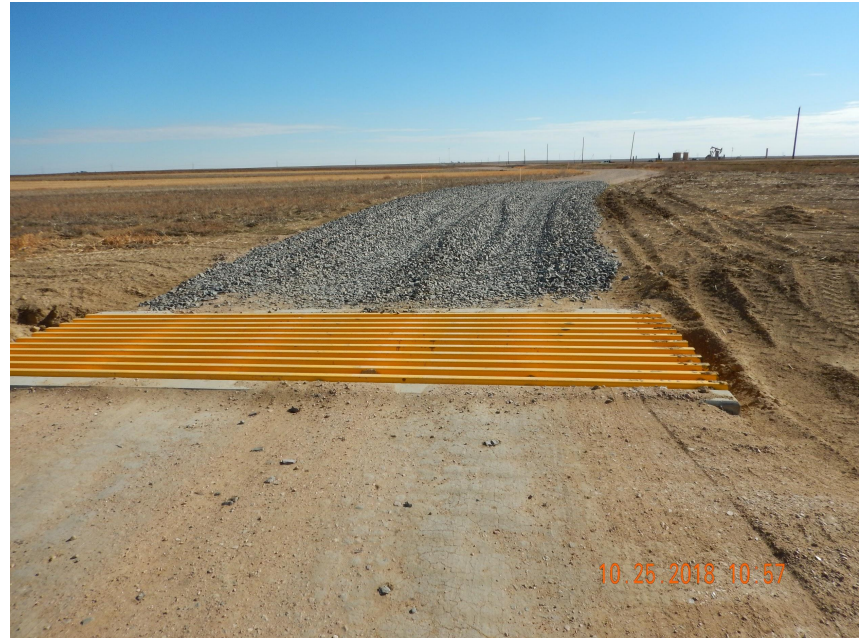
Photo 2. Photo taken from the entrance of the location, facing East. Operator has installed vehicle tracking devices which appear to be in proper functioning condition.

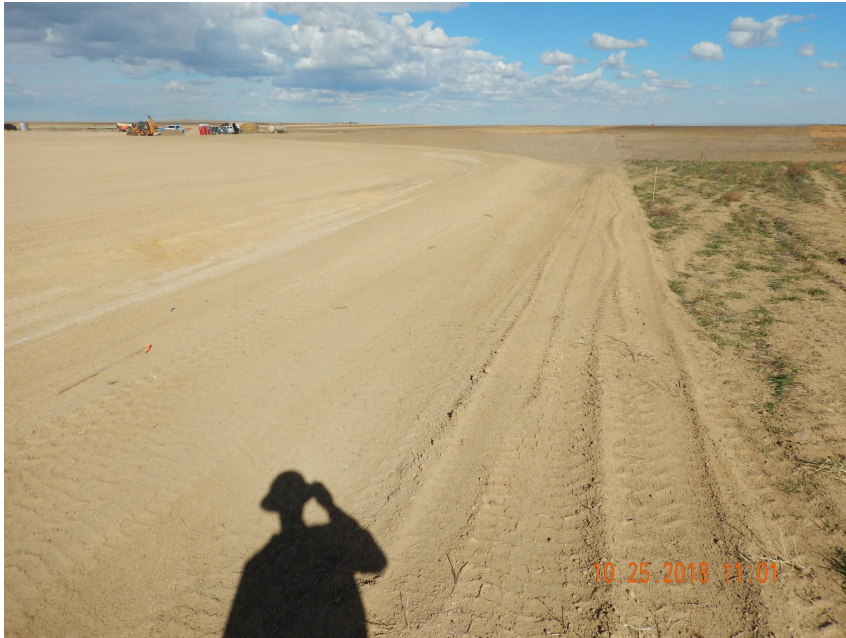
Photo 3. Photo taken from the eastern perimeter of the location, facing North. Operator has installed 2 sets of ditch and berm BMPs around the location.

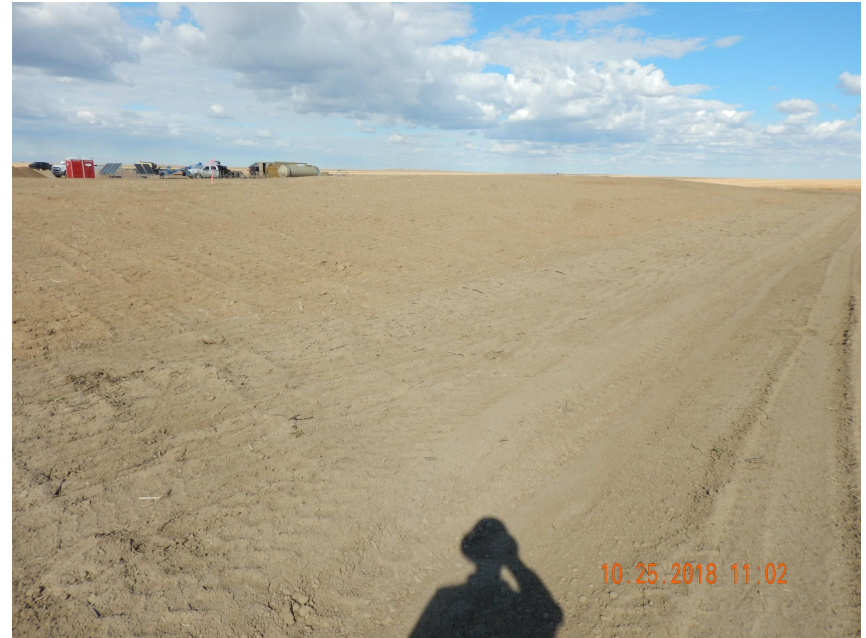
Photo 4. Photo taken from the northeastern perimeter of the location, facing North. Photo illustrates the topsoil stockpile which has been temporarily stabilized with equipment tracking.

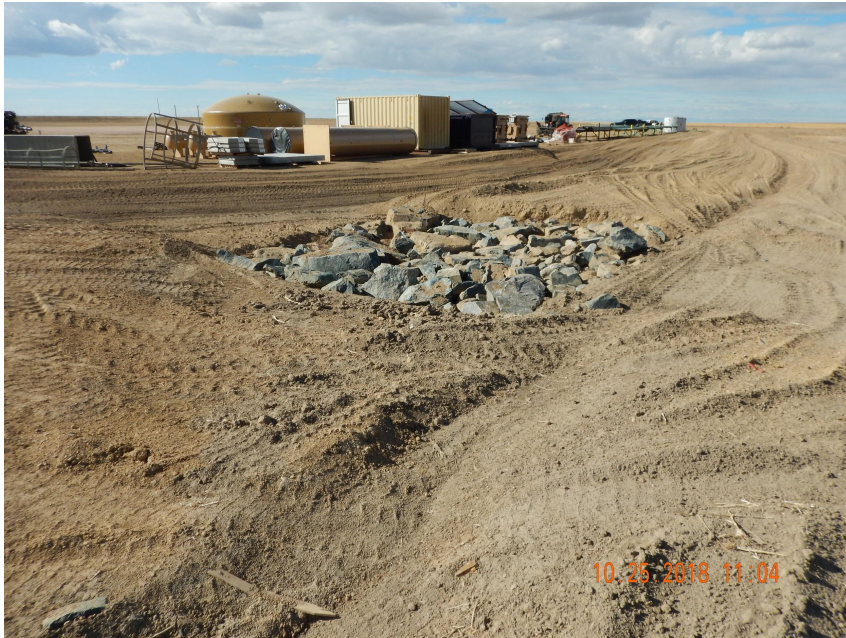
Photo 5. Photo taken from the northeast perimeter of the location, facing West. Operator has installed a sediment trap with a stabilized outlet.

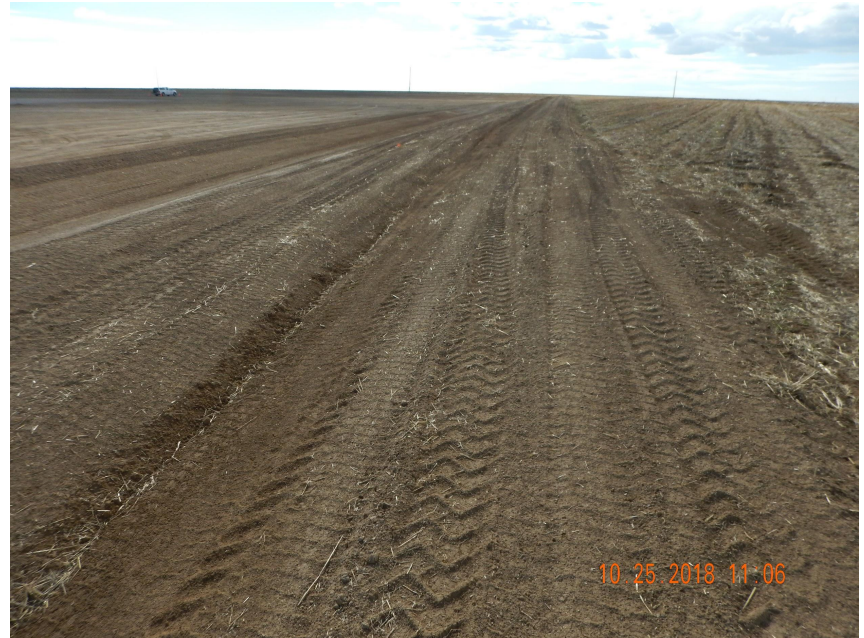
Photo 6. Photo taken from the northwestern perimeter of the location, facing South. See comments under Photo 3.

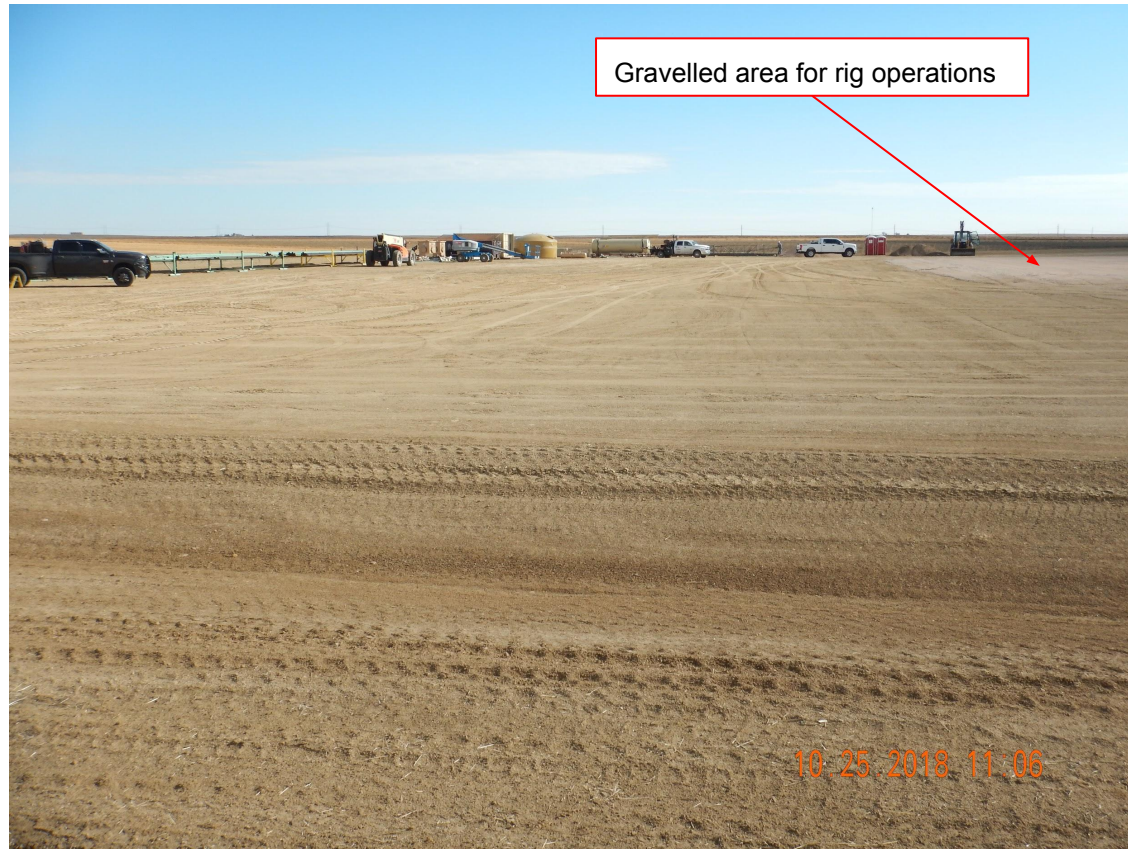
Photo 7. Photo taken from the northwestern perimeter of the location, facing East. Photo illustrates the northern well pad area which has been compacted but not necessarily stabilized from wind erosion. Operator shall ensure compliance with Rule 1002.e.(1) to reasonably control dust and minimize erosion which includes wind erosion.

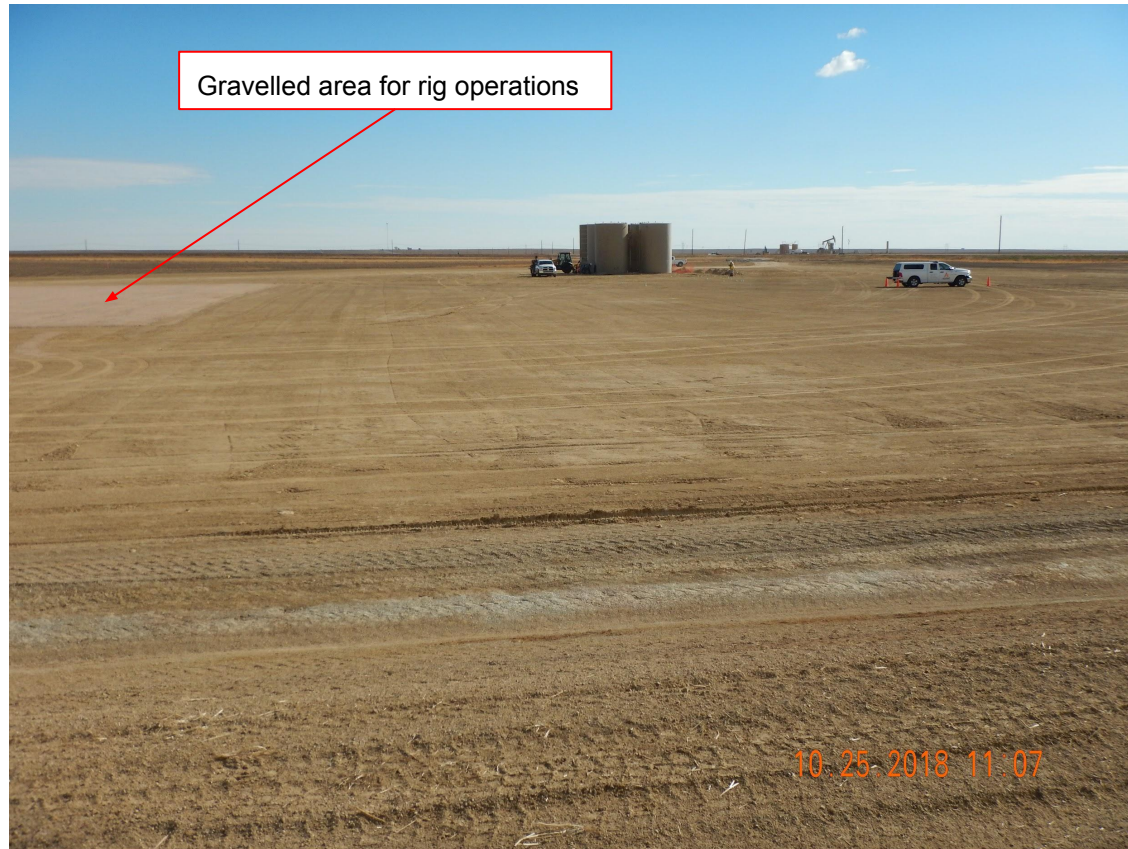
Photo 8. Photo taken from the western perimeter of the location, facing East. Photo illustrates the southern well pad area which has been compacted but not necessarily stabilized from wind erosion. See comments under Photo 7.

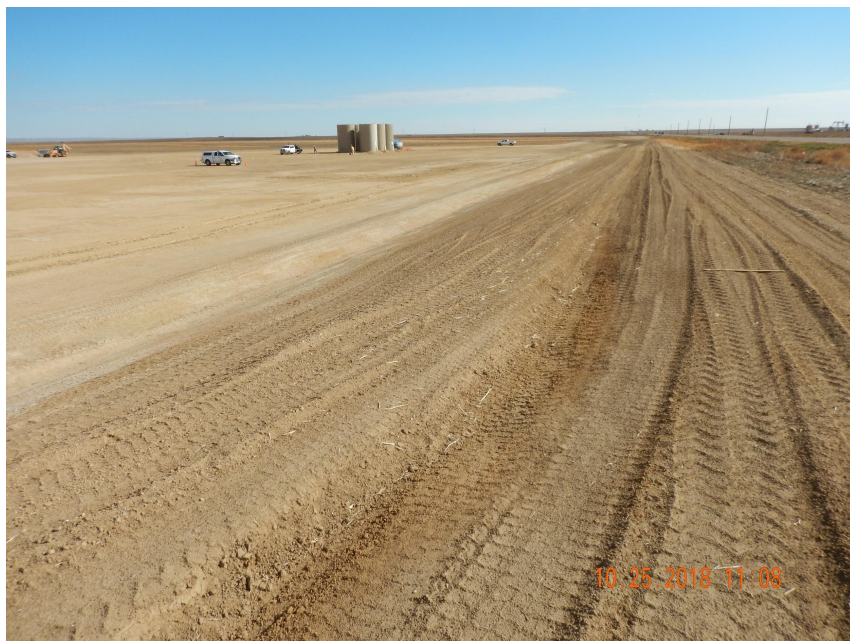
Photo 9. Photo taken from the southwestern perimeter of the location, facing East. See comments under Photo 3.

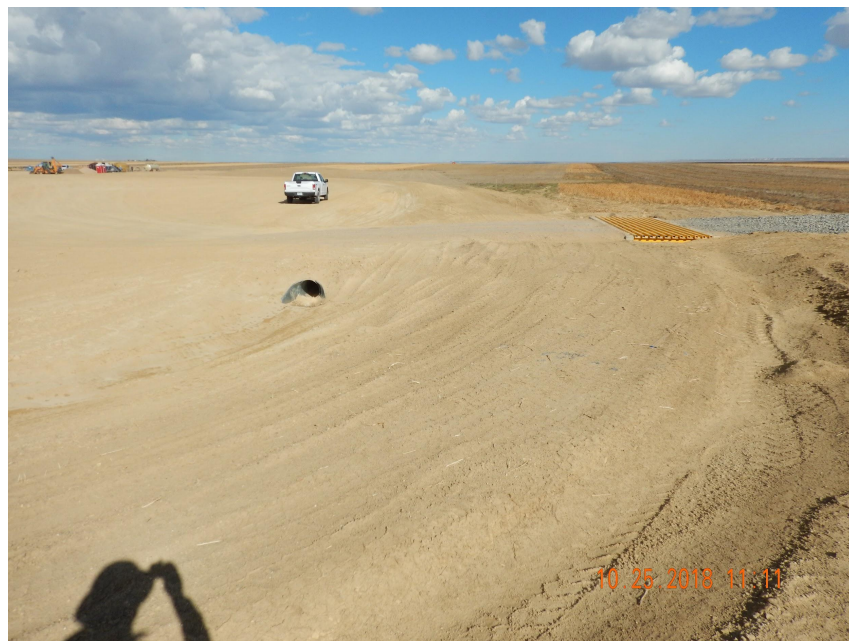
Photo 10. Photo taken from the southeastern perimeter of the location, facing North. See comments under Photo 3.
