Inspection Photos

Operator: BP Production

API: 05-067-06629

Date: 10/16/2018

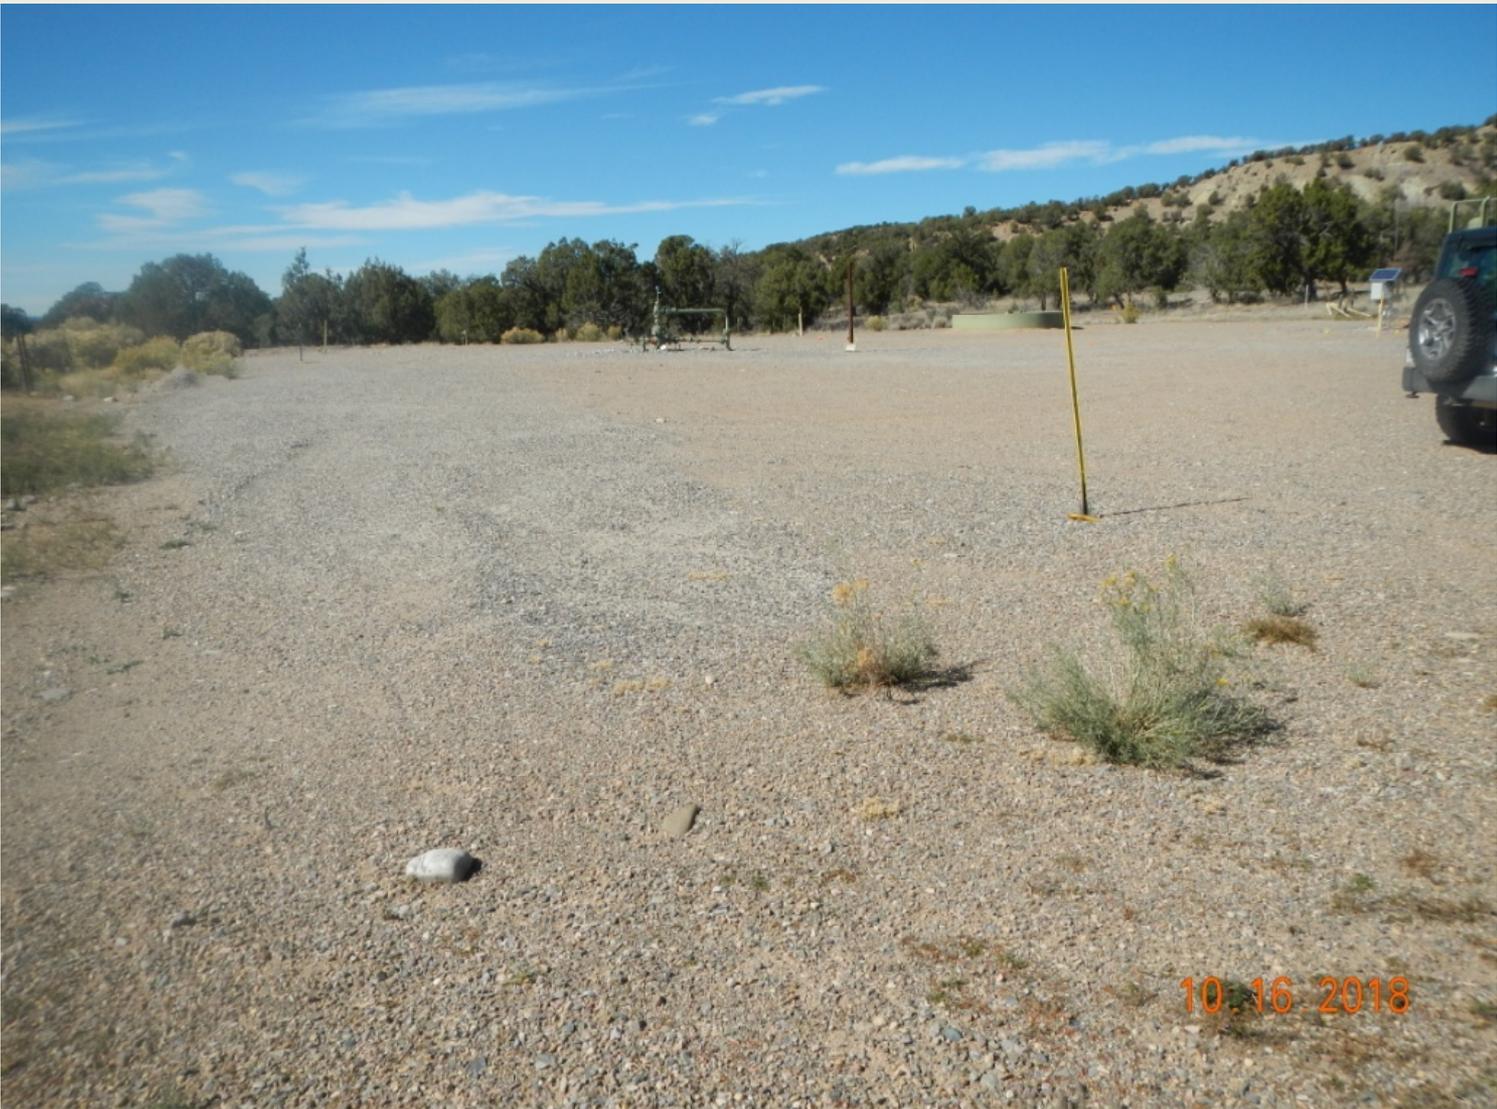
Photo 1. View of the project area from the southeastern corner facing center.

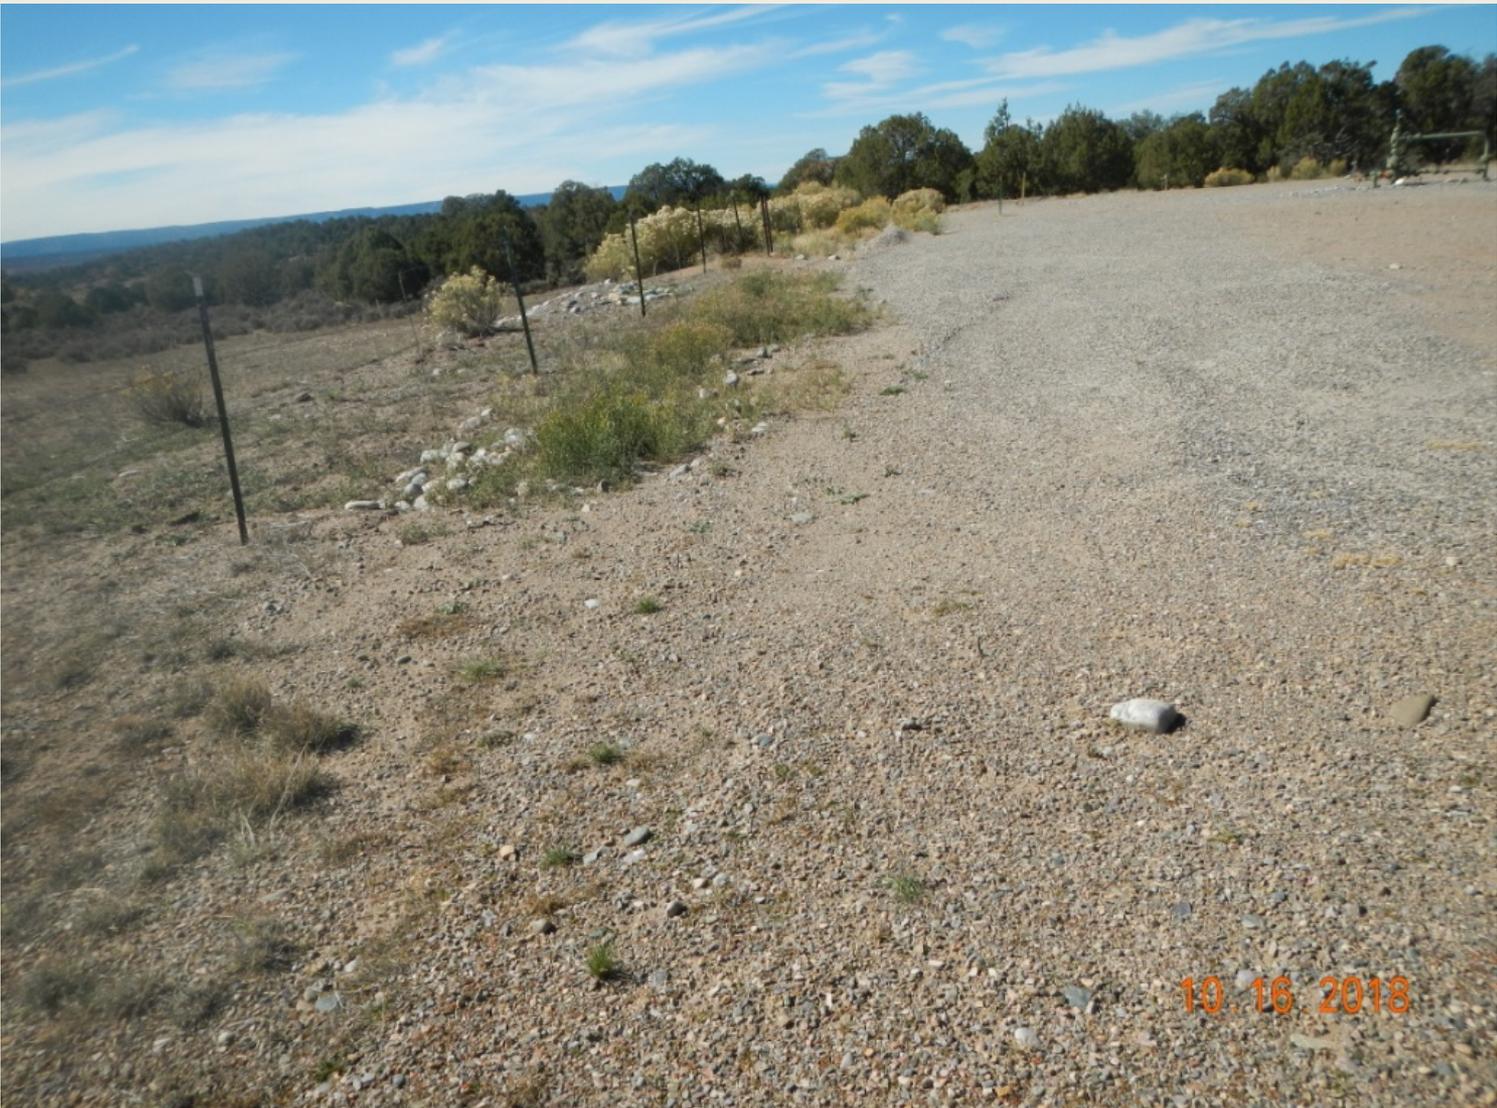
Photo 2. View of the southern project area from the southeastern corner facing westward. Vegetation is progressing with grasses such as sand dropseed (*Sporobolus airoides*) and western wheatgrass (*Pascopyrum smithii*).

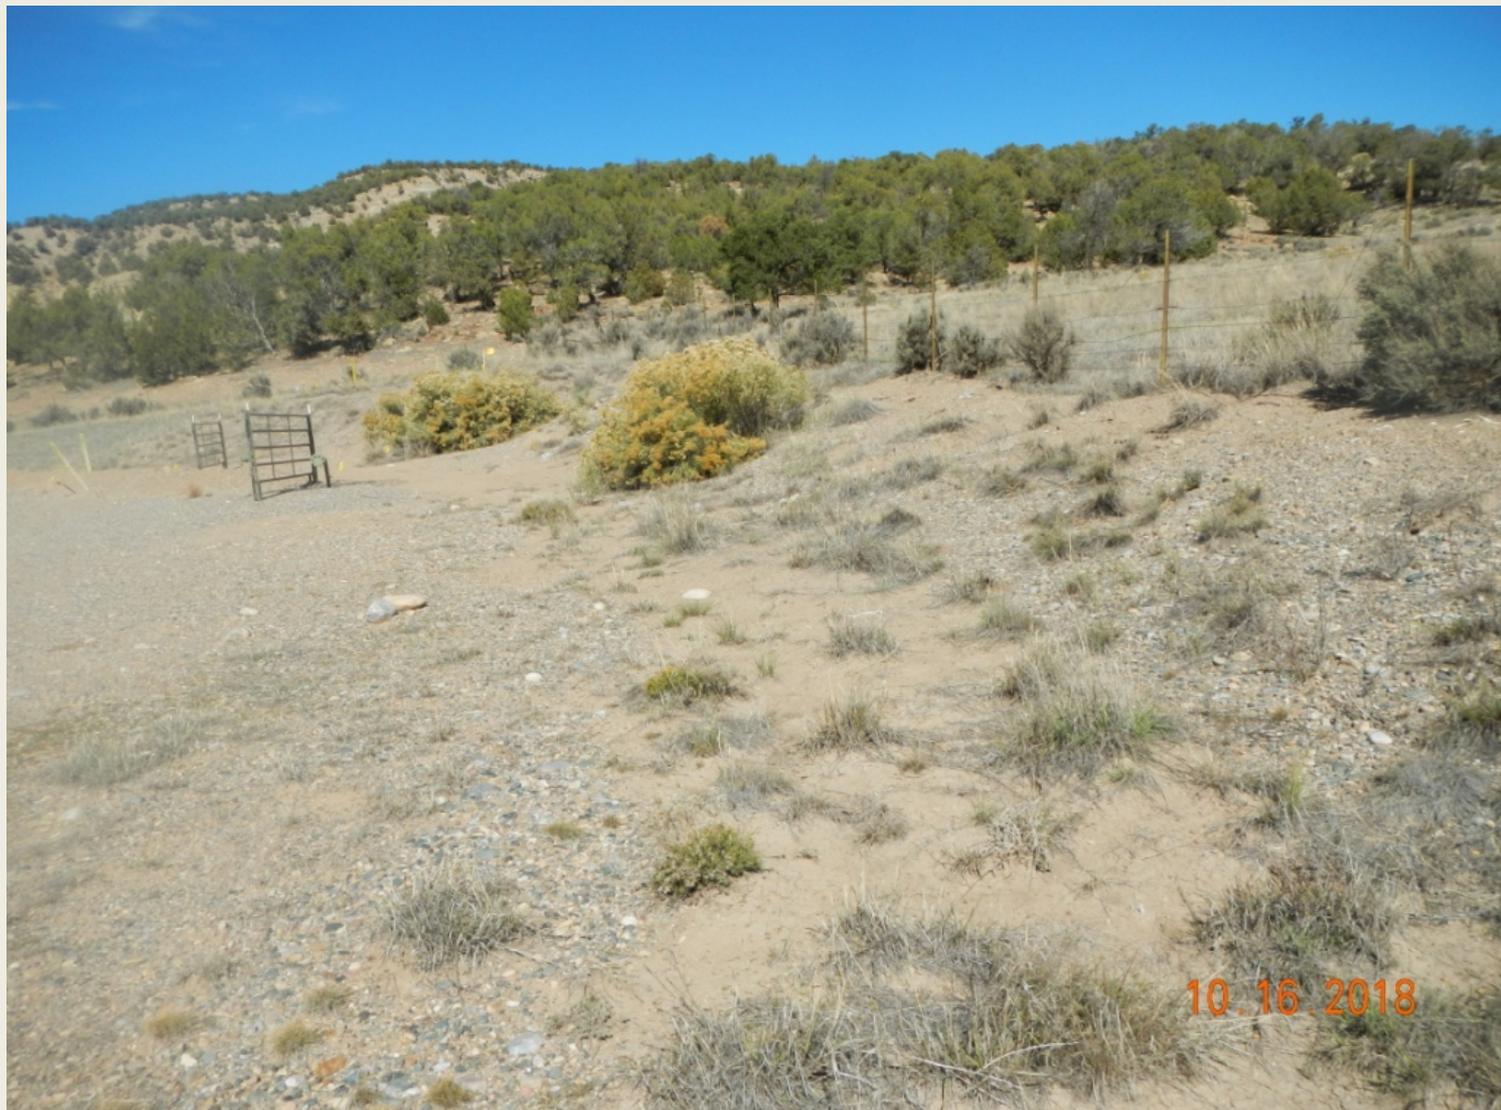
Photo 3. View of the eastern project area from the southeastern corner facing northward.

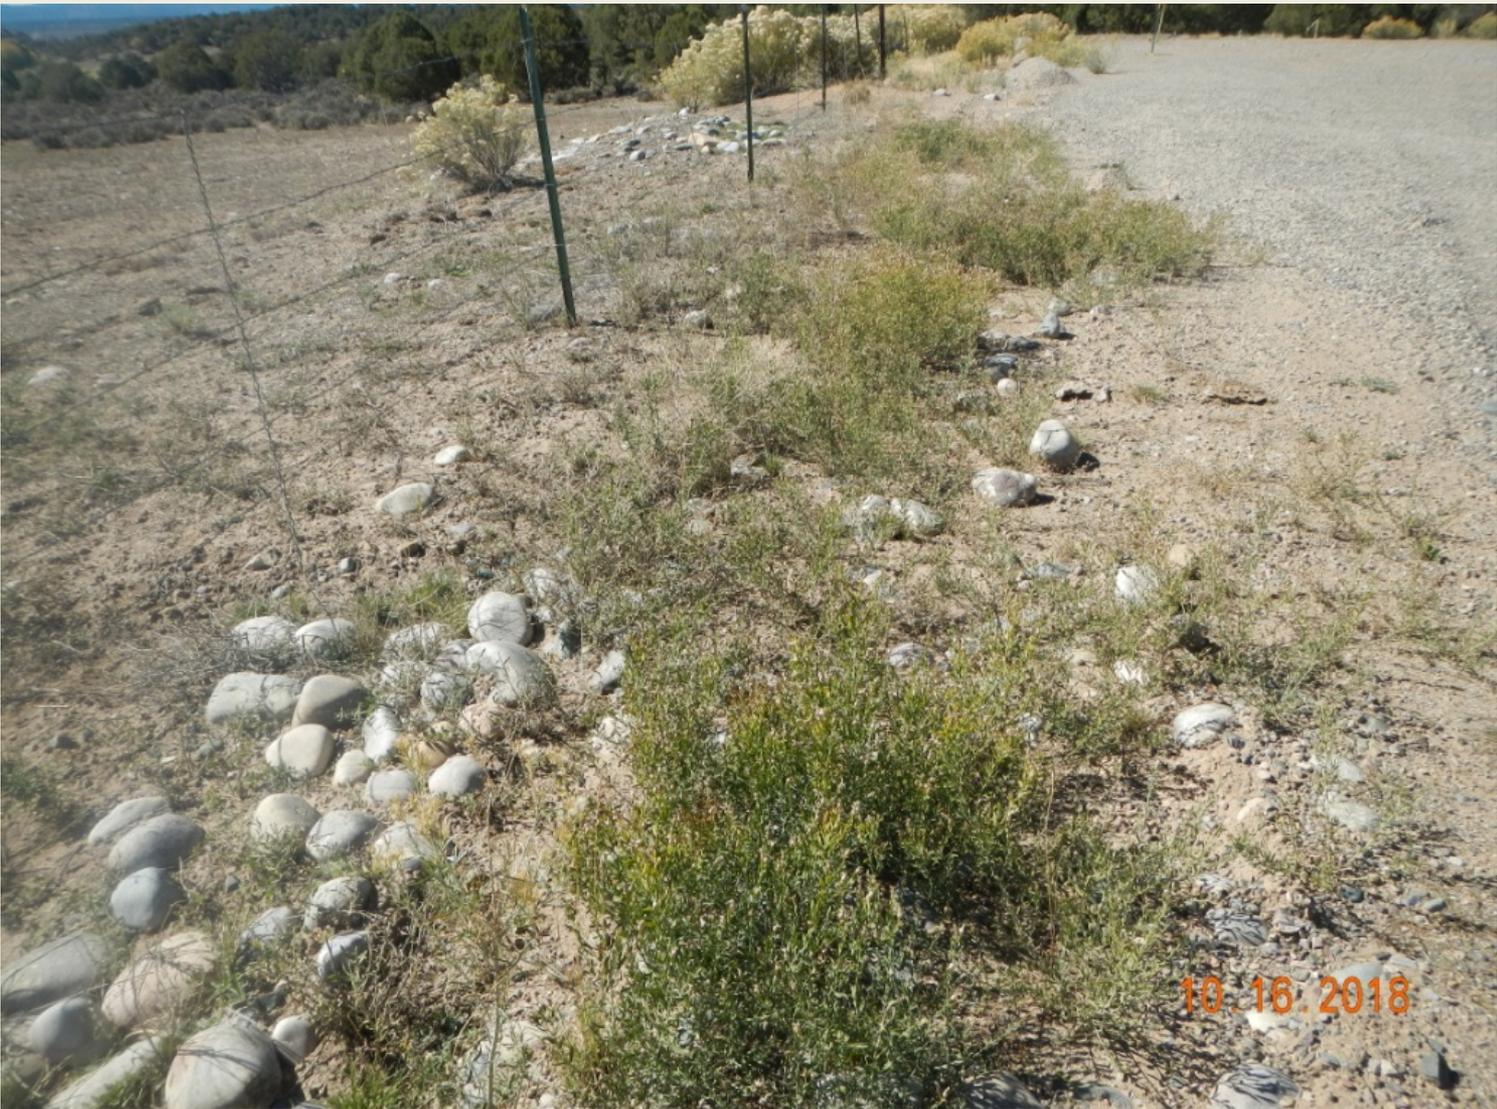
Photo 4. View of the Russian knapweeds (*Acroptilon repens*) within the southern project area. Approximately 1500 individuals observed.

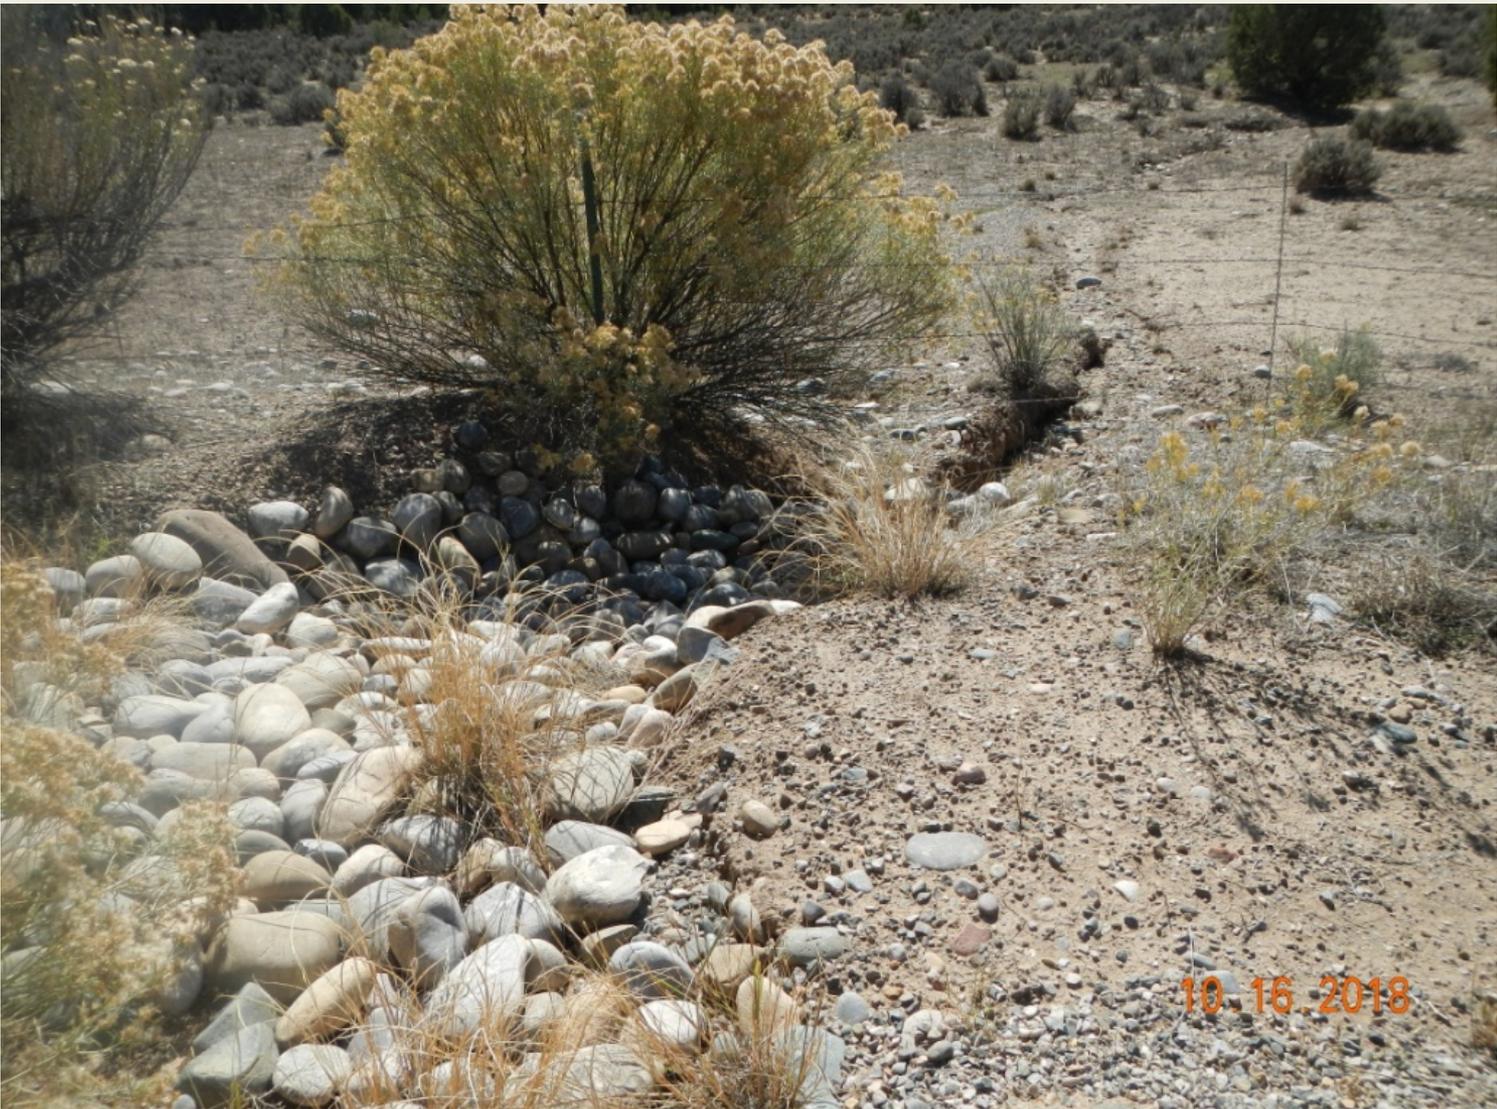
Photo 5. View of cobble run-down within the southern project area. Appears to be installed after formation of erosional channel. This needs to be monitored.
