Inspection Photos

Operator: BP Production

API: 05-067-06610

Date: 10/16/2018

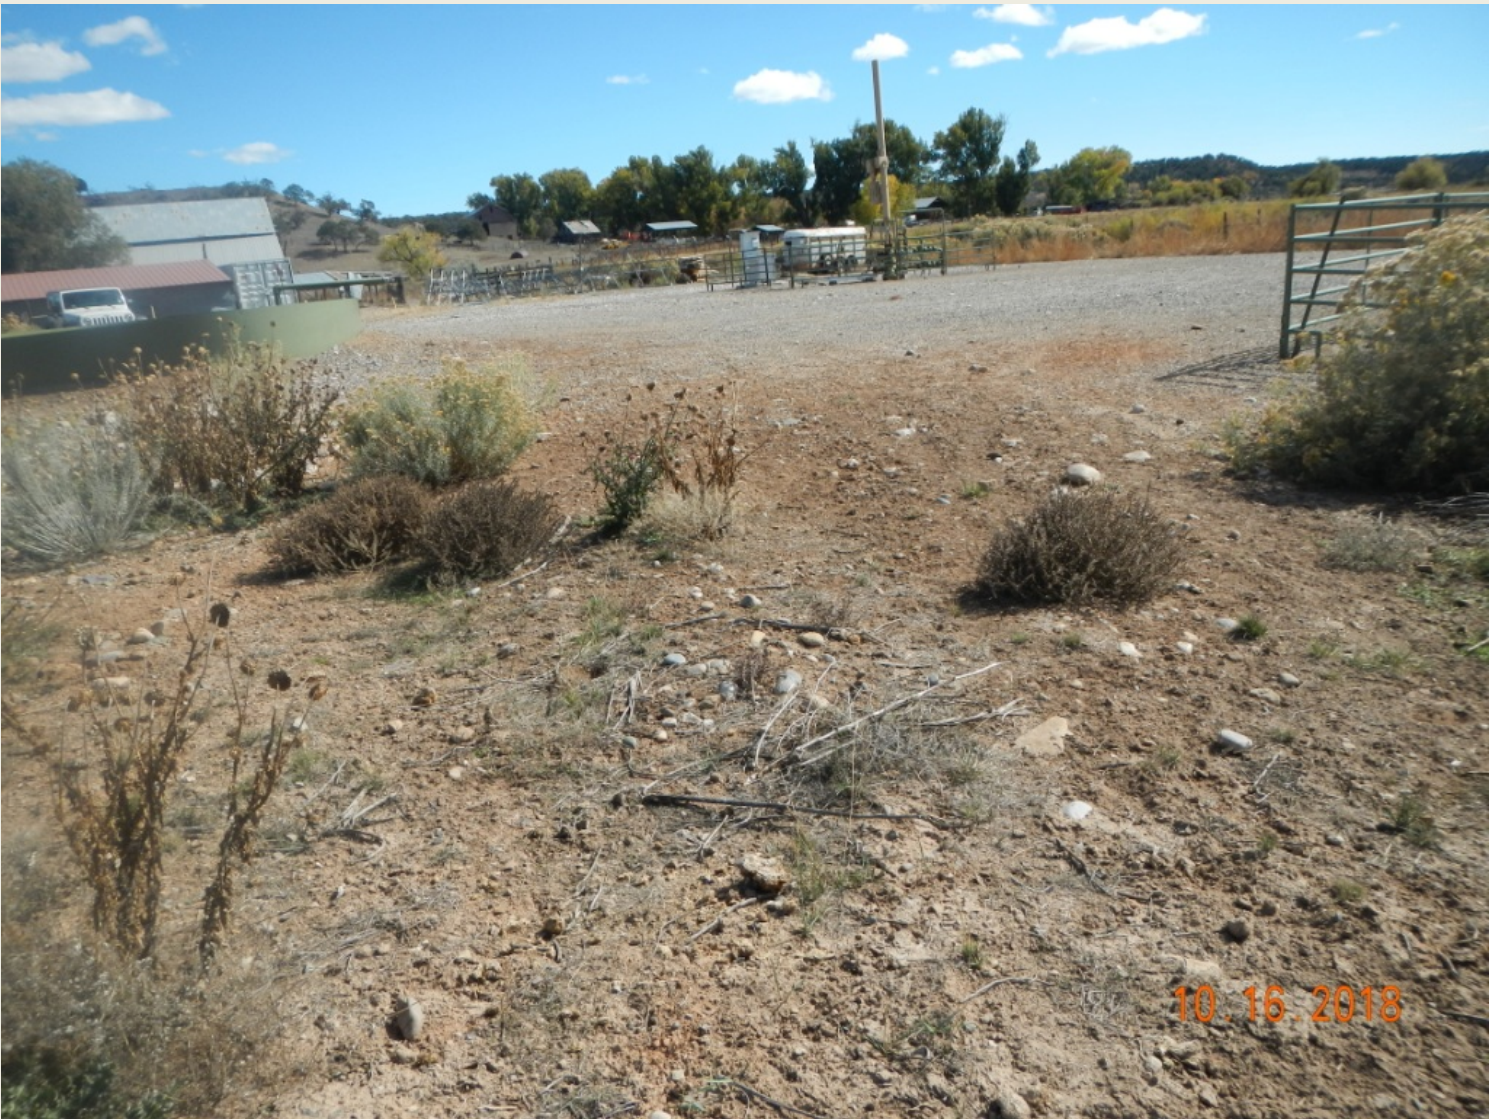
Photo 1. View of the project area from the southwestern corner facing center.

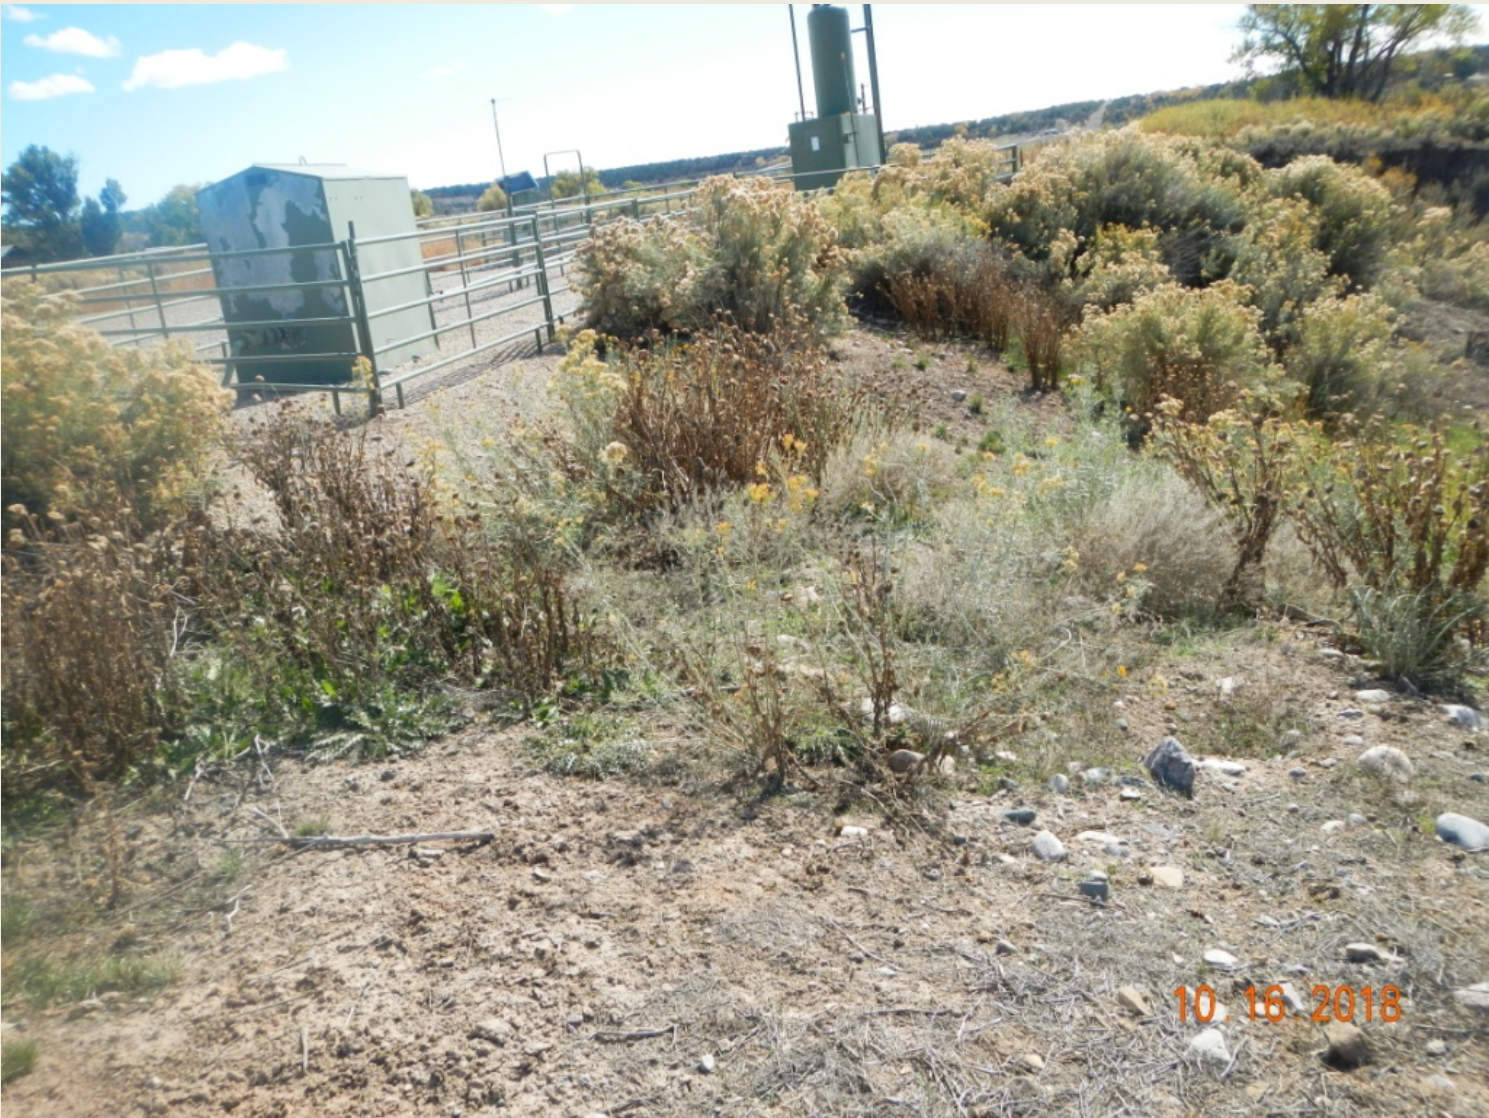
Photo 2. View of the western project area from the northwestern corner facing southward. Vegetation is progressing with shrubs such as rubber rabbitbrush (*Chrysothamnus nauseosus*).

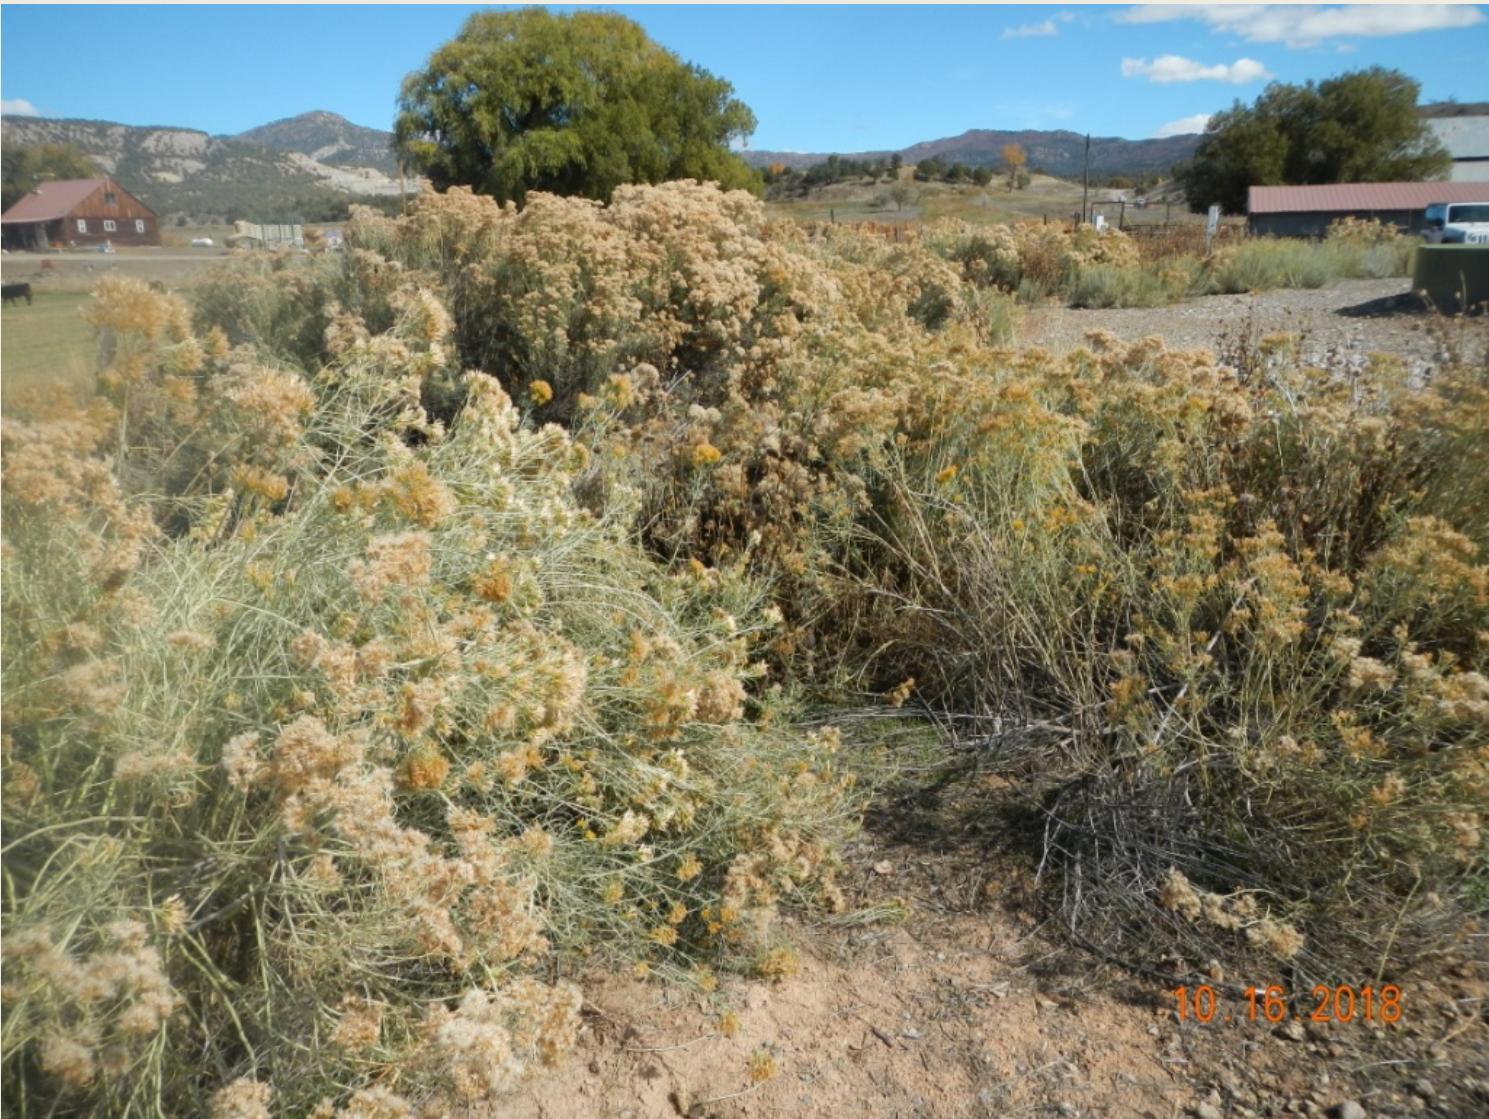
Photo 3. View of the northern project area from the northwestern corner facing eastward.

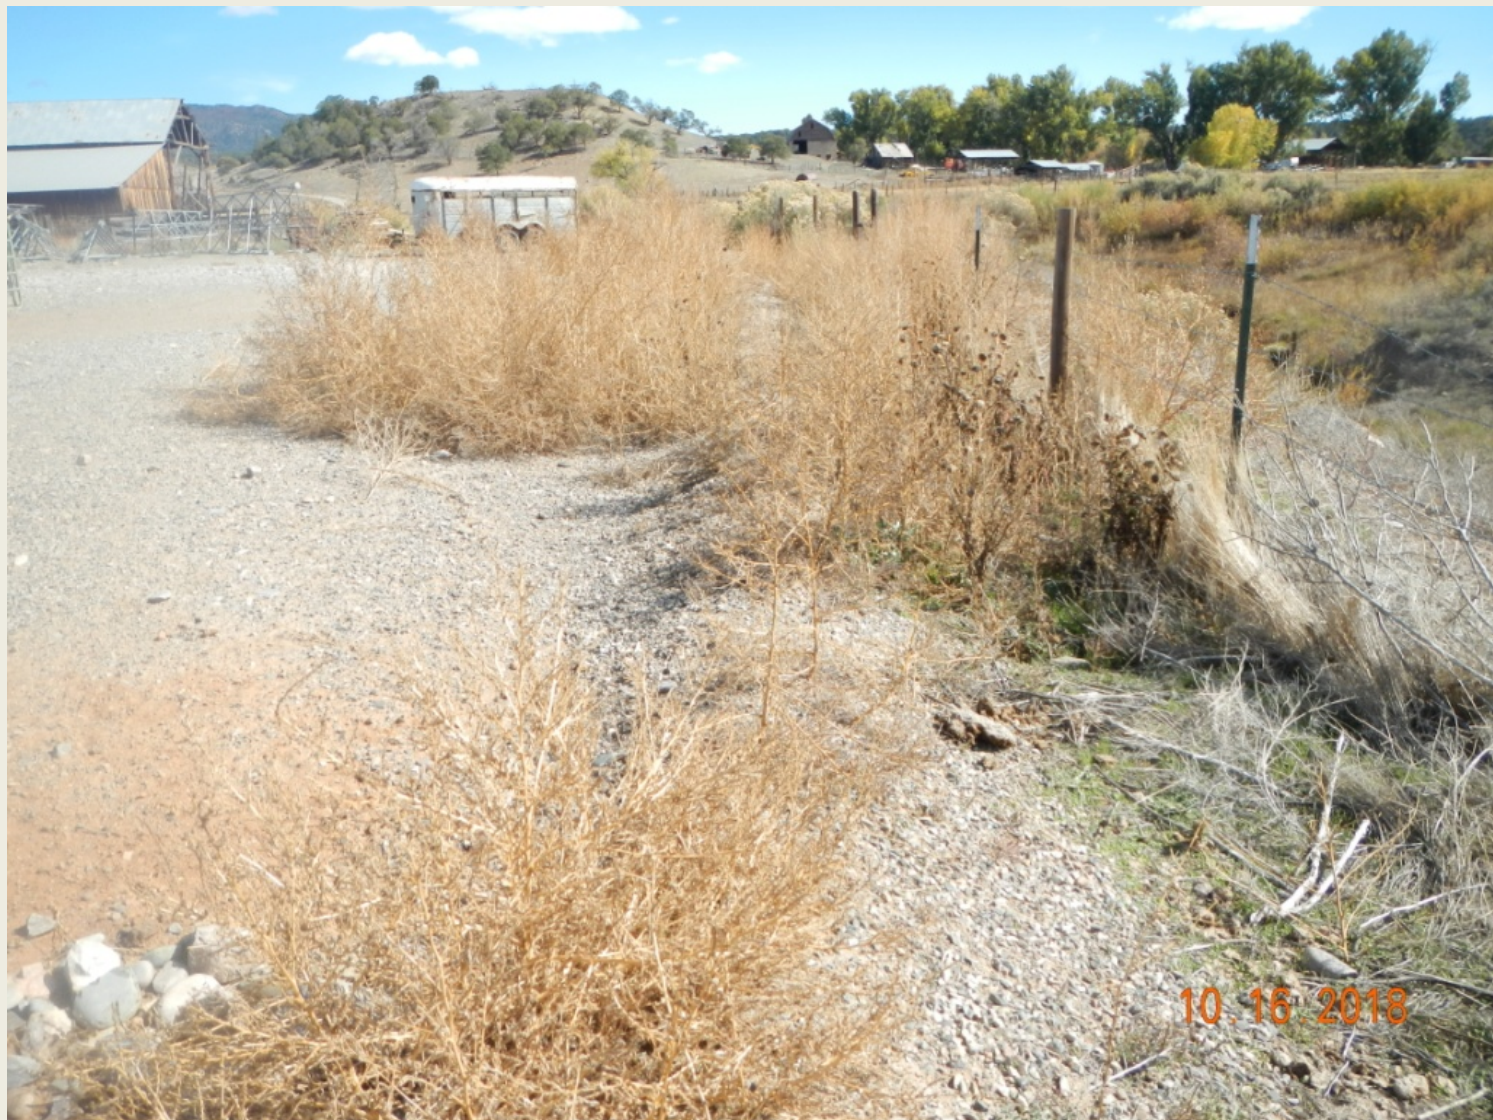
Photo 4. View of the southern project area from the southwestern corner facing eastward. Kochia debris, up to three feet tall, needs to be removed.

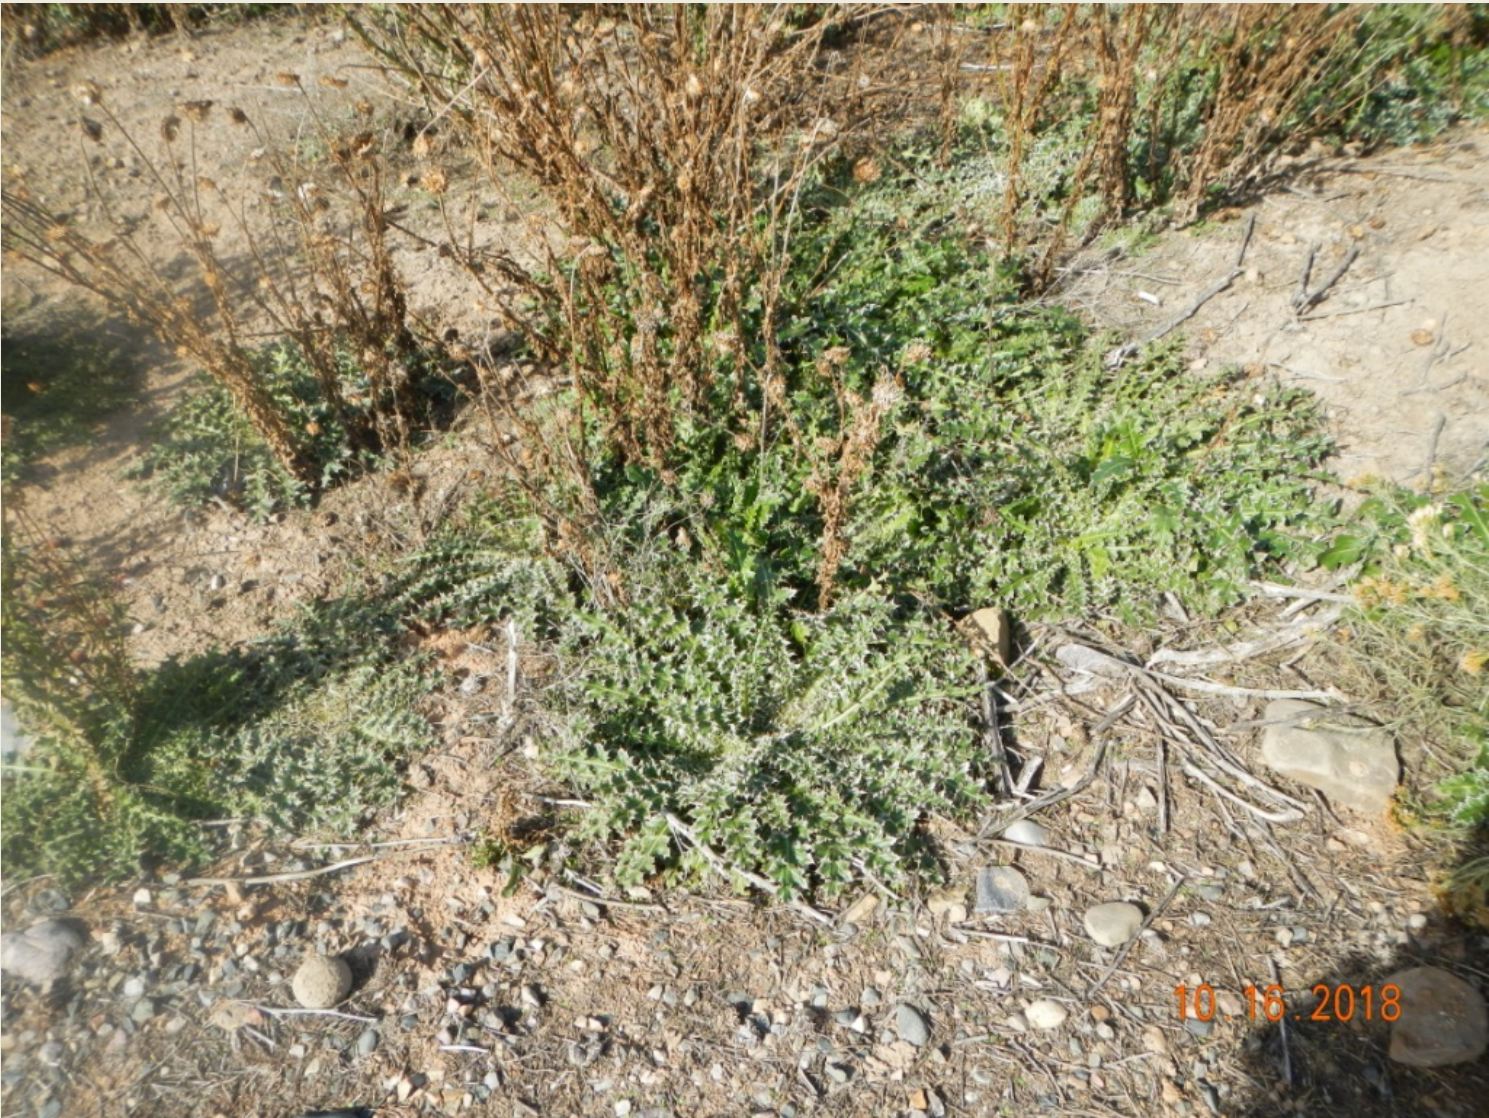
Photo 5. View of musk thistles (*Carduus nutans*) within the northern project area.

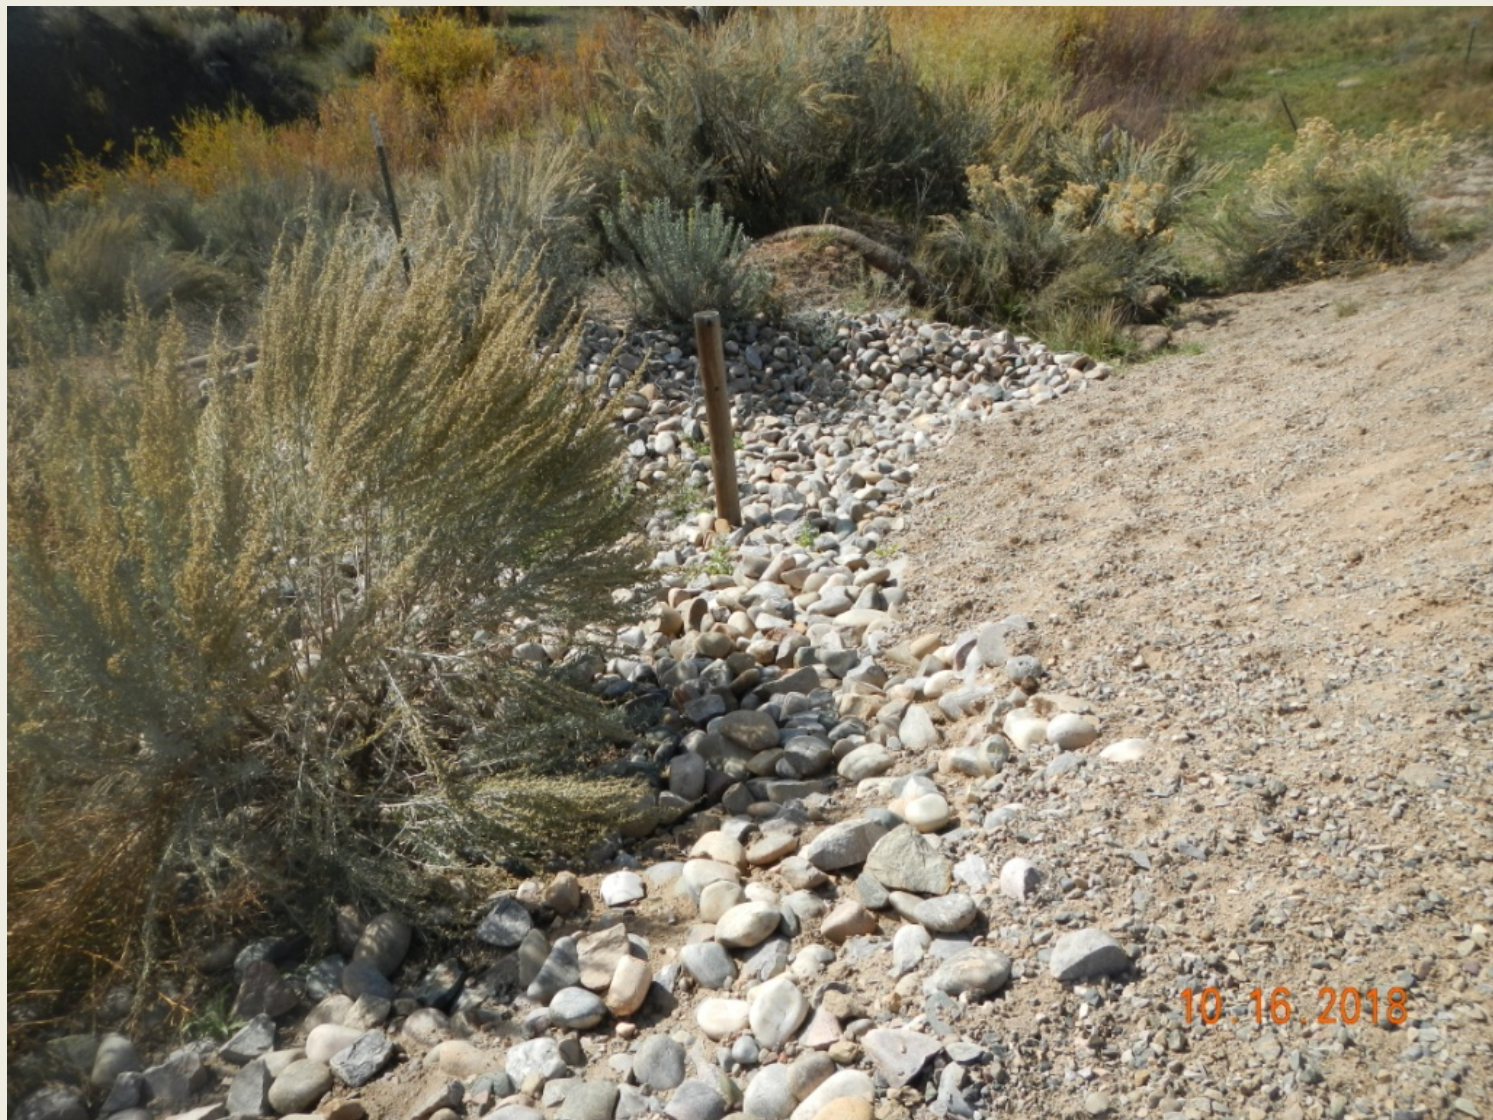
Photo 6. View of cobble run-down in the southwestern project area, appears to be functioning.
