Inspection Photos

Operator: BP Production

API: 05-067-06611

Date: 10/16/2018

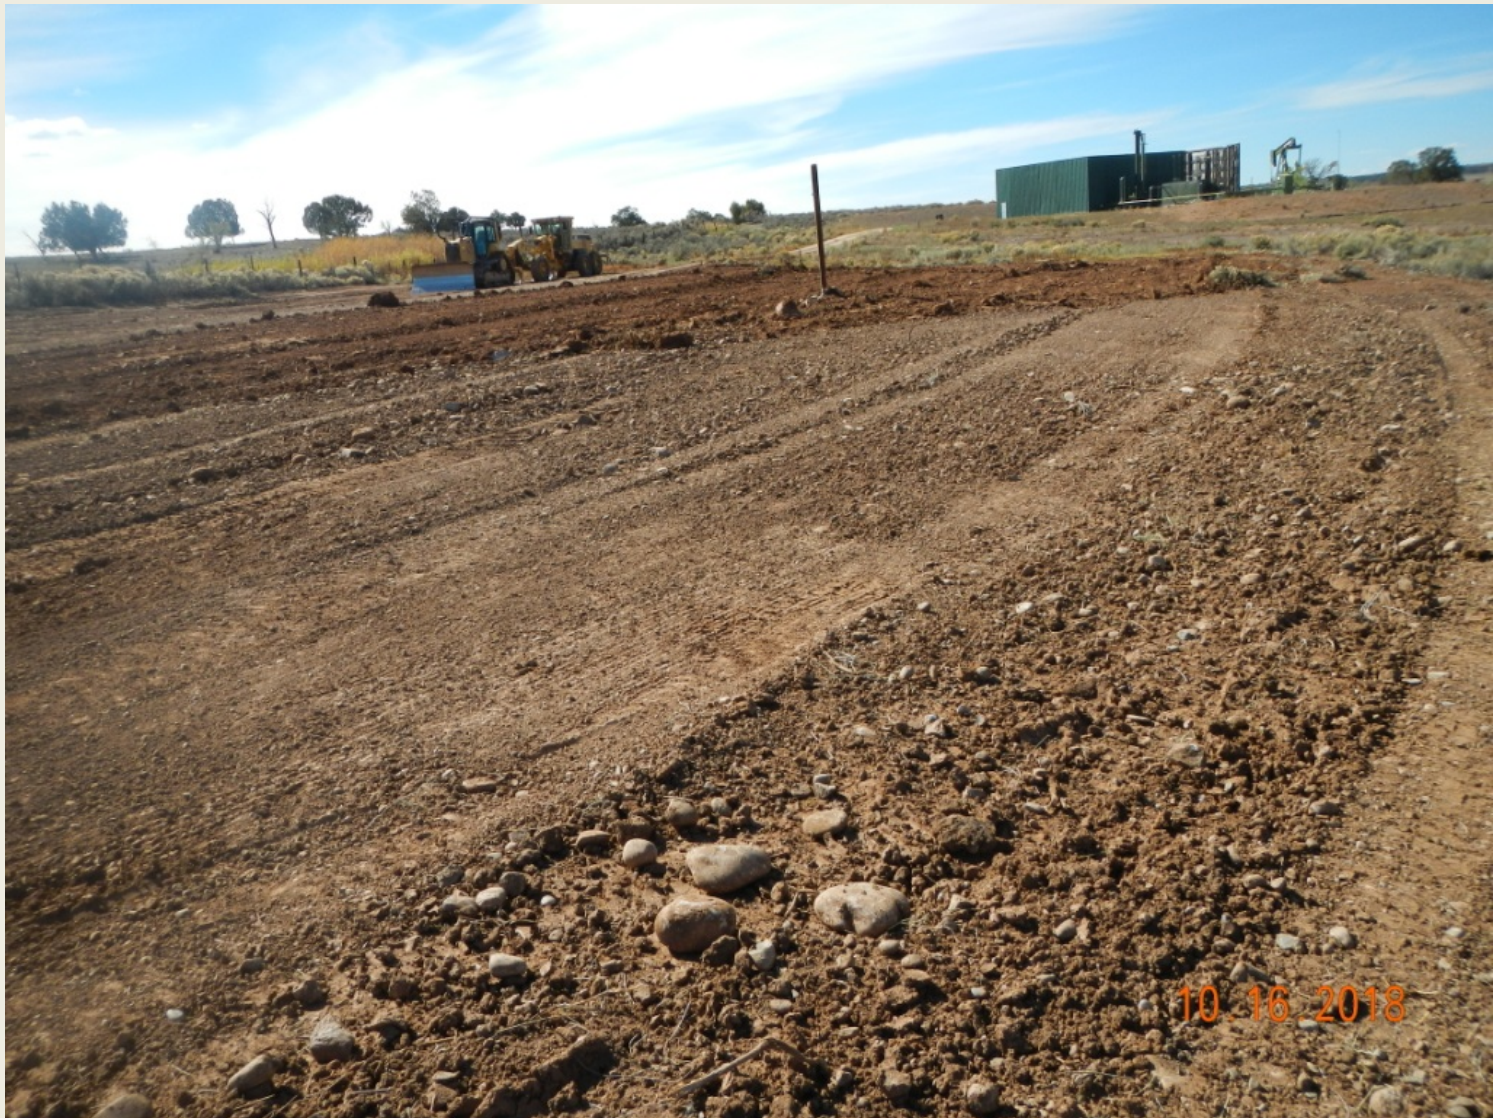
Photo 1. View of the project area from the northeastern corner facing center. Well pad is recently countoured. It appears topsoil is being spread.

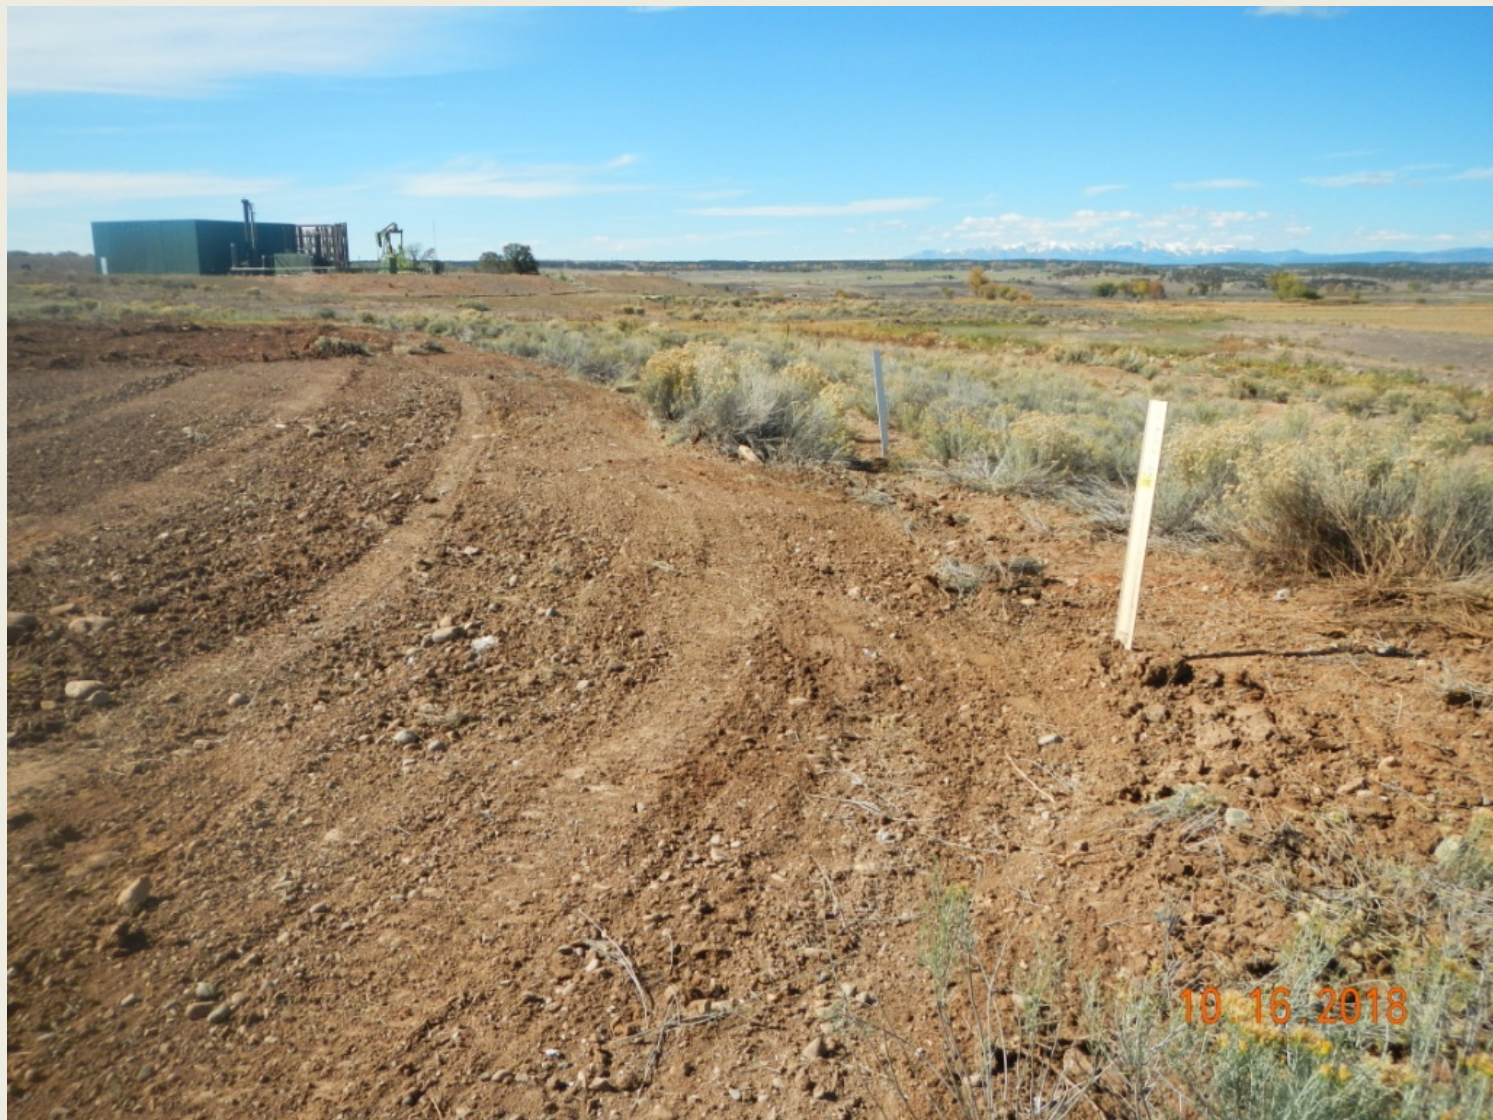
Photo 2. View of the northern project area from the northeastern corner facing westward.

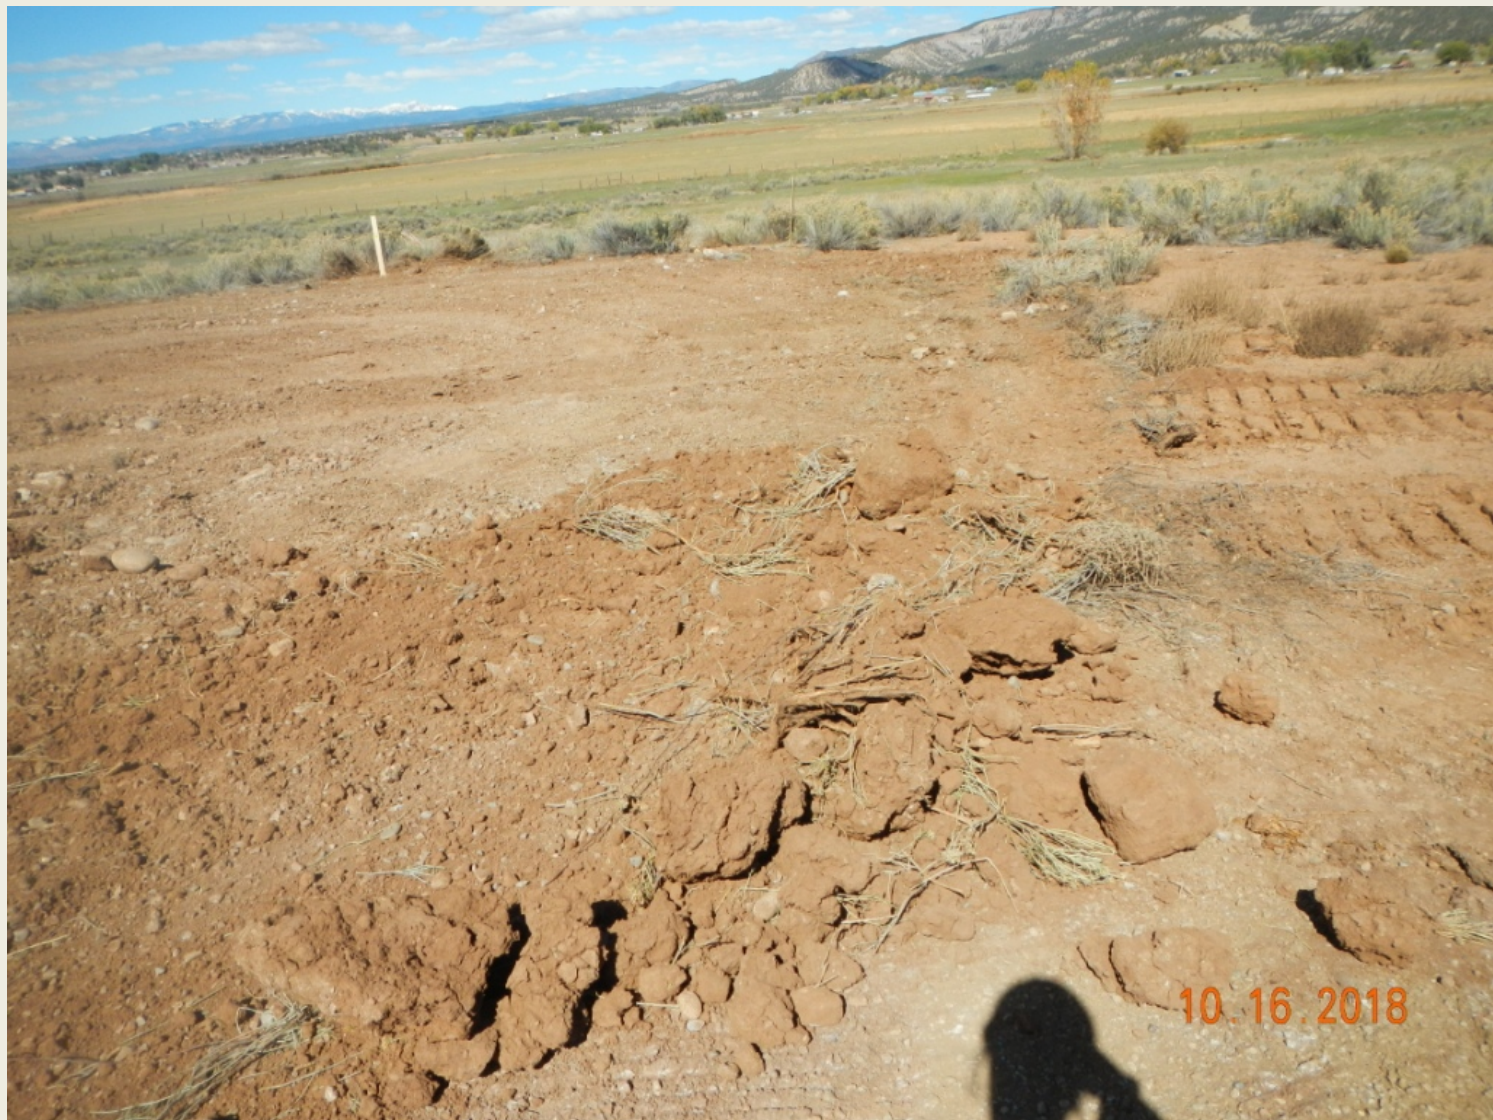
Photo 3. View of the eastern project area from the southeastern corner facing northward.

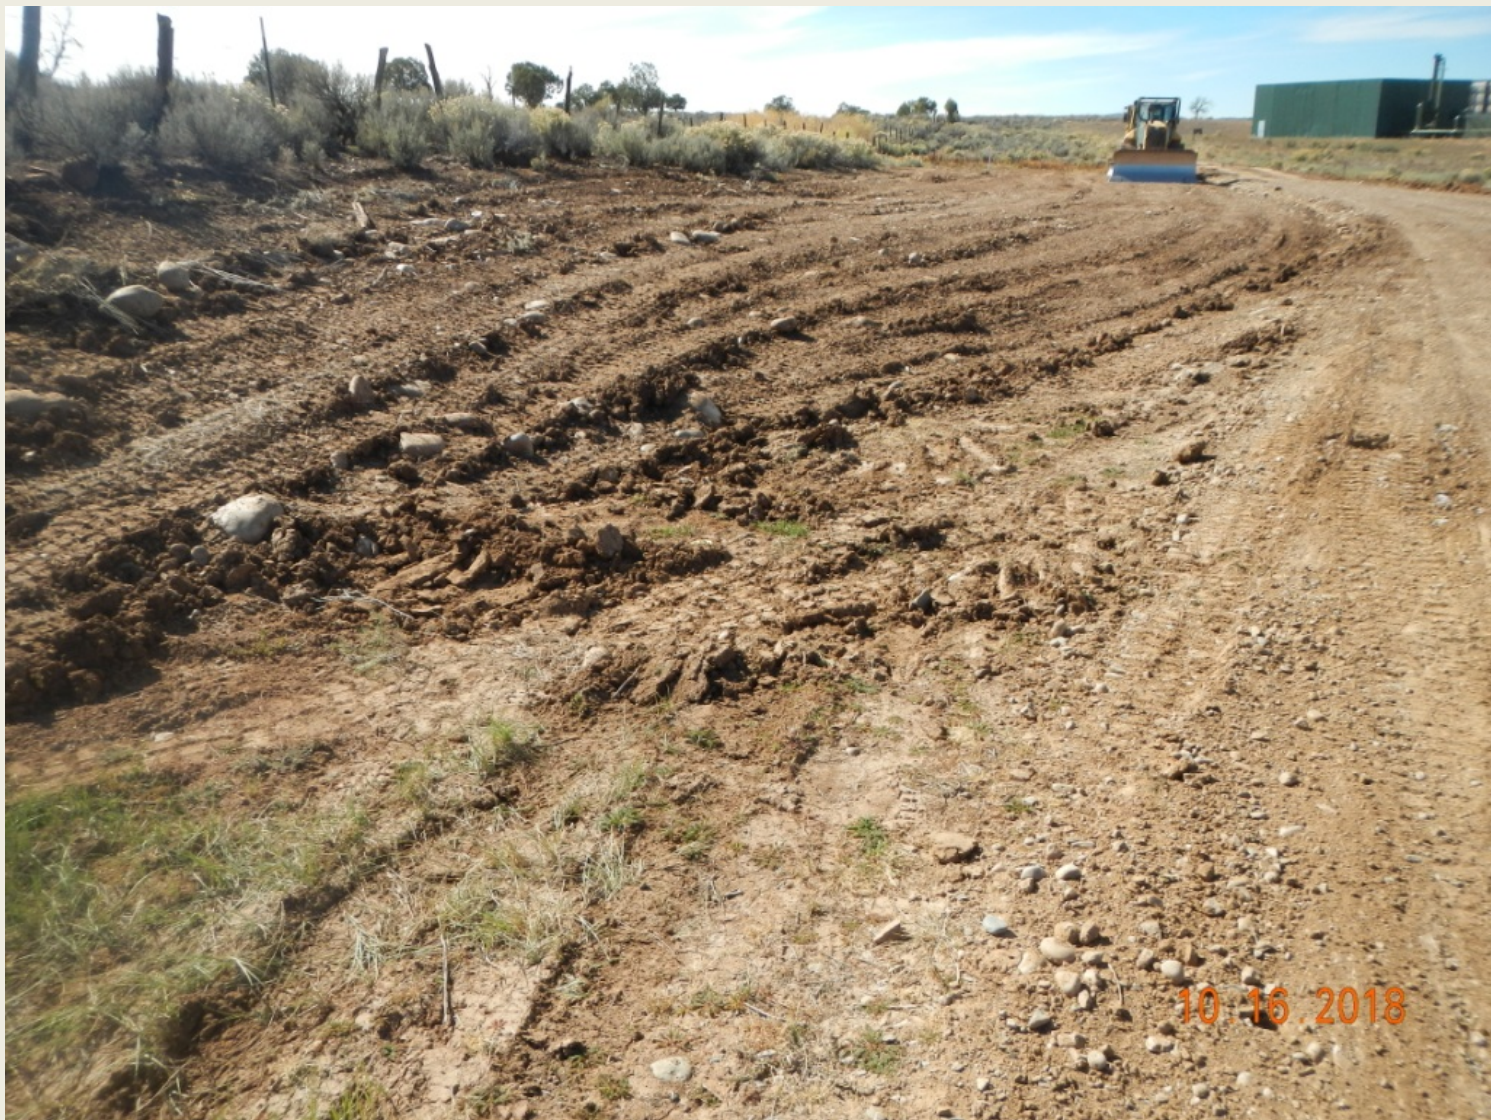
Photo 4. View of southern project area from the southeastern corner facing westward. Recontouring and other reclamation is in process.

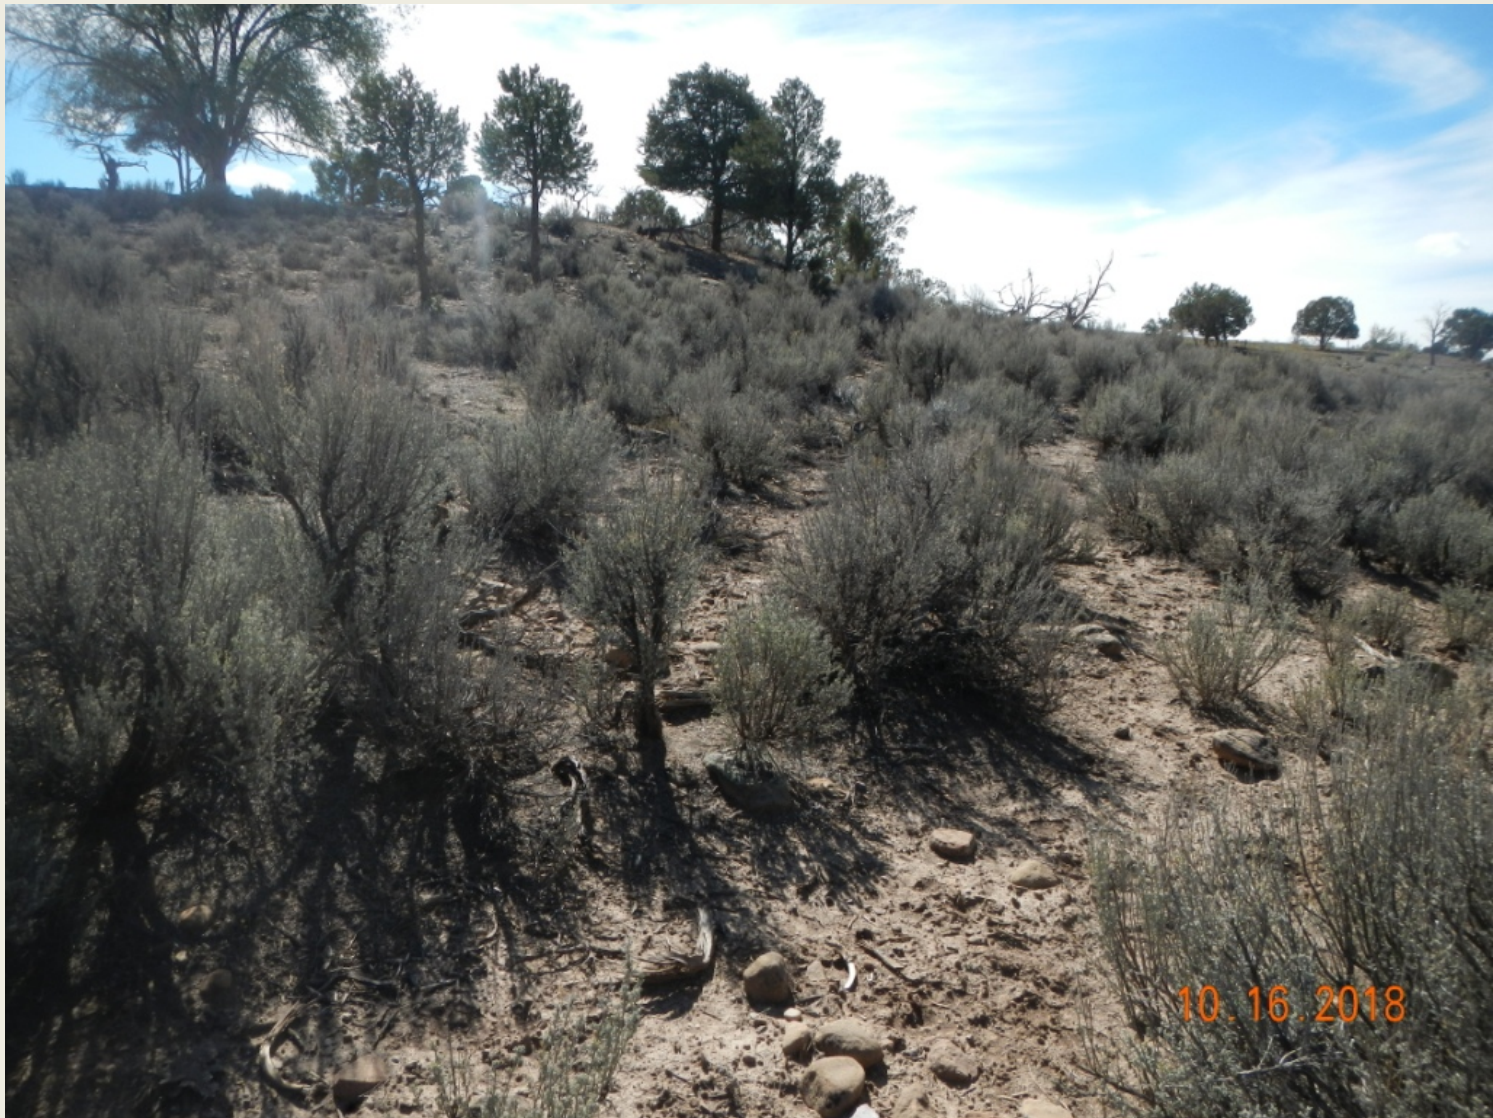
Photo 5. View of reference vegetation south of the project area.
