RECLAMATION MONITORING REPORT

**ALOHA MULA #6
LINCOLN COUNTY, COLORADO**

OCTOBER 2018

ALOHA MULA #6
Project Number: 050117002

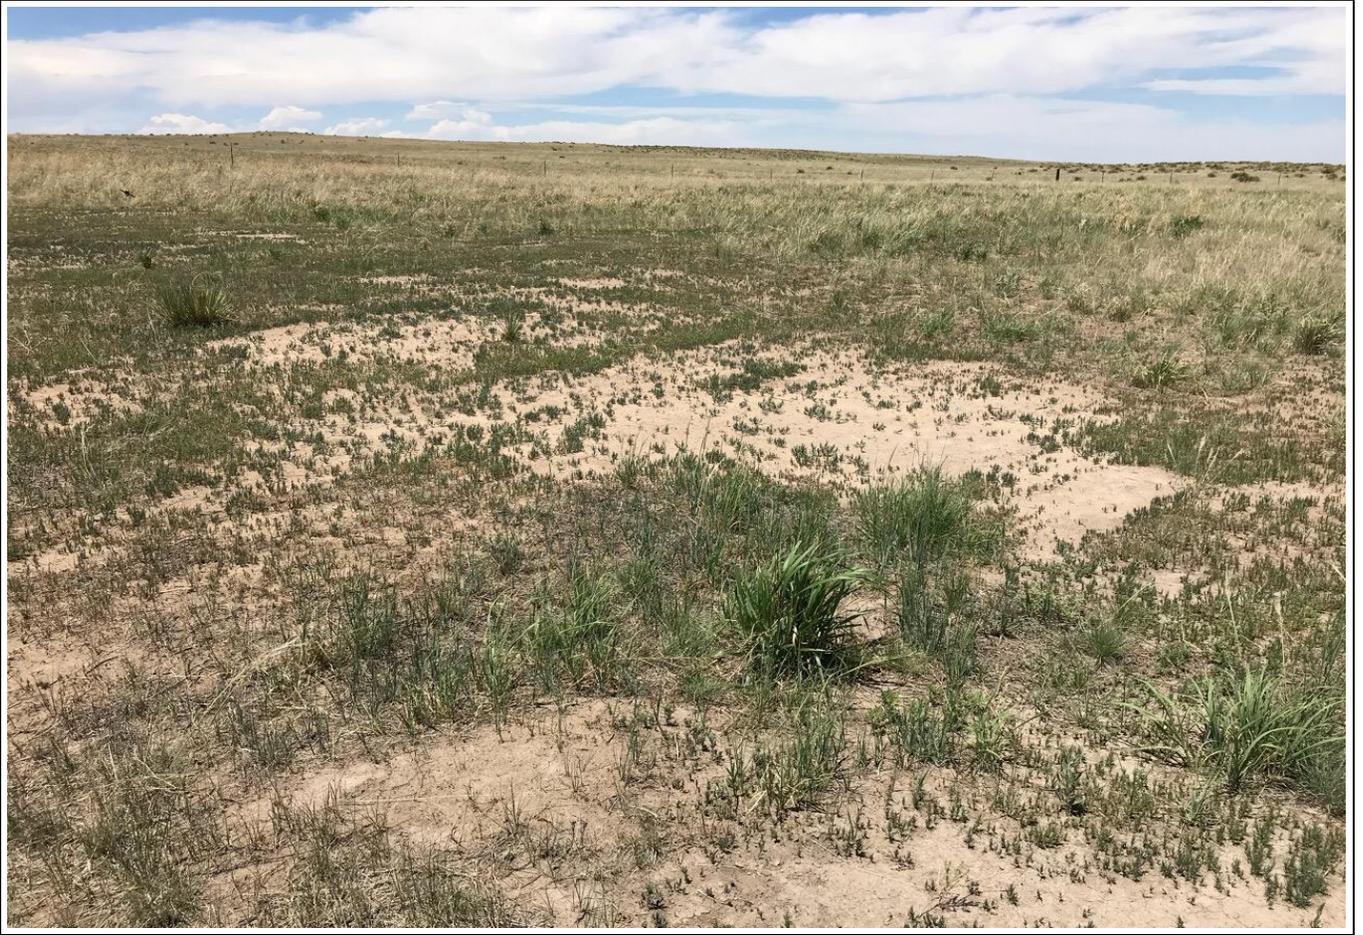
Photograph 5: Overview photograph.

Recommendations:	
Seeding	Yes
Weed Control	Yes
Erosion Control	No
Compaction Alleviation	No
Other: Mow Russian thistle in early July or 2-3 weeks after significant rain. SE corner of fenced area is dominated by Russian thistle and should be reseeded.

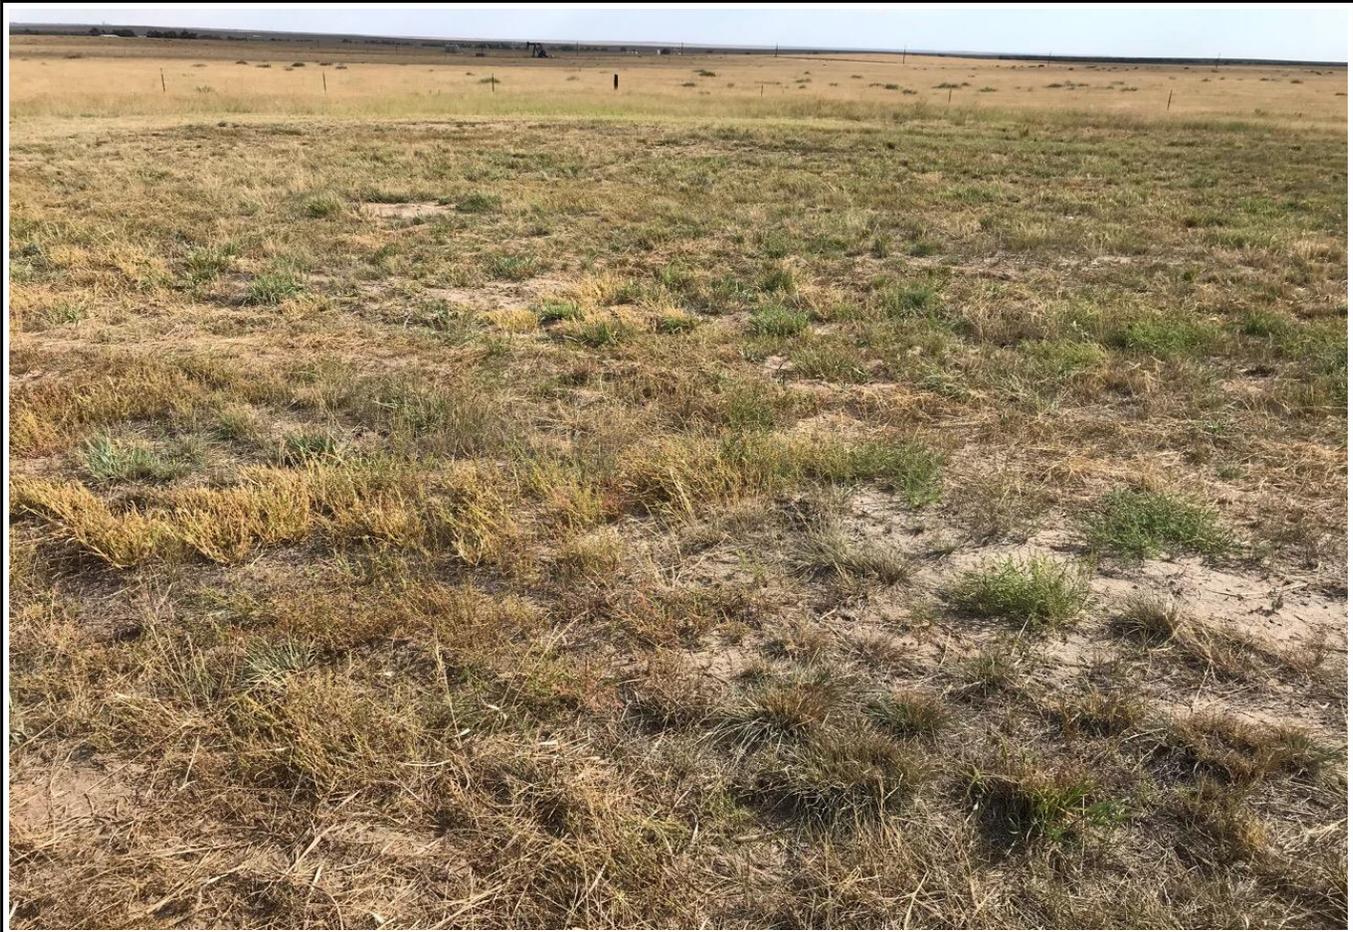
Photograph 5: Overview photograph.

Recommendations:	
Seeding	Yes
Weed Control	Yes
Erosion Control	No
Compaction Alleviation	No
Other: SE corner of fenced area is dominated by Russian thistle and should be reseeded.

Due to failure of native seed germination in certain areas of the reclaimed area, reseeding is recommended, at a minimum, in the bare spots on the Site. WFE will be implementing additional drill seeding of the bare spots and interseeding lightly vegetated areas. Halde Construction will be contracted to conduct the additional seeding and will use a no-till drill seeder to apply the seed mix. Seeding operations will begin in the fall of 2018 and be completed no later than April 1, 2019.
