Reclamation and Stormwater Inspection

October 25, 2018

Operator: CONFLUENCE DJ LLC- #10518

Inspection Photos
Location Name: Pickaroon South
Location ID: 457632

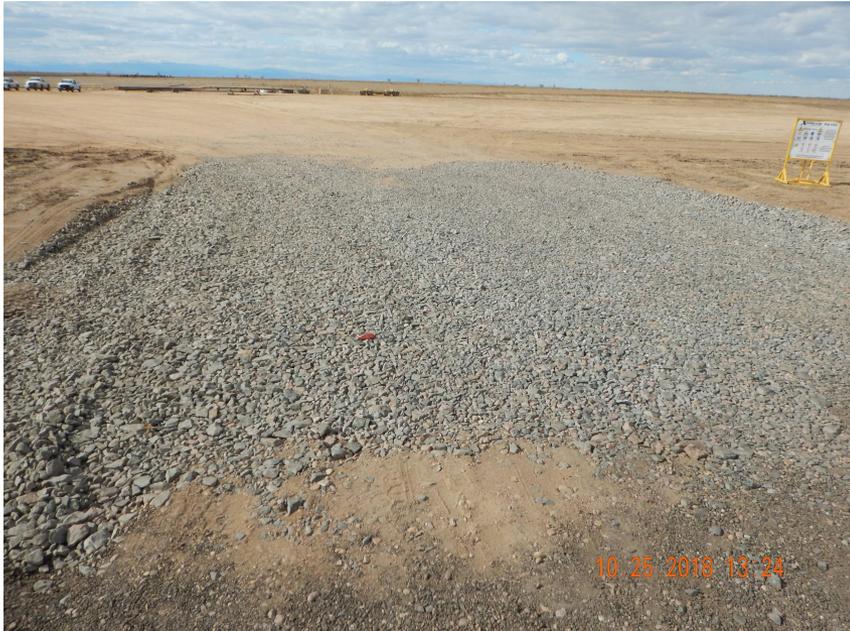
Photo 1. Photo taken from the entrance of the location, facing West. Tracking pad devices installed at the entrance off County Road 51 appears to be in proper functioning condition.

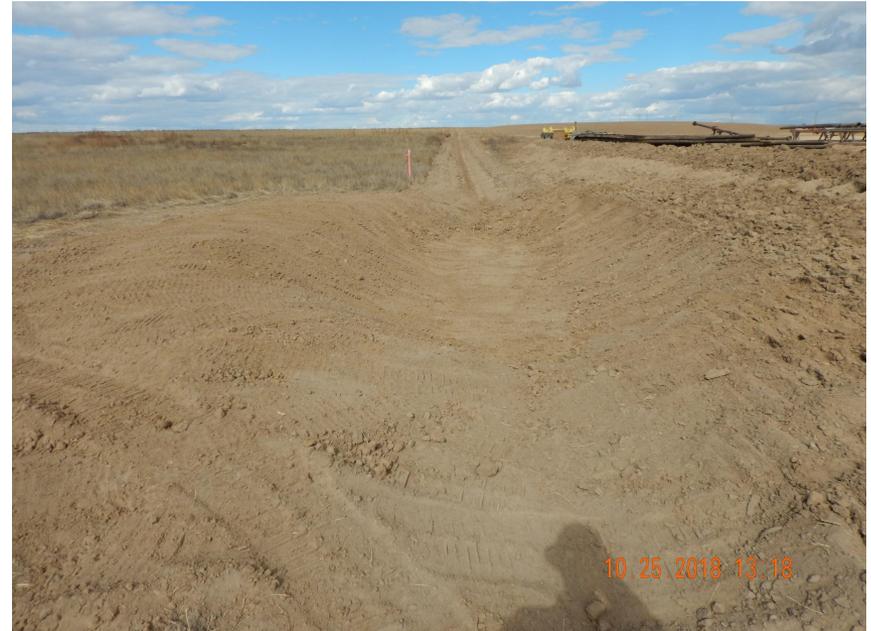
Photo 2. Photo taken from the western location, facing North. Photo illustrates a retention area installed in conjunction with a ditch and berm BMP. Appears portions of the berm have been tracked with equipment for temporary stabilization but portions have been left unconsolidated.

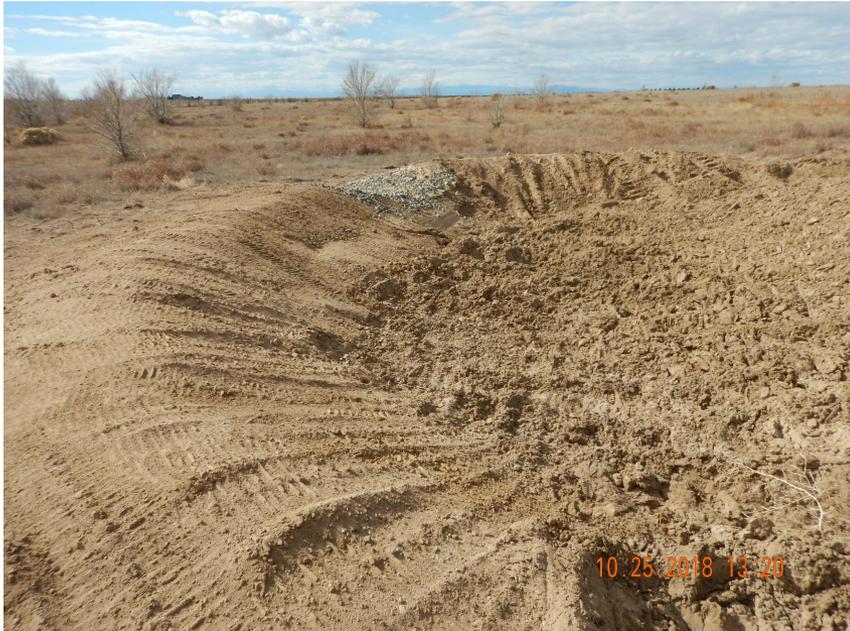
Photo 3. Photo taken from the southwest location, facing West. Photo illustrates a retention area with a stabilized outlet.

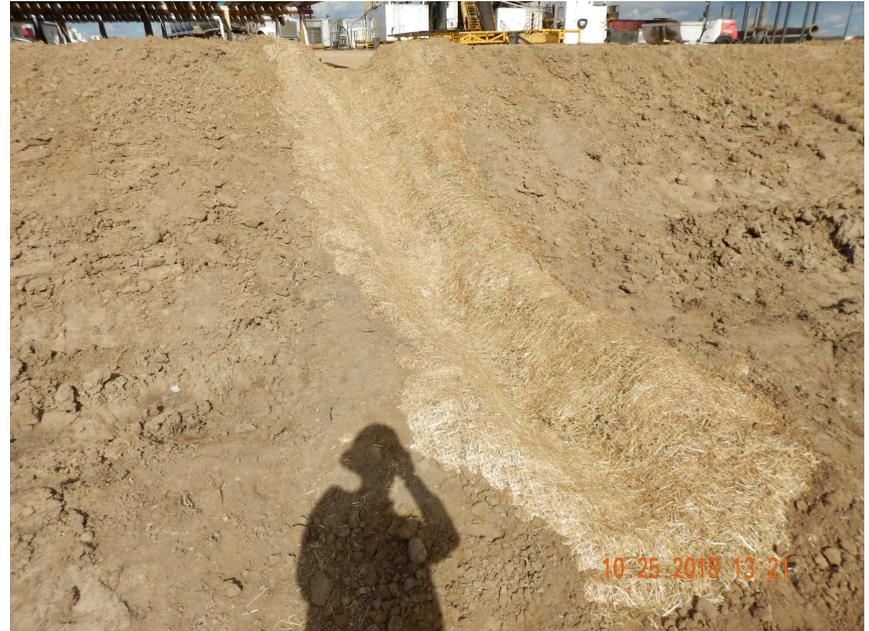
Photo 4. Photo taken from the southern location, facing North. Photo illustrates a temporarily stabilized outlet along the fill slope that is directed to the ditch and berm BMP. Fill slopes have been temporarily stabilized with equipment tracking.

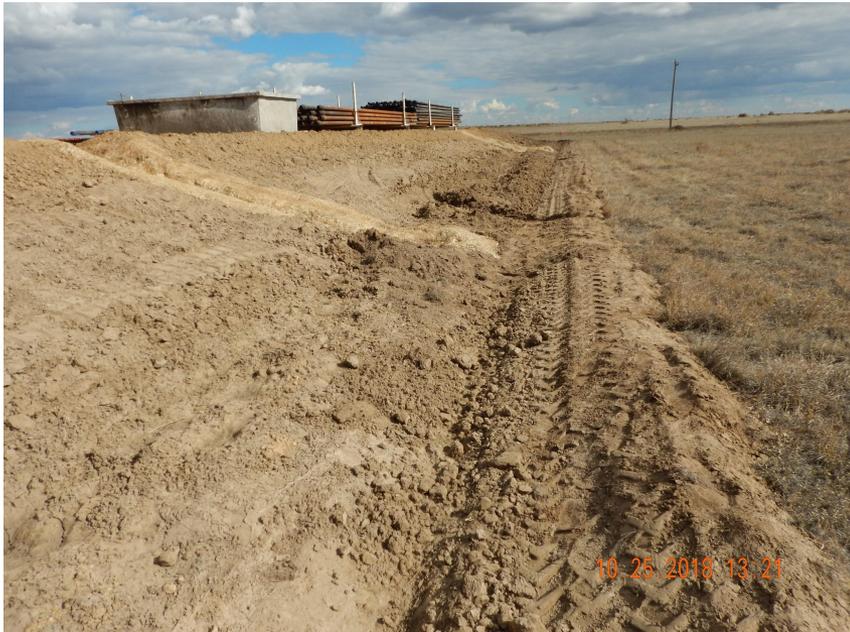
Photo 5. Photo taken from the southern location, facing East. A total of three temporary outlets have been installed along the southern fill slope. See comments under Photo 4. Photo illustrates the ditch and berm BMP. Does not appear portions of the berm have been sufficient stabilized.

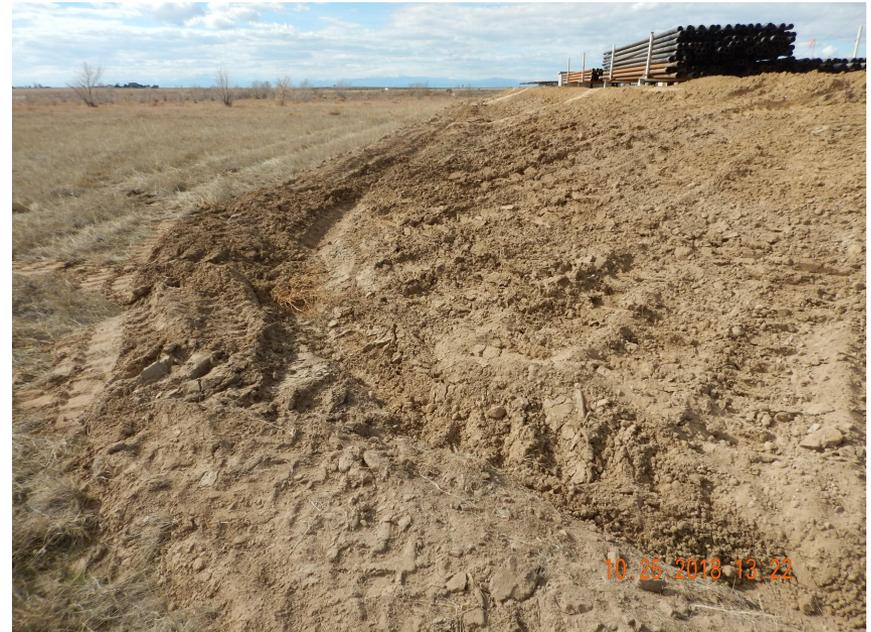
Photo 6. Photo taken from the southeastern location, facing West. Photo illustrates equipment that has damaged the ditch and berm BMP. Operator shall ensure stormwater BMPs are in proper functioning condition.

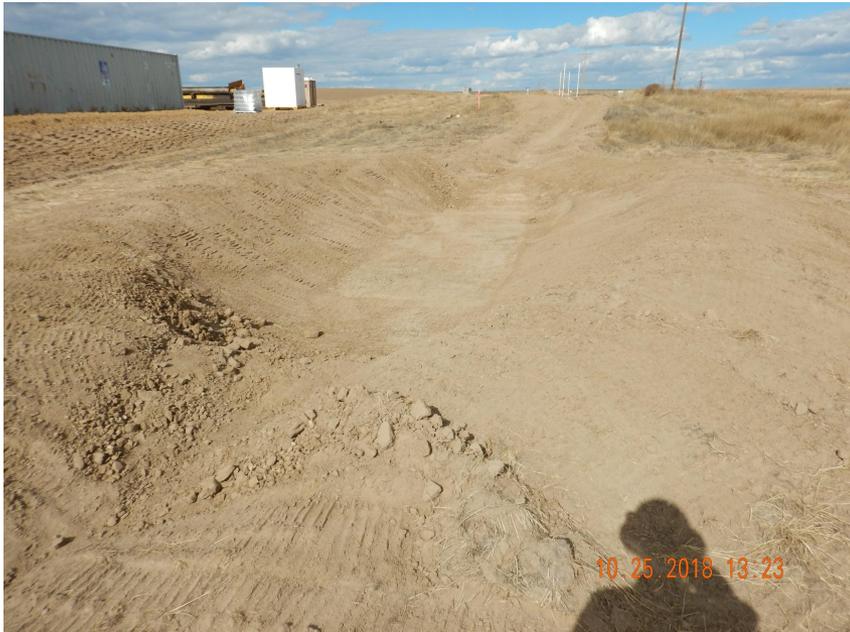
Photo 7. Photo taken from the eastern location, facing North. See comments under Photo 2.

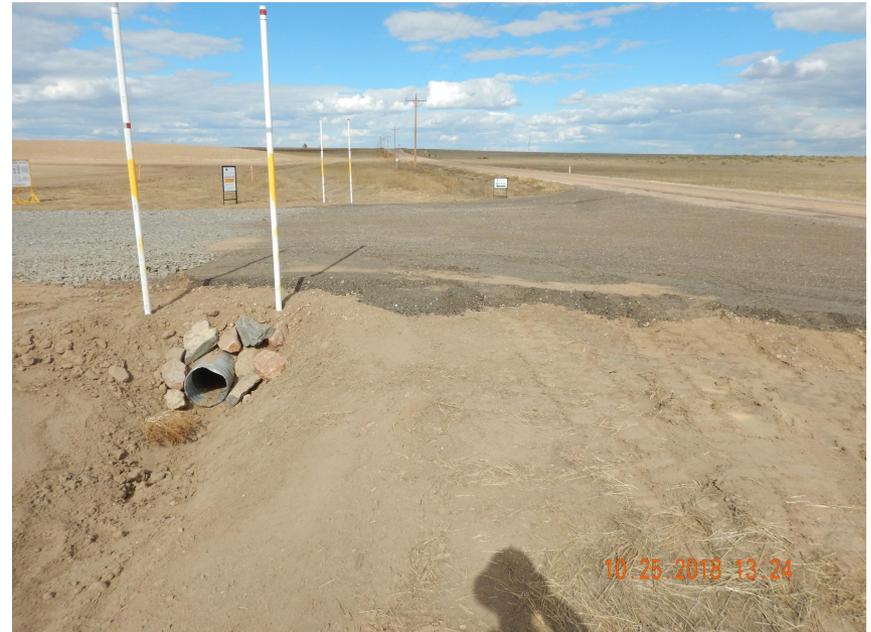
Photo 8. Photo taken from the entrance of the location, facing North. Photo illustrates a culvert installed in conjunction with the ditch and berm BMP. Also, photo illustrates the vehicle tracking devices.

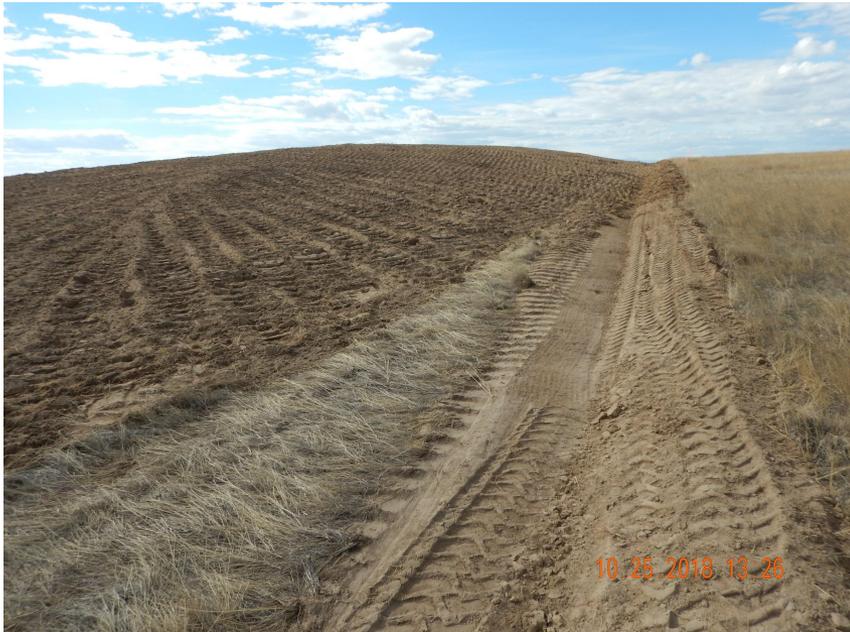
Photo 9. Photo taken from the northeastern location, facing West. Photo illustrates the topsoil stockpile that has been temporarily stabilized with equipment tracking.

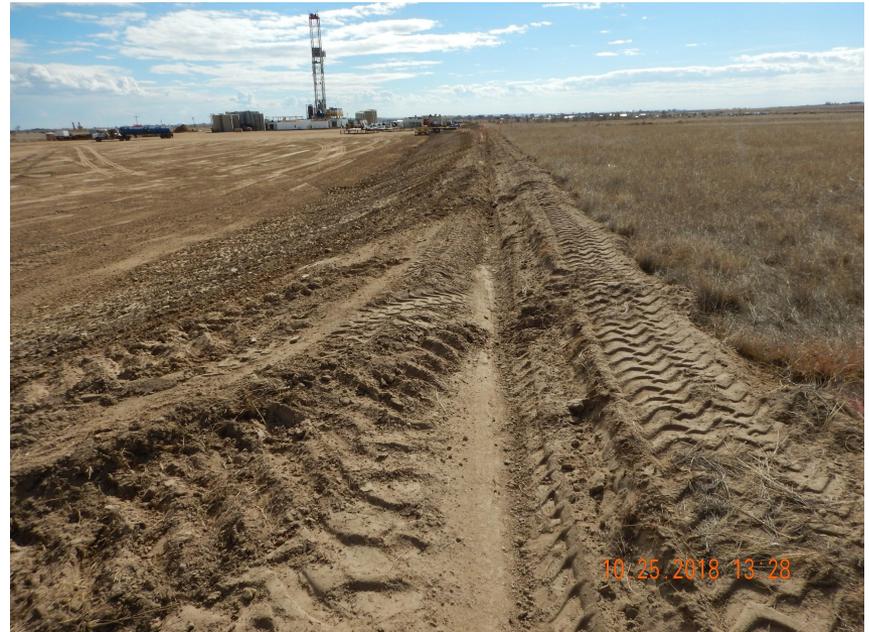
Photo 10. Photo taken from the northwestern location, facing South. See comments under Photo 5.

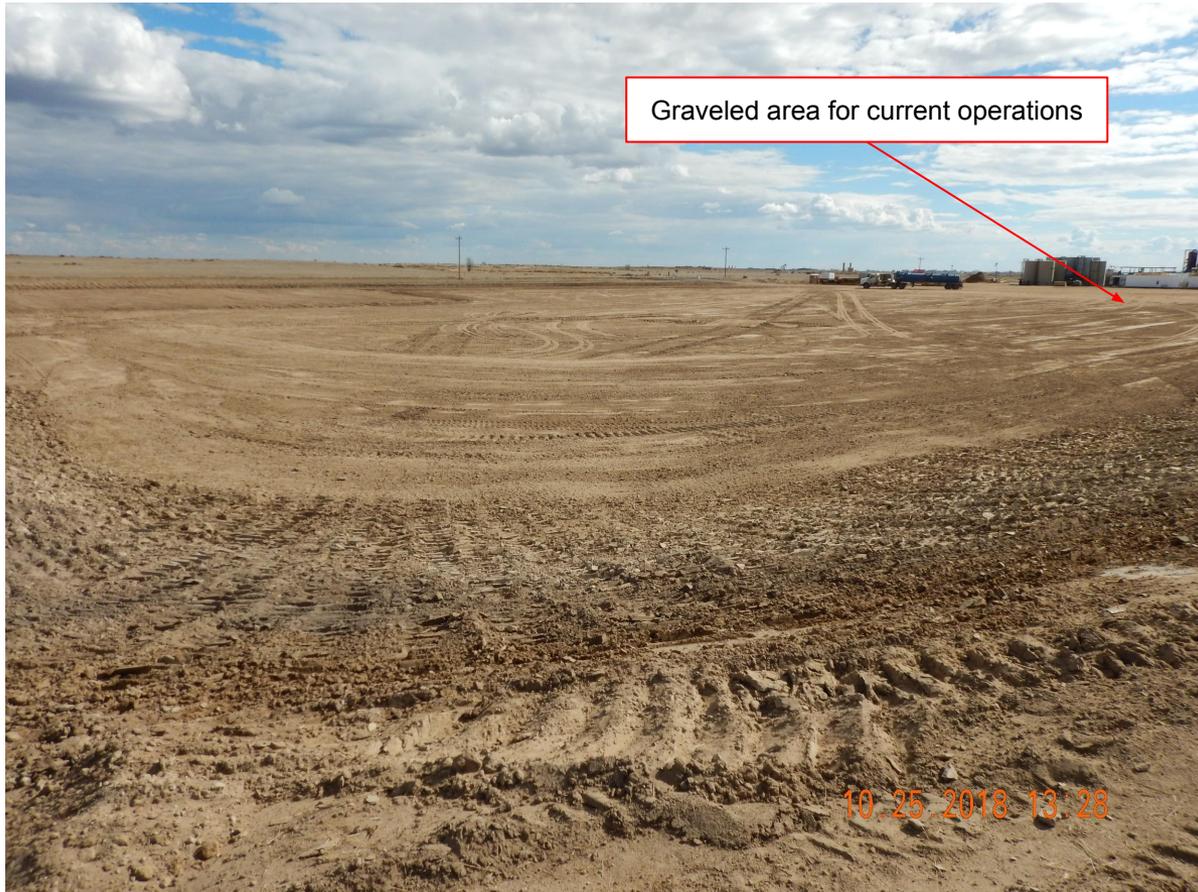
Photo 11. Photo taken from the northwestern location, facing Southeast. Photo illustrates the northern well pad area which has been compacted but not necessarily stabilized from wind erosion. Operator shall ensure compliance with Rule 1002.e.(1) to reasonably control dust and minimize erosion which includes wind erosion.

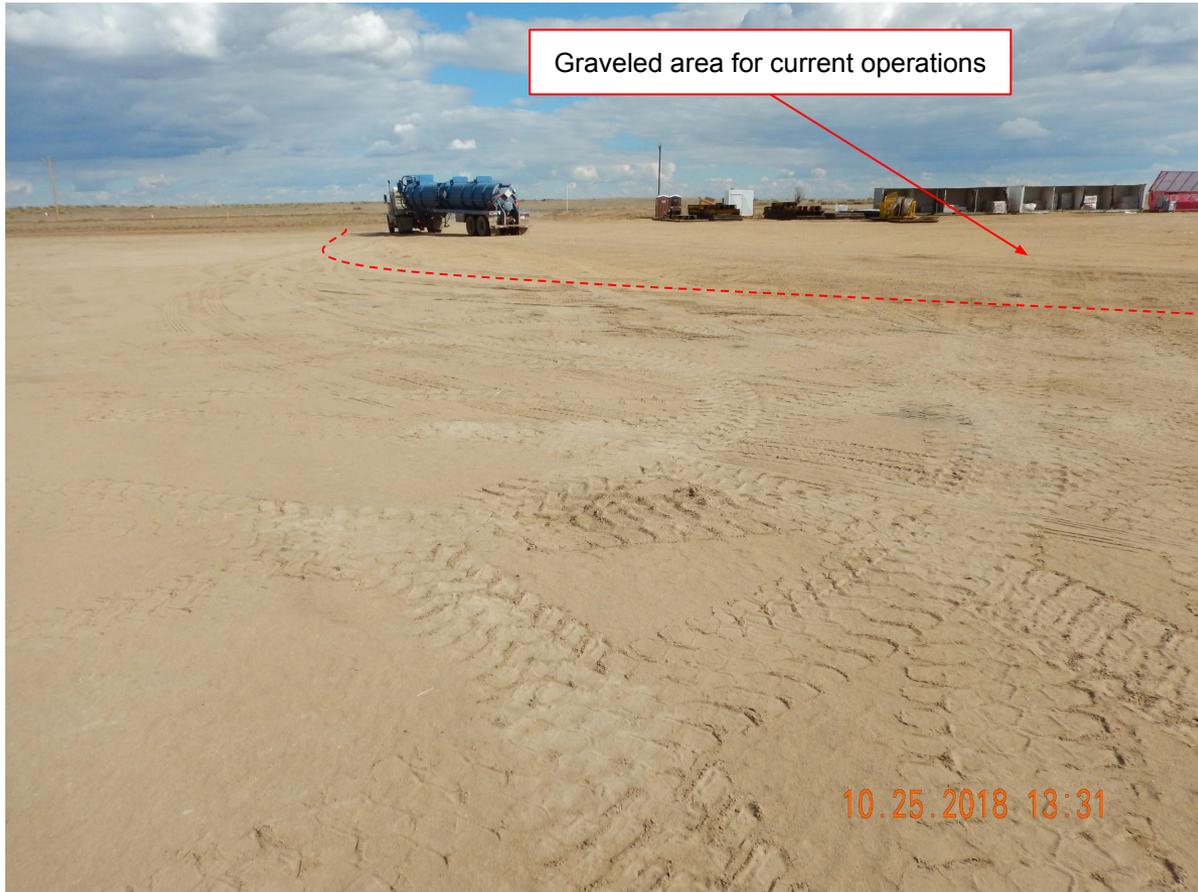
Photo 12. Photo taken from the western location, facing East. See comments under Photo 11.
