# Inspection Photos

Operator: Western Gas Resources

API: 05-067-08004

Date: 9/27/2018

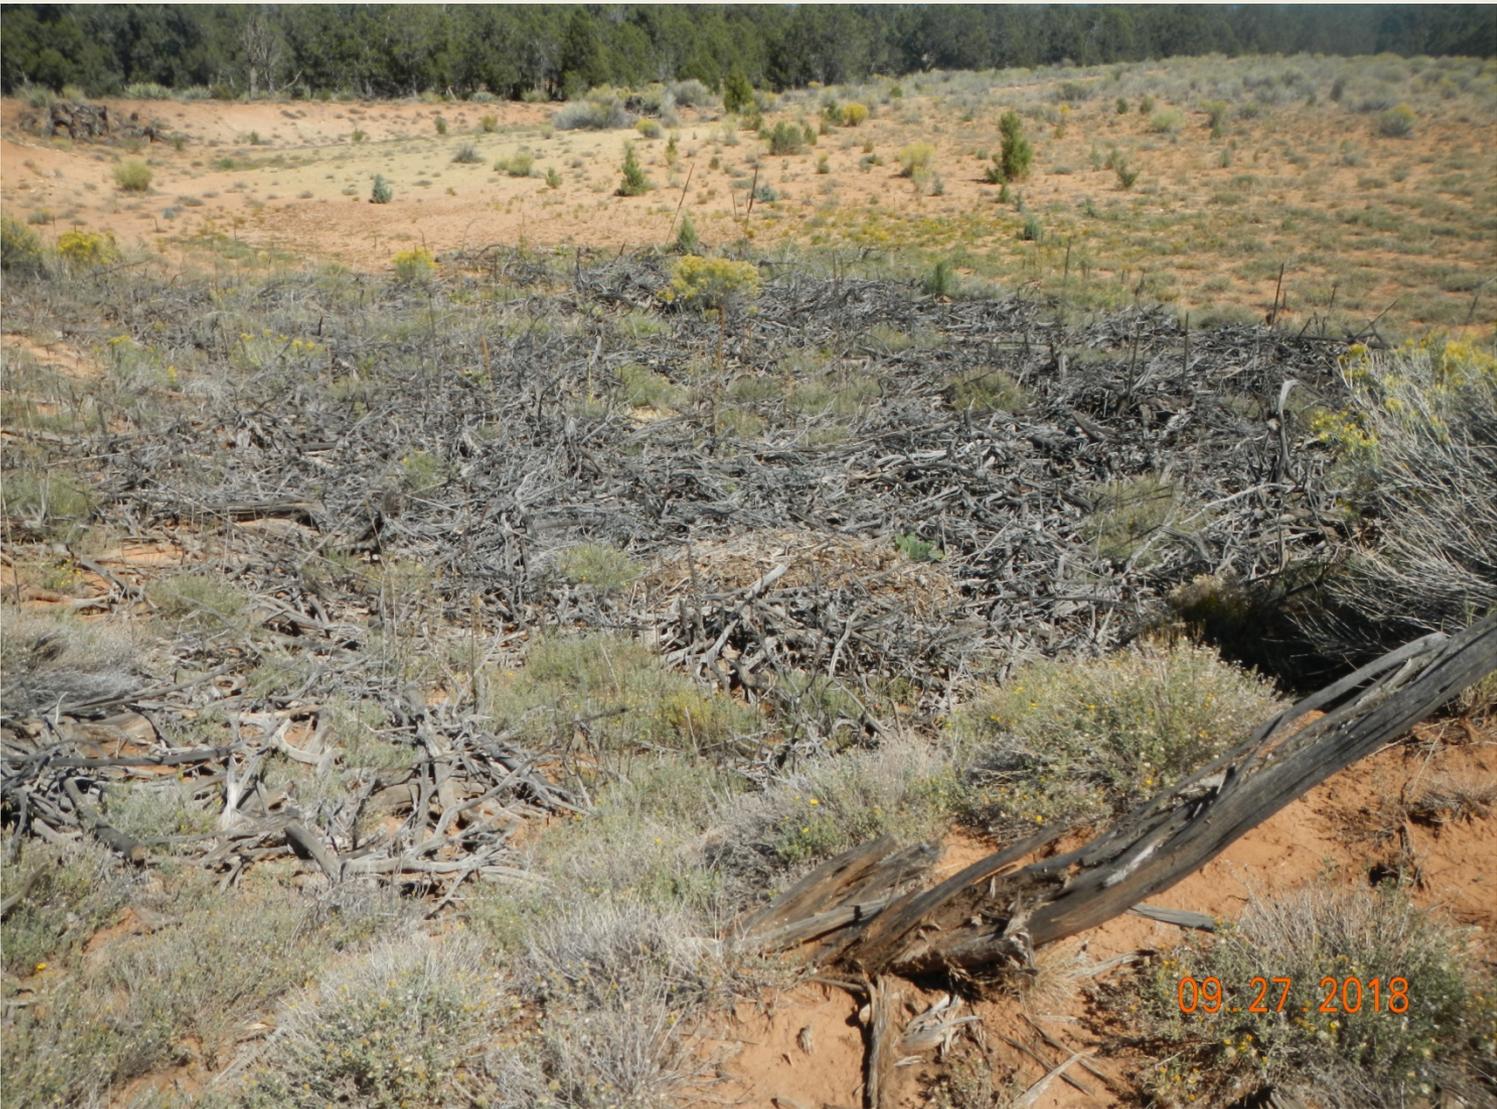
**Photo 1. View of wood debris in the southwestern project area, still in place.**

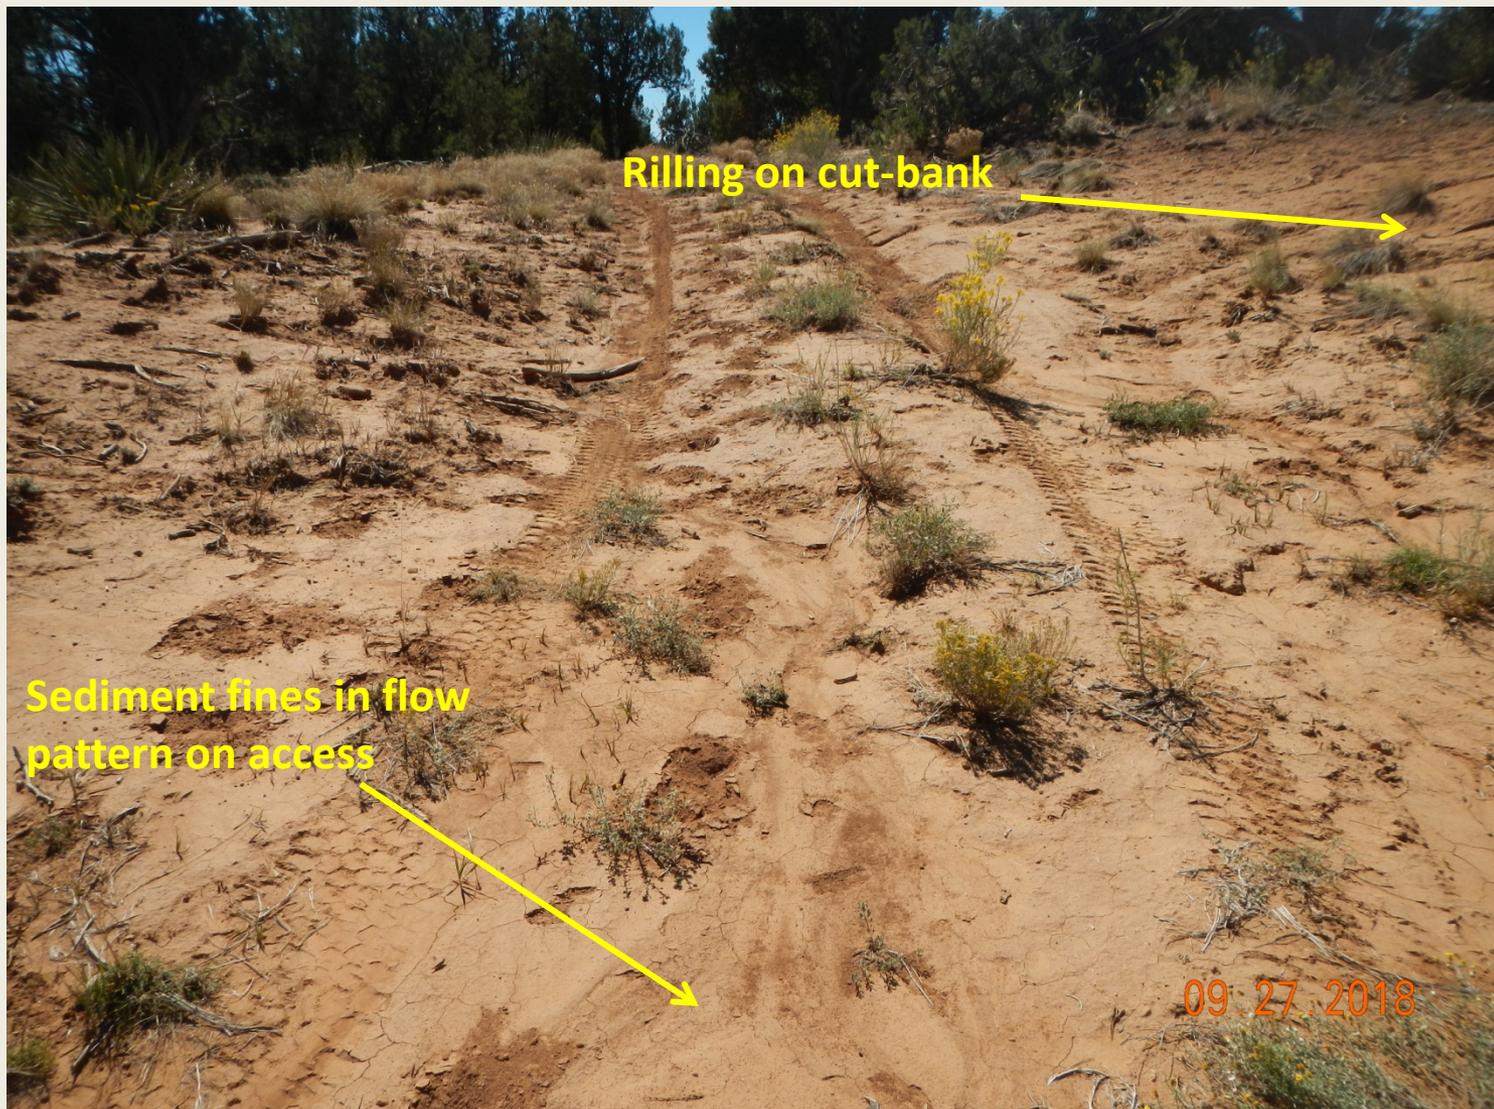
**Photo 2. View of access road, sediment deposition observable in foreground. Rilling on cut-banks also observable.**

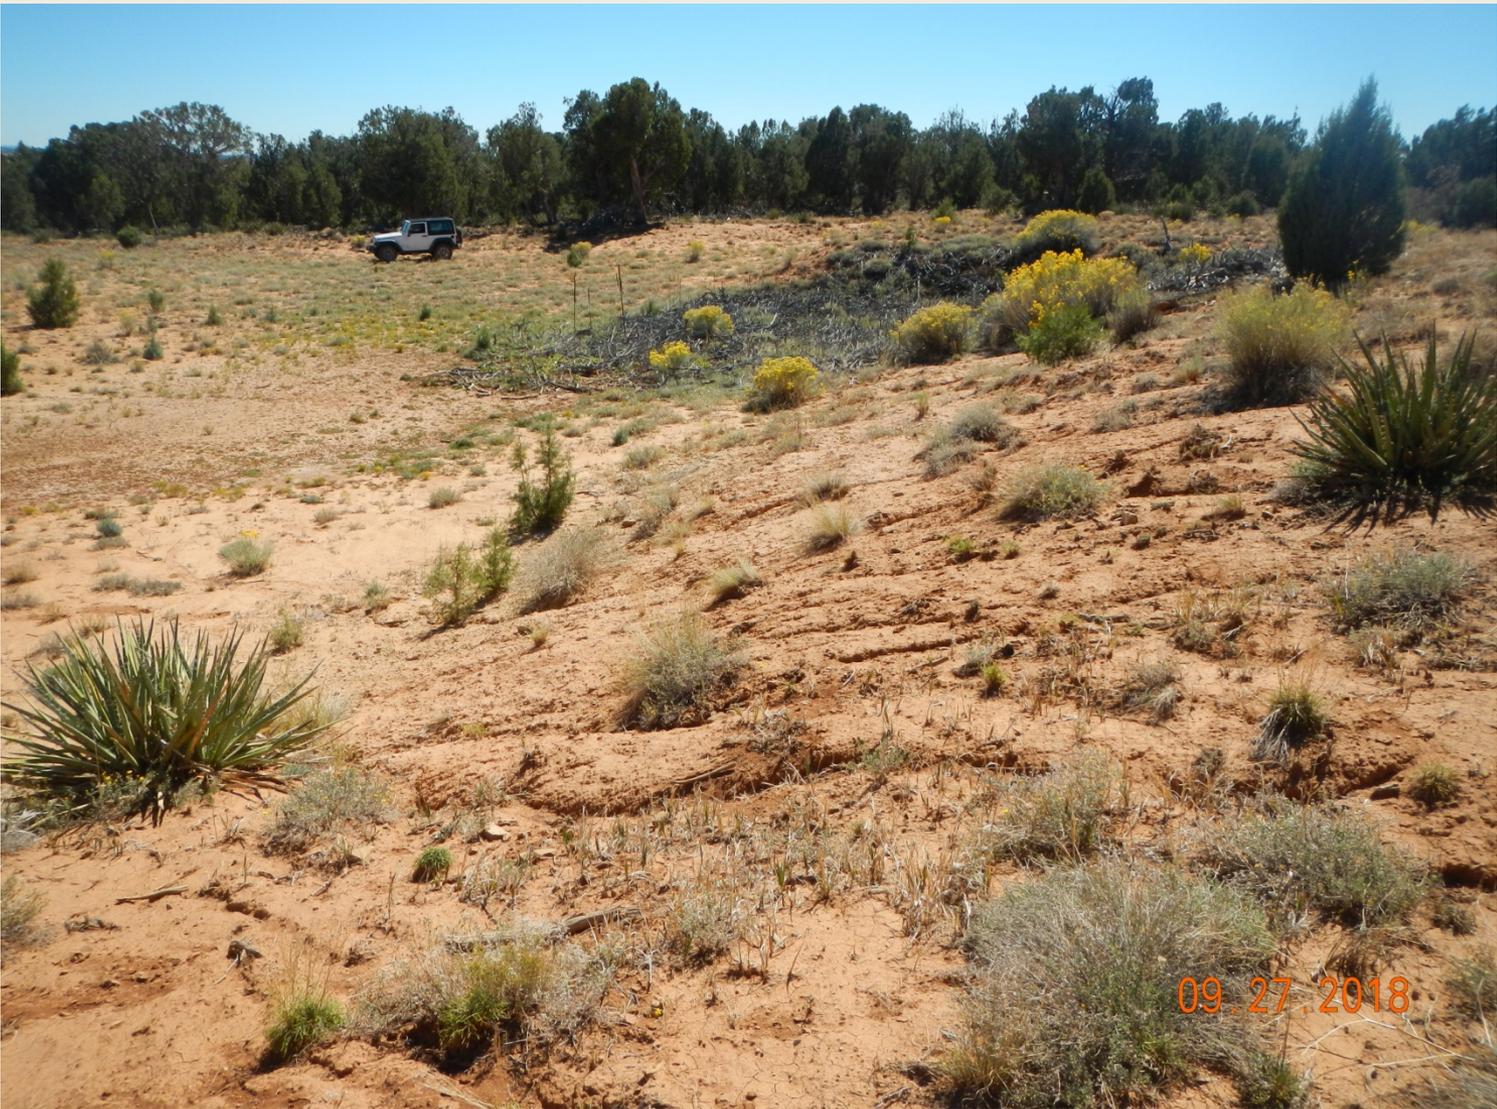
**Photo 3. View of the western cut-slope still in place. Sparse vegetation and rilling up to 12 inches deep occurring on the cut-slope.**

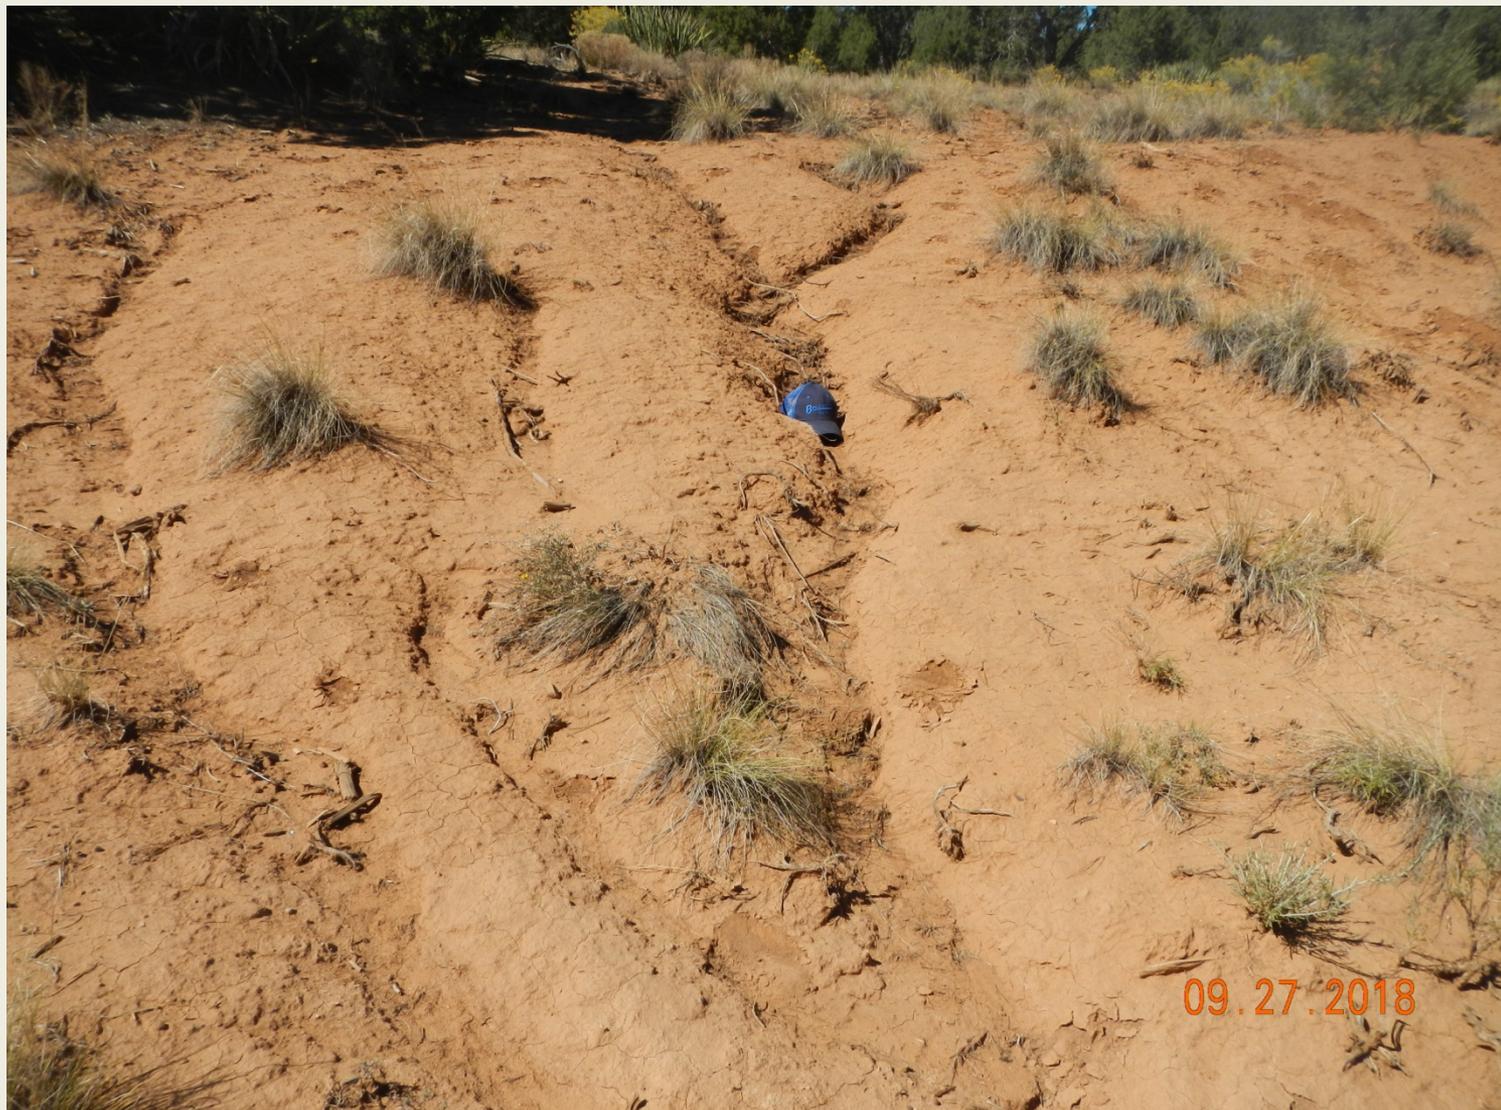
**Photo 4. View of rilling approximately 12 inches wide and deep in the southwestern cut-slope.**

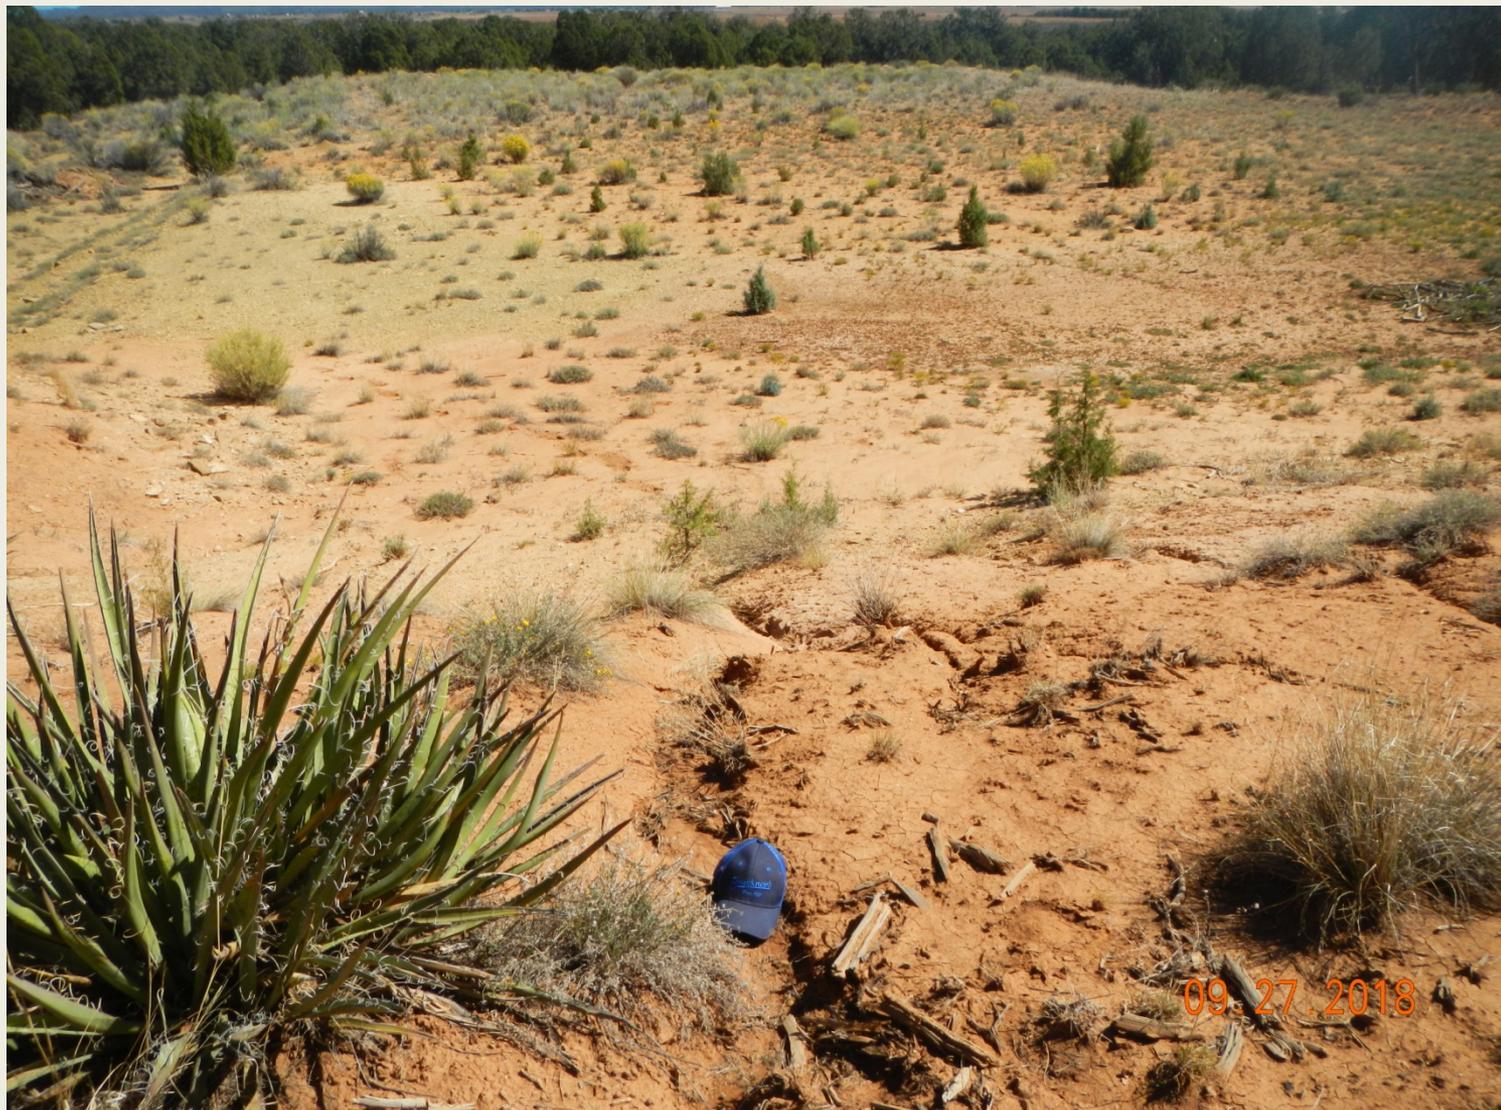
**Photo 5. Another view of erosional channels forming on the well pad cut-slope. This is in the northwestern cut-slope.**

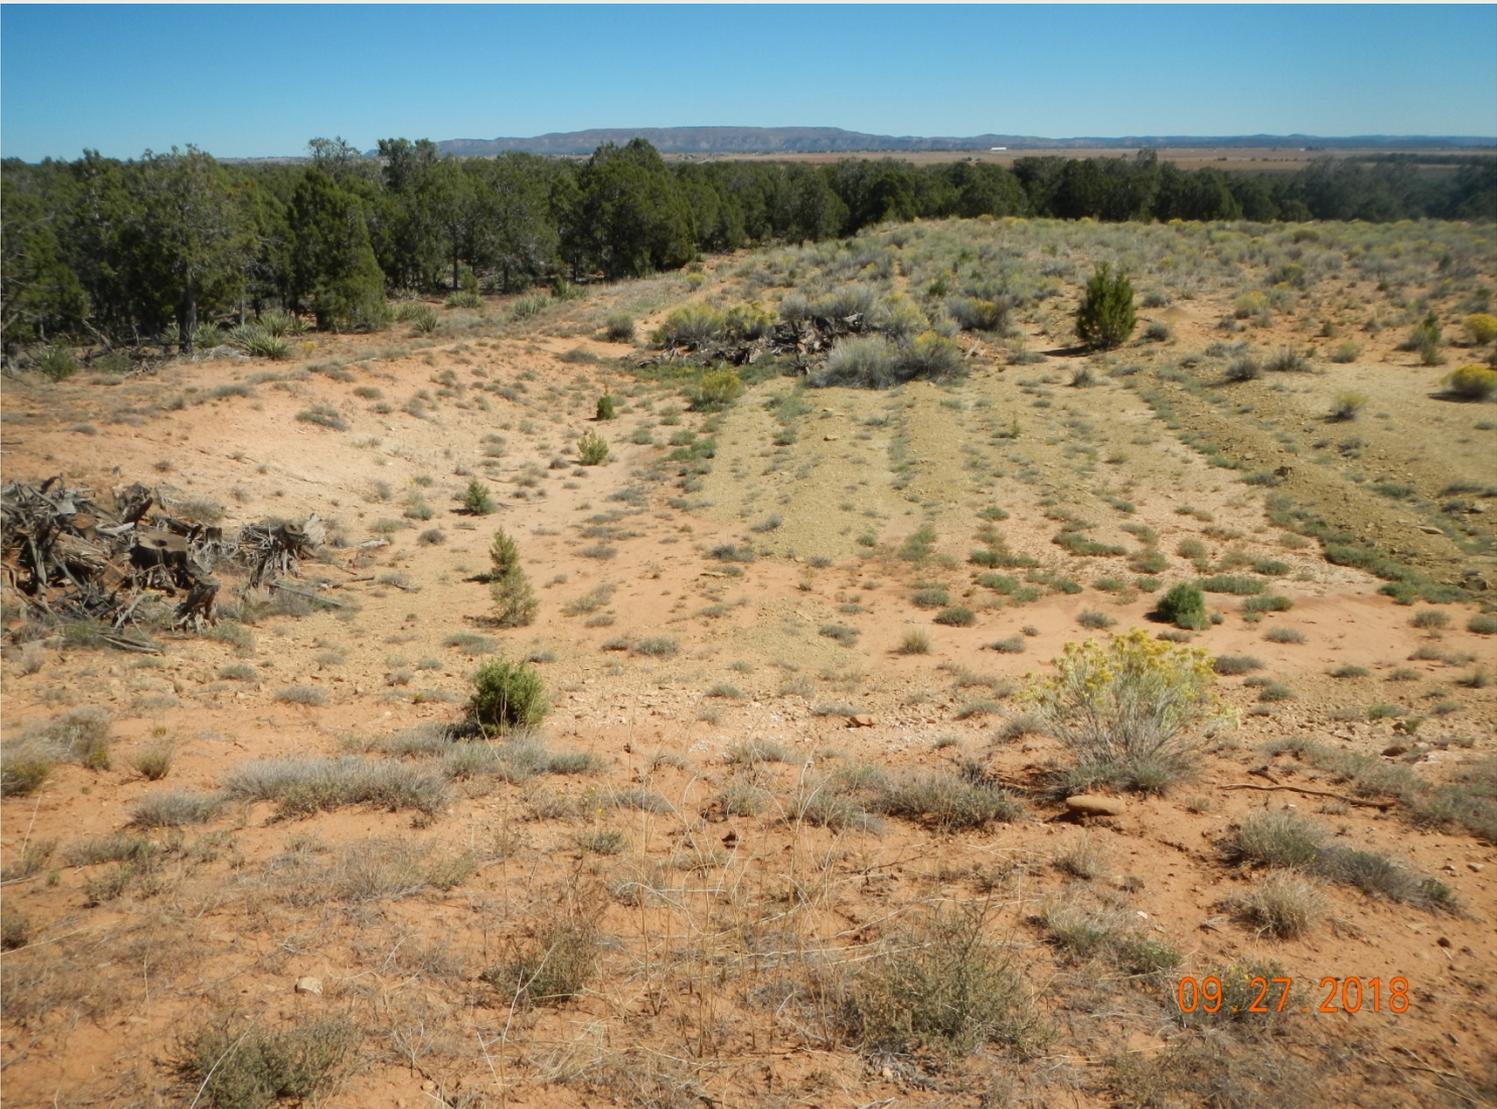
**Photo 6. View of bermed area and soil placed in rows in the northern project area.**

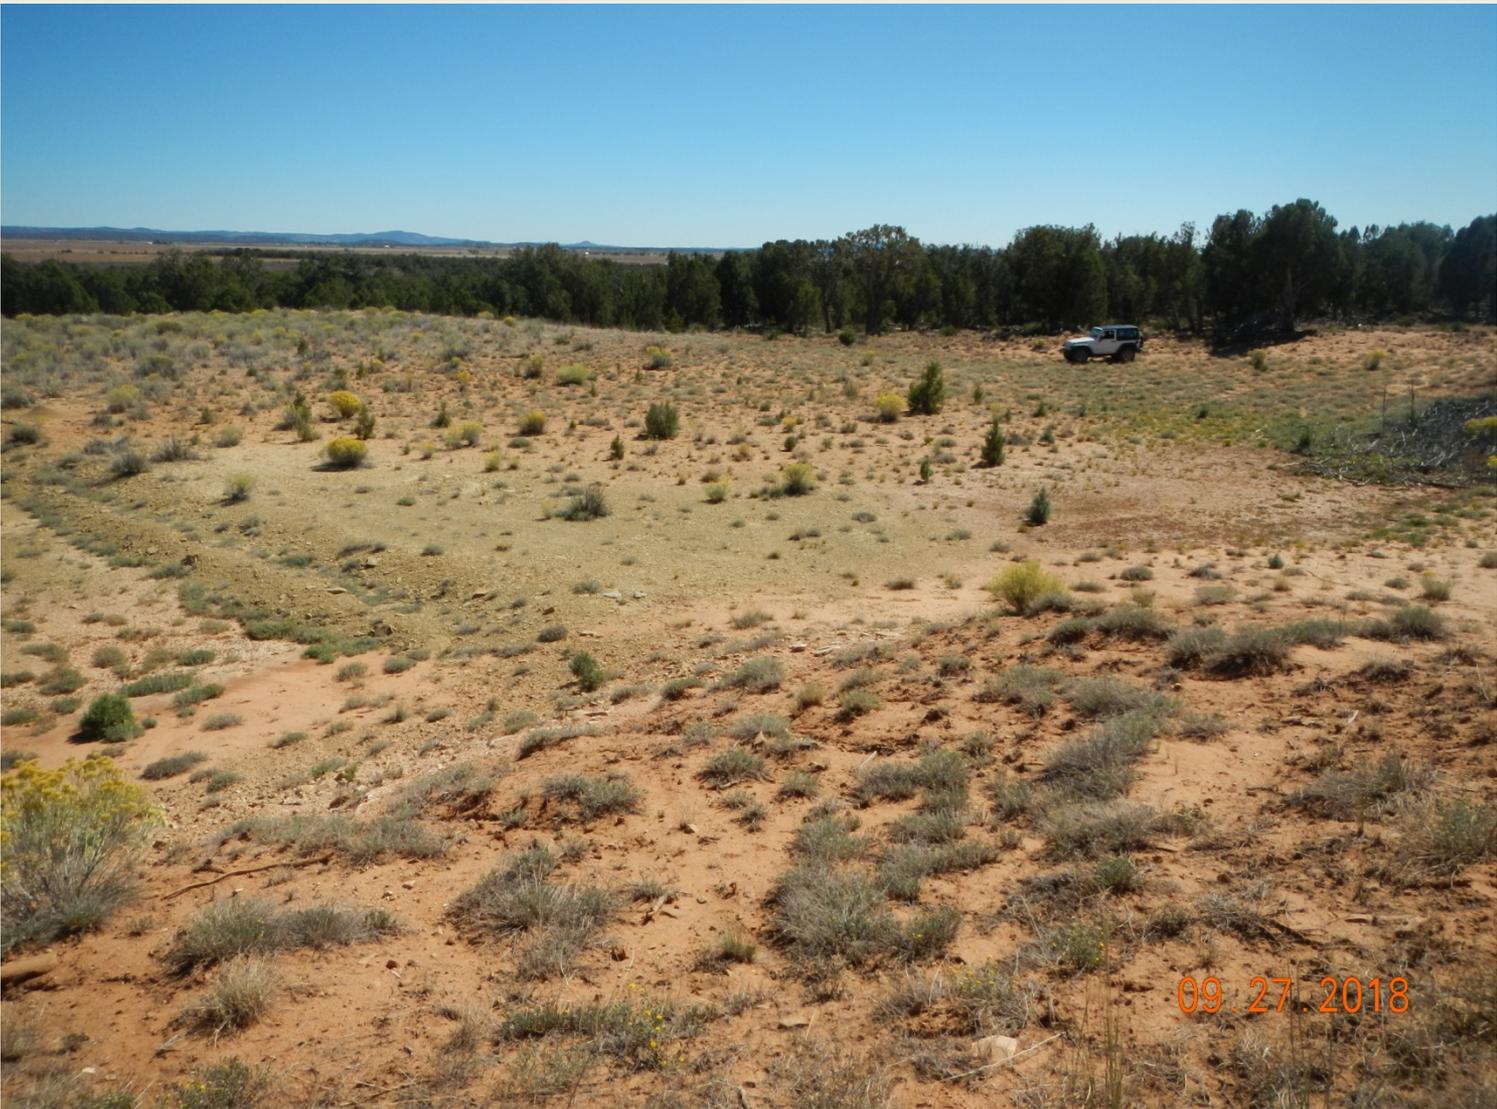
**Photo 7. View of the project area from the northwestern corner facing center.**

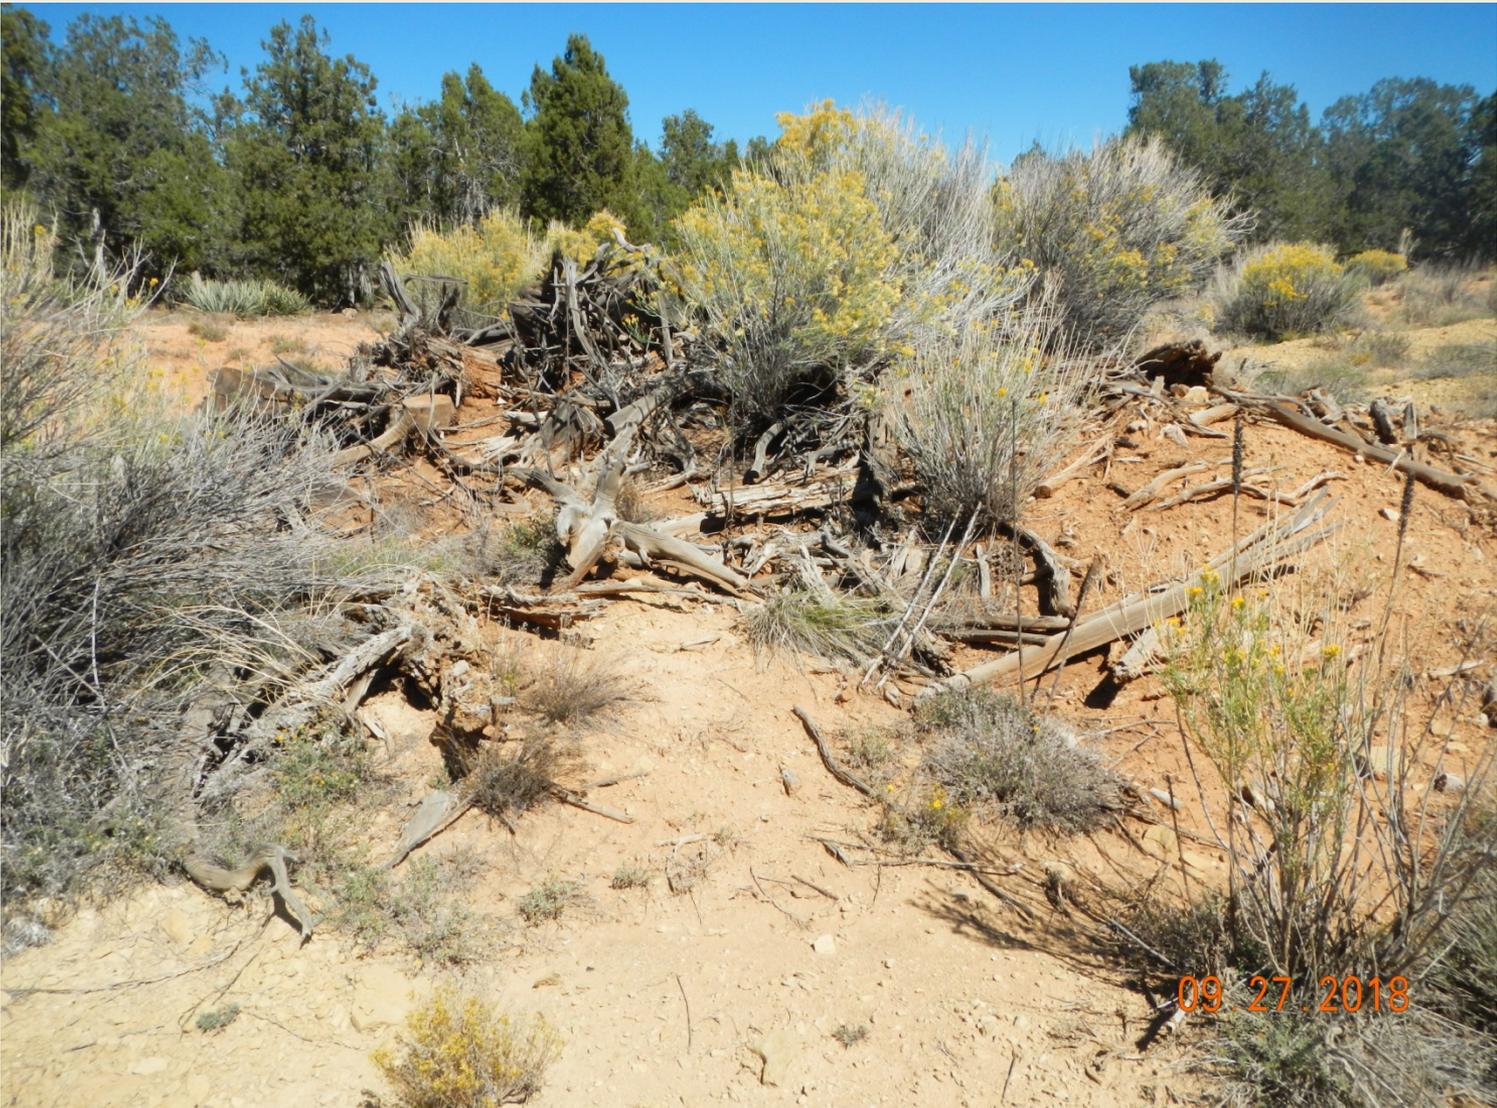
**Photo 8. View of more wood debris in the northern project area.**

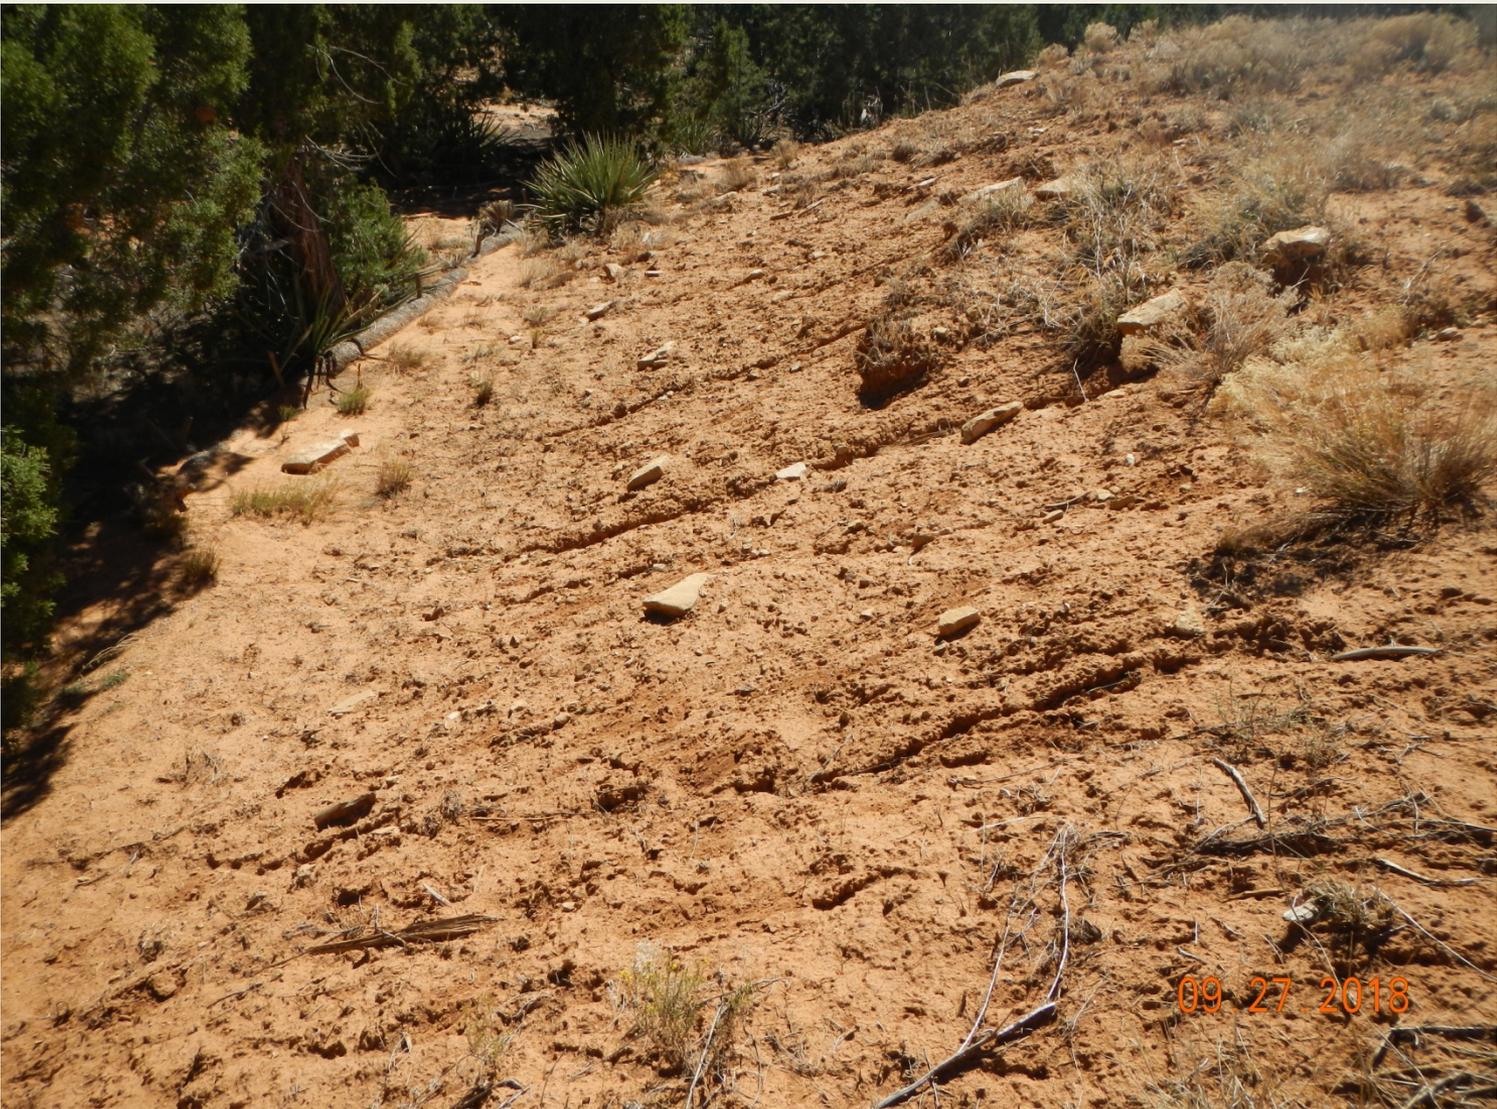
**Photo 9. View of the southeastern fill slope (east facing) from the eastern edge facing southward. Vegetation is sparse, rilling is occurring, and wattles are full of sediment.**

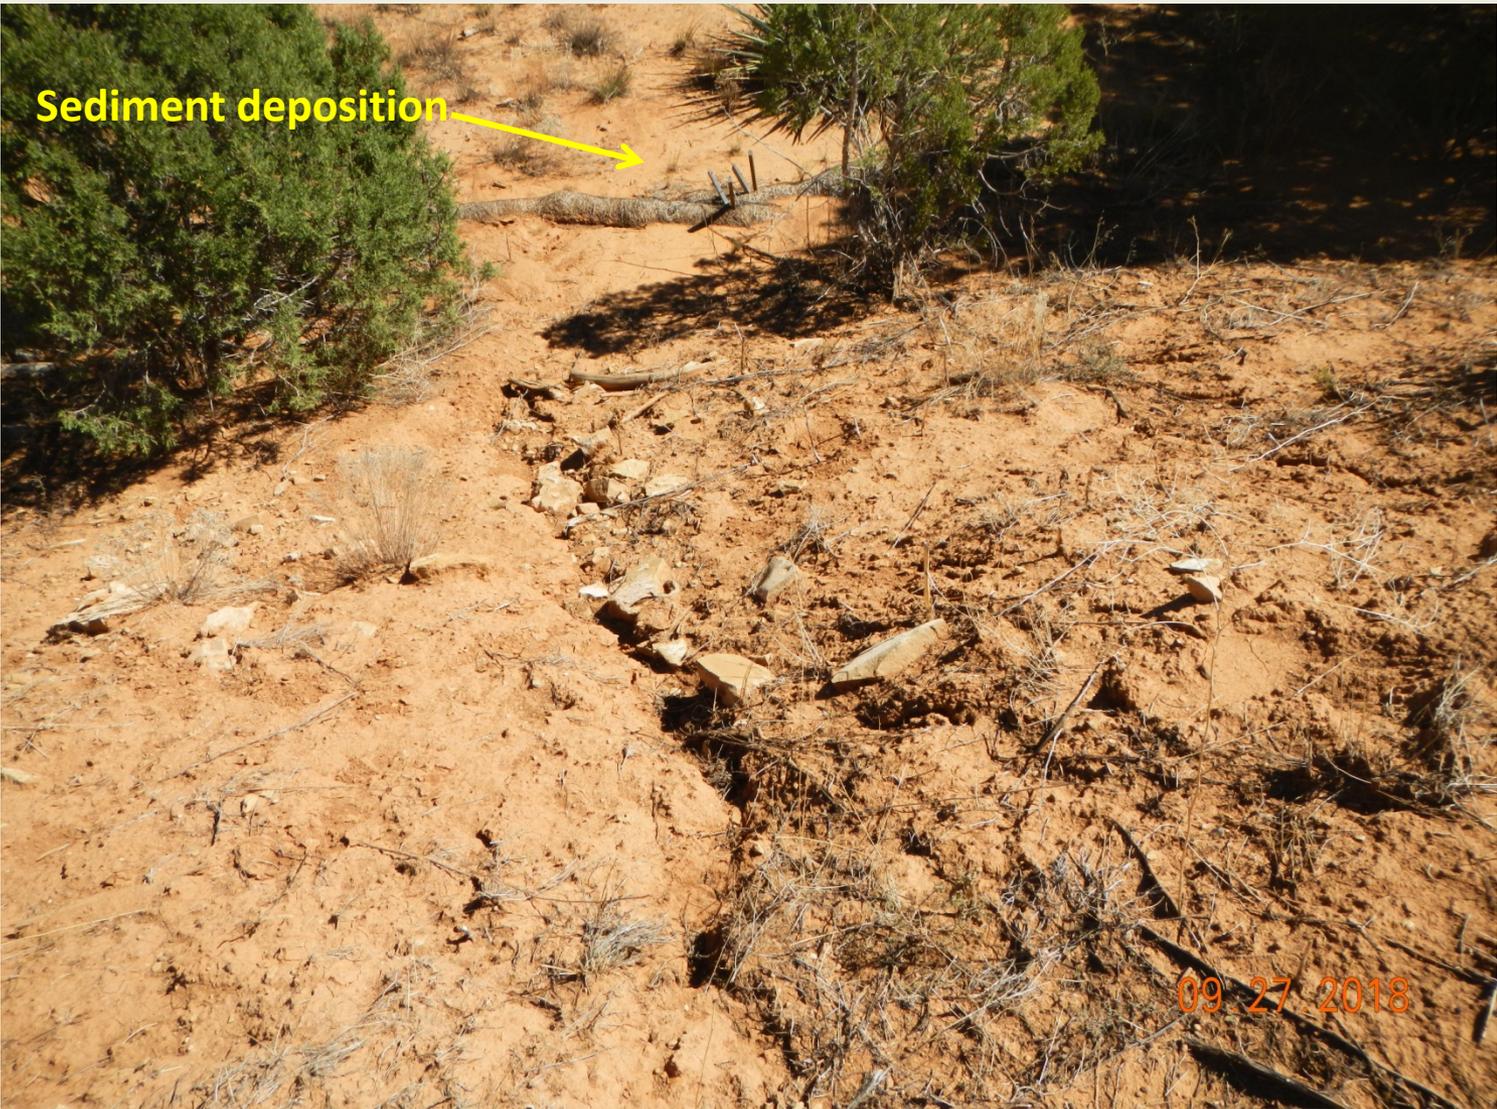
**Photo 10. View of rilling up to 10 inches deep in the southeastern project area. Sediment deposition is observed downstream from the wattles.**

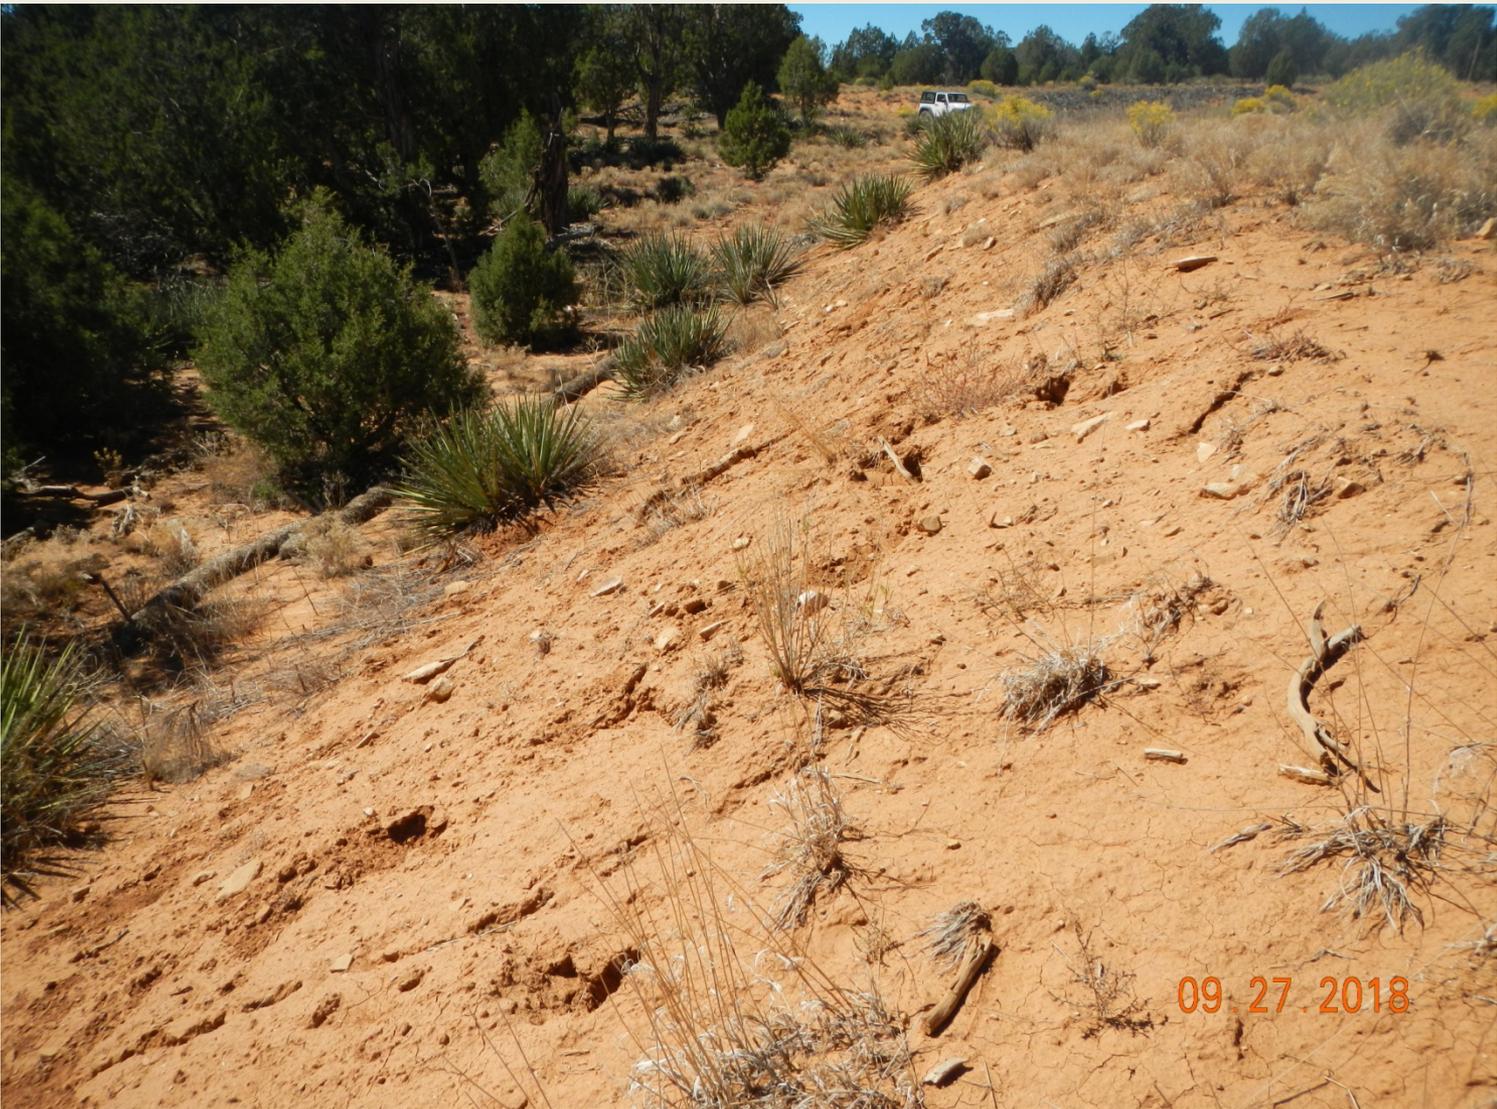
**Photo 11. View of the southern project area from the southeastern corner facing eastward. Sparse vegetation, rilling and sediment deposition observed here.**

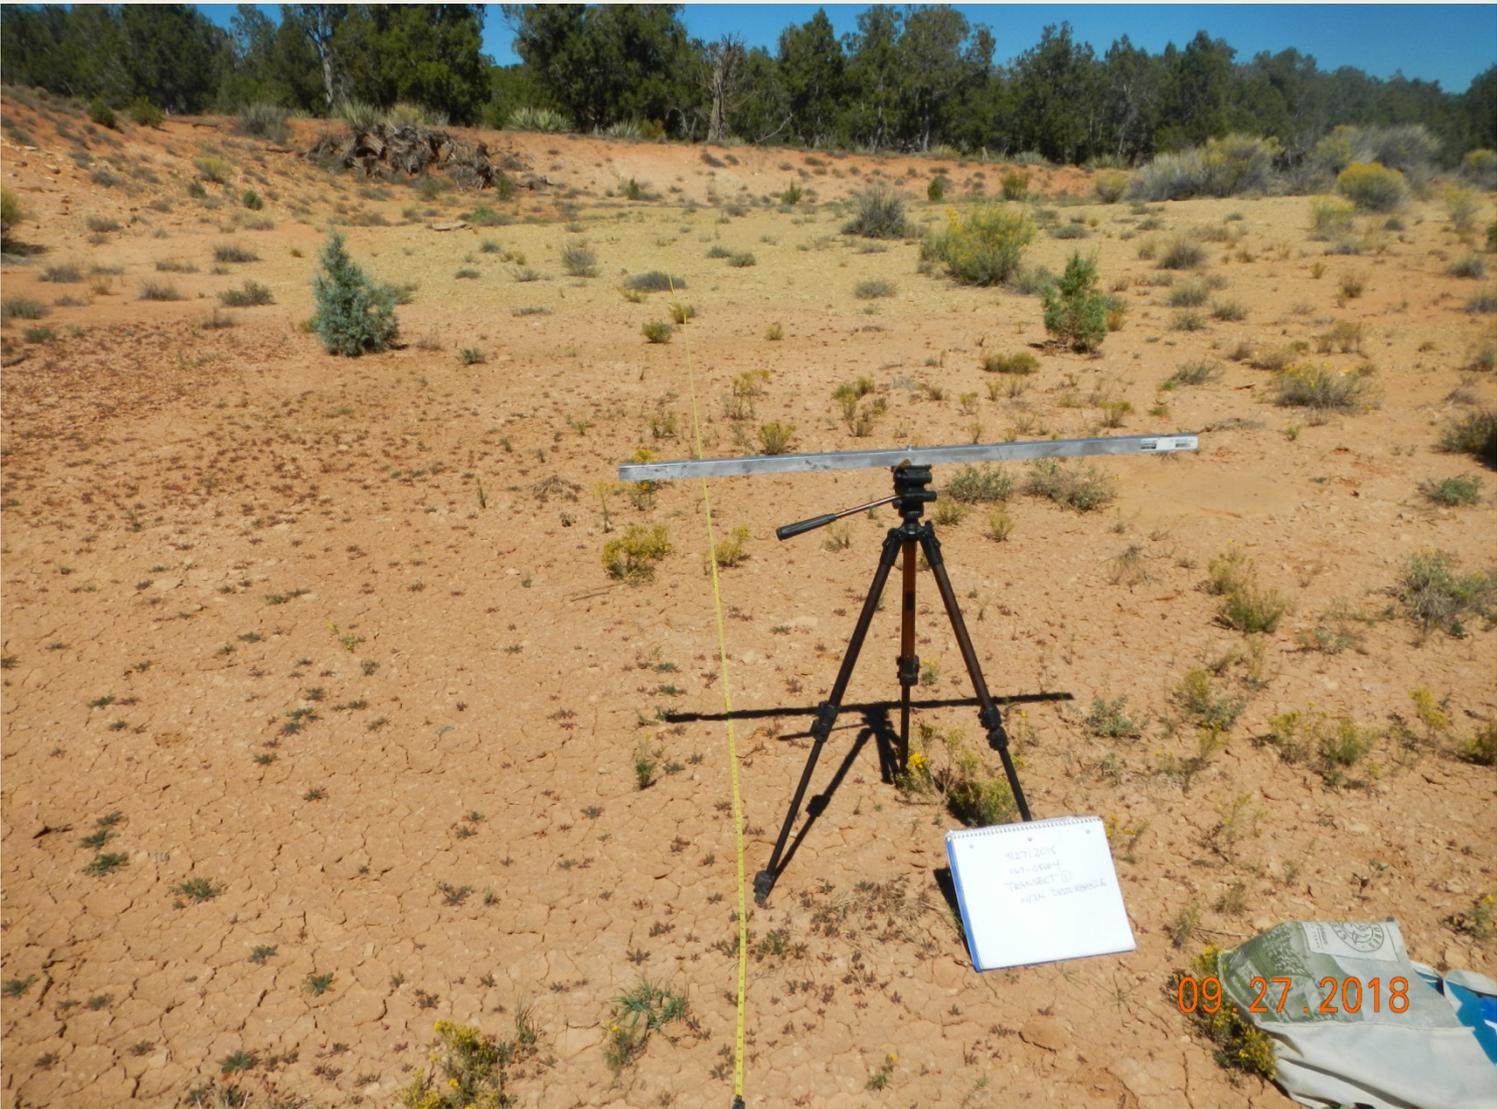
Photo 12. View of the beginning of Transect 1, within the project area facing northward.

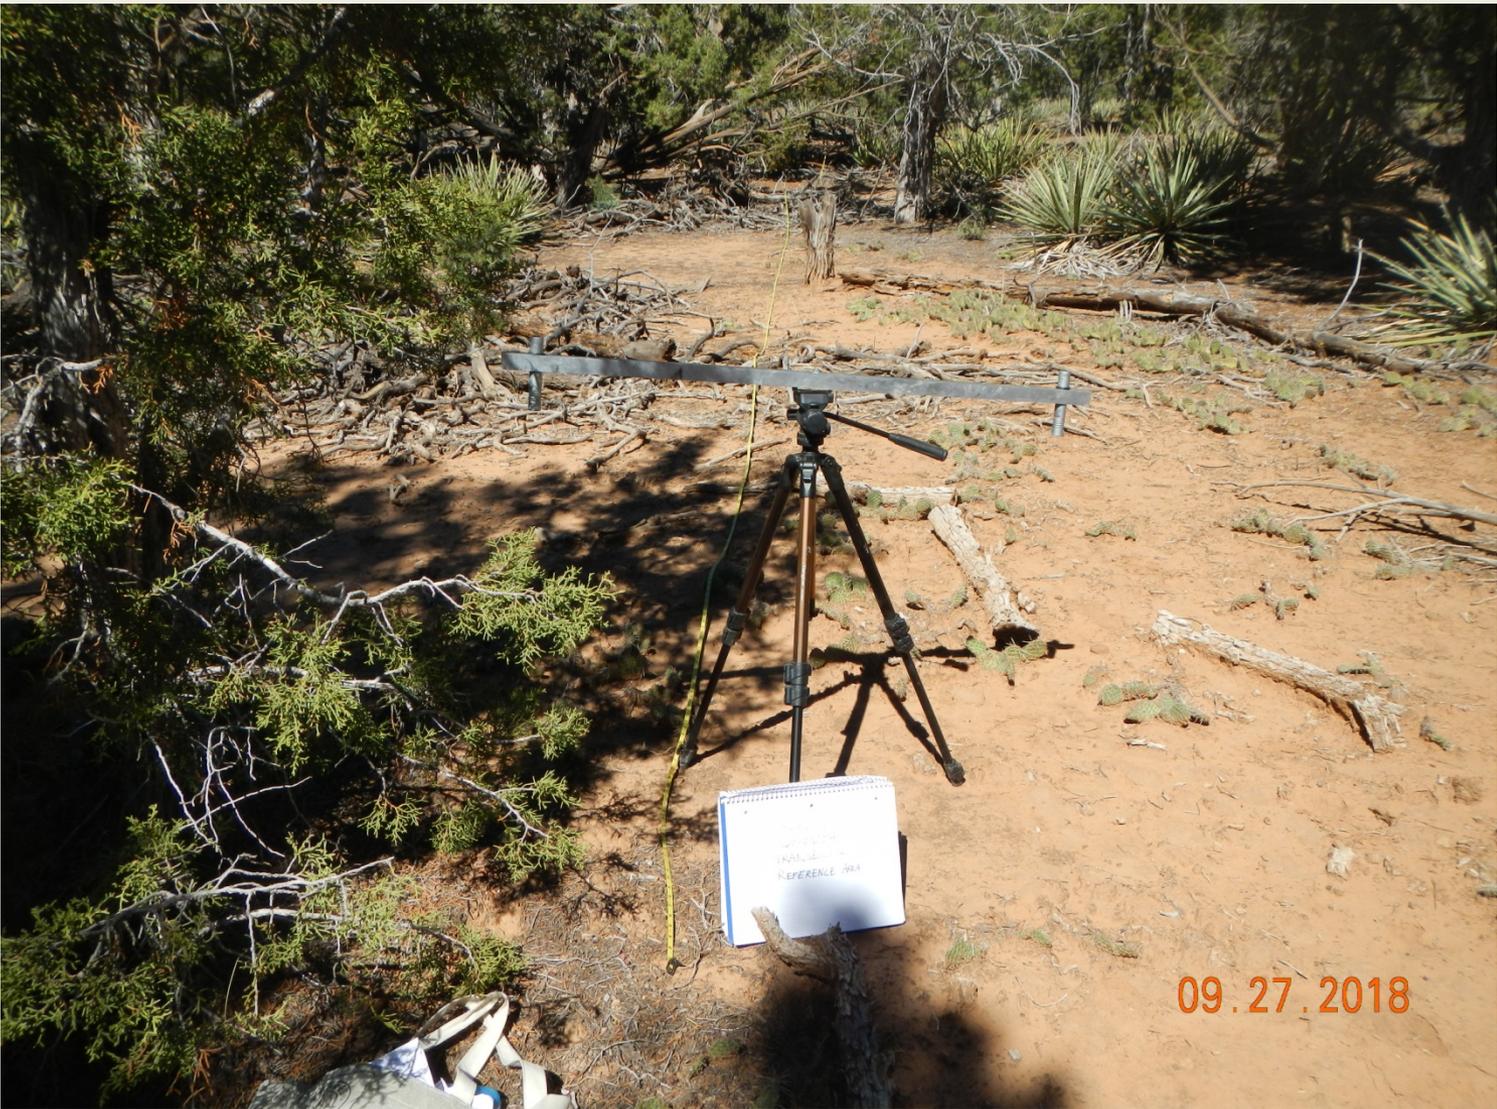
Photo 13. View the beginning of Transect 2, within the reference area facing northward.
