Inspection Photos

API: 05-055-06309

Operator: ALTA MESA SERVICES LP

Inspection Date: 10/19/2018

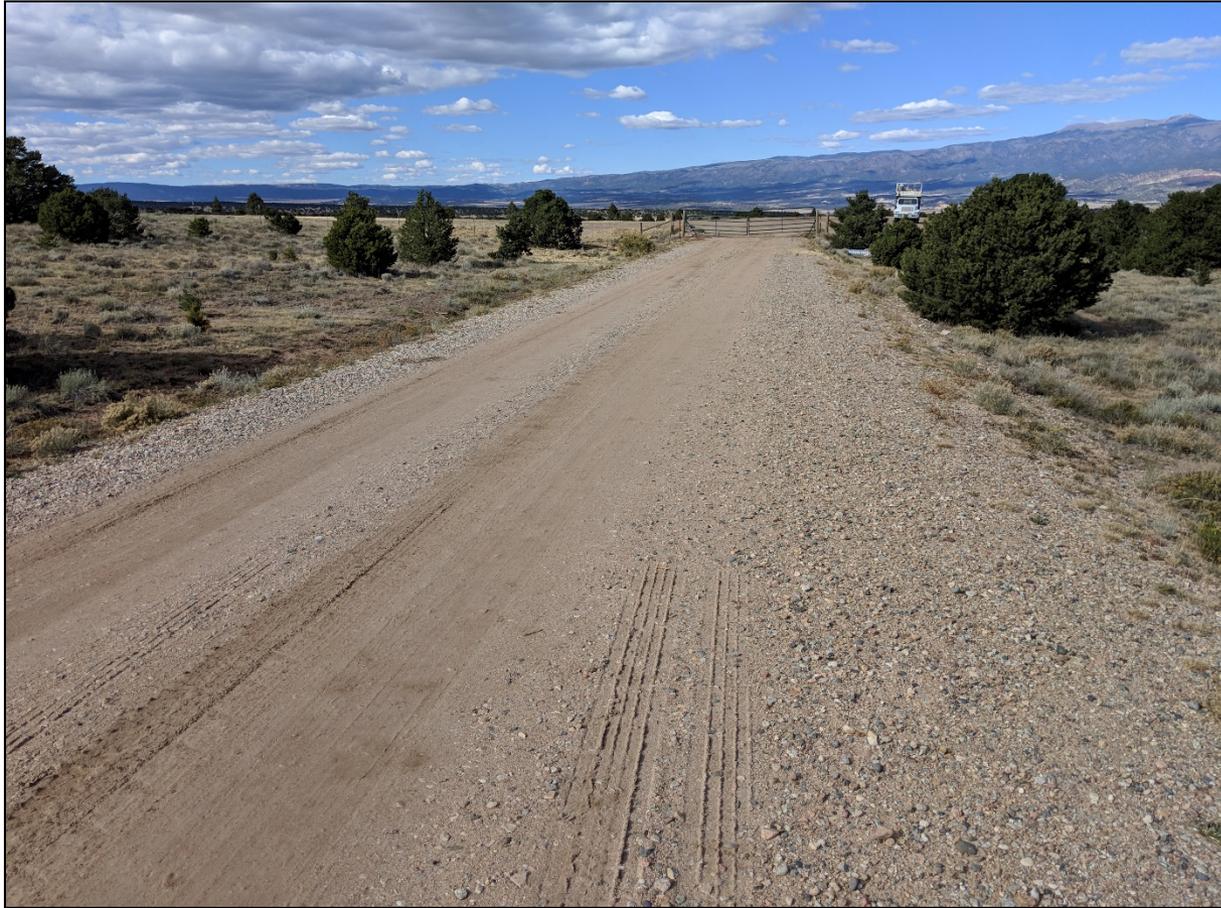
Photo 1. Facing north along the access road to the location.

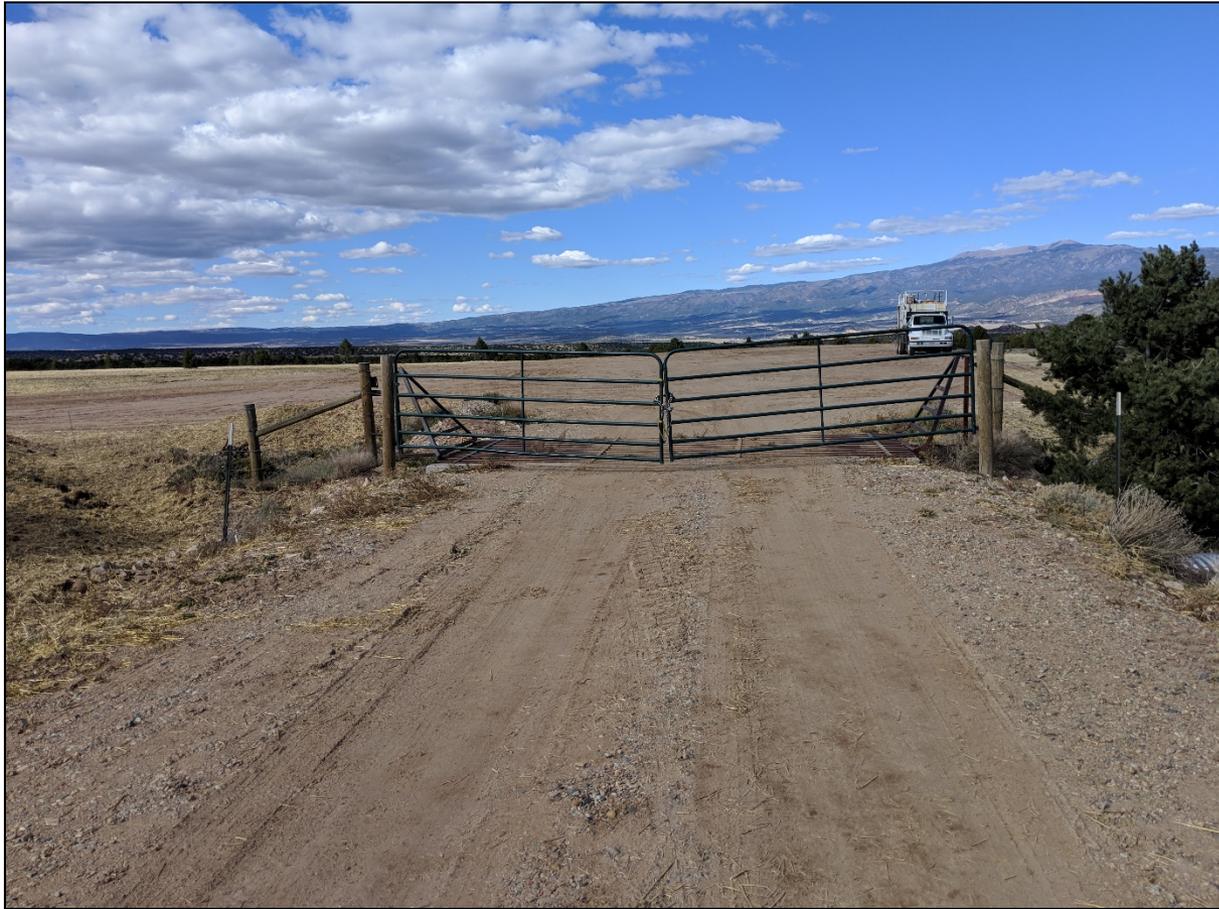
Photo 2. Facing north along the access road toward the location.

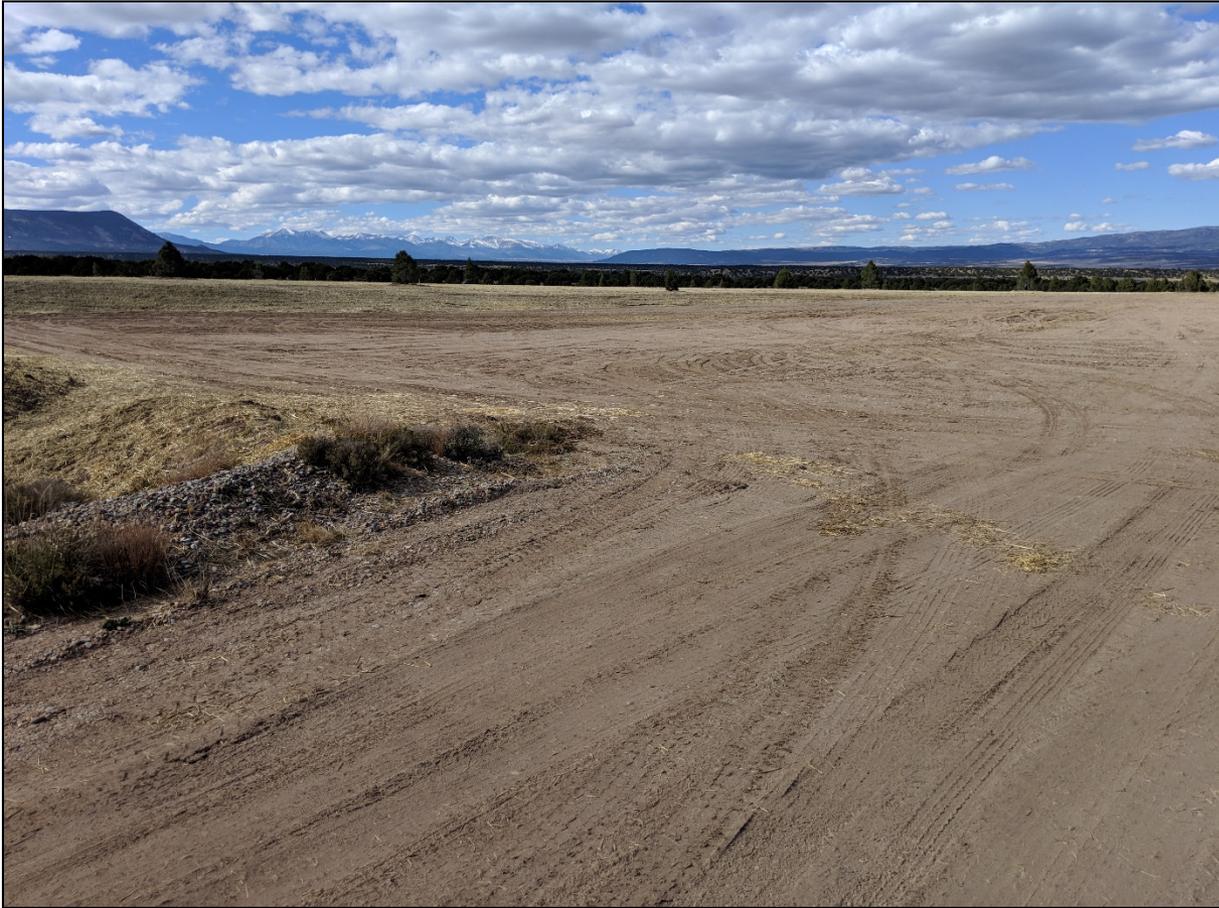
Photo 3. Facing northwest toward the location. The eastern portion of the location was not reclaimed.

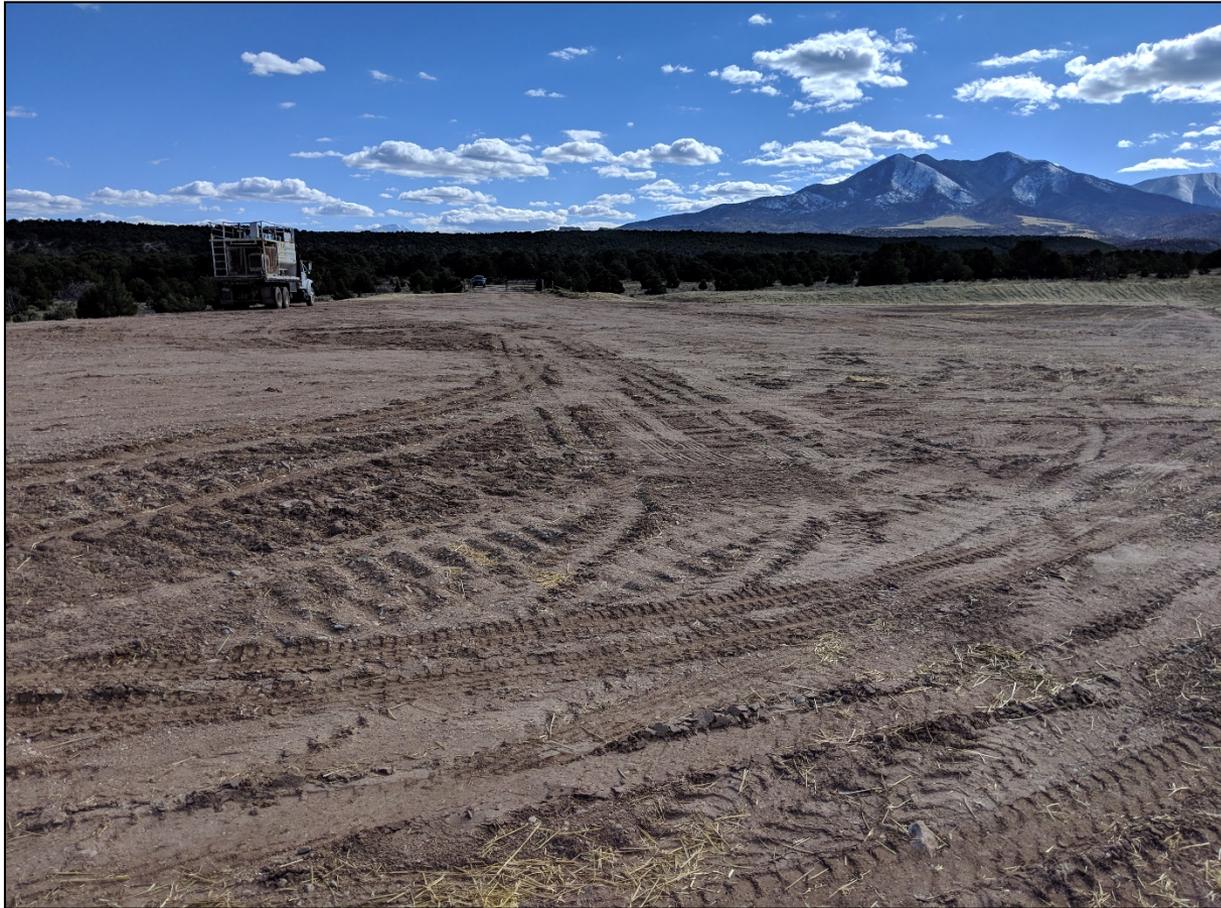
Photo 4. Northeast side of the location facing south. The eastern portion of the location has not been reclaimed.

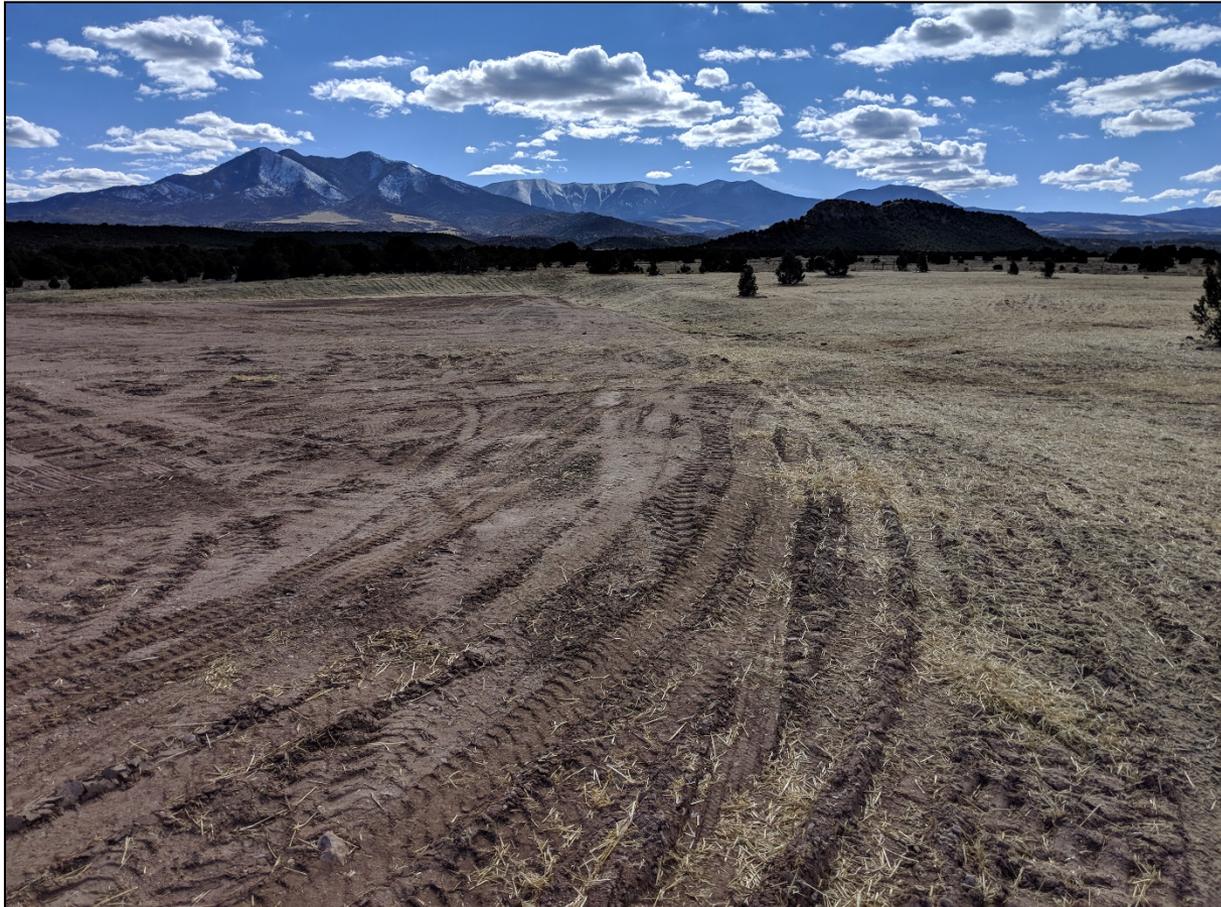
Photo 5. Facing southwest toward the location.

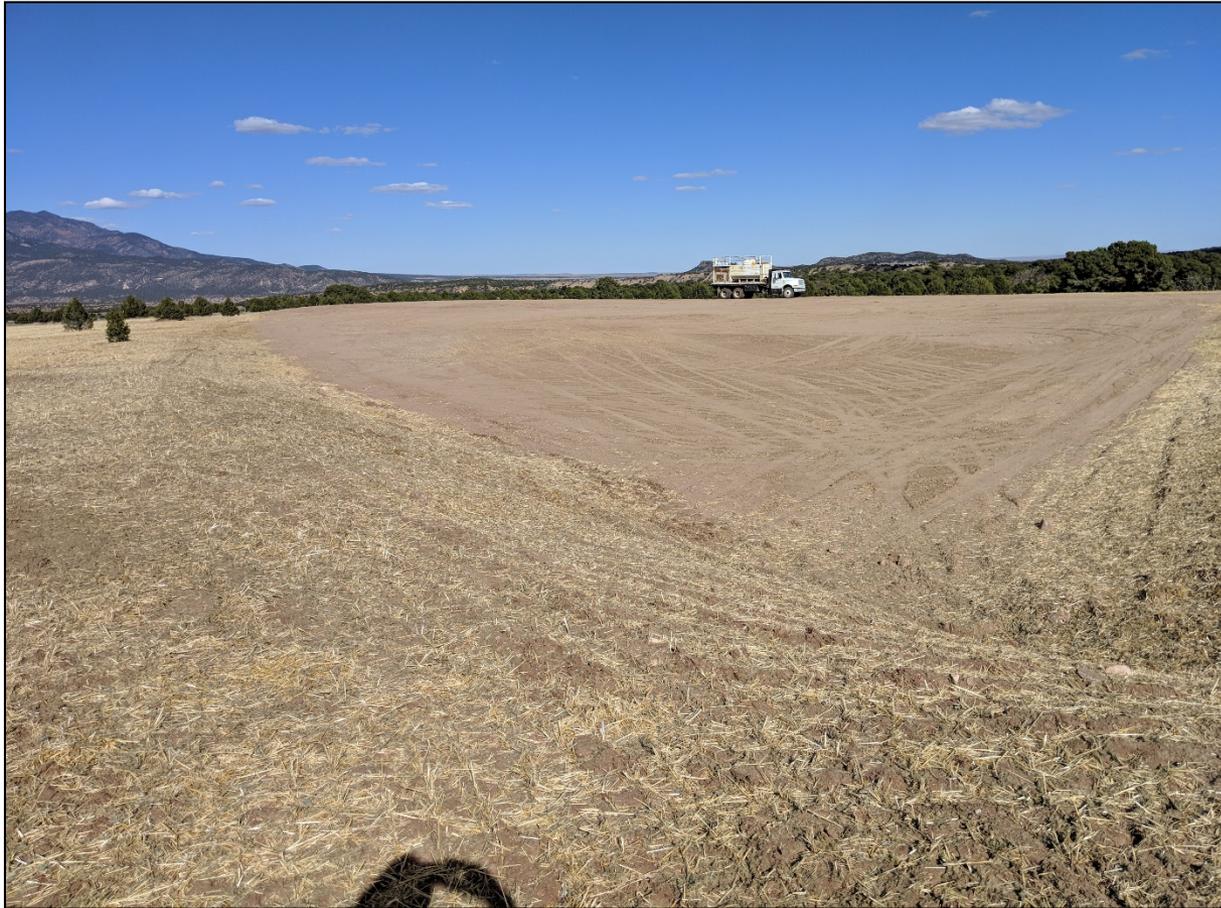
Photo 6. South side of the location facing northeast.

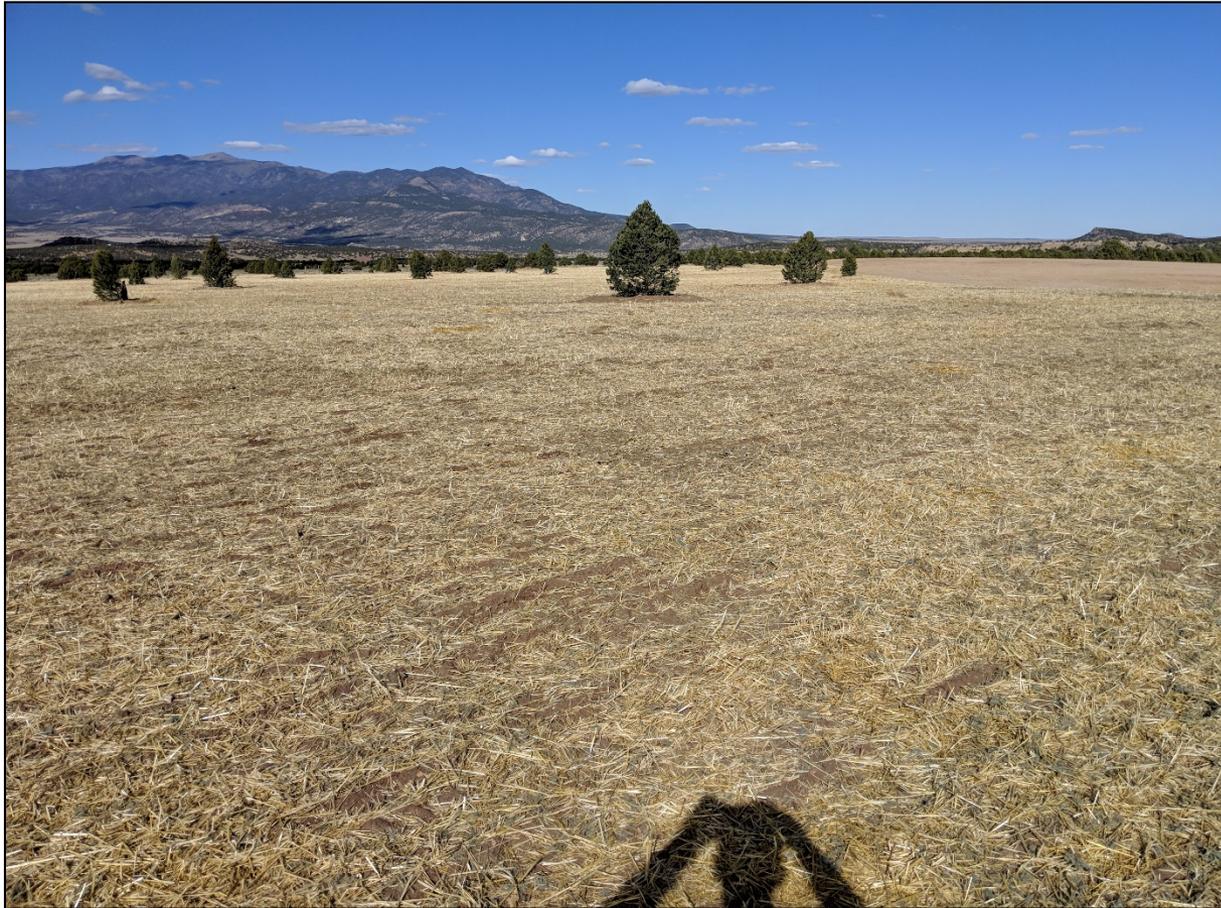
Photo 7. South side of the location facing northeast.

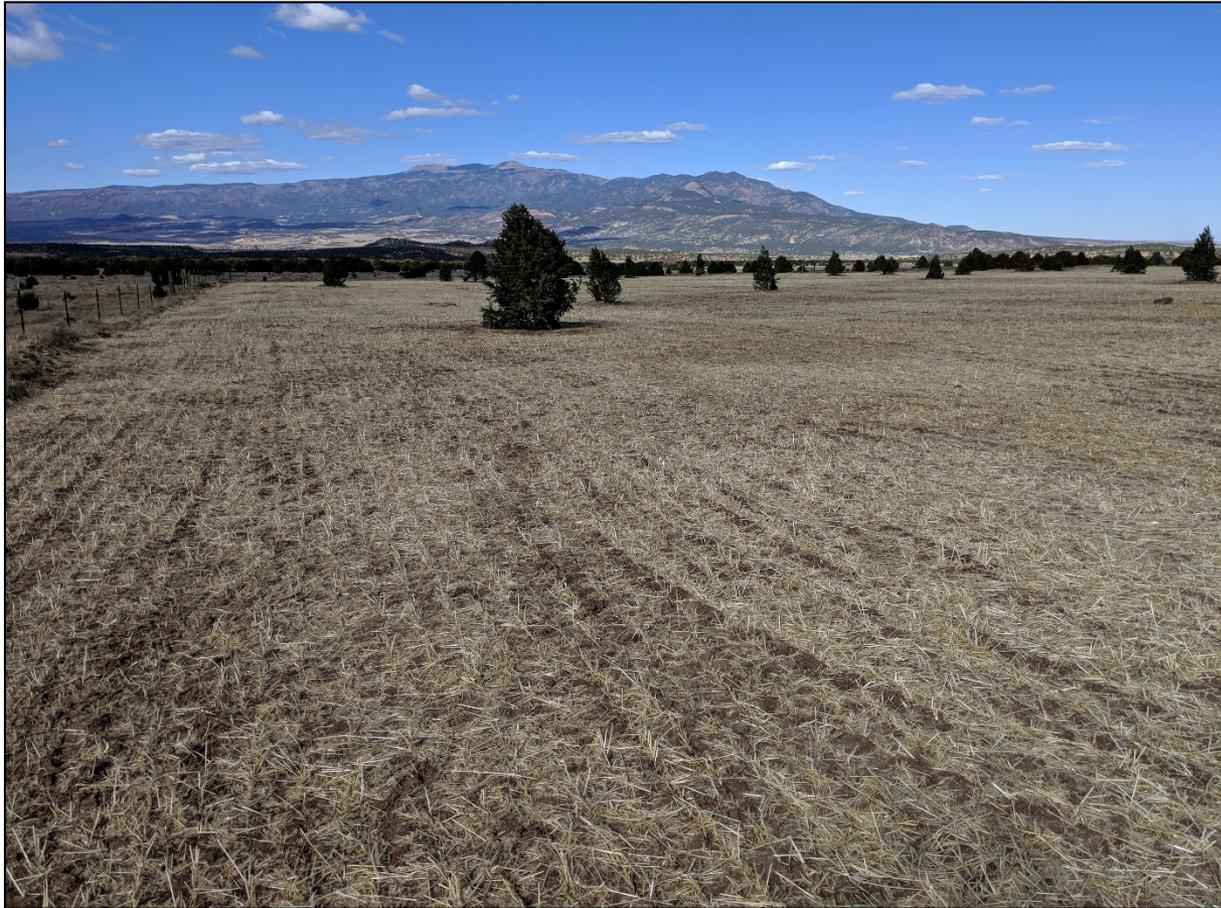
Photo 8. West side of the location facing north. The western portion of the location has been reclaimed.

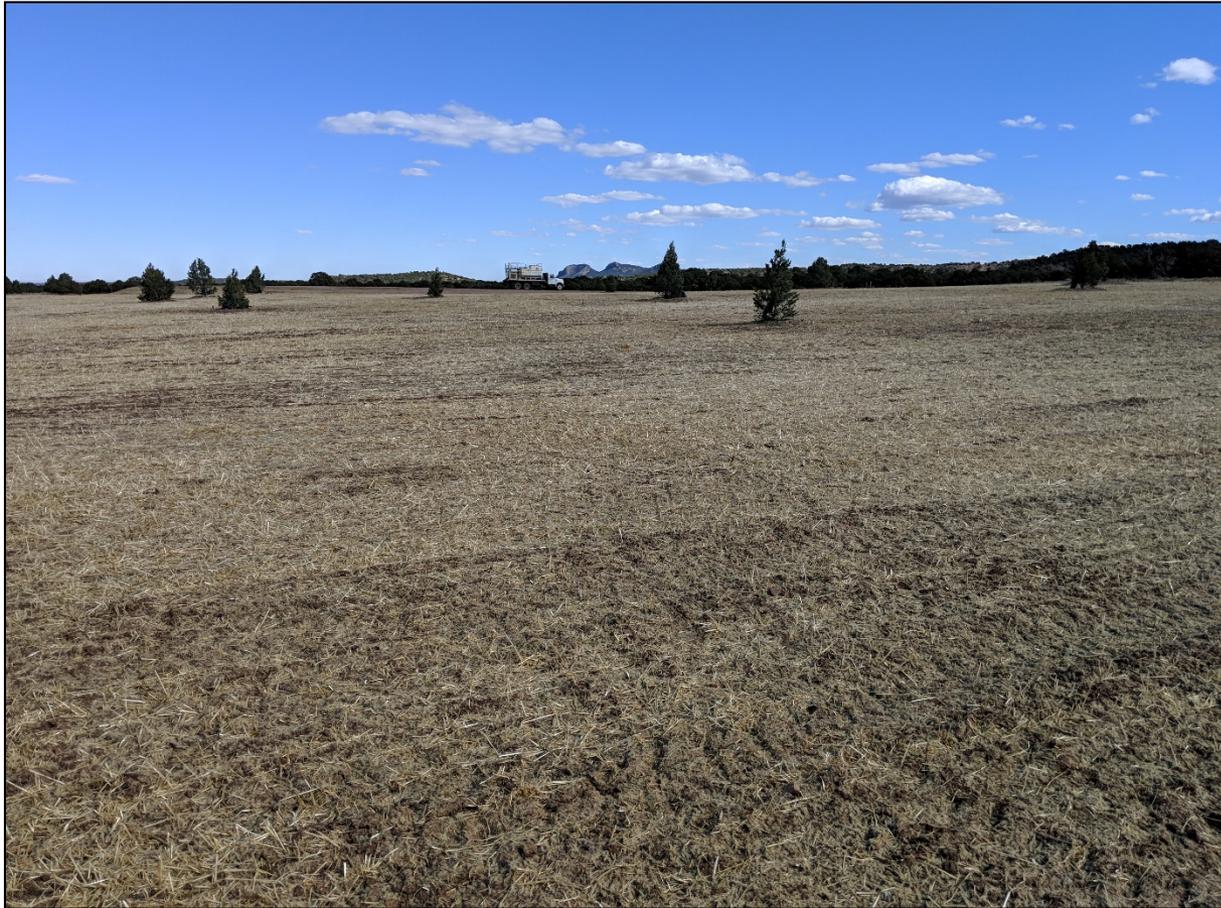
Photo 9. West side of the location facing east.

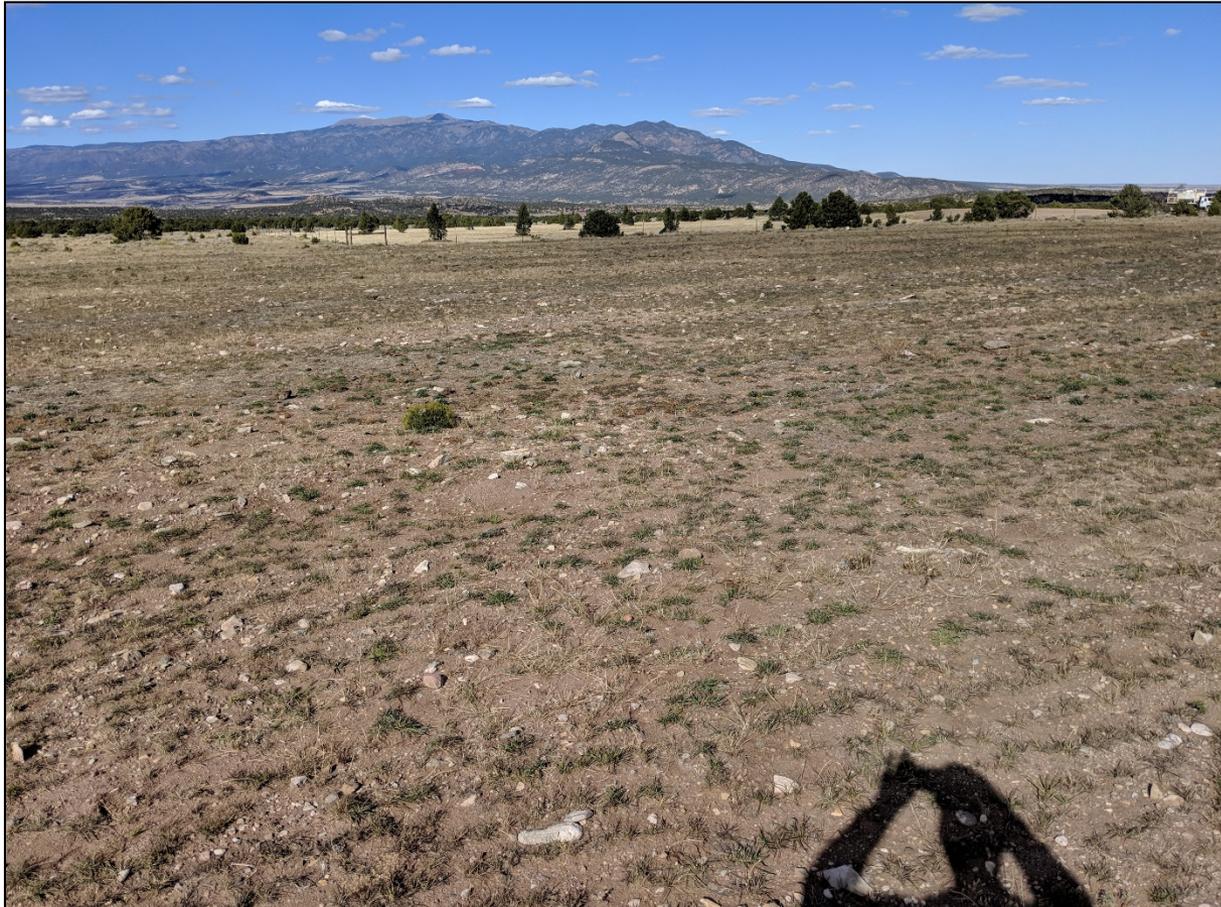
Photo 10. Southwest of the location where unpermitted disturbance occurred. Facing north.

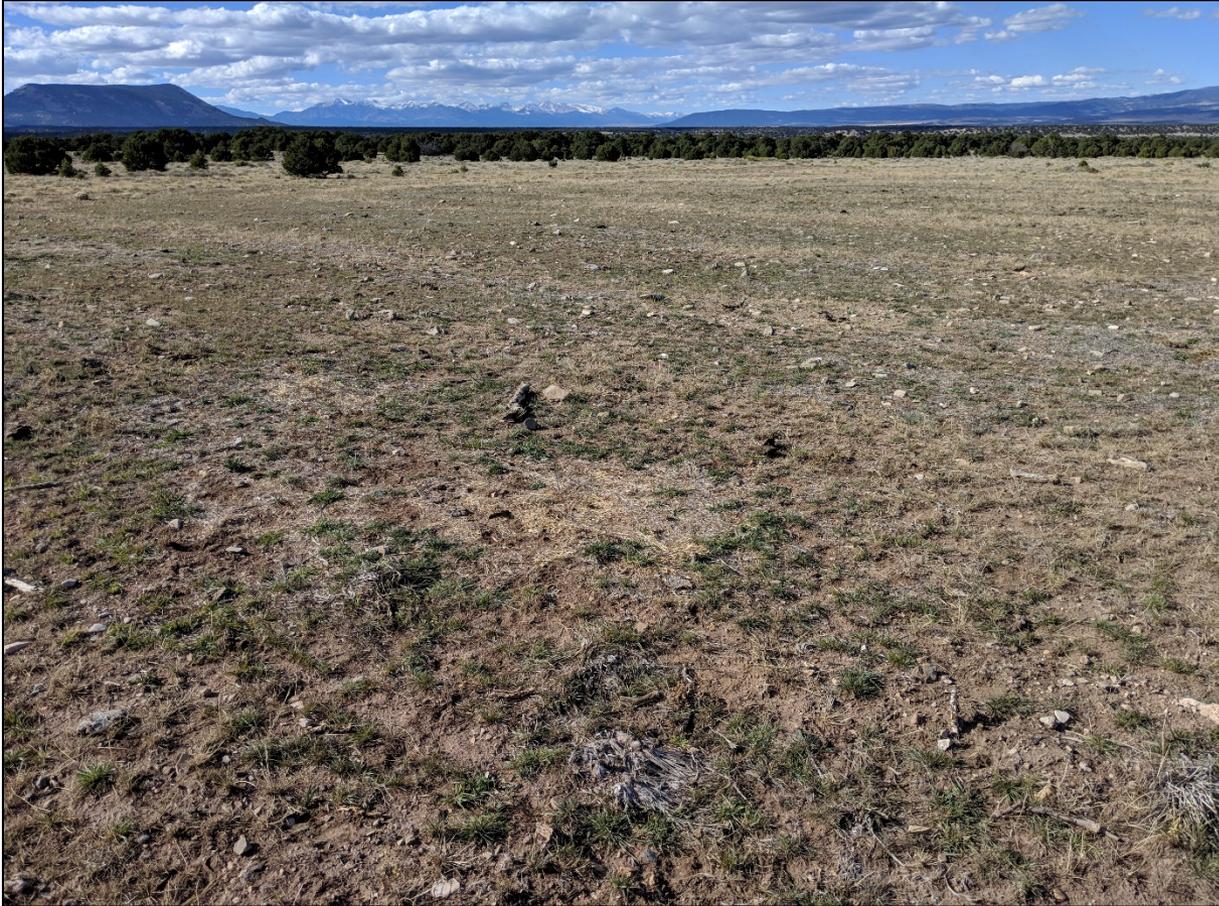
Photo 11. Southwest of the location where unpermitted disturbance occurred. Facing northwest.
