Inspection Photos

Location Name: 05-103-08920 (TAIGA MOUNTAIN 6-22)

Location ID: 315653

Inspection: 679701662

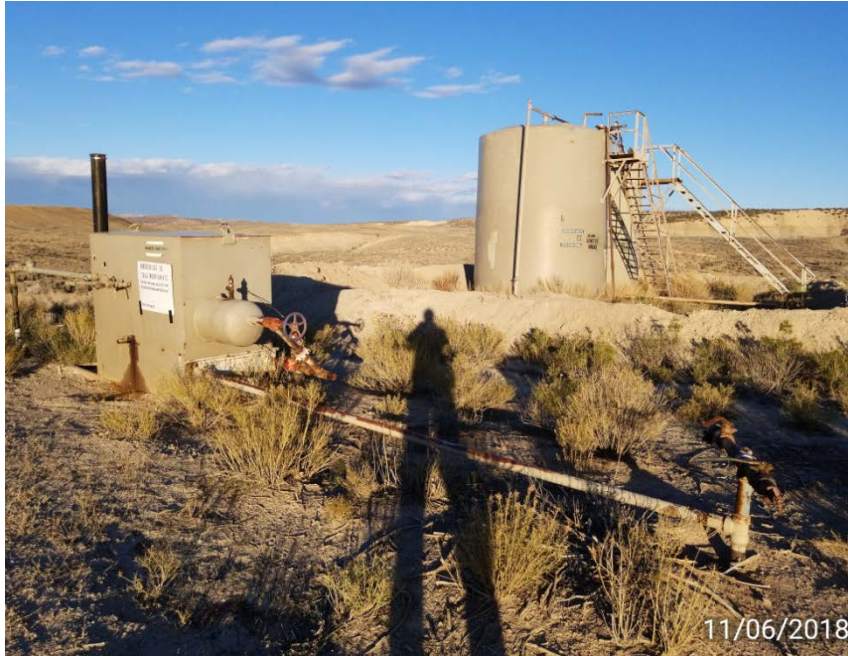
Location photo looking east

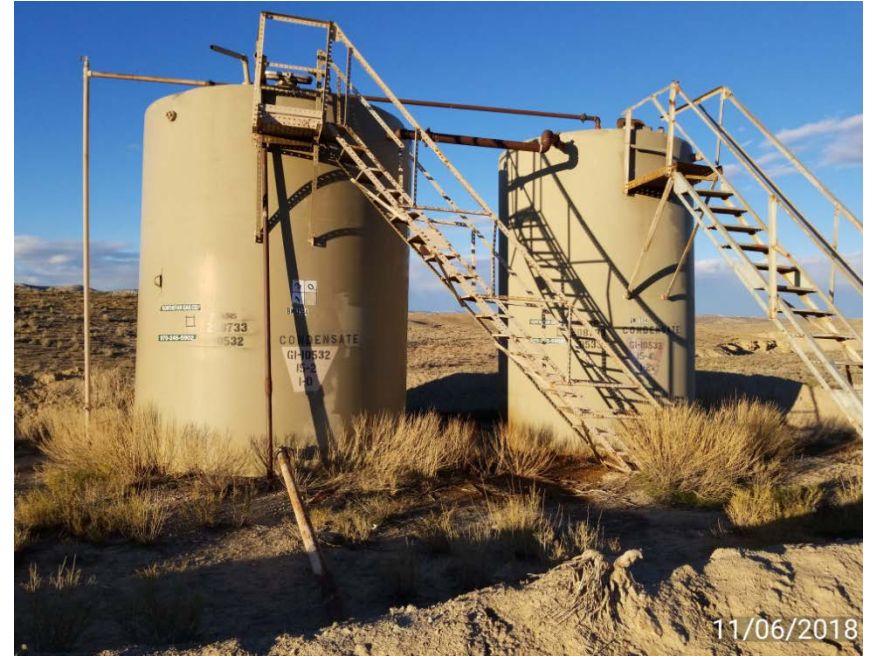
Tank battery

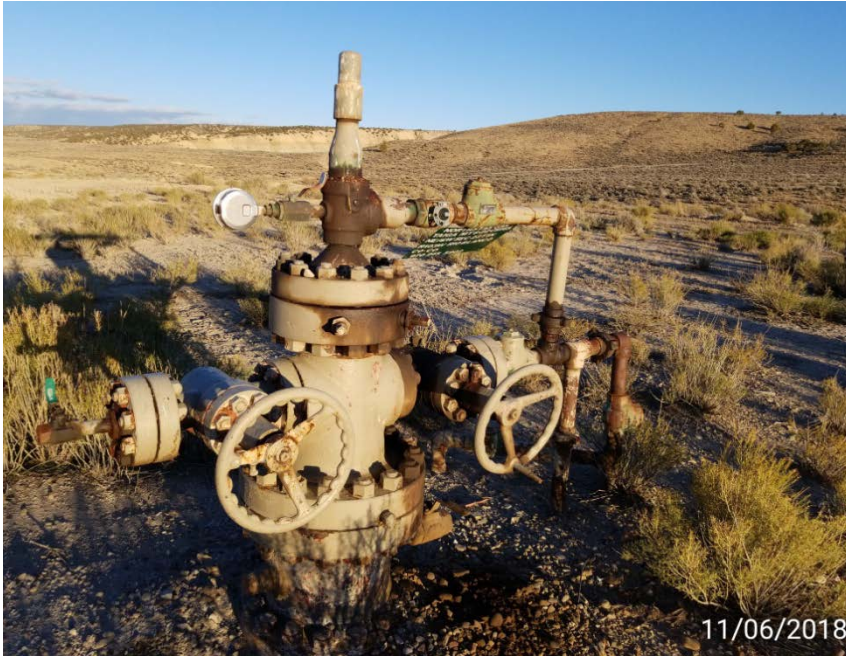
Well head

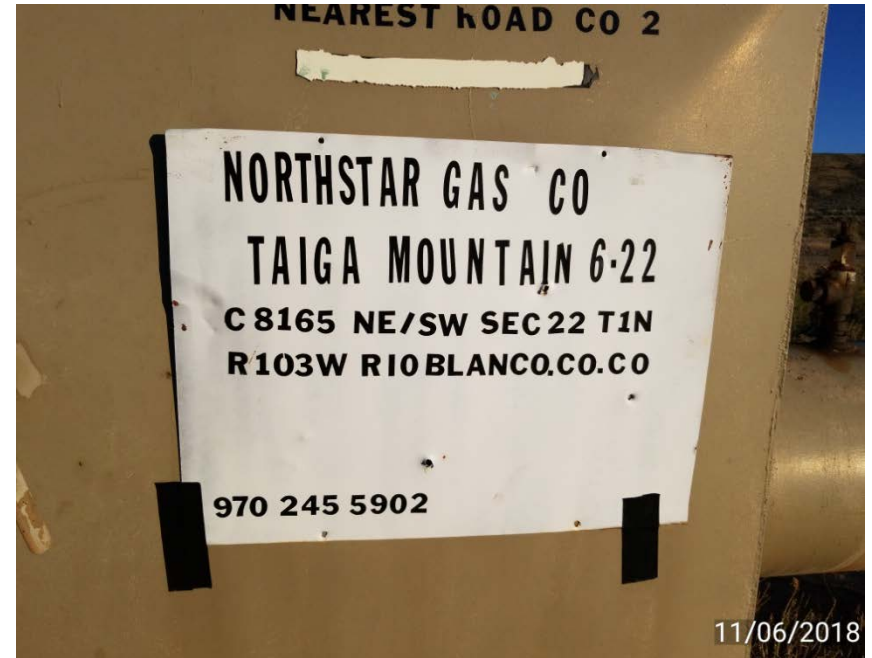
Battery sign

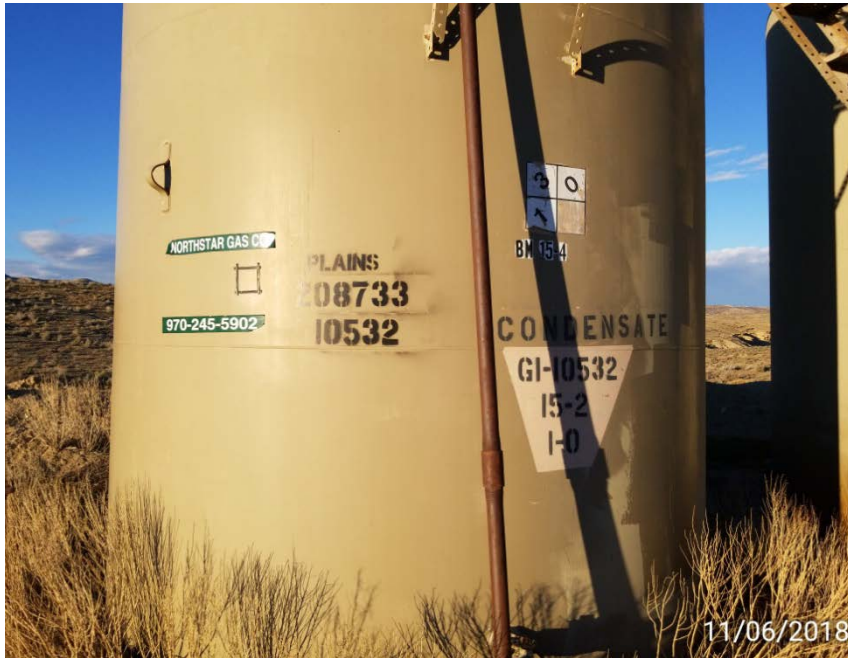
Tank missing NFPA label and current phone number

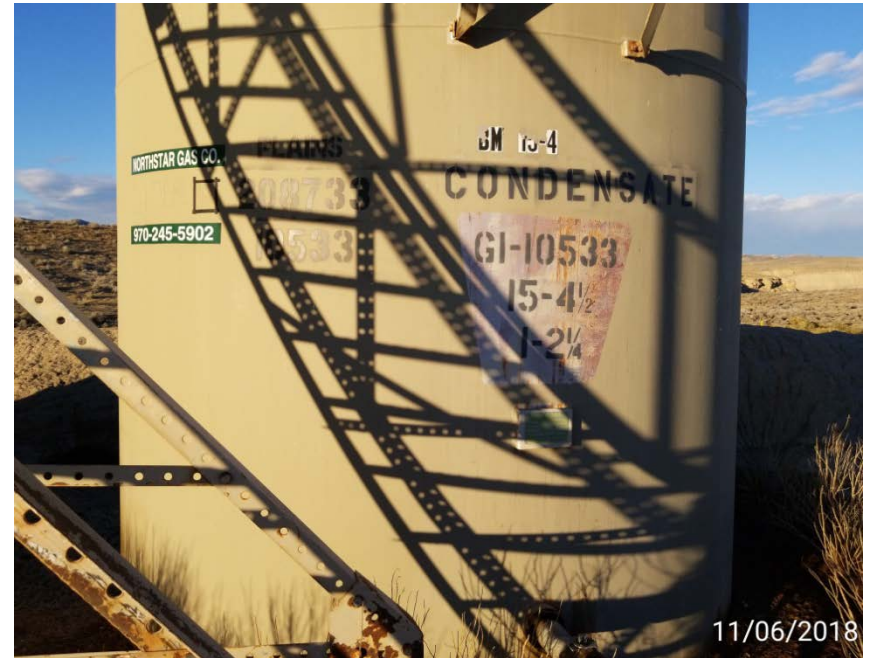
Tank missing NFPA label and current phone number

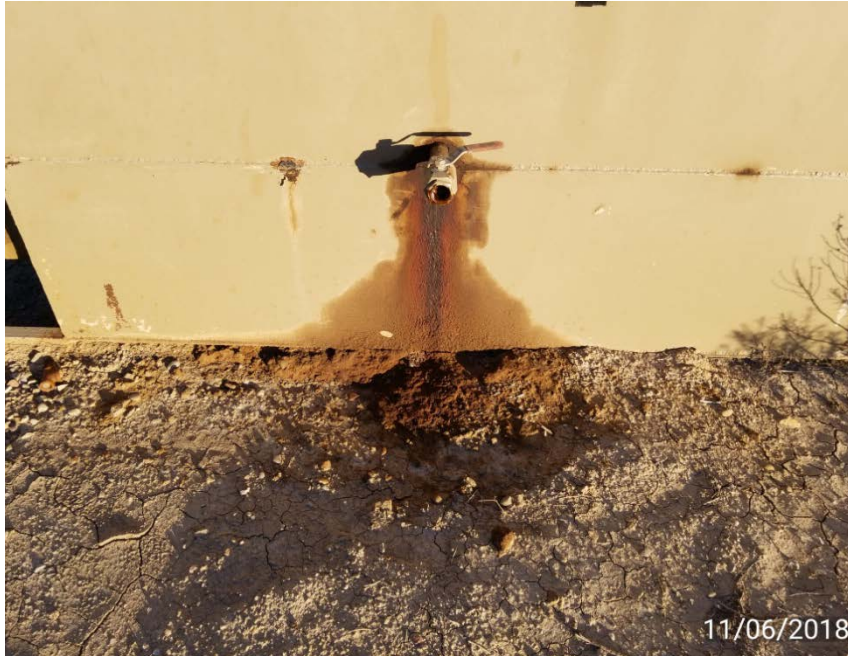
Separator had prior leak

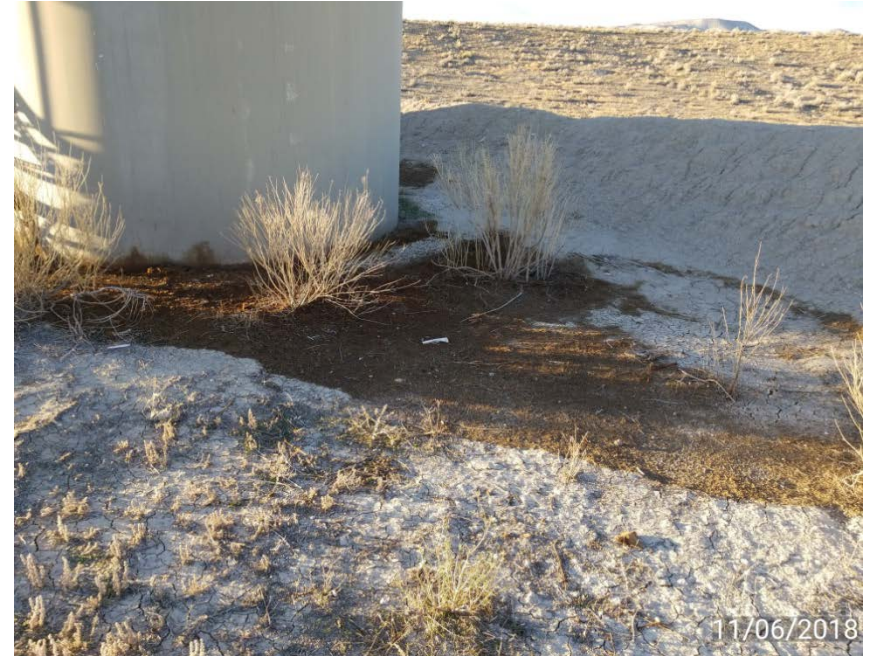
Condensate leaking from tank photo 1

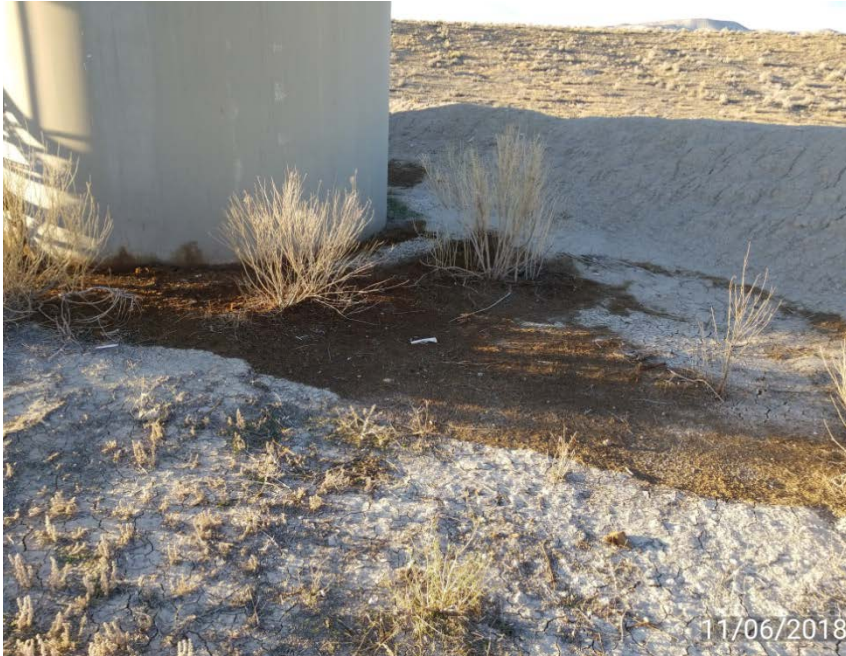
Condensate leaking from tank photo 2

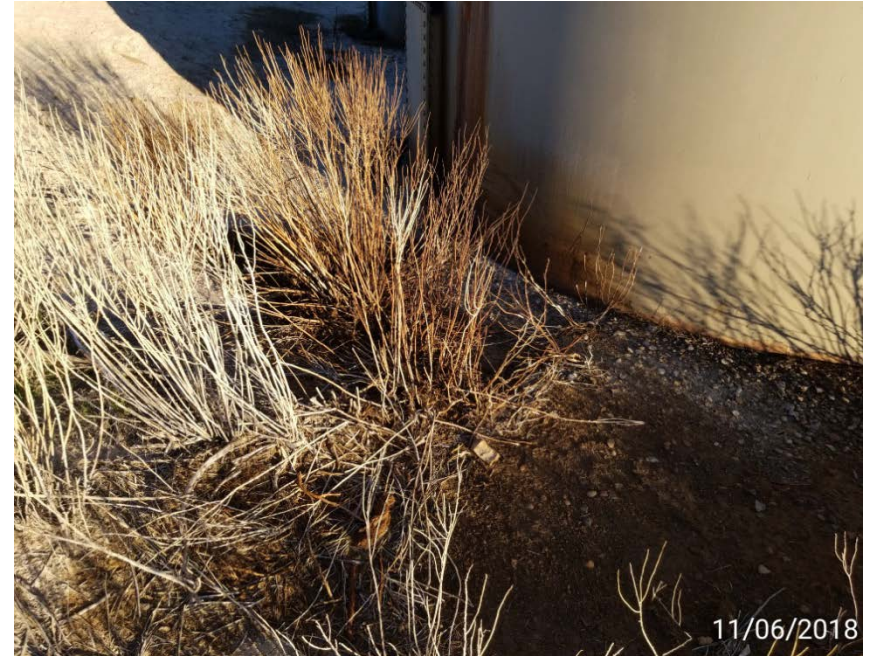
Condensate leaking from tank photo 3
