**Inspection Photo
EM 30-2
API # 045-09267
Inspection # 689302295**

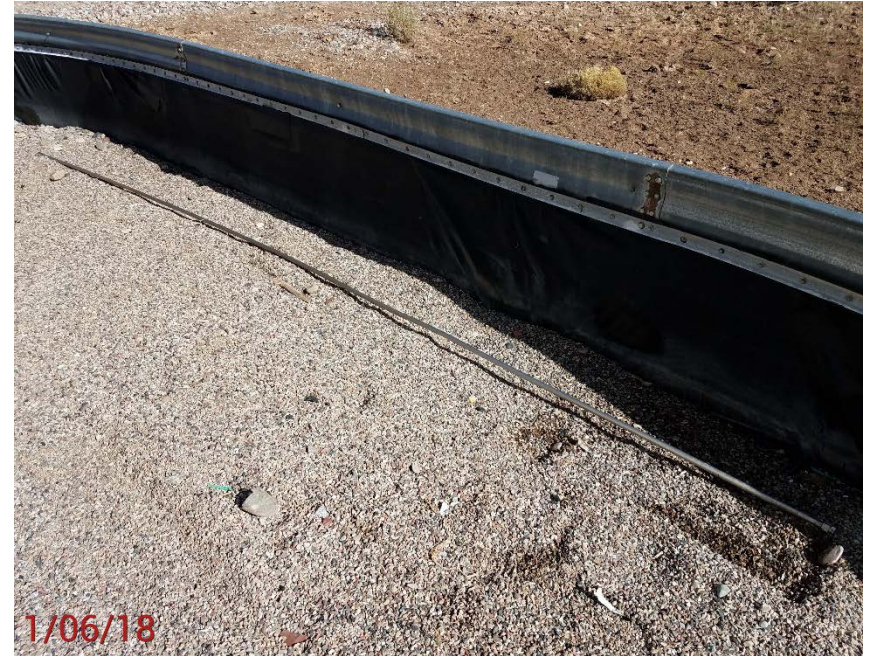
Location Photo #2, tank float rod in battery containment.

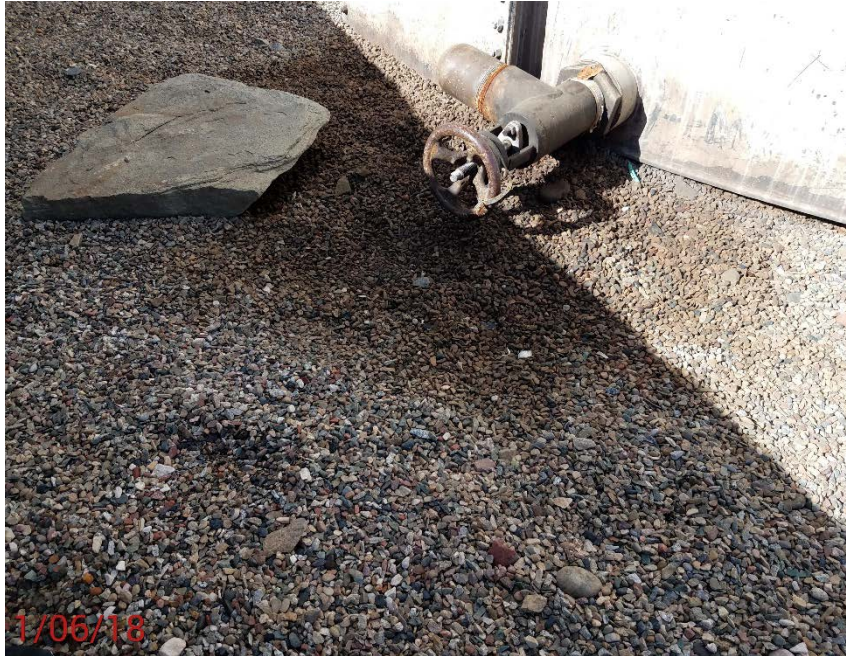
Location Photo #3, Oily stained rock in battery containment.

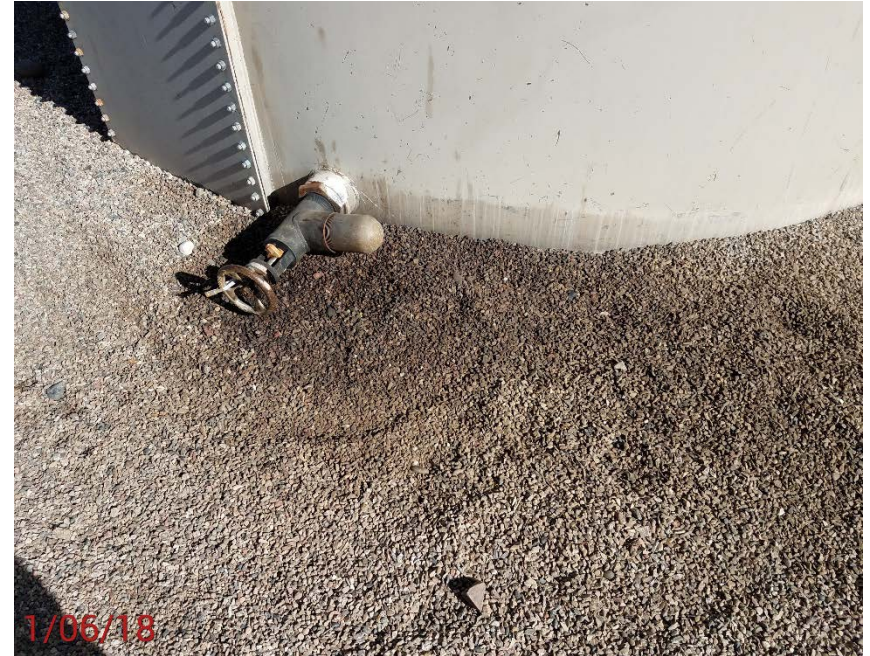
Location Photo #4, Oily stained rock in battery containment.

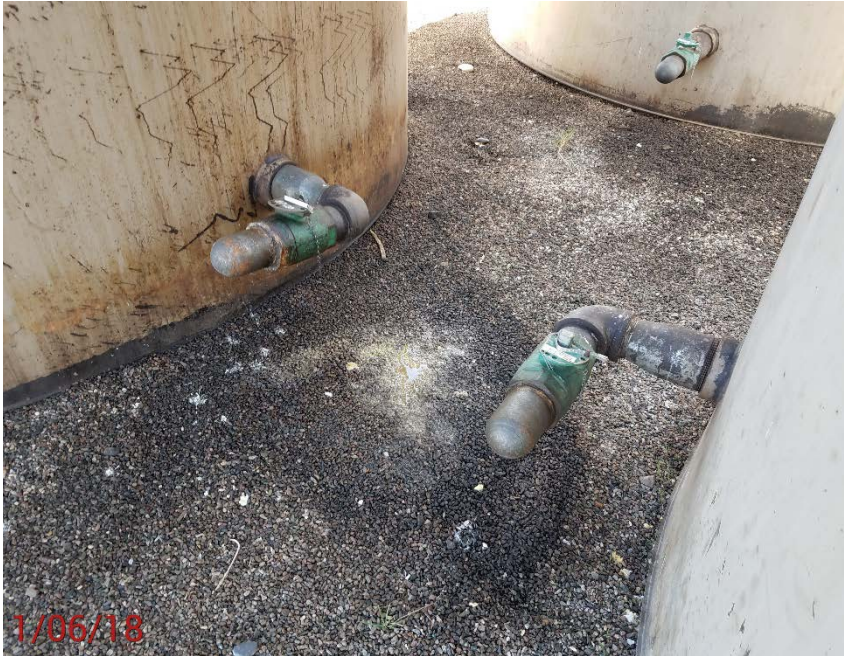
Location Photo #5, Oily stained rock in battery containment. Tank maintenance.

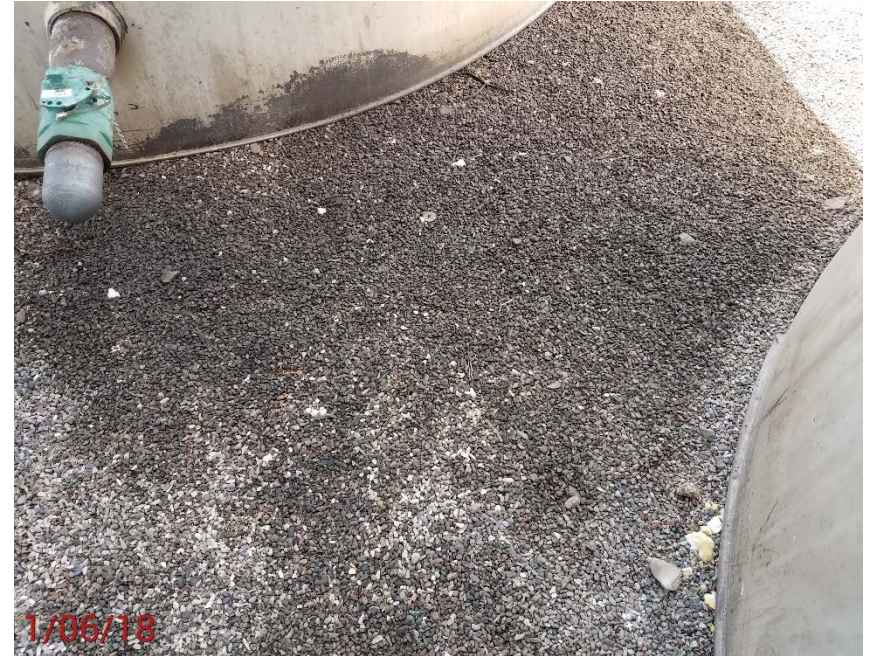
Location Photo #6, Oily stained rock in battery containment.
