**Inspection Photo**  
**Cruz 29-12C**  
**API # 045-11628**  
**Inspection # 689302301**

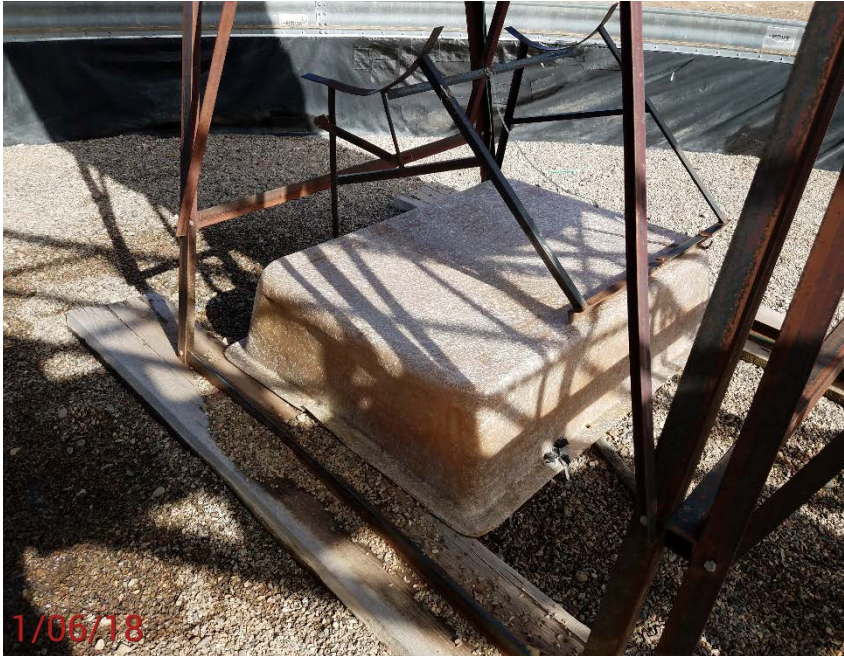
**Location Photo #3, unused equipment in battery.**

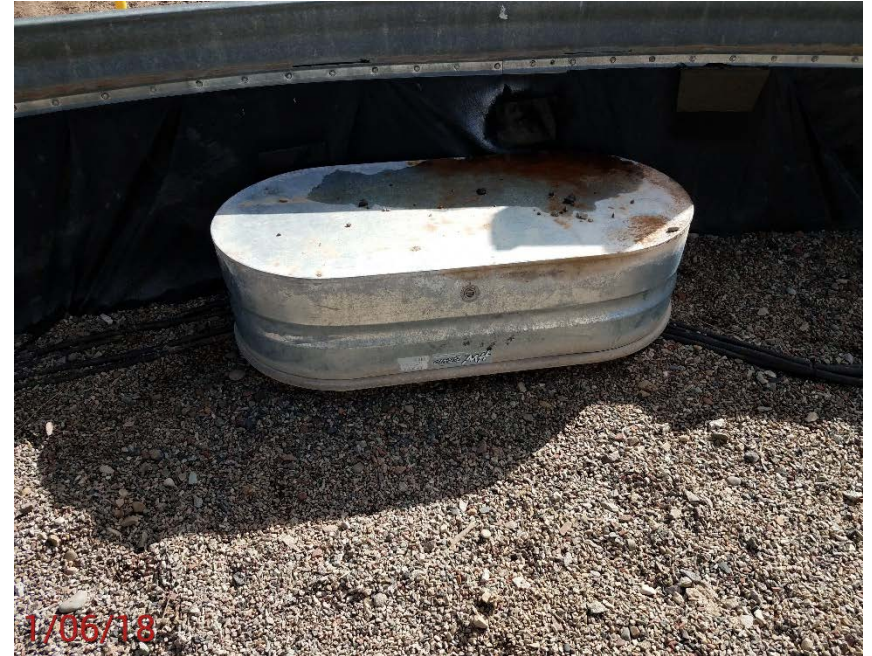
**Location Photo #4, unused equipment in tank battery.**

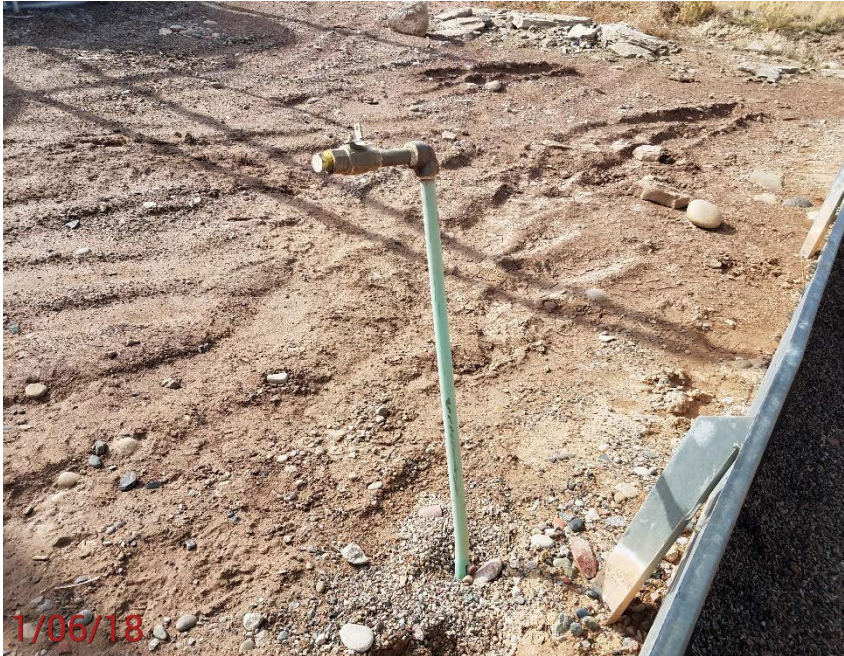
**Location Photo #5, unmarked flow line riser.**

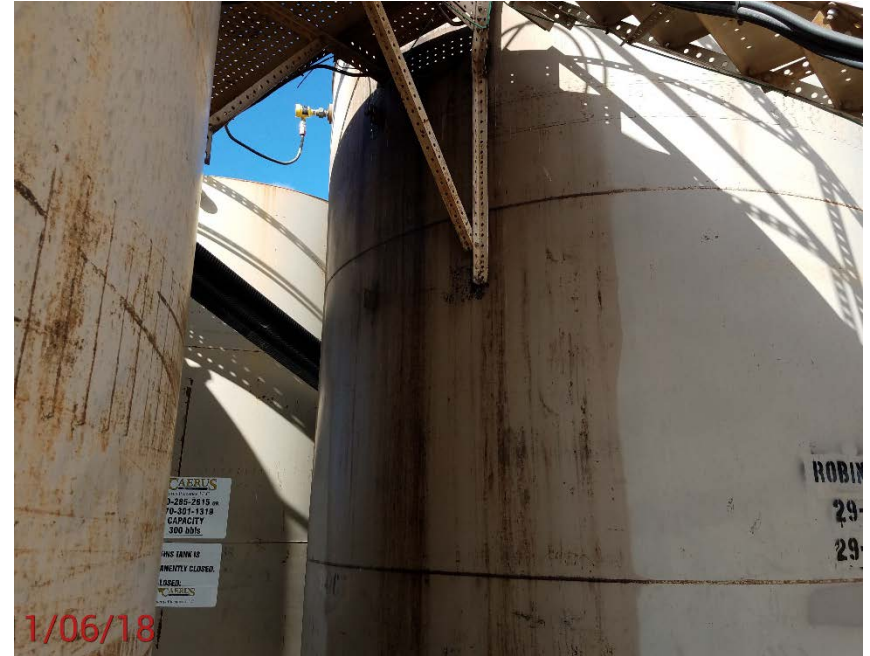
**Location Photo #6, Mechanical condition of gauge hatches.**

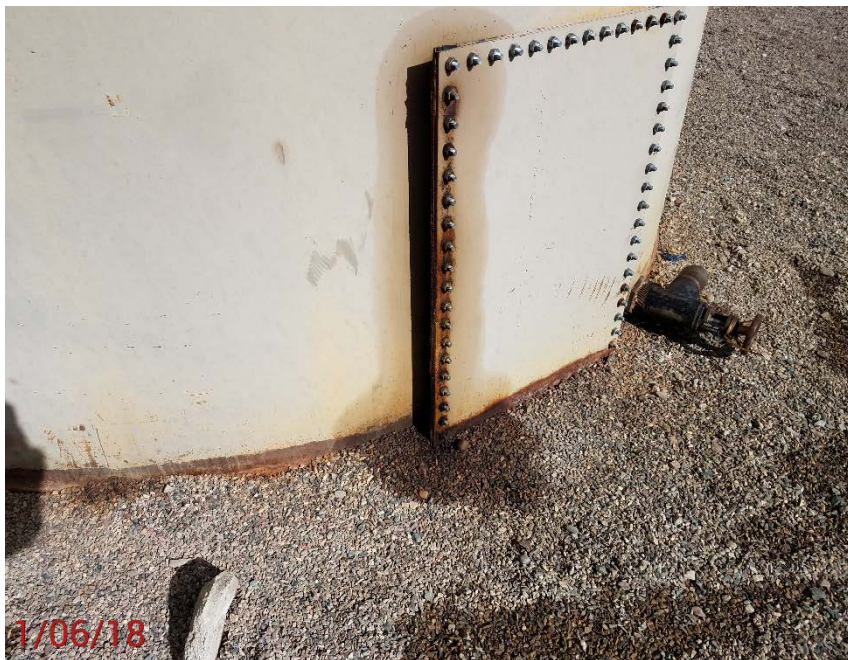
**Location Photo #7, Mechanical condition of tank.**

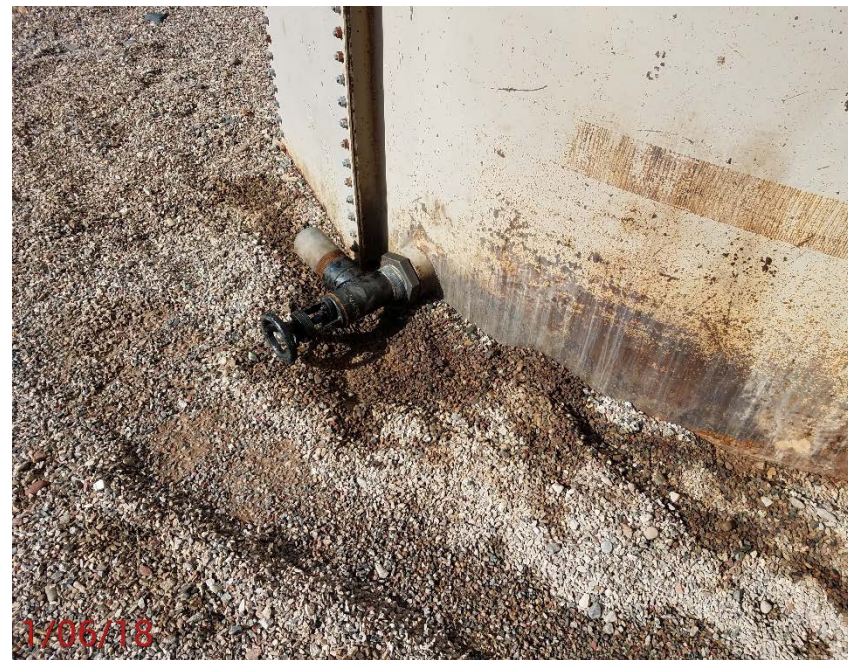
**Location Photo #8, Oily stained rock in battery containment area.**

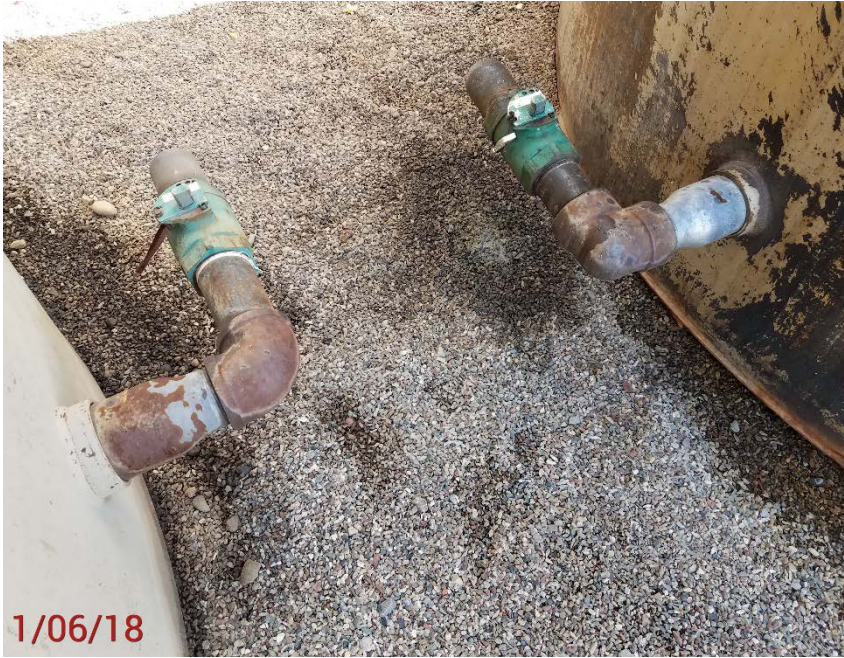
**Location Photo #9, Oily stained rock in battery containment area.**

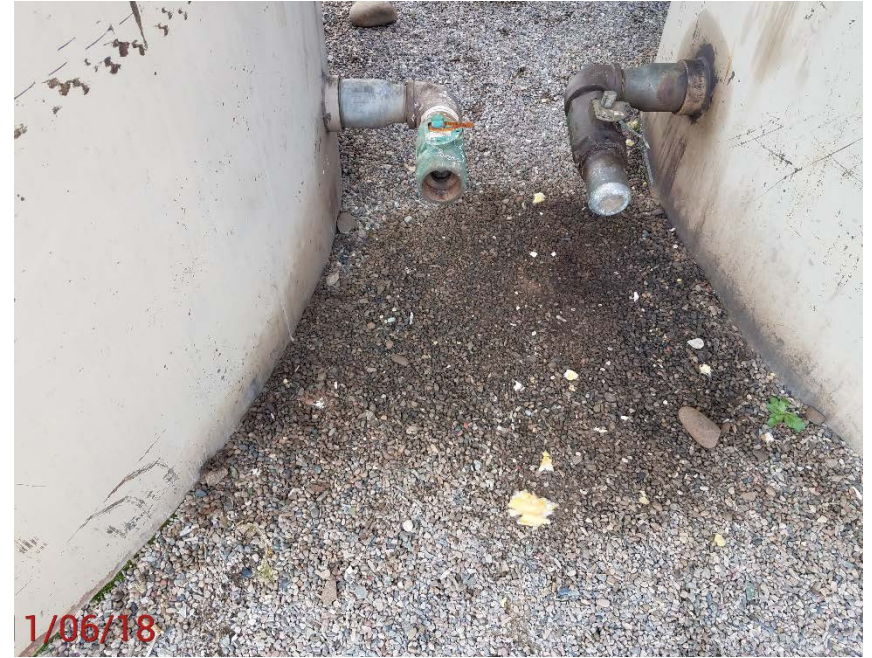
**Location Photo #10, Oily stained rock in battery containment area.**

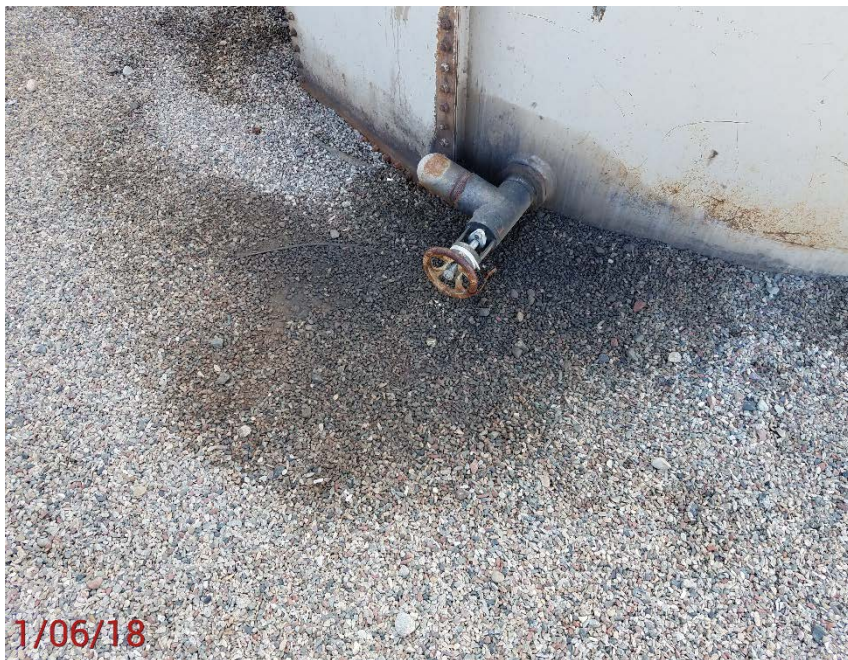
**Location Photo #11, Oily stained rock in battery containment area.**

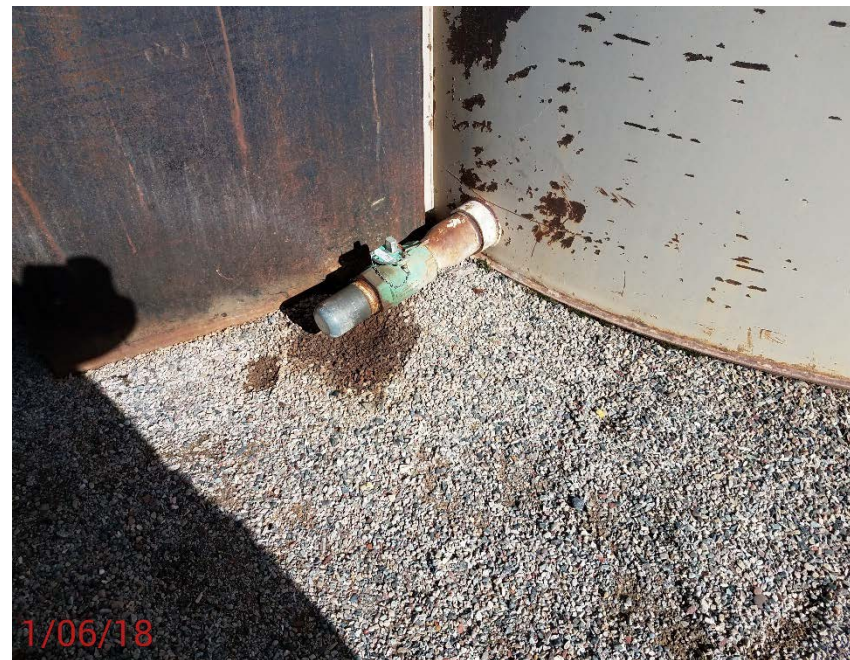
**Location Photo #12, Oily stained rock in battery containment area.**
