Inspection Photos

Location Name: Federal Goshawk - 68N60W / 28SWSW

Location #: 305200

COLORADO
Oil & Gas Conservation
Commission
Department of Natural Resources

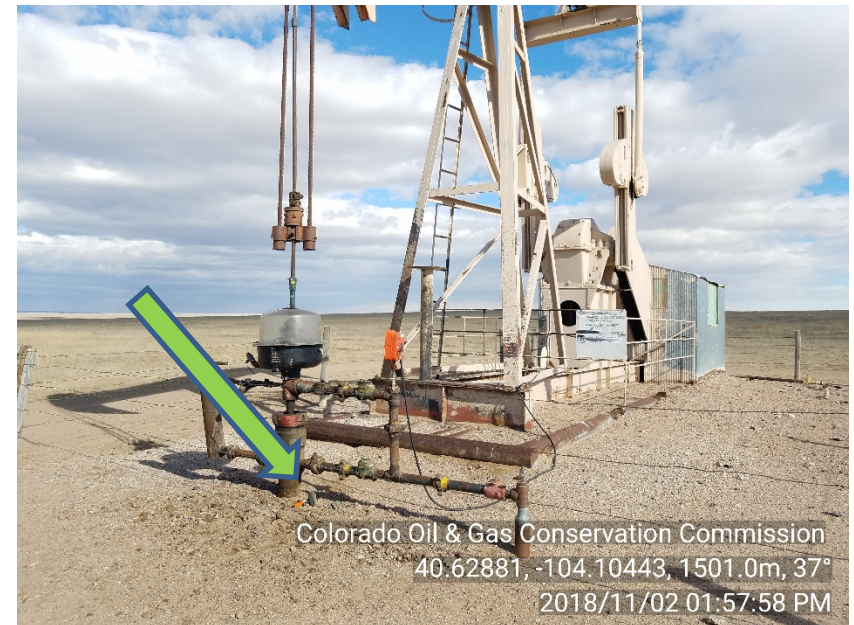
Photo #2

Federal Goshawk 28-13 wellhead

Sign is Legible

Bradenhead is plumbed to surface

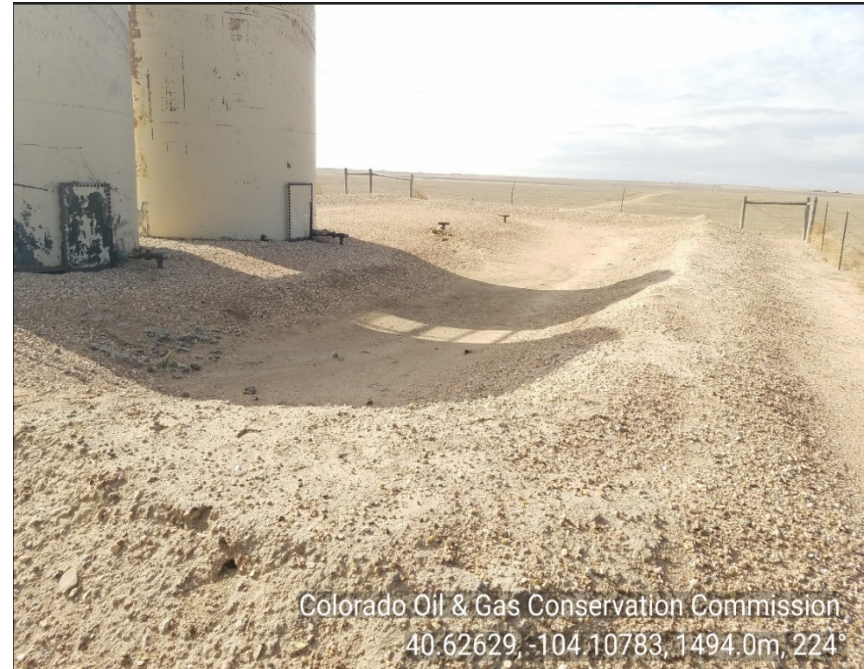
Photo #4

**Federal Goshawk 28-13, Fed Plover 28-5X,
Fed Toucan 28-14
Behind Tank Battery
Depression | Unpermitted pit**

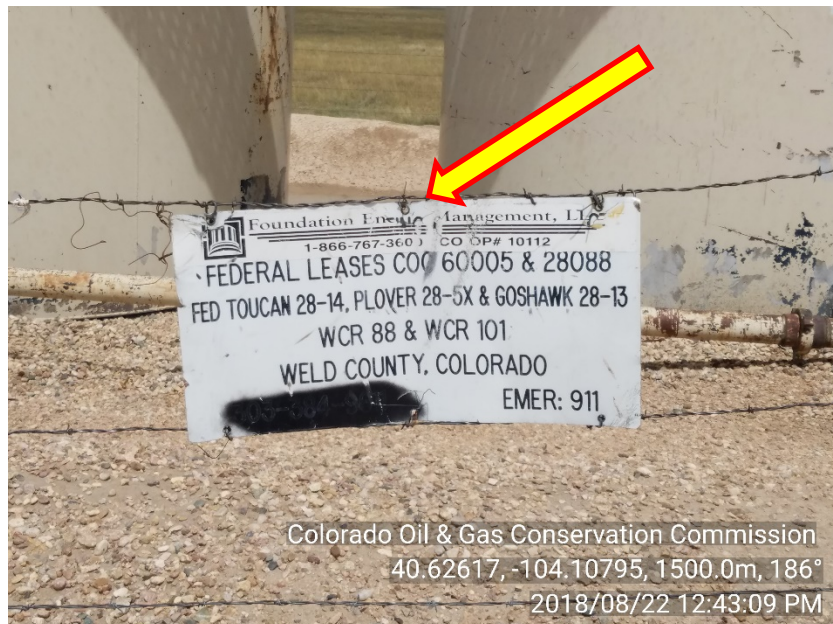
Photo #5

Federal Goshawk 28-13, Fed Plover 28-5X,

Fed Toucan 28-14

Battery Sign is illegible

From previous FIR

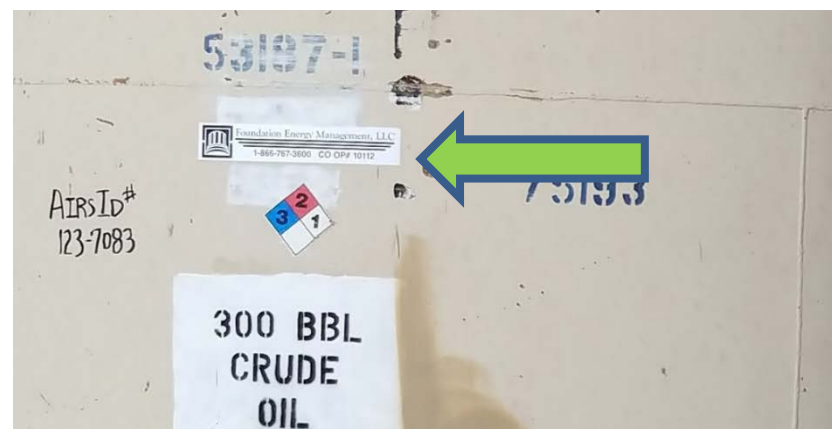
Photo #6

Federal Goshawk 28-13, Fed Plover 28-5X,

Fed Toucan 28-14

Battery Contact info is Legible

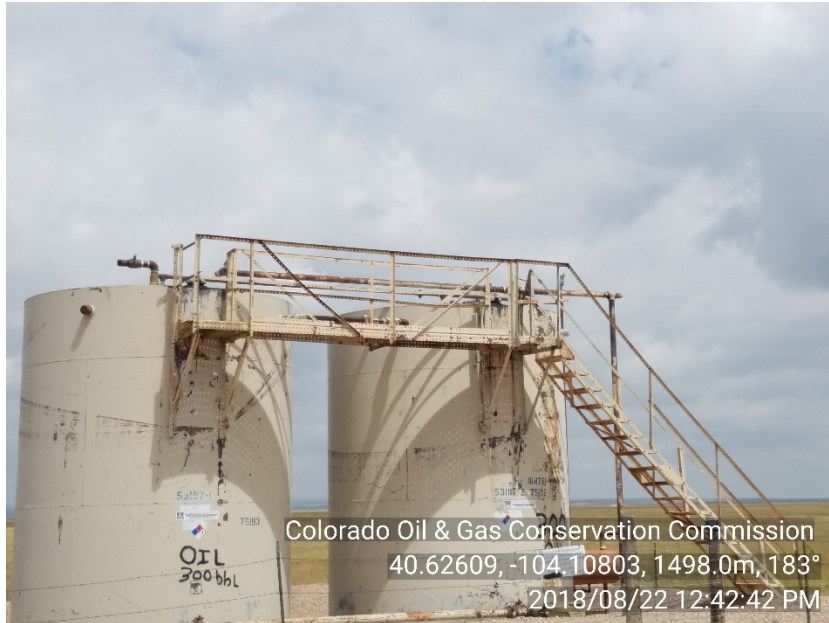
Photo #7

Federal Goshawk 28-13, Fed Plover 28-5X,

Fed Toucan 28-14

Crude oil tanks poor paint & rust

From previous FIR

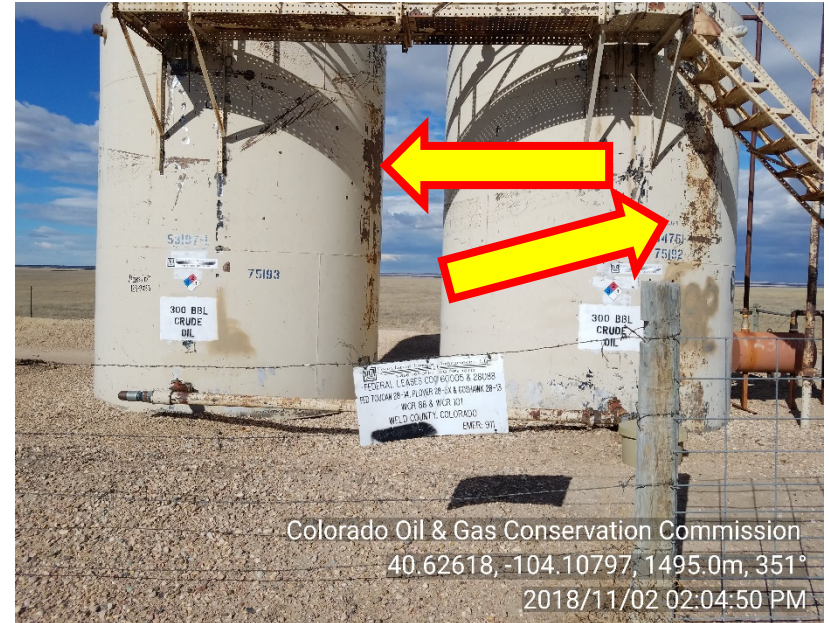
Photo #8

Federal Goshawk 28-13, Fed Plover 28-5X,

Fed Toucan 28-14

Crude oil tanks poor paint & rust

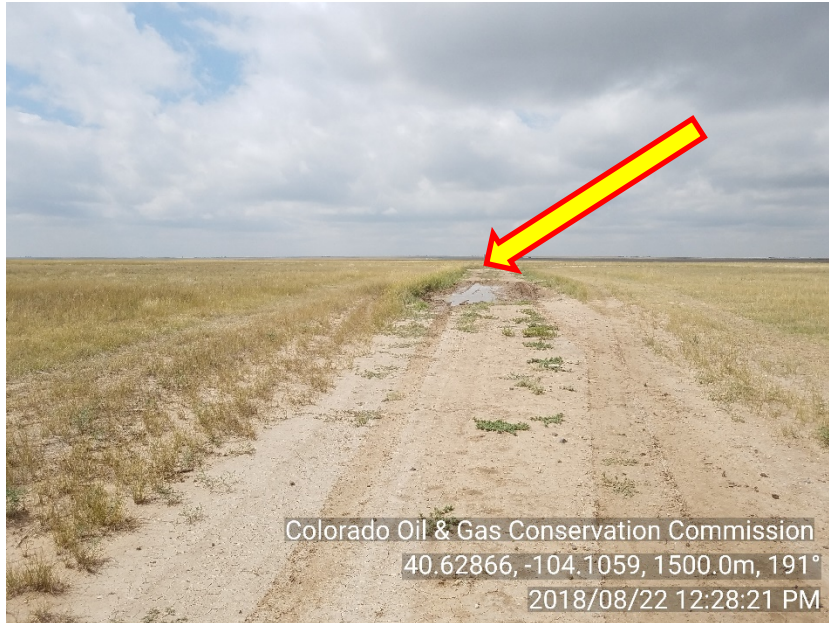
Photo #9

Federal Goshawk 28-13 Access road

Road needs repaired

From previous FIR

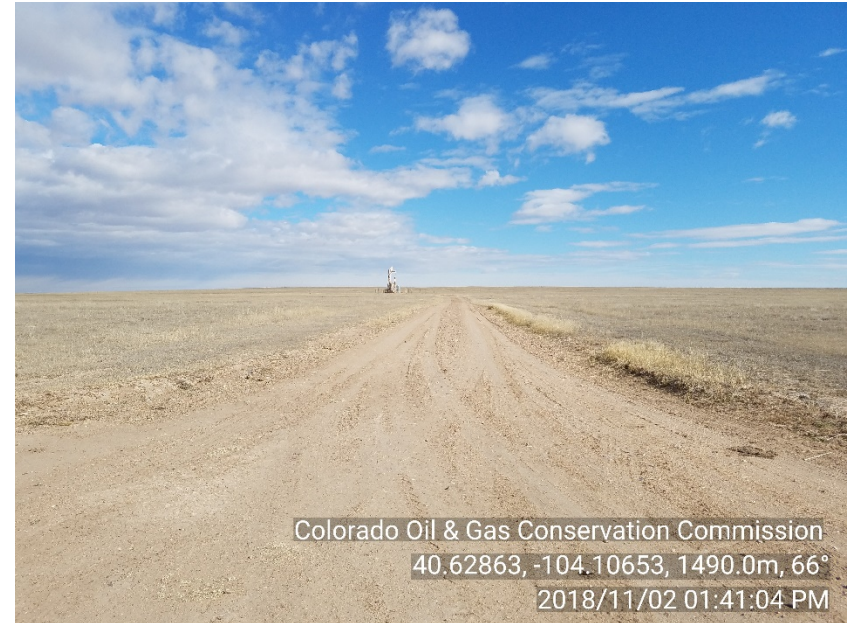
Photo #10

Federal Goshawk 28-13 Access road

Road has been graded

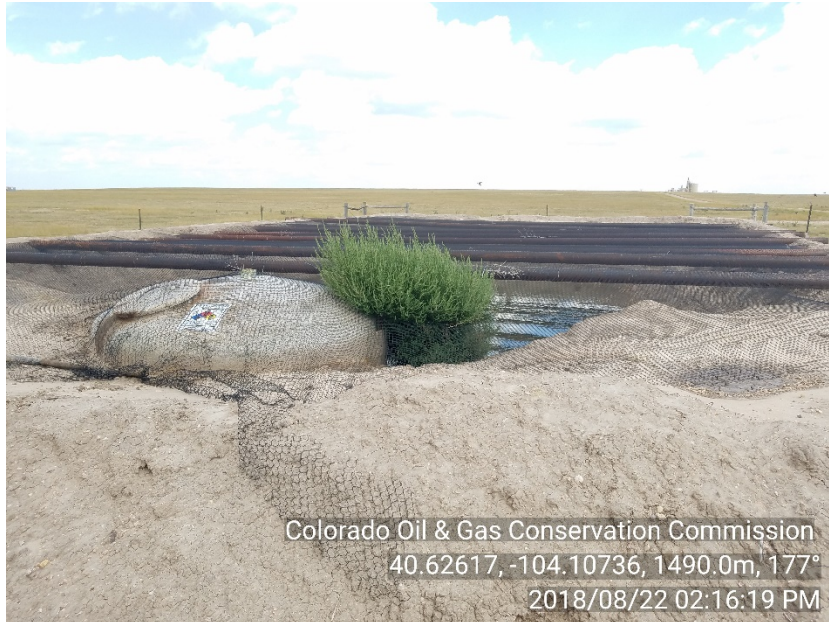
Photo #11

**Federal Goshawk 28-13, Fed Plover 28-5X,
Fed Toucan 28-14**

Weeds on pit bank – from prev. FIR

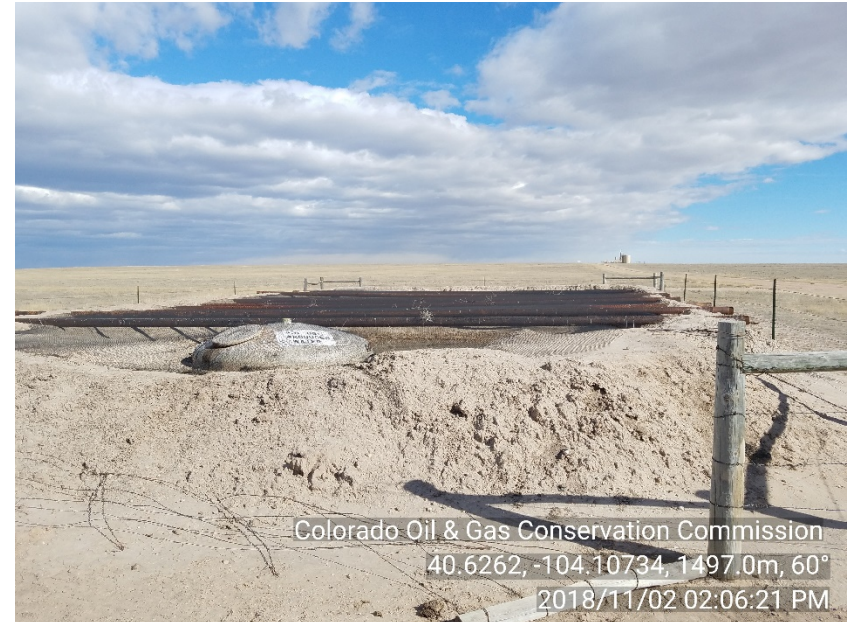
Photo #12

**Federal Goshawk 28-13, Fed Plover 28-5X,
Fed Toucan 28-14**

Weeds on pit bank - cleared

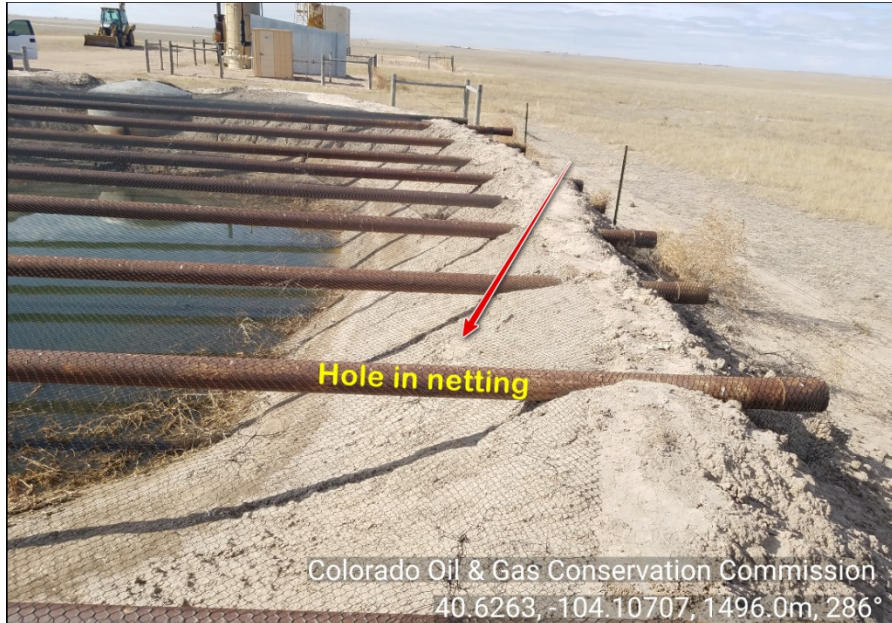
Photo #13

**Federal Goshawk 28-13, Fed Plover 28-5X,
Fed Toucan 28-14**

Gaps or holes in Pit netting

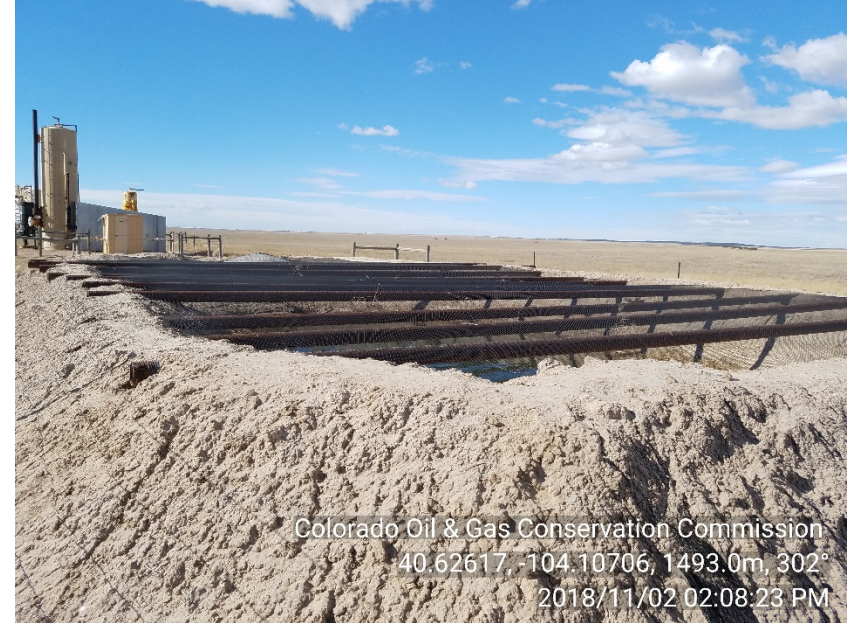
Photo #14

**Federal Goshawk 28-13, Fed Plover 28-5X,
Fed Toucan 28-14**

Unpermitted pit – SE corner

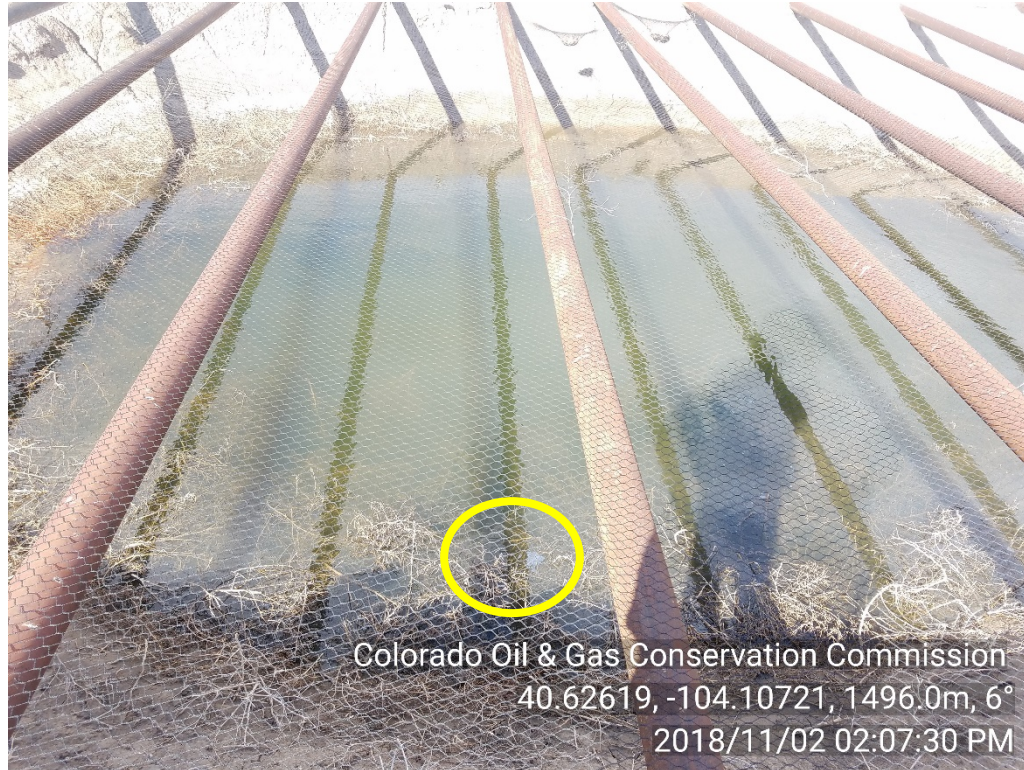
Photo #15

Federal Goshawk 28-13, Fed Plover 28-5X,

Fed Toucan 28-14

Sheen on pit – 3 inch
