Final Reclamation Inspection

Operator: KERR MCGEE OIL & GAS ONSHORE LP #47120

API: 05-001-09223

Inspection Photos
Location Name: HSR-DREYER #5-5
API: 05-001-09223

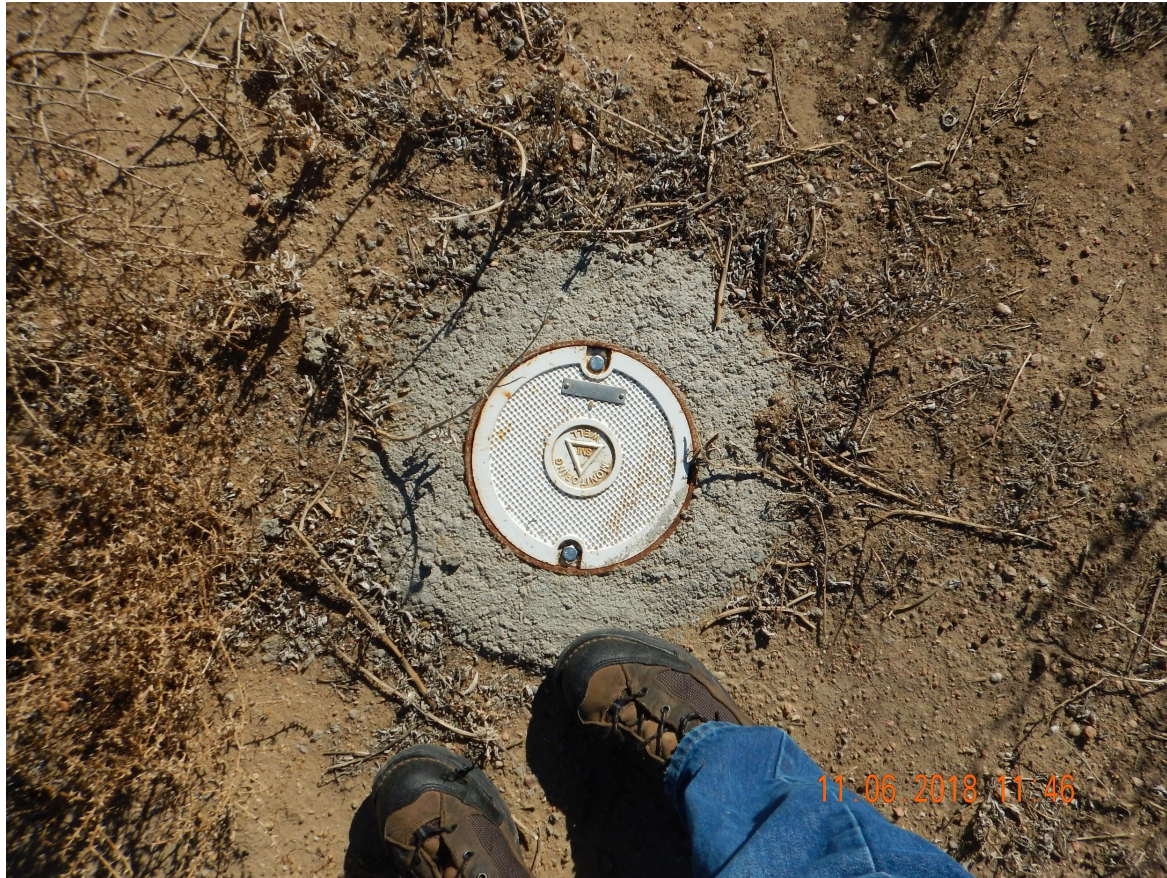
Photo 1. Photo taken from the northern location. Active Remediation (#4891) is still underway. Operator shall control weeds and erosion until the Location meets Rule 1004 standards, including during active remediation. Active midstream gathering equipment is located east, adjacent to this location- see Photo 3. Photo illustrates a monitoring well location.

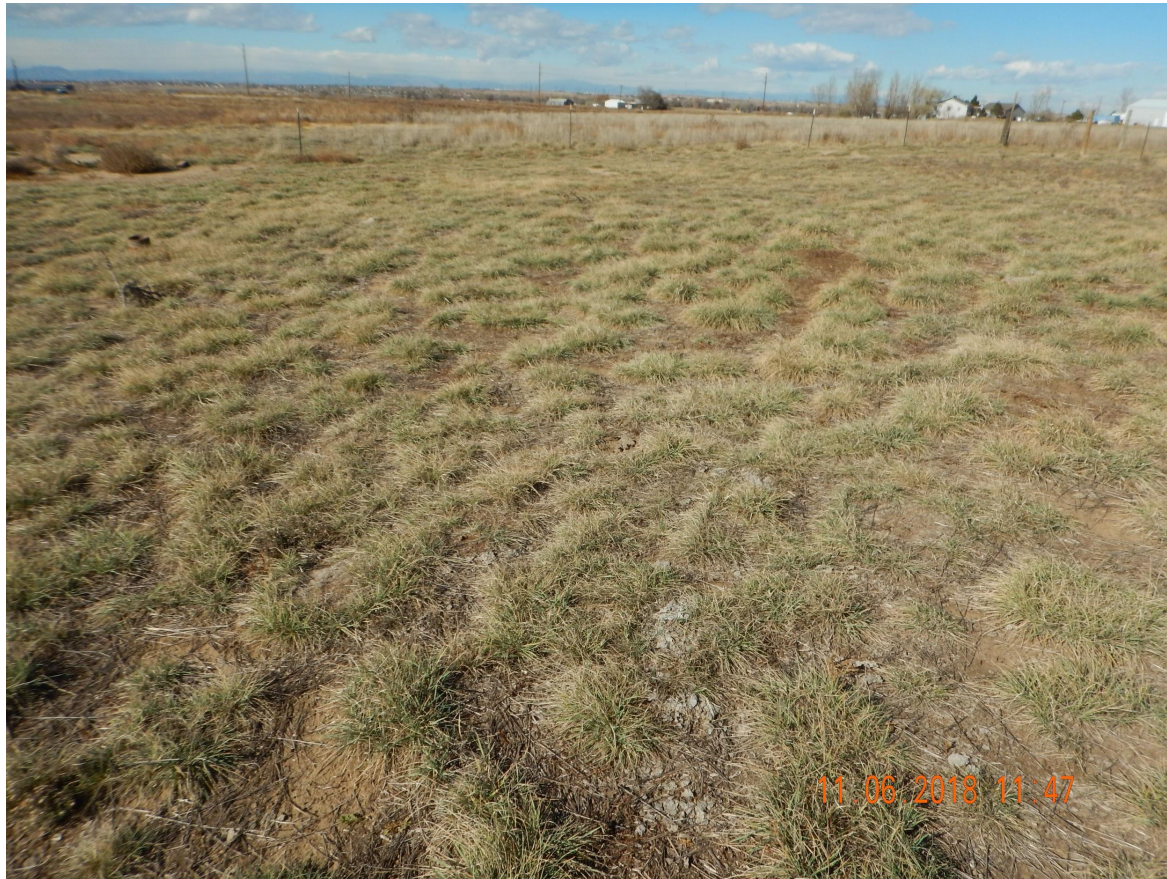
Photo 2. Reference photo taken north of location, facing Northwest.

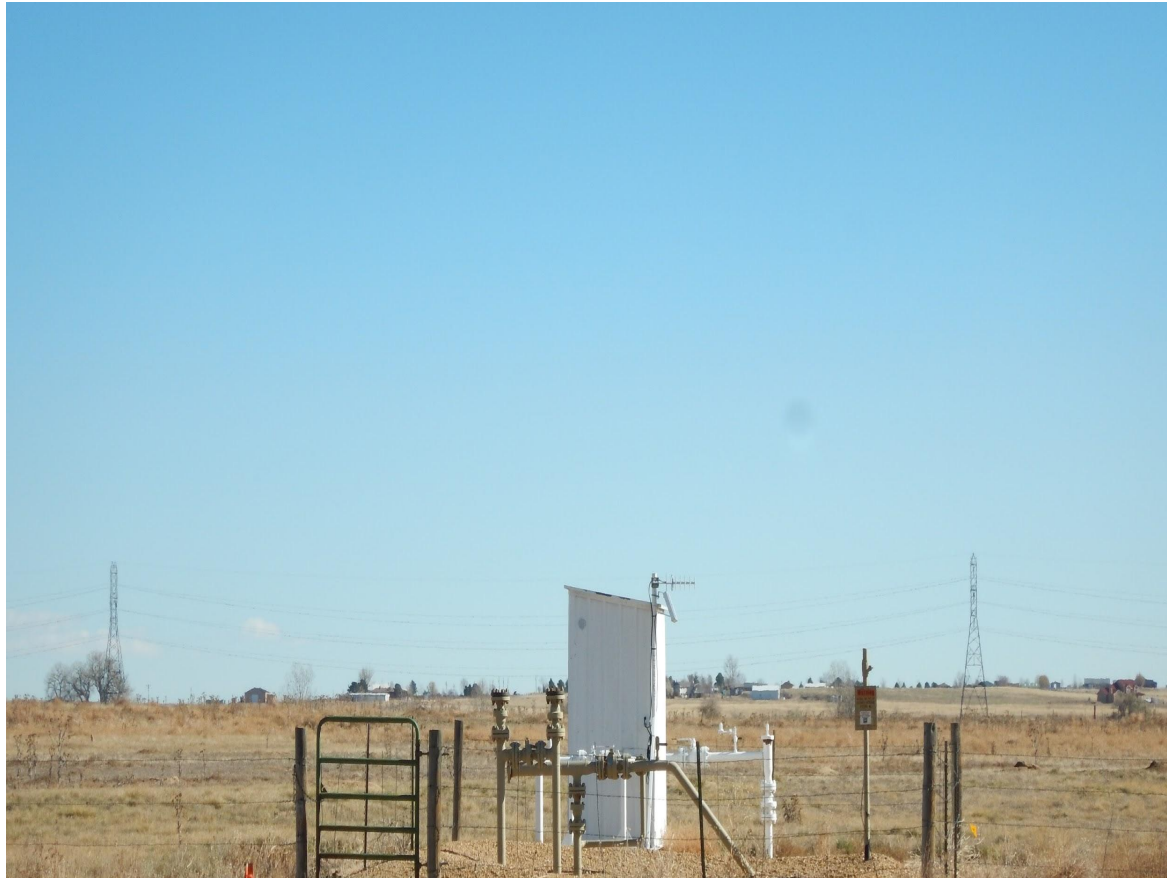
Photo 3. Photo taken from the approximate center of location, facing East. See comments under Photo 1.
