Inspection Photos

Operator: BP Production

API: 05-067-06667

Date: 10/24/2018

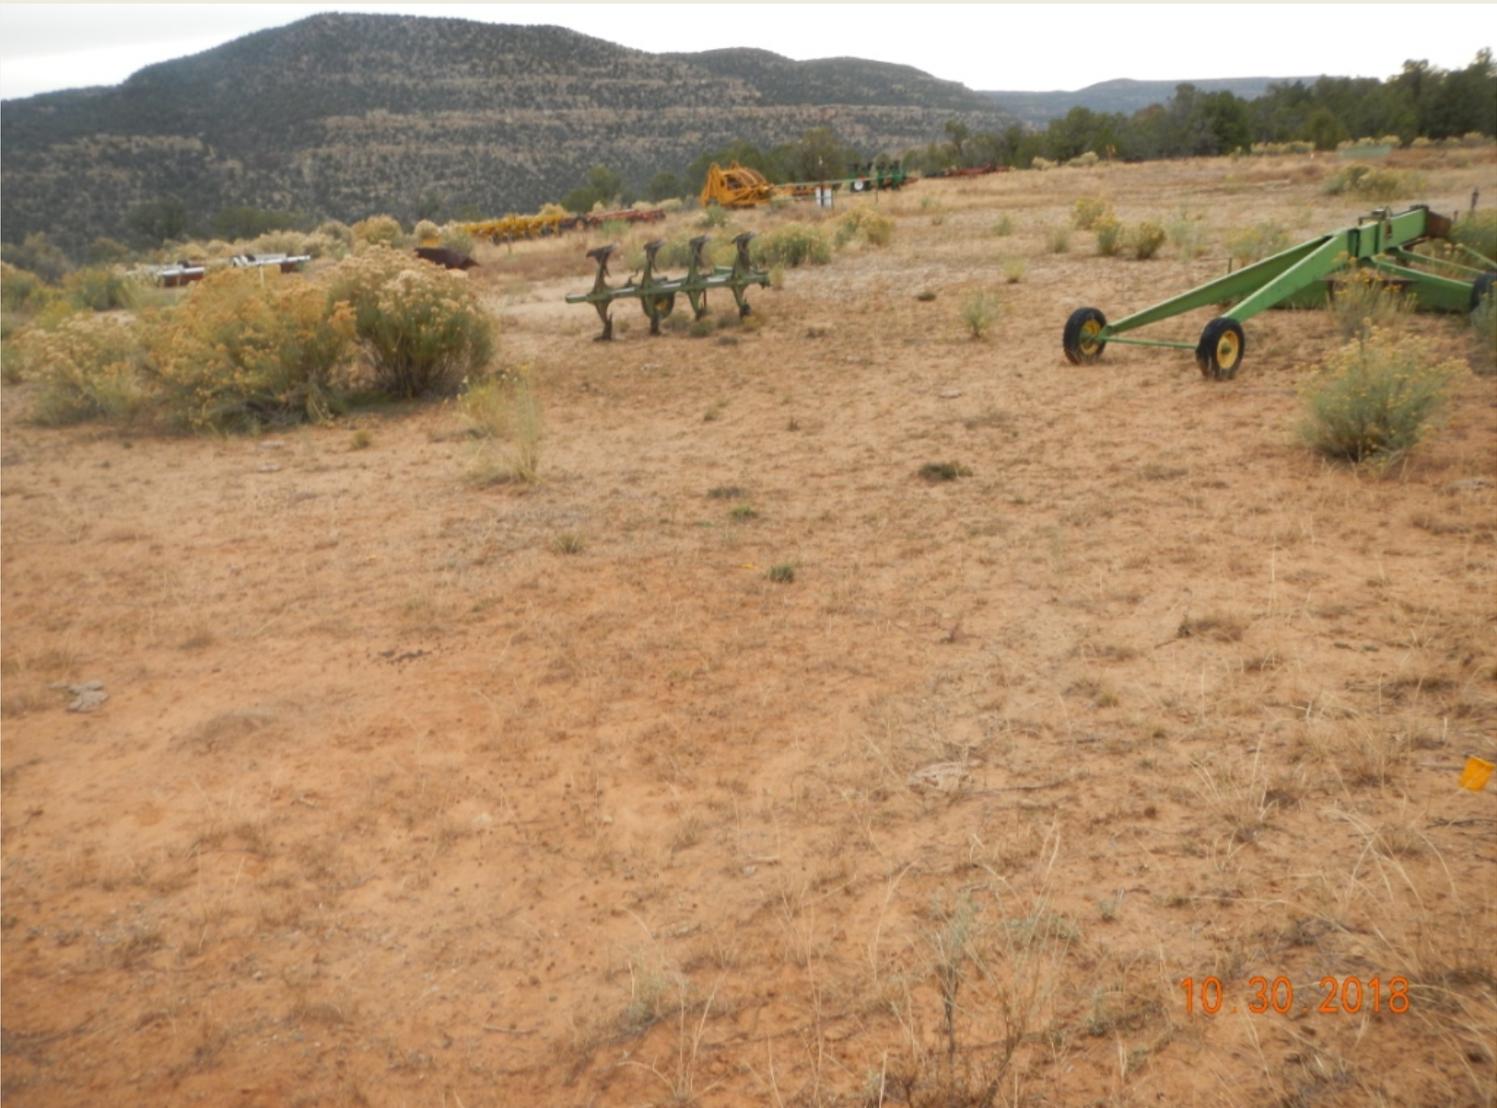
Photo 1. View of the project area from the northwestern corner facing center. Well pad is not recontoured. Farm equipment stored on the well pad.

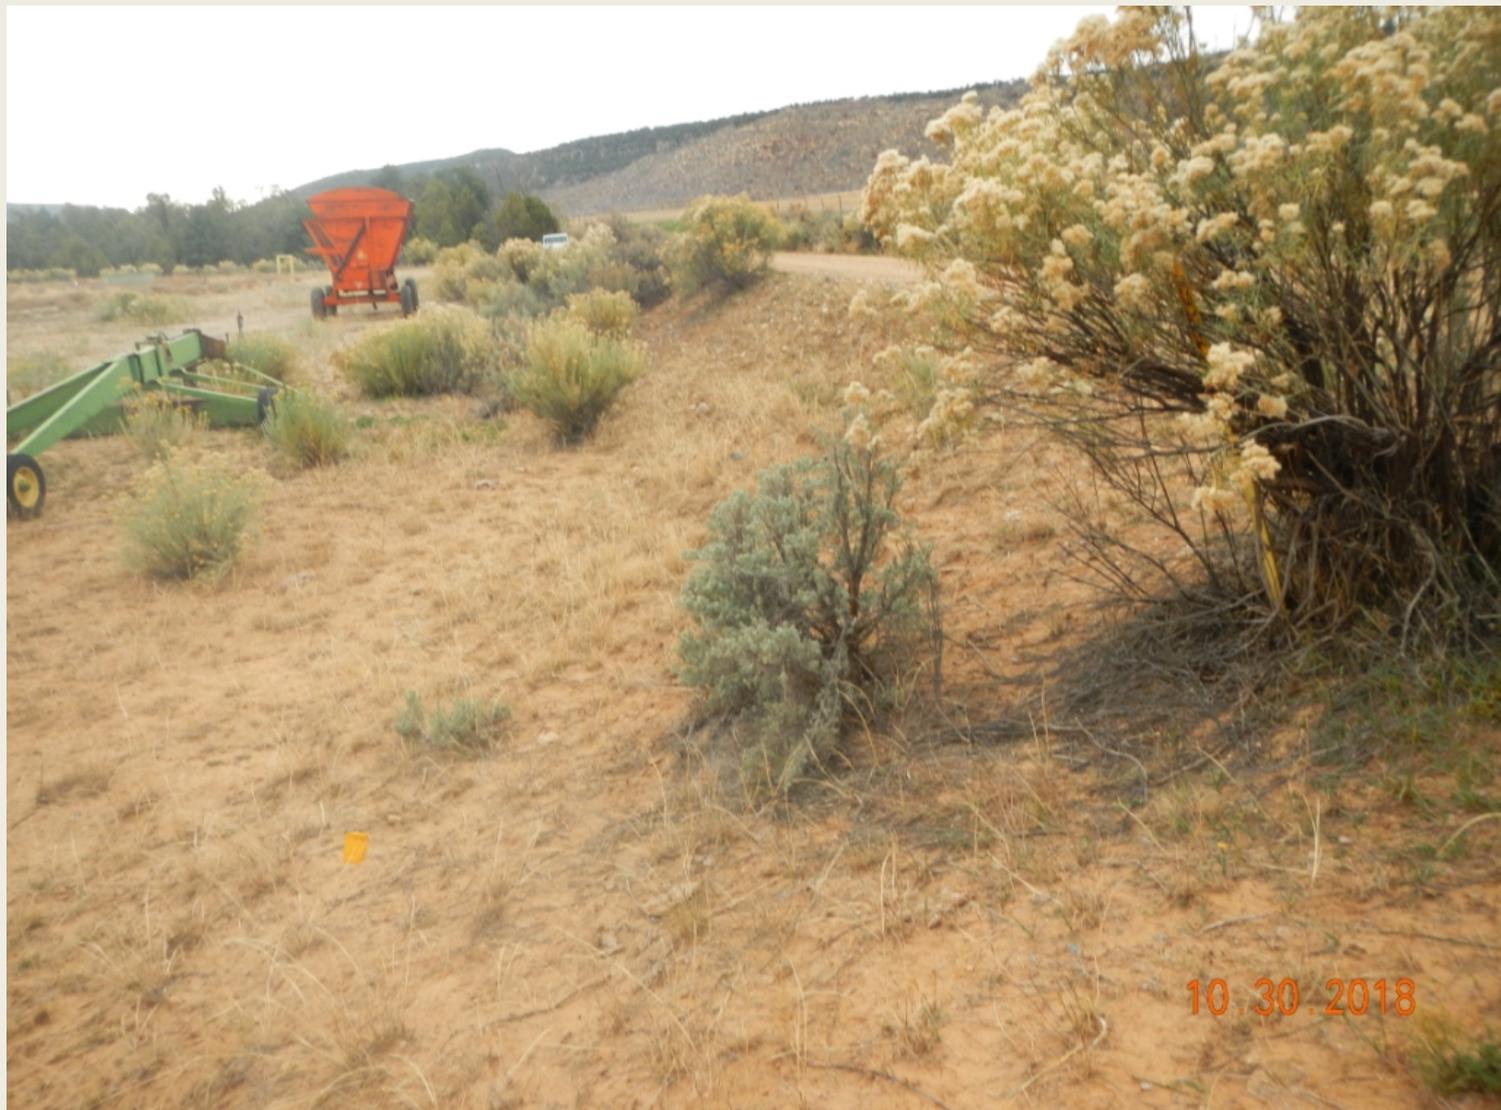
Photo 2. View of the western project area from the northwestern corner facing southward.

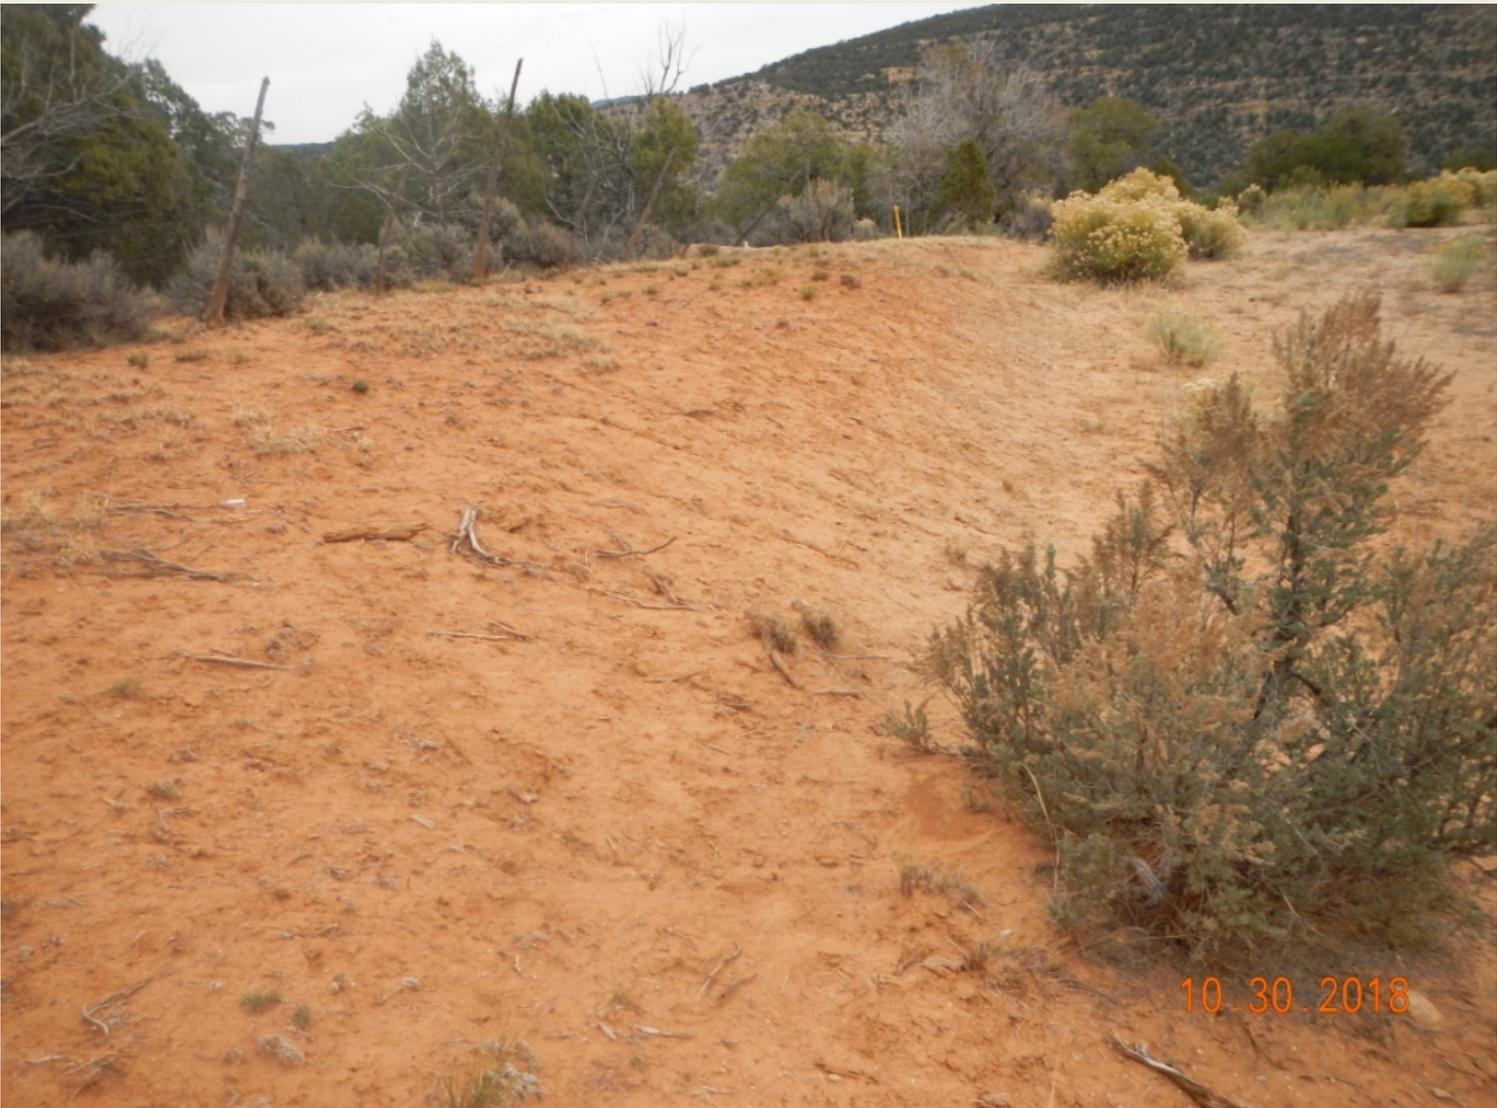
Photo 3. View of the northern project area from the northwestern corner facing eastward.

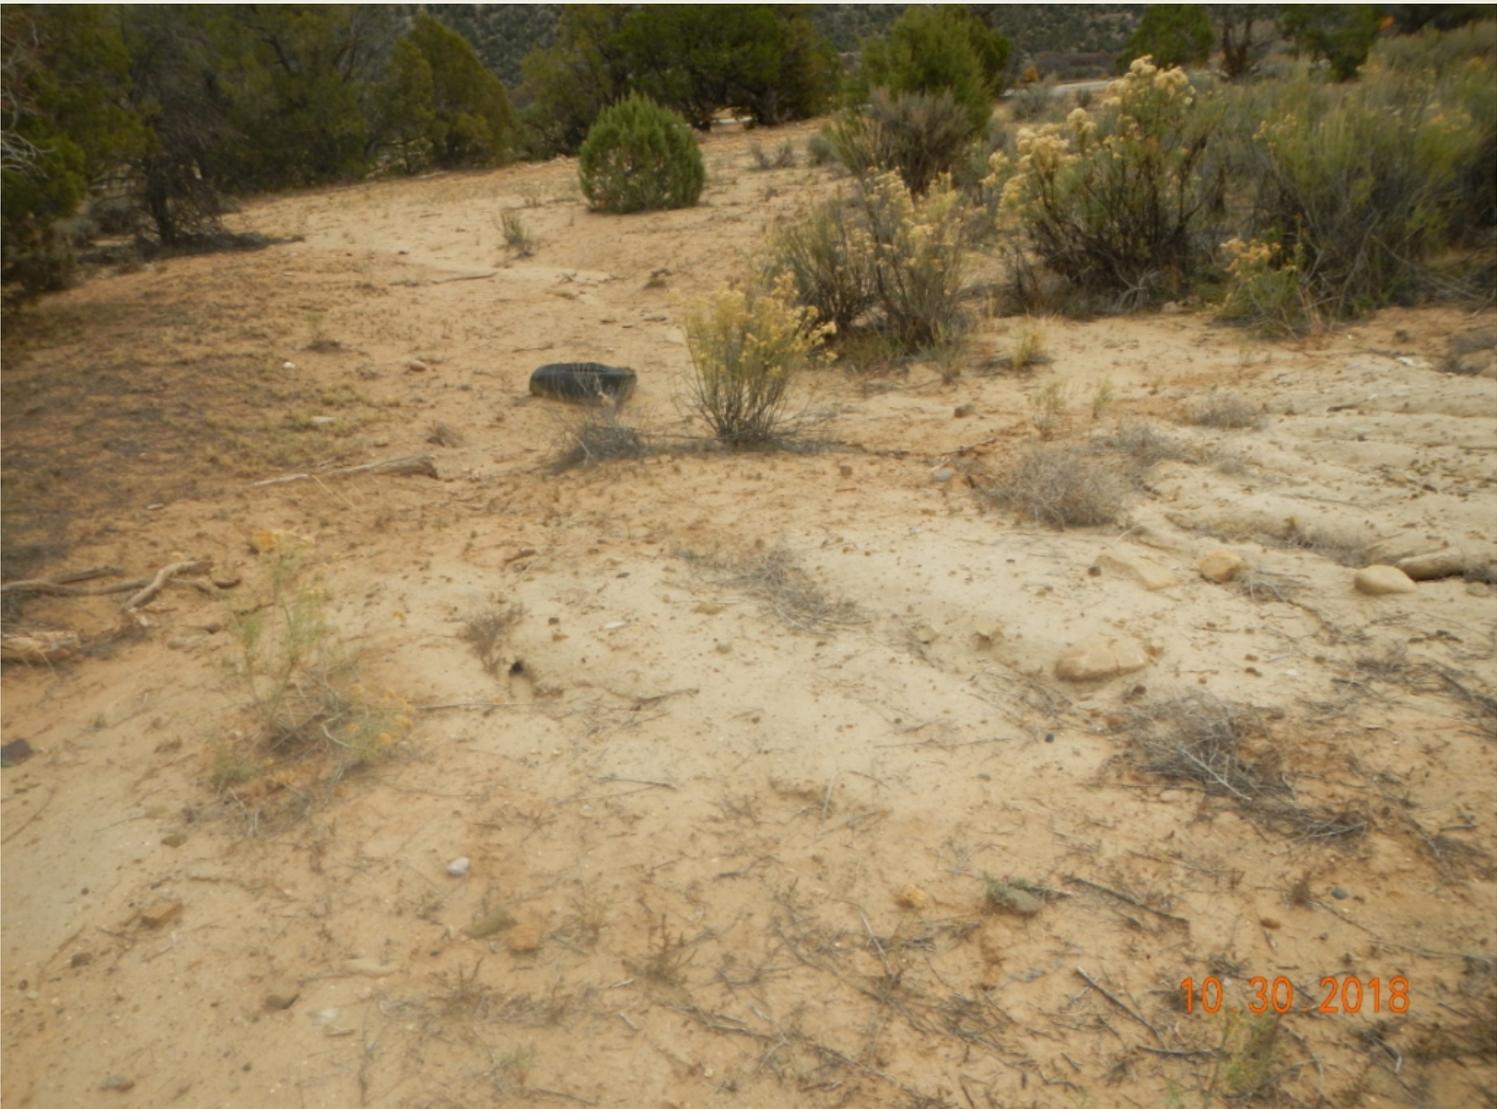
Photo 4. View of erosional channels in the northeastern project area where sediment flows off of the project area.

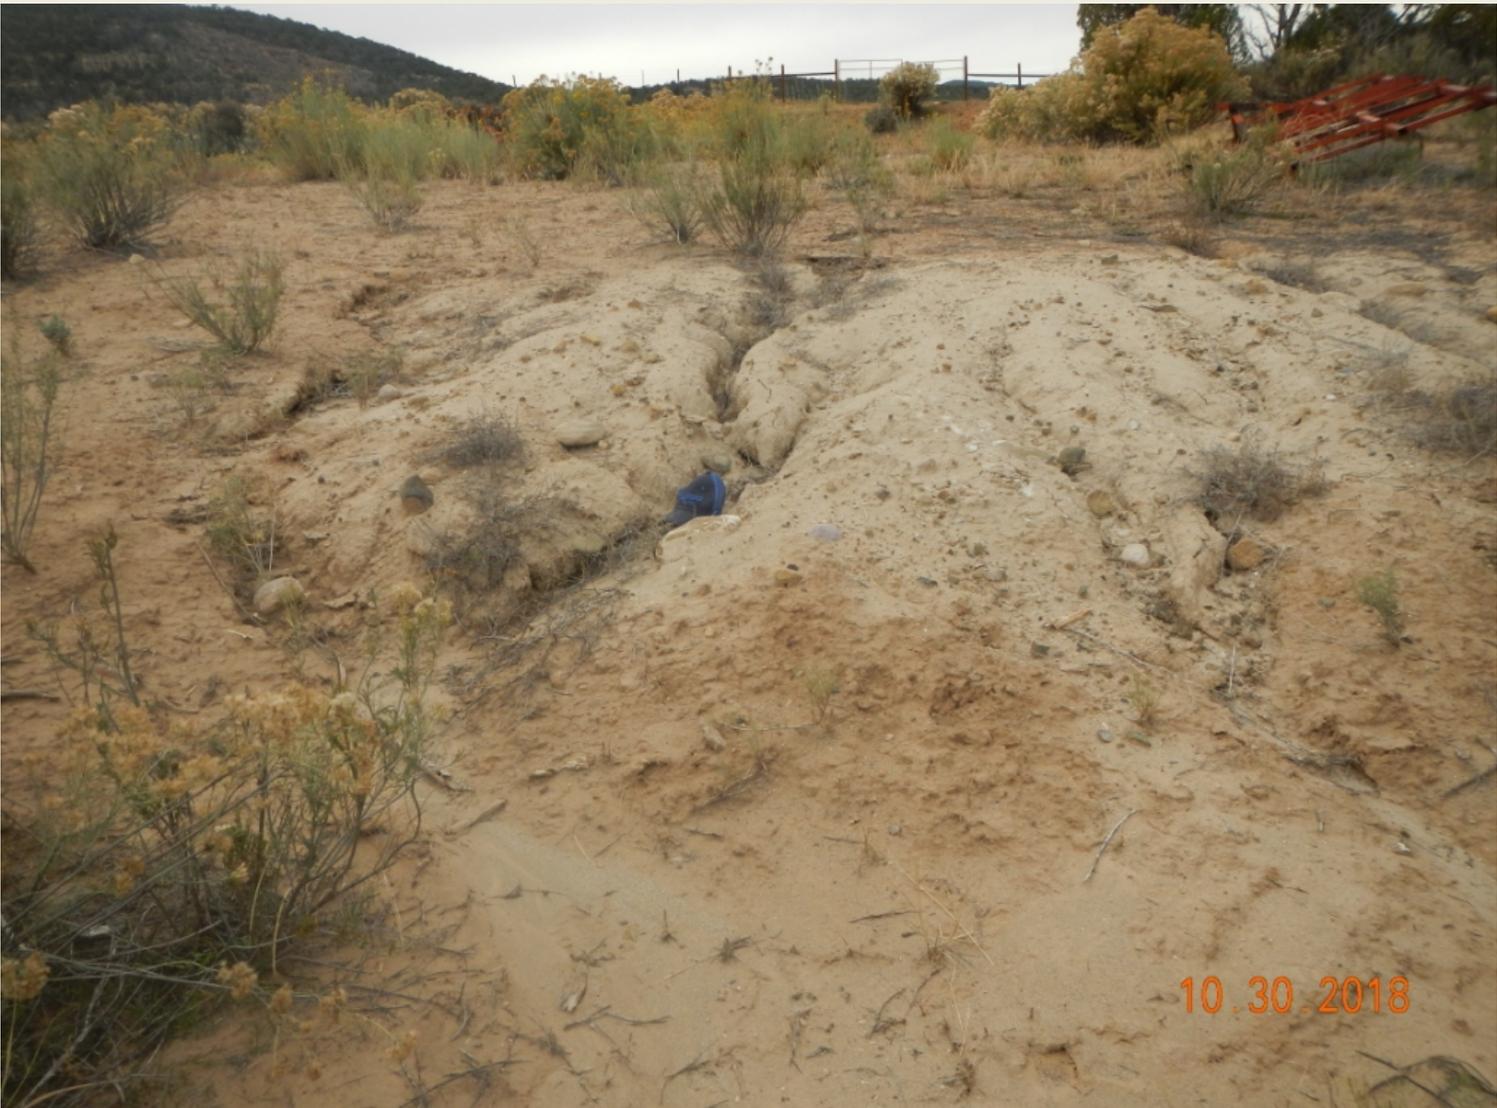
Photo 5. View of erosional channels up to 18 inches wide and deep within the northeastern project area.

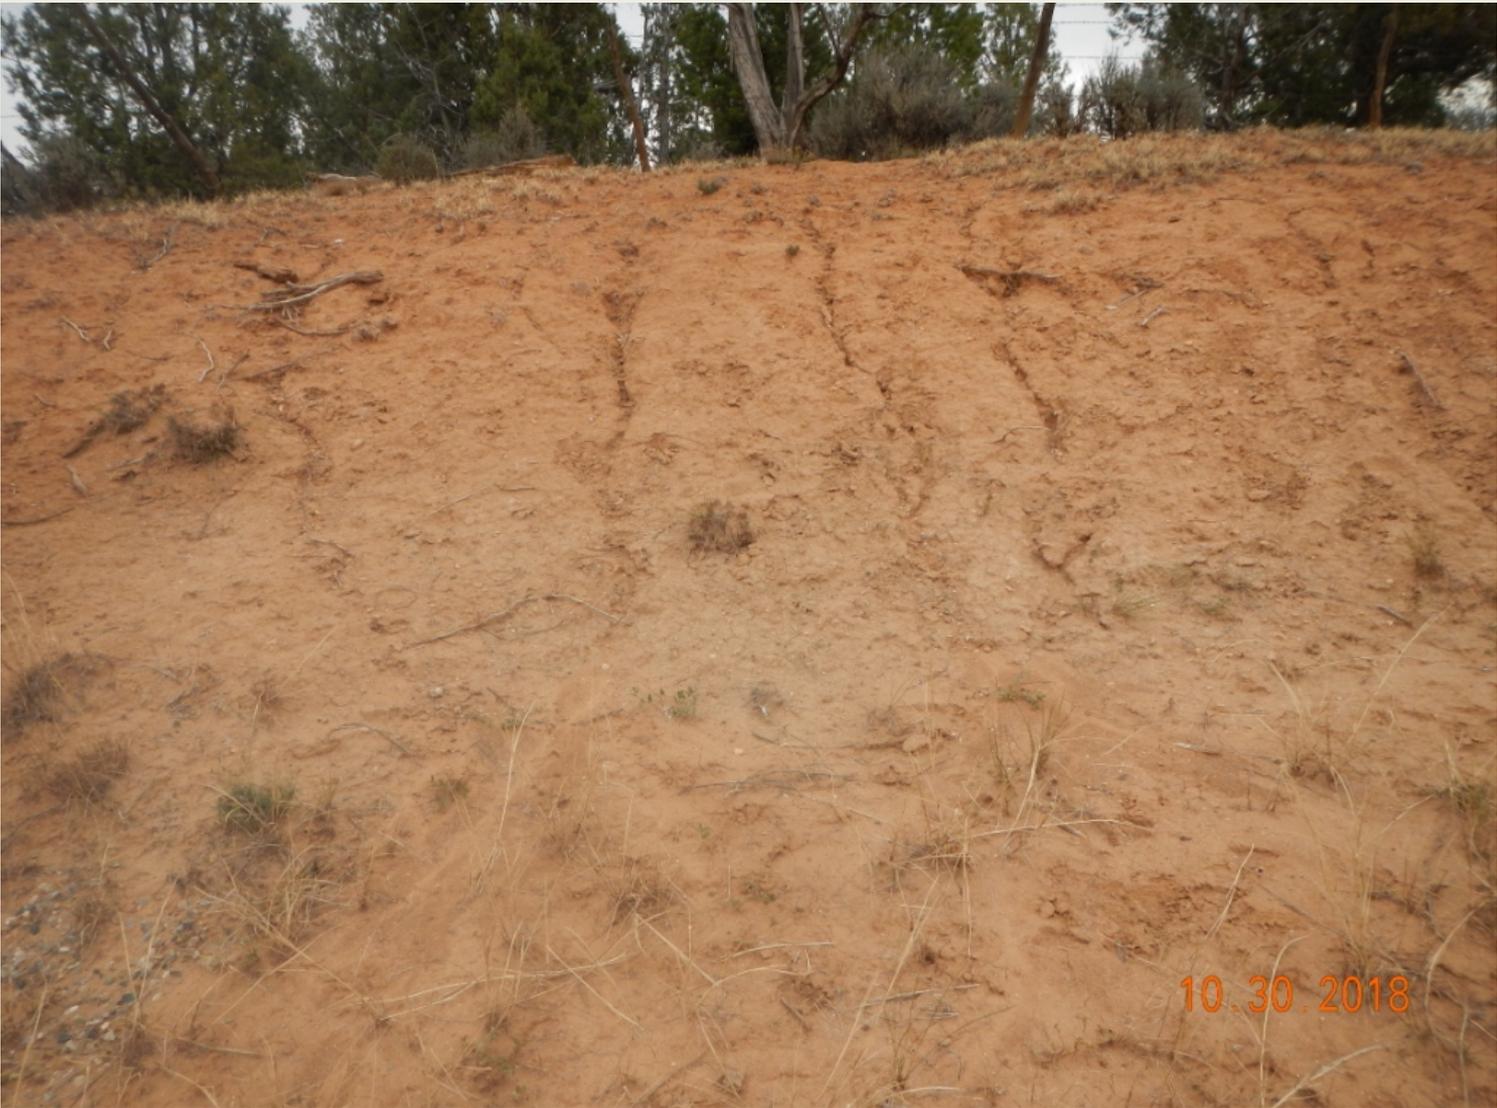
Photo 6. View of rilling within the northern project area.

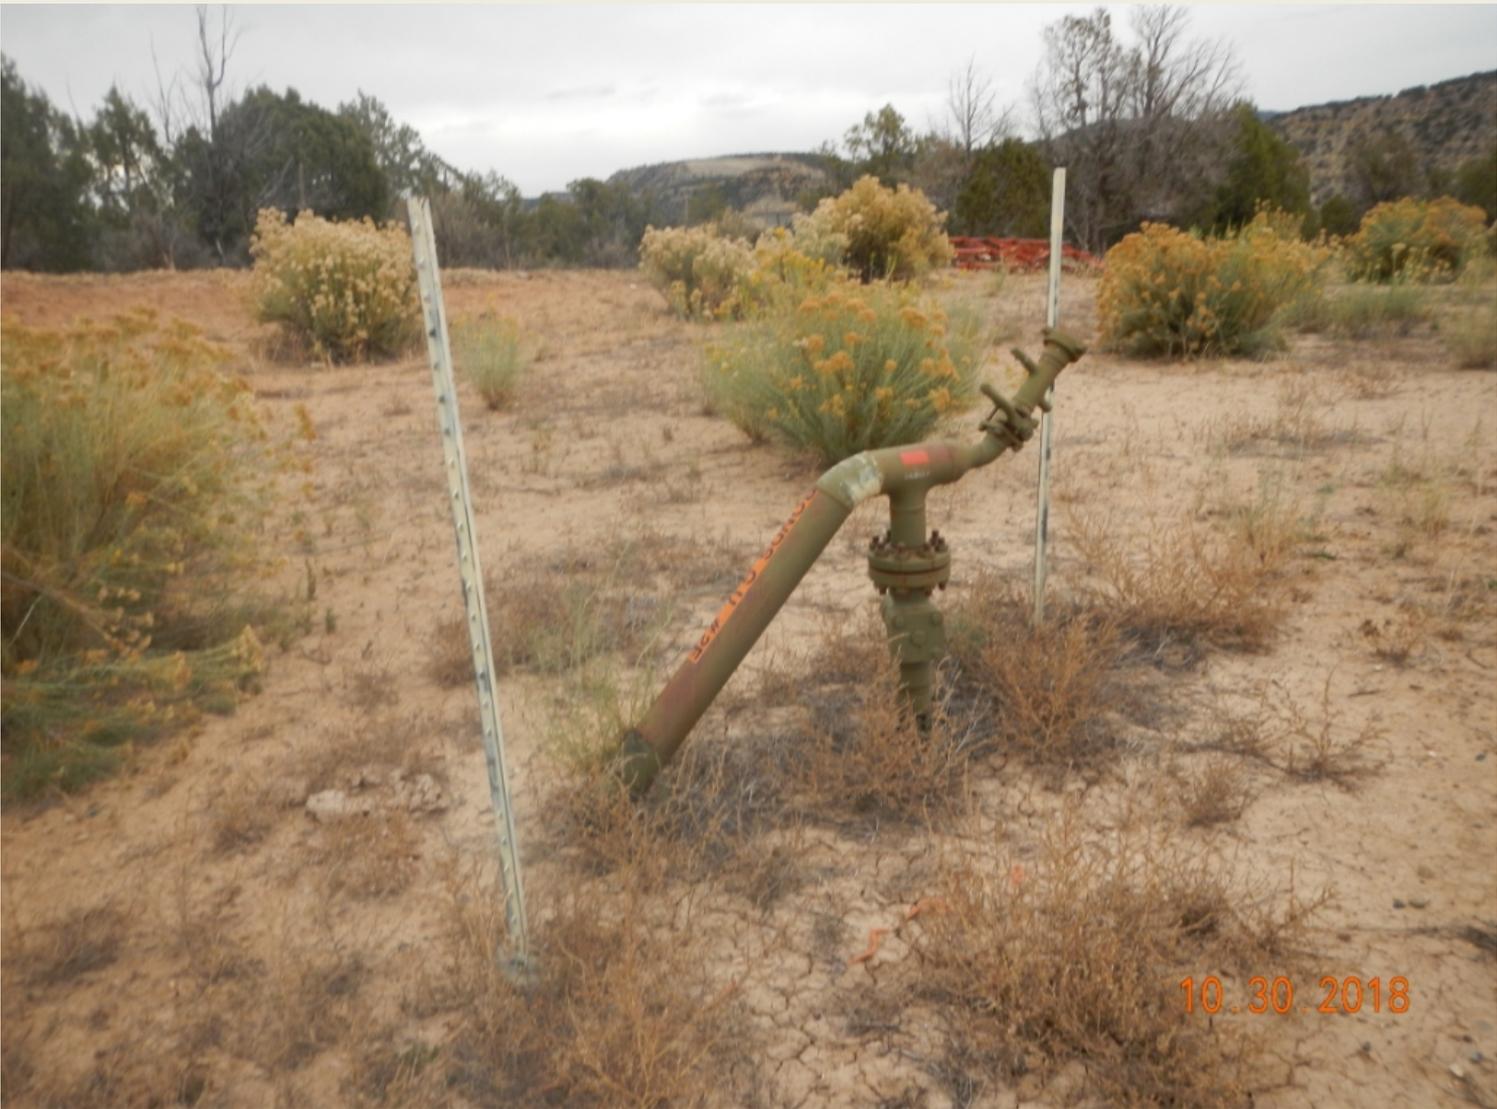
Photo 7. View of riser that remains within the project area.

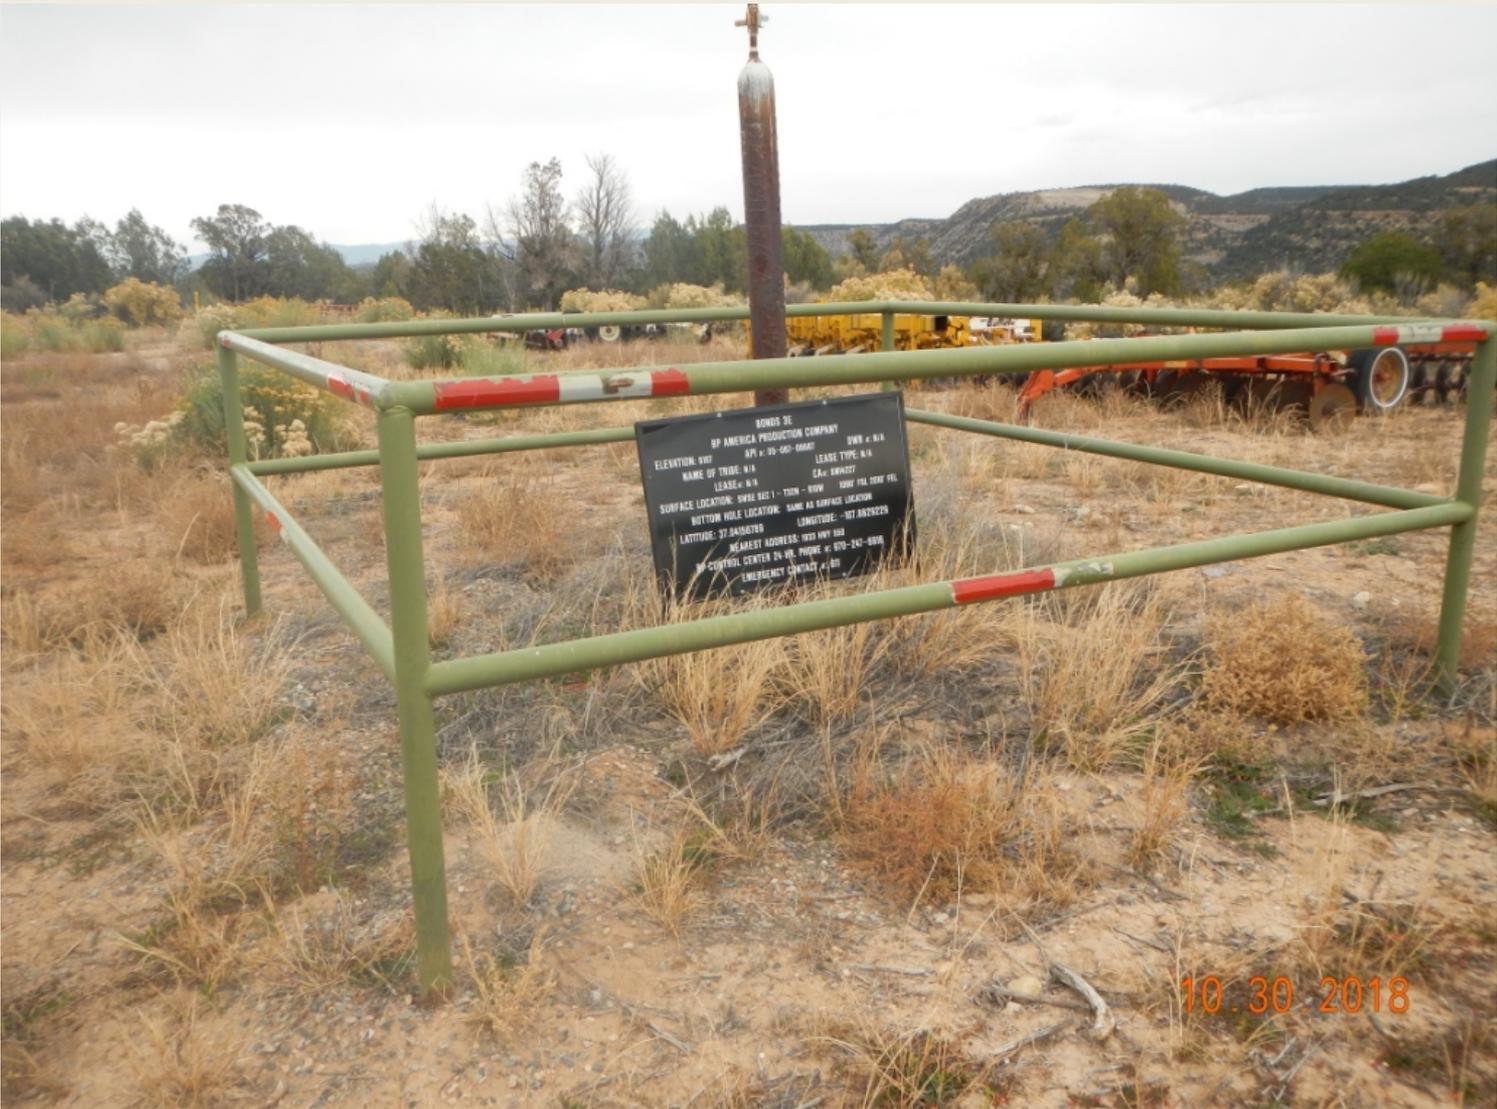
Photo 8. View of dry hole marker, barrier fencing, and signage at the plugged well head.

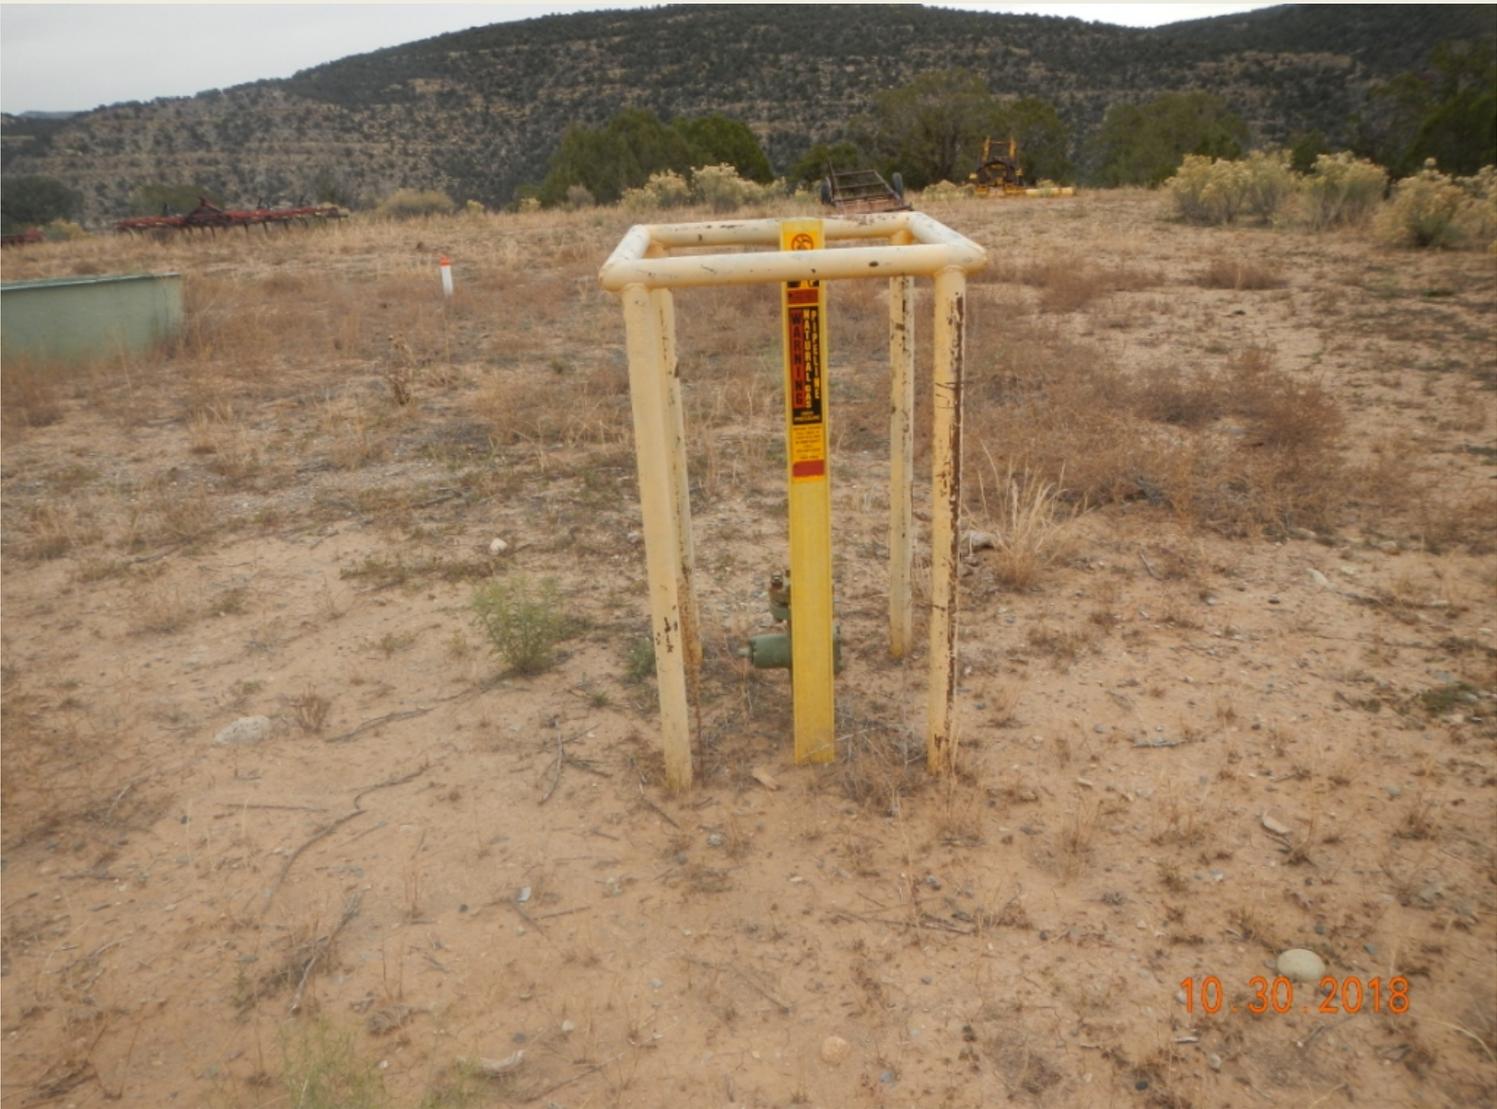
Photo 9. View of another riser that remains within the project area.

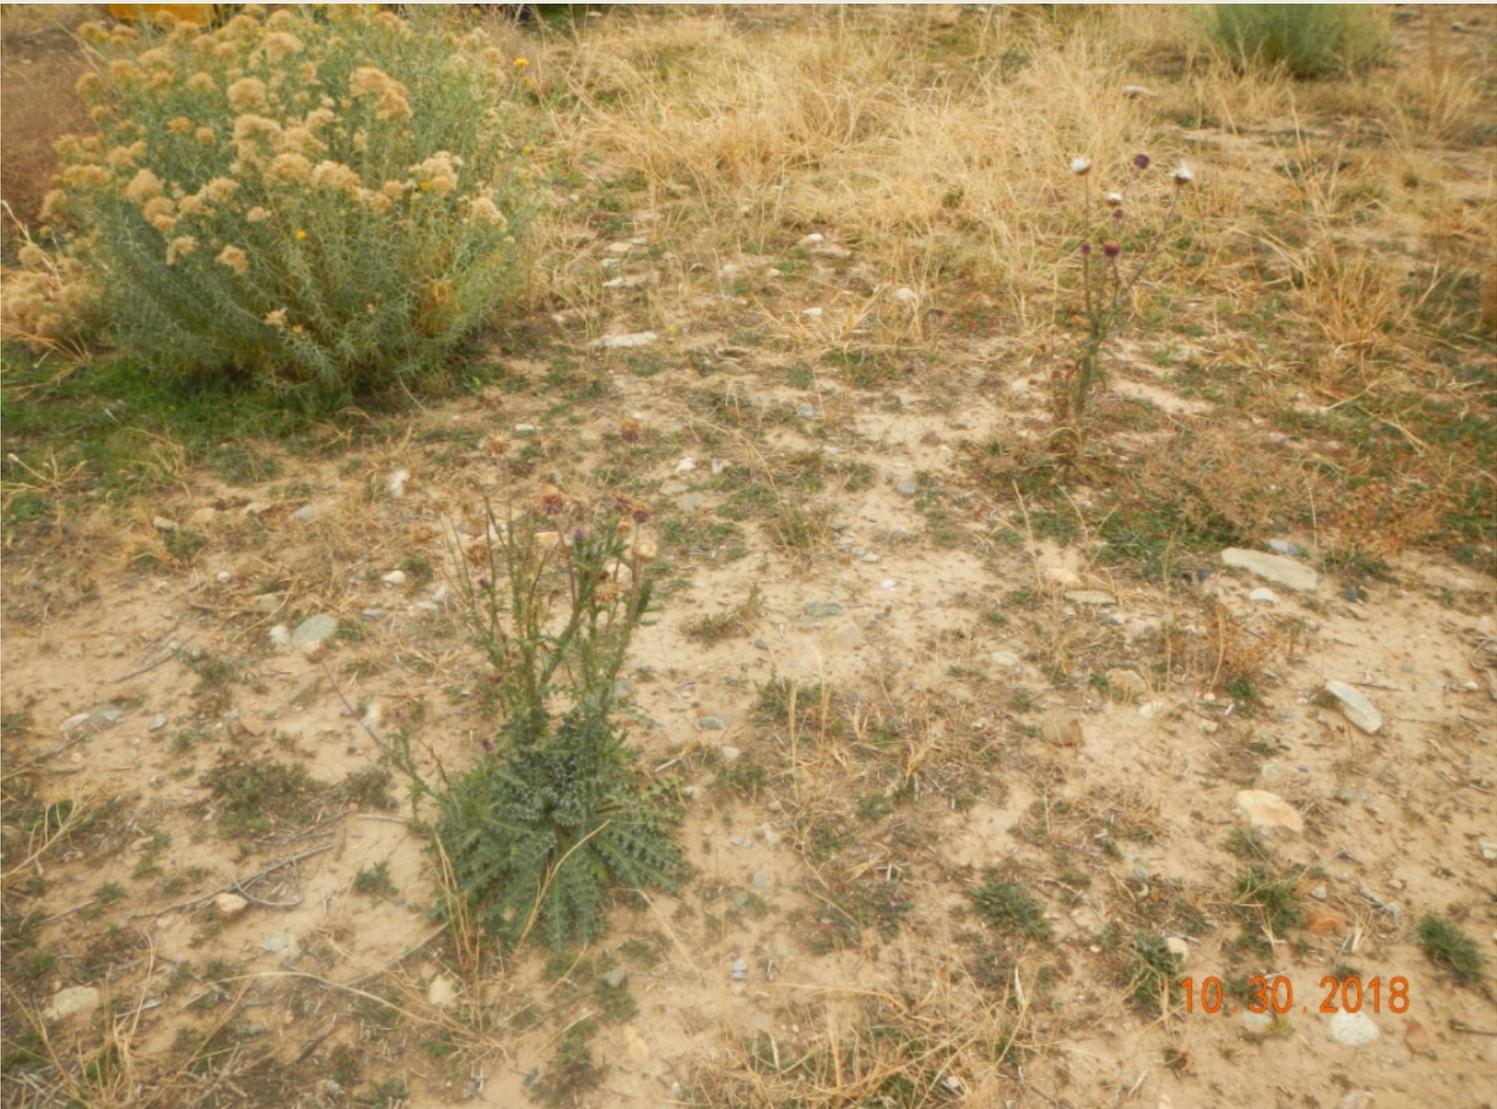
Photo 10. View of musk thistles (*Cirsium arvense*) west of the project area. Approximately 100 observed.

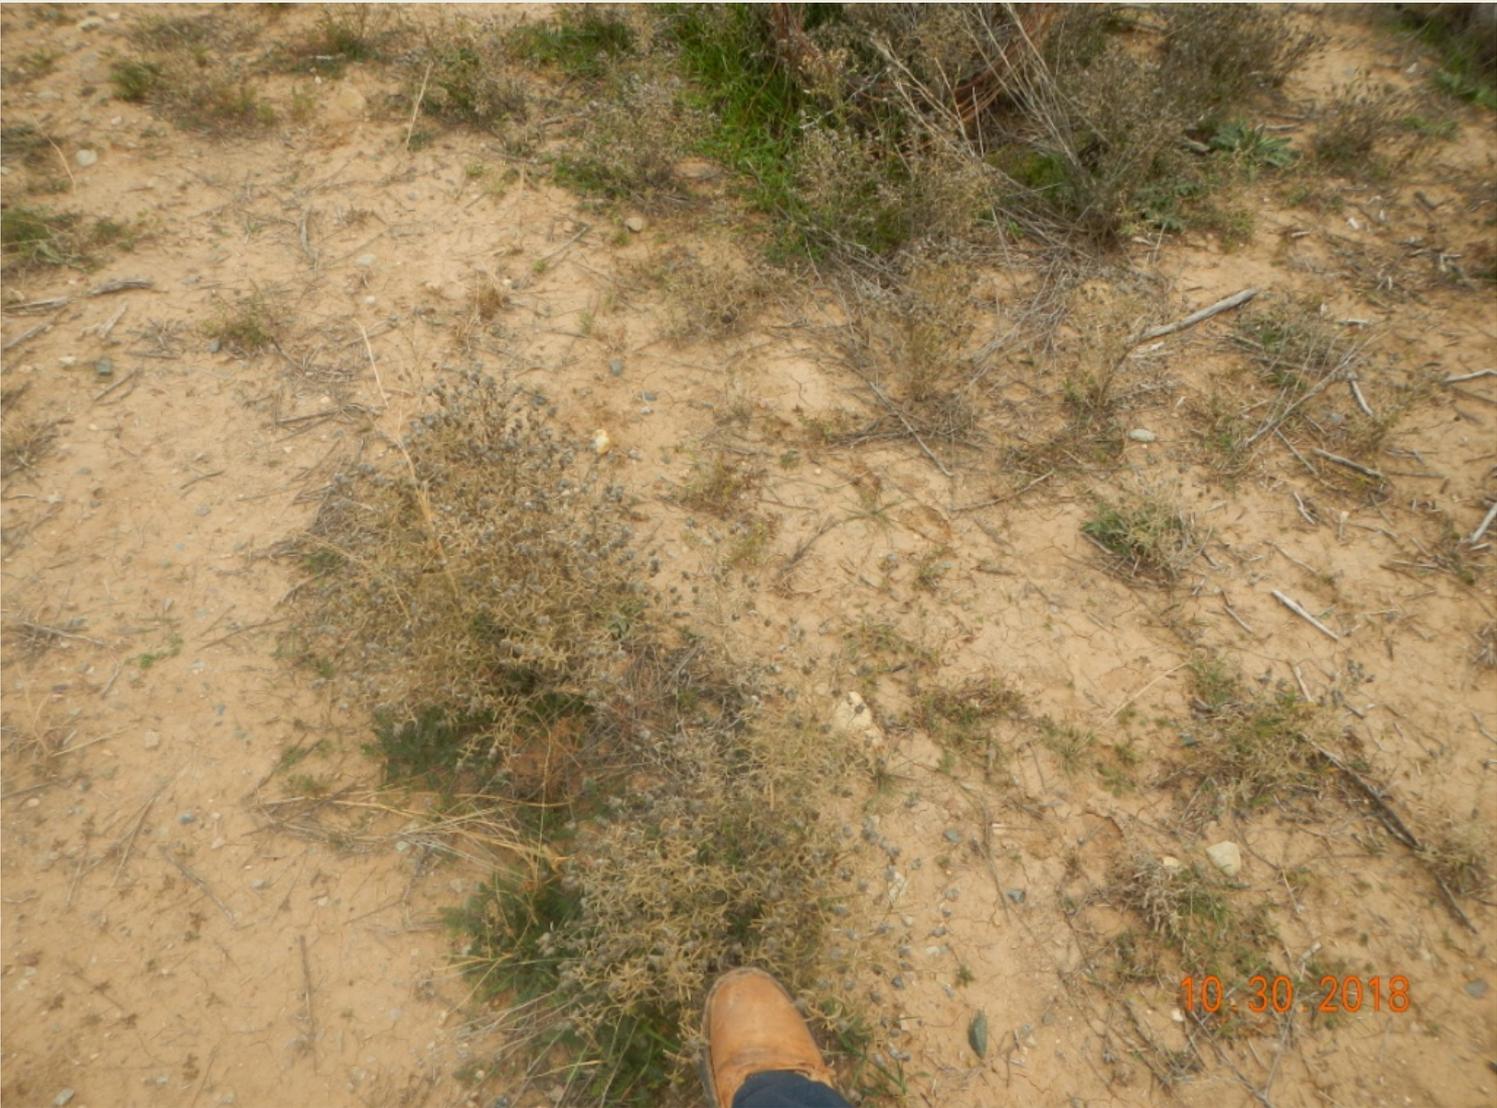
Photo 11. View of Russian knapweeds (*Acroptilon repens*) within the southwestern project area. Approximately 200 individuals observed.
