Inspection Photo
Roles 13-14B
API # 045-10056
Inspection # 689302323

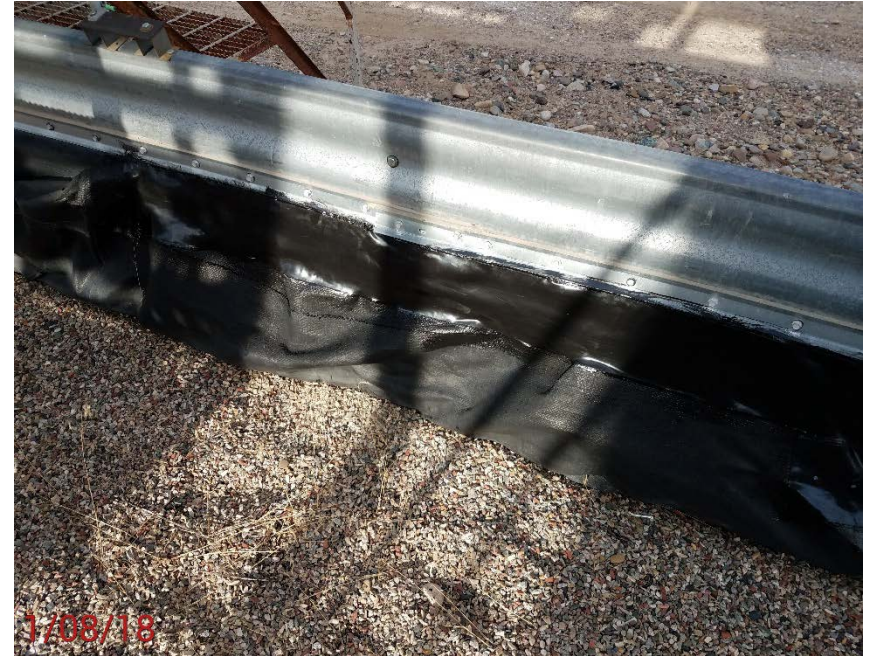
**Location Photo #2, secondary battery
containment repaired.**

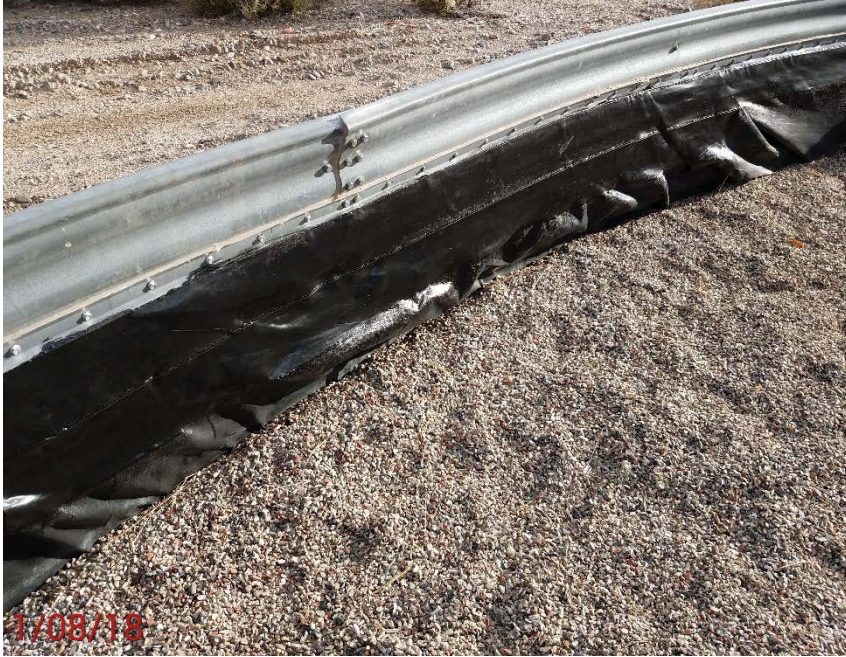
**Location Photo #3, Secondary battery
containment repaired.**
